## **Moisture management in exterior walls: case studies**

**By M.Z. Rousseau**

Highlights of three of the case studies presented by Morrison Hershfield Limited at BSI 2003 are given below. These case studies emphasize the importance of adequate detailing at junctions between walls and penetrating elements such as balconies, windows and doors.

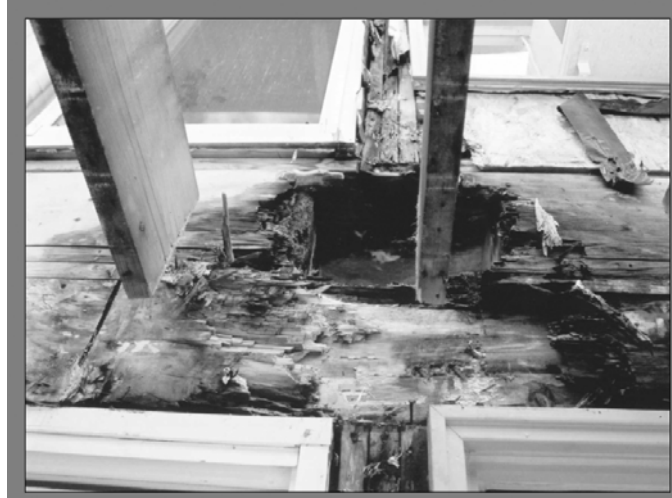
When the envelope specialists removed the siding during their assessment of the repair work needed, they observed that the wood-based sheathing board, and in places the stud cavity materials, exhibited severe deterioration resulting in a major loss of structural capacity (Figure 1).

Figure 1. Damage to the wall elements adjacent to a balcony joist/wall connection

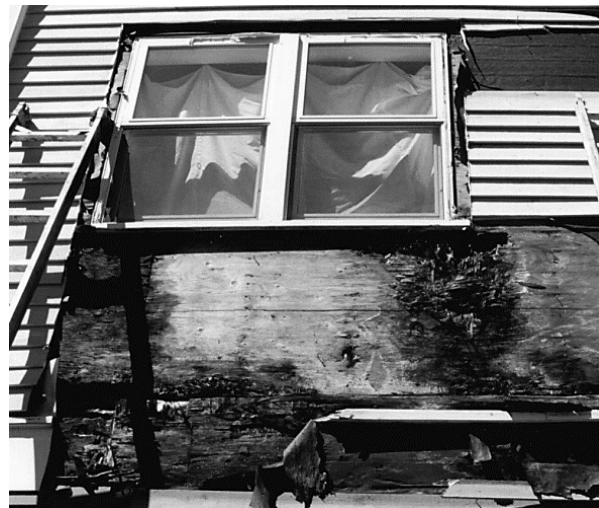
In certain cases, damage to wood materials adjacent to windows and doors (head and beneath sills) provided a clear trail of the water leakage and the location of its excessive accumulation (Figure 2).

Figure 2. Pattern of damage to the sheathing board underneath the windows (Project B)

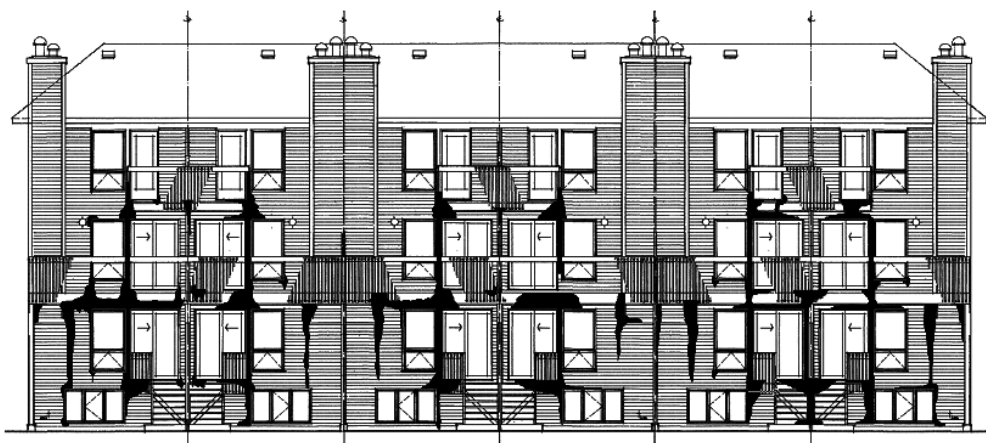
Lack of continuity of the second line of defence (i.e. the sheathing membrane – also called the water-resistive membrane – and the flashings) at the balcony level and at openings had allowed water infiltration on the interior side of the membrane, resulting in repetitive and excessive wetting of the moisture-sensitive materials of the walls. A portion of the water running down the face of the wood-based sheathing board was absorbed and remained there long enough to initiate rot. The spatial distribution of the damage on this element demonstrated clearly the water leakage path from floor to floor (Figure 3).

Figure 3. Pattern of distribution of the damage to the exterior sheathing board (Project A)

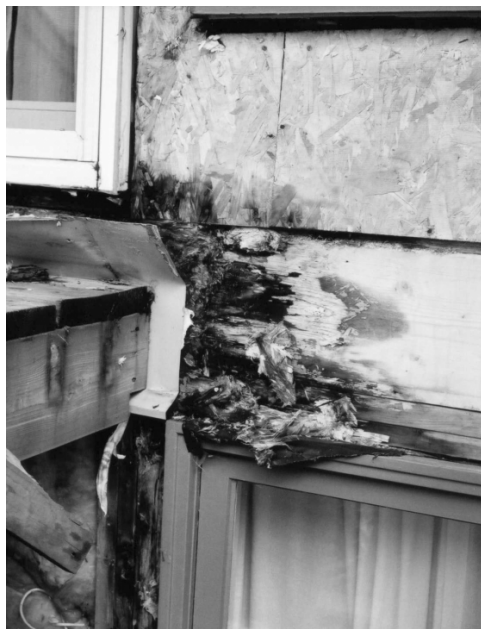
Figure 4. Flashing is in place, but is crushed between the wall and the ledger board, resulting in little potential for water drainage on its face (Project A)

- Ensure continuity of the second line of defence against water infiltration at the balcony level. This may be easier to accomplish when the balcony joists are fastened to the wall, as opposed to cantilevered joists penetrating all the way through the wall. This decision affects the sequence of construction, and needs to be acknowledged early on in the planning of the construction.
- Provide a clear path for water drainage at the face of the sheathing membrane, using a clear air space and properly lapped flashings (so that the situation in Figure 4 is avoided).

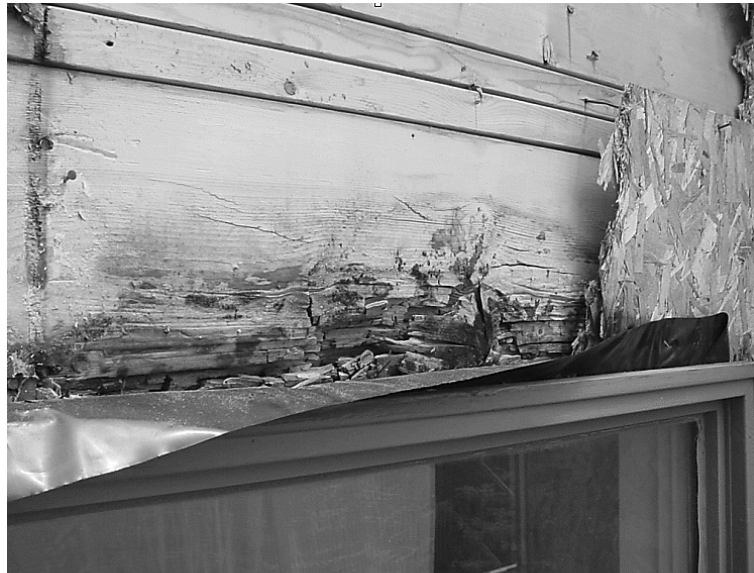
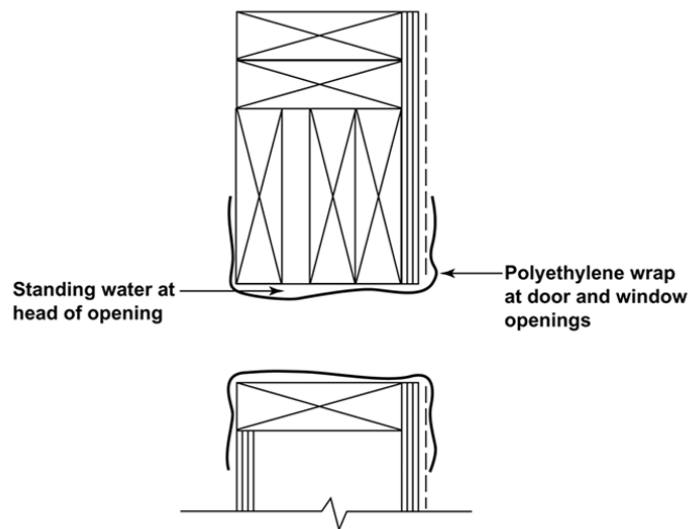
- The framing and flooring of the balcony were completed before the sheathing membrane was installed. With this construction sequence, continuity of the sheathing membrane vis-à-vis the balcony floor was hardly possible due to lack of accessibility.
- Again at the balcony level, no flashing or effective drainage plane was in place to direct the water that reached the outside face of the sheathing membrane back to the outside. In one case a metal flashing was in place but it was crushed against the wall by the ledger board (Figure 4), eliminating the possibility for a free path for water evacuation at this strategic location.
- The sheathing membrane and the flashing found at the wall/window junctions were installed in a reverse lap fashion, promoting the entrapment of water on the interior side of the sheathing membrane (Figure 5).

Figure 5. Example of reverse lap between membranes at the window head (Projects A et C)

- Ensure that membranes and flashing are installed in a shingle-like fashion to avoid water entrapment inwards of the sheathing membrane.
- Install a drip cap flashing at the window head, projecting laterally to protect the opening from excessive moisture loading, and with end dams to avoid redistribution of the water loads to the side of the opening.
- Avoid extending a waterproof membrane to the underside of the head of a rough opening. This will reduce risks of creating a pocket for water entrapment as seen in Figure 5 (for example, during weather exposure during construction work).
- Install a pan flashing over the rough sill of doors and windows. It is intended to collect any accidental water leakage and evacuate it back to the outside (with proper lapping).
- Install eavestroughs and downspouts on sloped roofs to reduce the water loading on the balcony decks.
