HVOF coating case study for power plant process control ball valve application

310b753908
HVOF Coating Case Study for Power Plant
Process Control Ball Valve Application

Velan, Montreal, Quebec, Canada

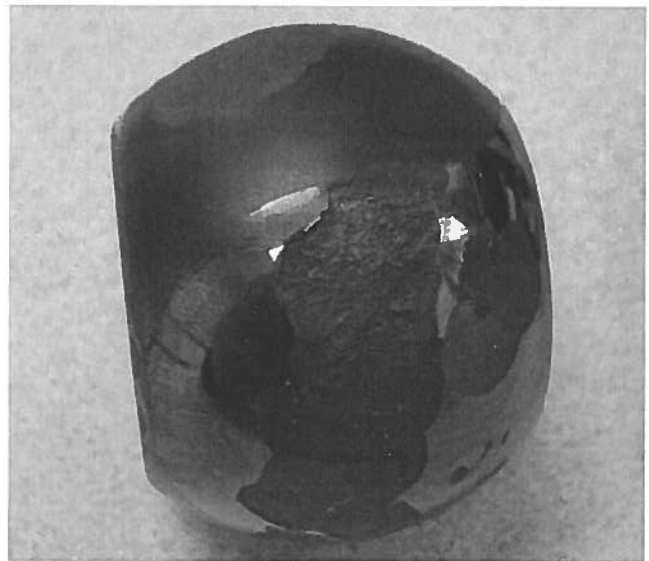
HVOF Cr_3C_2 -NiCr coating has failed after 1 year and less than 500 mechanical cycles in service on four balls exposed to supercritical steam, with deterioration extending to regions where there is no friction between ball and seats. Visual examination of damage components reveals minor frictional wear and typical stress/fatigue pattern (*Figure 1*).

Figure 1: HVOF Cr_3C_2 -NiCr coating exhibiting cohesive failure after 1 year in service.

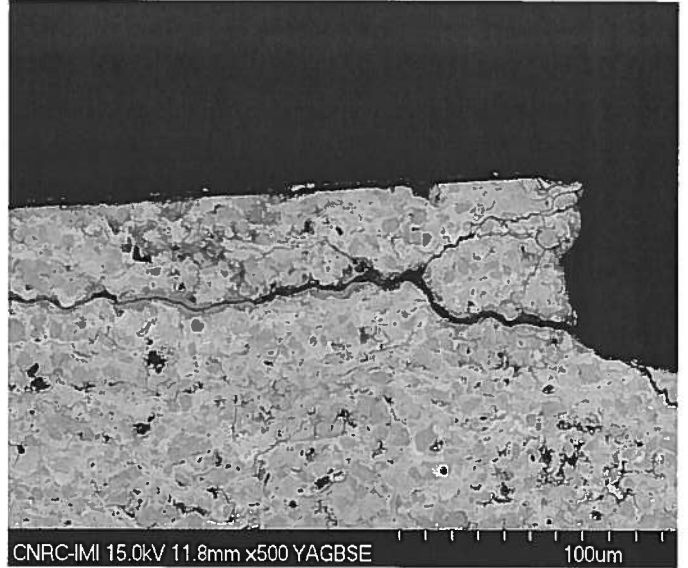
Figure 2: HVOF 80% Cr₃C₂ + 20% [80Ni-20Cr] coating, sprayed with C₃H₆ after 1 year in the field

The interface between coating/substrate was qualitatively inspected. Residual grit was regularly observed at the bond. Cracks formed in the coatings did not appear to originate at the coating/substrate interface nor due to excess porosity or grit. SEM observations unveil that cracks were propagating across the NiCr binder. SEM also shows the presence of oxides at the coating surface, at the surface of cracks, and as veins propagating in the coating (appears in dark gray on backscattered electron images – See *Figure 2*).

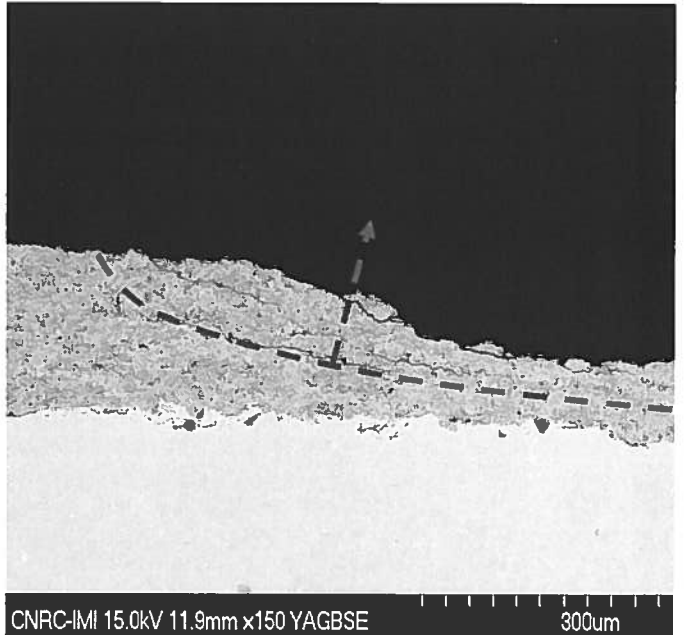
Figure 3: HVOF 80% Cr₃C₂ + 20% [80Ni-20Cr] coating, sprayed with C₃H₆ after 1 year in the field

However, it's difficult to determine if cracks propagate along oxides or if the crack surfaces oxidize afterward. Cracks form and propagate across the coating matrix or at the carbide/matrix interface, delaminating layer by layer the coating (See Figure 3).

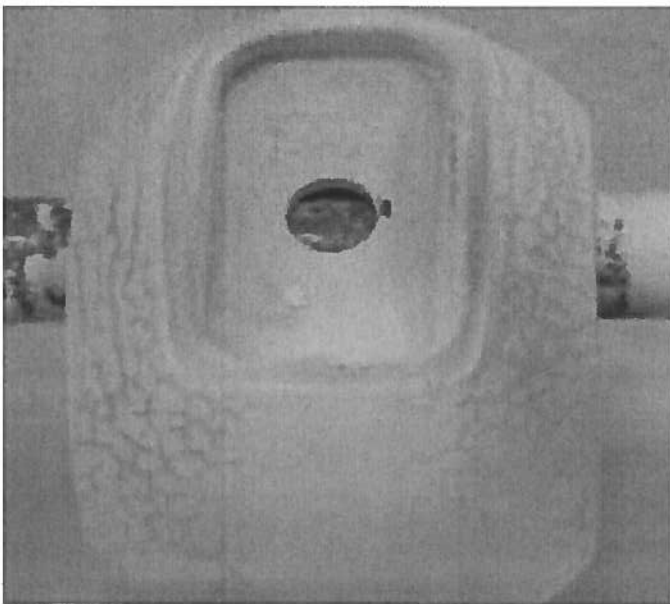
For the thermal stress resistance, new coated balls were brought to 675°C (1247°F) during 30 min using a conventional electrical furnace. Balls were then quenched into a bucket of room temperature water (20°C – 68°F). After 30 consecutive similar thermal shocks going from 675°C to ambient temperatures, HVOF Cr₃C₂-NiCr exhibits a crack network relatively similar to the one observed on the failed valves (See Figure 4).

Figure 4: HVOF 80% Cr₃C₂ + 20% [80Ni-20Cr] coating, sprayed with C₃H₆, after 30 thermal shocks going from ambient temperatures to 675°C.

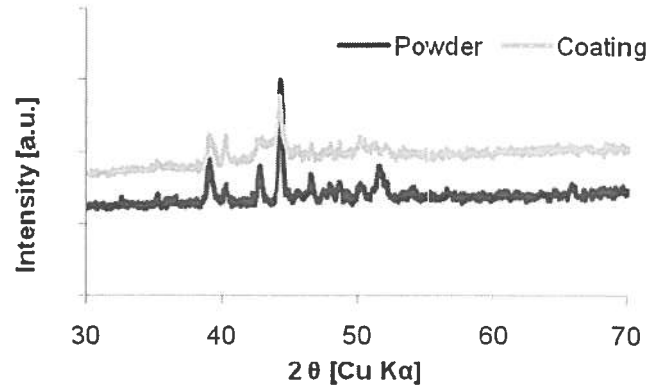
Figure 5: XRD spectra of HVOF 80% Cr₃C₂ + 20% [80Ni-20Cr] powder and coating, sprayed with C₃H₆.

The crystallinity index reduces by more than 35% after coating deposition, indicating significant crystalline phase dissolution during spraying.

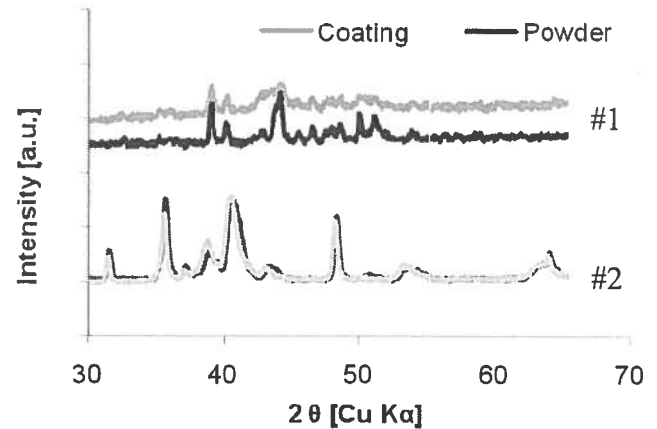
While coating #1 displays similar degradation level than the original coating, coating #2 crystallinity index remains much higher, indicating less amorphisation (See *Figure 7*). However, for coating #2, a partial phase transformation (WC → W₂C) was observed on the XRD spectra after deposition. Therefore, amorphisation is not the only degradation mechanism for this composition material.

Figure 7: XRD spectrums of HVOF material #1 and #2; powder and “as sprayed” coating.
