**FAILURE MECHANISM AND DAMAGE CHARACTERIZATION IN  
AXIALLY CRUSHED AlMg3.5Mn ALUMINIUM TUBES**

H. R. Shakeri and A. Rahem  
*Aluminium Technology Centre, NRC  
501 Université Boulevard East  
Chicoutimi, Quebec, Canada G7H 8C3  
[hamid.shakeri@cnrc-nrc.gc.ca](mailto:hamid.shakeri@cnrc-nrc.gc.ca)*

M.J. Worswick  
*Department of Mechanical Engineering  
University of Waterloo  
Waterloo, Ontario, Canada N2L 3G1*

R. Mayer  
*Vehicle Development Research Lab, GM R&D Center.  
30500 Mount Road, P.O. Box 9055  
Warren, MI, U.S.A. 48090-9055*

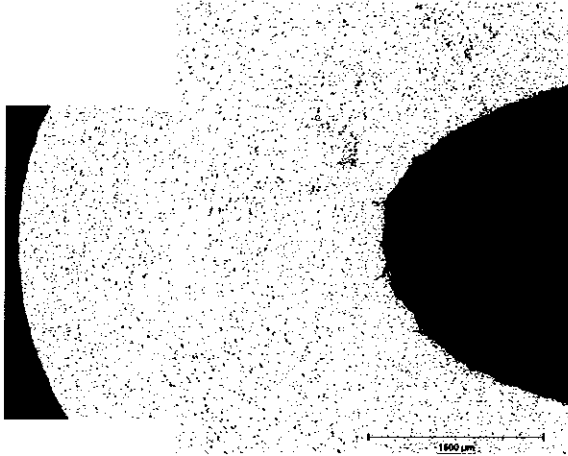
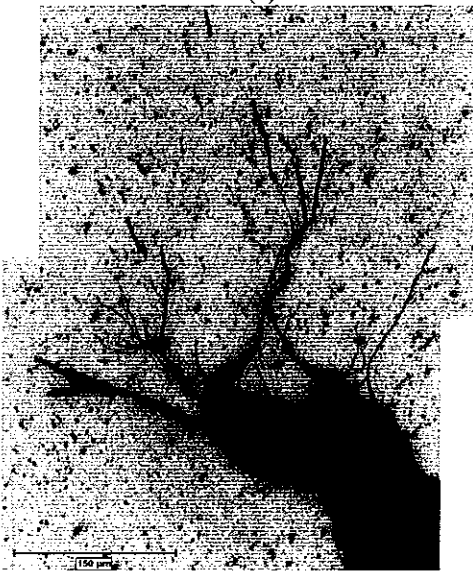
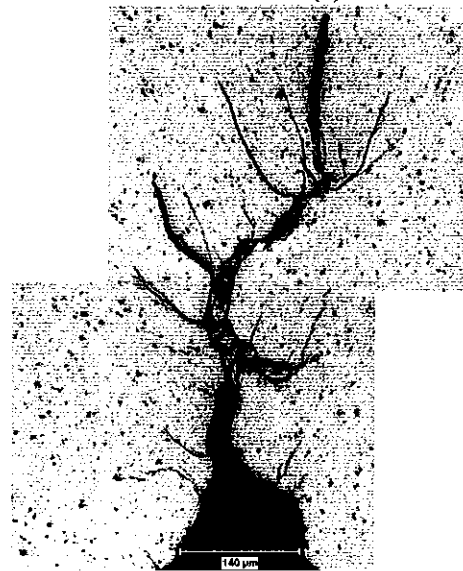
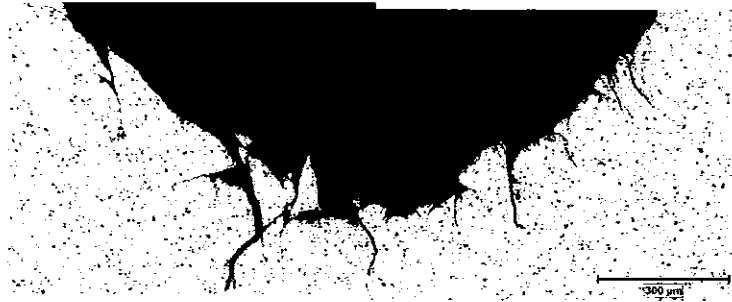
During the examination of the 2mm as well as 3.5 mm round tubes, similar common features were observed. Figure 7, illustrates some of these common features. One of these common features is concentration of the damage at the inner side of the folded segments in form of squeezed out with fishtail morphology. In addition, branched and blunt cracks that were detected in all specimens. Also the outer part of the folded segments (deformed in tension) hardly shows any significant sign of damage unless there are additional constraints imposed by an impact from one or more neighbouring segments, while the inner segments that are in compression consistently exhibit tremendous amount of materials flow toward the centre of the bend and as a result at the inner edges numerous cracks are observable that produces fish-tail or tooth-like sub-segments. Loss of inner bend symmetry as a result of interaction with neighbouring segment is another common feature in these specimens. It should be noted that in cases such as the one shown in Figure 7 c, d and e, the direction of crack growth and materials flow are against each other. In another word, as the cracks moves toward the centre of the thickness it enters the material that is both less compressed and less strain-hardened.

Figure 7 – Some of the segments with typical features that were frequently observed, (a) 2 mm thick specimen S-39 section “Ct” #4, (b) 3.5 mm thick specimen S-45 Section “B” #1., (c) 2 mm thick specimen S-32 section “A” #15, (d) 3.5 mm thick specimen S-43 section “D” #3, and (e) 3.5 mm specimen S-43 section “A” #3.

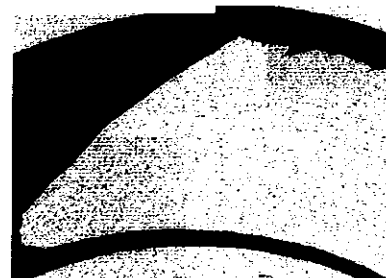
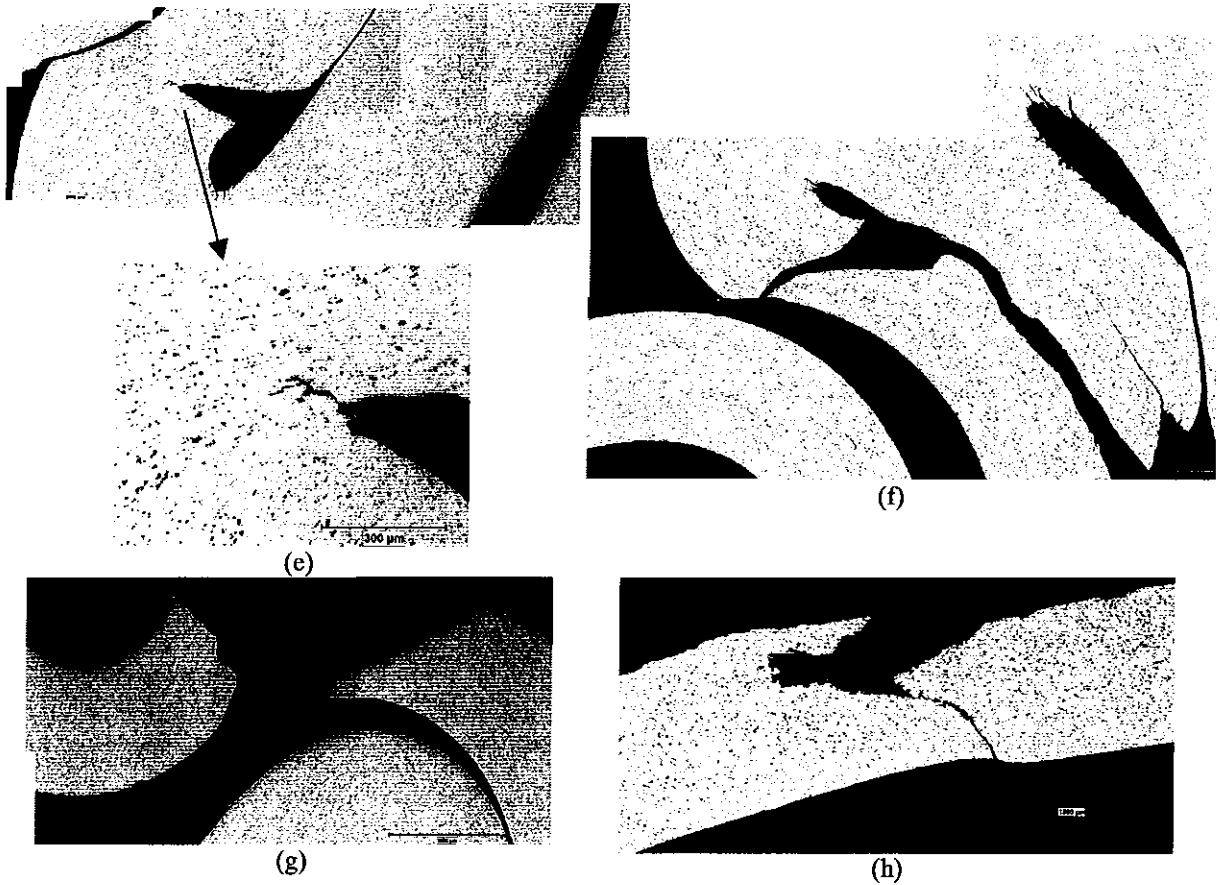
Figure 8 shows a series of mostly composite images of the fractured segments in 2 mm thick axially crushed tubes. Some of the segments shown in the figure clearly exhibit characteristics of a segment failed under shear. For instance, the cases shown in Figures 8a, c, and d are clearly clear cases of shear type of failure. In Figures 8b, e, f and g some of the characteristics of a case of fracture under shear are present but the clear necking in 8b, mismatch of the two parts of the failed segment in 8e, f and g could be result of other loading modes or at least a mixed mode of failure. Segment shown in Figure 8h does not exhibit characteristics of a segment fractured under shear. In most of the cases shown in Figure 8 it is clear that an impact from a neighbouring segment contribute to the fracture. In Figure 8c the direction of the impact is shown by an arrow and the shearing forces are also shown by the arrows near the failed segment, which has failed as a result of constraint imposed by the nearby folded segment as well as the impact from the adjacent segment. The insert included in Figure 8e is the higher magnification of the area pointed by the arrow that shows the tip of the fracture region. This suggests a rough rather than smooth surface as a result of zigzag fracture direction.

Figure 8 – Fractured segments in 2mm thick specimens, (a) S-30 section A # 4, (b) S-39 section B #10, (c) S-30 section A #16, (d) S-32 section Ct #5, (e) S-30 section D #18, (f) S-39 section A #4, 4a, 5 and 6, (g) S-39 section B #3, and (h) S-39 section Ct #5.

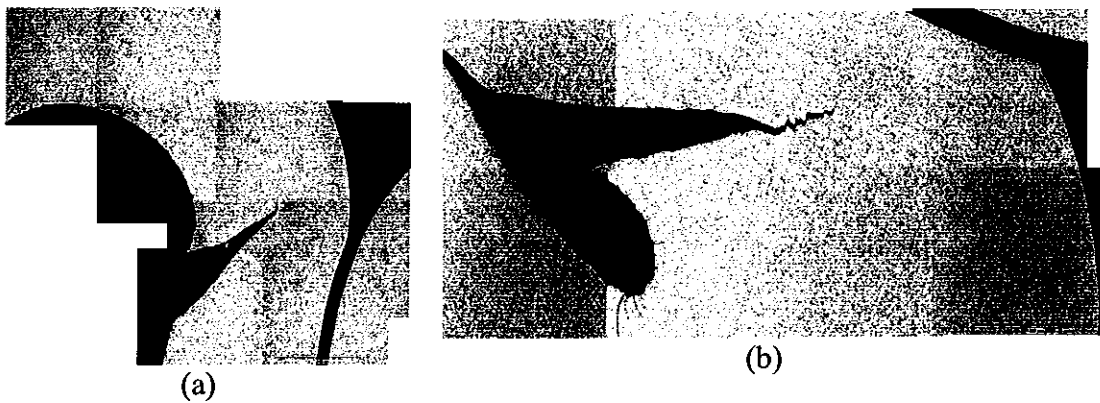
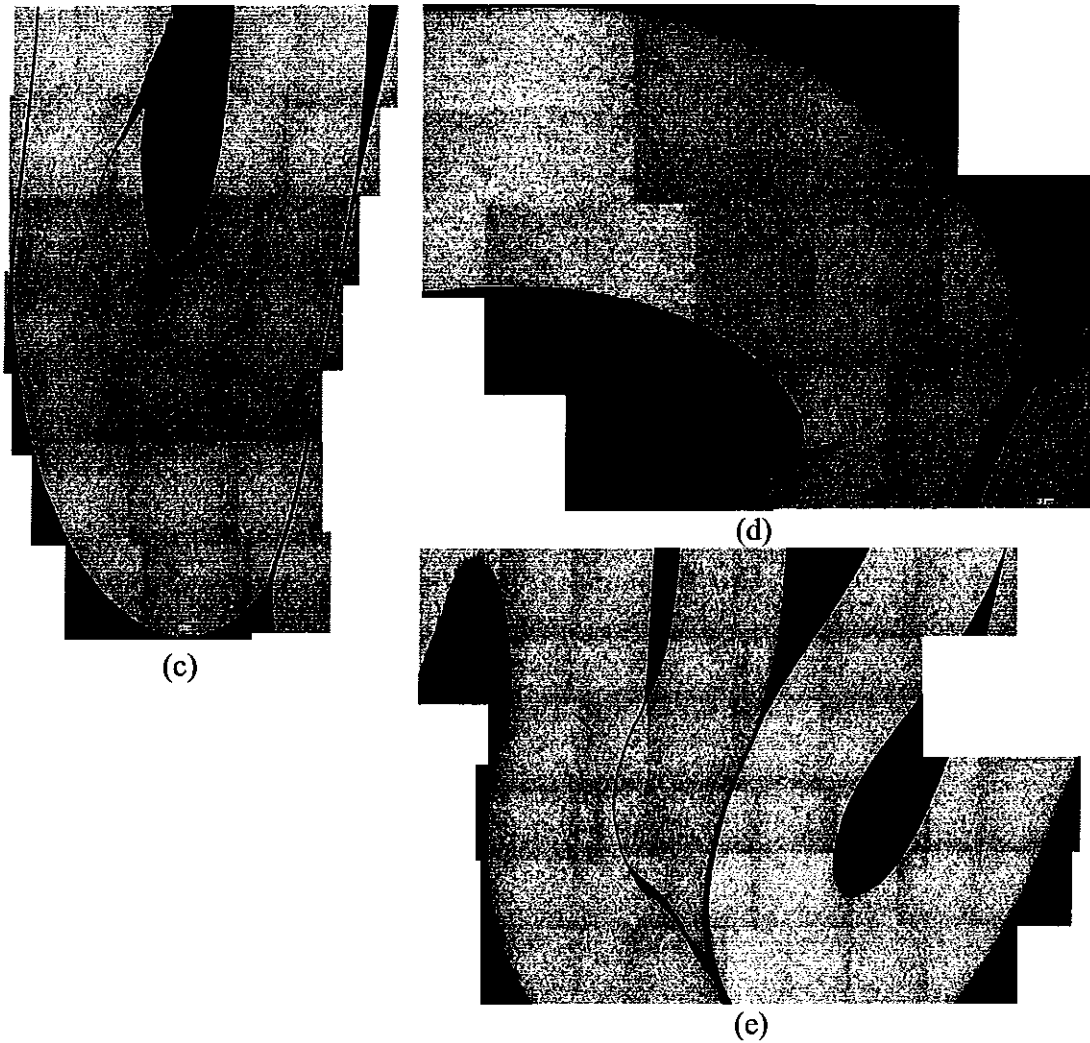
Similarly, Figure 9 is a series of composite images of some of the fractured segments in 3.5 mm thick tubes. In general, the fractured segments are very similar to those in 2 mm thick tubes. Once again the role of impact from the adjacent segments is evident. In most cases, fractured segments show the characteristics of a shear type of failure. In cases like the one shown in Figure 9b, due to the mismatch between the two side of the failed segments, fracture through a purely shear mechanism is unlikely. This observation is also supported by the zigzag morphology at the tip of the fractured regions in Figures 9b and d, similar to the one in Figure 8e, which are shown in a higher

Figure 9 – Fractured segments in 3.5 mm thick tubes, (a) S-28 section B #7, (b) S-28 section B #3, (c) S-43 section E #8 & 9, (d) S-45 section A1 #3 & 2, and (e) S-45 section A #3, 5 & 6

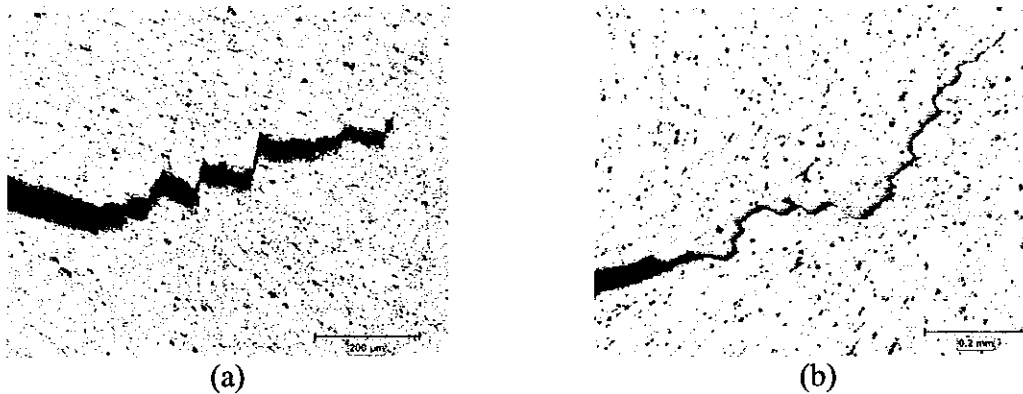
magnification in Figure 10. This might suggest that after partial fracture through shear mechanism, local loading condition at the tip of the fractured region changes due perhaps to consequential folding of the tube during the axial crushing.

Figure 10 – Tip of the fractured region in segments shown in (a) Figure 9b and (b) Figure 9d.

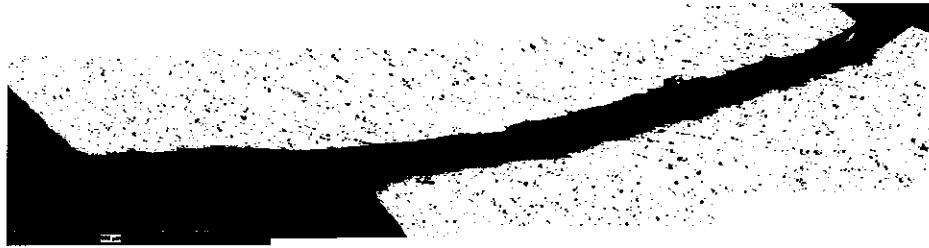
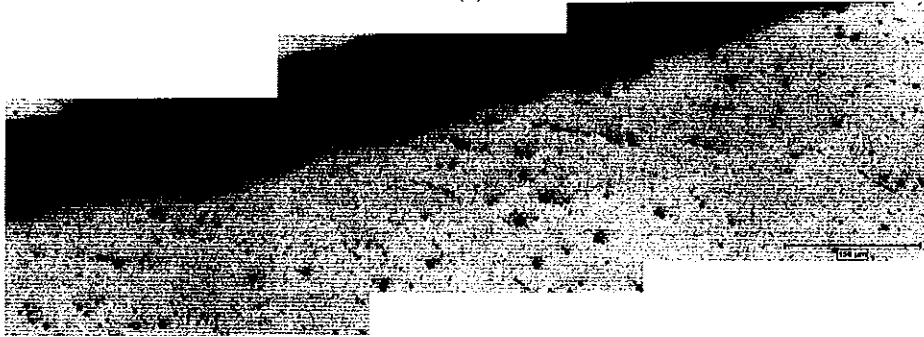
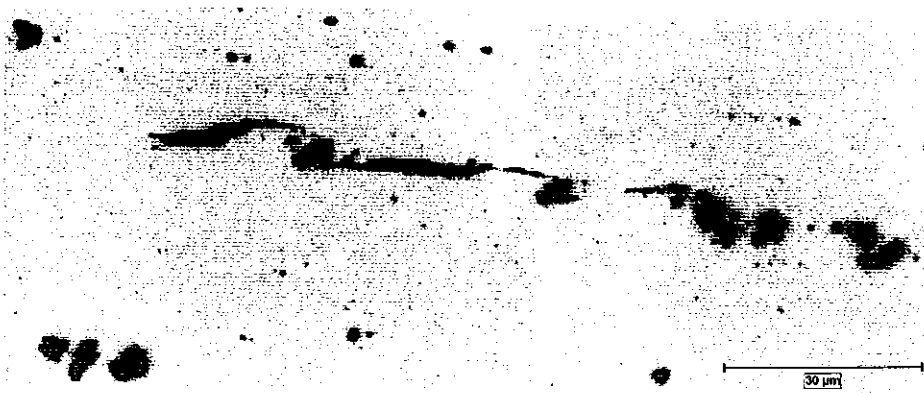
In this section it is also important to focus on microscopic aspect of damage and failure of these tubes. Figure 11 is one example of particle induced damage in 2mm thick specimen S-30 section that provides evidence for shear type of flow and failure in this case. Details of the failed region as shown in Figure 11 b and c clearly illustrate the role of particles in form of particle-induced damage leading to final failure. Evidences of similar type of failure in 3.5 mm tubes were also observed.

Figure 11 – Fracture edges in 2 mm thick tube S-30 section A #13, (a) general view, (b) flow of the material and convergence of the flow line as well as particle stringers, and (c) particle induced damage in one of the stringers.

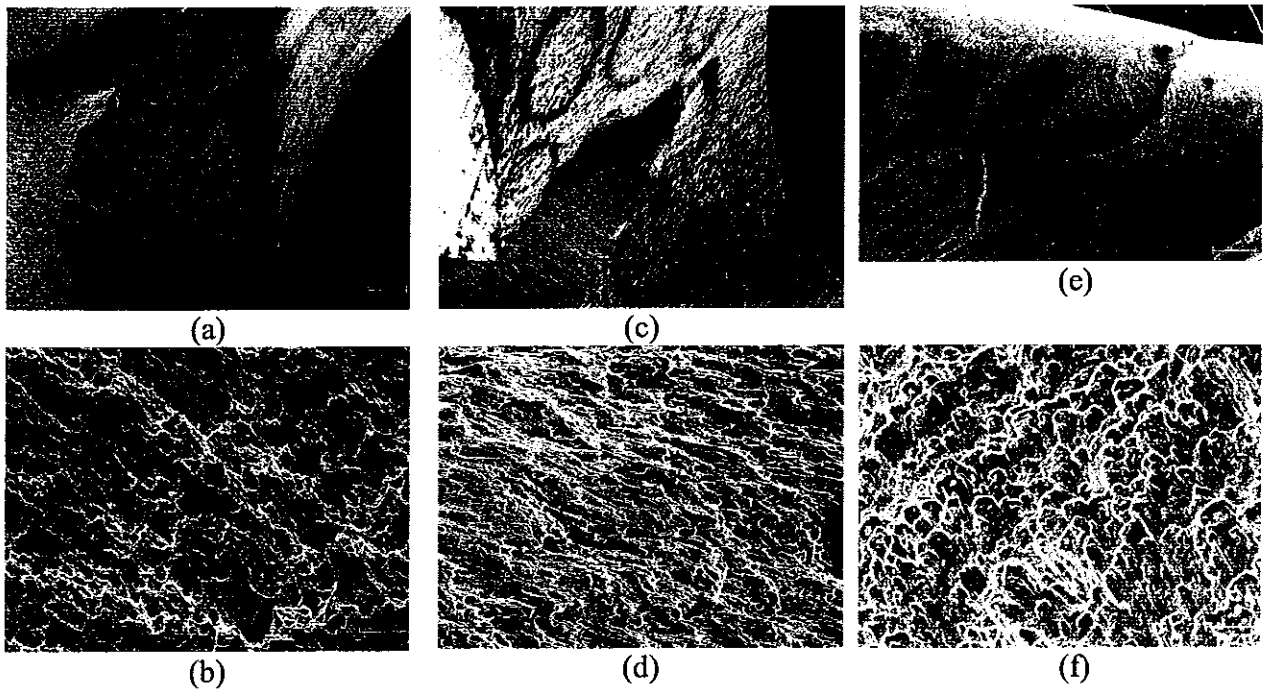
Several failed segments were removed from the crushed tubes and examined using SEM. One example is a failed segment from the bottom second fold of 2mm thick specimen S-39, shown in Figure 13a and b. In this case shallow oriented dimples typical of fracture surfaces produced under shear or tear are observable as shown in Figure 13b. Figure 13c and d show a failed segments in 3.5mm thick specimen S-28 at low and high magnification, respectively. Low as well as higher magnification view of the dimple morphology in this specimen suggests that the main failure mechanism at this location is mainly shear type. In another case in 2mm thick specimen S-39 a folded segment failed as a result of a second bending in a direction normal to the primary folding direction as shown in Figure 13e. Elongated dimples are observable in this segment as shown in Figure 13f. The segment also illustrates a set of secondary cracks normal to the primary fracture surface that supports mixed mode of loading.

Figure 13 Fracture surfaces in failed segments, (a) and (b) 2mm thick specimen S-39, (c) and (d) 3.5 mm specimen S-28, (e) and (f) another failed segment in specimen S-39.

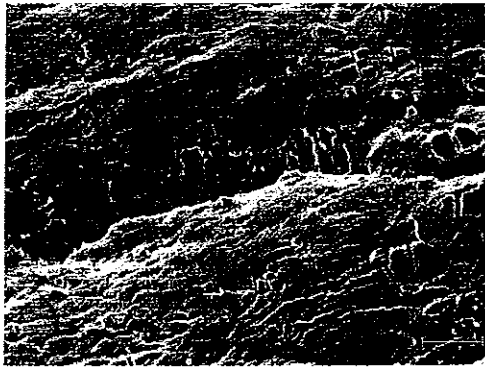
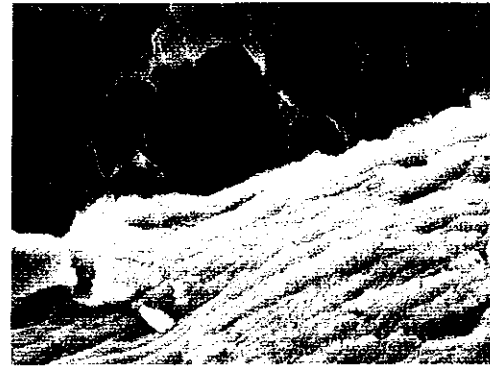
After all examination of the tubes it is clear that the deformation and failure are very complex due to complex phenomena occurred during axial crushing. Therefore, it is difficult to point at a single failure mechanism as the cause of failure. A segment might initially fail by one mechanism and failure might propagate by another mechanism. Nevertheless, it is fair to say that shear type of failure could be pointed out as the most frequently observed failure mechanism. This assessment is compatible not only with the general nature of the axial crushing but also with the microscopic observation reviewed herein. Specifically, it has been possible to view the very early stage of the shear failure in partially sheared segments frequently observed in the vicinity of the main failure surfaces. Figure 14 shows one of these partially sheared segments.

Figure 14 – (a) a partially failed area in specimen S-39, (b) higher magnification of the fracture surface showing the elongated dimples
