Monitoring the hygrothermal performance of a masonry wall with and without thermal insulation

MONITORING THE HYGROTHERMAL PERFORMANCE OF A MASONRY WALL WITH AND WITHOUT THERMAL INSULATION

A H P Maurenbrecher¹, C J Shirtliffe², M Z Rousseau¹ & M N A Saïd¹

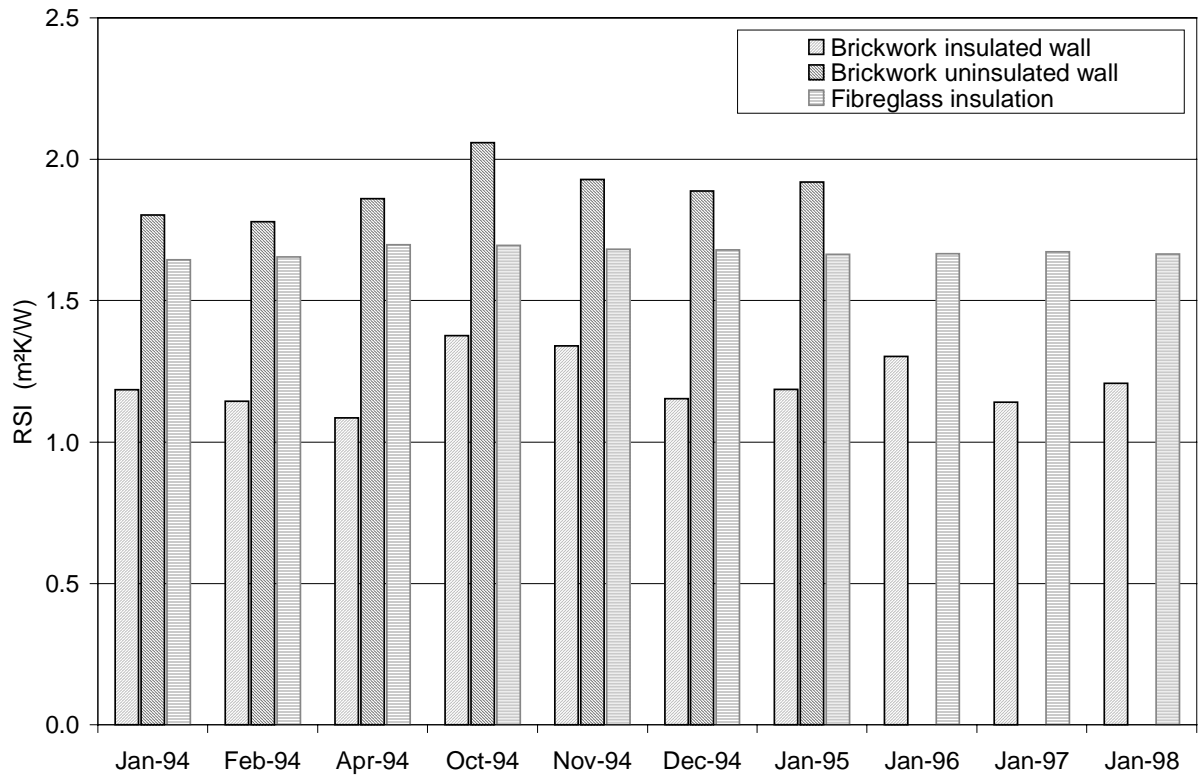
Figure 5 Variation in thermal resistance of the masonry and glass fibre insulation
Heat flux sensor removed from uninsulated wall in March 1995; $R = 5.68$ RSI

Figure 5 shows the thermal resistance of the masonry and the glass fibre insulation for the cold months in 1994 and, for comparison, January in the following years. The values do not include the interior and exterior surface air film coefficients. The mean RSI value for the masonry was 1.9 in the uninsulated wall and 1.2 in the insulated wall. The glass fibre insulation had an average value of 1.7. The value for the uninsulated masonry takes into account the effect a 2 to 5 mm thick layer of silicone sealant used to bed the heat flux sensor onto the uneven wall surface, and the effect of a 3.2 mm thick cork cover (the combined RSI value was assumed to be 0.1).

The mean thermal resistance of the masonry in the insulated wall was 37% lower than the masonry in the uninsulated wall. The reason for the large difference is not clear. Either the difference is real or there is a measurement error. If the difference is real, it could be due to a higher moisture content or to a difference in construction between the two wall sections. However the moisture sensors installed did not indicate high moisture levels and the modelling study predicted only slightly increased moisture levels (due to the lower thermal gradient across the wall which in turn, reduces the drying potential). Variation in the construction of the wall sections could include differences in the masonry within the wall including air voids, and possible voids around the steel columns in the wall. These factors require further investigation before firm conclusions can be drawn.

The thermal resistance of the 55-mm thick glass fibre insulation varied between RSI 1.6 and 1.7 which is close to the nominal design value of 1.58 at 24°C mean temperature (Fiberglas wall design guide; AF530 series). In Equation 1, the constant k was taken as 0.004 (based on laboratory measurement of a glass fibre sample of similar density, 48 kg/m³).

The total measured thermal resistance for the masonry and glass fibre insulation varied between RSI 2.8 and 3.1. Therefore the renovation of the wall resulted in an increase of the thermal resistance by 47 to 63% compared to the uninsulated wall. If the ASHRAE Handbook (1993) design conductivity of 0.7 W/(m.K) for clay brick had been assumed (density approximately 1700 kg/m³), the calculated RSI value for the masonry portion of the wall would have been 1.1, and together with the insulation it would add up to 2.7. This value is in agreement with the R value of the masonry and insulation in the insulated wall based on the field measurements. However for the uninsulated wall, the R value of the masonry wall as estimated with the ASHRAE Handbook (1993) is much less than the field measurements.

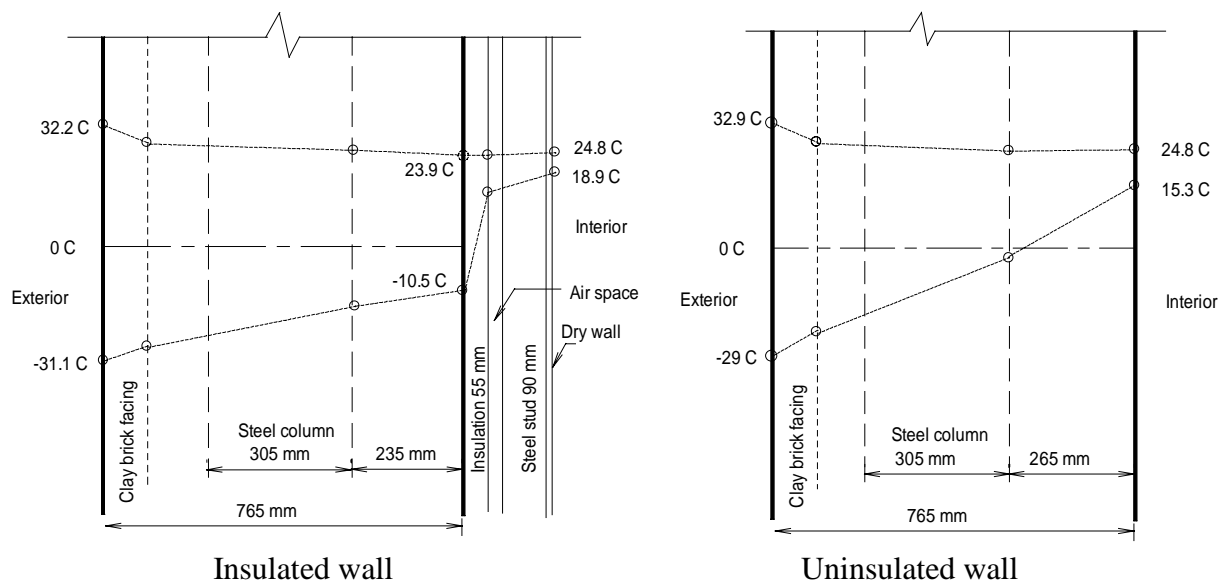
Figure 6 Maximum and minimum temperatures across the walls at mid-height in 1994
Maximum and minimum indoor air temperatures were 24.6 & 19.9°C
Maximum and minimum outdoor air temperatures were 28.9 & -29.8°C

Figure 6 shows the maximum and minimum temperatures recorded over a period of a year across the insulated and uninsulated walls (at mid-height). The temperature range on the exterior face of the brick wall is nearly the same for both walls (63°C). But the temperature range is much greater on the interior face of the brick in the insulated wall than in the uninsulated wall because of the added insulation (34°C compared to 10°C).

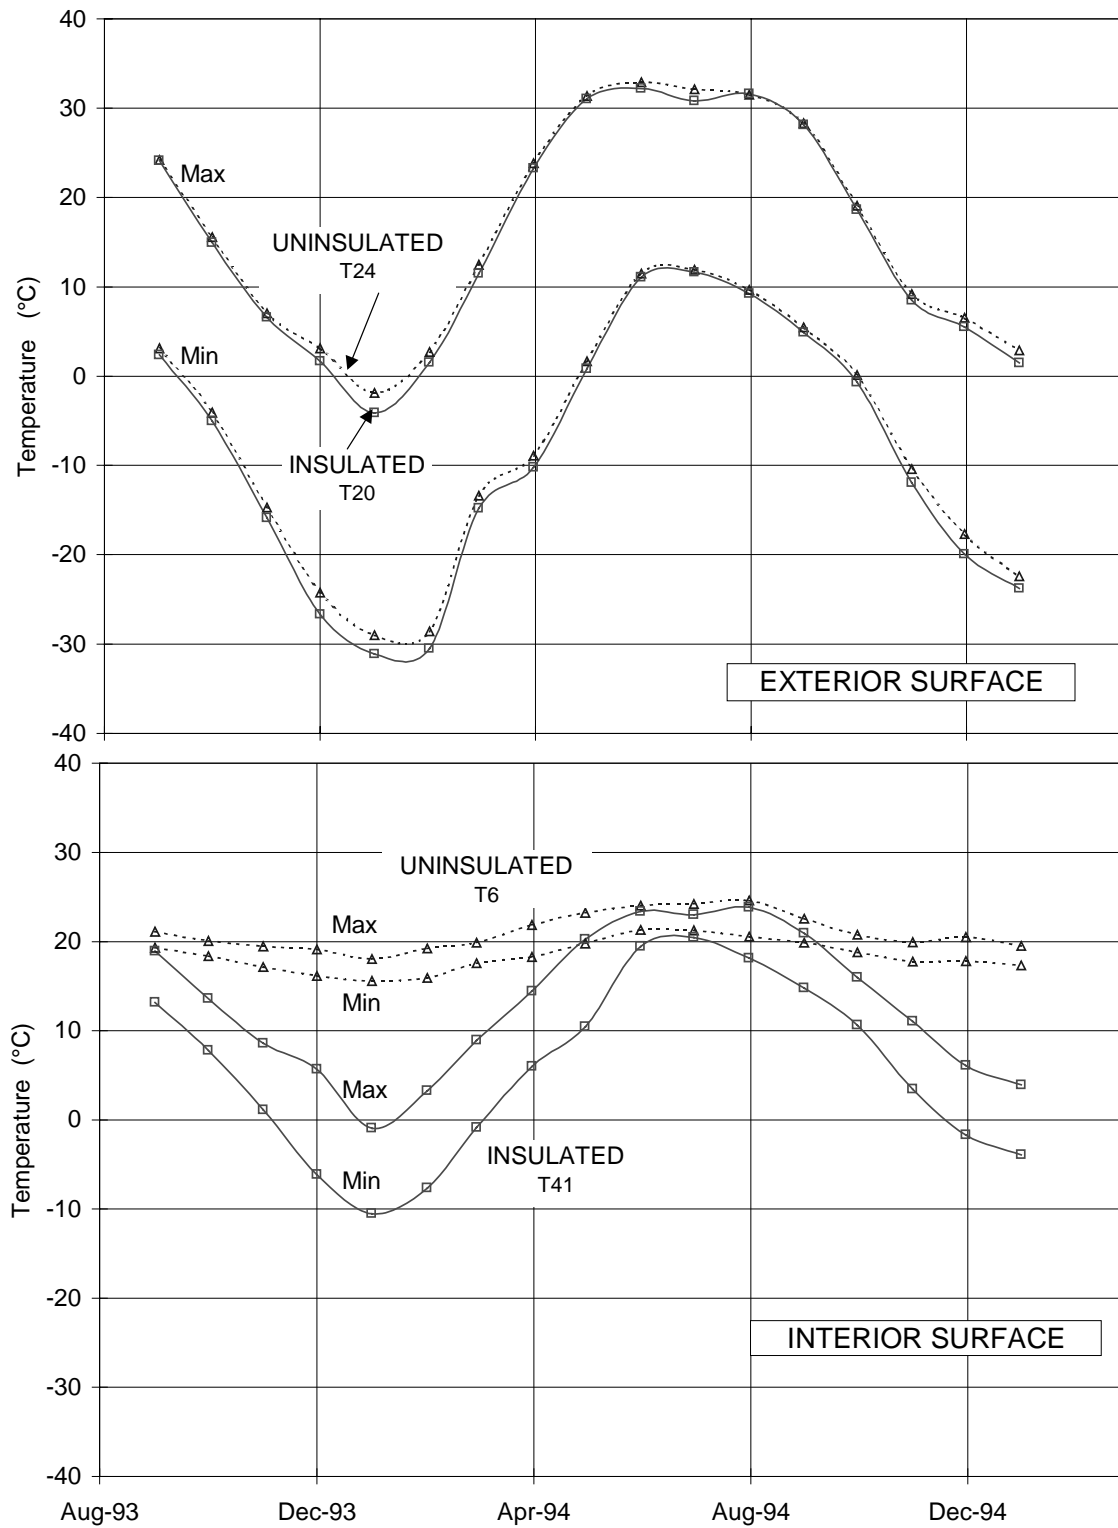
Figure 7 Monthly maximum and minimum temperatures on the exterior and interior masonry surfaces of the insulated and uninsulated walls (at mid-height)

Figure 7 shows the variation of maximum and minimum monthly temperature over a year and a half at the exterior and interior face of the brick in both wall sections. The addition of insulation on the inside face of the masonry hardly affects the temperature on the exterior of the wall. The temperature at that location is mainly affected by the outside air temperature (solar effects are minimal because of the northerly orientation).

In the coldest part of winter, the inside face of the masonry on the insulated wall can be 25°C lower than the inside face of the uninsulated masonry. The temperature on the inside face of the uninsulated masonry hardly dropped below 15°C while the inside face of the insulated masonry dropped below freezing for several months in the winter (in January 1994 the masonry in the insulated wall did not rise above 0°C). This data indicates that adding thermal insulation on the inside face increases the risk for condensation or ice formation on the inside face of the masonry should moisture transfer occur, either by diffusion or air exfiltration.

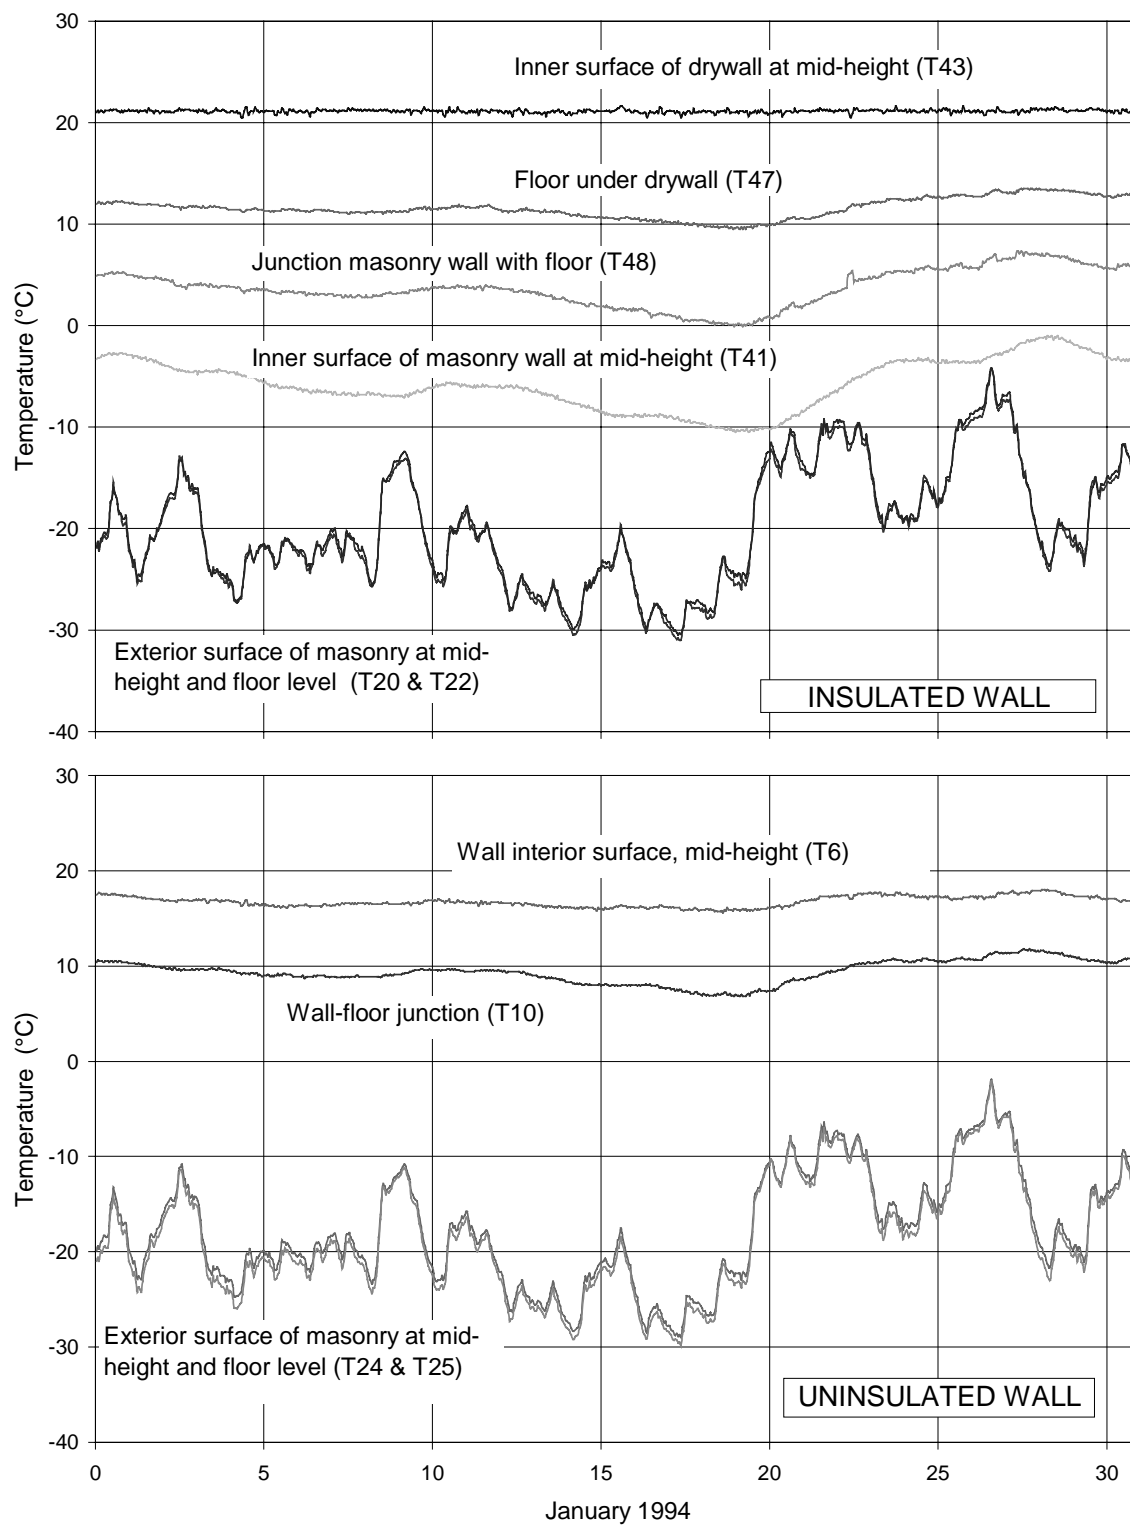
Figure 8 Temperature variation at floor and mid-height of walls in January

Figure 8 shows that the temperature in January at mid-height on the inside face of the drywall at mid-span between metal studs (T43) is quite steady at 21°C and is not affected by the fluctuations in the cold exterior surface temperature of the wall.

At the floor slab directly underneath the drywall (T47), the temperature fluctuates slightly between 10 and 12°C, that is 9 to 11°C lower than at mid-height (T43). The concrete slab is directly connected to the cold masonry and this increases the heat flow through the slab, resulting in a significant drop in temperature at the slab perimeter. The floor temperature may be low enough to cause discomfort if people were next to the wall. Standards on thermal comfort (ANSI/ASHRAE 1992) indicate that 95% of the people require a minimum temperature of 13-15°C near the floor for foot/ankle comfort.

At the junction of the floor and the masonry in the wall, the temperature fluctuates between 0 and 5°C (thermocouple T48); this is an 8°C temperature drop relative to the floor/drywall junction location (T47). Thermocouple T48 is located on the cold side of the insulation, which explains the temperature drop. However that location still benefits from significant heat flow from the slab: it is warmer (by 10°C) than the masonry at mid-height (T41). The floor slab, acting as a thermal bridge, warms up the masonry at floor level. The warming effect of the floor slab gets dispersed into the large mass of masonry as indicated by similarities between the temperature at the outside face of the masonry at floor level and at mid-height. Because that thermal bridge tends to raise the temperature of the adjoining masonry, it does not have a negative impact on the condensation potential on the wall; however it reduces its energy-efficiency.

Figure 8 shows that the temperature at mid-height on the inside face of the masonry (T6) is around 16°C to 17°C. This is about 5°C lower than the temperature of the inside face of the drywall of the insulated wall section. In terms of thermal comfort, the cooler uninsulated masonry wall surface may cause some thermal discomfort to nearby occupants because of radiative heat loss from their body towards the cooler wall surface. In terms of condensation potential, the uninsulated wall cannot sustain as high an indoor humidity level as the insulated wall section. However its surface condensation potential in the central part of the wall is low: it could sustain up to 60% RH without condensation. Condensation would first occur at the floor/wall interface because the temperature is lower at that location.

At the wall/floor interface, the temperature (T10) ranges from 7°C to 12°C. This large difference (up to 9°C) from the mid-height location (T6) would not be expected in a completely uninsulated wall system but in this building, only one wall section has been left uninsulated for research purposes. The wall on the second floor as well as a small section of its ceiling have been insulated (Fig. 4). Minimal heat flow from adjacent materials was available to raise the temperature of the masonry at the floor level of the monitored uninsulated wall section. If the wall underneath the uninsulated test section had not been insulated, the difference between the wall/floor junction and mid-height would have been much less. Based on the measured temperature, condensation would occur at the wall/floor interface when humidity level indoors exceeds 35% RH.

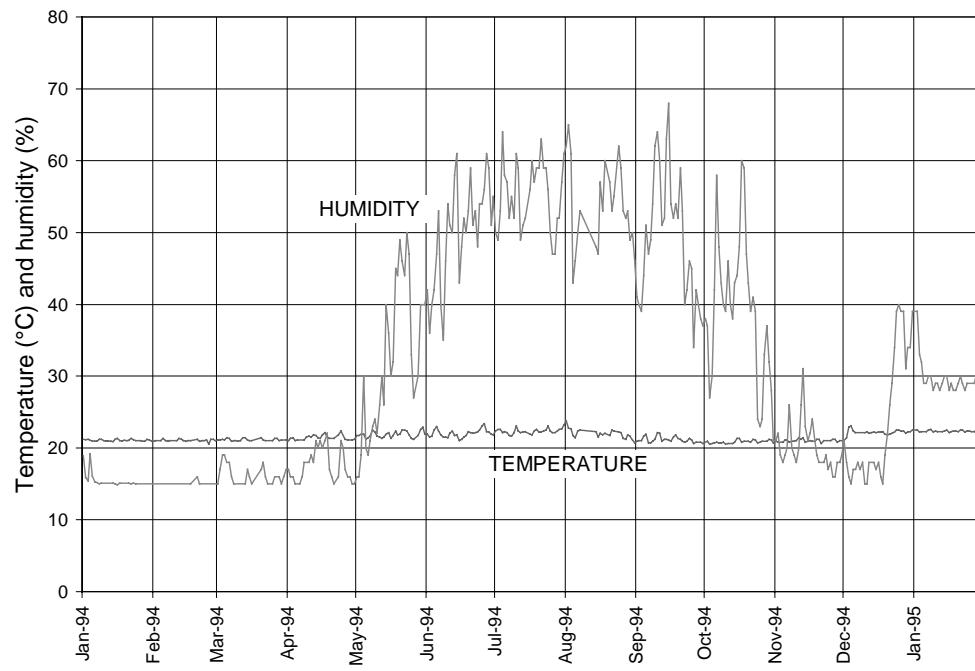
Figure 9 Average daily indoor air temperature and humidity

Condensation on inside surfaces is also a possibility but generally, during the winter, indoor humidity levels were low (Fig 9). For 23°C and 30% RH the surface temperature should be above 4°C to prevent condensation. The indoor relative humidity would have to be above 40% before condensation occurred at the wall/floor interface in the winter. Relative humidities of this magnitude would be difficult to attain in winter because the large surface area of ordinary double glazing in the building would act as condensers.

During winter months, the indoor air temperature was about 21°C. The relative humidity was very low except at the very end of the year when it jumped briefly to 40% and then settled down to an average of 30% the following January. In the following Januarys (1996-98) the average humidity ranged from 20 to 30%. For 16% RH and 21°C, the dew point temperature is -4°C and for 30% humidity, the dew point temperature is 3°C. Condensation on interior surfaces is then unlikely except on the windows.

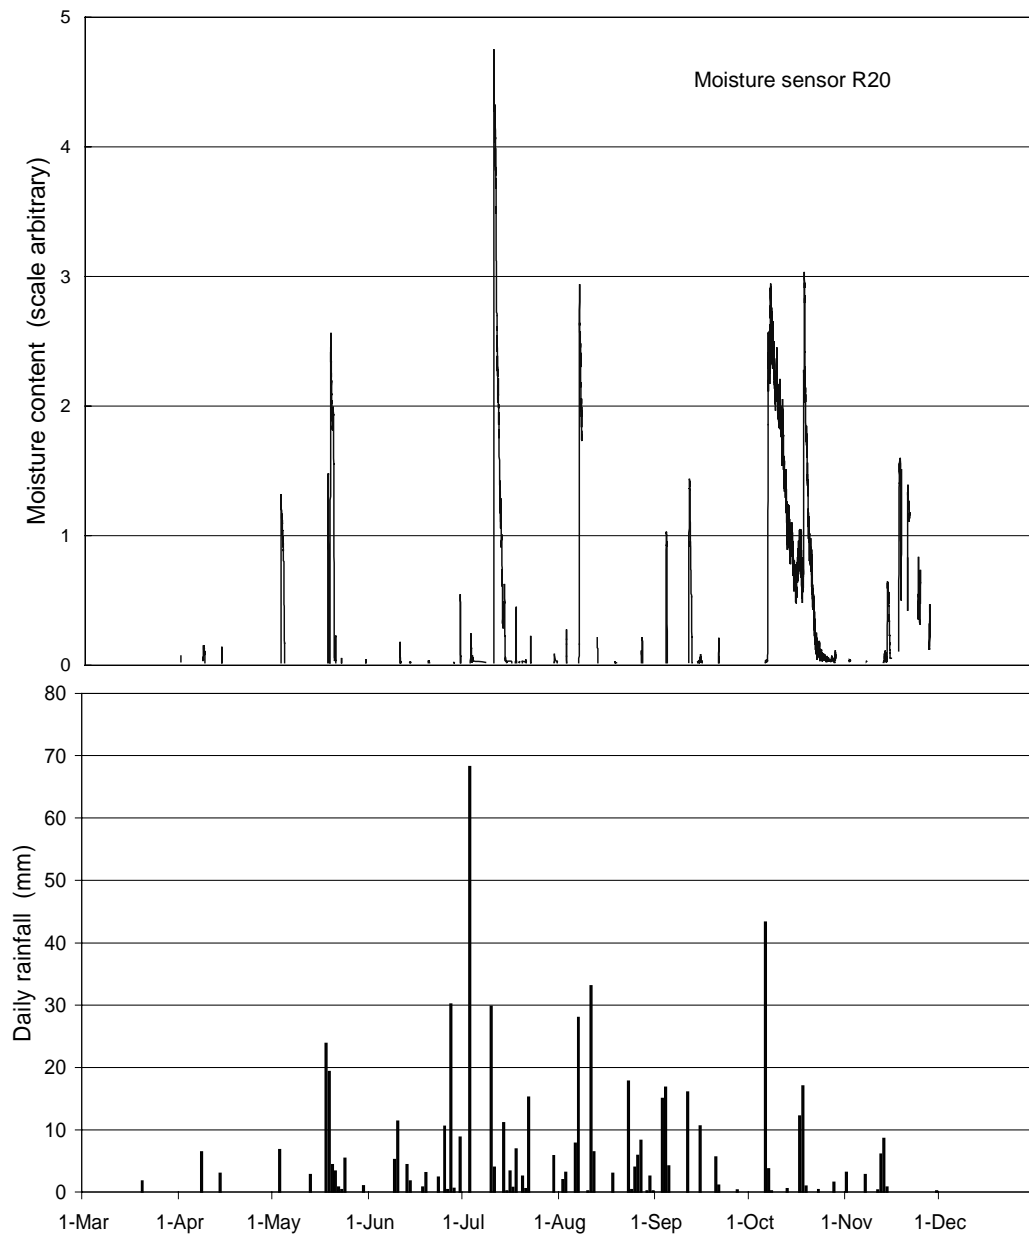
Wetting of the exterior face of the masonry often occurred during rain (Fig 10). In 1994, the longest periods of wetting for the monitored wall sections occurred in October/November while the highest moisture level occurred during a rainstorm in July. The wetting correlates reasonably well with the daily rainfall measured at the airport meteorological weather station. But there are anomalies. The heaviest daily rainfall recorded at the airport on July 3, 1994 hardly affected the wall. This is probably because the wind was from SSE directing rainwater away from the wall (the rain may also have been less severe in central Winnipeg).

Figure 10 Wetting of exterior face of the masonry in the insulated wall in 1994
 Daily rainfall measured at Winnipeg airport. Moisture measured with two pins fitted in holes drilled 10 mm apart in a brick; plot shows half hour averages of one minute readings. No data recorded between 8-13 Aug when the second large daily rainfall in August occurred.

This indicates that a small weather station installed at the monitoring site would be useful to provide a more accurate representation of the actual weather exposure of the building.

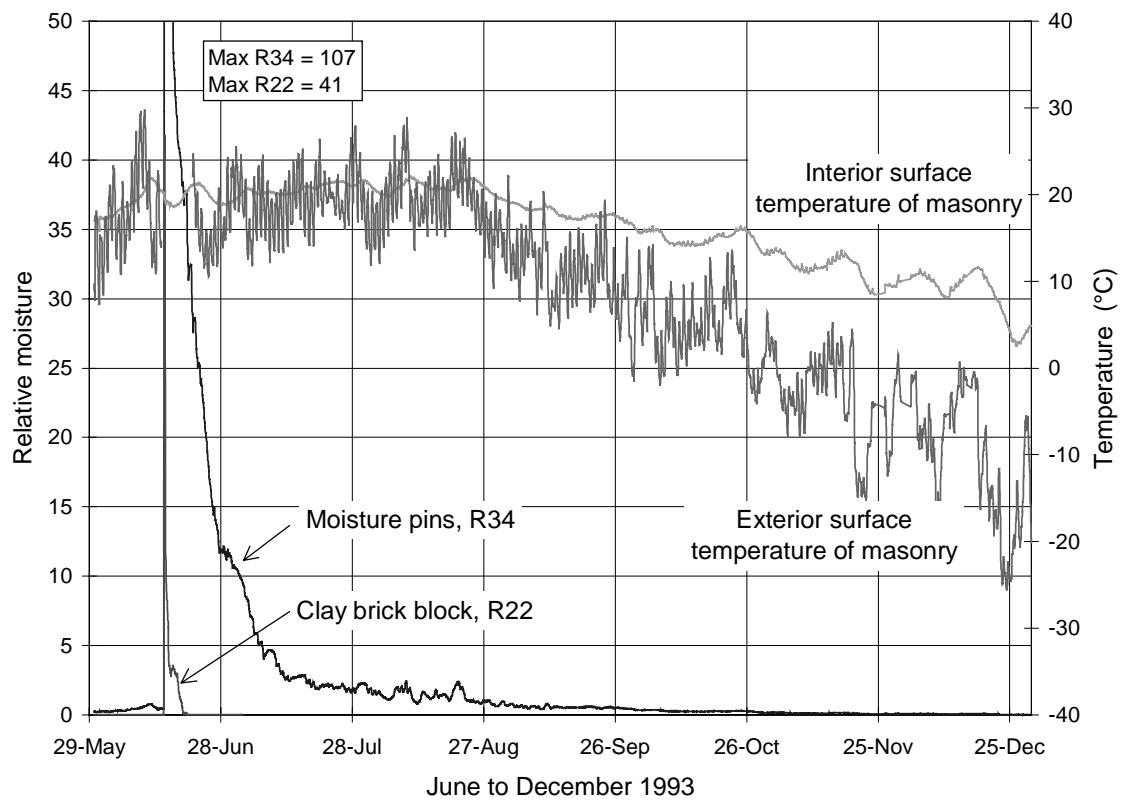
Figure 11 Moisture at the bottom of the inside face of the masonry of the insulated wall

During the installation of the instrumentation in the insulated wall section, it was observed that the base of the wall was damp. Moisture pins inserted into this part of the wall confirmed the wetness; the pins have kept measuring changes in moisture throughout the monitoring period. The temperature of this part of the wall did not drop below freezing because of the warming effect of the concrete slab. With one exception, the level of moisture measured was very low, the maximum occurring over the warmer months of the year and dropping to almost zero during the colder months. The one notable exception

occurred early in the monitoring (Fig 11, R34 and R22). This area of wall became completely wet, with even a ceramic block sensor located on the floor registering water. The block and the masonry around the moisture pins probably had very high moisture levels. The source of the water is not known (it may have been caused by a leak from the floor above; the ceramic block registered the moisture increase before the sensor in the wall; it occurred around midnight of June 16/17th 1993). The moisture level in the wall took several months to return to lower levels. When this area was inspected in July 1998, a resistance moisture meter indicated the surface was dry but below the surface it indicated there was moisture (when probes were inserted in holes formerly occupied by moisture pins).

Moisture levels in the monitored wall sections do not seem to be a problem. Only at one location, at the intersection of the masonry and the floor in the insulated wall, was a continuous low level of moisture measured. This moisture was present from the start of monitoring. Mould growth could have been a possibility there but none was observed.

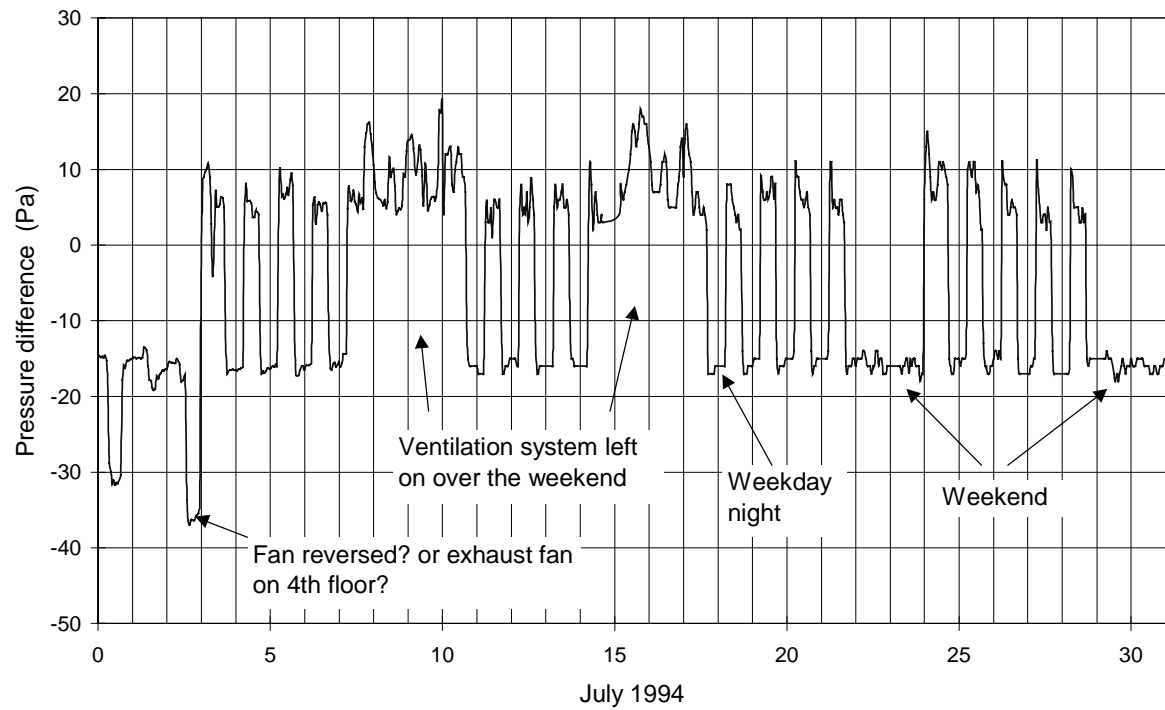
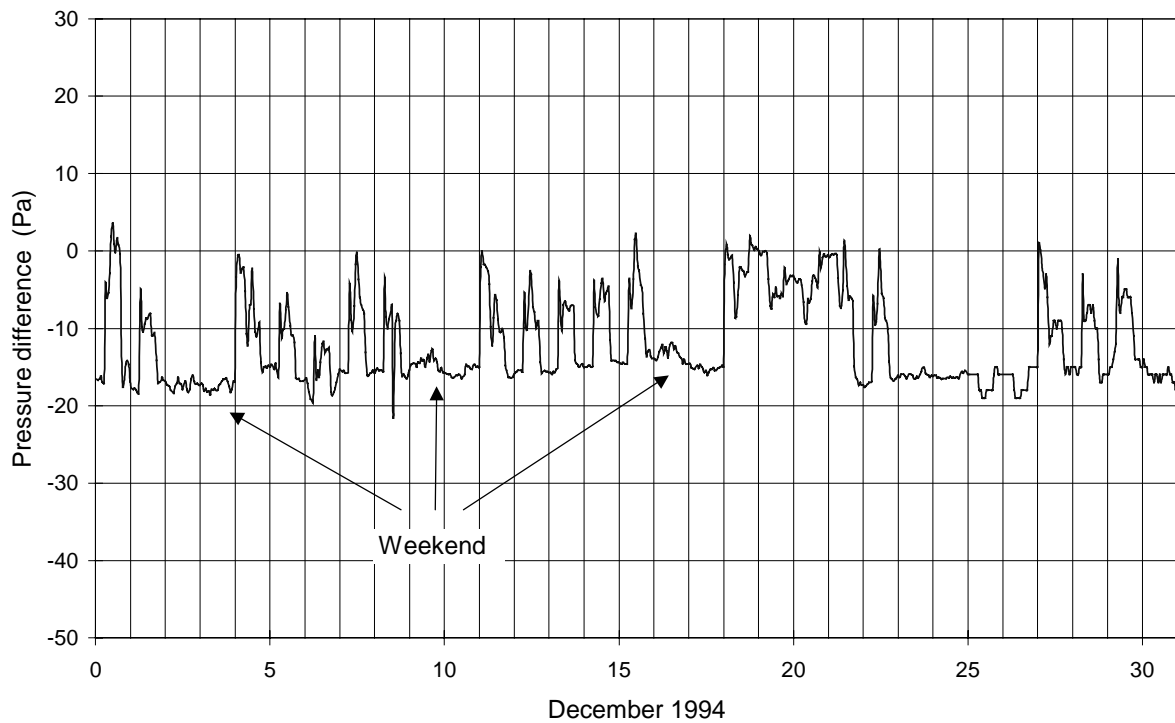
During the months of January, February and December of 1994 the outdoor air pressure was almost always higher than the indoor air pressure (negative pressure differential across the wall). The higher outdoor air pressure during the winter would lead to air infiltration at any openings in the wall. Therefore there was little potential for condensation within the wall from indoor air in winter. The dominating negative pressure across the third storey walls was induced by the independent ventilation system for the fourth floor laboratories (there are many exhaust fans on that floor; one operates continuously). This counteracted the positive pressure normally expected near the top of buildings due to stack effect in the winter.

During the rest of the year the indoor air pressure tended to be higher when the ventilation system for the bottom three storeys was switched on during the day (Figure 12 shows July & December). The HVAC supply fan for the first three storeys of the building normally operates during working hours only. Then there can be a positive pressure across the wall (see July).

Figure 12 Air pressure difference across wall in July & December (positive pressure indicates air pressure is higher inside than outside)
