**NRCC-48148**

## FAILURE CONDITIONS OF ASBESTOS CEMENT WATER MAINS IN REGINA

Y. Hu<sup>1</sup> and D.W. Hubble<sup>1</sup>

1. Centre for Sustainable Infrastructure Research, Institute for Research in Construction, National Research Council Canada, Regina, SK, Canada

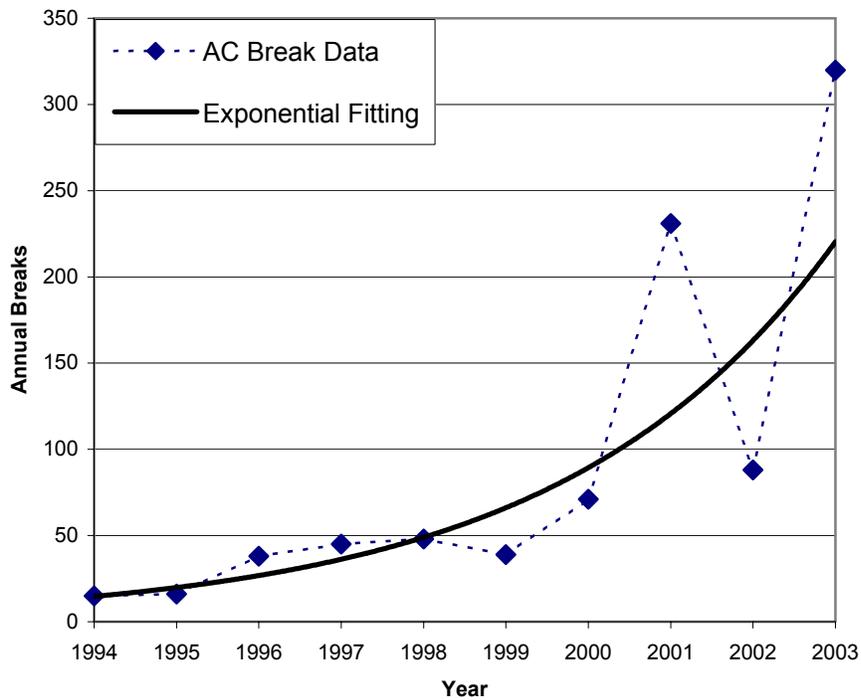
Figure 2. Break history of AC water mains (1994~2003)

The historic data plot shows that two peaks of breakage occurred in 2001 and 2003. The abnormal weather in these two years might be the major factor inducing more pipe breaks. In 2001, a record rainfall was noted in July followed by extremely low rainfall in August and September. City staff has reported that the higher number of breaks in 2003 might have been due to the high temperature and dry weather during the summer period of this year.

Climate appears to be one of the most important factors contributing to the observed AC water main failure patterns. Two peaks in the historic data plot (Figure 2) are all related to off-normal climate conditions in 2001 and 2003, respectively. The higher number of breaks in 2003 corresponds to a hot summer with a long dry period. Abnormal weather was also observed in 2001, with a record rainfall in July followed by extremely low rainfall in August and September. The cyclic pattern of the monthly pipe breakage, as illustrated in Figure 3, may also be attributed to the seasonal cyclic pattern of climate changes in this region.

The annual break curve of AC water mains (Figure 2) indicates that the system condition is deteriorating with time, especially in recent years. Since all the impacts induced by the physical, environmental and operational factors will accumulate with time, it is expected that more breaks will occur with increased pipe age. Therefore, the age of water mains is expected to be an overall factor affecting pipe breakage. However, the actual mechanisms behind the age effect have not been separately evaluated and these factors require further study.

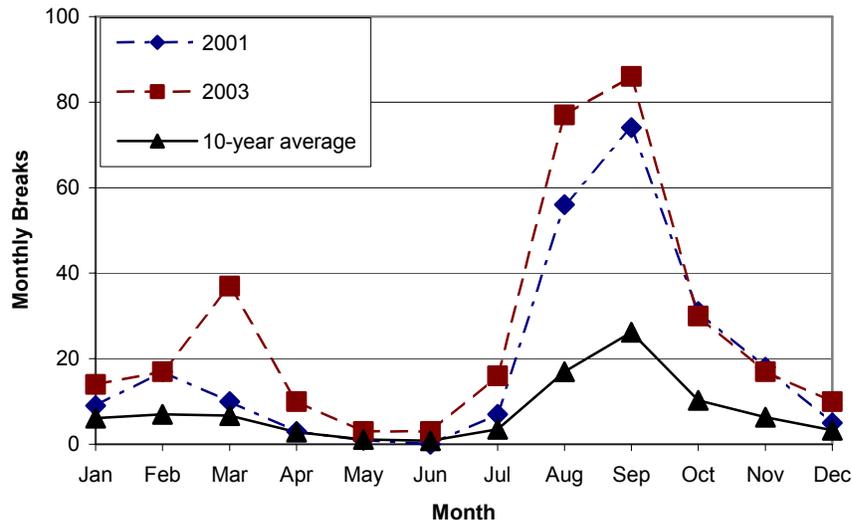
Figure 3. Monthly breaks of water mains in Regina from 2001, 2003 and the 10-year average (1994 to 2003)

The monthly breakage numbers are shown in Figure 3 for AC water mains in Regina. There are three curves, which represent the monthly break numbers for 2001, 2003 and the average number for the 10-year period from 1994 to 2003, respectively. The monthly break numbers for 2001 and 2003 are also included for comparison. This figure shows that high breakage rates occurred in August and September and sometimes in February and March. The highest breakage of water mains occurred in September.

The higher breakage in the summer season for both normal and off-normal years may be attributed to different factors. The high temperature combined with relatively low precipitation will desiccate the soil, inducing shrinkage and, consequently, differential movement, uneven bending support and/or uneven loading conditions. More traffic in summer may also impose extra loading on the buried pipes. The second peak for the two off-normal years may be related to extended periods of cold temperatures in these particular winter seasons. If a decrease in the ambient temperature is sustained, the frost will penetrate deeper into the ground, causing increased frost loads on the buried pipes, even though they are buried at some distance below the maximum frost penetration depth (Bahmanyar and Edil 1983).

Figure 3 also shows that a second peak in pipe break number occurs during the coldest period of the year for both of the abnormal years. This phenomenon has been observed by many researchers, including Rajani and Zhan (1996) and Selvadurai and Shinde (1993). It has been attributed to increased earth loads on the buried pipes due to freezing and expansion of the water in the ground. The process involves not only the water near the freezing front (0°C isotherm), but also the moisture around the front through migration towards the freezing front (Shah and Razaqpur 1993). A loss in moisture, as discussed previously, will further worsen the environment of water mains by causing soil movement around the pipes. In addition, a decrease in temperatures external to the pipe during the winter season will cause an increase in pipe tensile stress (Zhan and Rajani 1997). The very cold temperatures in the winter season of 2001 and 2003 may have contributed to the second peak of breaks that occurred in these two years.

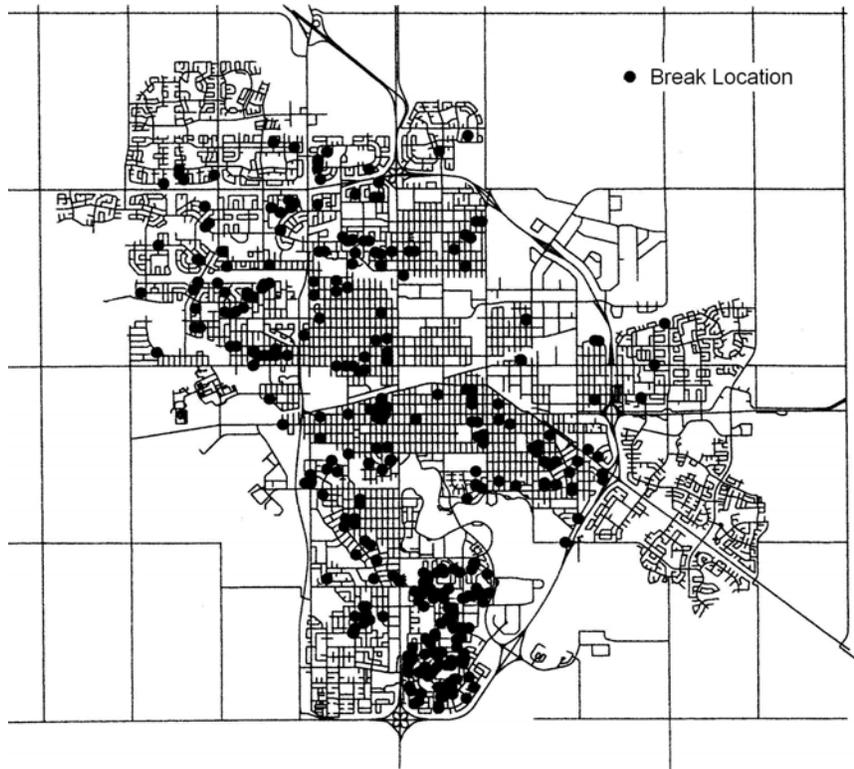
Figure 4. Water main breaks in 2003

To assess the system failure condition in the entire city, the breakage distribution for the AC water mains in the city was investigated. Figure 4 presents the breaks of AC pipes during a one-year period in 2003. It can be seen from Figure 4 that the water main breakage was not evenly distributed within the city. The breakage of AC pipe was most serious in the southern areas. Other areas that have a high concentration of AC pipe breakage include the central, central west and northern parts of the city. These areas were the earliest ones constructed using AC pipes. The southeast and northwest areas were developed since the 1980s and PVC pipes were used.

There are a few factors that may account for the spatial pattern of AC water main breaks as shown in Figure 4. In addition to the earlier development period and greater age of the pipes, the pipe length per unit area in these areas may also be a factor, i.e., the areas with greater pipe length per unit area may have more breaks. The higher density of pipe breakage in the southern area may be affected by low elevation and soil conditions as well.
