NRC PERD 079 Project - Task 1 - Findings from the Inuvit NT survey

NRC PERD 079 Project- Task 1

**Findings from the Inuvik NT Survey
prepared by
Madeleine Rousseau, Marianne Manning,
Nady Said, Mike Swinton and Steve Cornick
Feb. 2007**

Inuvik Survey

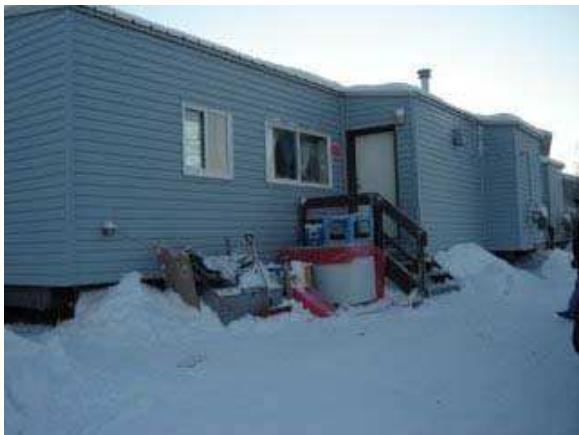
524 (#1)MT
EGH: 69

House No.	Hobo sensors & location	No. of occupants (day/night)	Windows	Source of humidification	House-general	Heating system	Ventilation	EGH rating / ACH @50 Pa	Problems
524 (#1)	840007: kitchen 840001: Bathroom	4 (2/4)	Vinyl sliders	No	Built 1977 2 bedroom semi-detached one-storey. Open crawl space	Shared natural gas boiler Hot water heat distribution	Manually-operated fans in bathroom and kitchen	69/6.9	Dew, frost and mould growth forming on windows in LR Water damage under windows Mould growth and staining in bathroom Ice buildup on exterior door
525 (#2)	840013: kitchen 840000: bathroom	5 (1/4)	Vinyl sliders	No	Built 1977 4 bedroom detached 2 storeys Open crawl space	Natural gas boiler Hot water heat distribution	Manually-operated fans in bathroom and kitchen	68/3.6	Minor dew and frost forming on windows Water damage at window sill in LR Air infiltration around windows and outlets. No mould growth observed

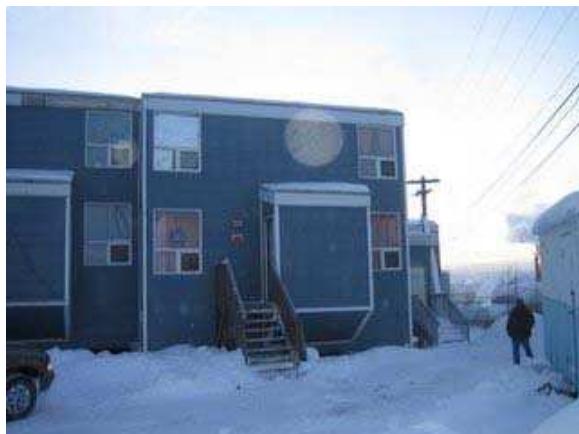
527 (#4) MT
EGH: 53

527 (#4)	840011: kitchen 8400006: bathroom	5 (5/5)	Vinyl sliders	No	Built 1975 4 bedroom row house Open crawl space	Shared natural gas boiler Hot water heat distribution	Manually-operated fans in bathroom	53/9.2	Frost on windows and water damage under windows and at sill/jambs in bedrooms Cold air infiltration around windows, at wall/ceiling junctions and at exhaust fan Mould growth observed around window frames
529 (#6)	839999: kitchen 839996: bathroom	3 (2/3)	Vinyl sliders	No	Built 1977 2 bedroom one-storey detached Open crawl space	Natural gas furnace Heated mechanical space under floor Forced air heat distribution	Manually-operated fans in bathroom	5/12.2	Air infiltration around windows, at penetrations, doors and exhaust fan Some moisture damage in bathroom /bedroom window No mould growth observed

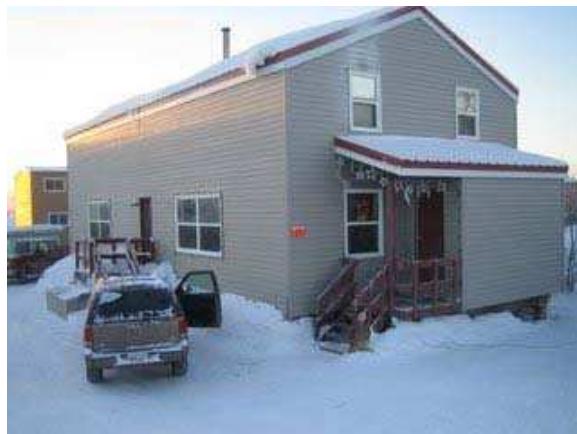
**526 (#3) NMT
EGH: 64**

Non-Moisture Troubled Sample										
House No.	Hobo sensors & location	No. of occupants (day/night)	Windows	Humidifier	House-general	Heating system	Ventilation	EGH rating / ACH @50 Pa	Problems	
526 (#3)	840008: Kitchen 840003: Bathroom	3 (0/3)	Vinyl sliders	No	Built 1985 2 storey 2-bedroom semi-detached Open crawl space	Shared natural gas boiler Hot water heat distribution	Manually-operated exhaust fan in kitchen	64/6.3	Frost on window panes and bottom of ext. doors Windows are leaky Ice buildup on fresh air intake vent	
528 (#5)	840004:kitchen 840012:bathroom	3 (1/3)	Vinyl sliders	No	Built 1975 2 storey 2-bedroom semi-detached Open crawl space Log home	Natural gas furnace Heated mechanical space under floor Forced air heat distribution	Manually-operated exhaust fan in bathroom	60/10.9	Ice on windows around dryer vent and plumbing stack No mould growth observed	
530 (#7)	840010:kitchen 840009:bathroom	5 (1/5)	Vinyl hinged	No	Built 1986 2 storeys 3 bedroom rowhouse open crawl space	Natural gas furnace	Manually-operated exhaust fan in bathroom and kitchen	58/12.2	Air leakage at windows and penetrations No mould growth observed

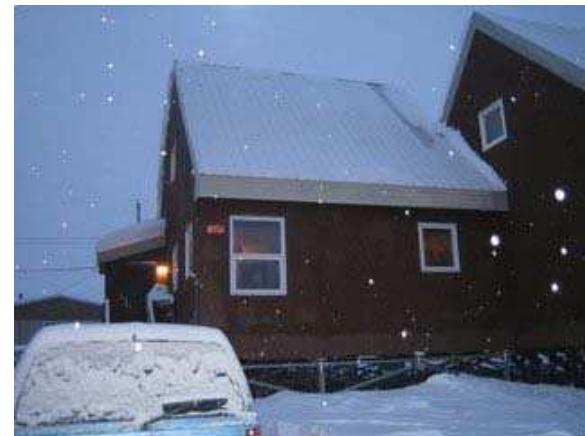
**531 (#8) NMT
EGH: 69**

531 (#8)	840005:kitchen 839995:bathroom	3 (1/3)	Vinyl hinged	No	Built 1979 2 storeys 2 bedroom semi-detached open crawl space	Shared natural gas boiler	Manually-operated exhaust fan in bathroom	69/4.5	Air leakage around door, dryer vent and penetrations frost buildup on windows Cracks in the walls
