EXPERIMENTAL PAINTING STUDIES:  
CENTRAL MORTGAGE AND HOUSING CORPORATION RENTAL PROJECTS,  
CORNWALL, ONTARIO

First Progress Report

Internal Report No. 361  
of the  
Division of Building Research

OTTAWA  
JULY 1968

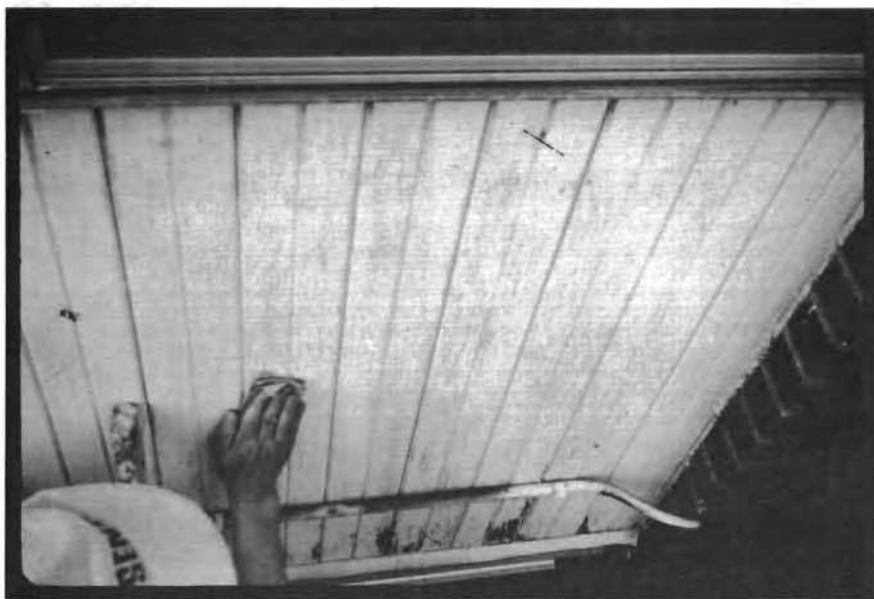
Figure 2. Preparation by Normal Methods

Their tools are usually a putty knife, approximately 1 to 1½ in. wide, and medium to coarse sandpaper. The knife is used as a prying tool to slip under loose edges of the old coating forcing it to break off. Sometimes the knife is held almost perpendicular to the surface and scraped over the scaling paint using firm pressure to remove curled edges at paint cracks and peeled areas. Sandpaper is then used for the finishing operation to remove any firmly adhering dirt, raised sides of cracks and to slightly feather the broken edges of peeled patches (Figure 2). The dusty, chalked surface is often rubbed with sandpaper in a dusting motion if it is thought necessary. Little attempt is made to reduce the total thickness of accumulated paint coatings or to renew the surface of exposed wood.

It appears that the normal surface preparation tends to remove any loose material that might break off under the brush in paint application and become mixed with the coating thus making imperfections in the dried film. The time consumed in surface preparation is not proportionate to the condition of the old paint. Severely deteriorated surfaces receive only the preparation necessary to remove the loose and bothersome paint. Any irregularities in the old coating such as imbedded dirt, sags, runs, or raised knots, are inevitably given particular attention with sandpaper so they will not interfere with the smoothness of the paint being applied.

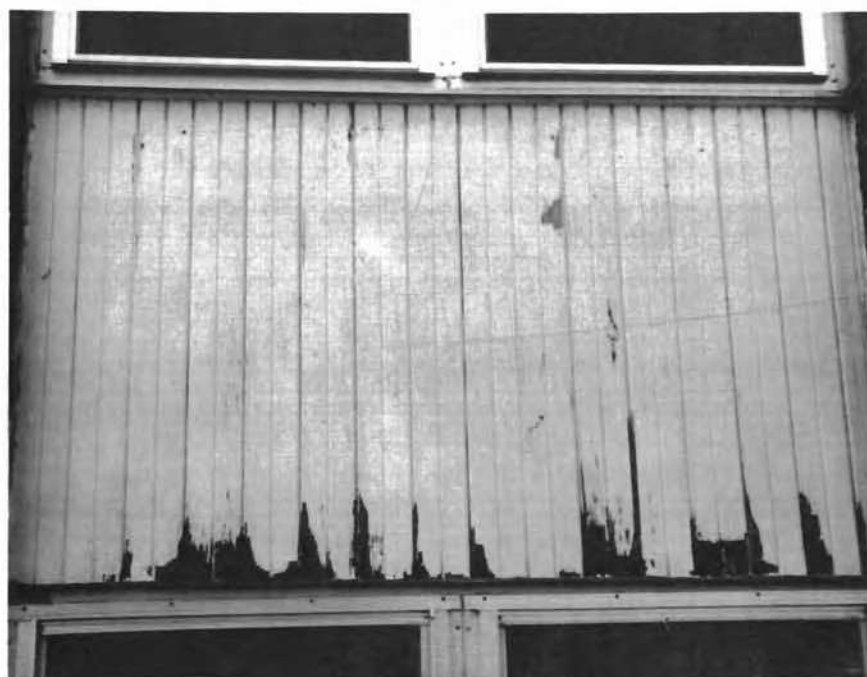
Figure 3. Preparation with Scraper, Brush and Sanding

Surfaces prepared utilizing hoe-type scrapers, wire brushing and sanding were not appreciably different than those prepared in the normal preparation category (Figure 3). The over-all appearance, however, suggested that more of the old paint was removed from the wood over a larger area. The hoe scraper rips off more of the marginally adhering paint adjacent to the peeled and cracked areas. It is also more effective in raking the vee joint of any scaling paint. The use of a wire brush seems unnecessary. Considering the labor involved the results of wire brushing are not obvious except on exceptionally loose or curling paint. It does, however, roughen the exposed wood and removes the grayed fibers on the surface. The hoe scraper will perform the same operation if used in a cross-grain direction but leaves a ragged surface which demands more sandpapering. The scraper - brush treatment in general, requires more sanding to feather the edges of the remaining paint. Less attention is given to areas of firm coating because additional time is consumed in sanding specific irregularities; consequently, more chalk is left on the surface.

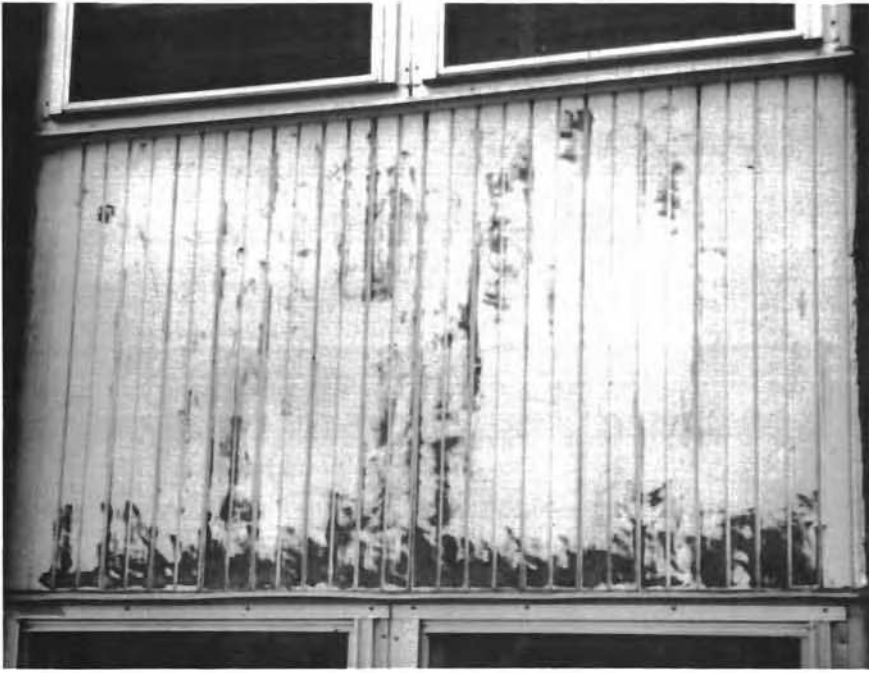
Figure 4. Preparation by Mechanical Sander

The sanding operation removes all the loose, scaling paint as well as some areas of apparently firm coating. A certain amount of caution is necessary to avoid burning or blistering the acceptable painted surface by frictional heat caused by sanding. When using the sander it is easier to do the whole area of the wood panel rather than only the spots that have obvious defects. This is desirable because the total thickness of paint is reduced, exposed wood faces are renewed, and the surface to be painted is moderately scored to promote better adhesion (Figure 4). Two of the painters, one of whom was the foreman, said they liked this method better than the scraping and agreed that the surface was well prepared to receive paint. One drawback was the necessity of scraping the vee joint by hand.

The time consumed in mechanical sanding averaged  $7\frac{1}{2}$  minutes per 25 sq ft;  $1\frac{1}{2}$  minutes were needed to change sanding discs. To approximate the time required to prepare similar surfaces by hand methods is difficult because each panel was only worked on long enough to obtain the required appearance. Observed times ranged from 5 to 11 minutes per panel. Some panels took longer than others depending upon the conscientiousness of the worker and the accessibility of the surface. The machine-sanded upper panels on the buildings were more uniformly prepared and compared more favorably with the lower panels than those prepared by either of the hand methods.

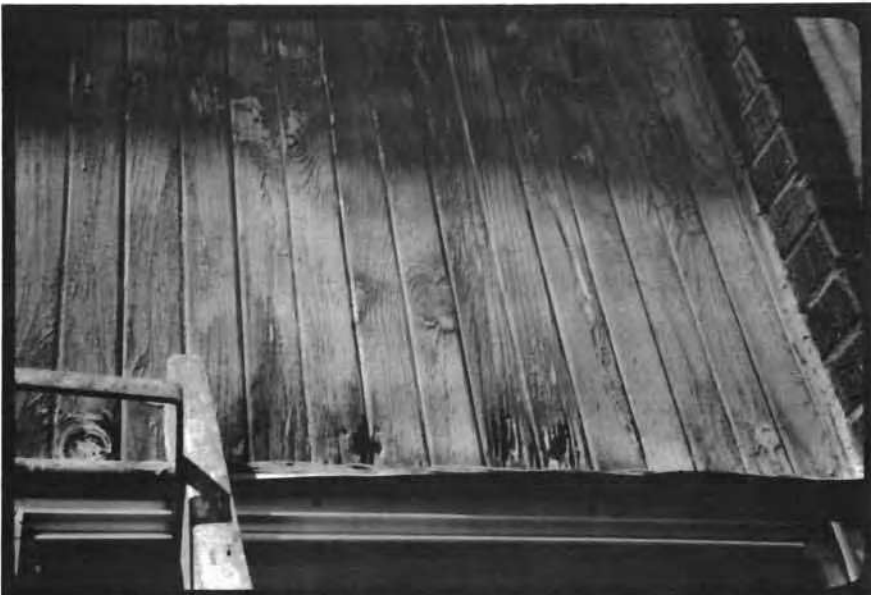
Figure 5. Preparation by Soft Sand Blasting

all of the softer wood. Knots and wide bands of late wood retain about 30 to 50 per cent of the old coating. There is a slight to moderate accumulation of old paint remaining in the vee joints. The wider cracks in the wood remain but small cracks and surface checks disappear. These wide cracks and some holes would require filling in any event. The surface, in general is very clean with a moderate stipple appearance apart from the raised areas around the knots (Figure 5).

Critical points in this procedure are air/sand pressure and distance from the nozzle to the surface being cleaned. An eighteen- to twenty-four-in. distance was found best using only enough pressure to remove the paint coating. Aluminum surfaces or window glass do not require protective masking at this rate of flow. The motion should be across the grain with a slight angle from the normal. The nozzle must be kept continually in motion otherwise the sand will create deep holes in the wood in a few seconds. This is especially true on sections of deteriorated wood such as on board ends located above window flashings where accumulated moisture has caused partial rotting of the wood, (Figure 5).
