### **Airborne Sound Insulation in a Series of Wood-Frame Apartment Buildings** Olynyk, D.

TECHNICAL NOTE

PREPARED FOR Central Mortgage and Housing Corporation

AIRBORNE SOUND INSULATION IN A SERIES OF WOOD-FRAME  
APARTMENT BUILDINGS

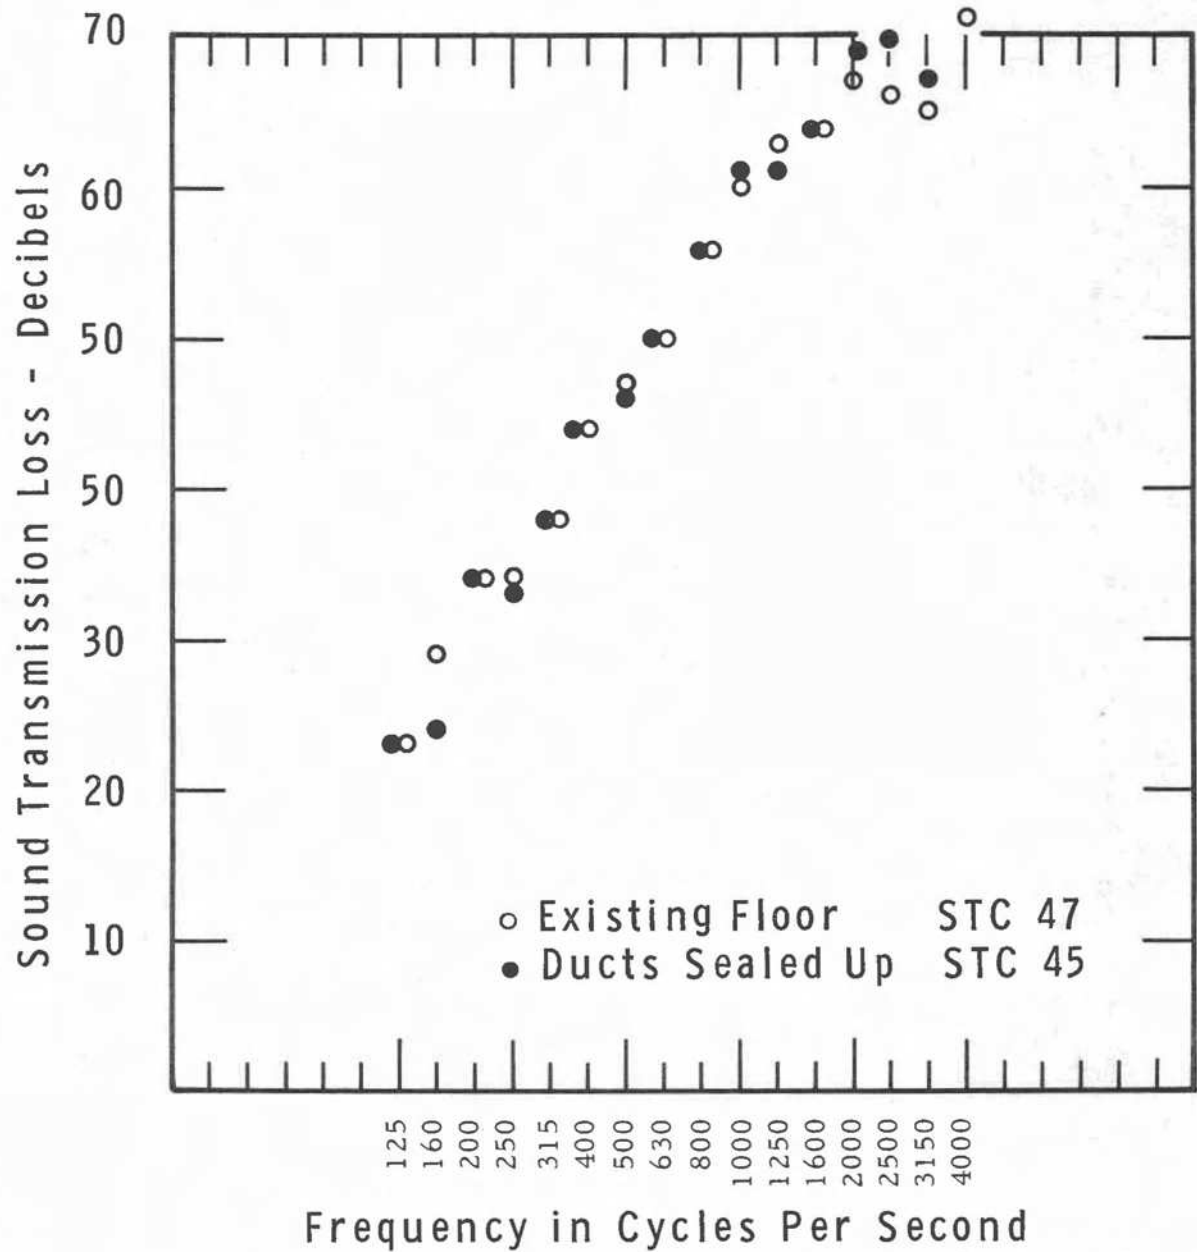
Figure 1(a)

Our investigation of hot-air heating systems showed that flanking transmission was quite serious with a plenum carrying the metal ducts and most serious when return air ducts were located adjacent to each other. This is exemplified by Building A where a maximum of STC 47 was obtained between living rooms with duct outlets sealed up and a minimum of STC 40 between hallways for the unmodified floor.

Building A:  
Sound Transmission Test on Floor Separating  
Living Rooms

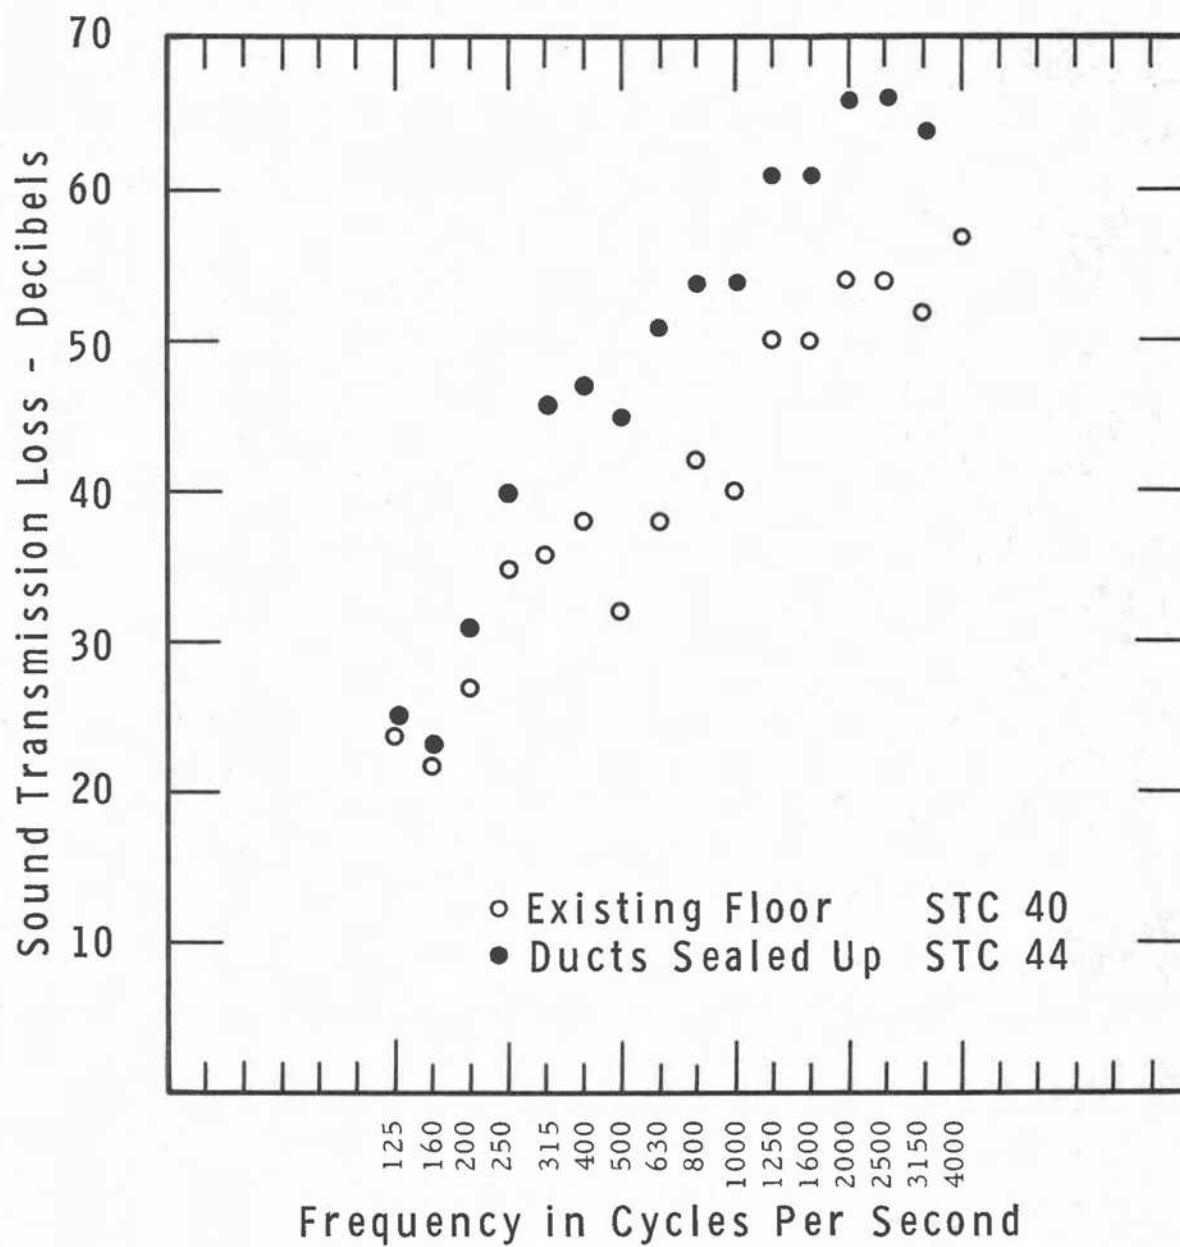
Figure 1(b)

Building A:  
Sound Transmission Test on Floor Separating  
Hallways

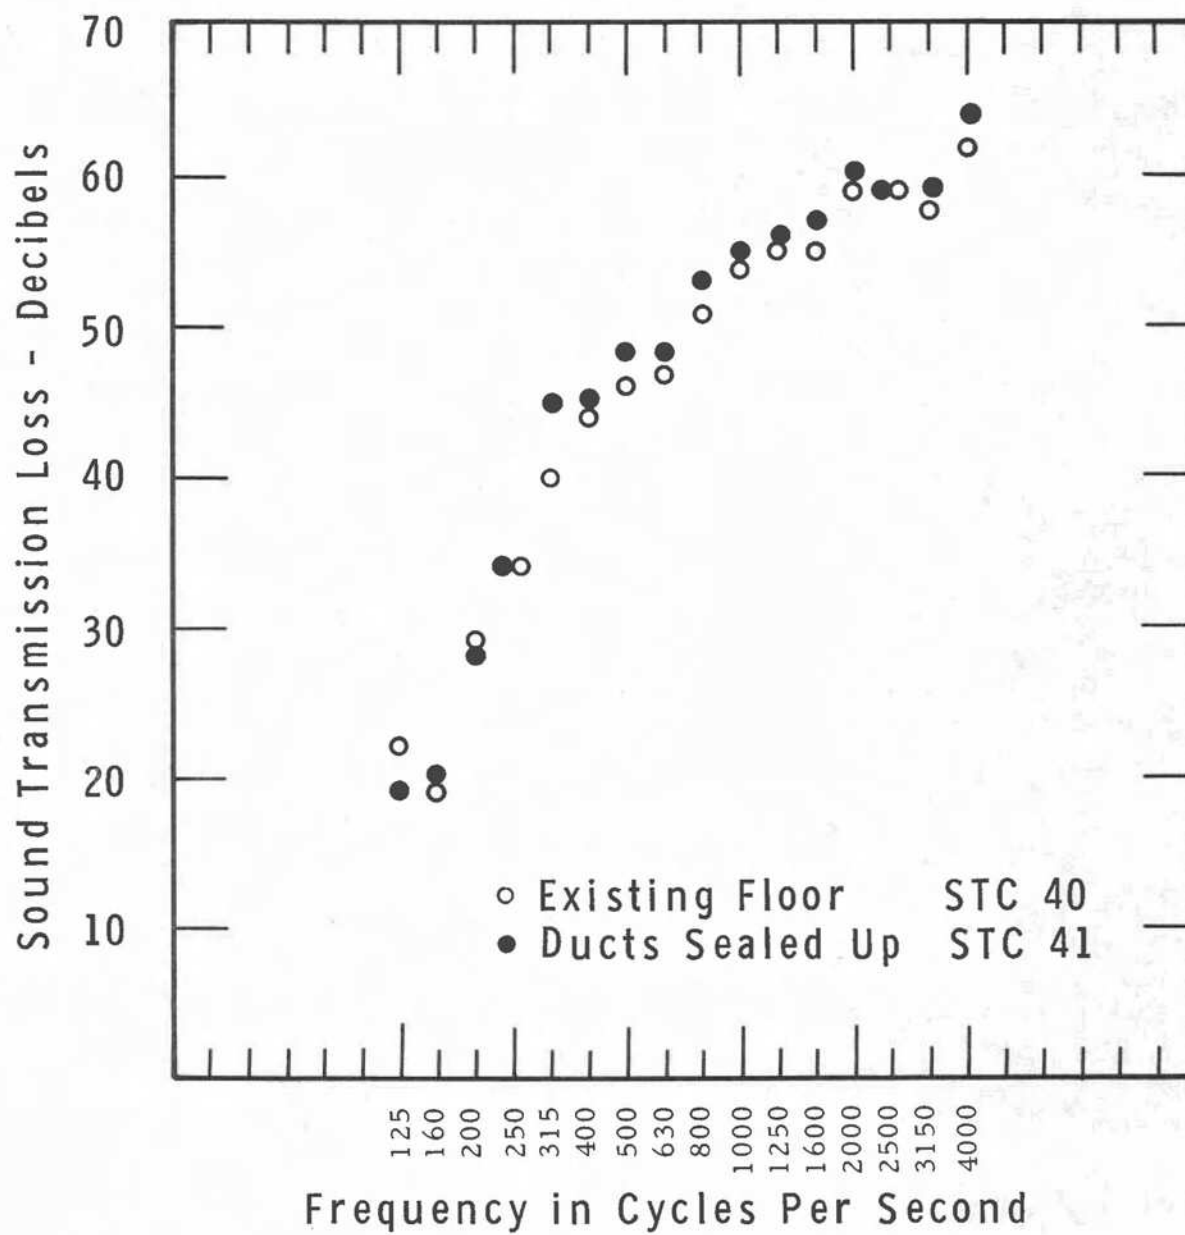
Figure 1(c)

Sound Transmission Test on Floor Separating  
Kitchens

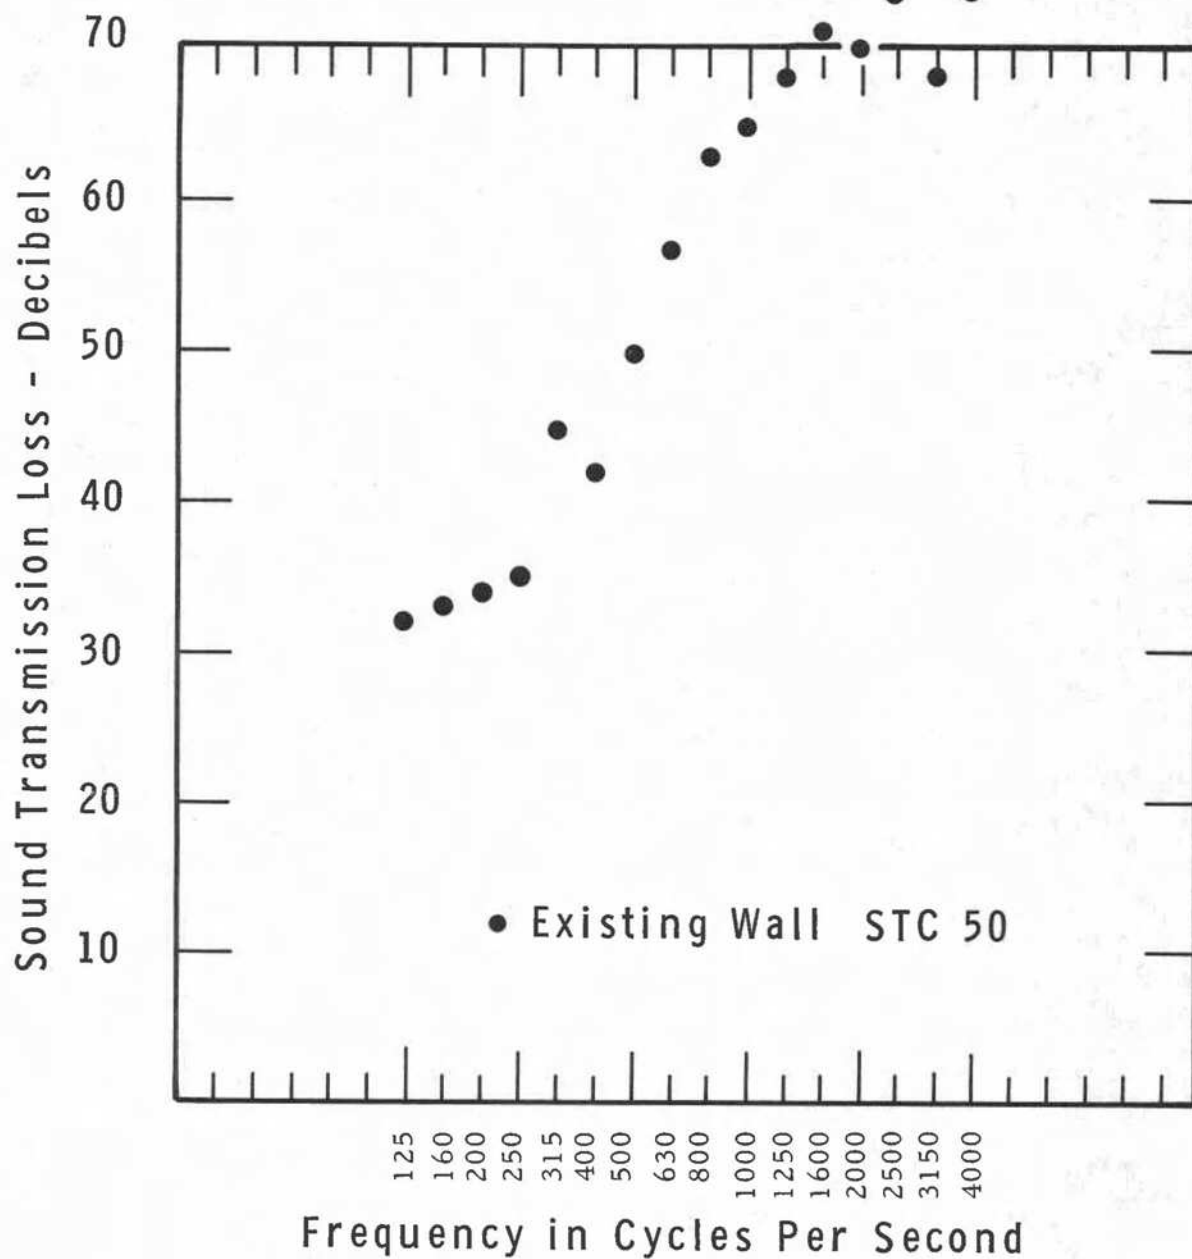
Figure 1(d)

The Sound Transmission Class 50 obtained in the one measurement of airborne sound through a party wall is about what would be expected in the laboratory. To protect against inadequacies of mortar and block porosity, it is desirable to seal with heavy paint or, preferably, plaster, one side of the block wall even though it is furred out. These precautions should help the wall to consistently achieve an STC 50 or more.

Building A:  
Sound Transmission Test on Party Wall  
Separating Bedrooms

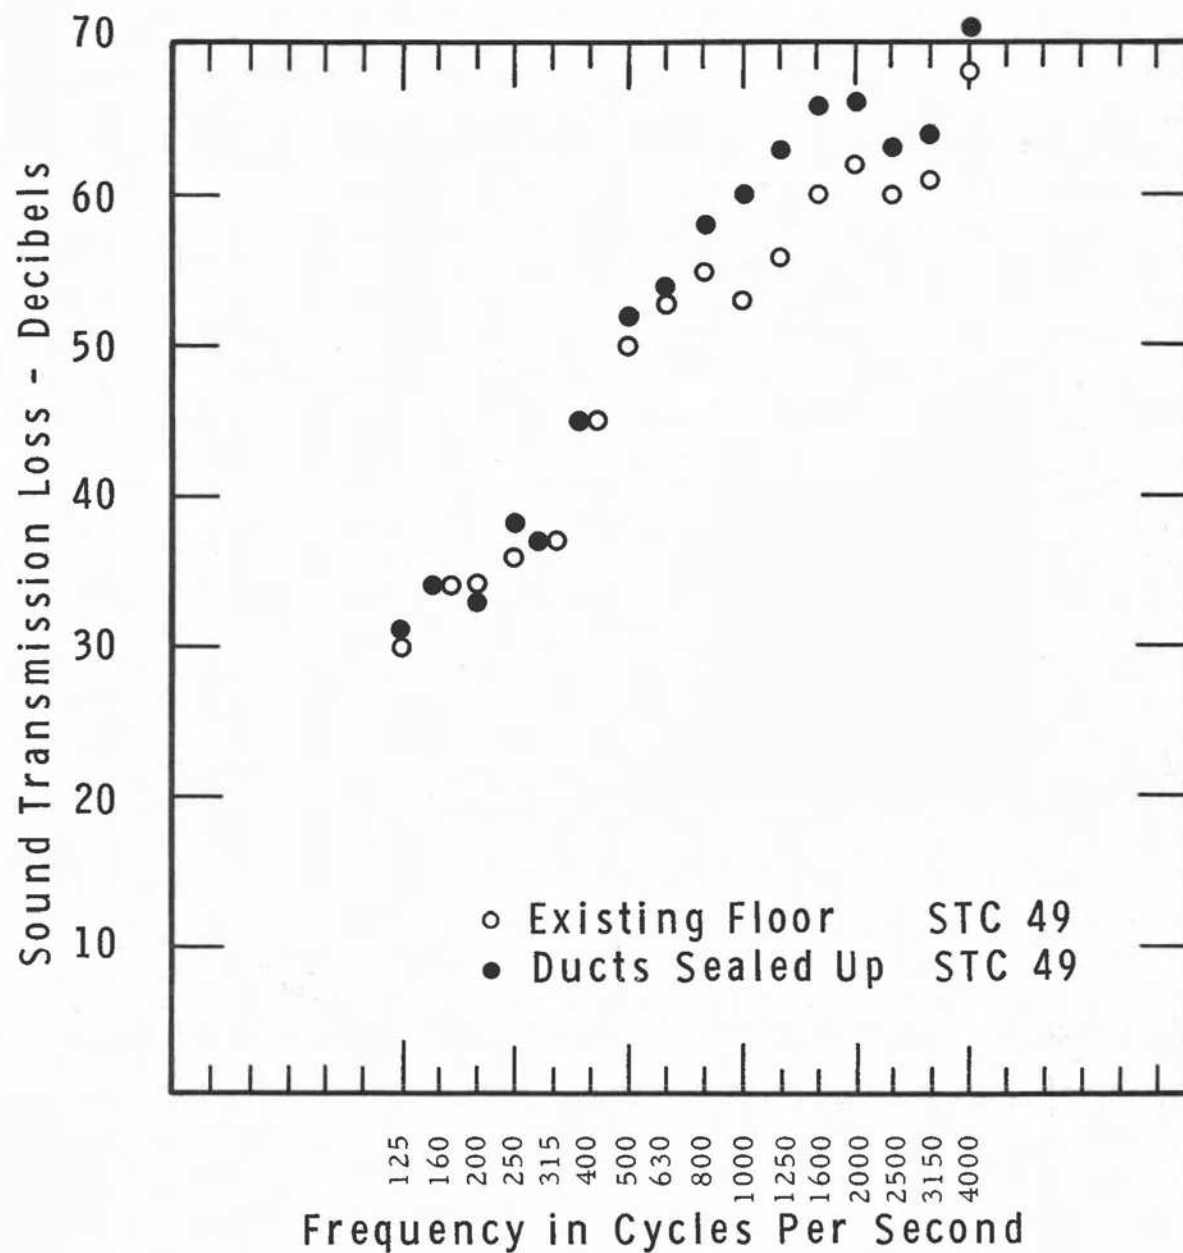
Figure 2 shows similar measurements in Building B with the same floor construction and a slightly different air distribution system in which the ducts are carried through independently in a vertical direction.

Building B, similar to Building A except for a different air distribution system in which the ducts are vertical and independent, was found to be unaffected by flanking transmission in the one room tested. The rating obtained, STC 49, is the maximum expected for this type of floor construction.

Building B:  
Sound Transmission Test on Floor Separating  
Living Rooms

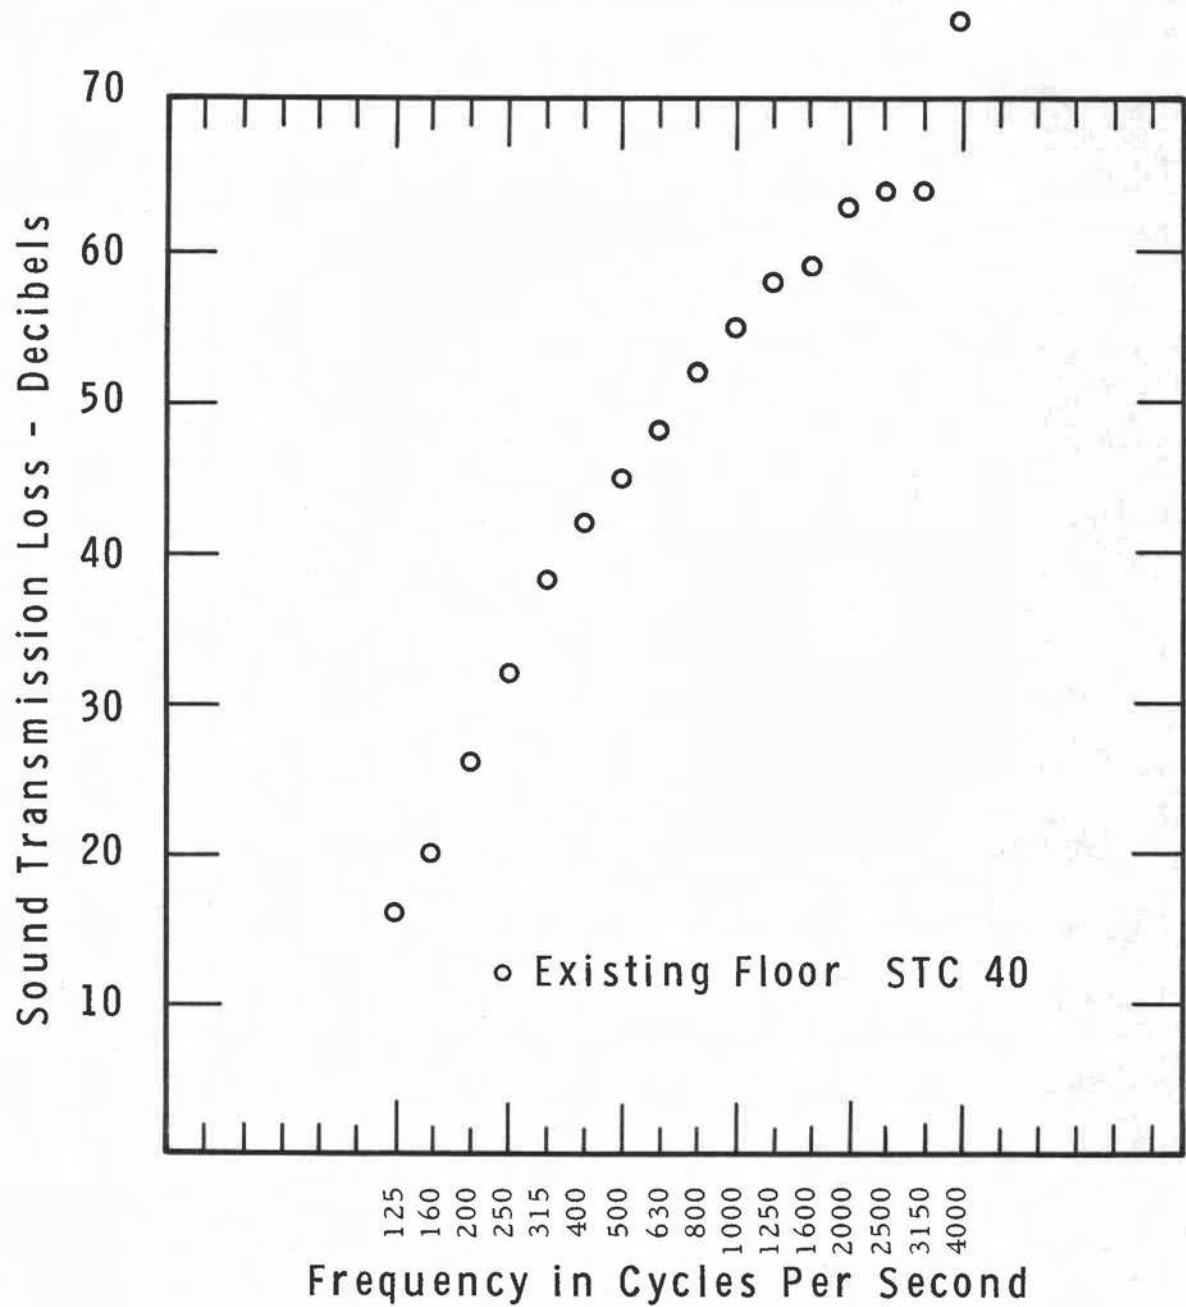
In Figure 3, data is obtained in Building C for essentially the same floor construction, except for a slightly different ceiling finish. The floor construction is free of ducts piercing the structure, as heating is by electrical means.

The most interesting inconsistency obtained was for Building C. The floor construction in this building is similar to that of Building A except for two details: (1) the fibreboard is nailed through, and (2) lath and plaster is used for the ceiling instead of plasterboard. In addition, Building C does not have any ducts piercing its floor construction. An STC 40 obtained between a set of bedrooms in this building was believed to be much too low; consequently, measurements made between a second set of bedrooms gave the same results. The effect of nailing through the fibreboard is small for airborne sounds; at most it would be 2 or 3 STC points and certainly not enough to account for the 7 to 8 dB discrepancy for this floor. The transmission loss is about normal at middle and high frequencies, but is very low at low frequencies. A possible explanation is that there is cavity communication in the external wall between upper and lower storeys. No detail is shown in the drawings, but the description suggests an unusual external wall construction, and it is possible that the

necessity of blocking at the floor level may have been overlooked. (This might be a serious omission from the fire viewpoint also.)

Figure 3  
Building C:  
Sound Transmission Test on Floor Separating  
Bedrooms

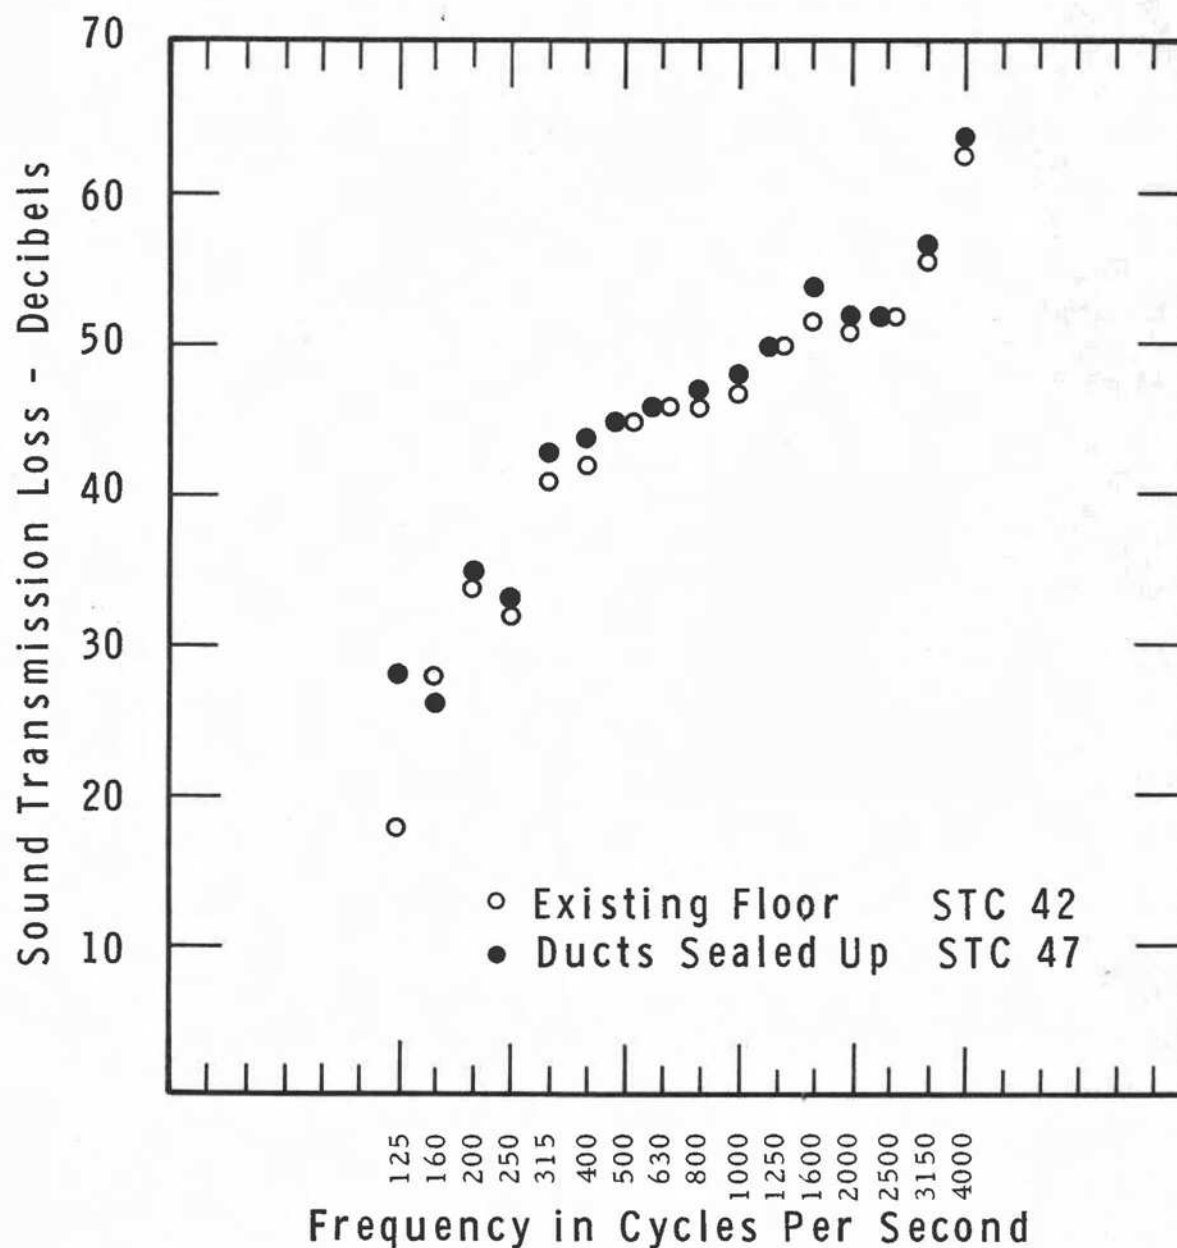
Figure 4 shows transmission loss data for Building D on a standard wood joist floor with plywood subfloor and a resilient channel suspension for the ceiling. The heating system is the same as that used in the second building.

Building D shows evidence of flanking transmission for the air distribution system with vertical ducts carried through independently.\* For this building, the combined floor area of living room and hallway was tested. The STC rating obtained for the unmodified floor is dictated by a severe dip in the low frequency range where measurement itself is quite difficult. Thus, the measured improvement obtained by sealing the ducts is not very precise. In addition, Building D was not completely finished and the measurements made are not as reliable.

Building D:  
Sound Transmission Test on Floor Separating  
Combined Living Room and Hallway Areas of  
Each Apartment
