PROBLEMS WITH CONCRETE TOWER SILOS

by M. Bozozuk

Reprinted from
Canadian Agricultural Engineering
Vol. 21, No. 2, December 1979
9 pp.

DBR Paper No. 877
Division of Building Research

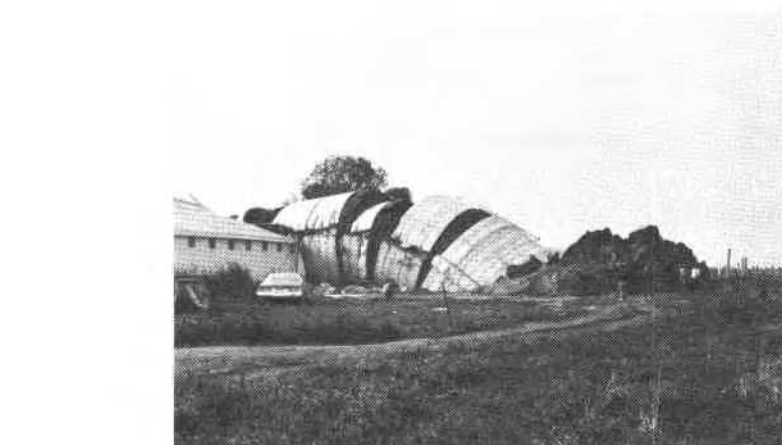
Figure 1. Bearing capacity failure of soil for 9.14-m diameter, 32.3-m high concrete silo at Richmond, 30 Sept. 1975.

On 30 Sept. when the silo was being filled, it overturned at a load of 1800 tonnes (Fig. 1). The combined mass of the structure and its contents at the time was 2260 tonnes. In falling, it destroyed a large part of a new barn, and damaged part of an old one; the

explosive force on impact blew the roof off the silo and overturned a truck parked on the other side of the new barn. Neighbours 0.5 km away felt the ground vibrations at the time of impact. Fortunately the livestock were evacuated from the barn just prior to the failure.

When the silo was being filled, it was observed that the concrete footing had cracked. As filling continued, the cracks widened, the toes of the cracked sections heaved, and the silo started tilting, at which time filling was suspended. Unfortunately the contact area under the foundation was reduced, and the silo overturned.

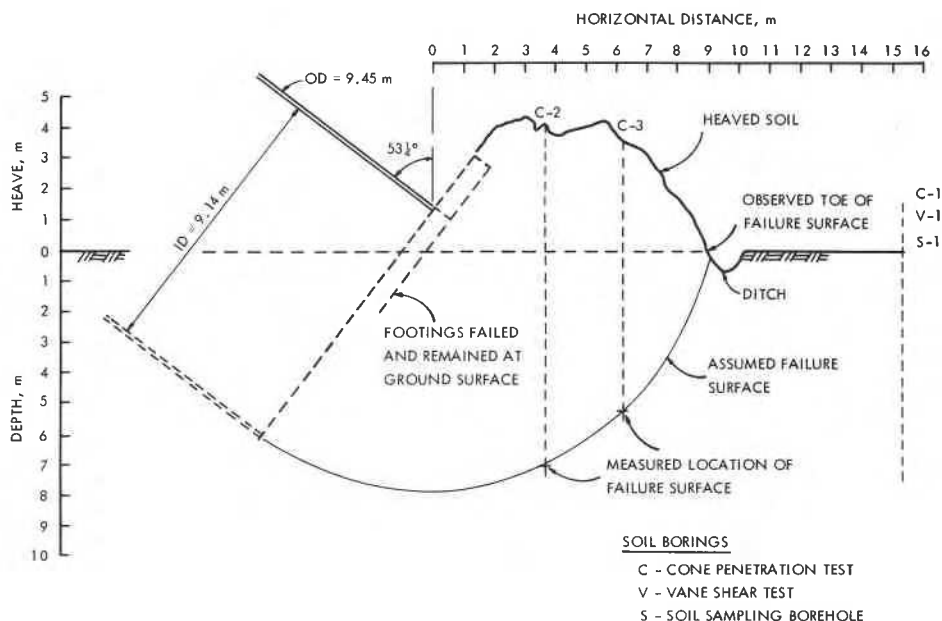
Figure 2. Richmond silo after failure showing silo heave, location of sliding surface and location of soil borings.

The position of the silo foundation after failure is shown in Fig. 2. The intact part of the silo was inclined 53° from the vertical. As the base rotated, part of the silo tube sank 6 m, whereas the opposite edge heaved 1.5 m. The soil heaved for a distance of 9 m and formed a mound about 4.5 m high.

The cone penetration tests were conducted through the heaved soil to locate the failure surface. As shown in Fig. 2, the soundings and the profile of the heaved soil delineated a failure surface which compared well with the theoretical circle of failure.

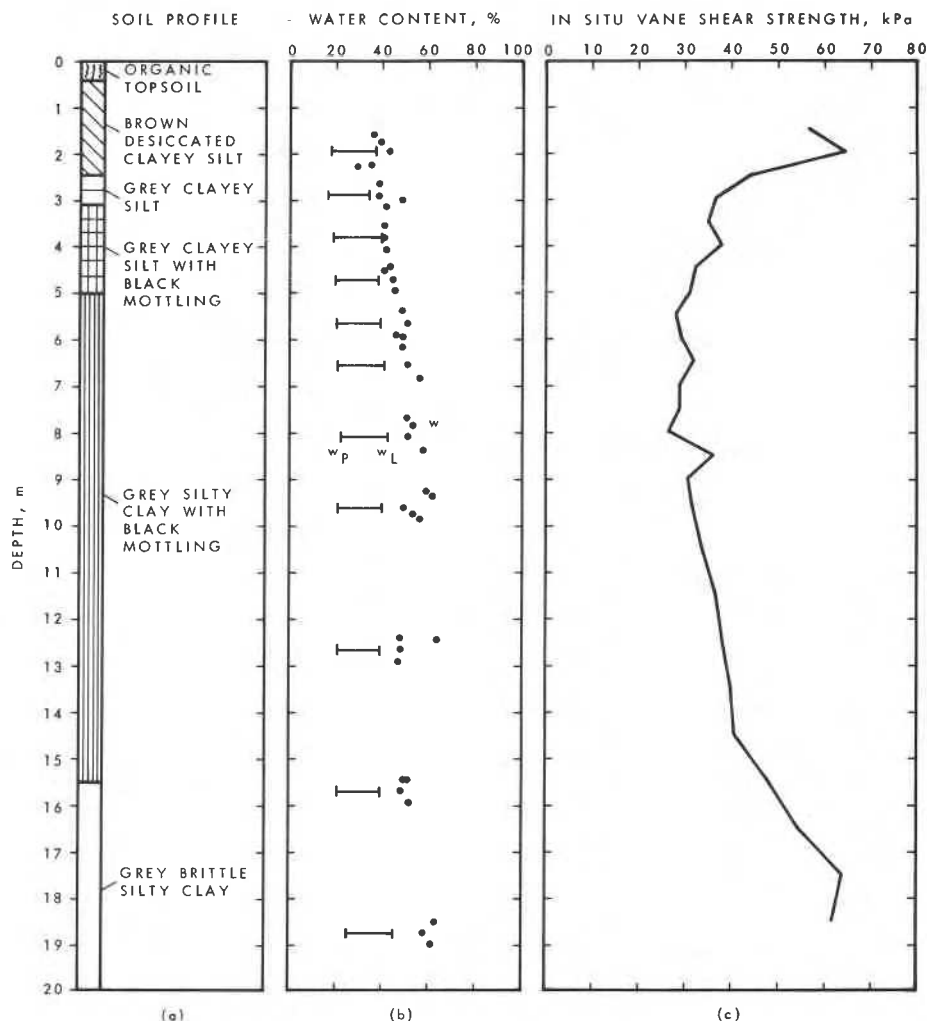
The soil profile is shown in Fig. 3a. Below the topsoil, a hard desiccated brown clayey silt formation extended to a depth of 2.4 m, the depth where the groundwater table was encountered. The underlying material was a softer gray clayey silt with traces of black mottling at 3.1 m. At 5.0 m the soil changed to gray silty clay with black mottling. This formation extended to a depth of 15.5 m. The last 4.5 m of the borehole contained brittle gray silty clay with no mottling.

The classification tests (Fig. 3b) indicated a plasticity index of 20% and a liquid limit of 40% for the soil profile. (The classification test results are indicators of the engineering behavior of the soils (Lambe 1951)). At 2 m the water content of the soil was about equal to the liquid limits, but it gradually increased with depth to 60% at 9 m indicating that the clays were extremely sensitive. Grain size analysis showed 37% clay and 63% silt size particles at 2 m, changing almost linearly with depth to 58% clay and 42% silt at 16 m.

The in situ shear strength of the soil measured with the NGI vane (Andresen and Bjerrum 1956) is shown in Fig. 3c. The strength was quite high in the desiccated crust, reaching 65 kPa. It reduced rapidly to 45 kPa at the base of this formation and continued to decrease to a minimum of 31 kPa at 5 m. The strength was about constant for the next 3 m, then increased with depth to the bottom of the boring. The average shear strength below the footing to a depth of two-thirds the outside diameter of the ring foundation was 36.5 kPa.

Figure 3. Engineering properties of soil at Richmond.

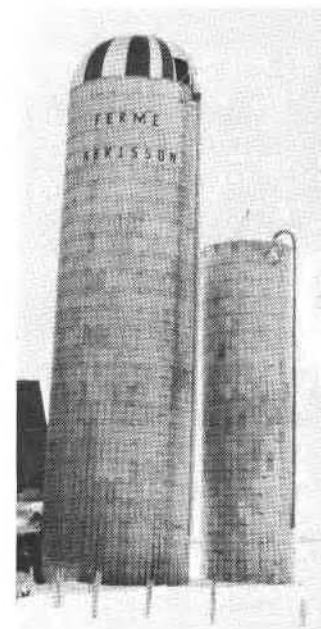
Figure 4. Casselman silo, 6.10 m diameter, 21.34 m high, leaning 765 mm from the vertical, 31 Jan. 1978.

Three concrete stave silos were constructed in a row on a marine clay plain about 40 km east of Ottawa. Number 1 was a 4.88-m diameter silo, constructed 6 yr ago to a height of 12.2 m. In 1977 it was raised to a height of 18.29 m. Number 2 was a 6.10-m diameter silo, 21.34 m high, constructed in 1975. Number 3 was 4.27 m in diameter, 15.2 m high, erected in 1977, and was empty. Number 1 performed well, even after its height was raised in 1977. Number 2 performed well but was never filled until 1977 when it was filled to capacity for the first time with wet grass silage to a height of 16 m, and topped with wet corn silage. Following this loading it started to lean drastically as shown in Fig. 4.

Silo No. 2 had settled vertically about 20 cm and was tilting 765 mm (2.05°) from the vertical, whereas Nos. 1 and 3 were performing satisfactorily. To determine

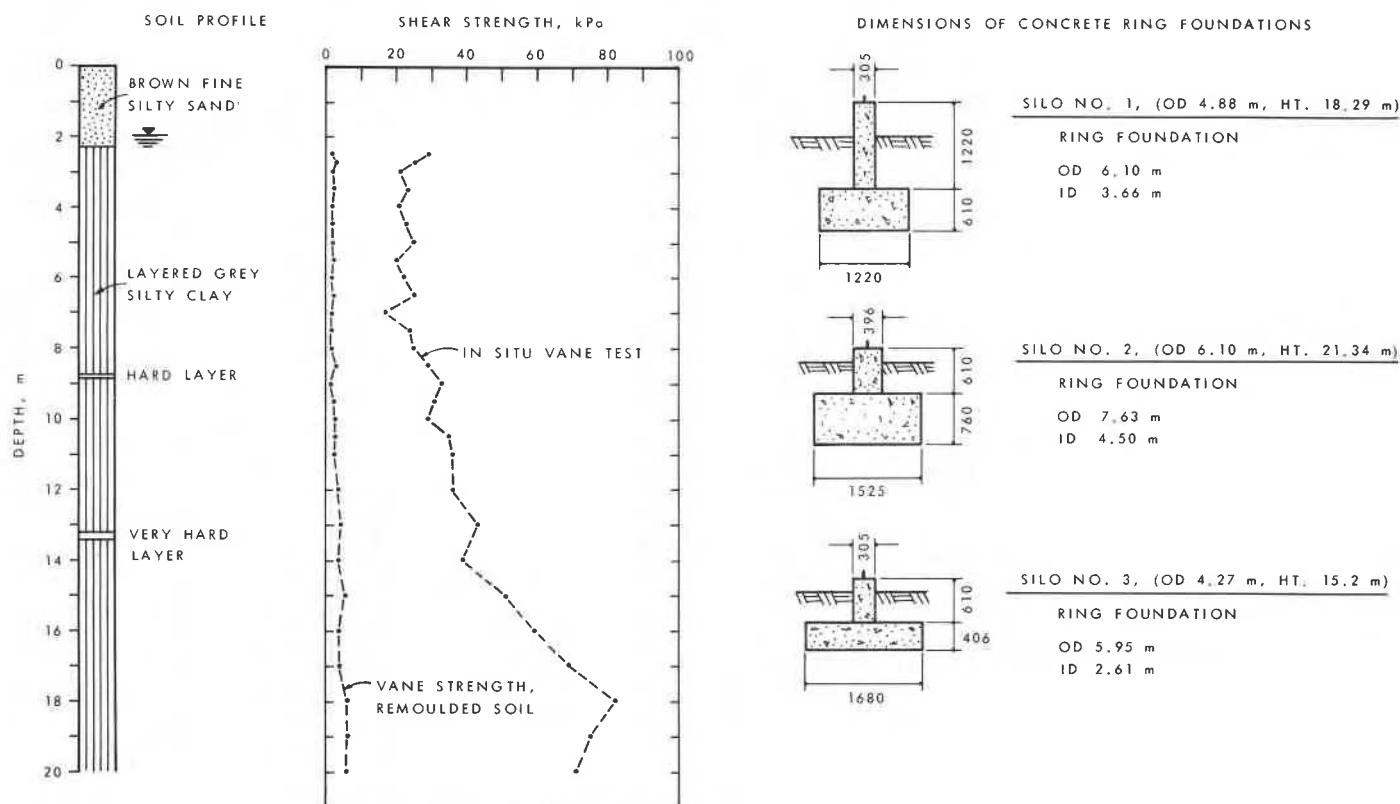
Figure 5. Soil profile, in situ vane shear strength and dimensions of concrete foundations for silos at Casselman.

The ring foundations for Nos. 1 and 3 were nonreinforced cast-in-place concrete with the dimensions given in Fig. 5. Drains were included in No. 1 to handle the silage juices.

The ring foundation for No. 2 was similar in design but larger (Fig. 5). Steel reinforcing was not used and drains were not installed. This foundation was constructed by the owner, who excavated a circular trench to the required dimensions using a backhoe.

Soil borings and in situ vane tests were performed in May 1978. Although samples were not taken for testing, the borings indicated 2.3 m of fine brown silty sand over layered gray silty clay (Fig. 5). The groundwater table was at a depth of 2 m.

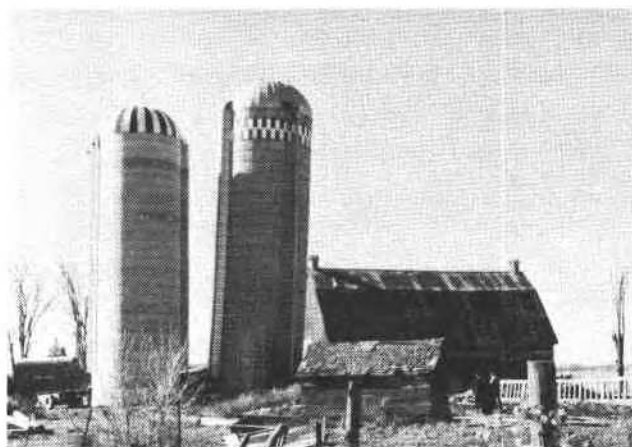
Figure 6. Foresters Falls silo, 6.10 m diameter, 21.34 m high, leaning 1213 mm from the vertical, 3 Nov. 1978.

On 3 Nov. 1978, measurements on the silo showed that it was leaning 1178 mm (3.16°) from the vertical in a direction away from the concrete silo and towards the barn. The spherical roof had flattened on two sides and bulged over the walls of the silo on the other two sides by about 20 cm (Fig. 7a) because the top part of the silo had deformed from a circle to an ellipse. Many of the concrete staves had cracked. These cracks were horizontal (Fig. 7b), diagonal (Fig. 7c) and vertical (Fig. 7d). They were caused by the stresses imposed on the staves as the silo leaned, twisted and bulged on its foundation. Two steel hoops near the base of the silo were also broken. Silage juices were seen bubbling up through the soil around the

It was evident that the structure was near collapse. If it fell it would destroy the barn, and the heaved soil from the rotation of the foundation could overturn the new cast-in-place silo located immediately behind it (Fig. 6). It had to be unloaded and dismantled as quickly as possible. Attempts to start the unloader located at the top of the silo were to no avail. Because the silo was no longer circular, the unloader would not work. It could be made to work with constant attention and adjustments, but was it safe to enter the silo? Was the silo still moving; how far could it lean before it fell over?

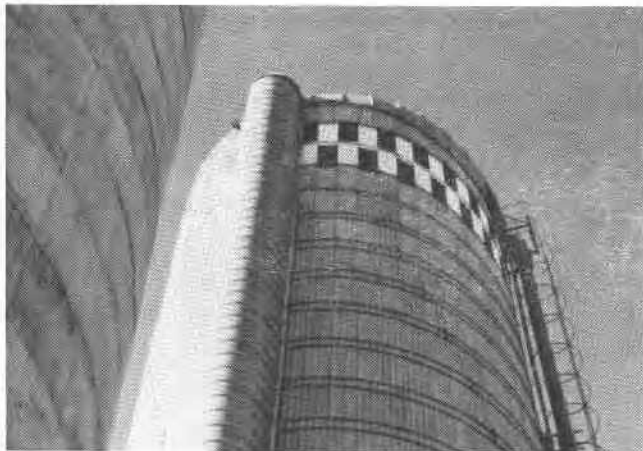
Figure 7a. Effects of structural distortion on silo: Overlapping bulge of roof due to distortion of stave.

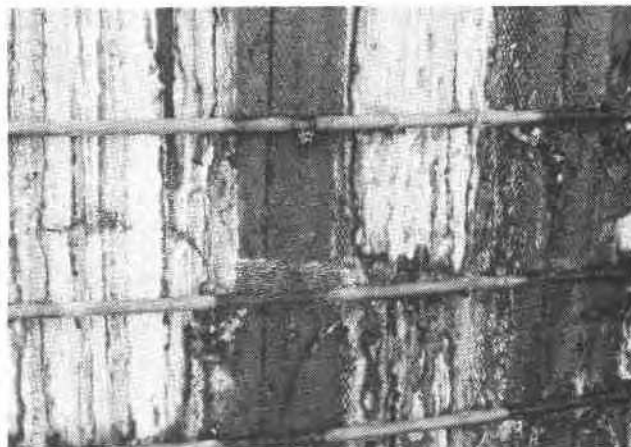
Figure 7b. Effects of structural distortion on silo: Horizontal cracks in concrete staves.

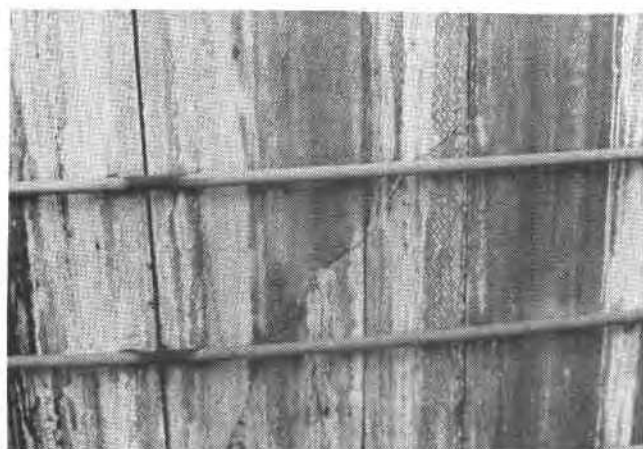
Figure 7c. Effects of structural distortion on silo: Diagonal cracks in staves.

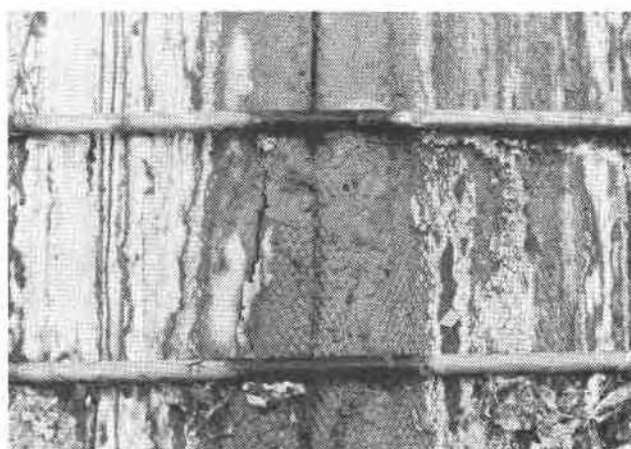
Figure 7d. Effects of structural distortion on silo: Vertical splitting and spalling of staves.

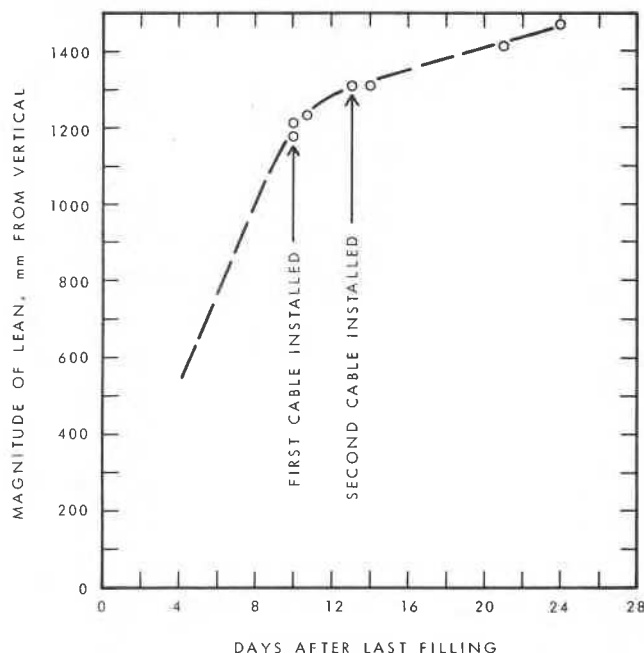
Measurements taken late in the afternoon of 3 Nov. showed that after 3½ h, the tilt had increased by 35 mm to 1213 mm (3.25°) from the vertical. It was not safe to climb the silo. To stop this rapid movement and perhaps prevent the silo from overturning, a steel cable was fastened to one of the steel hoops, 15 m above the base, and anchored to two large trees 80 m away. A few days later a second cable was attached to the silo 18 m above the base. The movements, as shown in Fig. 8, were drastically reduced, enabling the owner to modify the unloader and start removing the silage. The additional movement measured after the cables were attached was partly due to the upper part of the silo flattening out into a flatter ellipse because the steel cables were anchored to the flexible steel hoops at one point only.

Figure 8. Tilt measured on leaning silo at Foresters Falls.

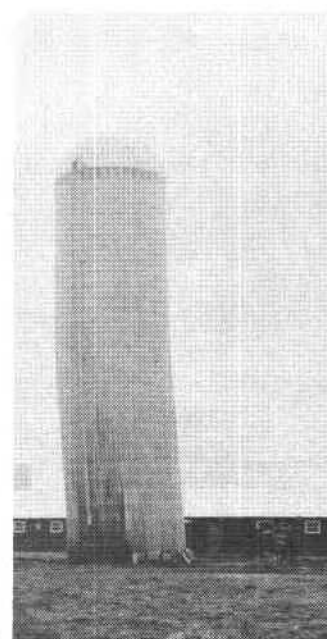
Figure 9. Embrun silo, 7.32 m diameter, 24.38 m high, leaning 1475 mm from the vertical, 7 Nov. 1978.

Measurements on the structure showed that the silo had tilted 1475 mm (3.46°) from the vertical, and that the foundation had settled differentially 130 mm on the side of the lean. The foundation was not cracked and the drains were working well.

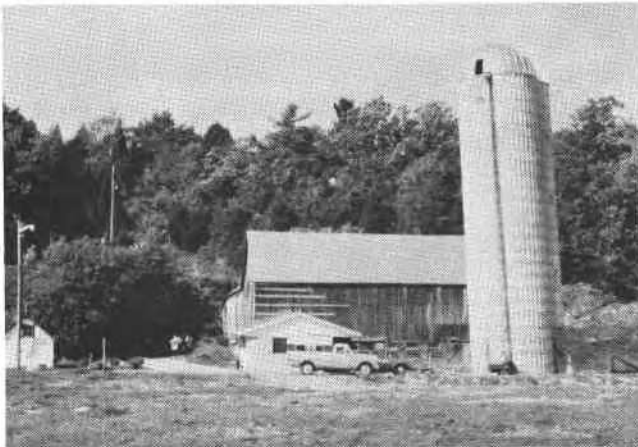
Figure 10. Mallorytown silo, 4.88 m diameter, 18.29 m high, leaning 737 mm from the vertical, 29 Sept. 1978. Rock escarpment behind barn.

Measurements on the silo showed that it was leaning 737 mm (2.31°) from the vertical, and that the foundation had settled more on the side of the tilt by about 175 mm. The concrete ring foundation was 610 mm wide, 1370 mm thick, with drains.

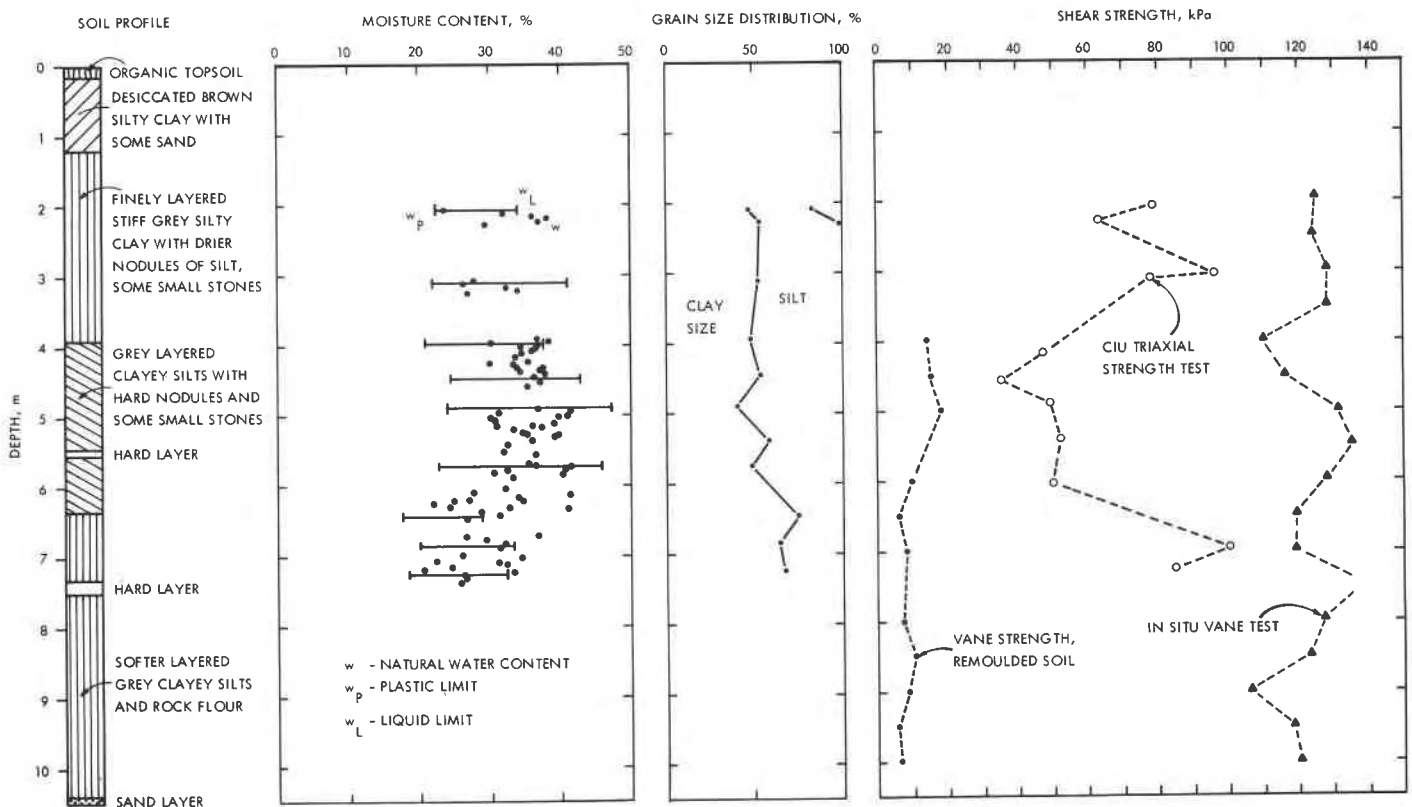
Figure 11. Engineering properties of soil at Mallorytown.

tests (Fig. 11) indicated a soil of low plasticity, with an average plasticity index of 16%. The natural water content varied from 21 to 41% and was generally less than the liquid limit of the soil. Based on the grain size analysis and the plasticity index, the soils were mainly finely ground rock flour, which behaves as a pure silt.

The in situ shear strength of the soil measured with the NGI vane (Fig. 11) varied with depth from 107 to 135 kPa. The average strength below the foundation to a depth of two-thirds of the outside diameter of the foundation was 120 kPa.

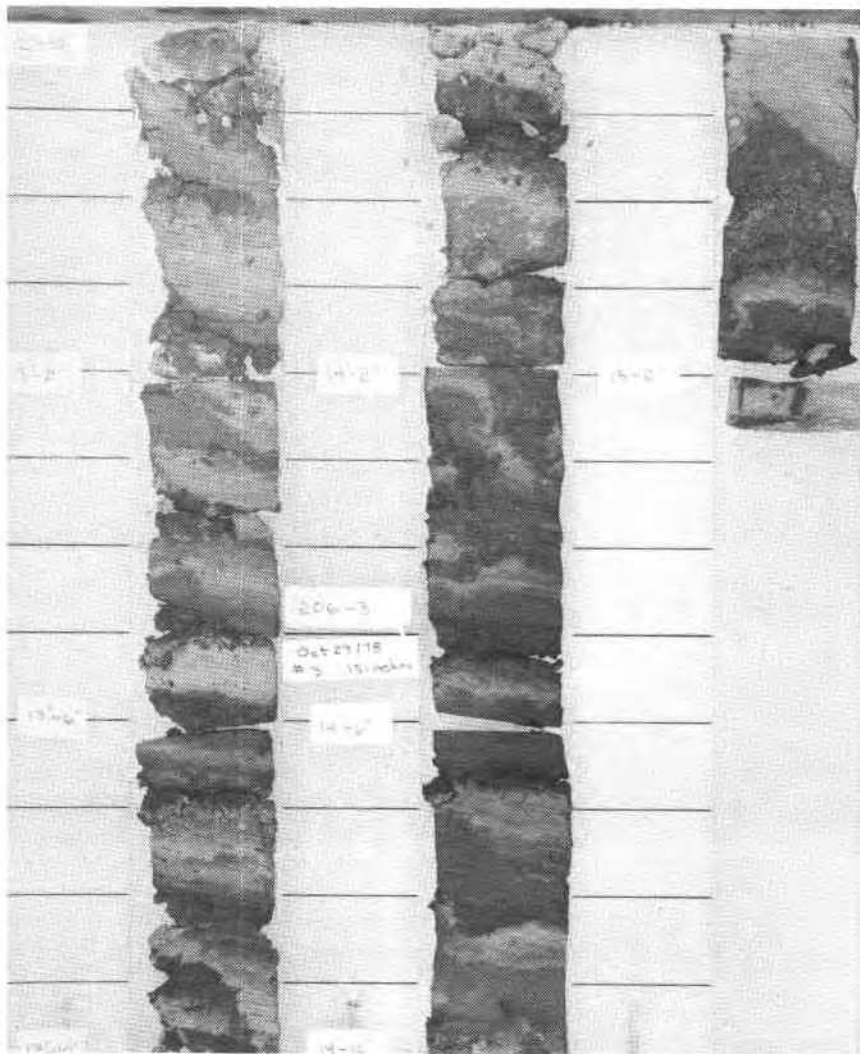
Figure 12. Layered soil formations at Mallorytown silo.

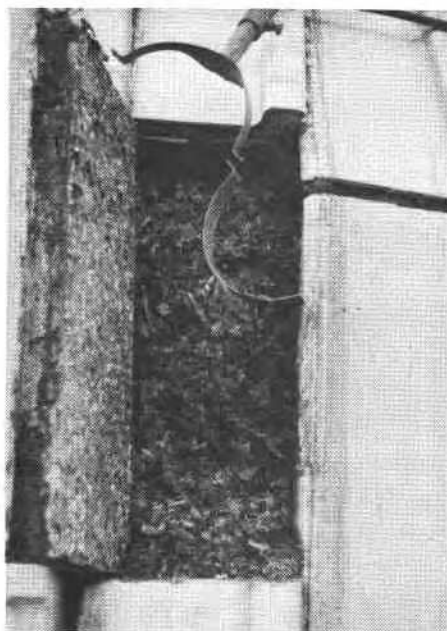
Figure 13. Effect of acid attack on staves in collapsed silo near Harriston, 1974. Photo courtesy H.E. Bellman, OMAF, Walkerton, Ont.

9.14 m in diameter, 24.38 m high, near Harriston, Ontario, fell over. Visual inspection of the failure indicated that silage acids had attacked the concrete and reduced the effective thickness of some staves at the base of the structure from 51 to about 38 mm (Fig. 13). Structural tests were not performed on the staves, but it is probable that the loss in strength was proportionally greater than the reduction in thickness. The owner reported that some of the staves had buckled and crushed prior to the collapse.

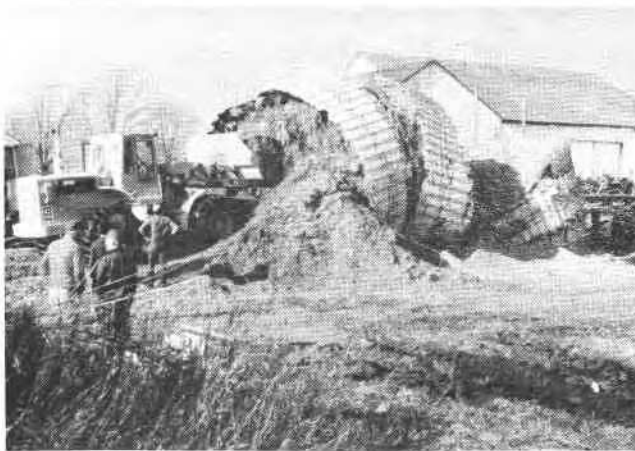
Figure 14. Port Elgin silo, 7.32 m diameter, 21.34 m high. Collapse due to acid attack on staves at base of silo, 1978. Photo courtesy H.E. Bellman, OMAF, Walkerton, Ont.

In 1978, a 12-yr-old stave silo 7.32 m in diameter, 21.34 m high, collapsed near Port Elgin about 2 wk after being refilled for the second time (Fig. 14). Visual inspection of the staves near the base of the silo showed that a considerable amount of deterioration had occurred due to chemical attack from silage acids (Fig. 15). The standard 51-mm thick concrete staves were reduced to less than 41 mm thick, and had an extremely crumbly and porous interior surface. It was practically impossible to locate an unbroken stave in the debris at the base of the silo.

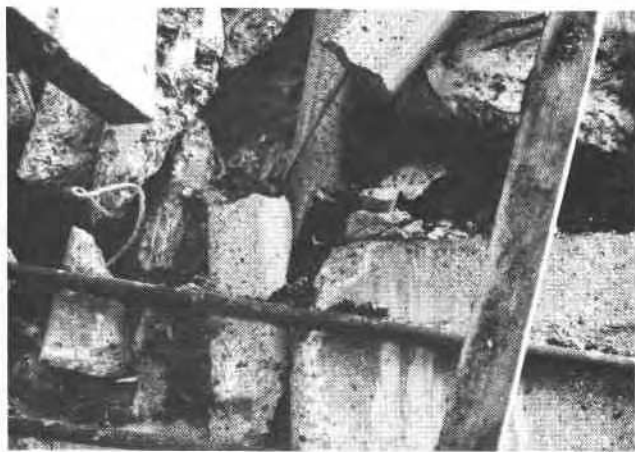
Figure 15. Port Elgin silo, condition of staves in collapsed silo, showing deterioration from acid attack. Photo courtesy H.E. Bellman, OMAF, Walkerton, Ont.
