The Tire Fire at Saint Amable, Quebec, May 16 to 19, 1990

J.R. Mawhinney, P.Eng.

Internal Report No. 595

Date of Issue: July 1990

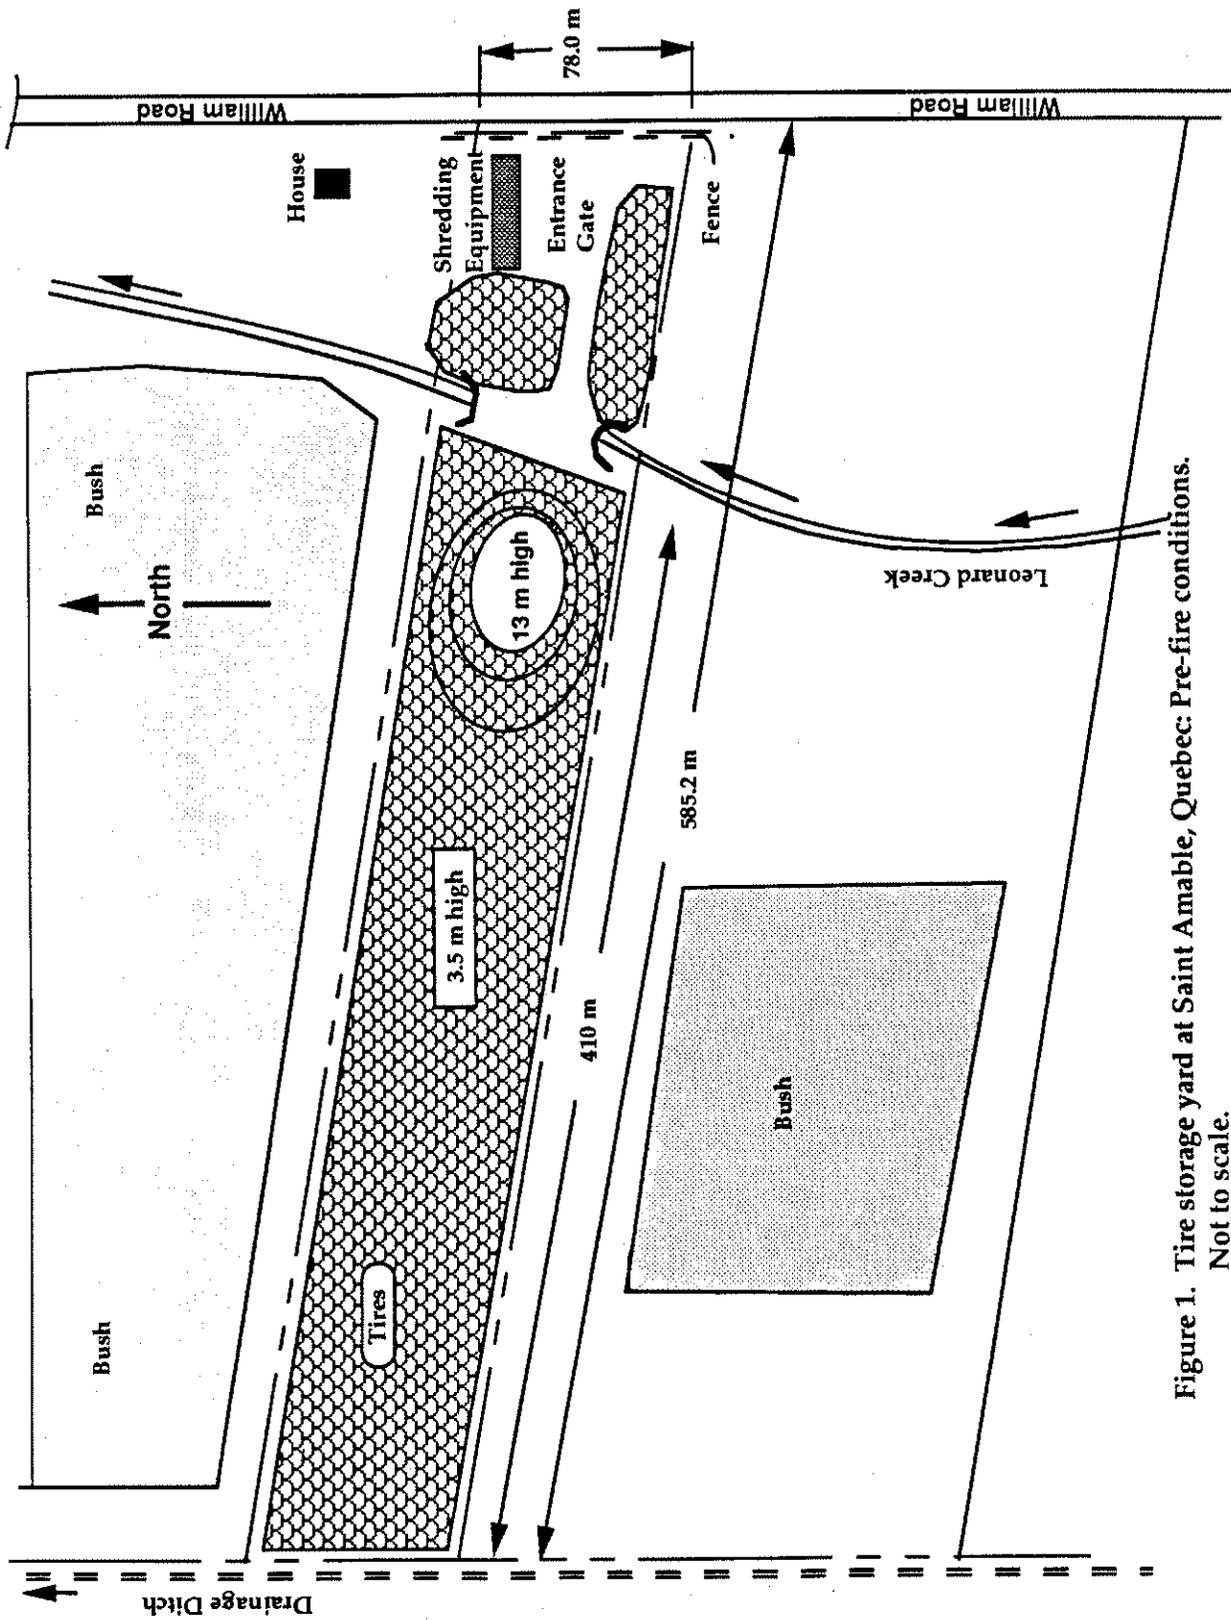
The first 150 m in from William Road, at the eastern end of the property, was used for receiving and sorting tires. At the time of the fire, this area was being used to shred tires in an attempt to recycle the rubber, and thereby reduce the number of tires on the site. The mass of scrap tires that burned had been built up over many years on the back part of the property, stretching from Leonard Creek in a continuous pile 410 m to the west property line, across the full 78 m width of the property. No roadway had been constructed around the perimeter of the pile, and an internal roadway, that at one time provided access to the west end of the property, had reportedly become blocked with tires.

A crane had been used to pile tires to an estimated height of 13 m at the east end of the pile, nearest the stream. Beyond the reach of the crane, however, the average height of the tire pile was only about 3.5 m. In total, the pile covered an area of 31,000 m² to an average depth of 3.5 m, with a mound approximately 13 m high stretching for about 20 m at one end. It is very difficult to estimate the number of tires contained in the pile, given that large truck tires were mixed with smaller automobile tires. It may be more accurate to characterize the size of the fuel load by the overall volume of the pile, rather than the number of tires. In this case, the total volume of tires is estimated to have been about 125,000 m³.

Figure 1. Tire storage yard at Saint Amable, Quebec: Pre-fire conditions.
Not to scale.

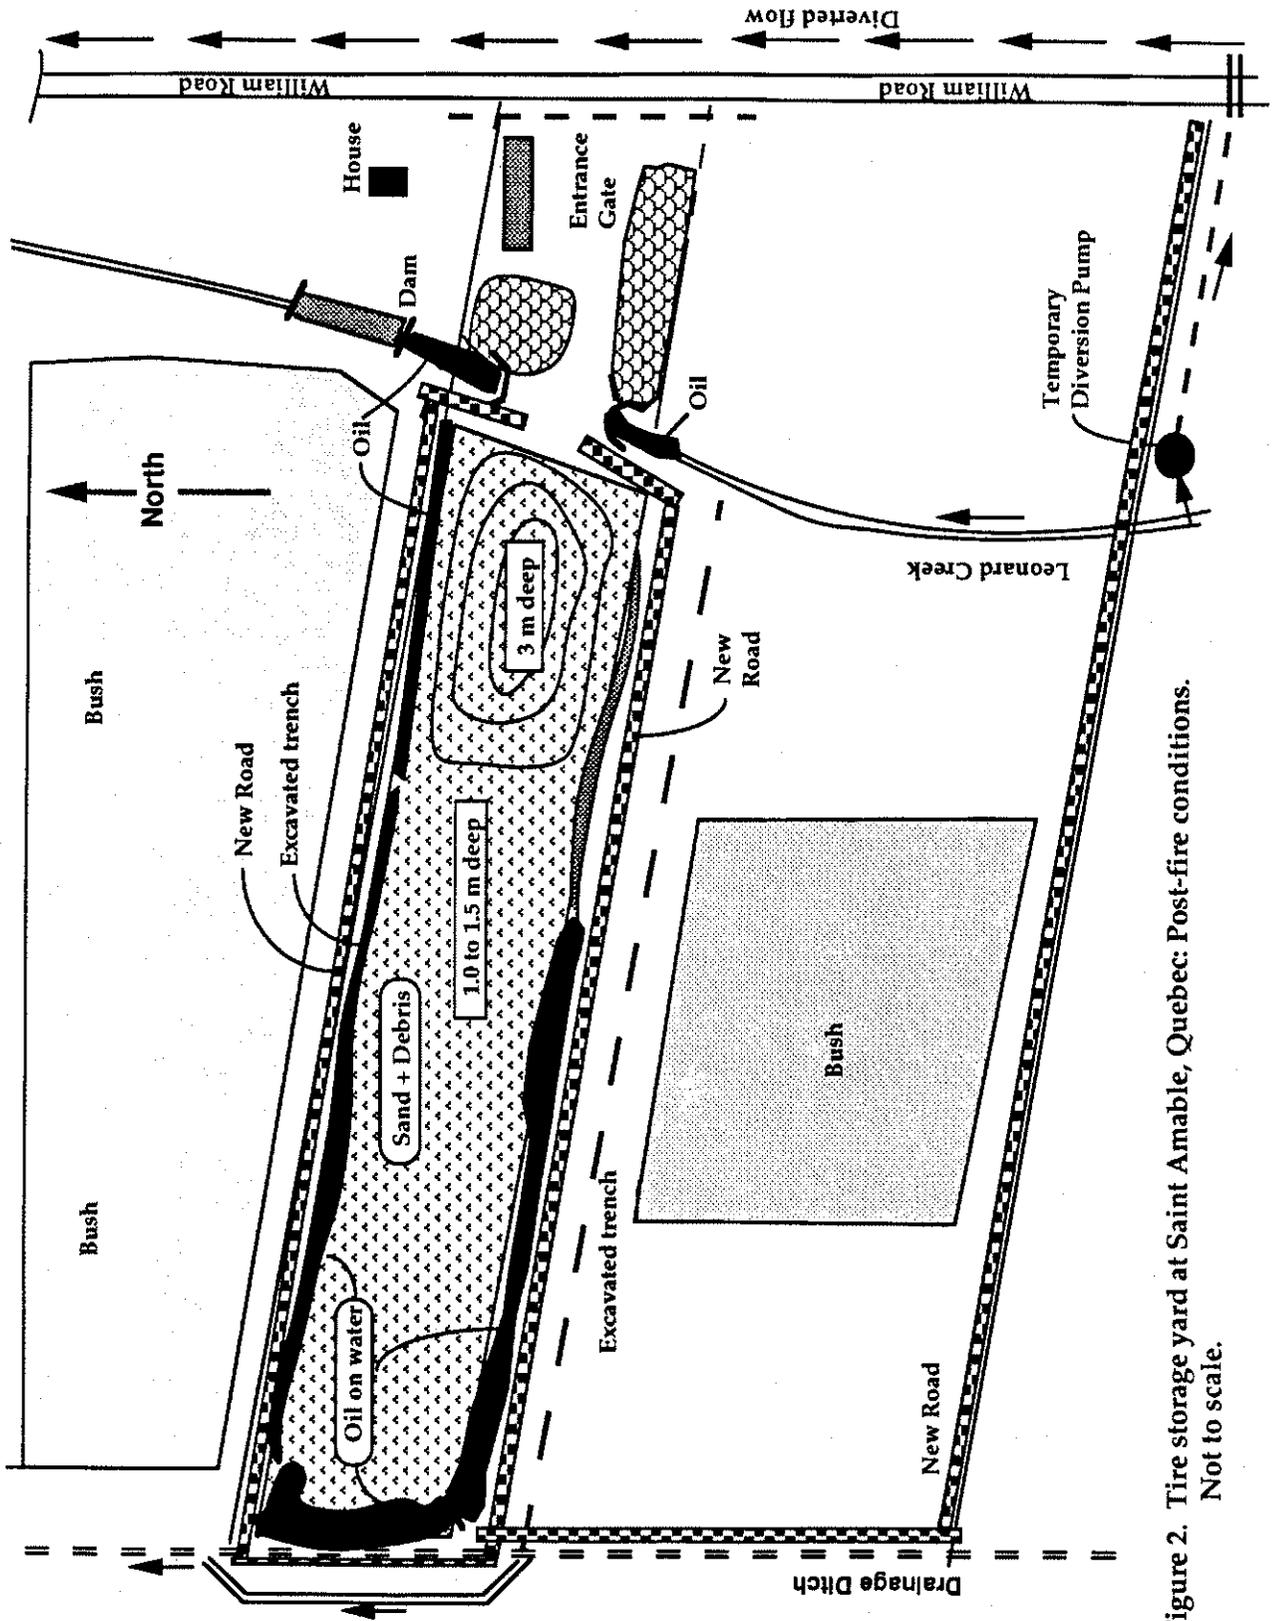
On Thursday, sand and gravel were brought in from nearby pits to construct an access road along the north side and around the southeast corner of the pile (see Figure 2), upwind of the smoke plume. Late Friday, the wind shifted to come from the south, pushing the column of dense, black smoke to the north thus making the north side inaccessible. Equipment operators then began building a road and drainage trench along the south side of the pile. In addition, a road was pushed in from the south, across the adjacent fields, along the drainage ditch at the west end of the property.

In order to reduce the flow of water in Leonard Creek, an engine-driven dewatering pump was set up approximately 350 m upstream (south) of the property (see Figure 2). Pipe was then laid on the surface of the ground to William Road. A local contractor installed a pipe under William Road using a "push-pipe" technique, so that water from the creek could be diverted into the drainage ditch on the south side of William Road without

Figure 2. Tire storage yard at Saint Amable, Quebec: Post-fire conditions.
Not to scale.
