### Damage by spalling of painted brickwork of former C.M.H.C. houses in Kingston Ritchie, T.

*Technical Note (National Research Council of Canada. Division of Building Research); no. TN-133, 1952-11-21*

SUBJECT Damage by Spalling of Painted Brickwork of Former C.M.H.C. Houses in Kingston

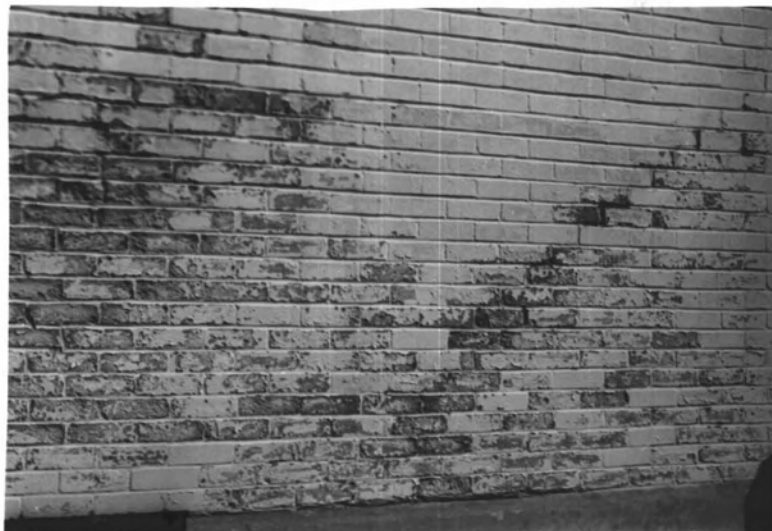
Fig. 1 South Wall of 325 Palace Road, Kingston

The south wall of 325 Palace Road has been extensively disfigured by flaking and spalling of paint and masonry at the surface of the wall. This is shown by the photographs in Fig. 1 and Fig. 2. In almost all cases, a piece of brick or mortar has been removed with the flake of paint. Most of the exposed areas of brick have a slight film of greyish white salt deposit.

The damage has occurred only on the south walls of the buildings. These walls face Lake Ontario, and may be subjected to greater rain than the other walls (Mrs. Symons pointed out that the south wall of her basement and not the others showed dampness in heavy rains). Also, the south walls probably undergo a greater number of temperature fluctuations above and below freezing.

The painting of the wall surfaces with what was probably an oil-base type paint, which would probably effectively seal the surface, undoubtedly is related to the damage.

The disfigurement of the houses through the spalling or flaking at the surface probably requires that some repair programme will be carried out. Removal of the paint would seem to be desirable to guard against a continuation of the trouble. This could be done by sand-blasting or other abrasive methods or possibly by the application of heat.

If the surface is re-painted it would seem advisable to use a porous, non-sealing type of paint (cement-base type).

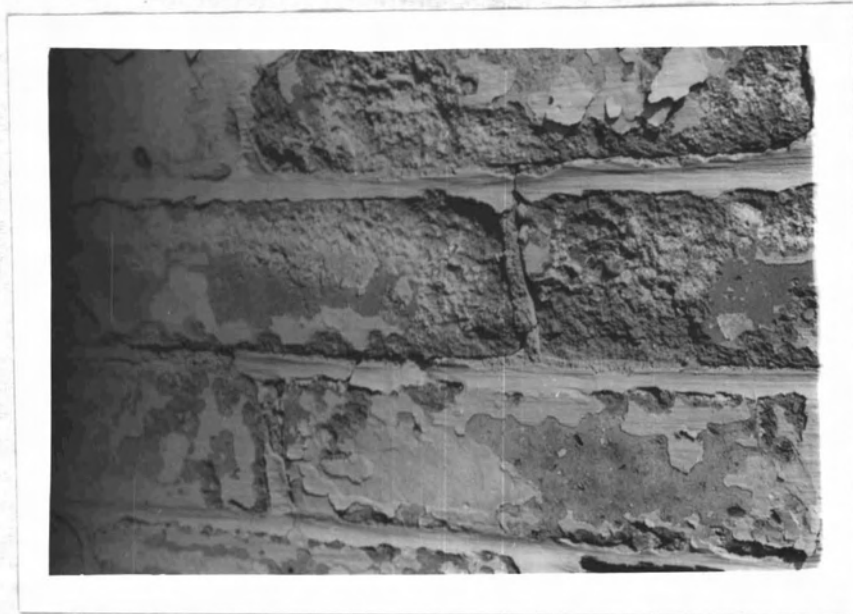
Fig. 3 South Wall of 325 Palace Road, Kingston

The spalled surface is shown in greater detail in the photograph of Fig. 3.

Another explanation of this damage may be found in the slight efflorescence noted in areas where spalling had taken place, the possibility being that a formation of salts beneath the surface has exerted enough pressure to flake off the surface. It is felt, however, that the salt formation probably took place after the flaking of the surface.
