### An example of the entry of snow through an attic vent

408

# TECHNICAL NOTE

AN EXAMPLE OF THE ENTRY OF SNOW THROUGH AN ATTIC VENT

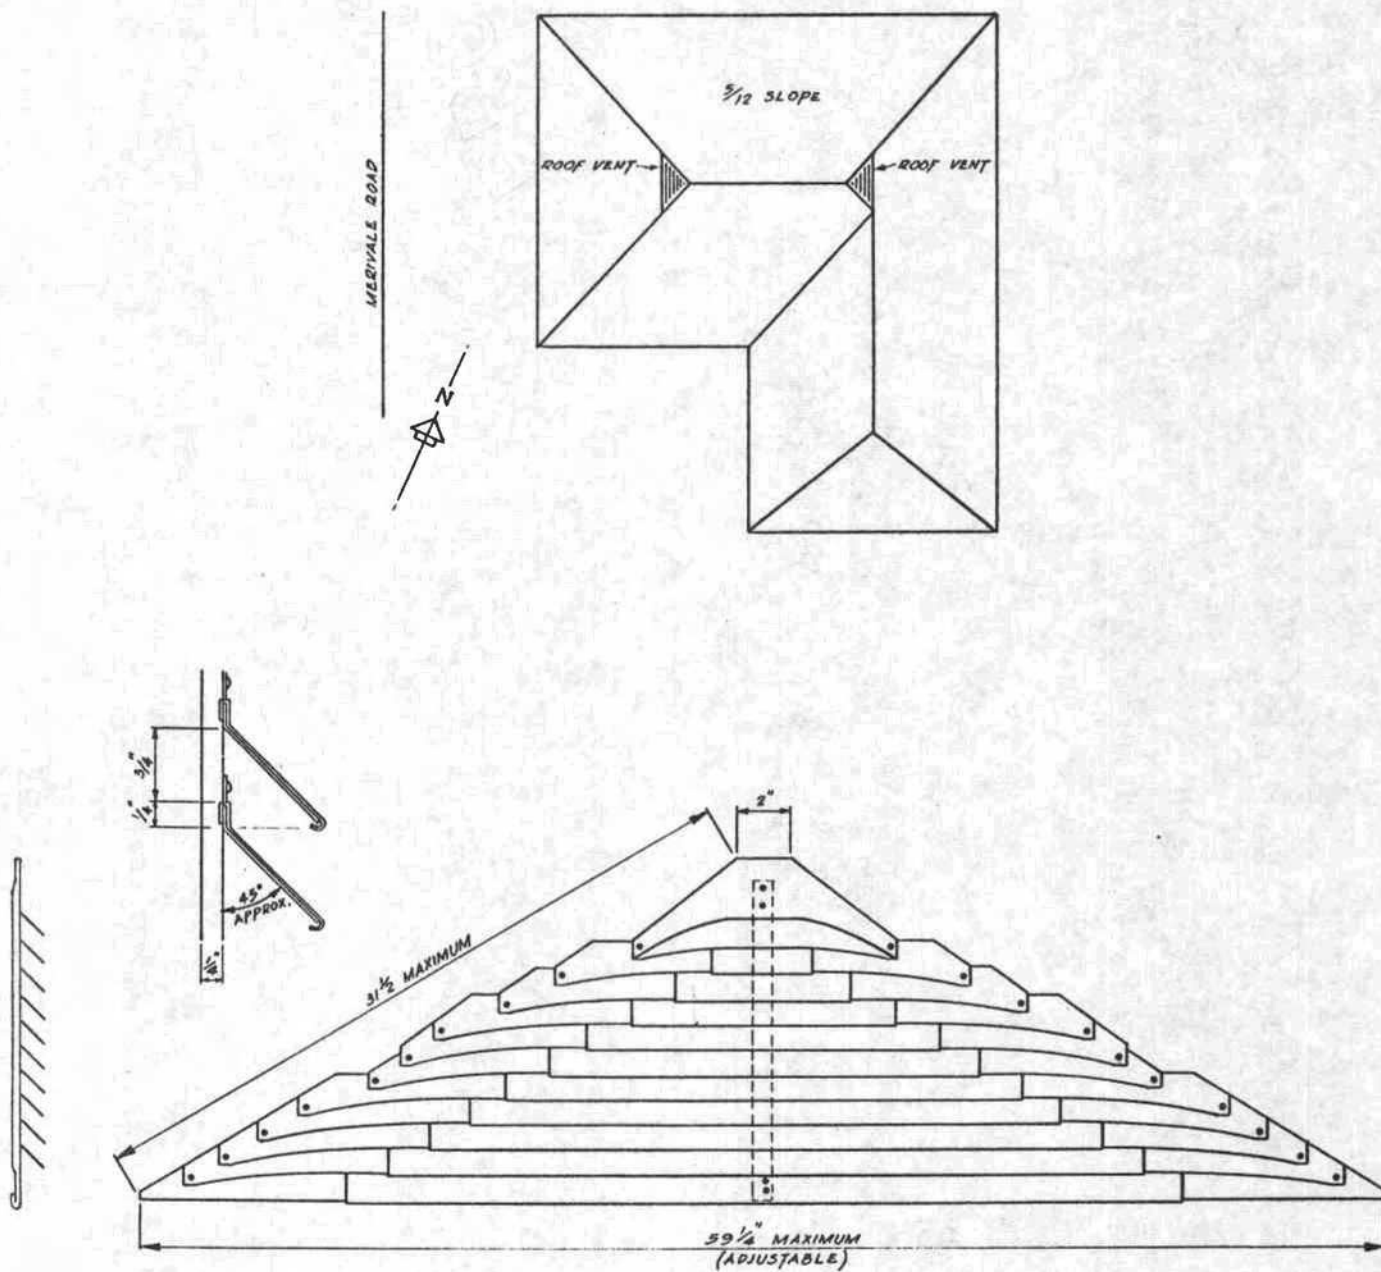
Figure 1

Two roof vents were installed at the ridge and no venting was provided at the eaves. The garage ceiling was not enclosed, however, and it is directly connected to the attic space above the living area. The vents are adjustable for roof slope and are formed from aluminum sheet. This type of vent is most commonly used on the gable ends of houses at the roof peak.

There are many houses with a ridge venting arrangement similar to that reported but in the writers' knowledge this is the first detailed report received by the Division of Building Research of a serious problem with such an installation. One might assume, however, from an examination of the vent openings in relation to the sloping roof surface, that an arrangement of this type would be prone to the entry of wind-driven snow, and rain leakage in extreme conditions. Perhaps the only conclusion that should be drawn from this report is that an arrangement similar to that illustrated should be avoided in buildings in exposed locations.

DETAIL OF ROOF VENT

The tendency to leakage by such an arrangement might be reduced by an alteration in the design of vents. An increase in the weather lap might provide some improvement. It is interesting to note that vents used in this case appear to meet the requirements of C.S.A. Specification A93-1961, Aluminum Vents for Housing.

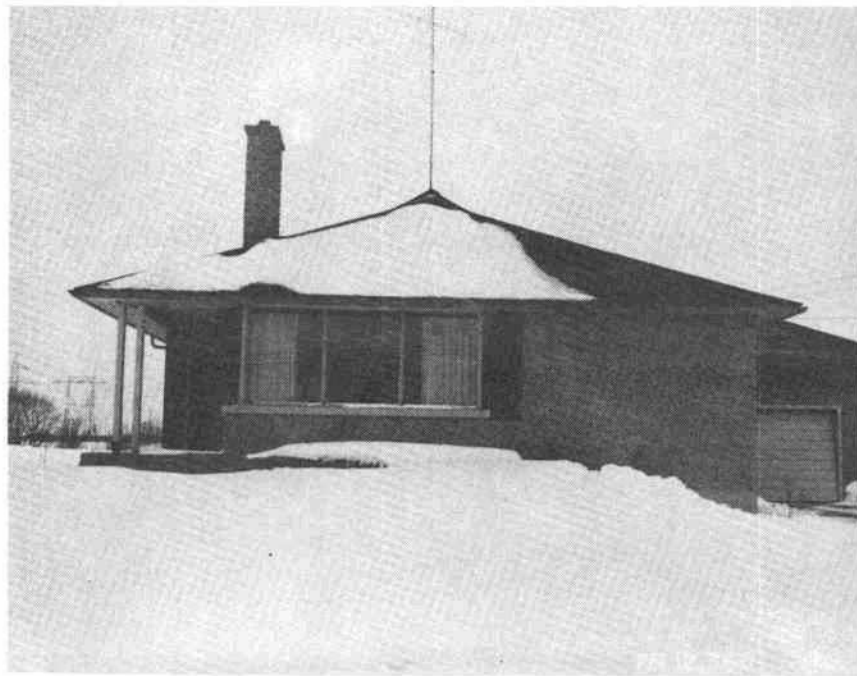
Figure 2

The house is located on the east side of the Merivale Road in Ottawa, Ontario. Buildings in the area were not closely spaced and there were few trees to provide shelter. The house therefore is in an exposed location in respect to wind.

View of house from west side showing snowload from wind action over roof. Snow entered through opposite vent where roof is blown clear of snow.

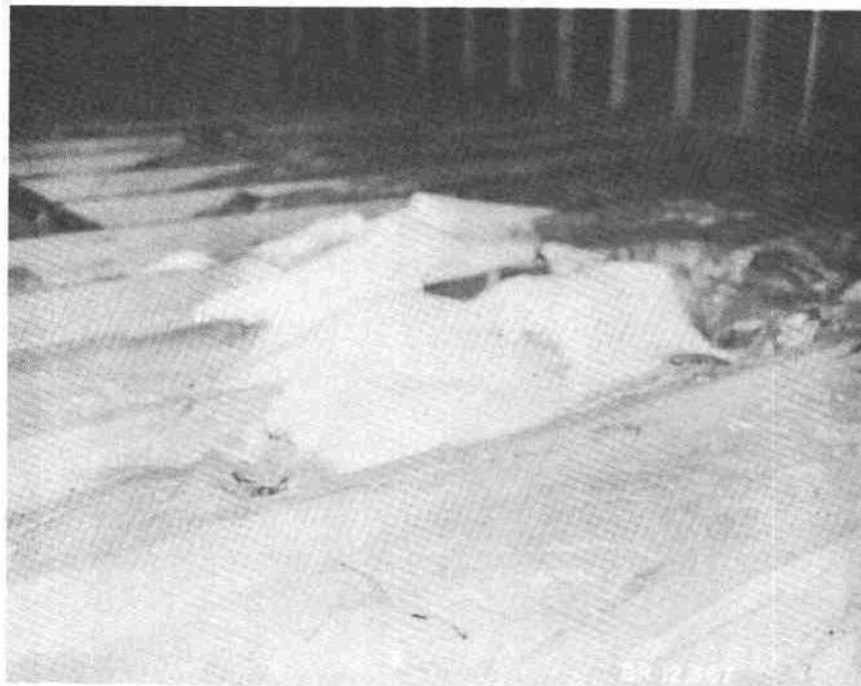
Figure 3

The presence of snow in the attic was first noted on 31 December 1959 when water started to drip through the ceiling of the hallway which is located centrally in the house. The snow storm of four days' duration began on

Interior of attic space showing a part of accumulated snow. Picture taken about a week after snow storm.
