## **Tornado Damage in Aylmer, Quebec on August 4, 1994**

by W.A. Dalglish and D.E. Allen

Internal Report No. 669

Date of issue: November 1994

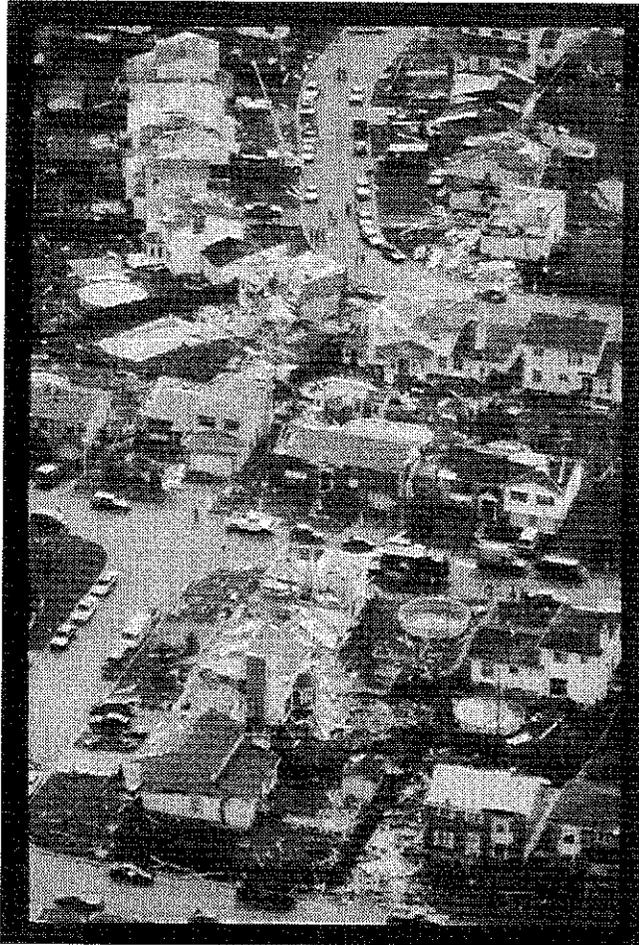
The trail of damaged buildings is shown in Figure 1, starting with Polyvalente Grande-Rivière on Foran, traveling from WSW to NNE, and ending at Conrad Valera. Many of the news photos featured damage at the eastern end of Beausoleil, shown at the top of Figure 2

Figure 2 Aerial view looking back at trail of damage along tornado path.

**Sheathing to Roof Trusses:** This detail was not investigated, although the tornado damage (e.g. Figure 2) indicates variations in quality control. For example, Hurricane Andrew has shown that there is a quality control problem with the use of stapling guns for attaching sheathing, because the carpenter gets no direct indication if the staples miss the roof truss.

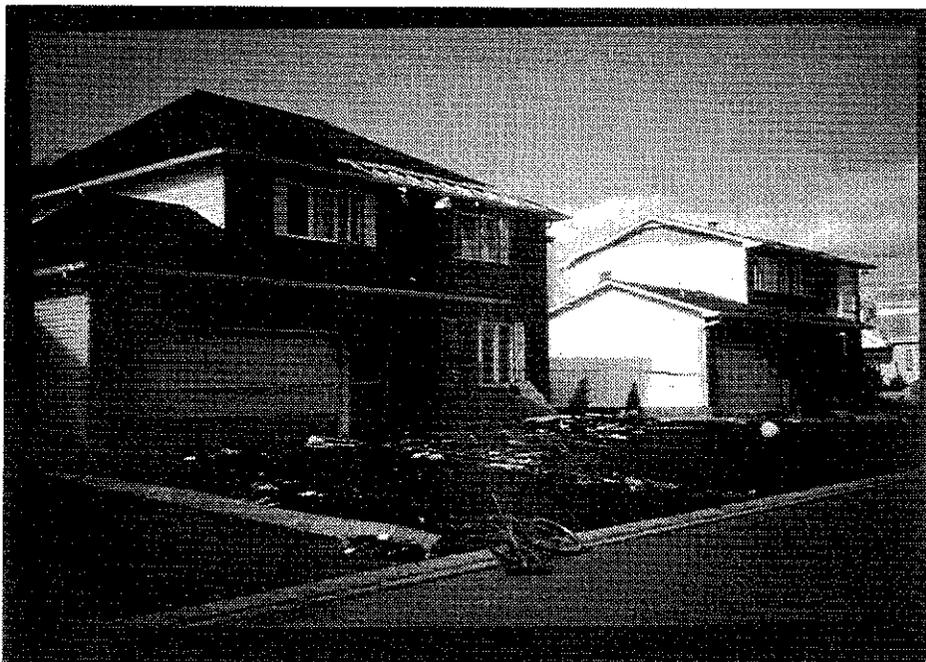
Damage to roofs seemed to begin, and was often limited to, removal of shingles and roof sheathing in the region of the SW corner of the building (Figure 3). Often there were punctures of roofs and walls by missiles carried by the wind from earlier damage sites (Figures 4, 5,6). Another common form of damage was the stripping of cladding from walls (Figure 7). Although more often occurring on walls parallel to the tornado path, sometimes windward walls suffered the same fate (Figure 8).

Figure 3 Wind damage limited to eave area at southern end of hip roof.

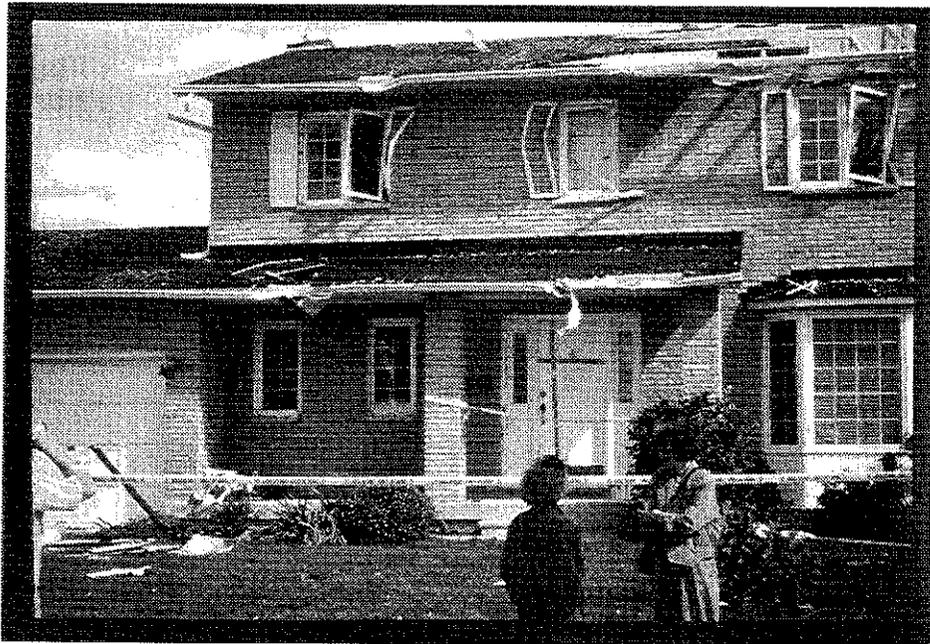
Figure 4 Roofing and sheathing failure of southern third, (both slopes) of gable roof, plus missile damage.

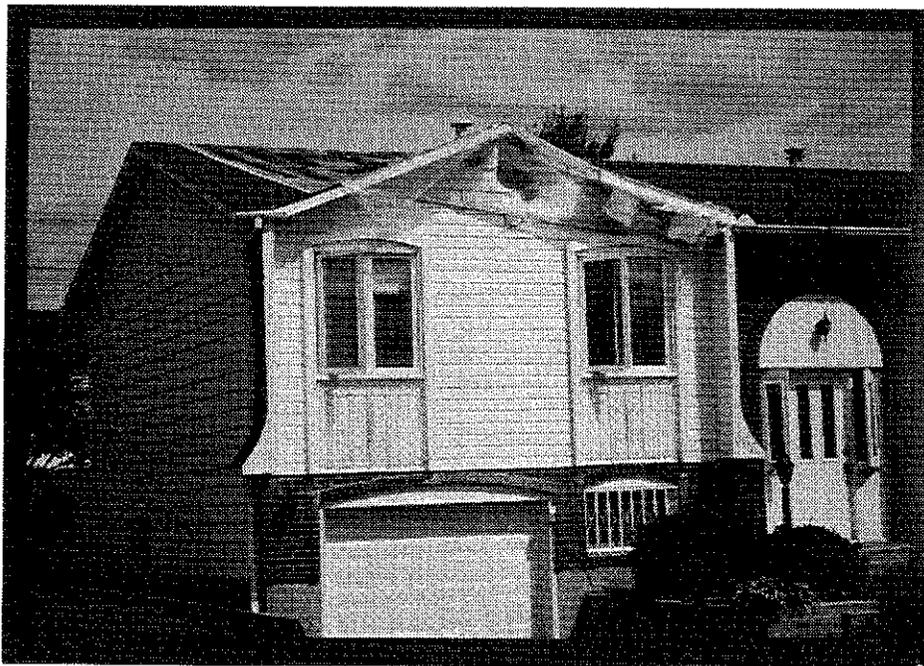
Figure 5 Puncture of top of windward wall by missile.

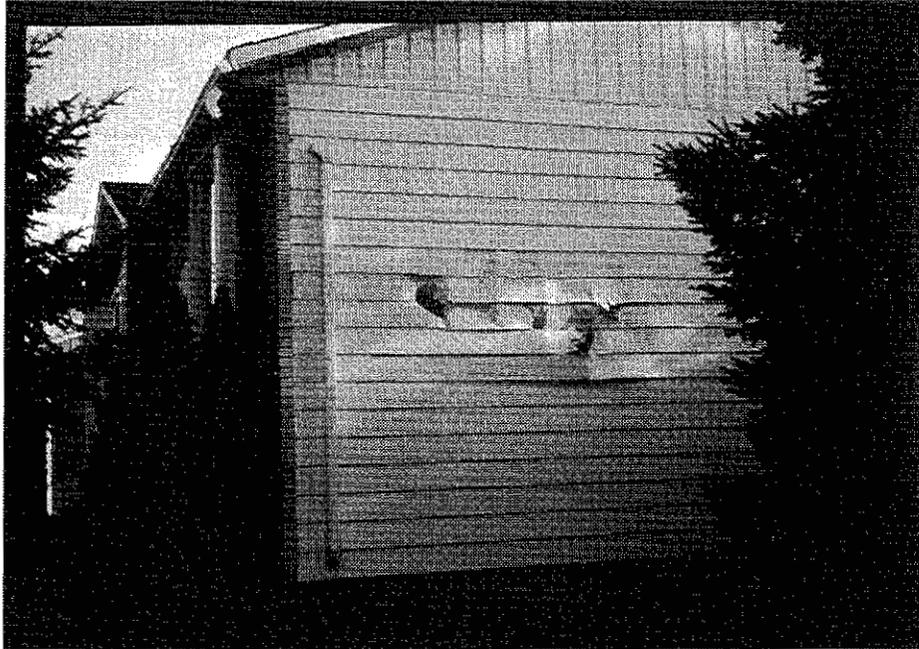
**Figure 6** Siding punctured at mid-height of wall by missiles.

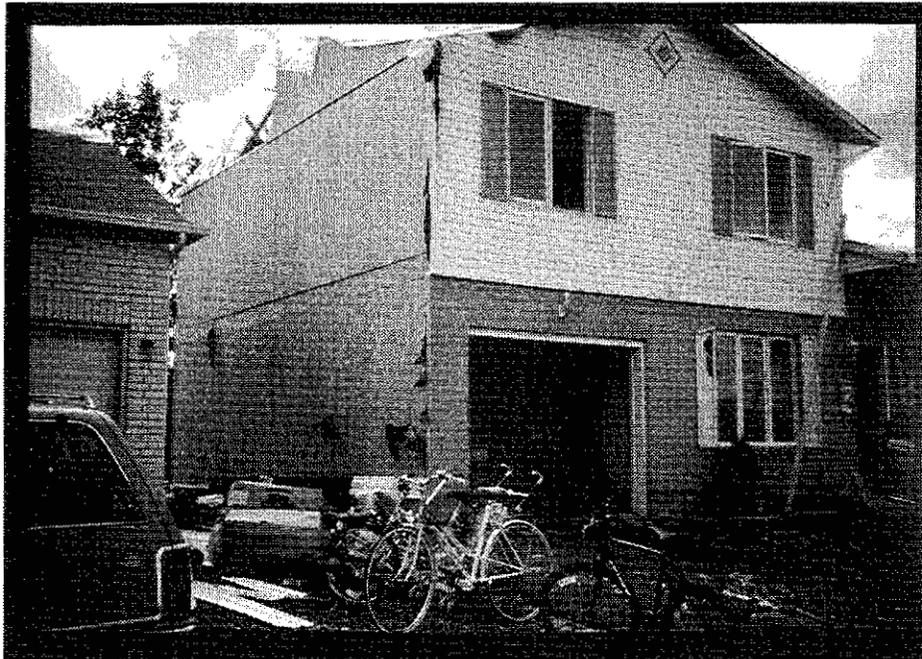
**Figure 7** Siding stripped off south wall, roughly parallel to tornado path, with insulation splattered on east (leeward) wall.

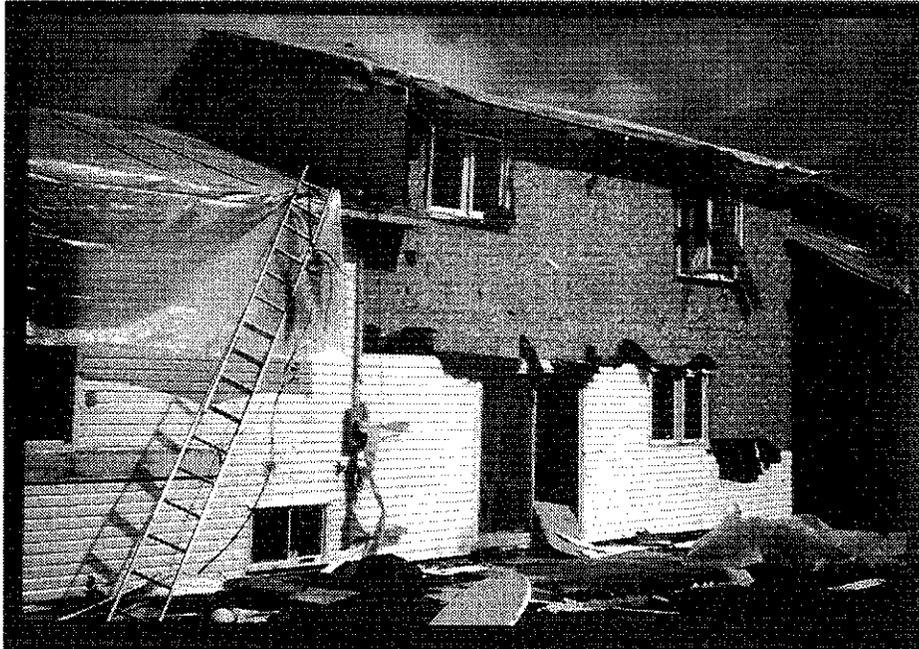
**Figure 8** Siding stripped from west (windward) wall of house in Figure 7.

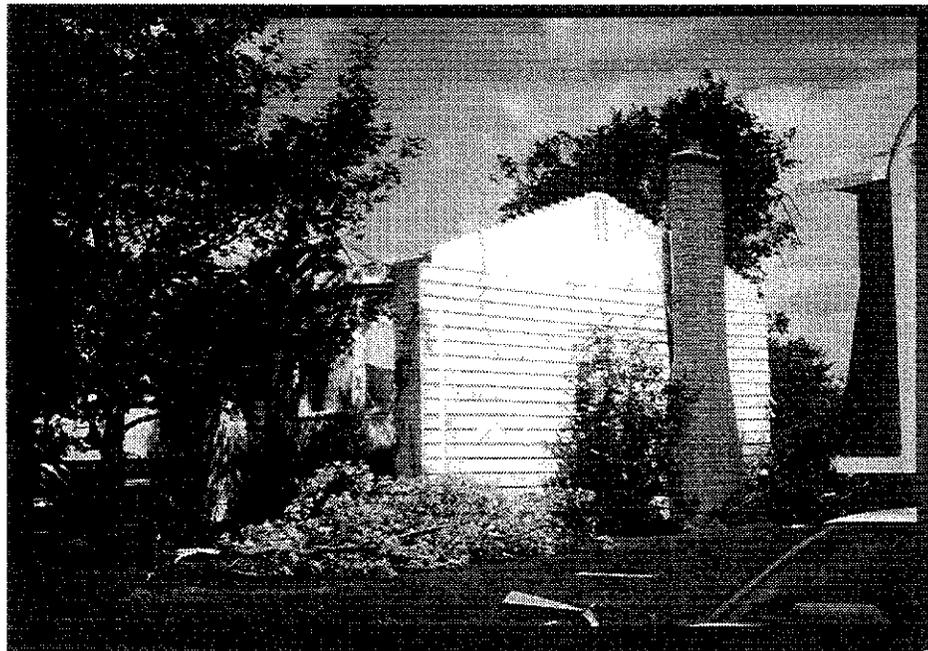
More serious for both building structure and contents, some roofs in the path of the tornado were completely lifted off the walls (Figure 9). The house in Figure 9 had a large living-room window that was shattered about the same time, and air rushing into the room would cause an increase in pressure, adding to the uplift of the wind accelerating over the roof. As seen in Figure 10, the loss of the roof allowed the gable-end wall to sway left, away from the chimney, which remained plumb. Although a missile crashed through another windward window, narrowly missing an occupant in another room, the main hazard was flying glass from the living-room window, resulting in lacerations to the lady of the house.

A car at the curb in front of the house in Figure 9 was picked up by the wind, rolled across the lawn, and jammed upright against a tree.

**Figure 9** Gable roof lifted off single-storey house, showing south wall, roughly parallel to tornado path.

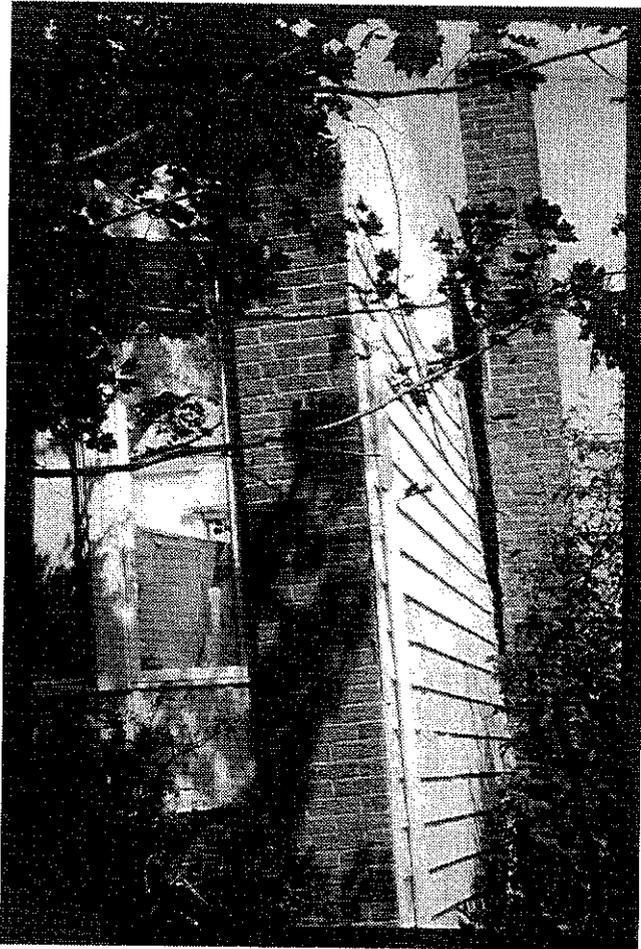
**Figure 10** South wall of house in Figure 9, leaning left away from chimney, which is still plumb.

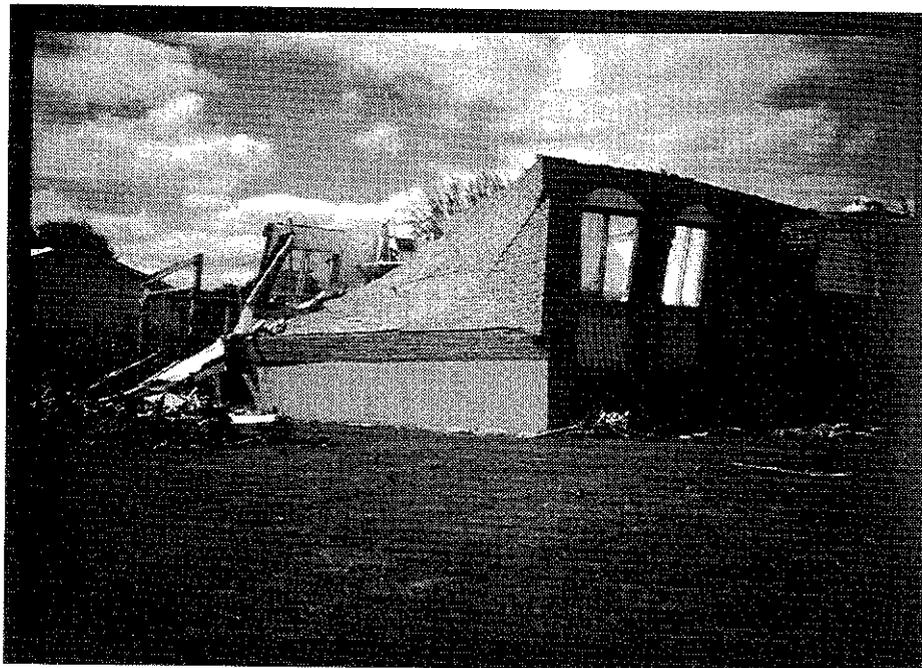
The progression of damage following loss of top support for walls when the roof lifts off, is illustrated well by the damage to the house in Figure 11, which also lost its attached garage on the west (windward) side. The same is true of the house in Figure 12, of which the upper storey has lost both the south wall parallel to the tornado path, and the east (leeward) wall. Usually the walls were sucked out, but the south wall in Figure 11 blew in after failure of the connection between the south and west walls.

**Figure 11** Brick wall collapse showing progressive failure once roof is gone and connection to west (windward) wall is lost.
