NATIONAL RESEARCH COUNCIL OF CANADA

LR - 308

ICING AND DE-ICING FLIGHT TESTS OF A
KAMAN HU2K-1 HELICOPTER

MAY 1961

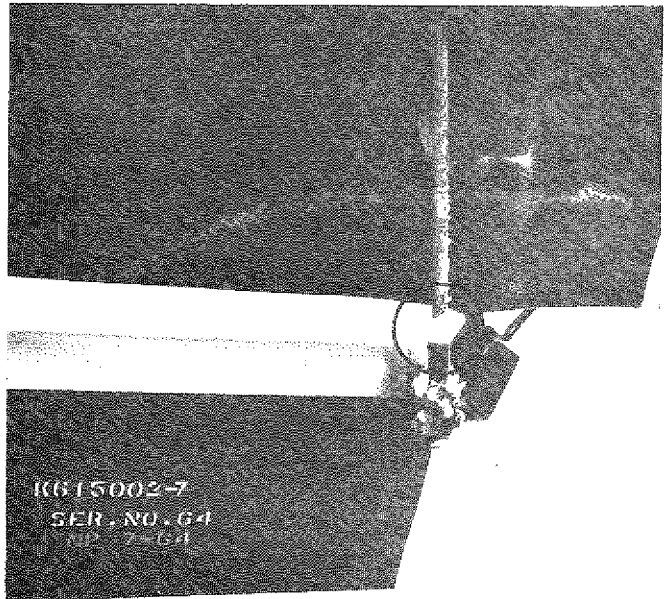
Ice was accreted to the tips of the main rotor blades

below about -12°C and to the tips of the tail rotor below about -18°C . An example of main rotor blade icing is shown in Figure 6. At temperatures higher than these, self-shedding occurred before the ice could build to any appreciable thickness on the outer portions of the blades. The maximum chordwise extent on the main rotor was 1 in. (5 percent chord) on the top and $3\frac{1}{2}$ in. (17.5 percent chord) on the bottom surface (except on high temperature runs (see Fig. 13a) and in freezing rain (Fig. 10) where it was greater because of runback, particularly on the top surface). The maximum chordwise extent on the tail rotor was about $\frac{3}{4}$ in.

EXAMPLE OF HEAVY MAIN ROTOR ICING

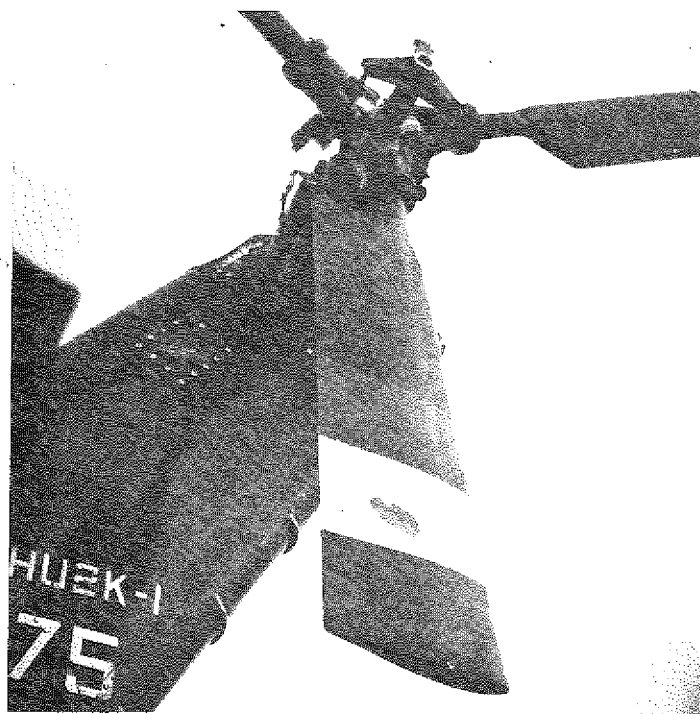
Damage was caused by ice thrown from the rotor blades during many of the runs. Some bad and many small tail rotor dents were caused by ice thrown from the main rotor and a few dents were made in the main rotor from shed tail-rotor ice. Some of these dents were severe enough to necessitate the replacing of the blades. Figure 7 shows the tail rotor damage after run 3-1 and further dents in the same blade after run 4-3. Most of the bad dents were made in the first few days of testing when the rotors were started up with ice from a previous accretion run on the blades. The ice which had been partially loosened because of the flexing of the blades was thrown from the main rotor blade directly into the tail rotor while the coning angle of the main rotor was still low. At normal coning angles most of the ice would have been thrown right over the tail rotor disc. Only slight dents were made in the tail rotor blades after the de-icing procedure was changed.

(a) DENTS AFTER RUN 3-1

icing conditions below about 20°F. Although the worst damage to the tail rotor did occur when ice was shed from the main rotor blades when starting up, this could happen in actual practice, and, moreover, some dents were produced from normal self-shedding and from induced shedding during the de-icing cycle. This fact, that the maximum thickness of ice allowed to build up on the blades will have to be closely controlled to prevent damage, accentuates the need for a sensitive ice detector and, ideally, a rate-of-icing meter for this helicopter.

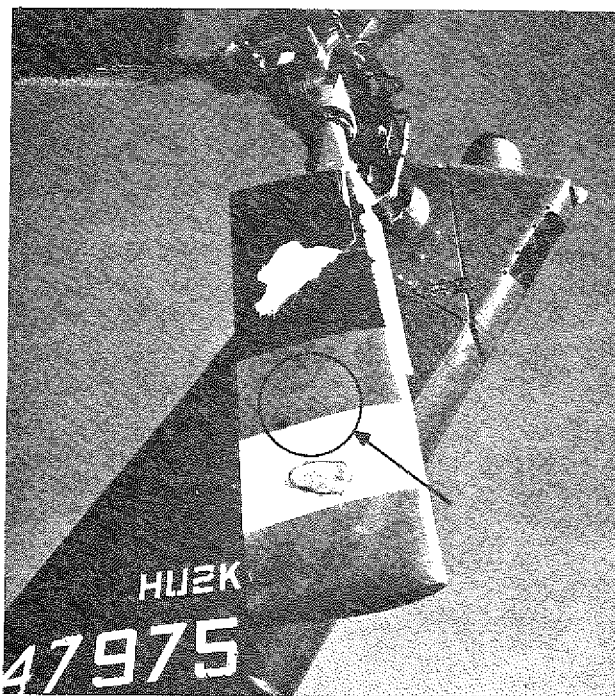
(b) ADDITIONAL DENTS AFTER RUN 4-3

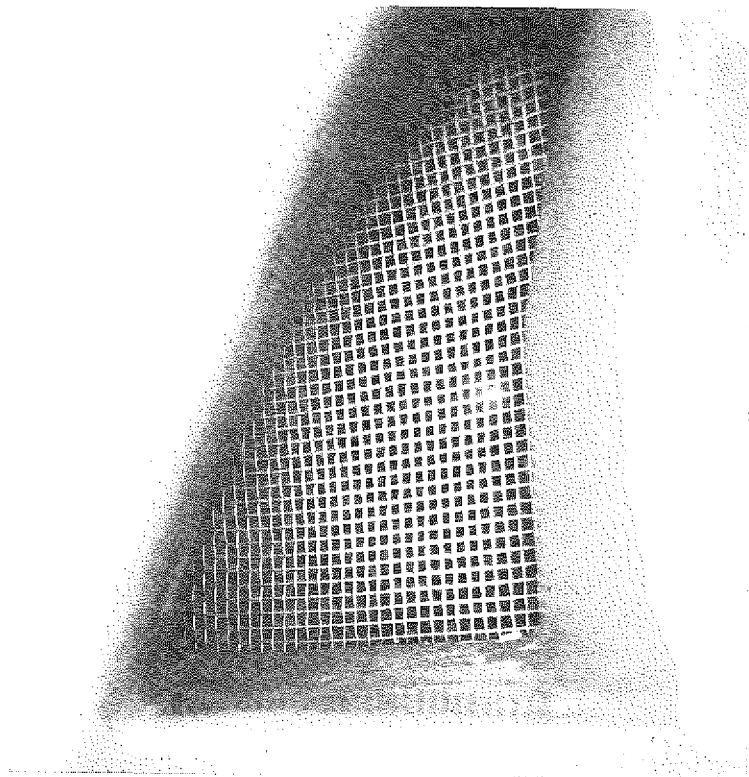
RUN 7-2

It was found that the screen in the engine inlet iced very quickly and that only very light icing on the screen was necessary to cause the blow-in door to open. Examples of inlet screen icing sufficient to cause the blow-in door to open and of heavy screen icing are shown in Figure 8. The screen on the port through which air was drawn when the door was open also iced very quickly and was removed after the first day's testing. Although the blow-in door opening was large enough to supply sufficient air for engine operation through its operating range, it was usually necessary to terminate a run whenever the door did open because of the danger of grease or foreign matter being carried from around the transmission housing directly into the engine.

SCREEN ICE SUFFICIENT
TO CAUSE BLOW-IN
DOOR TO OPEN

The speed with which the engine inlet screen iced up enough to cause troubles indicates that further modifications and testing are required. Because this engine is so intolerant to particle ingestion it is unlikely that the screen can be greater than ½-in. mesh for normal operations. Therefore, some means of anti-icing the screen or retracting it in icing conditions will be necessary. Also a redesign of the plenum chamber is likely required to smooth out the airflow and stop ice from forming on the chamber walls. This will prevent chunks of ice from building up and shedding into the engine but there will then be the possibility of heavier icing in the engine itself. Therefore all the engine inlet components, possibly even the bellmouth, will have to be adequately anti-iced.

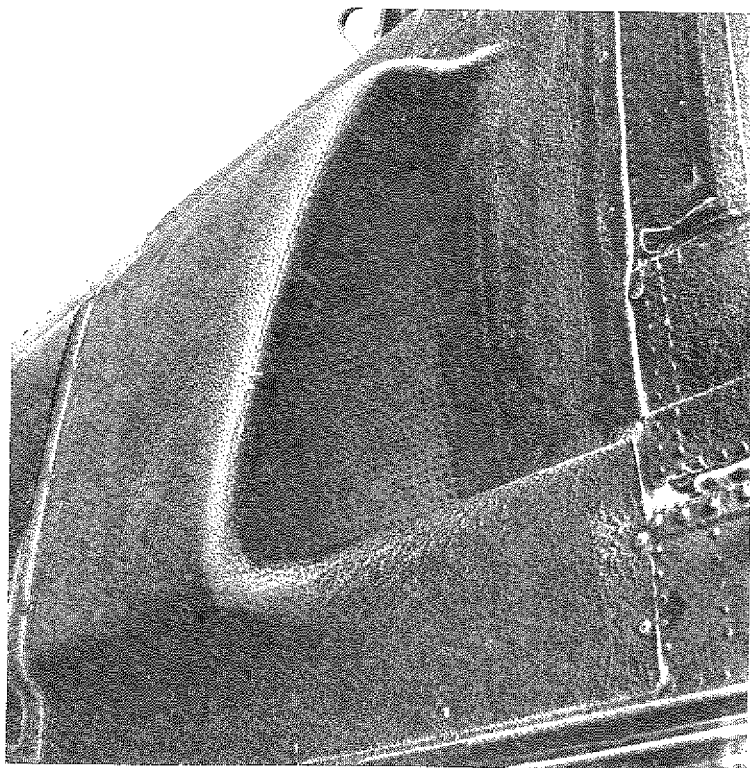
RUN 6-4

HEAVY SCREEN ICING

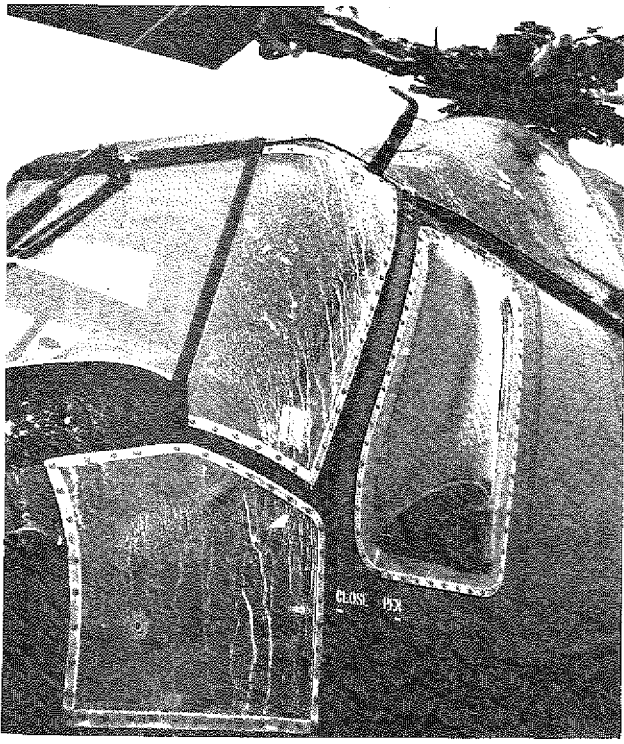
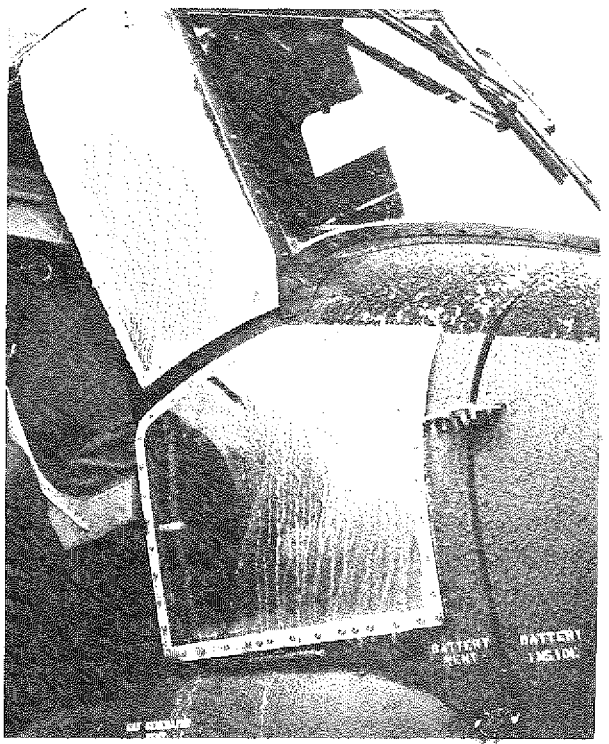
RUN NO. 5-3
TEMP. -3.4°C
TIME IN ICING 12 min.

ICE ACCRETION IN SIMULATED FREEZING RAIN

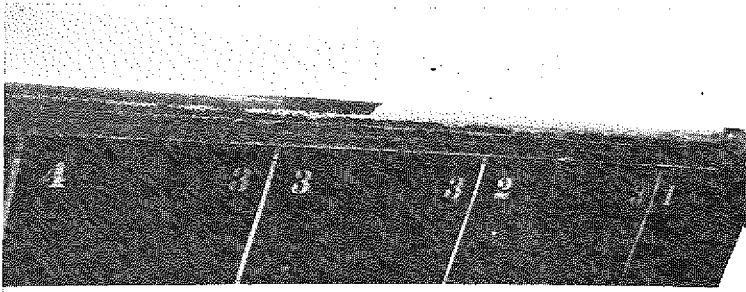
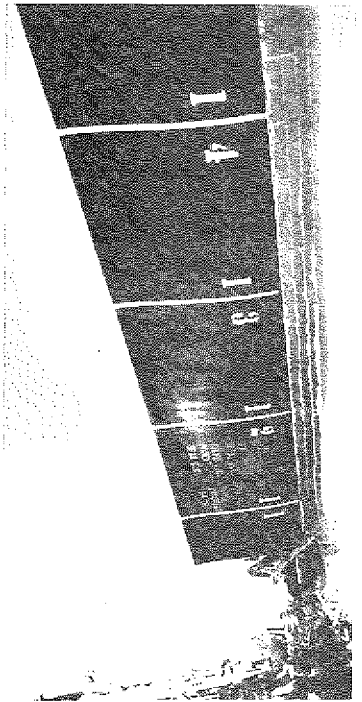
No mechanical or electrical difficulties were experienced with the de-icing heater mats during the tests (a total of approximately fifty heating cycles) other than a slight variation in shedding efficiency of the main rotor mats. However, creases formed in the thin stainless steel abrasion shield when the main rotor blades drooped and it is possible that, in time, fatigue cracks could result particularly from operations in cold temperatures. These creases can be seen in Figures 12b and 13a.

(a) RUN 8-3

(b) RUN 8-3

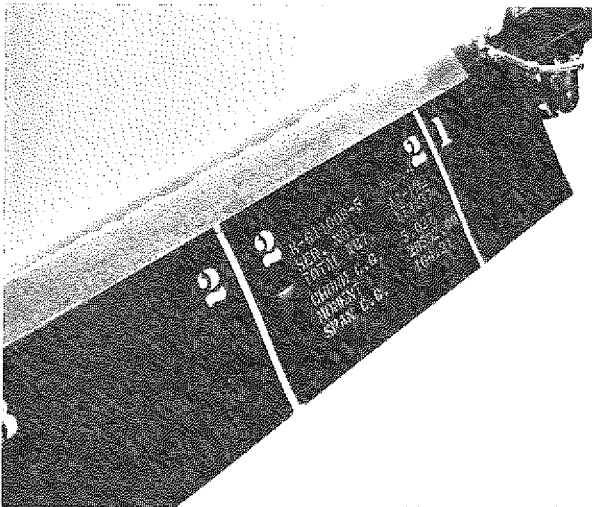
(d) RUN 4-2

On both extended runs 4-3 and 4-4 the maximum power-on time of 4.6 sec. was used, but it was not long enough for the particular temperatures ($< -15^{\circ}\text{C}$). In both cases the ice continued to build up through the run and only a few patches of ice had shed from the main rotor blades at the end of the flight, some of which had been shed on landing. On run 4-3 slight damage was caused to the tail rotor by some of this shed ice. On both runs the ice on the blades had been partially melted over the heated areas but was anchored by the cold strips. Only very slight runback was produced on these runs.

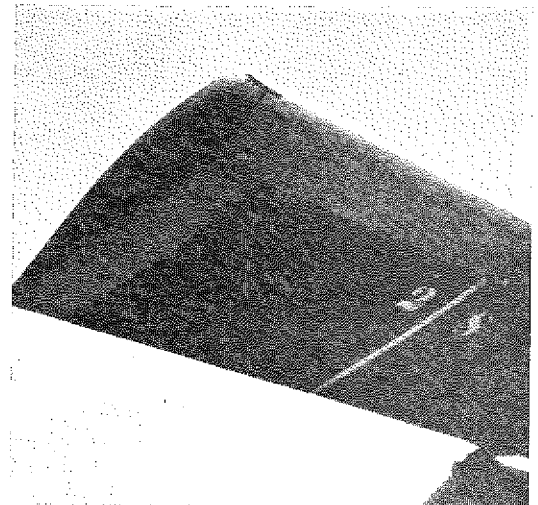
(e) RUN 4-1 TIP CAP ICE

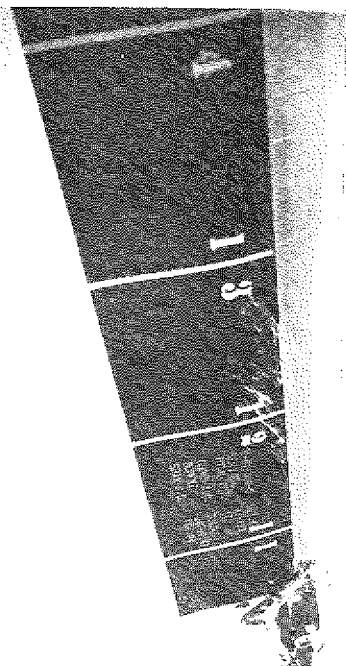
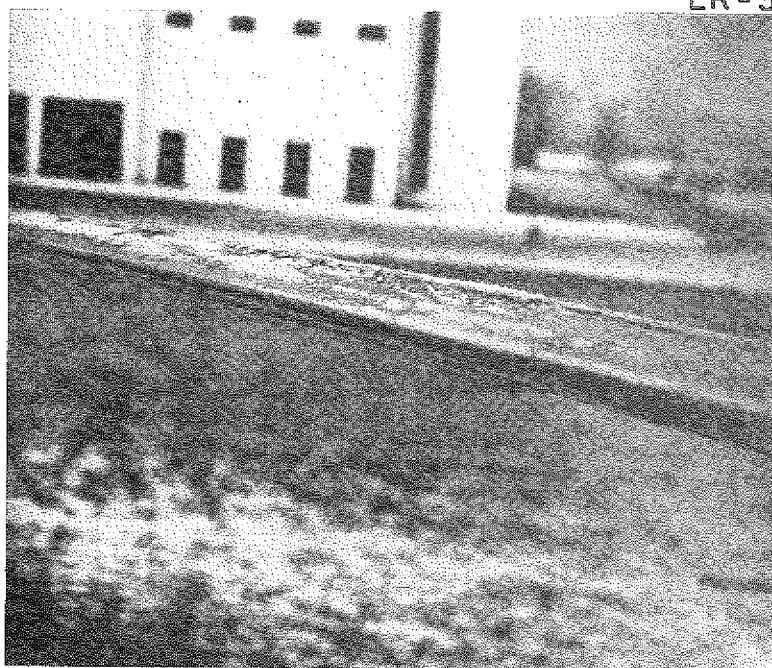
(a) RUN NO. 5-4 NATURAL RUNBACK
TEMP. -2.6°C L.W.C. 0.5 gm./m.^3 TIME IN ICING 15 min.

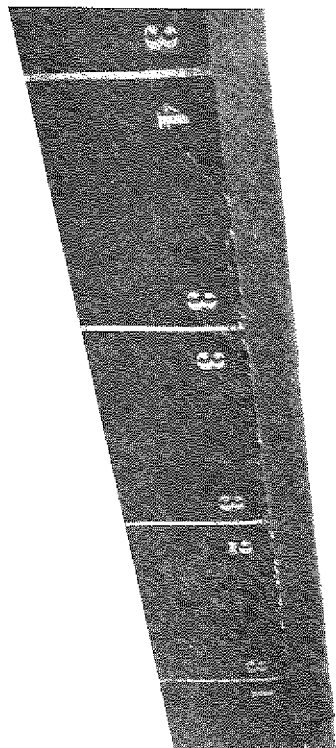
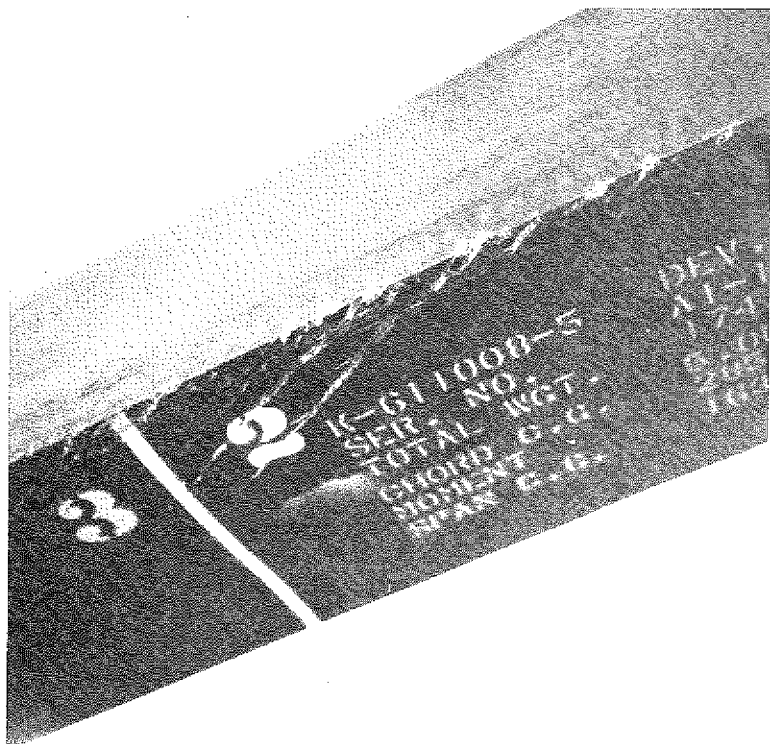
(b) RUN NO. 7-6 RUNBACK FROM EXCESSIVE DE-ICING ON TIME
TEMP. -3.4°C L.W.C. -0.5 gm./m.^3 POWER-ON TIME 4 sec.
