B707 lap joint specimen No. 349 - NDI inspections Taremi, F.; Bellinger, N.; Brothers, M.; Gould, R.

Report No.: **LTR-SMPL-2003-0271**

**B707 LAP JOINT SPECIMEN No. 349
NDI INSPECTIONS**

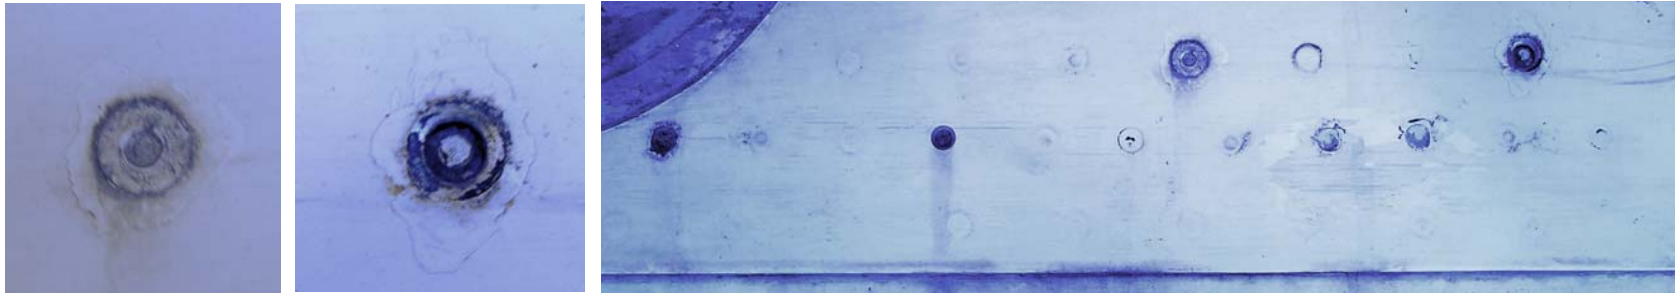
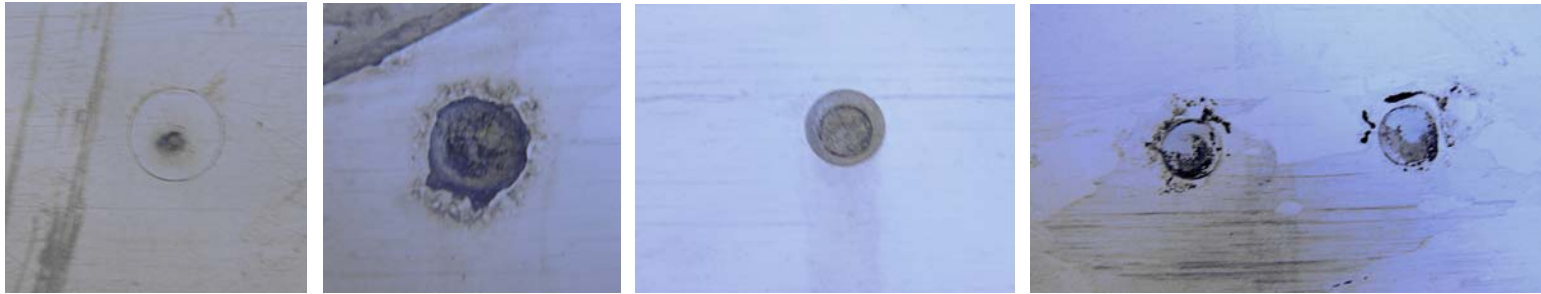
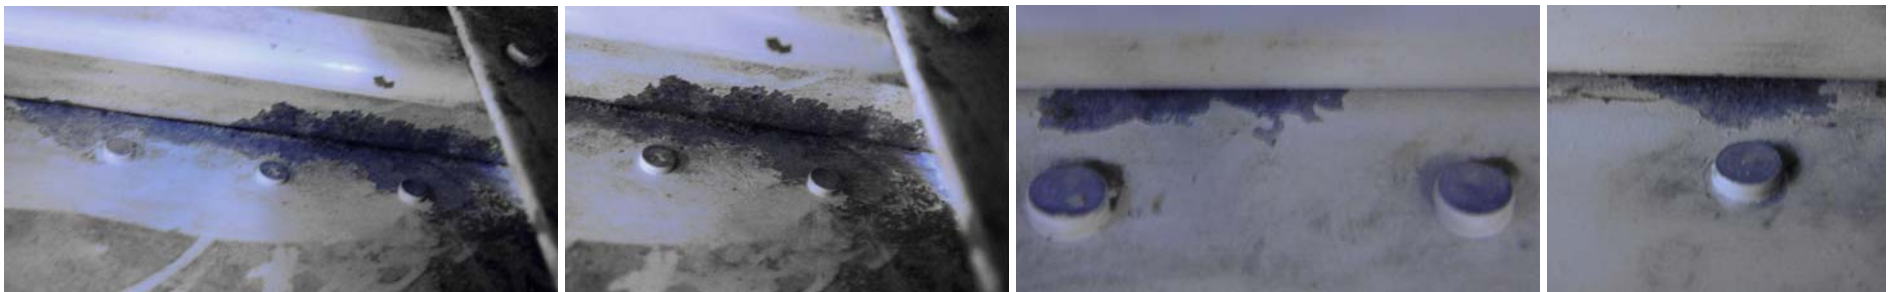
Figure 5. Photographs showing 349A problem areas.

T 40

T 43

RH: M 46 - 54

M15 (failed 02/12/2004) M 44

M 47

M 52,53

B 22 - 24 Rear

B 22 - 23 Rear

B 32-33 Rear

B 42 Rear

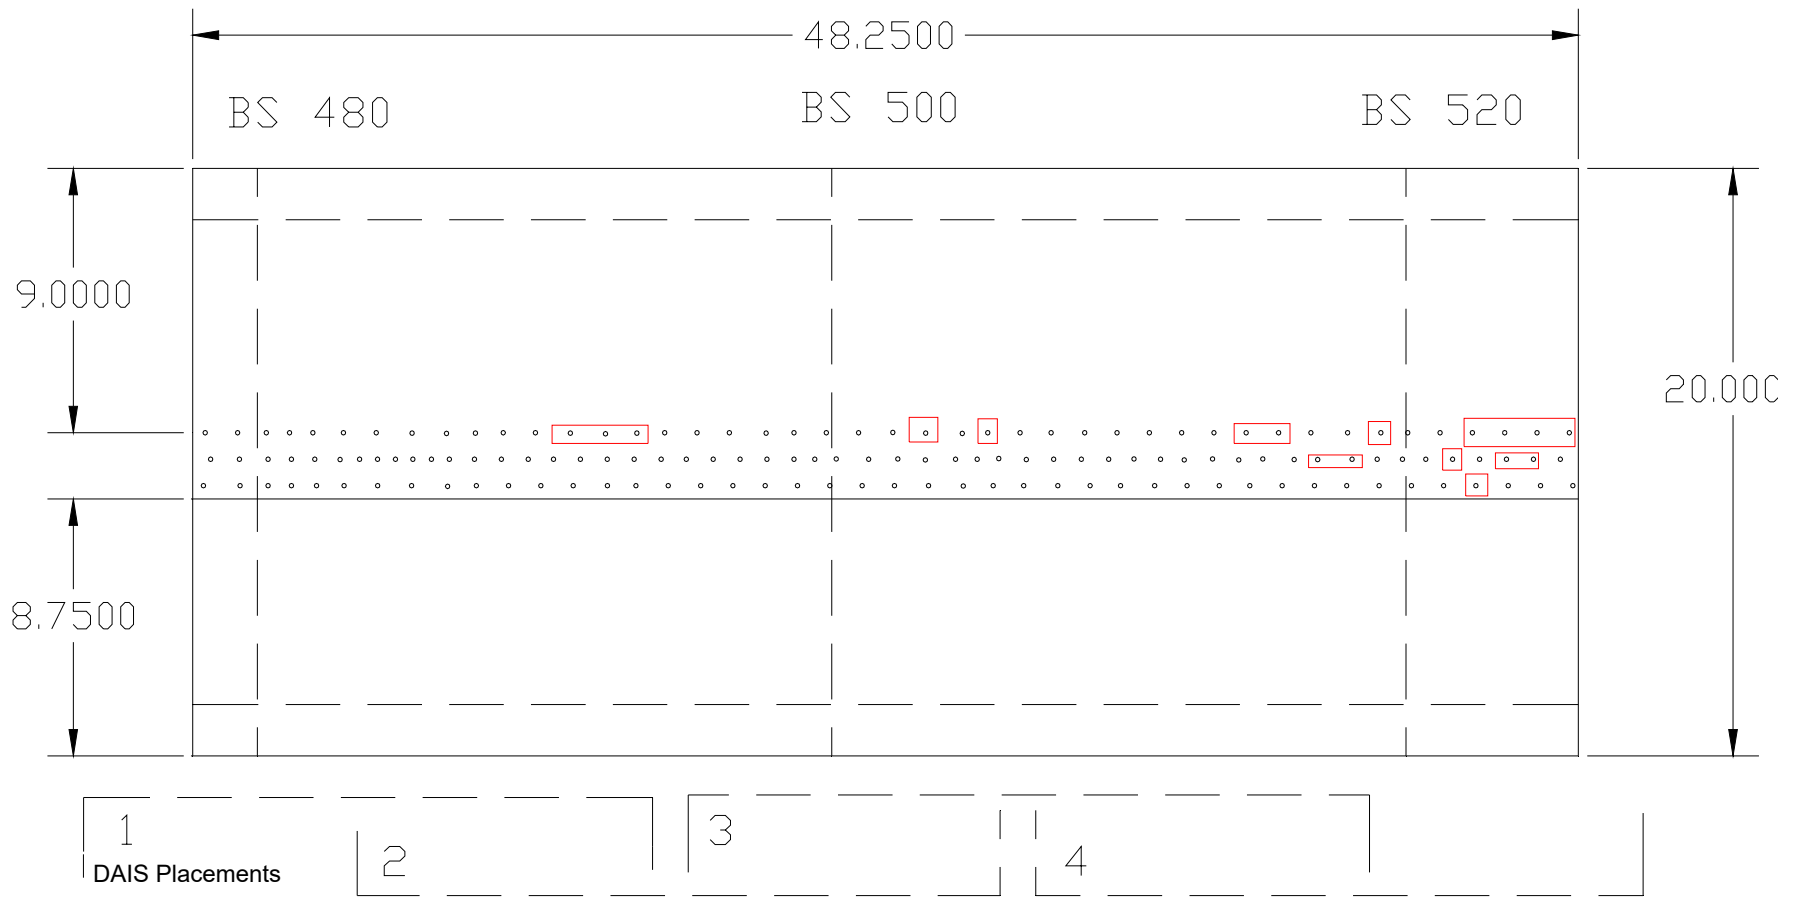
Figure 6. Schematic of lap joint 349A showing DAIS Placements 1 to 4 and locations of pillowing cracks (Red boxes).

Significant amounts of corrosion pillowing as well as failed and deformed rivets were observed. An advantage of using D Sight over other automated NDI methods was that the ends of the specimen could be inspected. The surface roughness can significantly affect the D Sight images because this technique uses reflected light to highlight the out of plane deformation caused by corrosion pillowing. To obtain better D Sight signatures of the joint surface the paint was removed. The surface was inspected with the aid of SolidHi™ as negative pressure was applied to conform a 10 mil black vinyl sheet. The use of the SolidHi technique provided uniform reflectivity over the inspection area. These inspection images are shown in Figure 7b).

Figure 6 is also used to mark the areas containing pillowing cracks as detected by X-ray inspection of the joint.

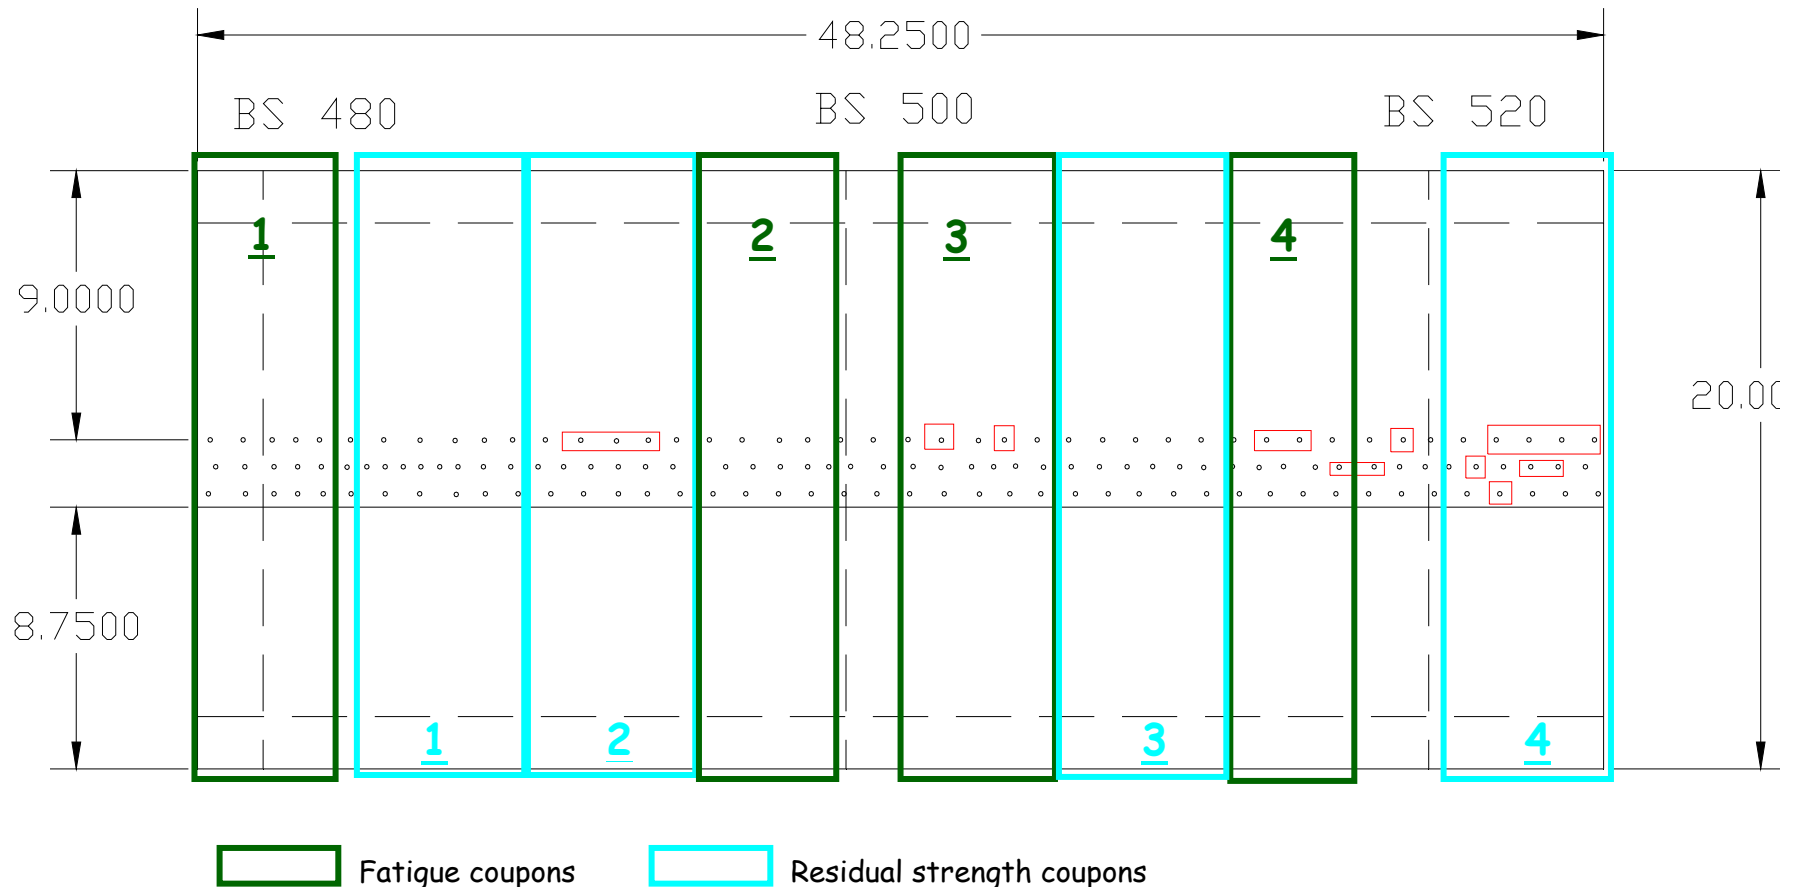
Figure 11. Sketch of Specimen 349A. Numbered boxes indicate nominal location of test coupons.

The X-ray inspection results are not presented for this lap joint. The areas of X-ray detected pillowing cracks are marked with red boxes in Figures 6 and 11.

Boxes (Red) indicate presence of pillowing cracks.

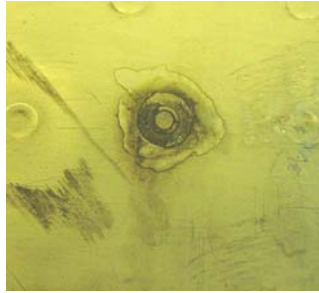
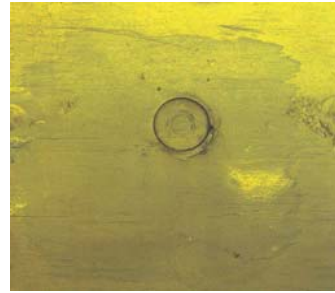
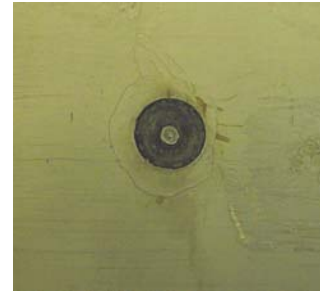
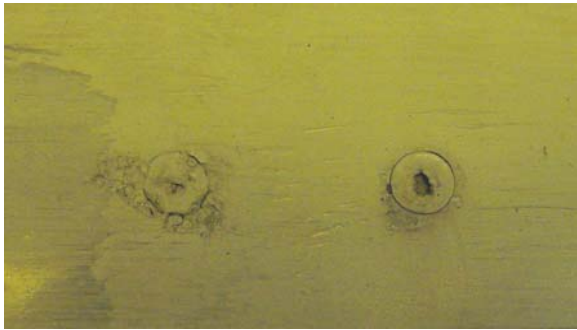
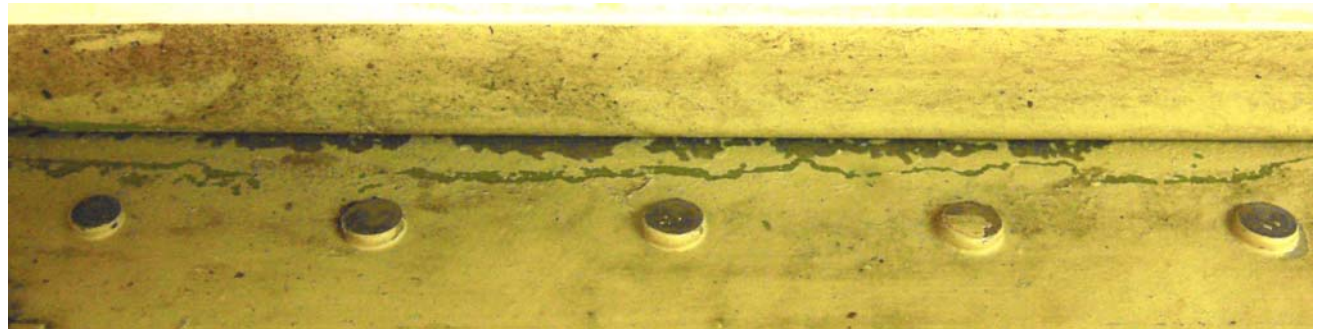
Figure 13. Close-up photographs showing various problem areas for Specimen 349B.

M 19

M 21

M 24

M 22, 23

B 8 - 12 Rear

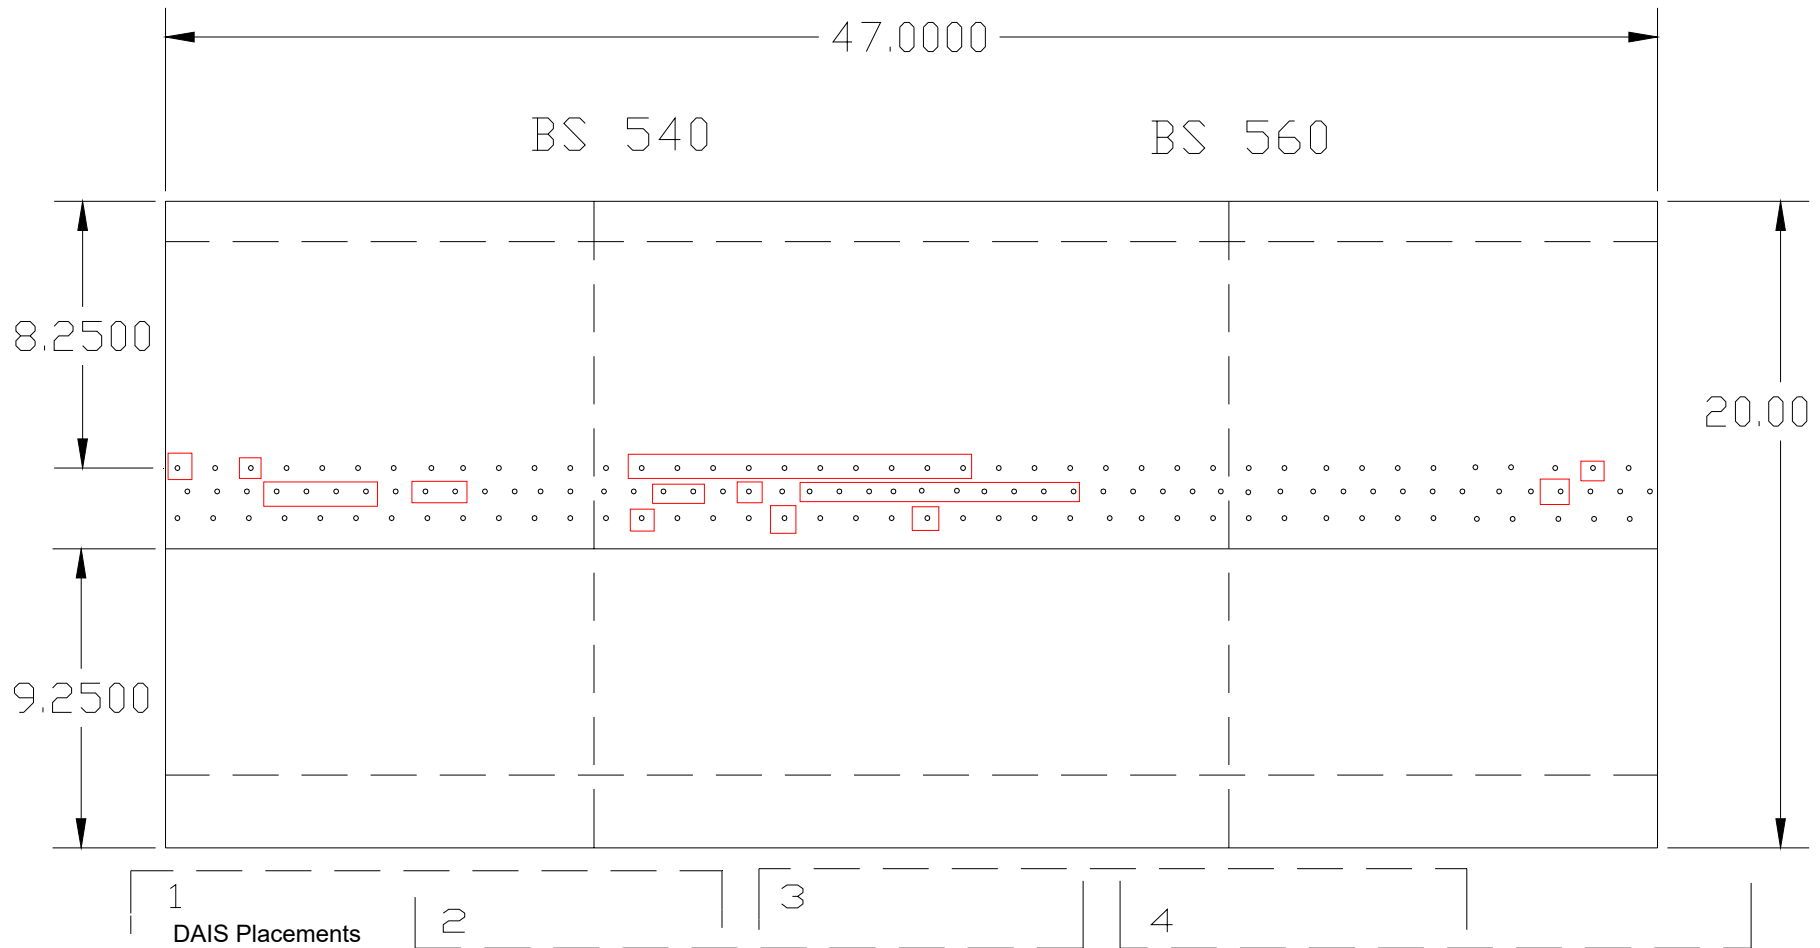
Figure 14. Schematic of lap joint 349B showing DAIS Placements 1 to 4 and locations of pillowing cracks (Red boxes).

A schematic of lap joint 349B showing the location of the DAIS 250C inspections is shown in Figure 14. Four D Sight images were taken with 50% overlap to cover the total length of the joint and the results are shown in Figure 15a. To obtain better D Sight signatures of the joint surface the paint was removed. The surface was inspected with the aid of SolidHi and negative pressure to conform a 10 mil black vinyl sheet. These inspection images are shown in Figure 15b). Figure 14 is also used to mark the areas containing pillowing cracks as detected by X-ray inspection of the joint.

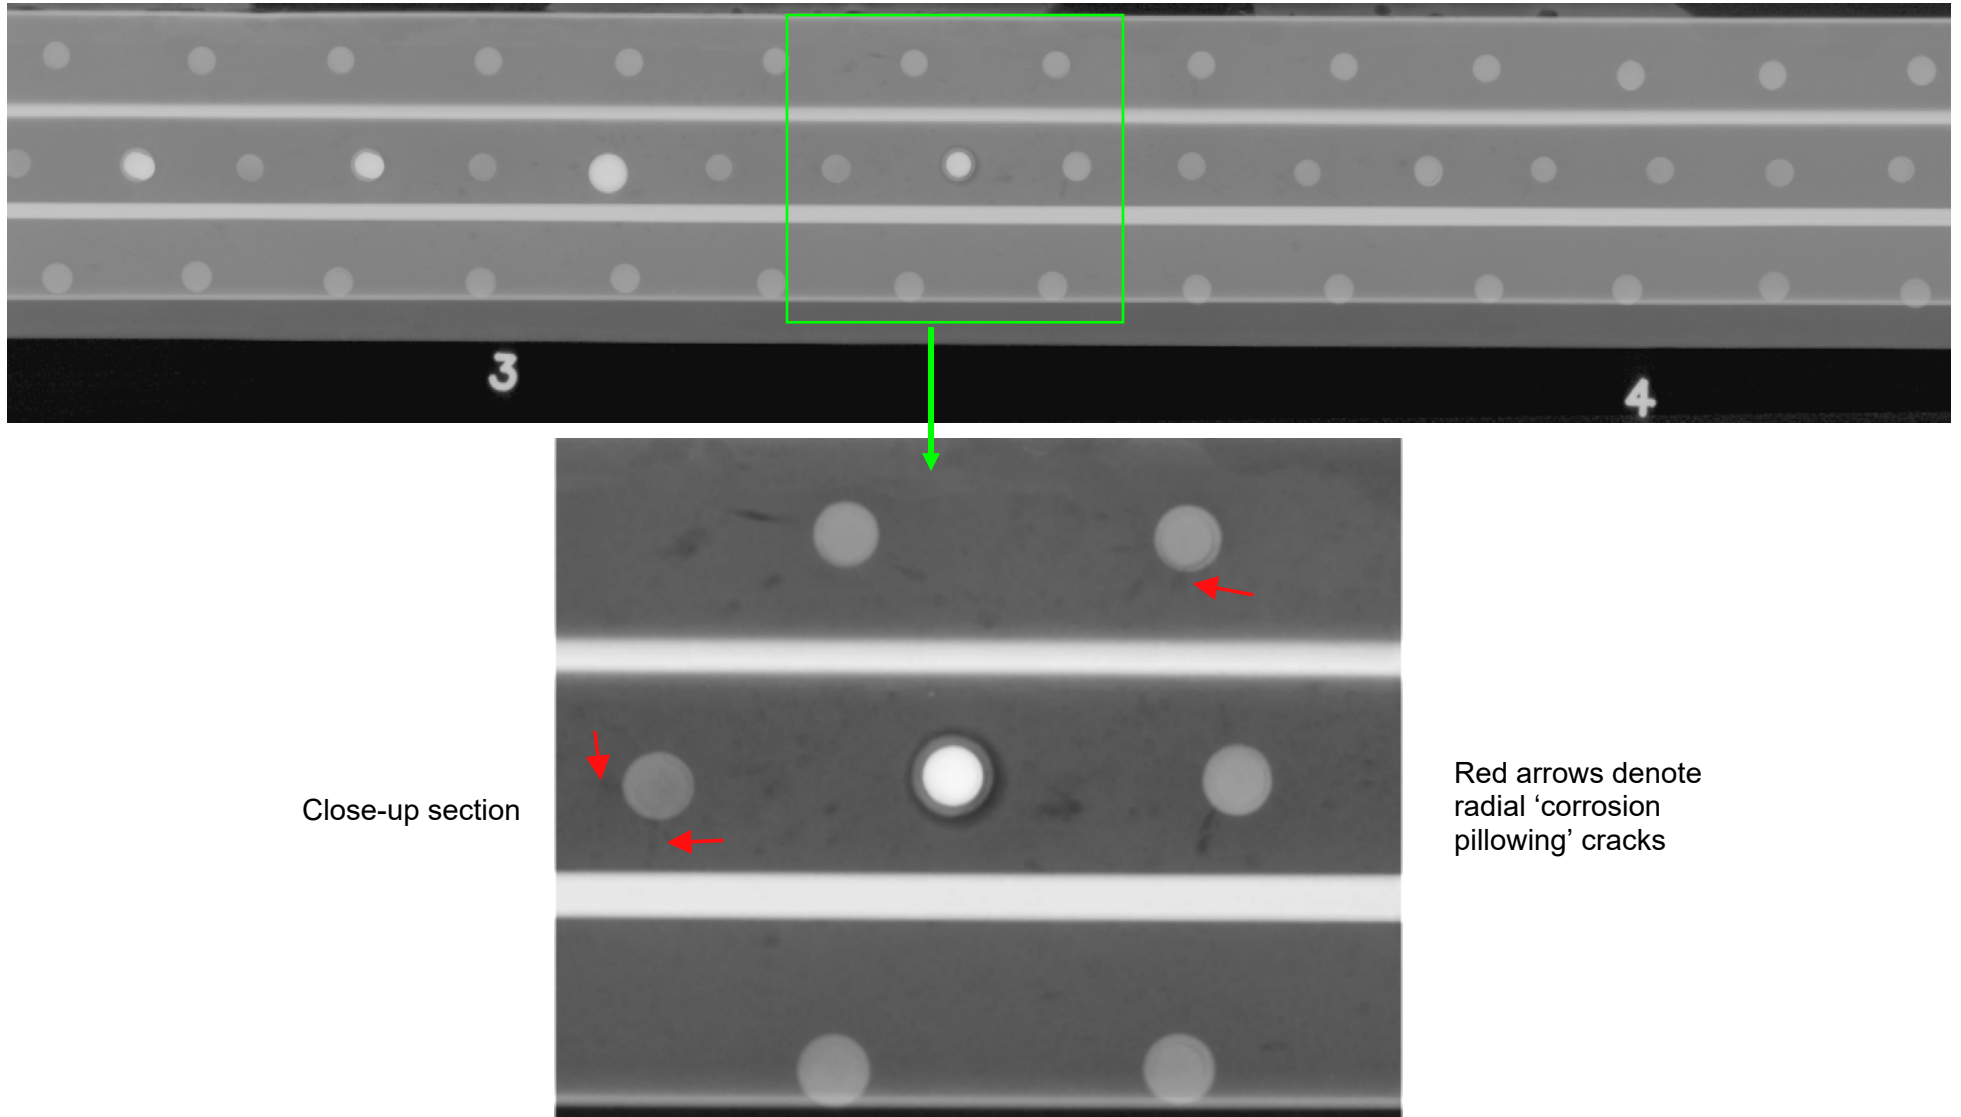
Figure 19. . X-ray inspection result for a section of lap joint 349B.

The X-ray inspection displayed several cracks around the majority of the rivets. The X-Ray image for a portion of Specimen 349B is shown in Figure 19. The areas of X-ray detected pillowing cracks are marked with red boxes in Figures 14 and 20. Four films were required to cover the length of the joint.

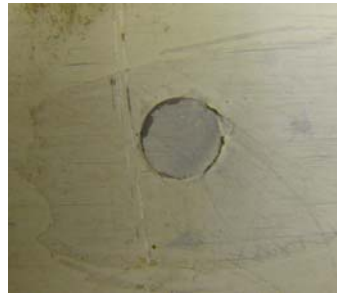
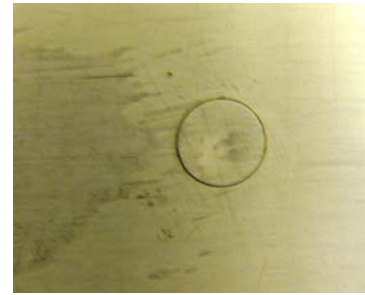
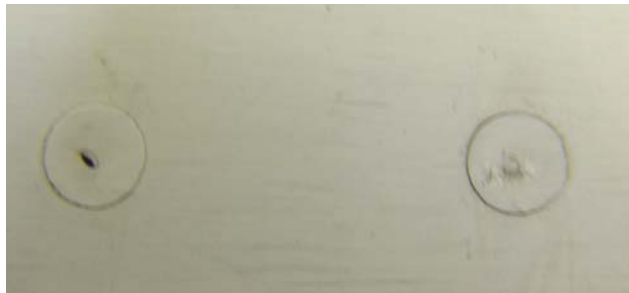
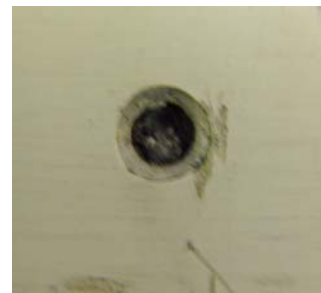
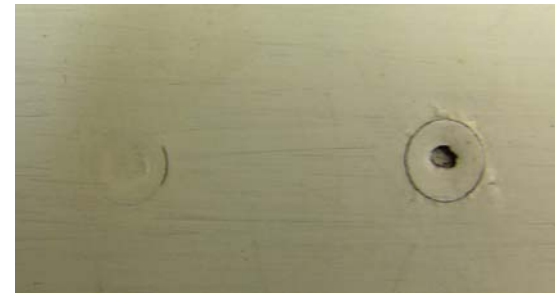
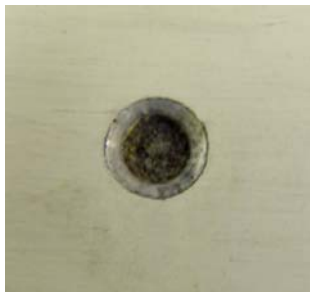
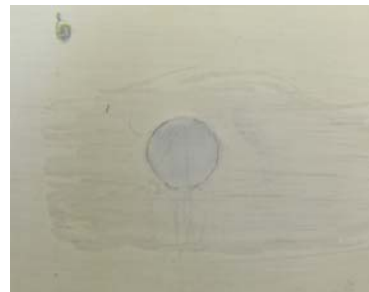
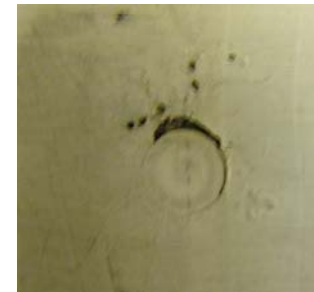
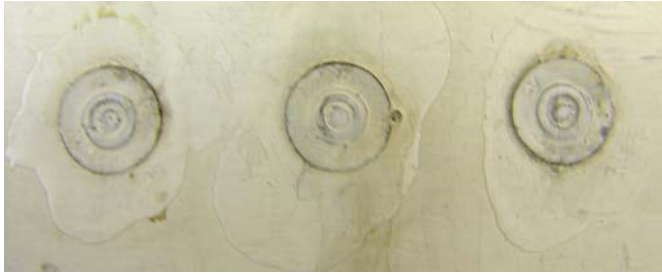
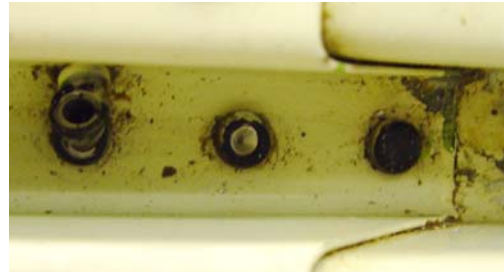
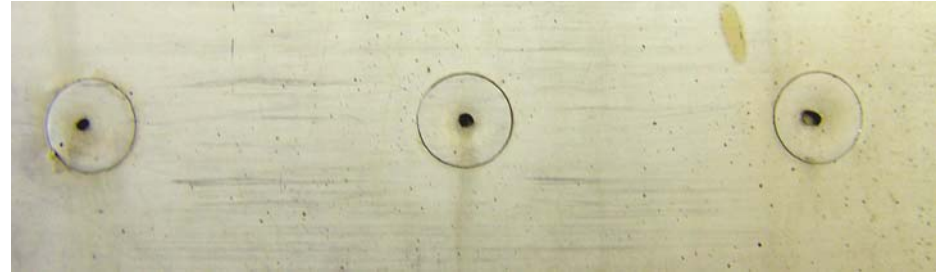
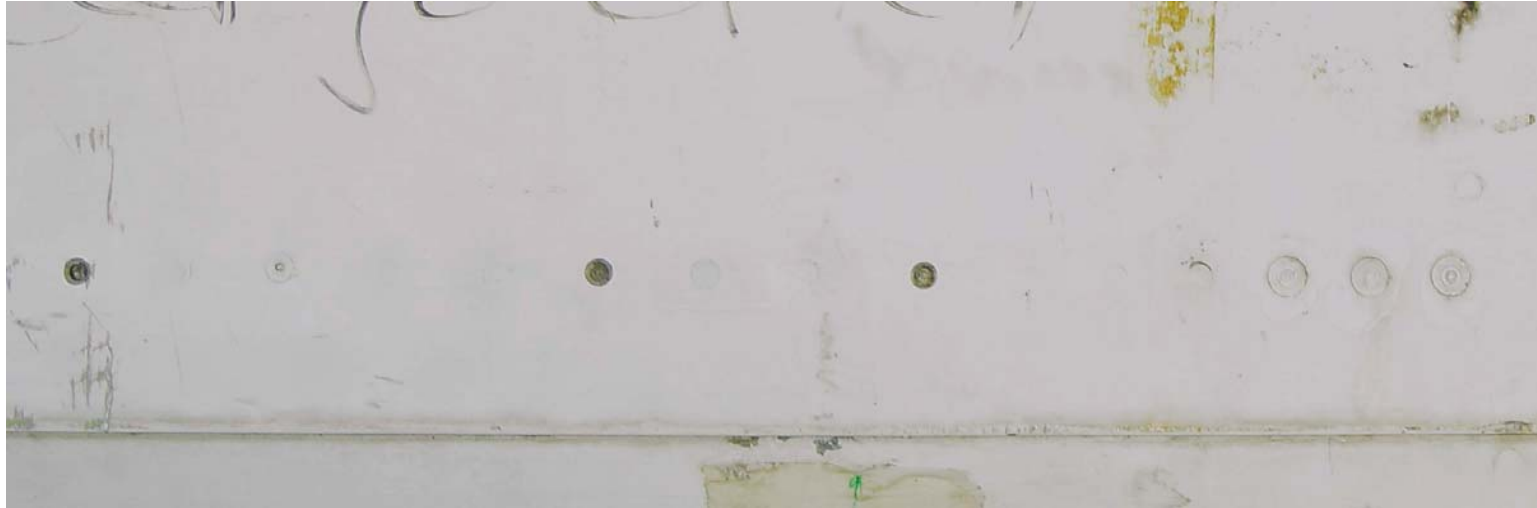
Figure 22.. Photographs showing problem areas in lap joint of Specimen 349C.

This 49 inch long lap joint specimen was located between BS580 and BS600D on STR24L. The specimen suffered from pillowing due to corrosion as well as corrosion on the inboard skin and stringer. Some of the original rivets replaced with steel fasteners, while others were sheared off due to the pillowing stress. Some of the rivets were cracked or had pitting corrosion and some were on the verge of popping out. Photographs of both front and rear surfaces of the specimen are shown in Figure 21 **Error! Reference source not found.**. The results from the visual inspections indicating the problem areas such as replaced or popped out rivets are presented in Table 4 and images of these areas are shown in Figure 22 **Error! Reference source not found.**.

Front (F) / Rear (R)	Damage Description	Rivet Location	
		Row	Number
F	Cracked rivet	T	18
F	Popped out rivet	T	40
F	Popped out rivet	M	10
F	Cracked rivet	M	11
F	Popped out rivet	M	15
F	Cracked rivet	M	16
F	Popped out rivet	M	17
F	Popped out rivet	M	20
F	Replaced rivet, same size	M	21
F	Popped out rivet	M	23
F	Deformed rivet	M	26
F	Replaced rivet, larger, deformed	M	27-29
F	Replaced rivet, same size, popped out	M	43
F	Popped out rivet	M	44
F	Filiform corrosion	M	45
F	Popped out during disassembly	M	46
R	Rivet missing (not popped out), exfoliation on the inboard skin	M	29-30

T 23

T 24

M 10,11

M 15

M 16,17

M 20

M 21

M 26

M 27-29

M 27-29 Rear

M 44-46

LHS of BS600

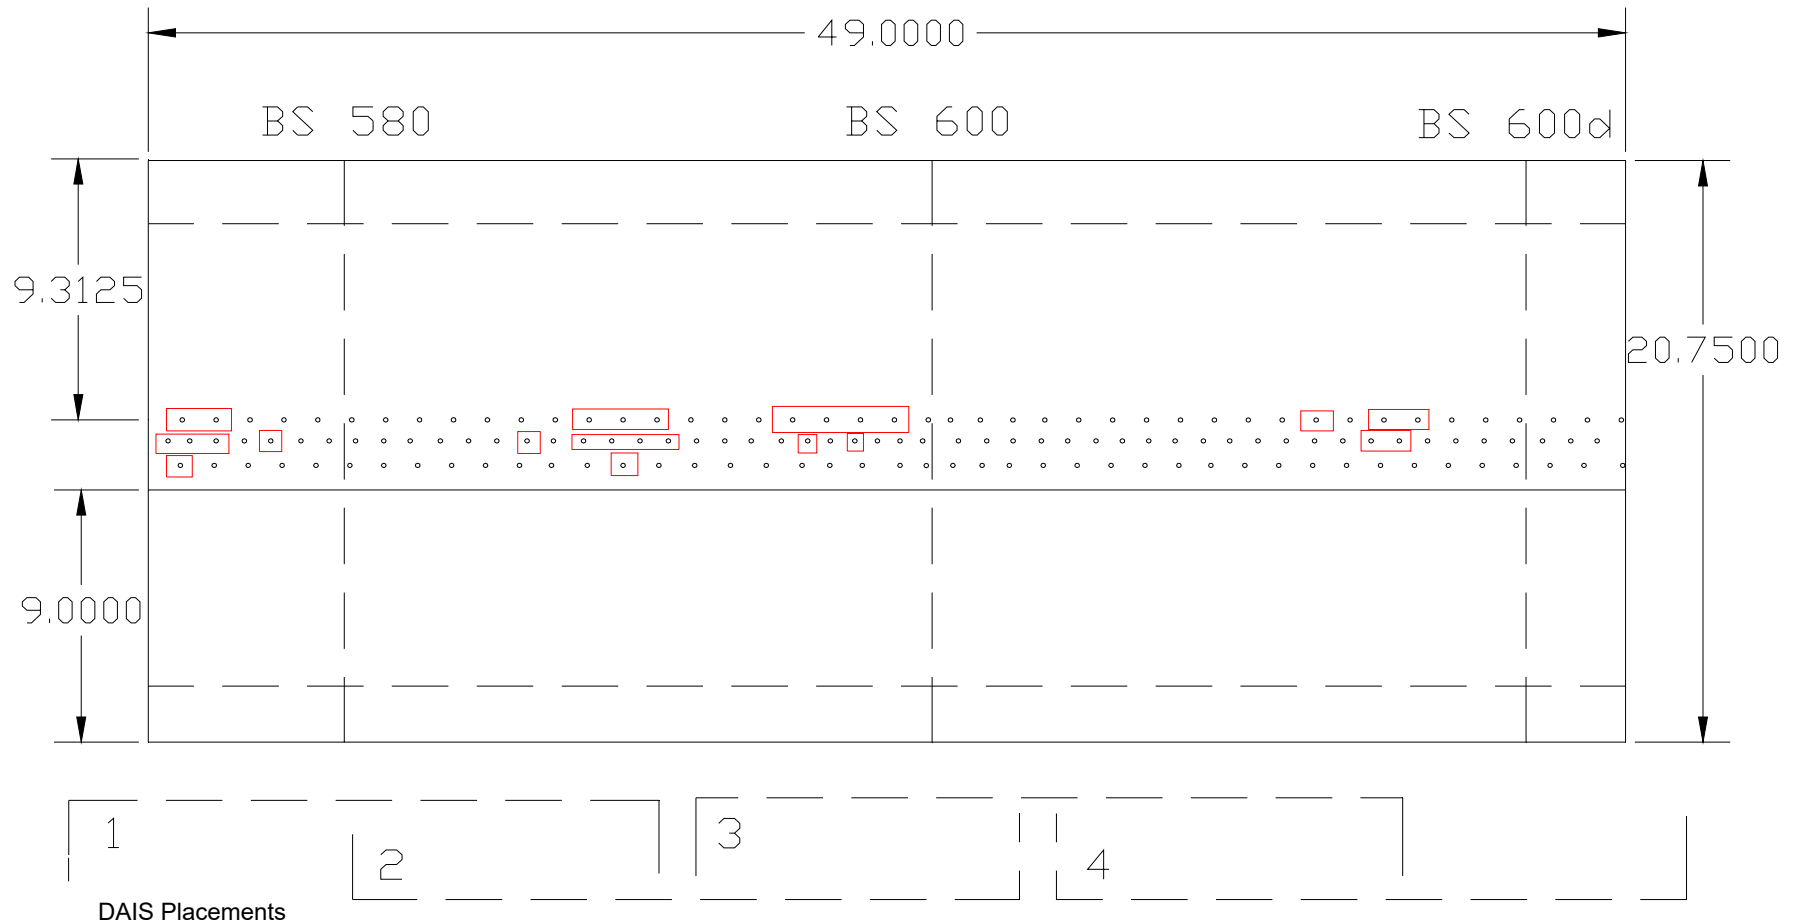
Figure 23. Schematic of lap joint 349C showing DAIS Placements 1 to 4 and locations of pillowing cracks (Red boxes).

A schematic of lap joint 349C showing the location of the DAIS 250C inspections is shown in Figure 23. Four D Sight images were taken with 50% overlap to cover the total length of the joint and the results are shown in Figure 24a. To obtain better D Sight signatures of the joint surface the paint was removed. The surface was inspected with the aid of SolidHi and negative pressure to conform a 10 mil black vinyl sheet. These inspection images are shown in Figure 24b). Figure 23 is also used to mark the areas containing pillowing cracks as detected by X-ray inspection of the joint.

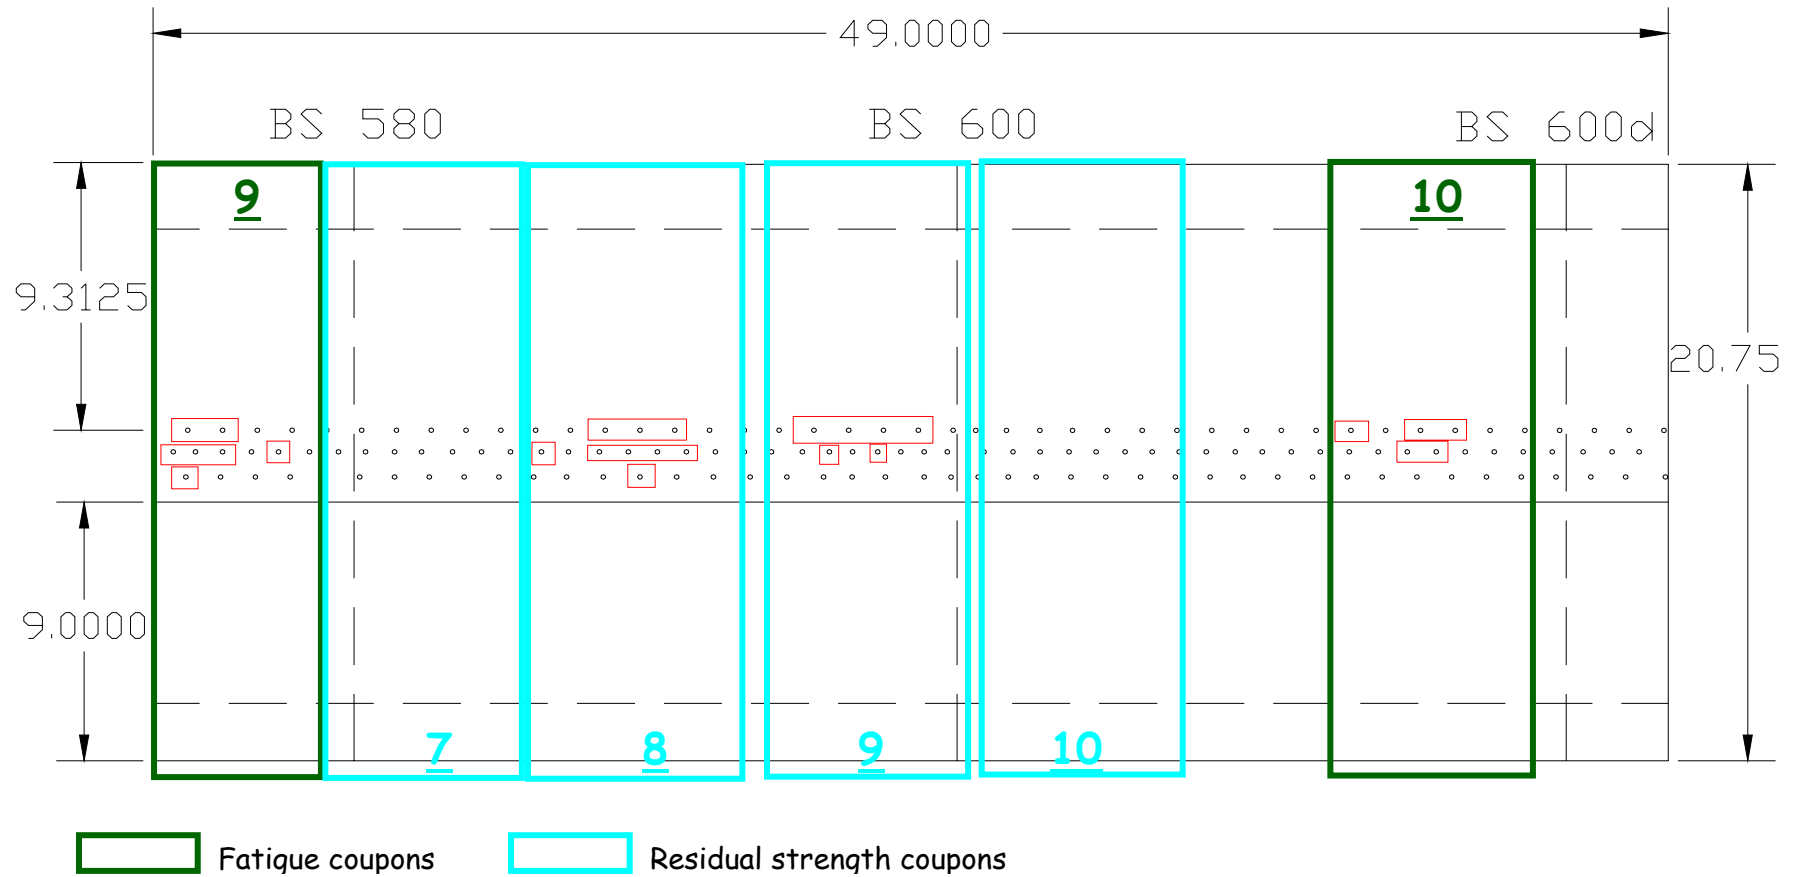
Figure 28. Sketch of Specimen 349C. Numbered boxes indicate nominal location of test coupons.

The X-Ray inspections are not presented for this lap joint. The areas detected to contain pillowing cracks are marked by the red boxes in Figure 28.
