A Report on the Alexis Nihon Office Complex Fire

G.C. Gosselin and J.R. Mawhinney

Internal Report No. 531

Date of issue: April 1987

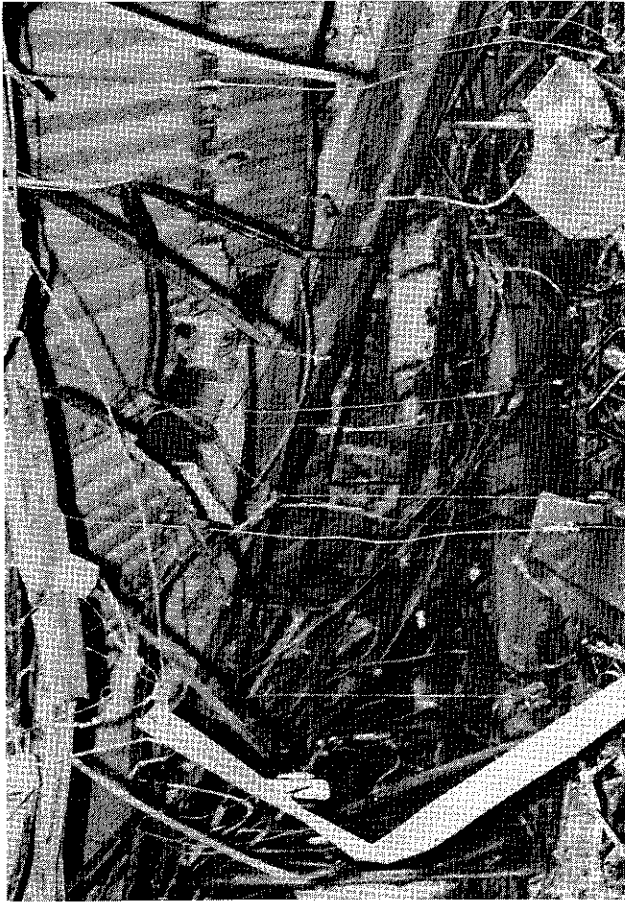
Fig. 5 (Left) Collapse of primary girder and floor
it supported on 10th storey

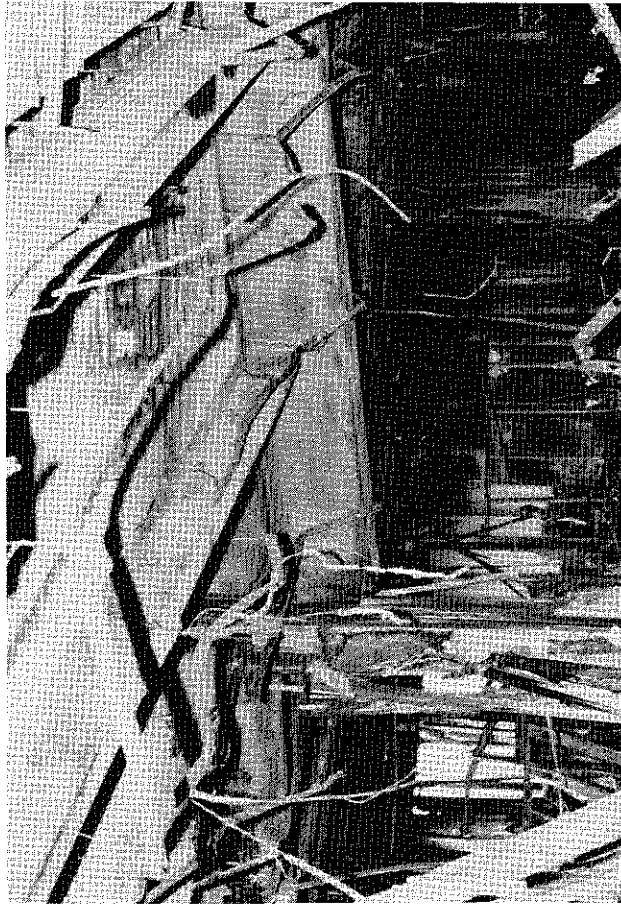
Fig. 6 (Below) Partial collapse of primary girder
on 12th storey

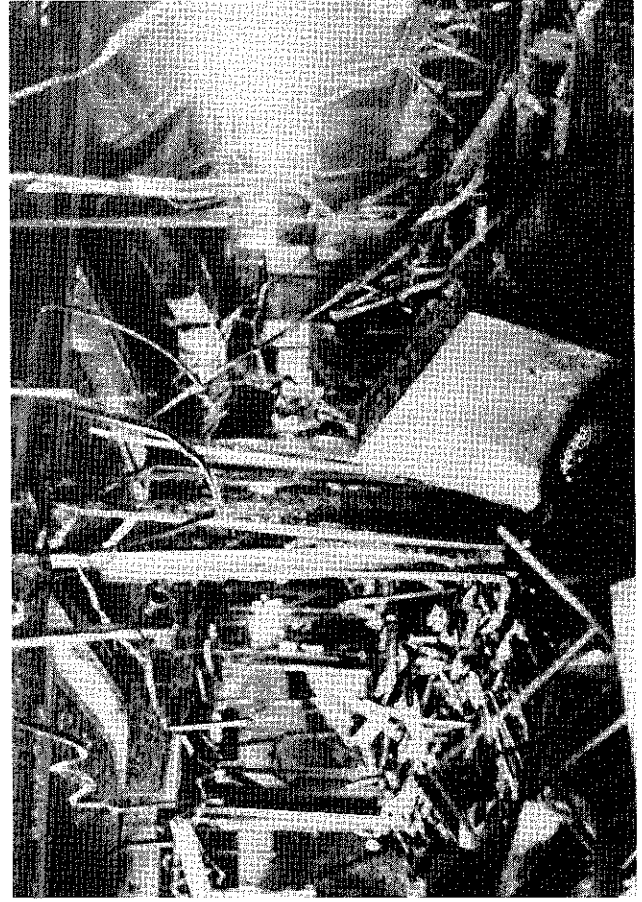
The statement that the door was too hot to open, if correct, suggests that a fire on the 10th floor was already fully developed at the time fire fighters determined the exact location of the outbreak. An attempt to put out the 10th floor fire was eventually made from the North stairwell but with no success, for reasons to be elaborated on later. We will only note here that the fire grew in intensity to a point where a second alarm had to be given, reportedly at 17:45, a third at 17:54, and additional alarms at 18:23 and 18:37. A total of 200 fire fighters were said to have combatted the blaze, which eventually destroyed (approximately) 75% of the contents on the 10th floor, 40% on the 11th, 60% on the 12th and 100% on the 16th floor. In addition, partial floor collapses were sustained on the 10th and 12th floors (Figures 5 and 6), and the roof above Floor 16 (15th storey) deflected considerably (Figure 7).

Fig. 7 (Left) Extensive deflections of
(non-loaded) roof above 15th floor.

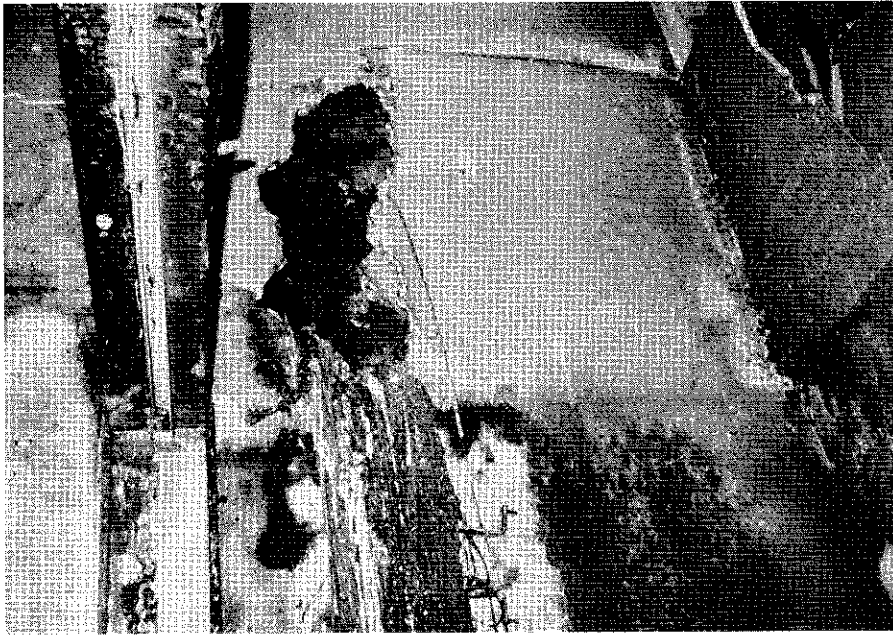
Fig. 8 (Left) Melted communication cables hanging from poke-through hole in South exit stairwell (11th floor).

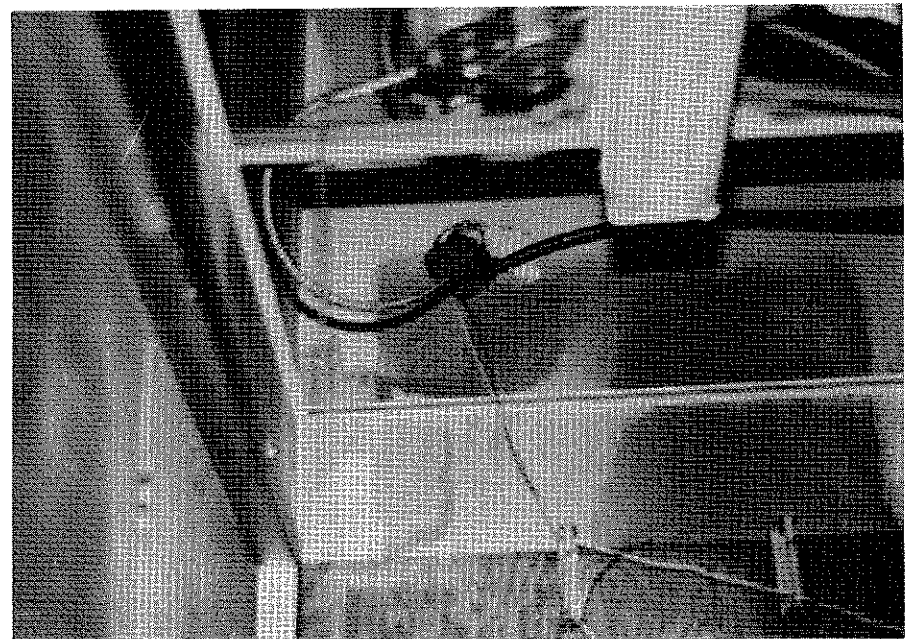
First, there is little doubt that the fire started on the 10th floor. The exact location, however, is uncertain and the cause unknown. It may have started in the communication cabinet located within the South exit stairwell, and spread into the adjacent floor area through an inadequately firestopped electrical and communication cable opening poked through the gyproc shaftwall. Or, vice versa, the fire may have started first on the tenanted floor area side, and spread to the communication cabinet via the same small opening. Irrespective of where the fire actually started, there is evidence to suggest that it spread through the fire separation enclosing the South exit stairwell via the poke-through hole for communication cables (see Figure 8). Similar holes were observed on Floors 14 and 15 (Figure 9). As a matter of fact, it was apparent that fire had broken out of the stairwell onto the tenanted floor area on Floor 14 through this unprotected penetration. Fortunately, the spread of fire onto that floor was limited to a few metres within the concealed ceiling space, allowing this determination to be made.

Fig. 9 (Below) Poke-through hole in the South exit fire separation leading from communication cabinet to concealed ceiling on 14th floor.

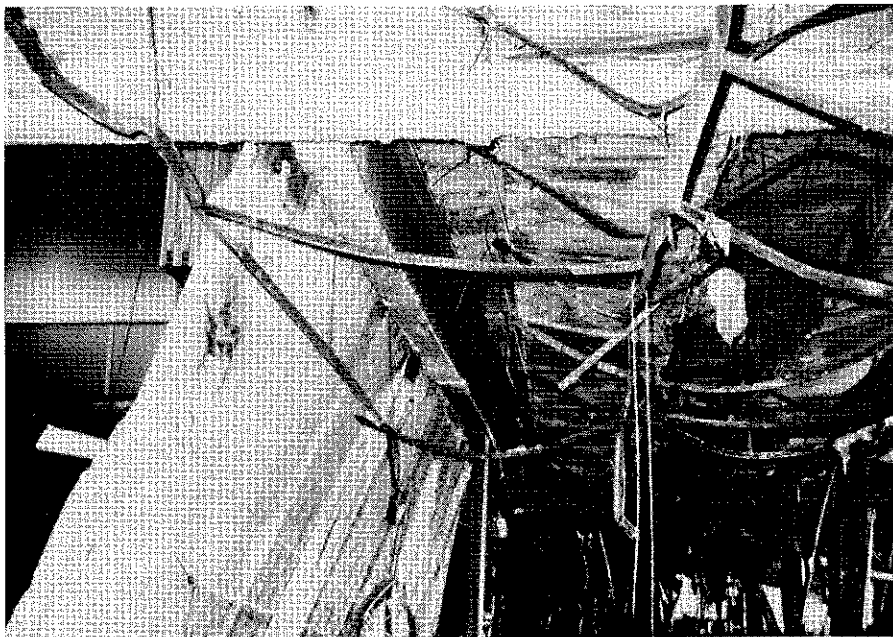
At some point during the fire on the 10th floor, a 9.1 m x 9.1 m (30 ft x 30 ft) floor/ceiling section immediately adjacent to the South stairwell collapsed (see Figures 10 and 11). Close inspection of girder to column connections suggested that collapse was likely due to a failure of the welds attaching the angle connectors to the columns (Figures 12 and 13). The angle connectors, which were bolted to the girders, remained attached to the latter. The exact timing of the collapse could not be ascertained during our visit; however, assuming that (a) the welds were not substandard, (b) the sprayed-on protection was uniformly applied over all areas of the floor assembly, and (c) fire fighters could not effectively cool off the fire on the 10th floor due to inadequate water pressure, one can estimate

Fig. 10 (Left) South-East view of collapsed floor section.

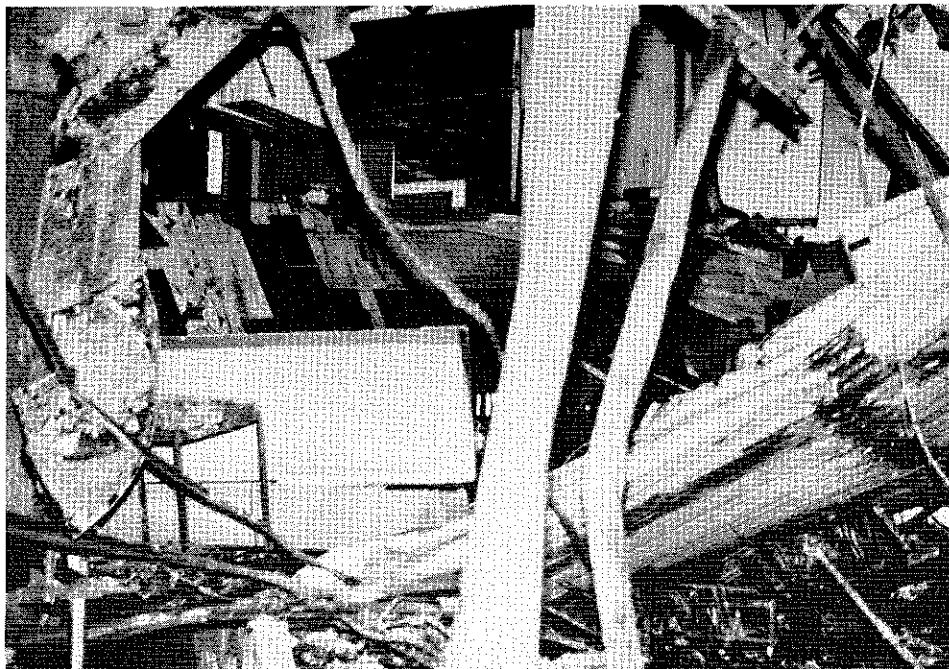
Fig. 11 (Left) North-West view of collapsed floor assembly

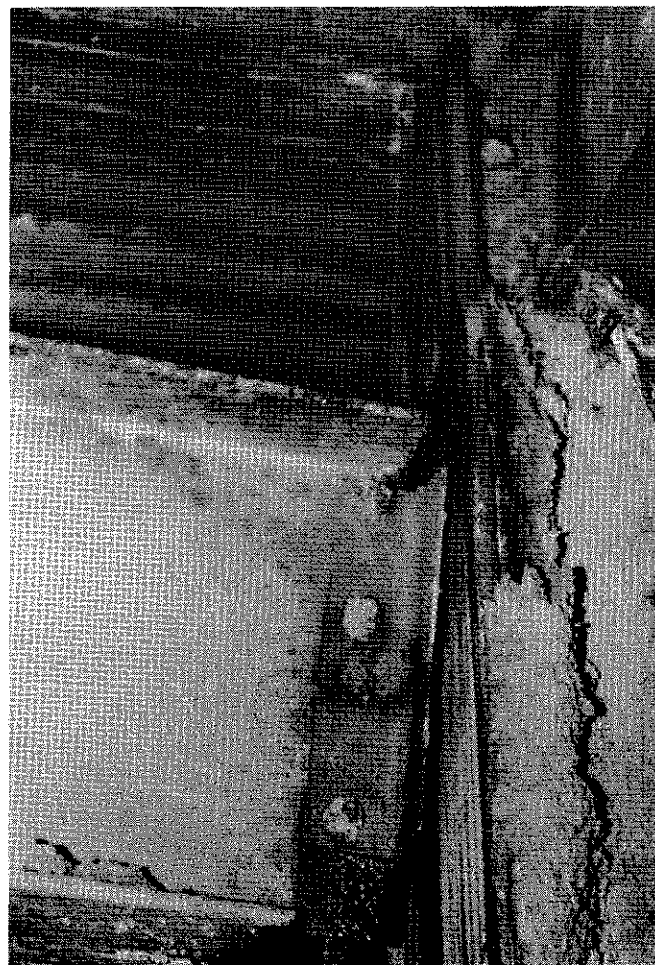
This estimate appears to be in line with one newspaper report which indicated that an order to evacuate the restaurants along St-Catherine Street was given at approximately 20:15 (3 hours after the general alarm), because of concerns that the structural elements on the fire floor were beginning to show some sign of structural weakness. If, on the other hand, collapse actually occurred within the first 2 hours of the fire (perhaps fire fighters have noted the approximate time of this event), then the adequacy of the welds or of the sprayed-on protection is in question.

Fig. 12 (Right) Partial collapse of primary girder showing shear failure of weld connection between angle and column

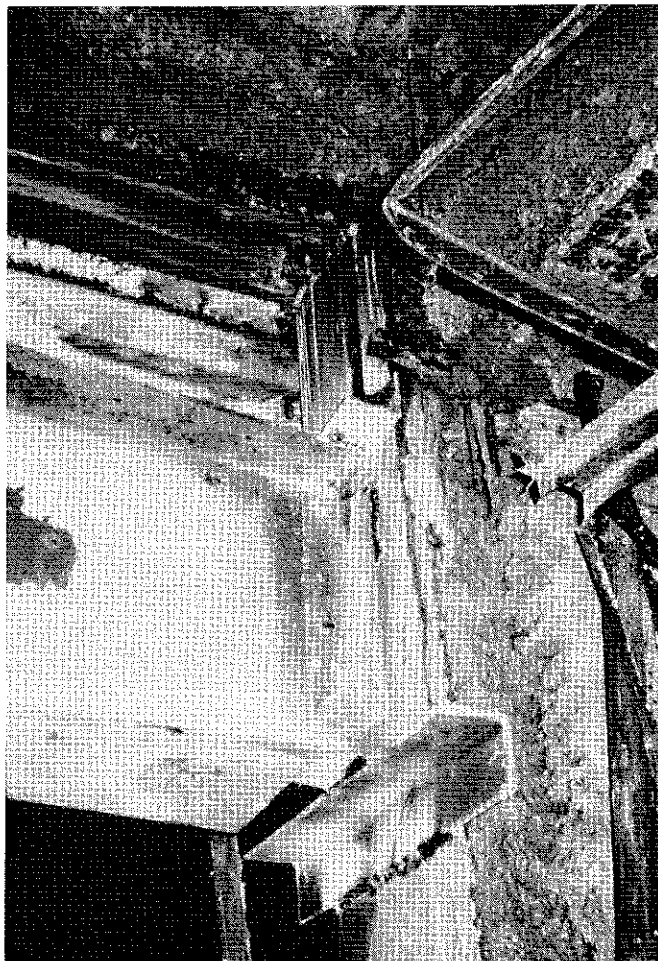
Fig. 13 (Left) Partial collapse of another girder again showing failure of the welded connection.

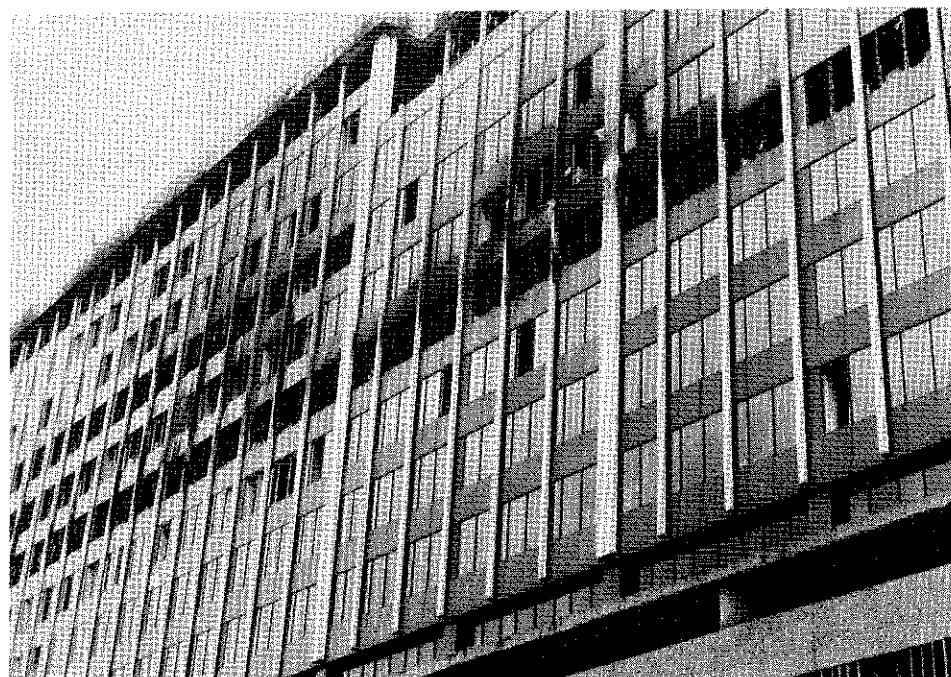
The vertical window to window separation along the exterior wall was estimated at 1.4 m on the basis of window heights (≈ 2.1 m) and storey heights (≈ 3.5 m). This spandrel protection (see Figure 14) should have been quite effective in preventing storey-to-storey convective fire spread by flames projecting out of exterior windows. This claim is supported by observations of unconsumed combustible items, such as nylon strings on vertical blinds, bookcases, desks, etc., located immediately adjacent to windows on floors directly above heavily damaged areas on the storey below. Pictures taken at advanced stages of the fire and published in local newspapers also support the assumption that the fire did not spread to upper storeys via flames issuing out of windows.

Fig. 14 (Below) View of office tower from Atwater Street showing spandrel protection between storeys.

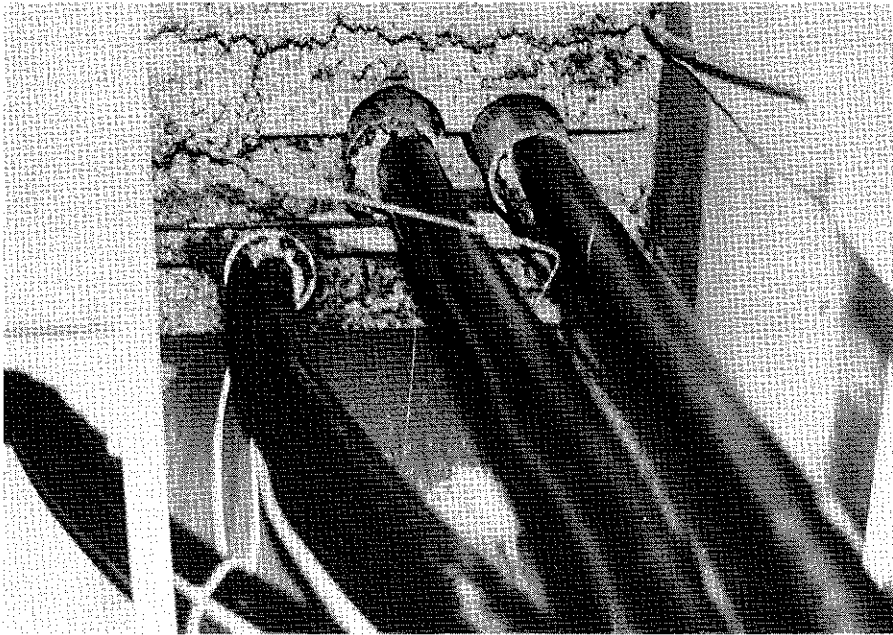
conduit penetrations in areas of the floors which had been completely consumed by the fire. We were not able to detect any through-opening in these areas. As the pictures in Figures 15 and 16 illustrate, the service penetrations appear to have been adequately firestopped. Naturally, a heated metallic pipe or conduit could have conducted sufficient heat to ignite combustible materials on the floor above. However, this scenario would have been possible only if combustible items were stored in direct contact with the conduits.

Fig. 15 (Left) Firestopped electrical cable penetrations through floor slab.

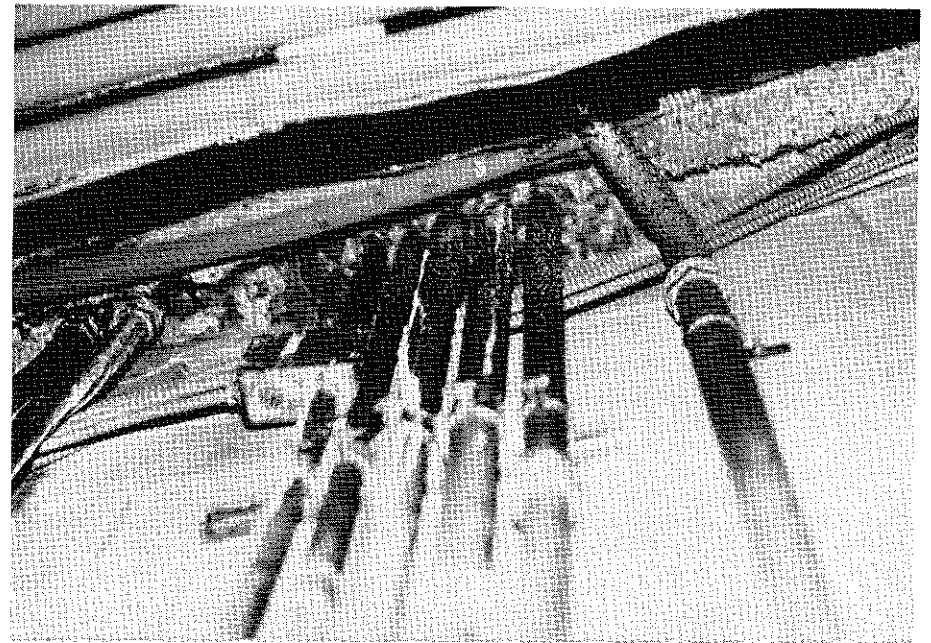
Fig. 16 (Below) Service penetrations through floor assembly below the fire floor.

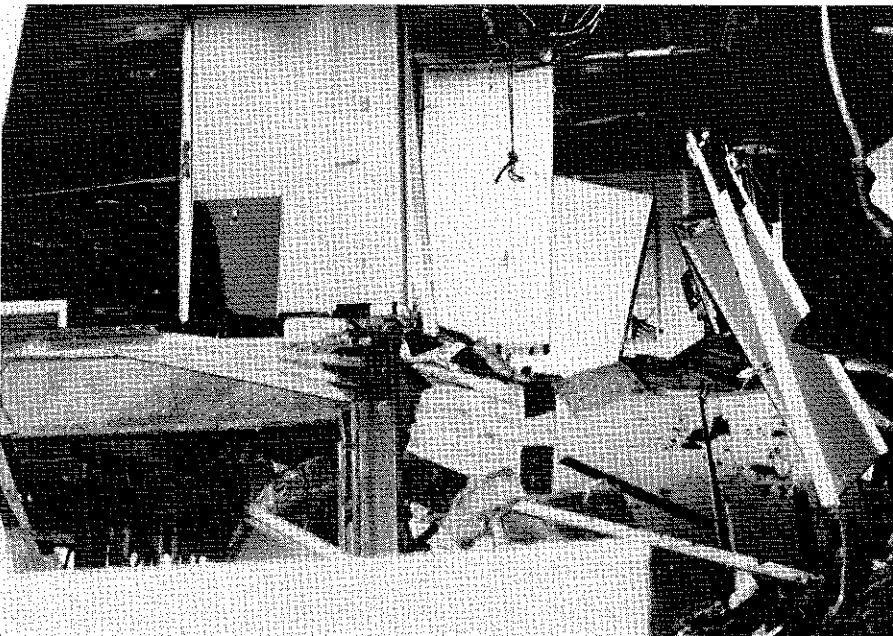
The second possibility of sufficient heat conducting through the floor slabs was rejected after observing that no combustion had taken place on floor assemblies directly above the areas of the 10th floor collapse and the 12th floor partial collapse (see Figures 17 and 18, respectively). These are the areas where one would have expected the fire to be the hottest and, hence, where the potential for conductive heat spread would have been the greatest. Yet this did not occur.

Fig. 17 (Left) Unburned combustible items directly above collapsed 10th floor assembly.

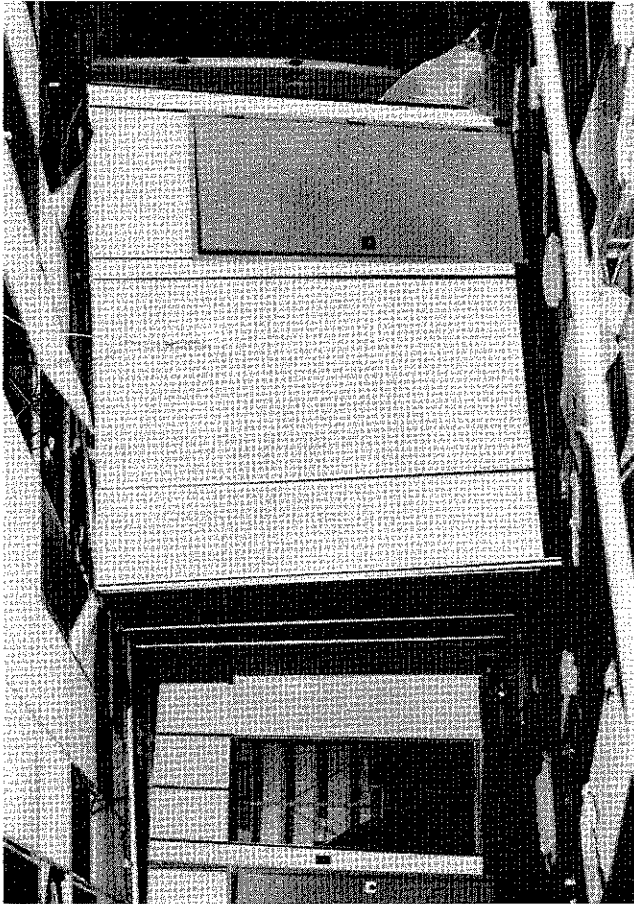
Fig. 18 (Left) No ignition of combustible material directly above partially collapsed floor assembly on 12th floor.

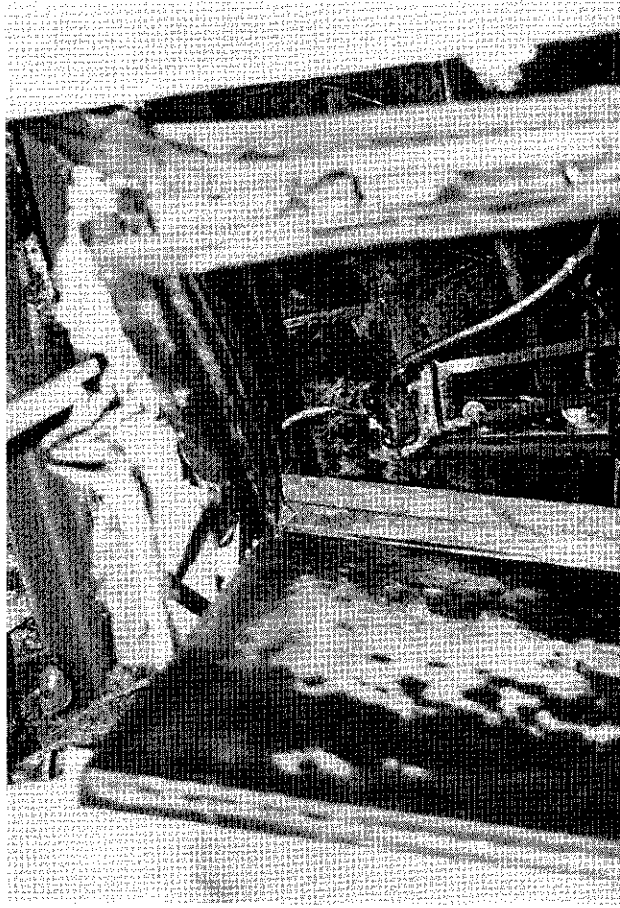
Fig. 19 (Below) Distorted exit door frame on 10th floor as seen from South stairwell side.

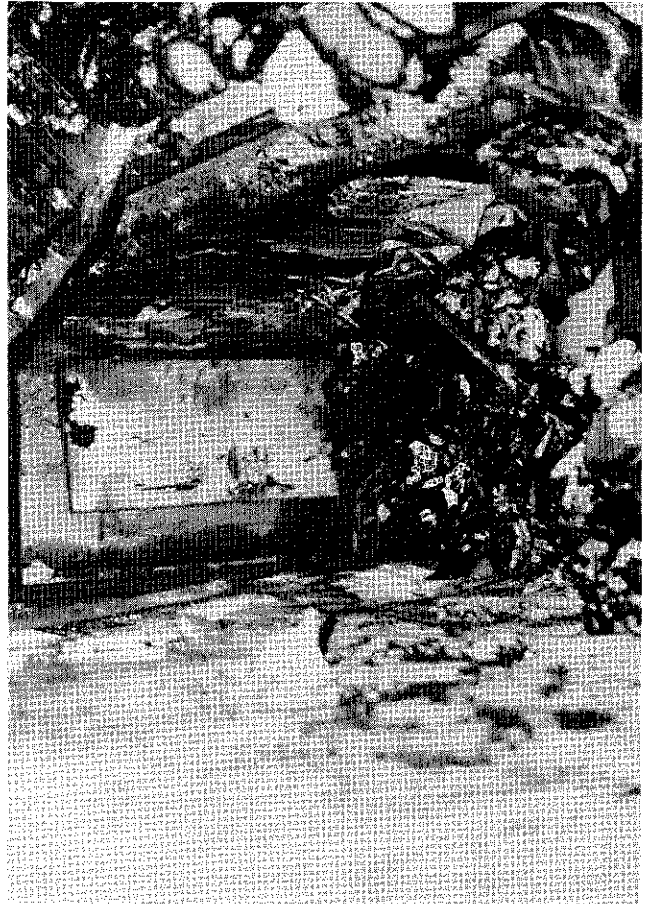
We believe the most likely spread mechanism between the 10th floor level and the two levels above it was by convective spread of hot gases and flames in the area of the South exit stairwell. In collapsing, the floor panel on the 10th storey tore down the fire separation around the South stairshaft, and allowed hot convective gases to enter the stairwell (see Figure 19). Since the fire separations around the stairwell on the next two floors up (11th and 12th storeys) were also breached due to collapse or partial collapse of beams and girders immediately adjacent to and supporting these separations, fire could have spread onto these two floor areas (Figure 20). No structural collapse occurred immediately below the 13th floor exit shaft walls, leaving the fire separations intact to prevent spread on that storey.

Fig. 20 (Left) Breached fire separations around South exit stairwell.
