Tornado wind damage to buildings observed after the Sarnia tornado of May 21, 1953

TORNADO WIND DAMAGE TO BUILDINGS OBSERVED
AFTER THE SARNIA TORNADO
of May 21, 1953

Report No. 111
of the
Division of Building Research

February, 1957

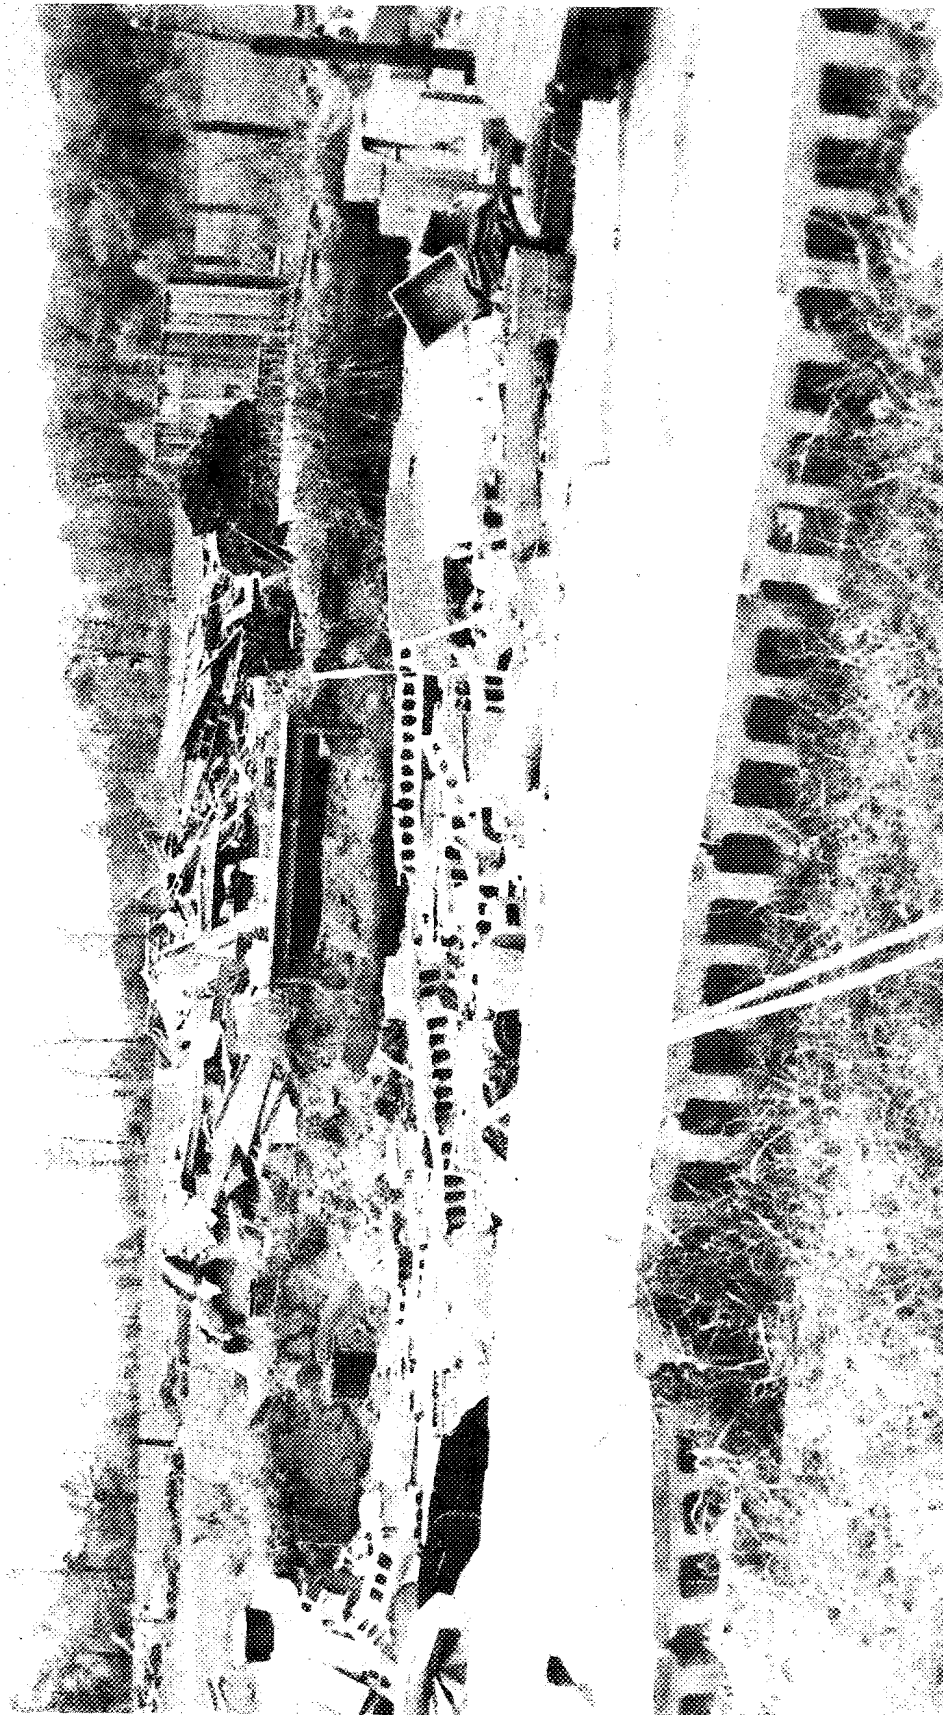
There were not many examples of concrete block construction in the commercial district of Sarnia, but, of the three examples reviewed, two one-storey structures were almost completely demolished. The third, a garage with a hotel occupancy on the second floor, appeared to have been damaged considerably by racking and some of the walls were out of line both laterally and vertically. Since this building had been in disrepair, however, and probably had been altered several times, it was impossible to determine whether the damage had been the result of forces of the tornado.

Figure 3 Completely destroyed concrete block construction

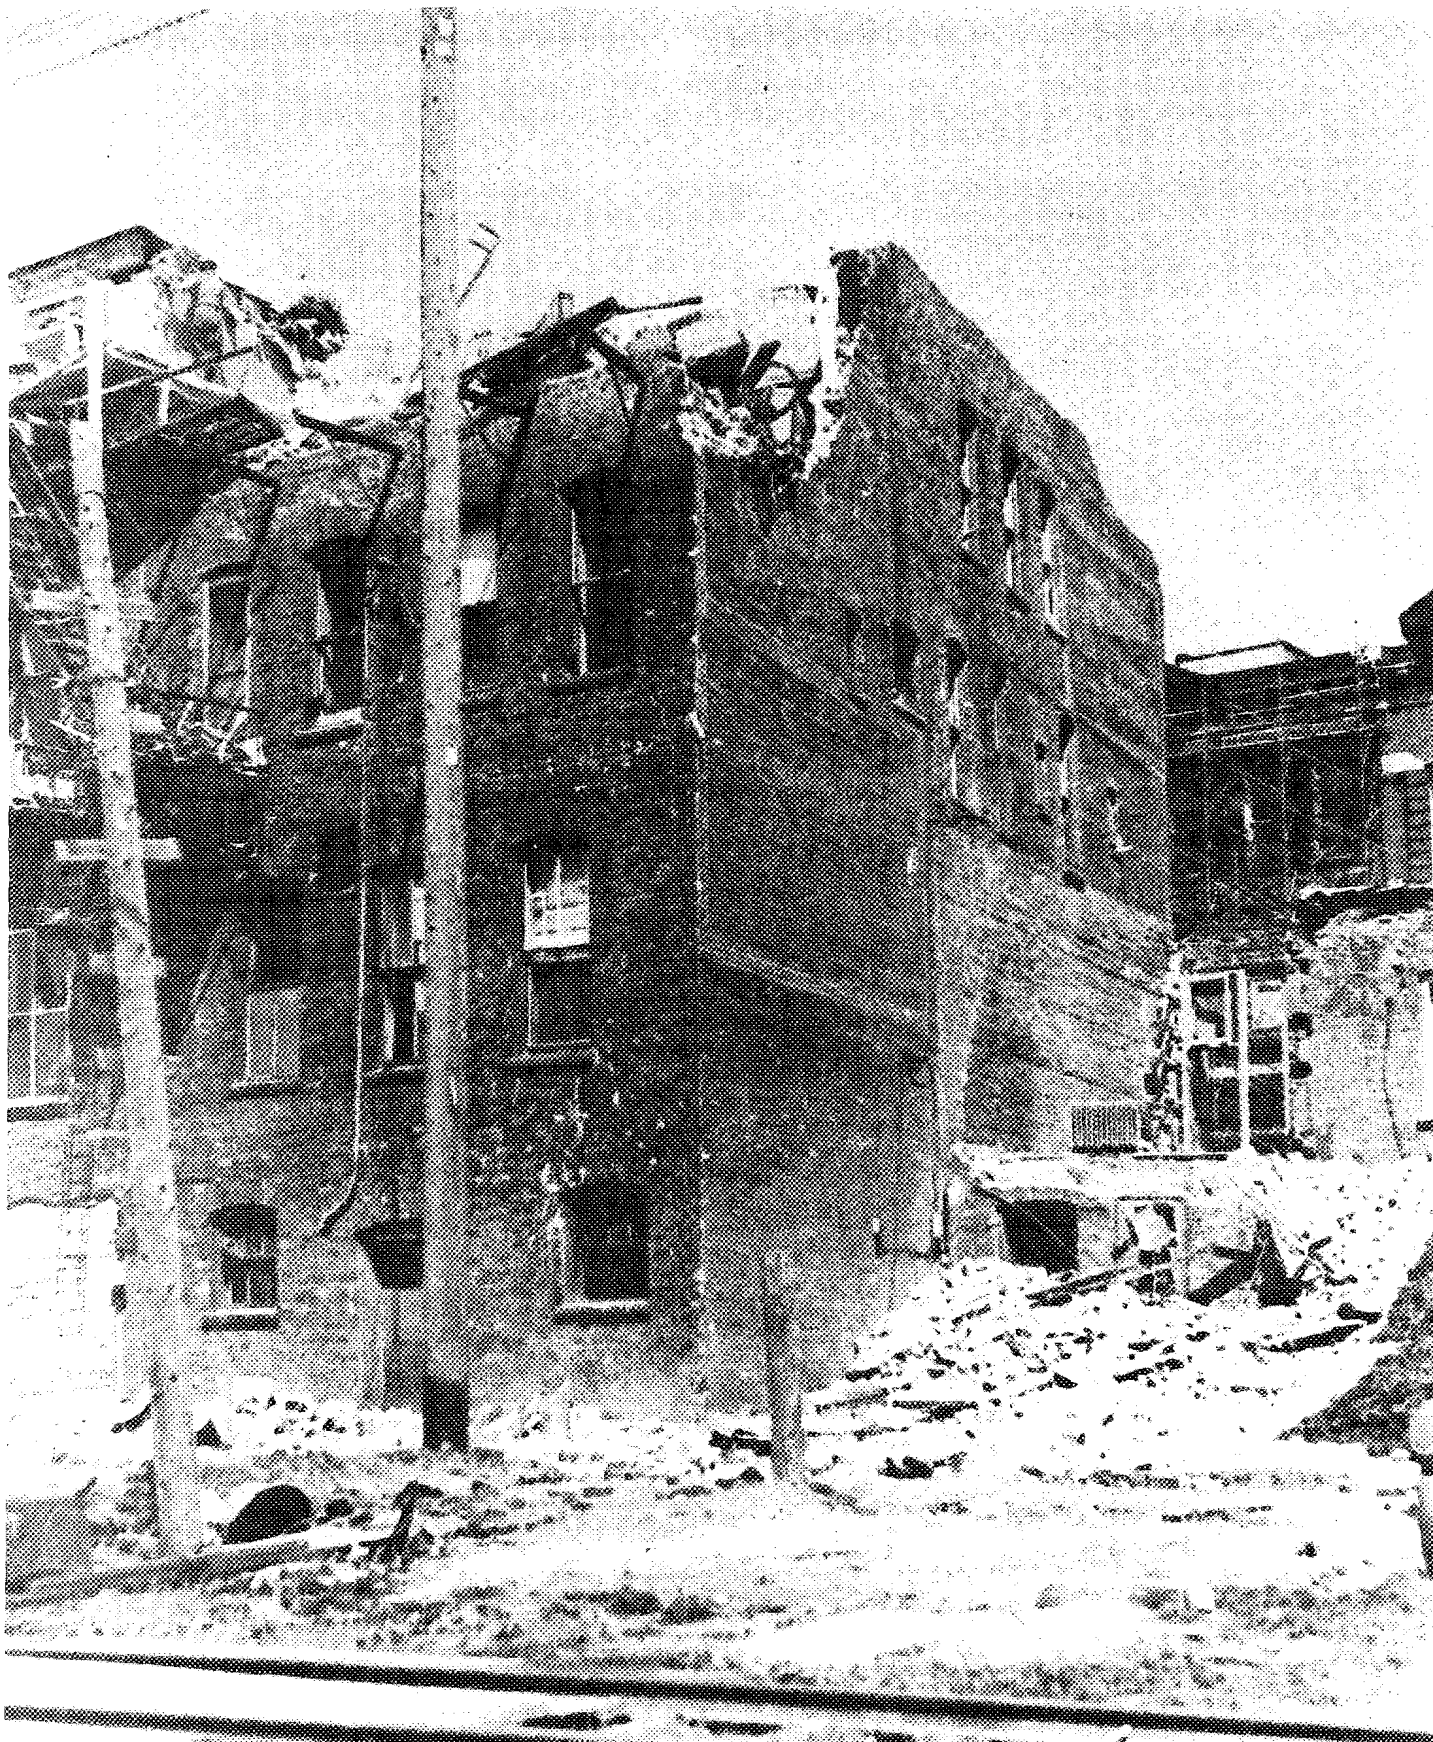
The first buildings in Sarnia to experience the tremendous forces of the storm were of this type of construction along the river front on Front Street. Damage to these consisted of the removal of portions of the complete roof, or the collapse of the top-storey walls (Figs. 4, 5, 6). The Hotel Vendome received considerable damage to its third- and fourth-storey walls. Portions of these walls on the west side (facing the approaching storm) and the fourth-storey wall on the south side were blown out. The large, many-sided tower portion of the building received little damage, indicating the effectiveness of laterally supported or buttressed masonry walls.

- 8, 9. Damage to old building of masonry bearing wall type along waterfront (note bicycle still on third floor). (Fig. 4 in DER Report No. 111 - photo 9.)

Figure 4 Damage to old building of masonry bearing wall type along waterfront (note bicycle still on third floor)

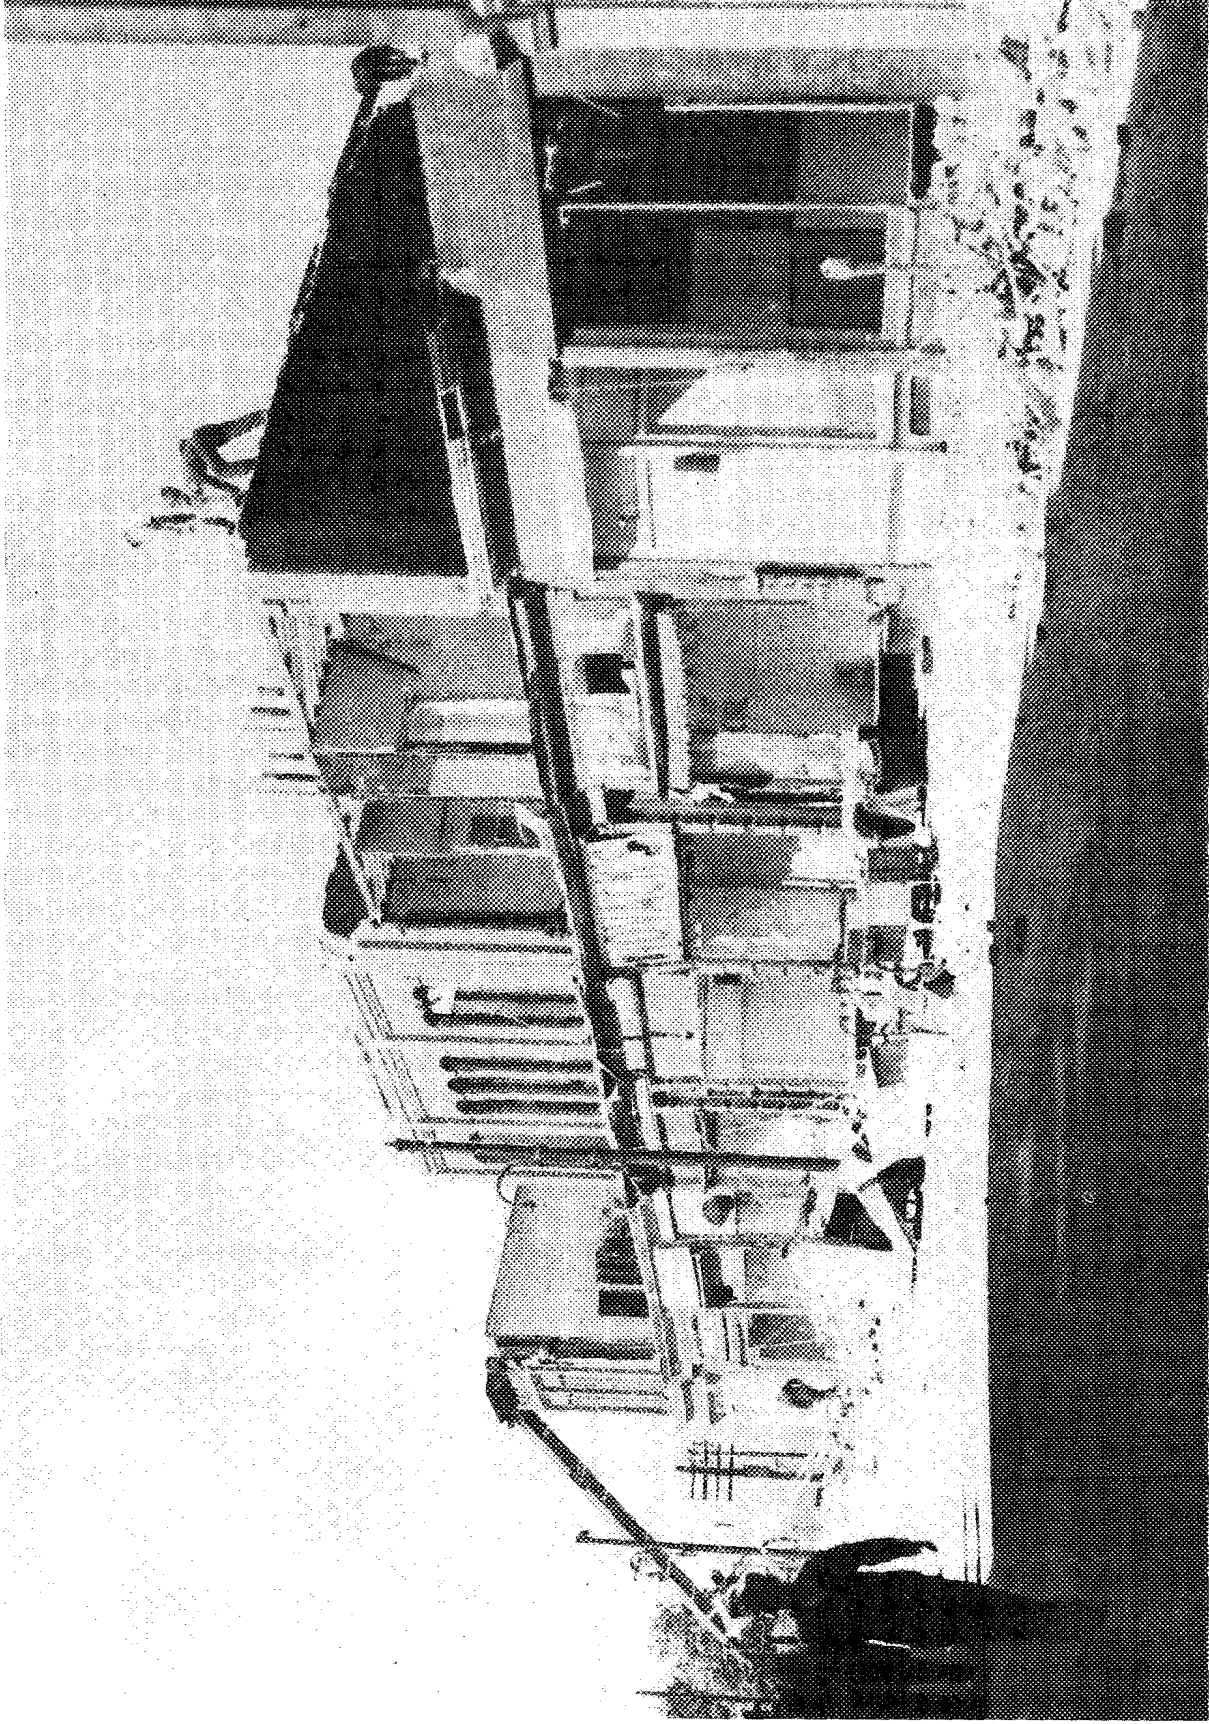
Figure 5 Front Street. Street cleared, building repairs started

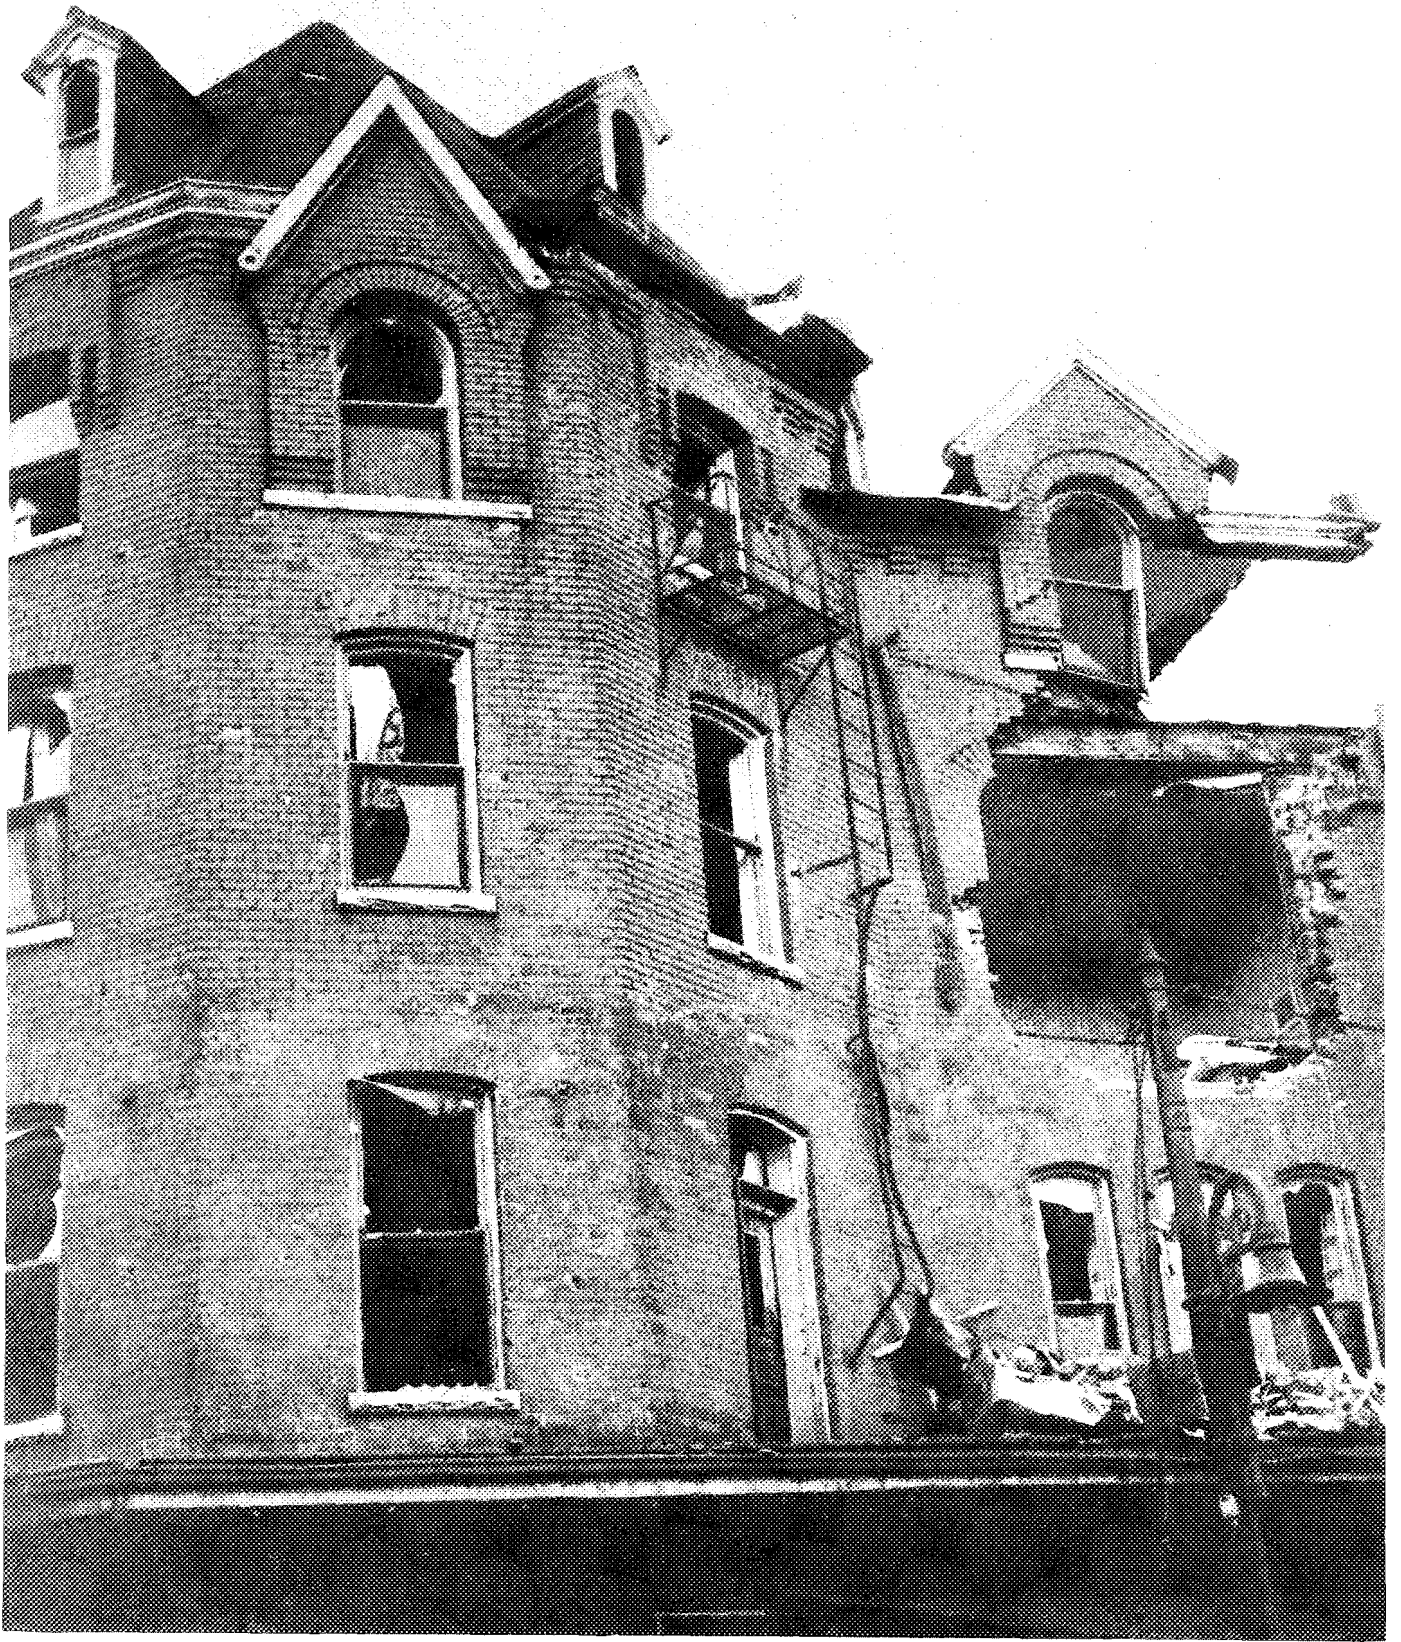
Figure 6 Hotel Vendome

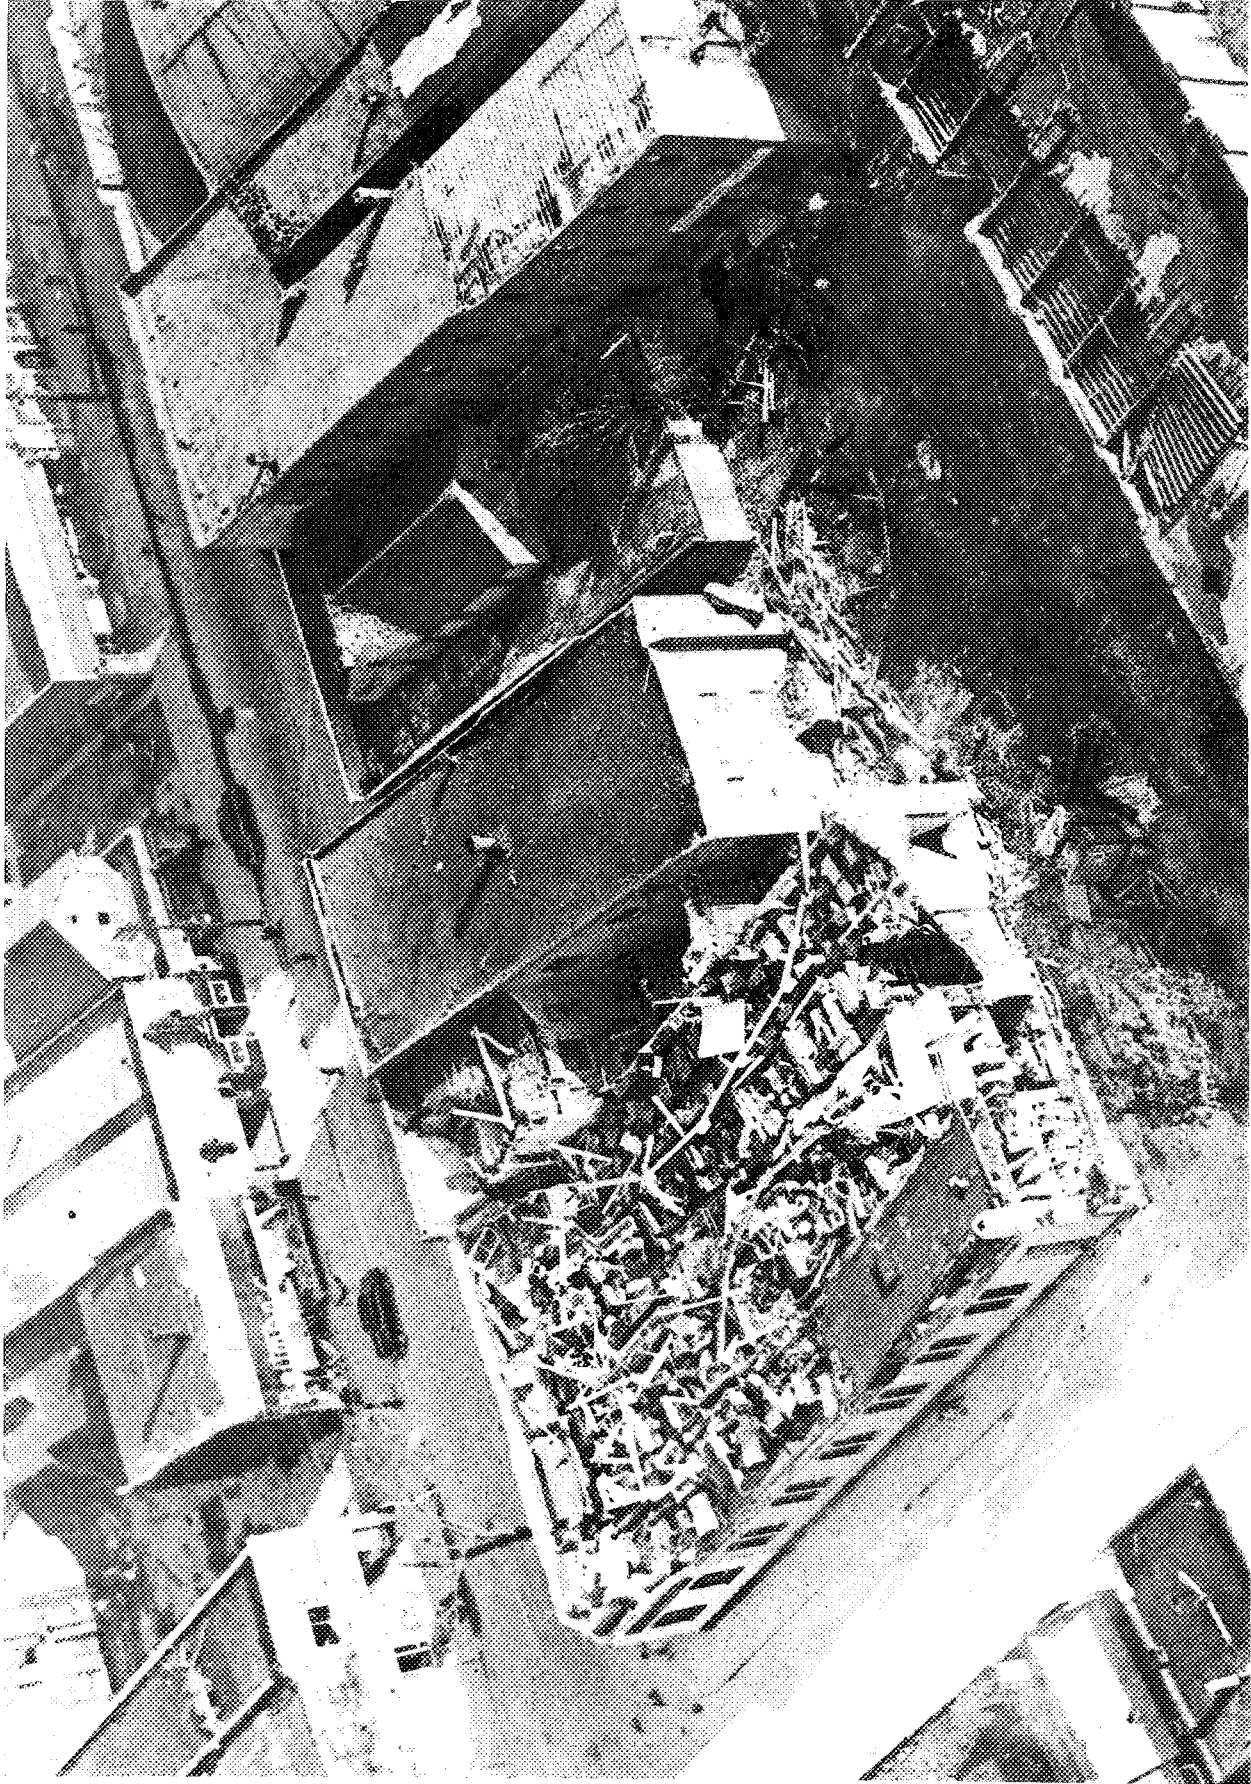
One building that received extensive damage was the two-storey building on Christina Street occupied by a bank and furniture store. The entire roof was removed together with the second-storey wall. The furniture in the second floor show-room appeared to have been relatively undisturbed, and was entirely exposed to the elements after the storm had passed (Fig. 7). Water damage to the first floor was due to the second floor sprinkler system which was broken in the storm.

Photo by London Free Press
Figure 7 Aerial view of business block, showing Imperial Bank and Taylor's Furniture Store. Note extensive damage to roofs caused by low pressure and centre of storm

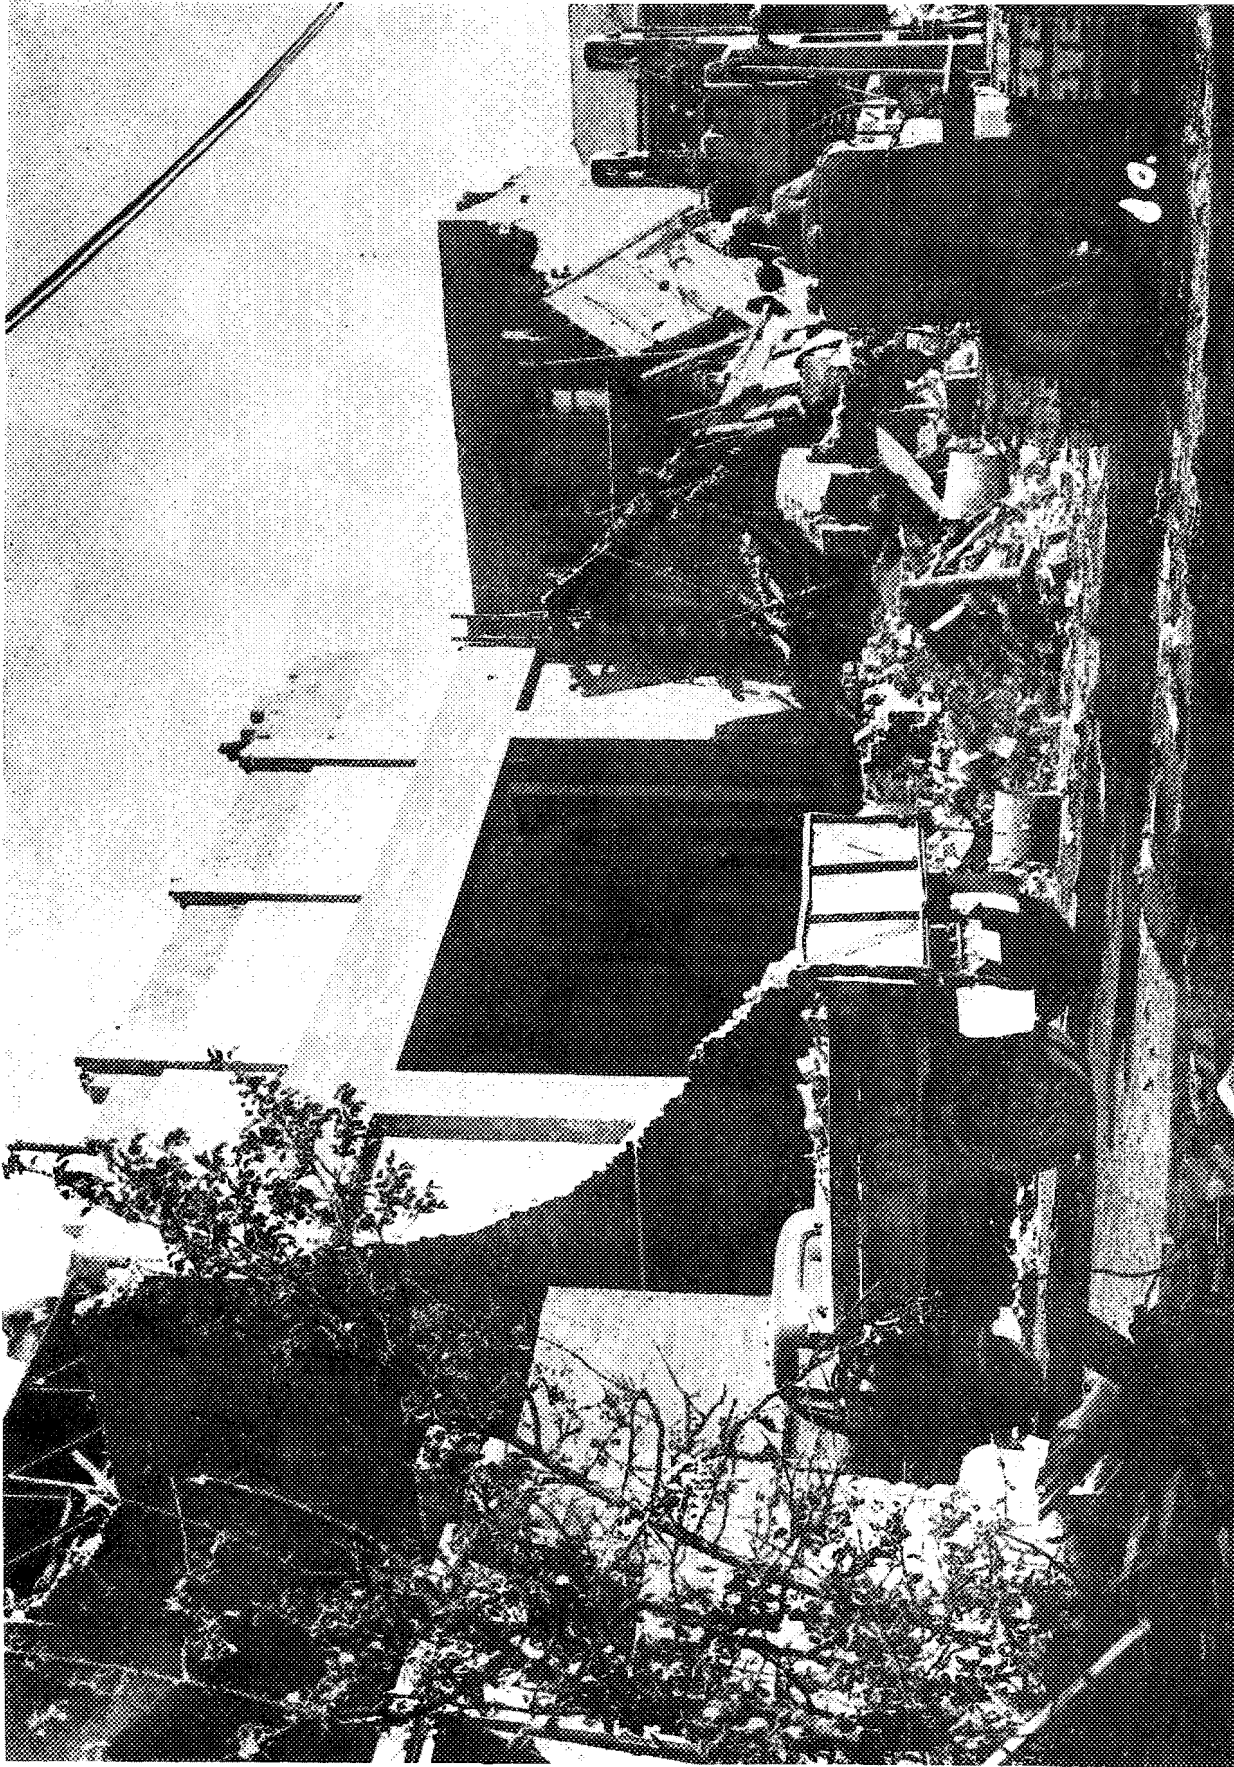
The entire stage portion of the Imperial Theatre, consisting of a large expanse of laterally unsupported masonry bearing wall, was totally demolished (Fig. 8). The remainder of the building, constructed of a steel and reinforced concrete frame, was damaged only in the bays adjacent to the stage portion of the building. The damaged portion of the building was on the lee side of the approaching storm and failure probably was due to the differential of pressure between the atmospheric pressure on the inside of the building and the low pressure of the core of the vortex on the outside.

Photo by Roy Paisely, Sarnia
Figure 8 Imperial Theatre. Collapse of brick wall behind stage and part of roof.

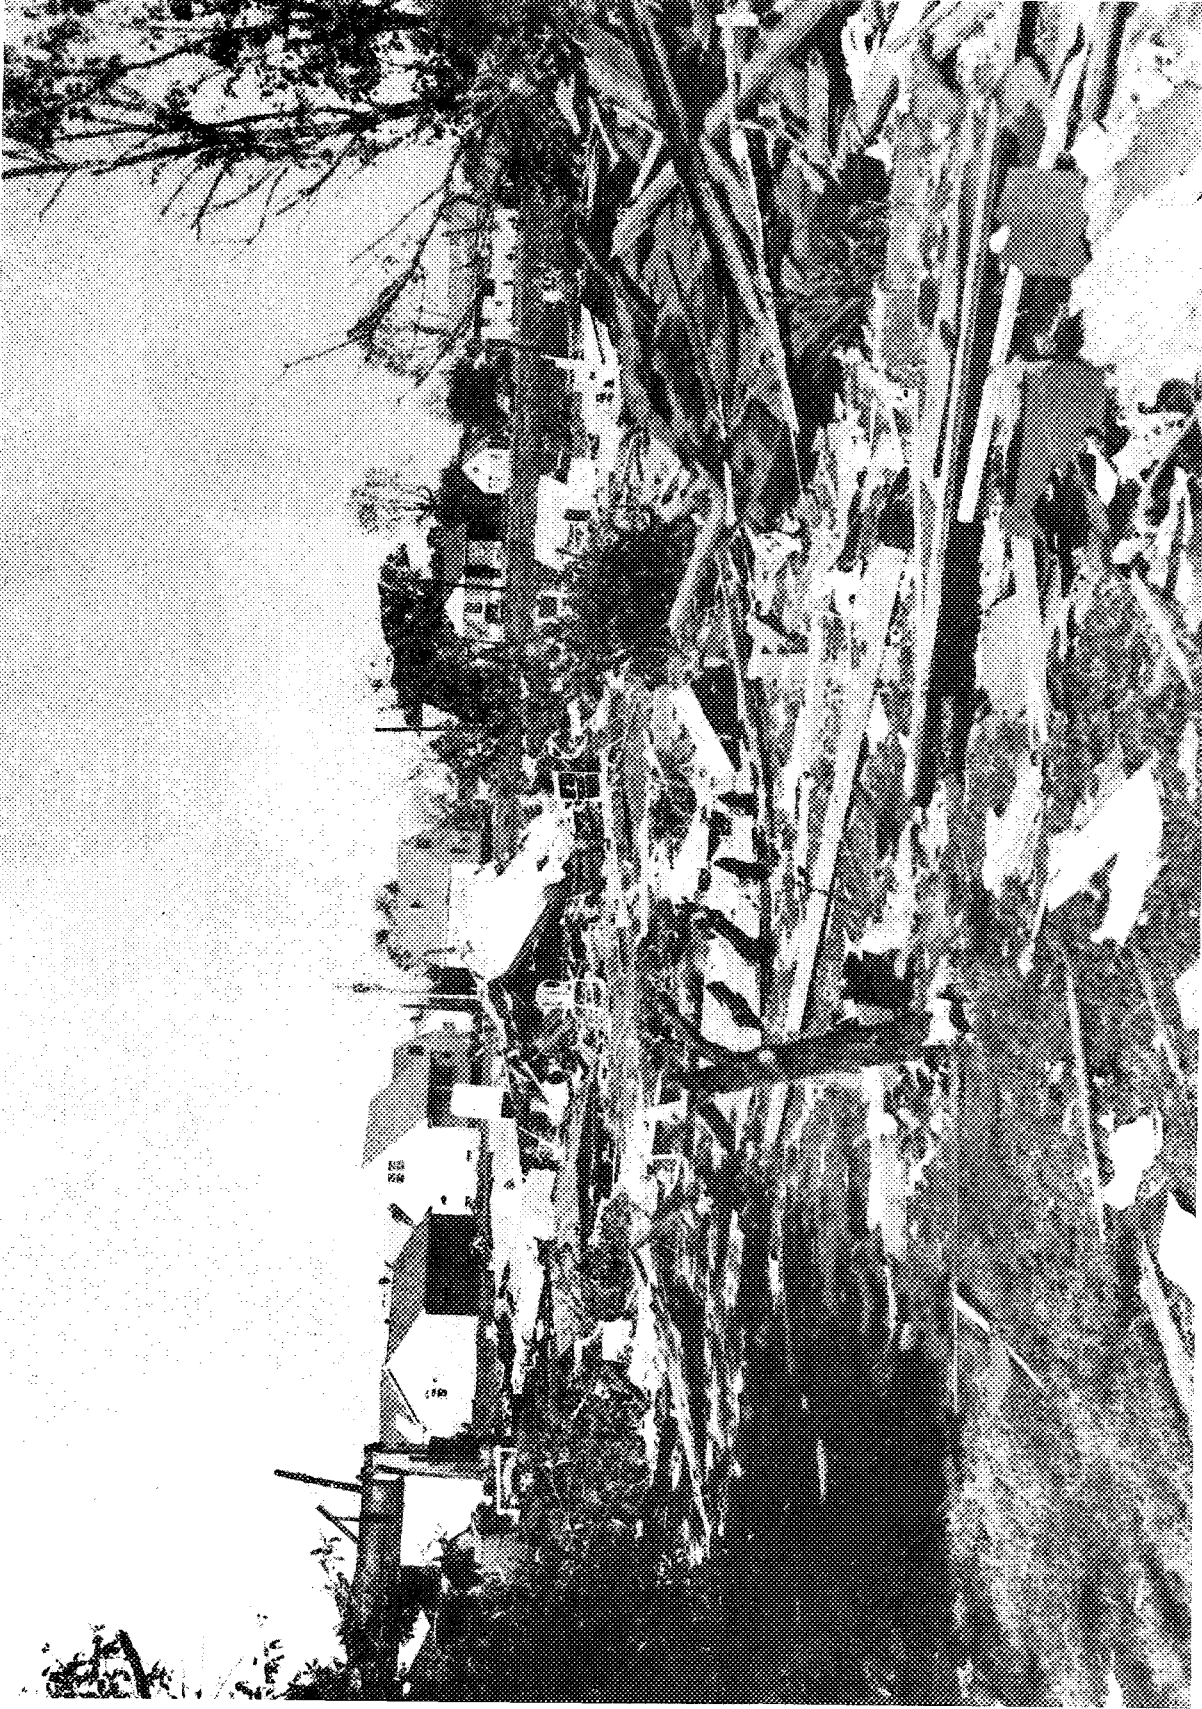
Damage to residential construction varied considerably. Some houses were entirely demolished (Fig.9); others had their roofs torn away (Fig.10); and some were moved off their foundations (Fig.11). These were the more severe results of the storm's passage. Less severe damage consisted of loss of portions of the roof or of roofing material, loss of siding, or damage from flying debris, such as parts of other buildings and falling trees.

Photo by Canadian Observer, Sarnia
Figure 9 Damage to frame houses. Note limited area of damage

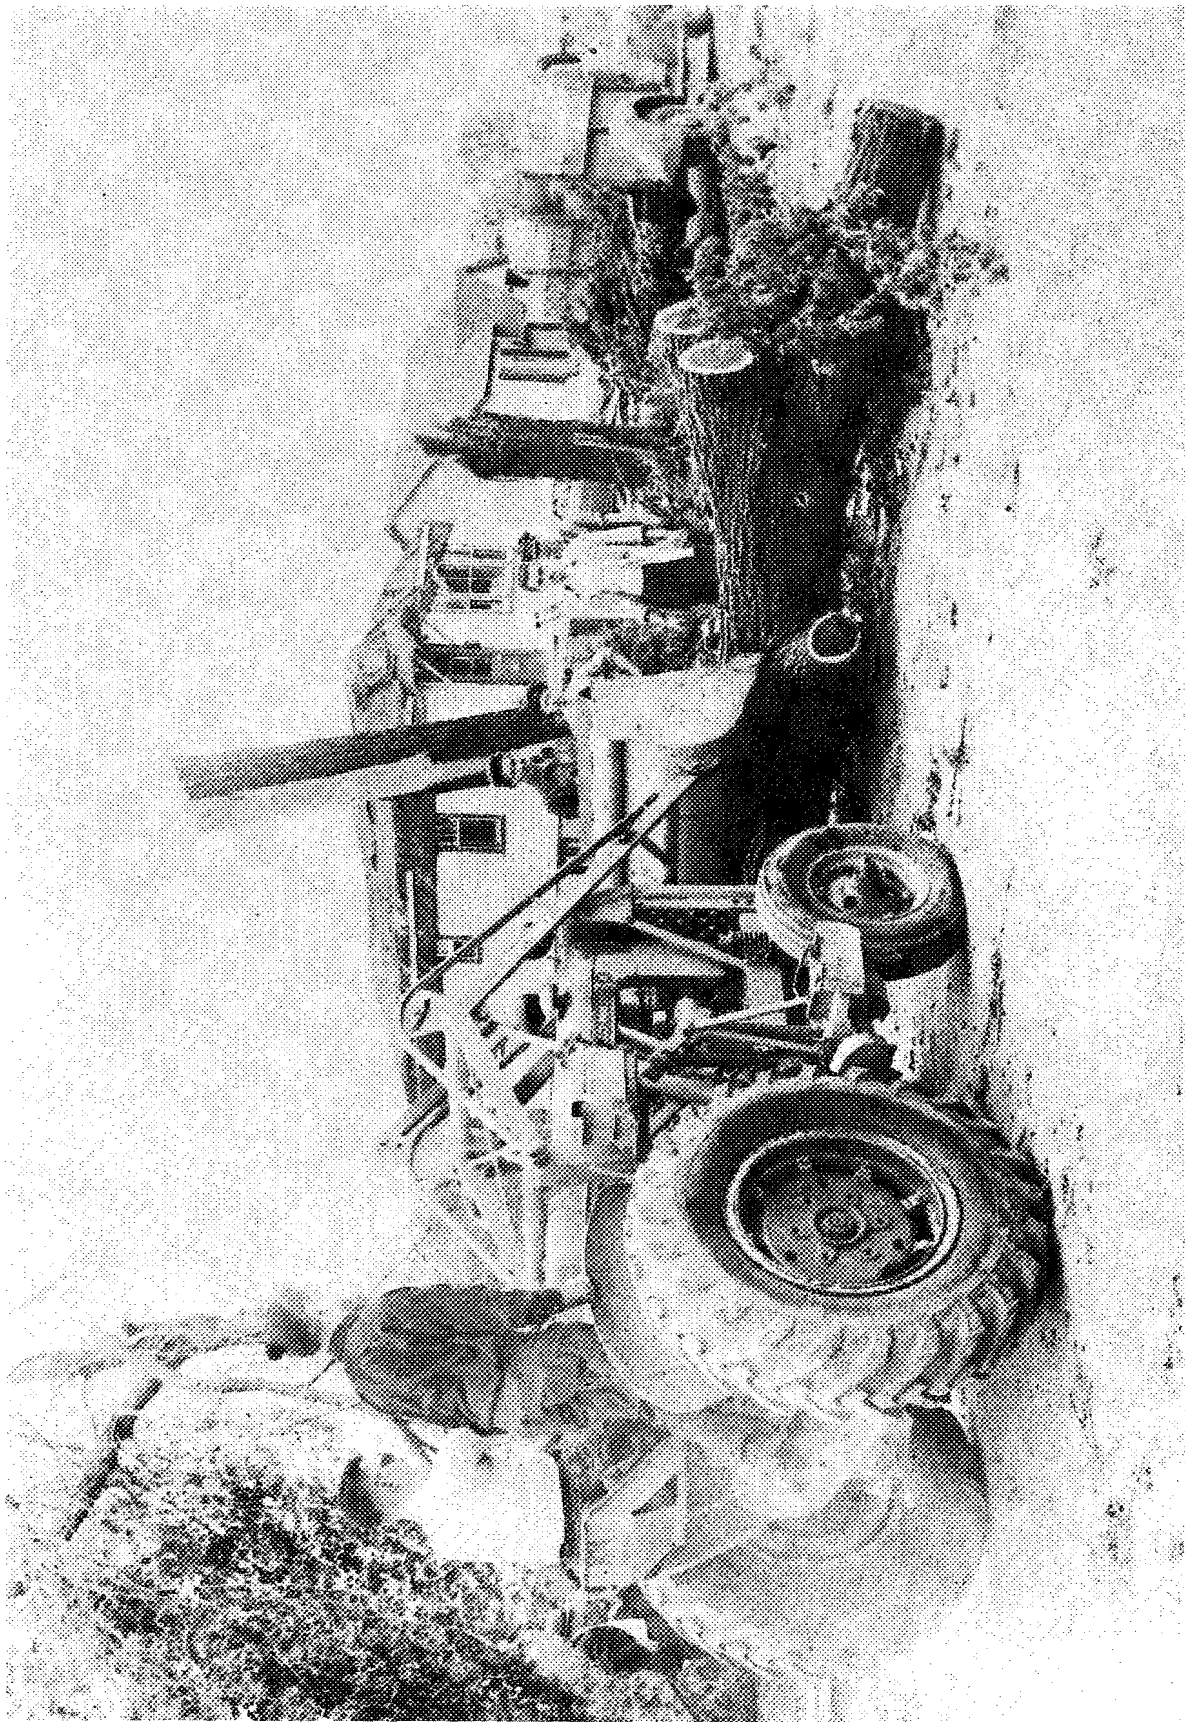
The loss of roofs and movement off foundation indicated inadequate fastening details at these points. In many of these cases adjacent houses, apparently built by different contractors,

did not receive similar damage (Fig. 10).

Photo by Canadian Observer, Sarnia
Figure 10 Tree damage. Note one house with, and one house without, roof

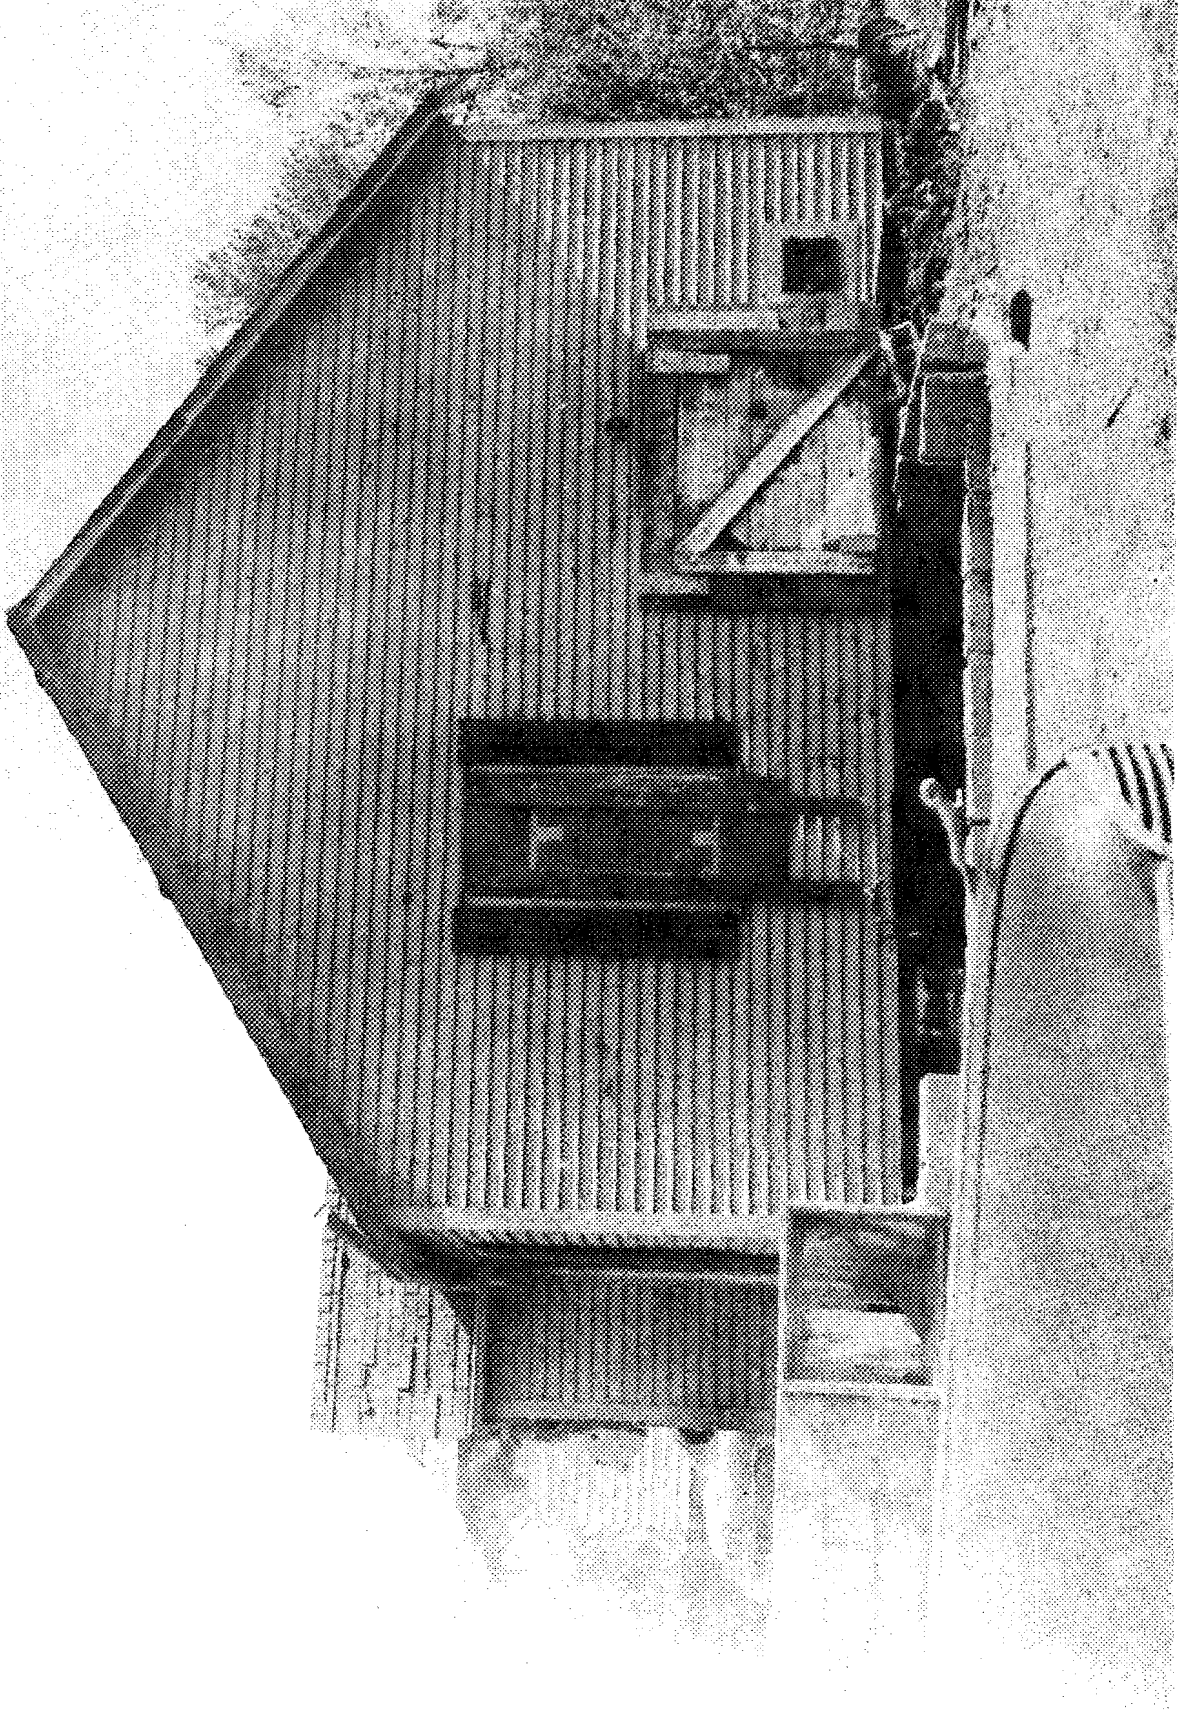
Figure 11 Frame house dislocated from foundation

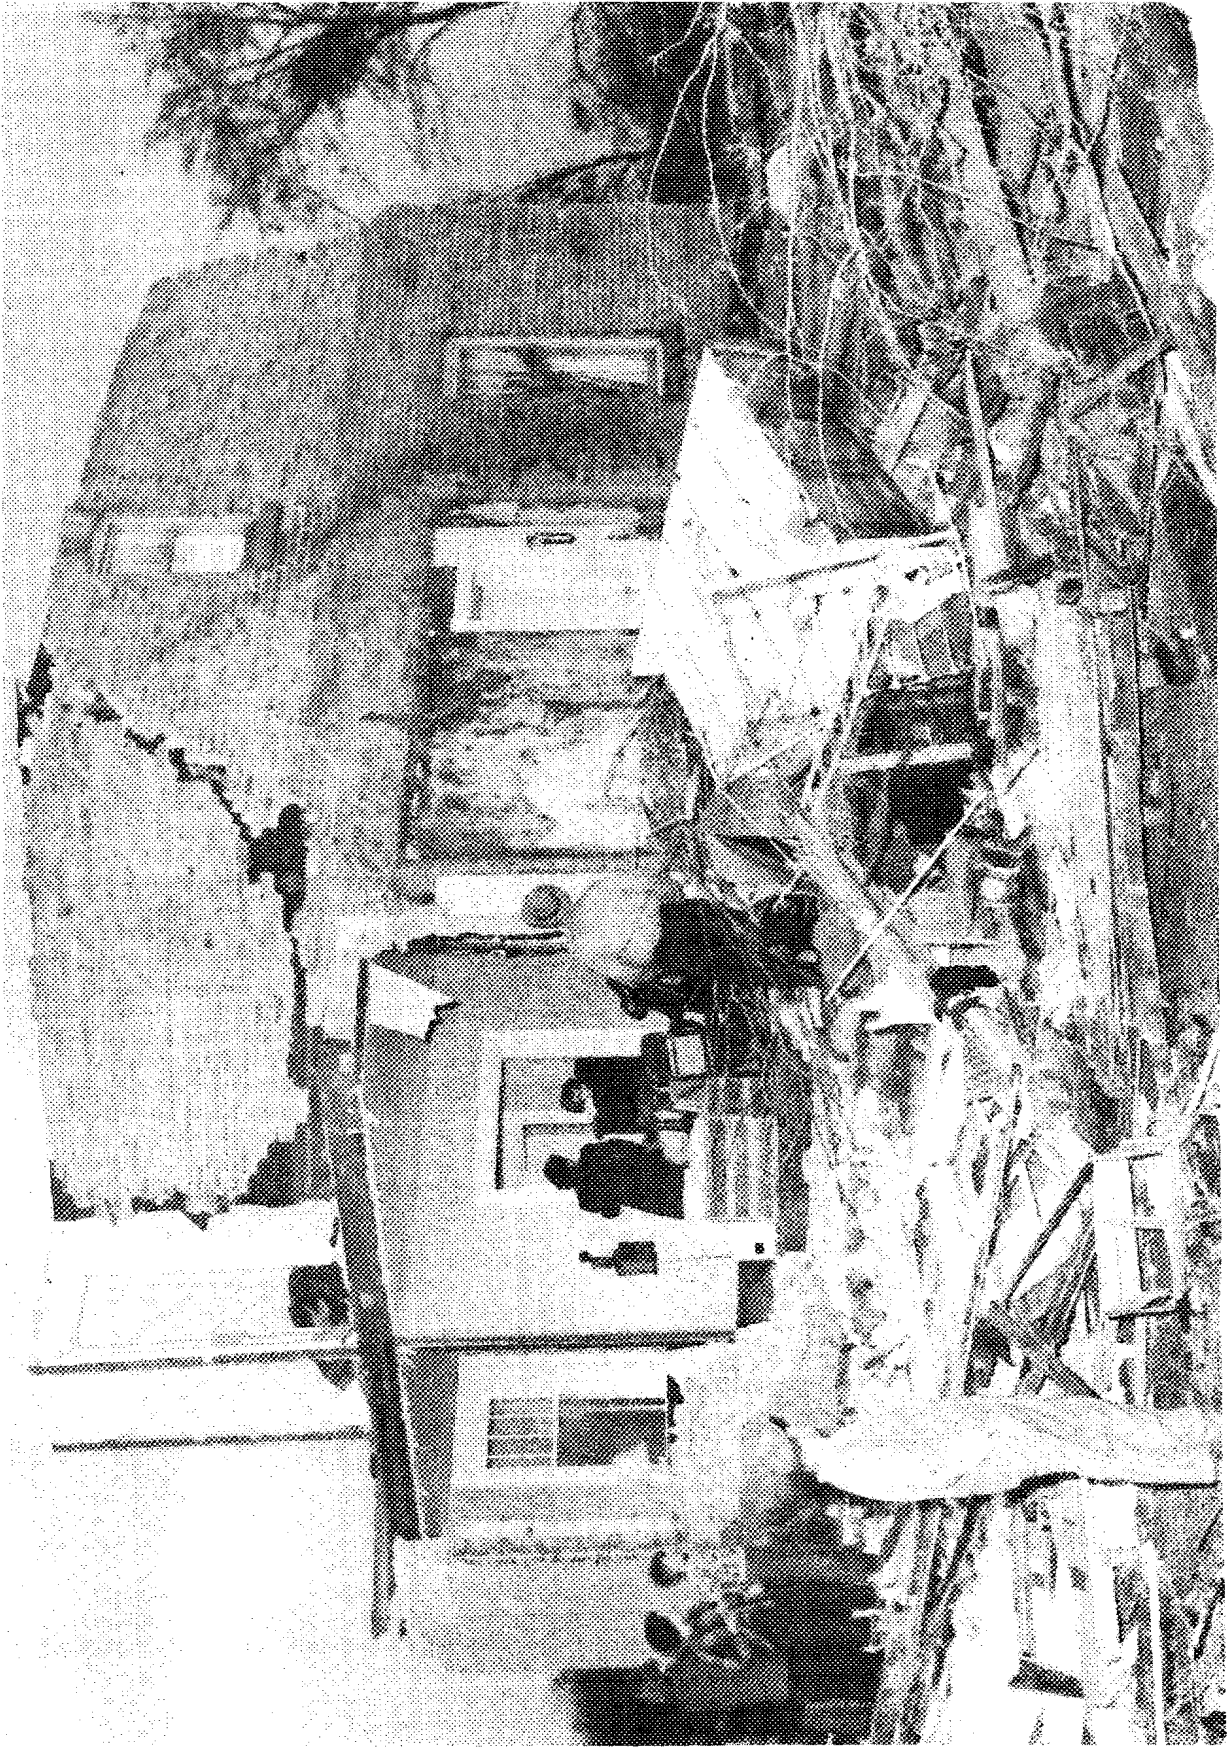
Most of the farm residences were of masonry veneer construction and generally suffered extensive damage, if not complete demolition (Fig. 12). The completeness of this damage probably was due to the fact that, in most cases, these buildings were completely exposed to the full effects of the storm.

Figure 12 Damage to farm homes
