Tornado wind damage to buildings observed after the Sarnia tornado of May 21, 1953

TORNADO WIND DAMAGE TO BUILDINGS OBSERVED
AFTER THE SARNIA TORNADO
of May 21, 1953

Report No. 111
of the
Division of Building Research

February, 1957

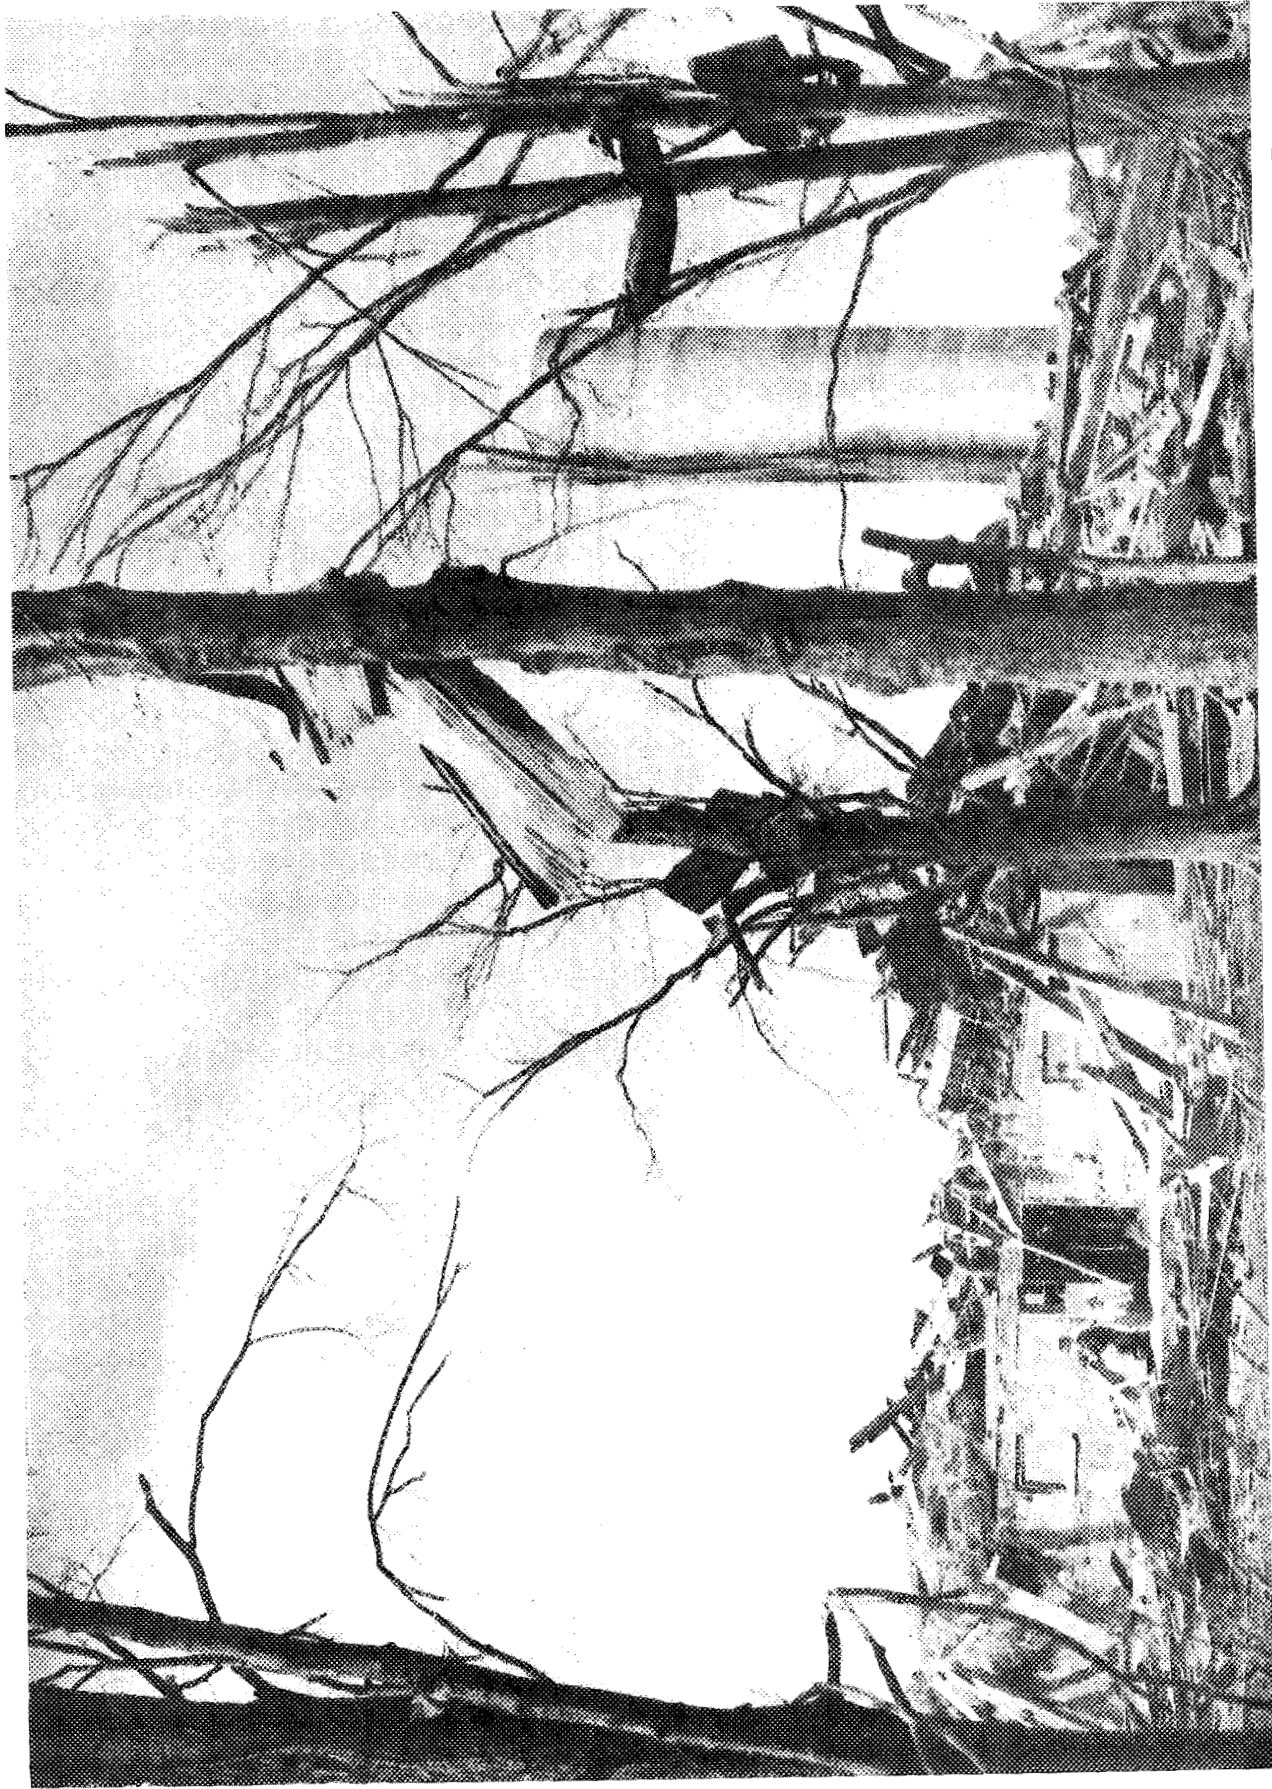
of the roots of many trees in Sarnia were pulled out when the trees toppled over, while the trees in the London Township district, in many cases, were broken off 5 to 10 feet above the ground (Fig.13). This seemed to indicate that the main differences in tree damage were due to a variation in the average ground water table levels in the two areas. The water table level was closer to the ground surface in Sarnia and thus the root penetration was not as deep as in the London Township. Of the two types, the failure at the roots necessitated more clearing up after the storm because generally the trunk had to be sawed off at the base before any clean-up operation could be started. This type of failure also caused considerable damage by breaking portions of the street surfaces, curbs, and sidewalks. Tree debris in the London Township could be cleaned up merely by pushing it aside.

It is interesting to note that silos withstood the full force of the tornado. On farms where demolition was otherwise complete, silos were left standing and apparently unaffected by the storm. It was not determined whether or not the tops of these structures were removed by the storm. If such was the case, the possibility exists that inside and outside pressures were equalized almost immediately and thus prevented collapse. The absence of failure in these silos may also be due, wholly or in part, to their cylindrical shape.

Figure 13 Damage to farm buildings and trees where silo is still standing
