THE WHITEHORSE ESCARPMENT

(Prepared for the Advisory Committee on Northern
Development, Department of Northern Affairs and
National Resources)

R.F. Legget and G.H. Johnston

Report No. 136
of the
Division of Building Research

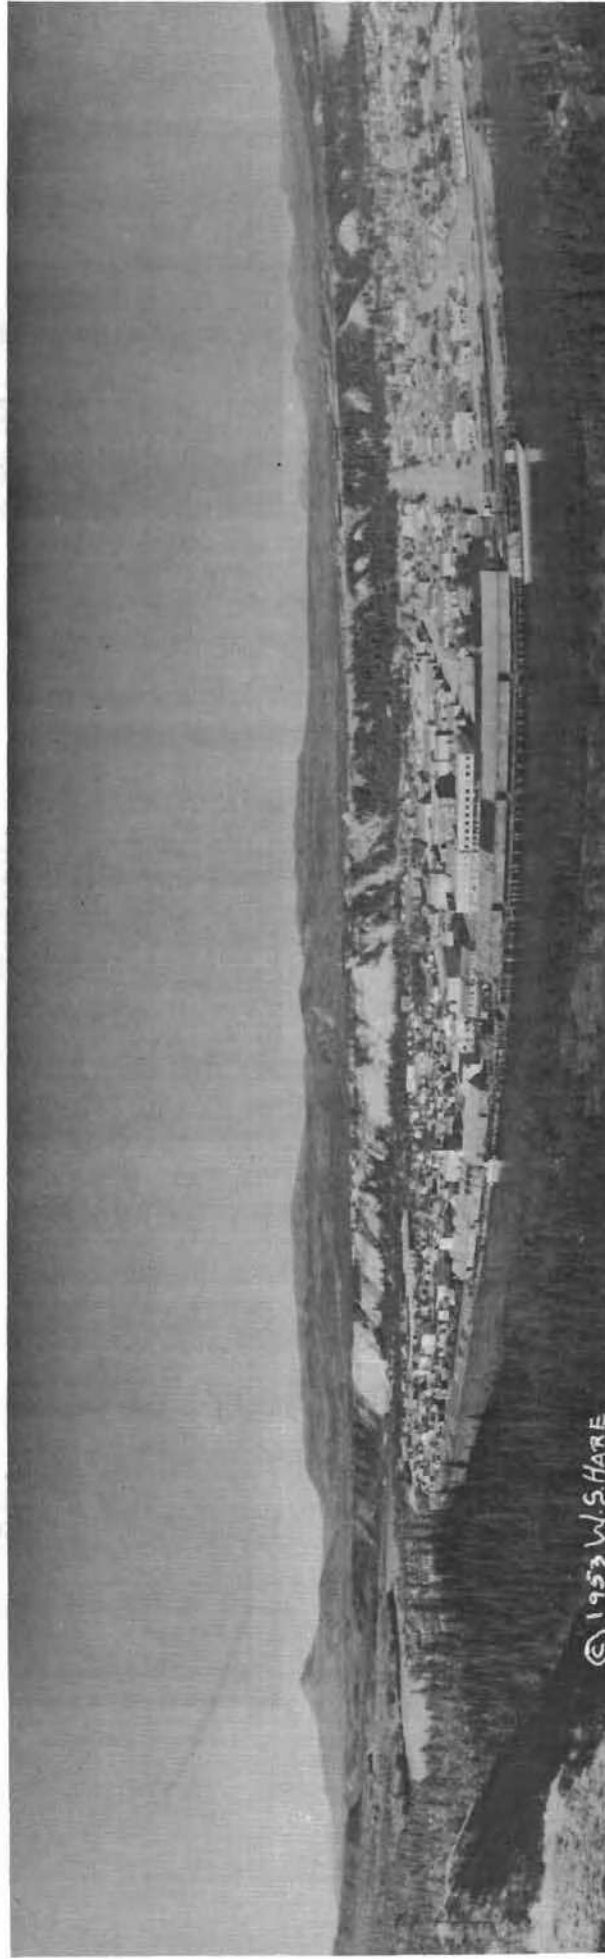
Figure 5. Whitehorse, 1953 (Photo by
W.S. Hare)

In contrast with what is shown on old photos (Figs. 1 and 4), which show the face of the escarpment in a relatively well-wooded condition, the vegetation today (Fig. 5) has been totally destroyed or at least badly disrupted on that portion from the southern extremity of the building area on the top of the escarpment to approximately a point in line with the cross runway or about 1,000 feet north of the northern limit of the building area. The total length of escarpment involved is about 4,000 feet.

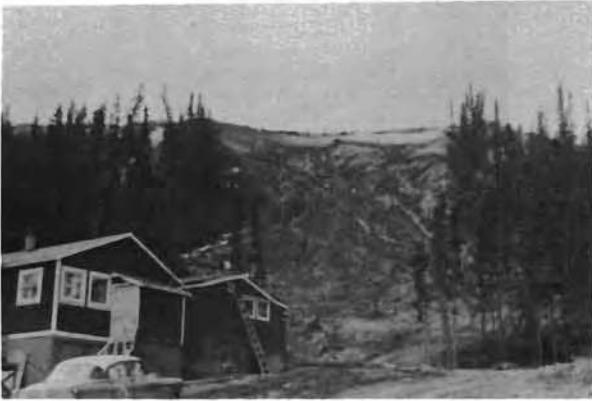
At the time of the junior writer's visit (29 April to 10 May 1957) sloughing of the escarpment was taking place along the whole face. Large drifts of snow still remained at the tops of two of the large scalloped portions north of the building area (Fig. 9). The face of the escarpment, wherever flows were occurring, was found to be frozen. Melt water from the snow-drifts and the frozen face picked up material as it trickled down the slope. The soupy mixture dammed up at obstructions on its way down the slope until a sufficient quantity accumulated so that 2 or 3 cubic feet of material would then slide as a mass increasing in velocity and aided by the slippery surface of the frozen face. By the time it reached the bottom of the slope, the material was flowing in a relatively large stream which decreased in velocity as it spread out on the flats below. At night, because of cooler air temperatures, the flows diminished greatly, in some cases ceasing altogether, indicating that this first sloughing was caused primarily, if not totally, by melt water.

Figure 6. Mud flows on escarpment, east end of cross runway, May 1957. (Note snow drift at top of scalloped portion (DBR photo BR 6762))

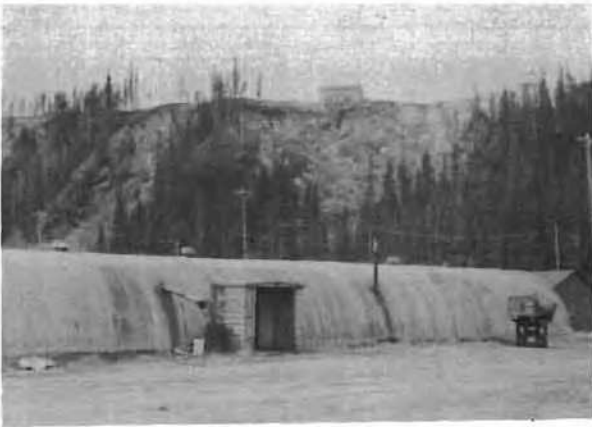
Figure 7. Sloughing on slope at DOT garage (at top of bank), May 1957 (DBR photo BR 6763)

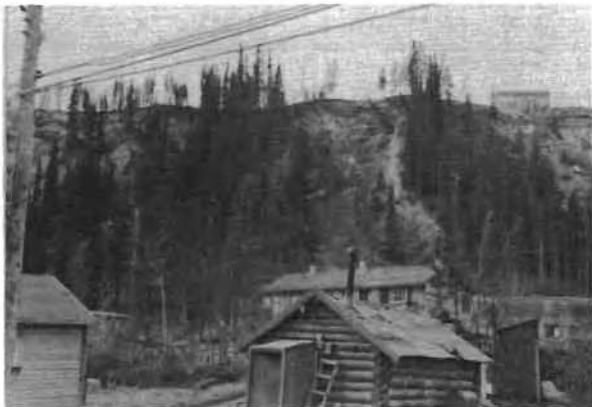
Figure 8. Sloughing near DOT garage, May 1957. (DBR photo BR 6764)

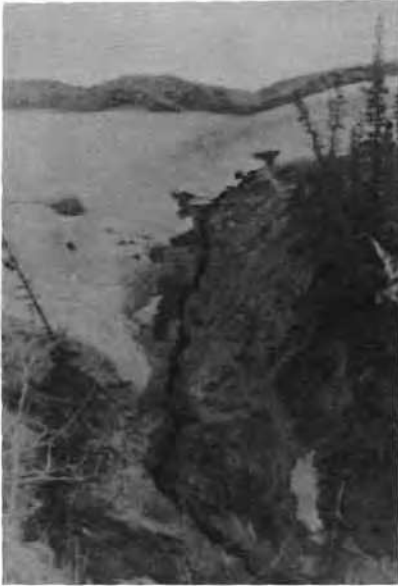
Surface run-off from the airfield had caused gullying in two places adjacent to the east end of the cross runway (one being opposite the culvert through the road to the west side of the field). Both had dried up but had evidently carried a good deal

Figure 9. Snow drift on scalloped area east of cross runway. Gully caused by surface runoff from airfield can be seen at edge of slope in line with gully on face, May 1957 (DBR photo BR 6765)

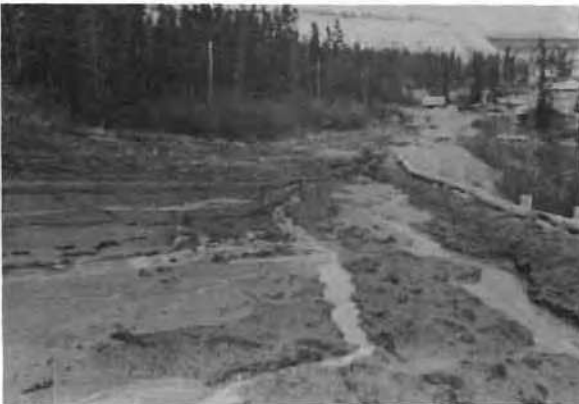
Figure 10. "Mud" streams flowing down lower sections of abandoned access road, May 1957 (DBR photo BR 6766)

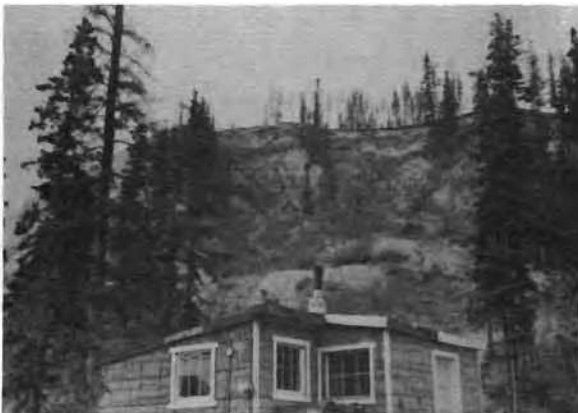
Figure 11. Erosion of bank behind DOT residences (at top of slope), May 1957 (DBR photo BR 6767)

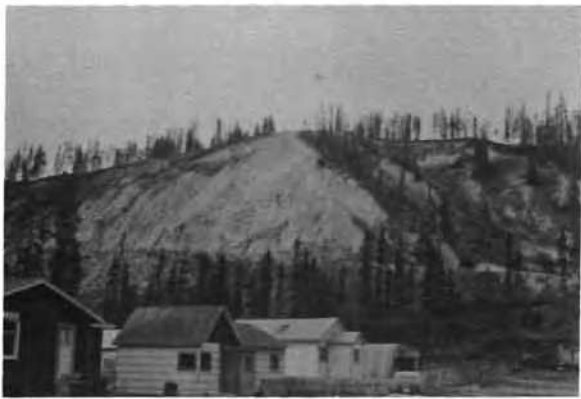
Figure 12. Dry face of escarpment immediately behind DOT residences (at top of slope), May 1957 (DBR photo 6768)

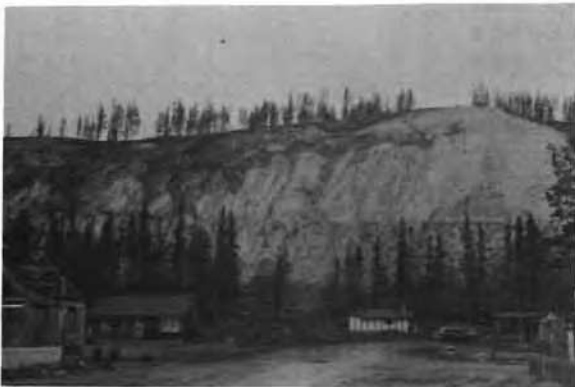
Figure 13. Another view of dry face of escarpment, May 1957 (DBR photo 6769)

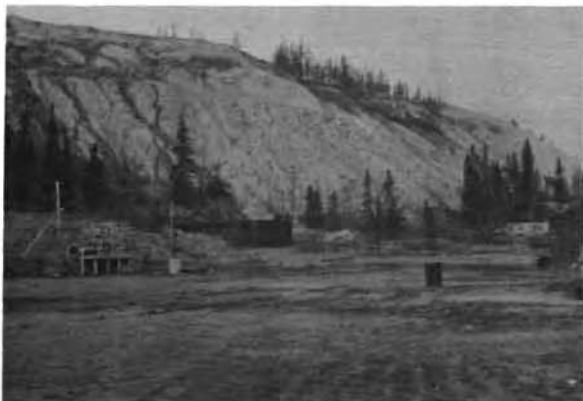
Figure 14. "Mud" runs flowing around oil storage tanks and down into town over railway Y tracks, May 1957 (DBR photo BR 6770)

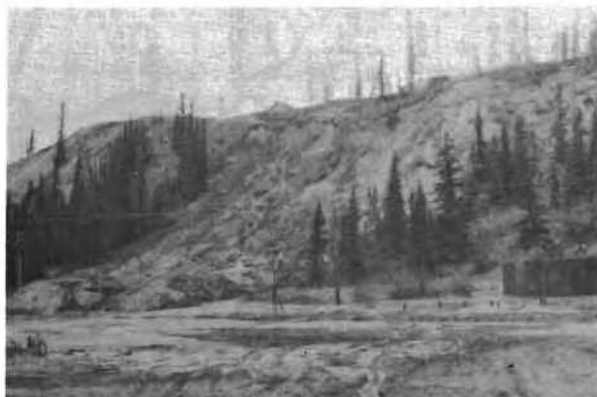
Figure 15. Extensive sloughing on slope has completely obliterated access road at its upper end, May 1957 (DBR photo BR 6771)

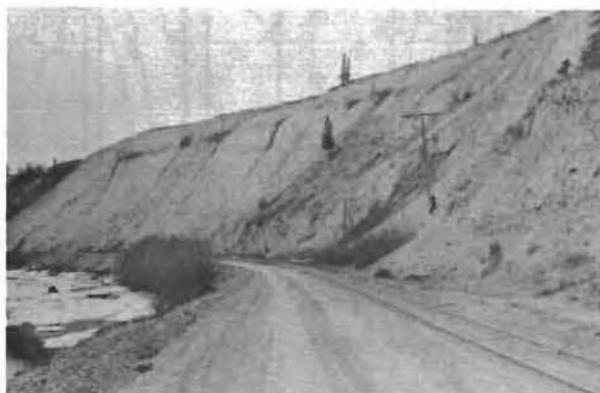
Figure 16. Steep, dry slope adjacent to railway south of Whitehorse, May 1957. Note occurrence of some gullying on face and also soil stratification on right side of photo (DBR photo BR 6772)

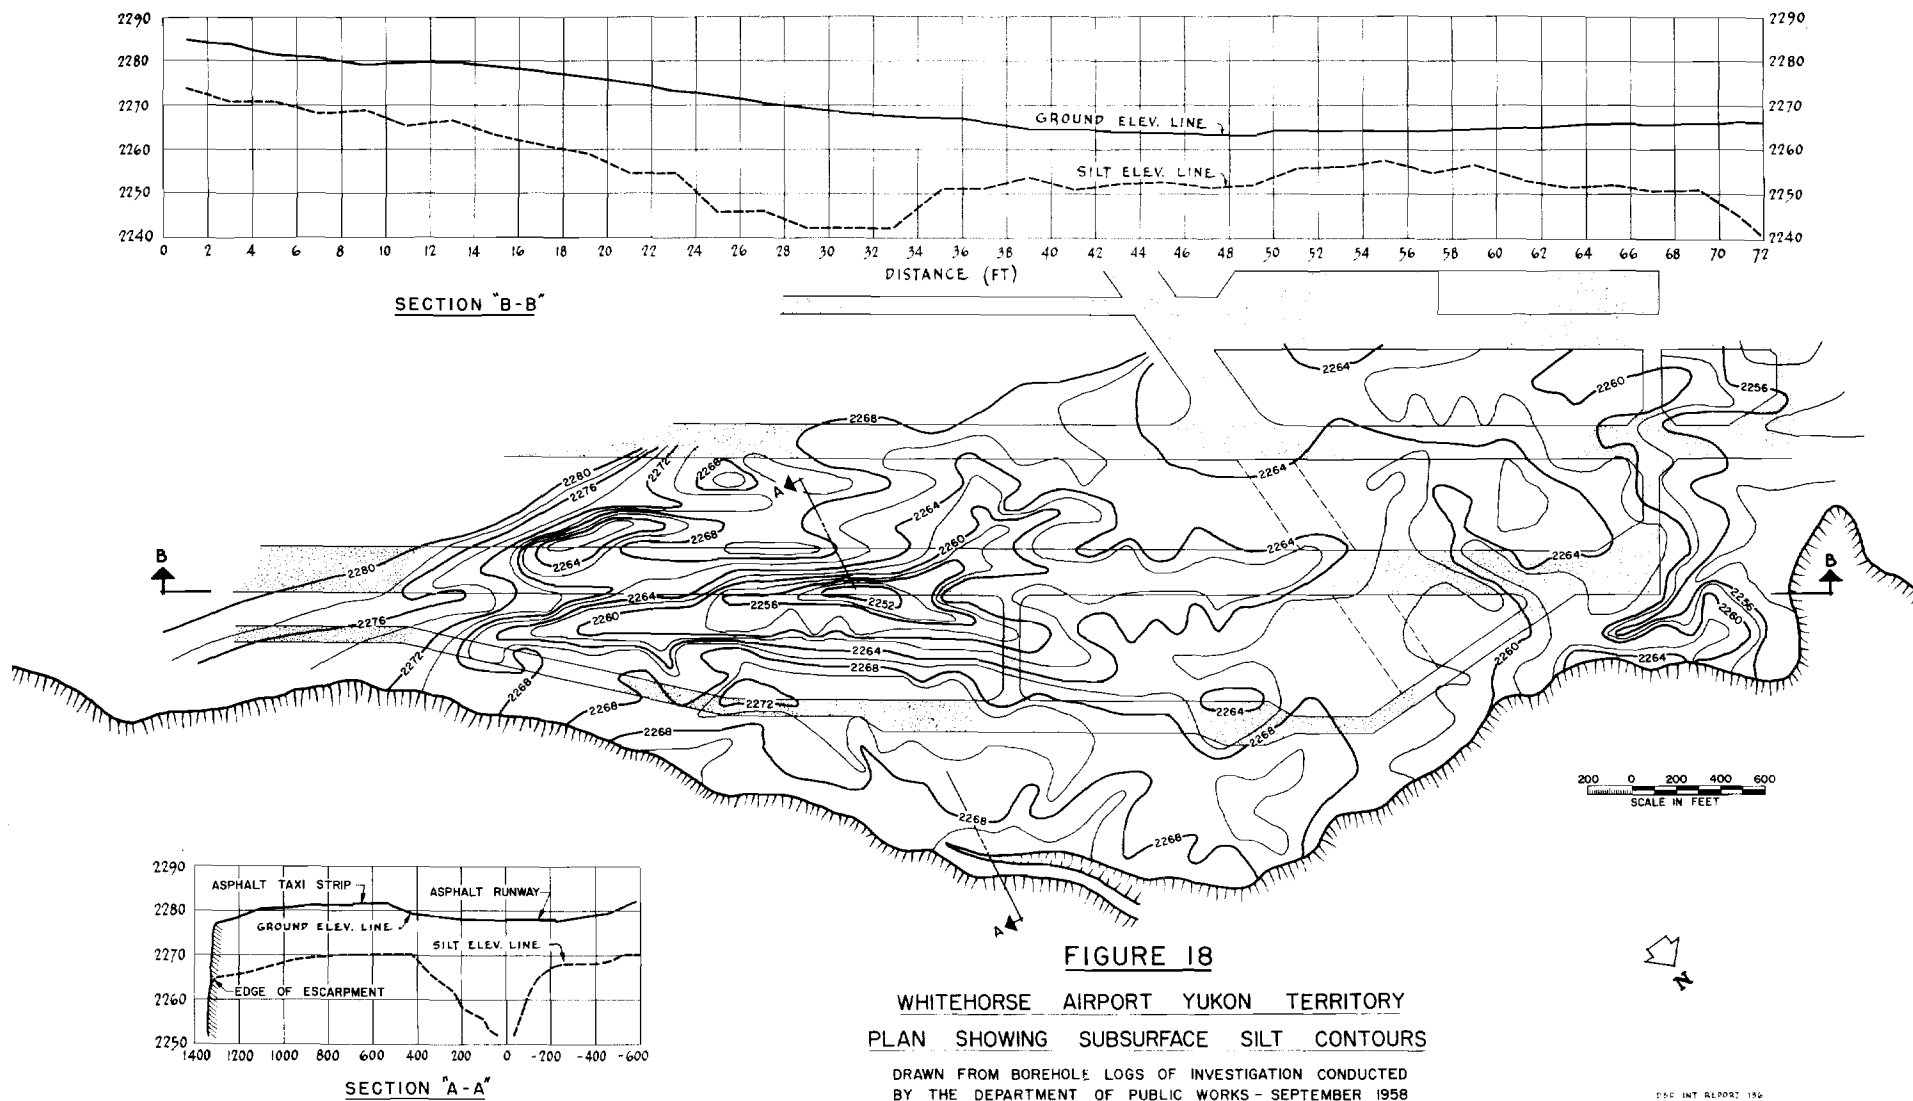
In 1950, further sliding of the slope around the outfall sewer necessitated cribbing and backfilling to prevent freezing and further damage to the line. The occurrence of more slides (D, Fig. 17) along the escarpment was endangering several dwellings in the Town of Whitehorse at the base of the slope. A preliminary engineering investigation by D.O.T. engineers indicated the need for considerable study of the problem before remedial measures could be taken.

The most serious slides occurred (A and E, Fig. 17) in 1953 when large quantities of "soupy" material flowed down into the Town of Whitehorse causing considerable damage to private property. Light snowfall (and thus deep frost penetration) and excessive rainfall in the preceding winter and during the spring respectively were thought to have been a major contributing factor. Sloughing and mud flows, varying in degree of seriousness, have occurred each year since, on the face of the escarpment (F, Fig. 17).
