Canadian & Cold Regions Rail Research Conference 2021, pp. 56-63, 2021-11-09

Rail failure root cause analysis on North American railway

Daniel Szablewski and Robert Caldwell
*National Research Council Canada Automotive and Surface Transportation,
Ottawa, ON, Canada*

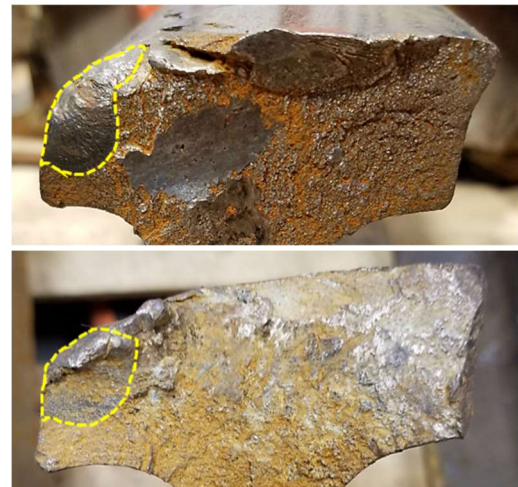
- ALGOMA C.C. 115RE 1985 standard rail
- High rail position in a 5.0 deg lubricated curve
- An approximate life-cycle tonnage of 130MGT
- Last grind cycles in 2005 (at 65MGT)
- Penny-sized fatigue cracks originating in high rails at the GFC in multiple locations (see Figure 1)

The rail sections had two main fracture zones. However, only one of these led to a critical rail failure that resulted in the train derailment. Both defects initiated at the GFC as fatigue cracks (indicated by yellow dotted zones in Figure 1). These fatigue cracks grew relatively slowly over time (as evidenced by fatigue growth rings). Once the remaining rail cross-section could no longer bear the load, critical failure took place. This critical failure was instantaneous, as evidenced by the fast brittle fracture of the remaining rail cross-section.

Figure 1. Examples of two (2) slow growth GFC fatigue defects (circled) that grew over time, which led to one of them causing the rail critical brittle failure.

It is important to point out that both of the gauge corner fatigue cracks formed and grew in the high rail section independently, but through the same growth mechanism (i.e. metal fatigue due to load reversal that occurred during train travel over these defects). These defects formed over time as a result of inadequate rail grinding. As these defects were relatively deep compared to remaining rail cross-section the suggested course of action was rail replacement. It was also advised to replace any rails that displayed similar gauge corner fatigue defects in track.

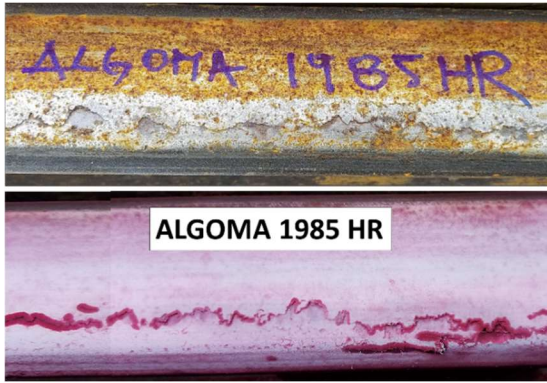
During the track inspection portion of this work NRC took photographs and EC measurements of the scrapped rails which were still on site. This data was compared to the results acquired from the broken rail sections sent to NRC for analysis. The measured crack depths were in the same range (4-5 mm), with GFC damage being very similar to the one investigated at the NRC laboratory (see Figure 2).

Figure 2. Rail running surface condition of ALGOMA C.C. 115RE 1985 standard rail taken out of service at approximately 130MGT indicating severe GFC damage.

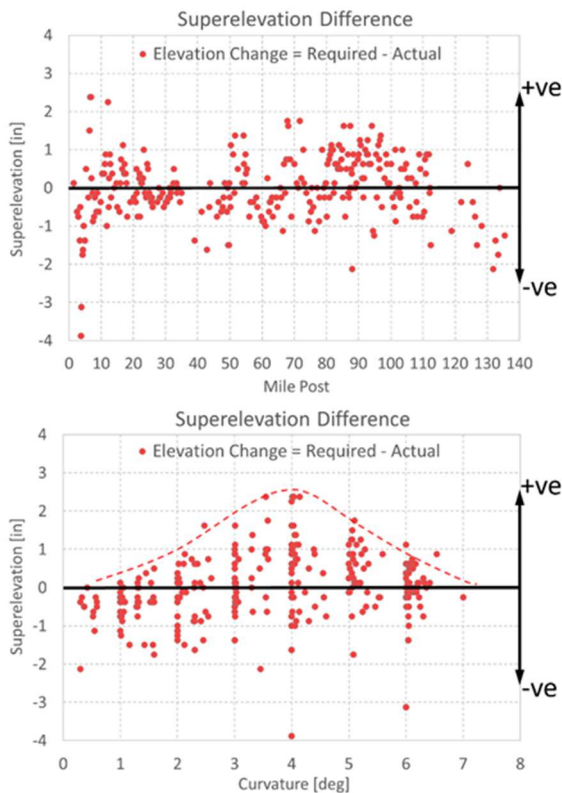
Figure 8. The elevation change (i.e. difference between required and actual superelevations) vs. MP and curvature on the subdivision.

Plotting the cant deficiency (i.e. the difference between the 'required' and 'actual' superelevations) across both MP and curvature (see Figure 8) revealed two things:

1. That superelevation difference varied up to ± 2 inches across the entire subdivision.
2. That there appeared to be a normal distribution to the superelevation difference as a function of curvature for positive differences (i.e. when the high rail was overloaded due to insufficient curve elevation).

Therefore a cant deficiency increases loading on the high rail, and this loading increases as the positive difference increases. Curves in the 3-5 degree range are the ones that had the greatest cant deficiency, and therefore suffered the greatest elevated loading on their high rails (see Figure 8).

- Review of subdivision track speed, grade for multiple train passes
- Review of track geometry (curve & tangent lengths) vs. train lengths in the track subdivision
- Review and adjustment of track elevation to fit the two conditions above

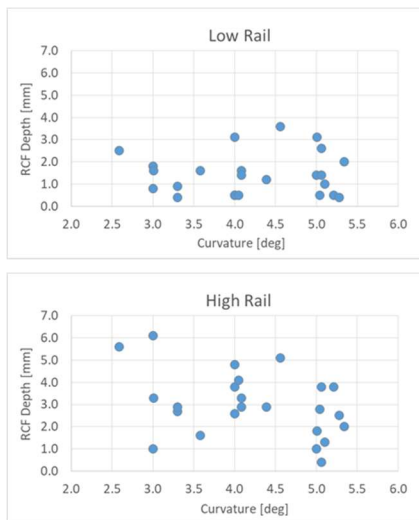
The EC measurements for the RCF cracking at each location were graphed for both high and low rails as a function of track curvature (see two representative locations in Figure 10). These results indicate that maximum low rail cracking was approximately 3.5 mm in depth, whereas in the high rail its maximum depth was approximately 6.1 mm. In all locations, the crack depth on the high rail was greater than that on the low rail.

Figure 10. Eddy current RCF crack depth assessment in low and high rails as a function of track curvature in the 30 mile stretch of track.

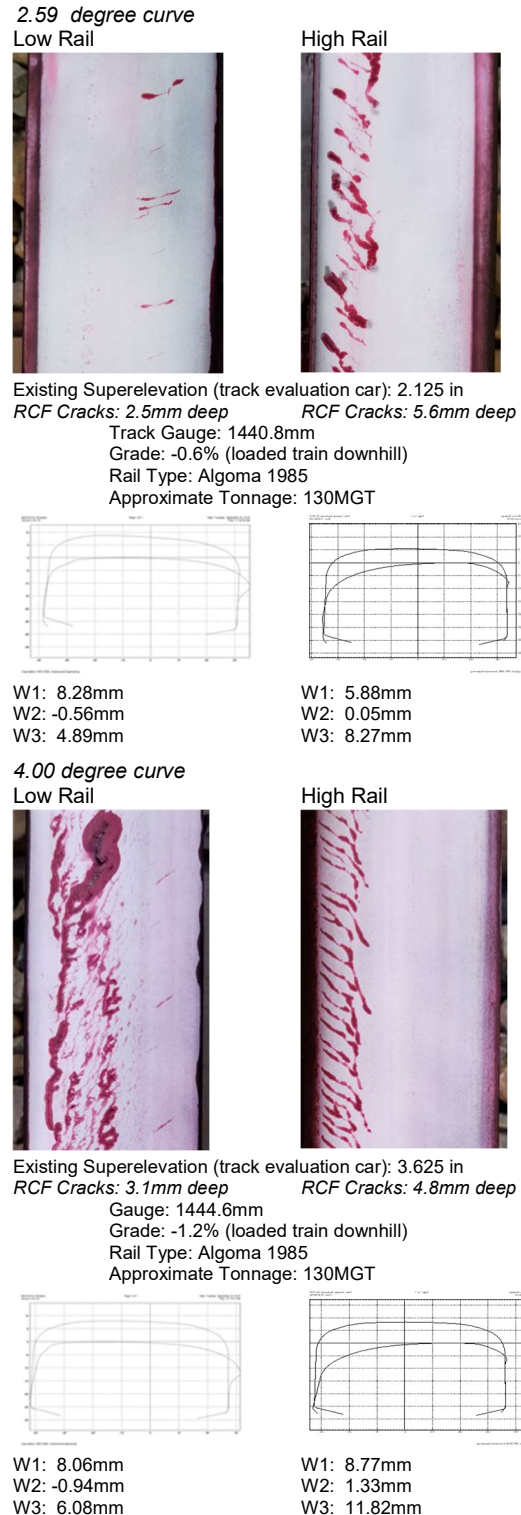
Two representative locations were selected to show typical low and high rail damage observed in curves below 3 degrees of curvature, and in curves of 4 degree curvature and above. Results of these are shown in Figure 11.

Figure 11. Select track inspection results for a 2.59 and 4.00 degree curvatures.
