Paint performance studies at DOT lighthouse stations, Nova Scotia: a preliminary report Robson, D. R.

PAINT PERFORMANCE STUDIES
AT
DOT LIGHTHOUSE STATIONS, NOVA SCOTIA

Internal Report No. 348

September 1967

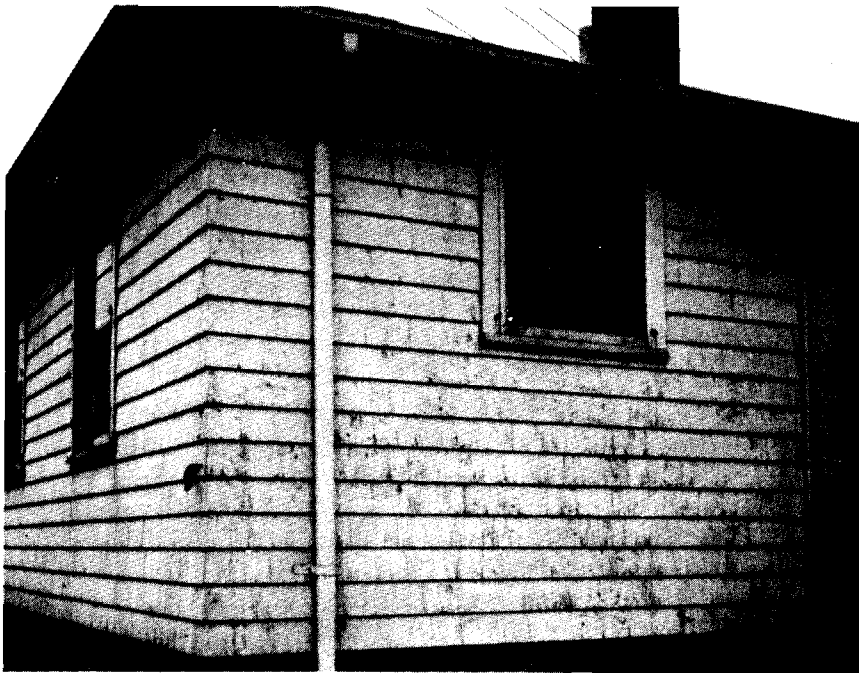
FIGURE 22 a

Discoloration and General Failure - South Wall
(Whitehead - Building 3)

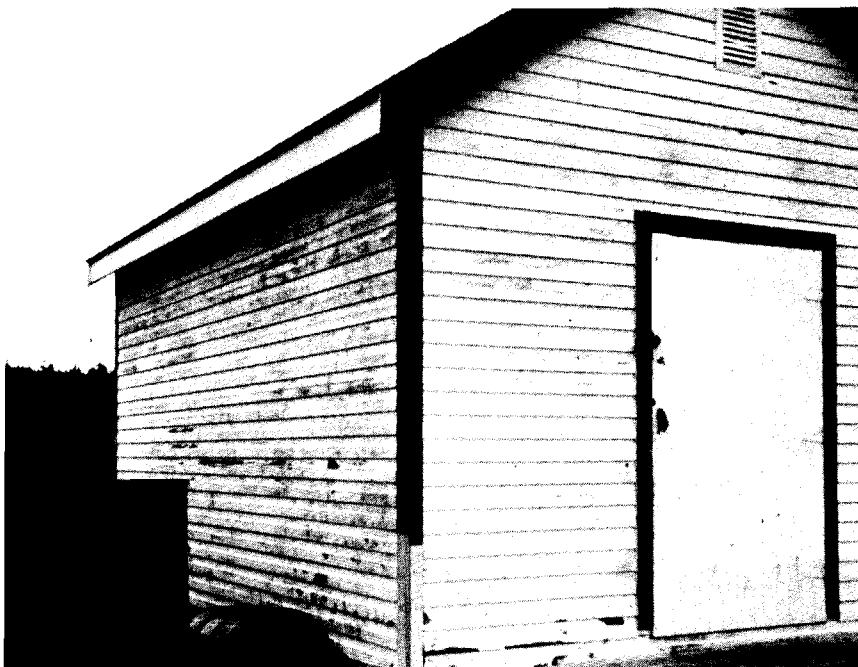
FIGURE 22 b

Peeling and Discoloration - South and West Walls
(Whitehead - Building 4)

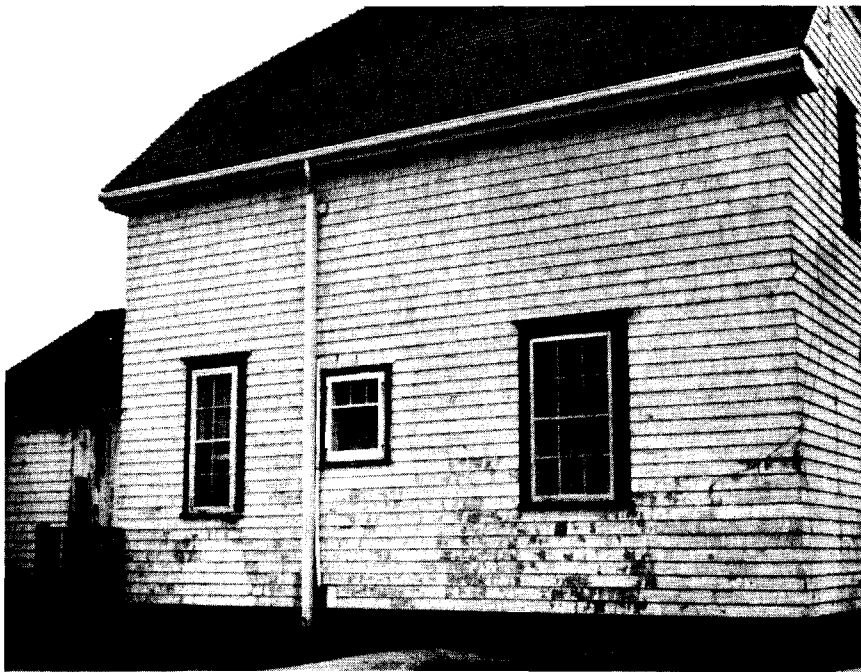
FIGURE 23a

Peeling and Cracking - Southwest Exposure
(Whitehead - Building 2)

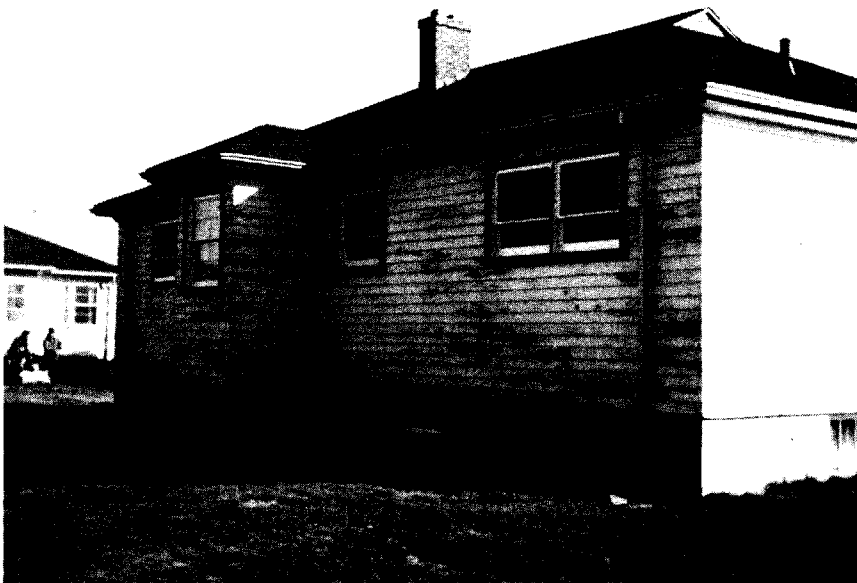
FIGURE 23b

The three houses on this station were painted in 1960, just after they were built, and have been repainted three times since then, the last time in 1964. The paint has usually failed by peeling and blisters within two months of the time of painting.

Peeling - South Exposure
(Flint Island - Building 1)

recommended that removal of old paint by sanding and burning be done on each wall of each house (one half of the wall sanded, the other half burned). It has also been suggested that a different type of paint be used on each house - 1GP28 on one, 1GP59 on the second, and acrylic latex on the third.

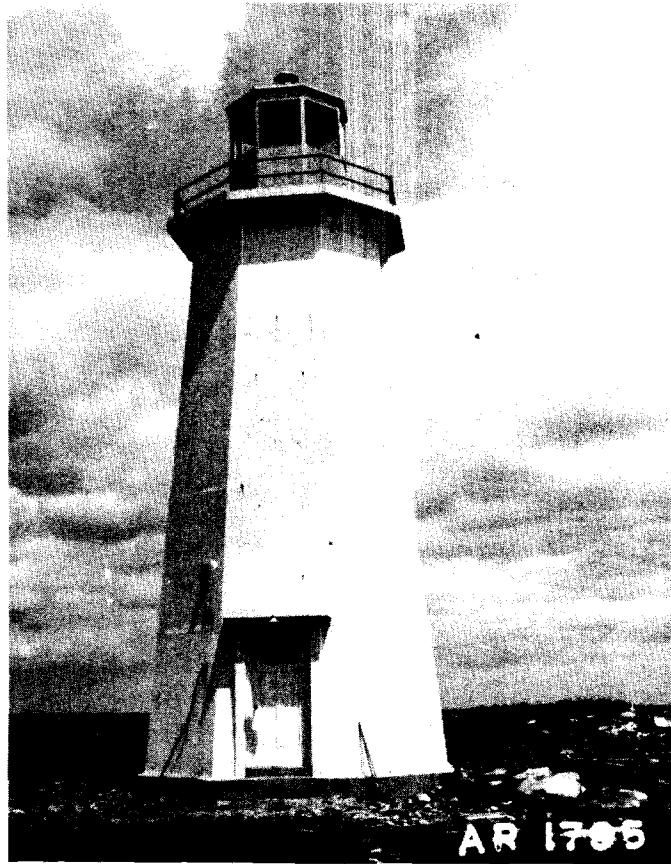
FIGURE 24a
Mildew - Southeast Exposure
(Cape Roseway - Building 1)

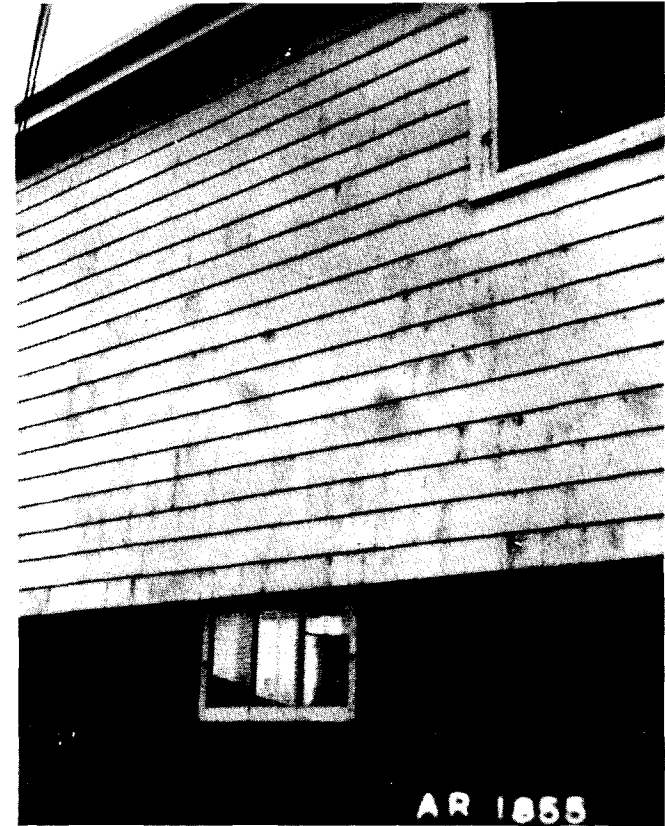
FIGURE 24b
Nail Staining - Southwest Exposure
(Country Island - Building 1)

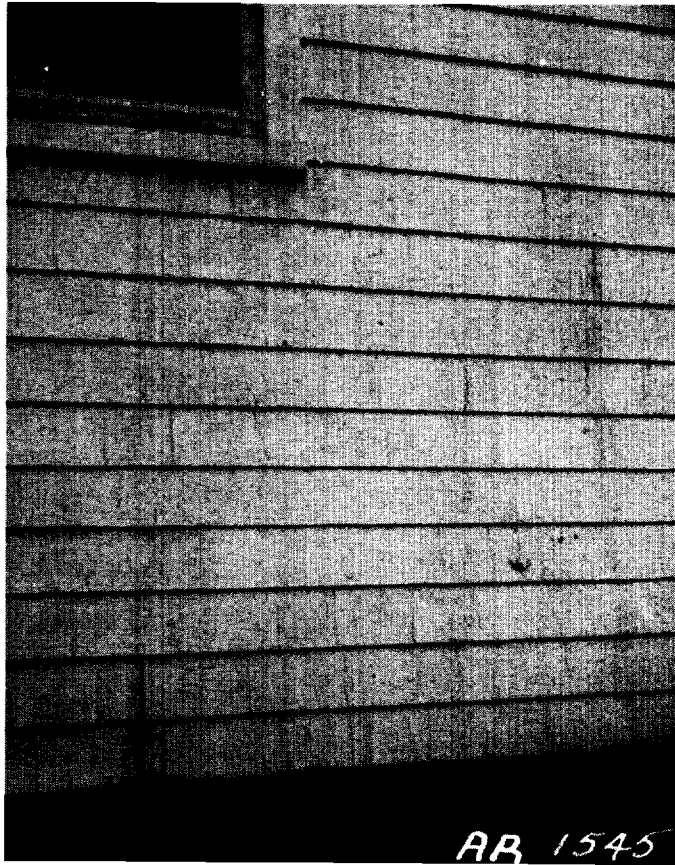
FIGURE 25a

Cracking and Checking - East Exposure
(Cross Island - Building 5)

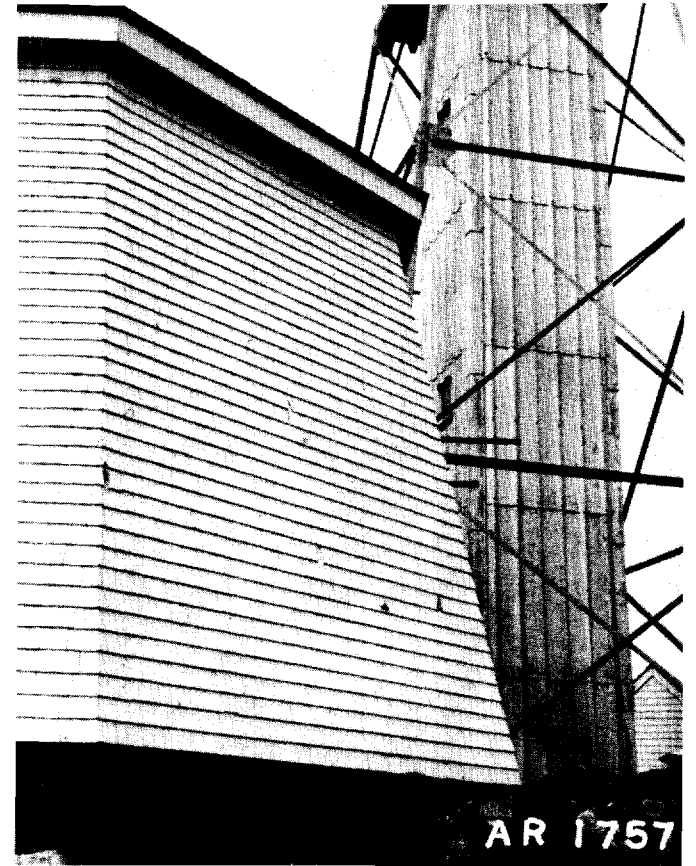
FIGURE 25b

Peeling and Cracking - Southeast Exposure
(Egg Island - Building 4)

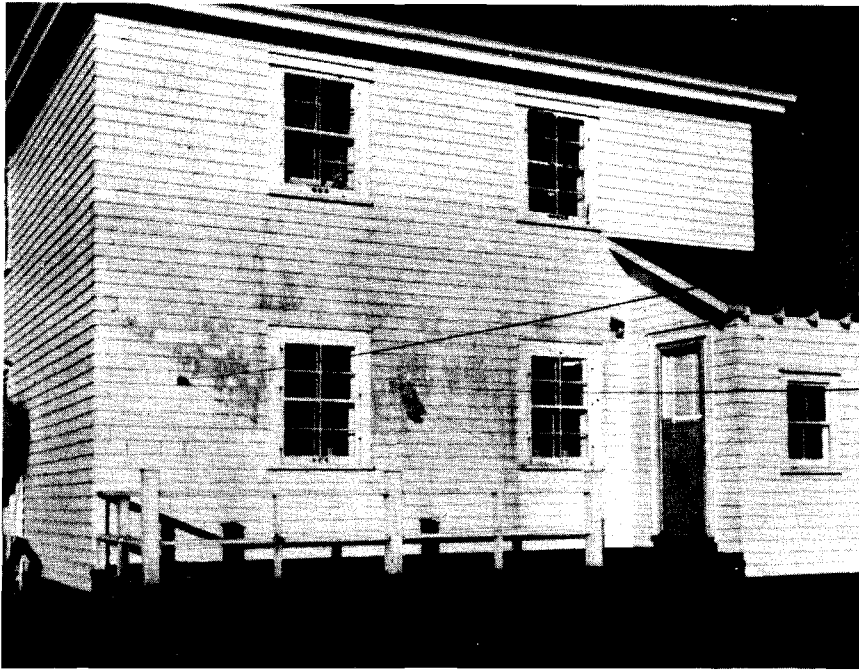
FIGURE 26a

Staining - Southeast Exposure
(Bickerton - Building 2)

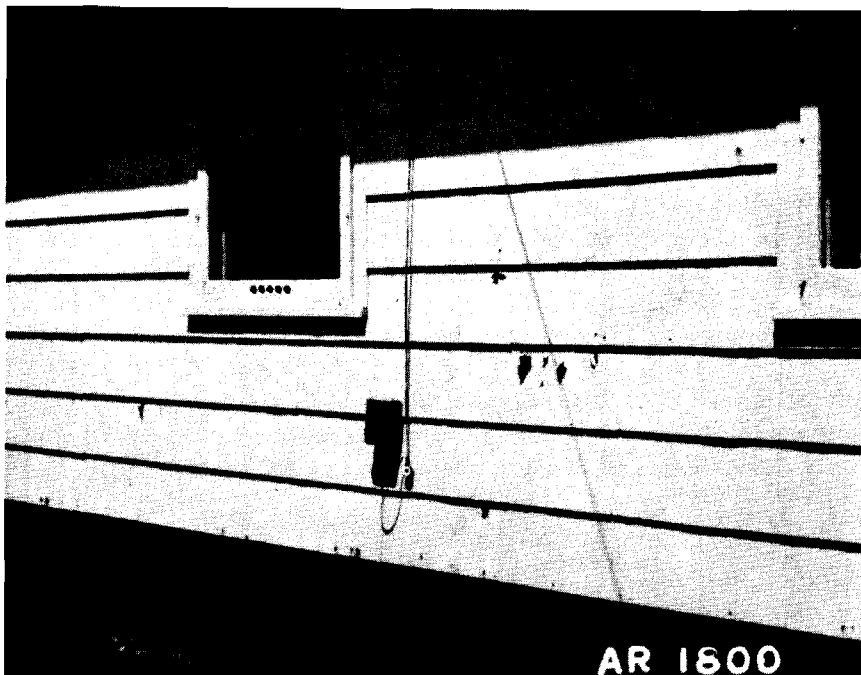
FIGURE 26b

Peeling - Southwest Exposure
(Bickerton - Building 3)

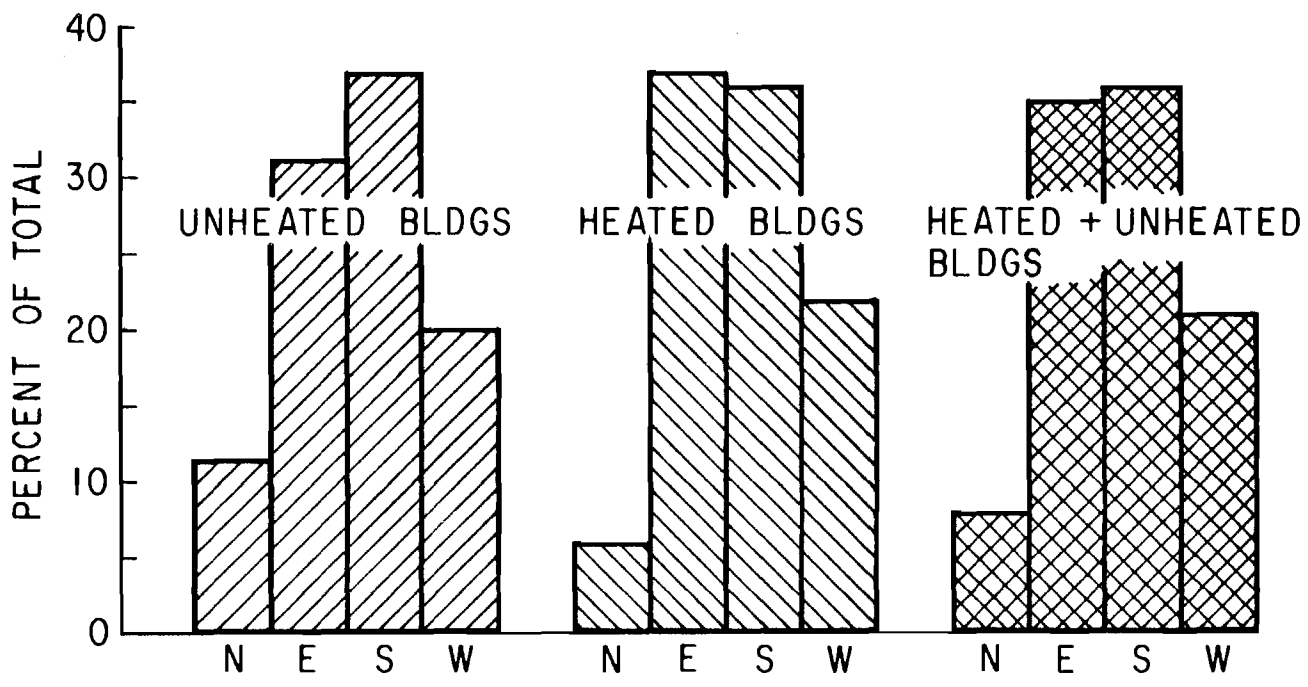
FIGURE 30 EFFECT OF EXPOSURE

There is very little difference between the heated and unheated buildings in the effects of exposure. On the buildings that exhibited paint failure, the south and east exposures are almost equally bad (35 per cent on the east, 36 per cent on the south) and the west exposure accounts for 21 per cent of the failures.

Ninety-two per cent of the paint failures occurred on the east, south or west walls. This follows the pattern established by extensive surveys on mainland houses.

Most of the severe storms that would cause wetting of the siding (wind-driven rain) would come from seaward, which is southerly in most instances (SE through south to SW).

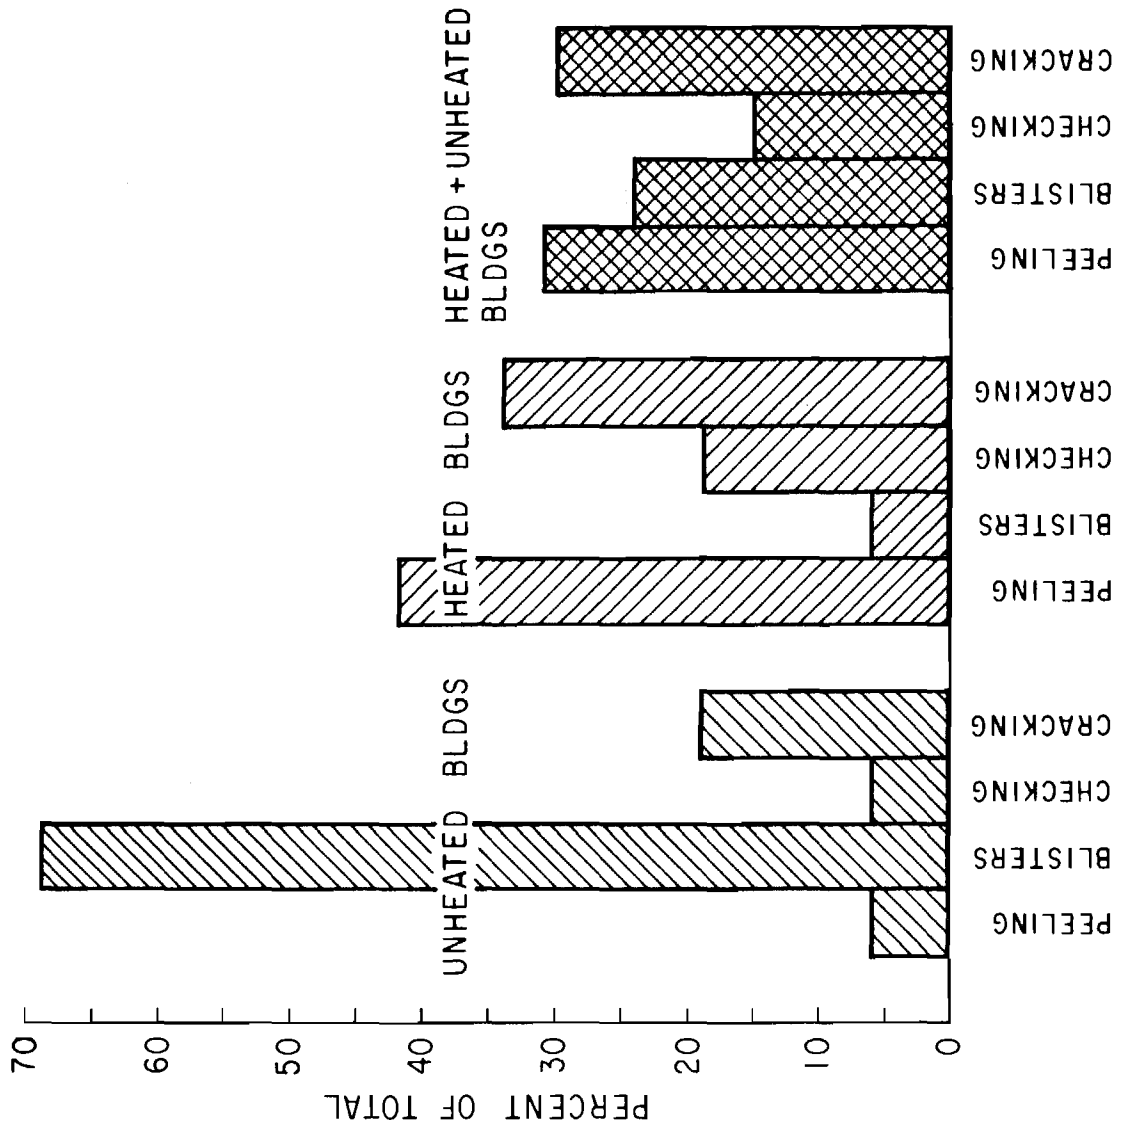
FIGURE 31 TYPE OF PAINT FAILURE

On all of the buildings with a failure of the paint film (59 per cent of the buildings had paint failure), 45 per cent of the failures can be attributed to cracking and checking, 31 per cent to peeling and the remainder to blisters.

More heated buildings (73 per cent) showed paint

failure in one form or another than unheated buildings (40 per cent). It should be remembered that only 29 per cent of the heated buildings are over 20 years old.

The heated buildings showed less failure in the paint film from blisters ($5\frac{1}{2}$ per cent) than the unheated buildings (69 per cent).
