Lifting fans for VTOL aircraft: Investigation into a quill-shaft failure in a 12 in. dia. gear-driven fan
Levy, G.G.; Rimmer, R.J.

SUBJECT Lifting Fans for VTOL Aircraft: Investigation into a Quill-Shaft Failure in a 12 in. dia. Gear-Driven Fan

TEST REPORT PM-68-22

FAILURE OF MODEL FAN DRIVE

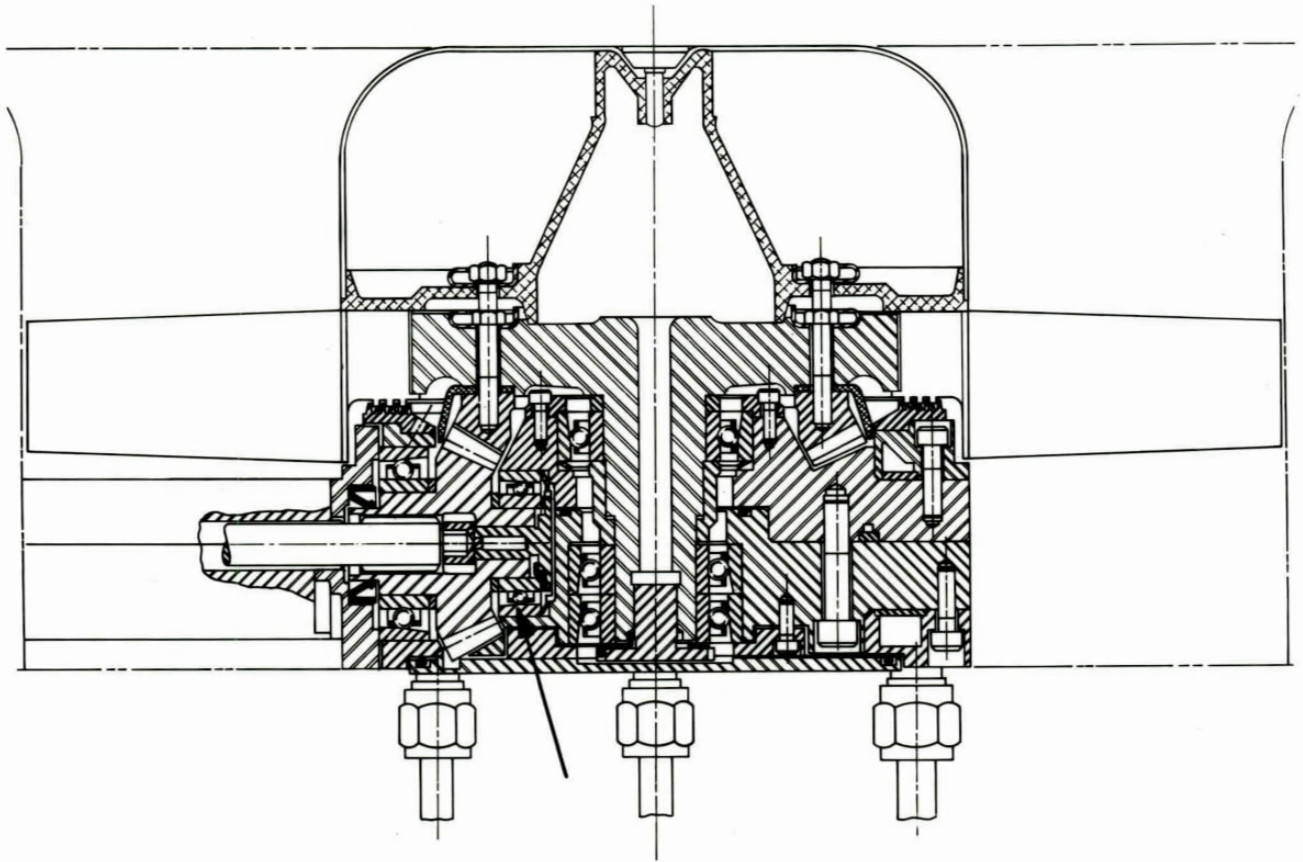
FIG. 2

The inboard bearing of the straddle mounted pinion assembly (Fig. 2) had failed, thus permitting the pinion to rock about its axis. The lower half of the outer race showed severe surface spalling; but, there were no signs of heat discoloration and no signs of lubrication breakdown.

SECTION THROUGH FAN HUB

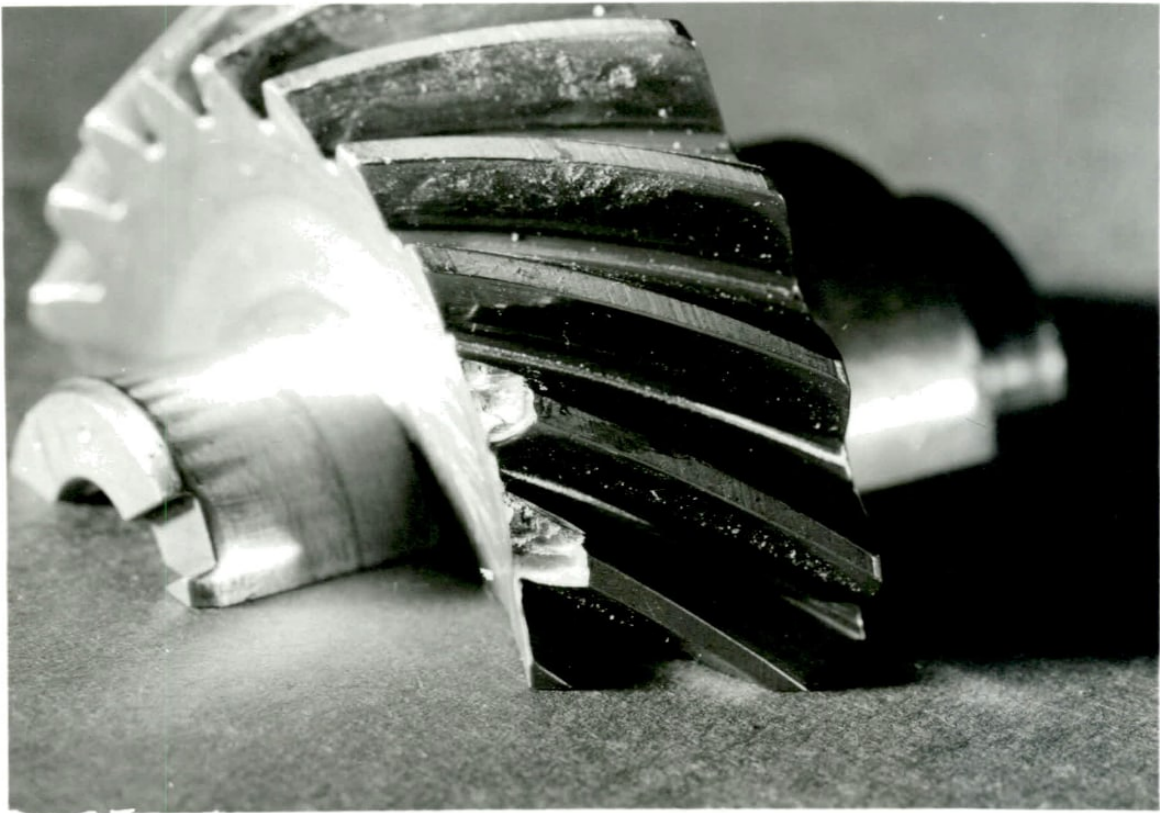
FIG. 3

The tips of 3 pinion teeth were chipped (Fig. 3) and there were damage marks on the housing adjacent to the pinion (Fig. 4).

The bevel pinion teeth showed no abnormal wear patterns, but the location of damage marks on the housing indicated very clearly that contact had been made either with the toe of the pinion teeth or with a piece of broken tooth. In the former case it would be reasonable to postulate that the bearing had failed, thus permitting the necessary movement of the pinion towards the housing, and that the teeth were intact until the moment of impact. In the latter case, a fatigue failure of the teeth may be implied, resulting in the momentary trapping of a piece of tooth between pinion and housing, followed by bearing failure triggered by shock loading.

CHIPPED PINION TEETH

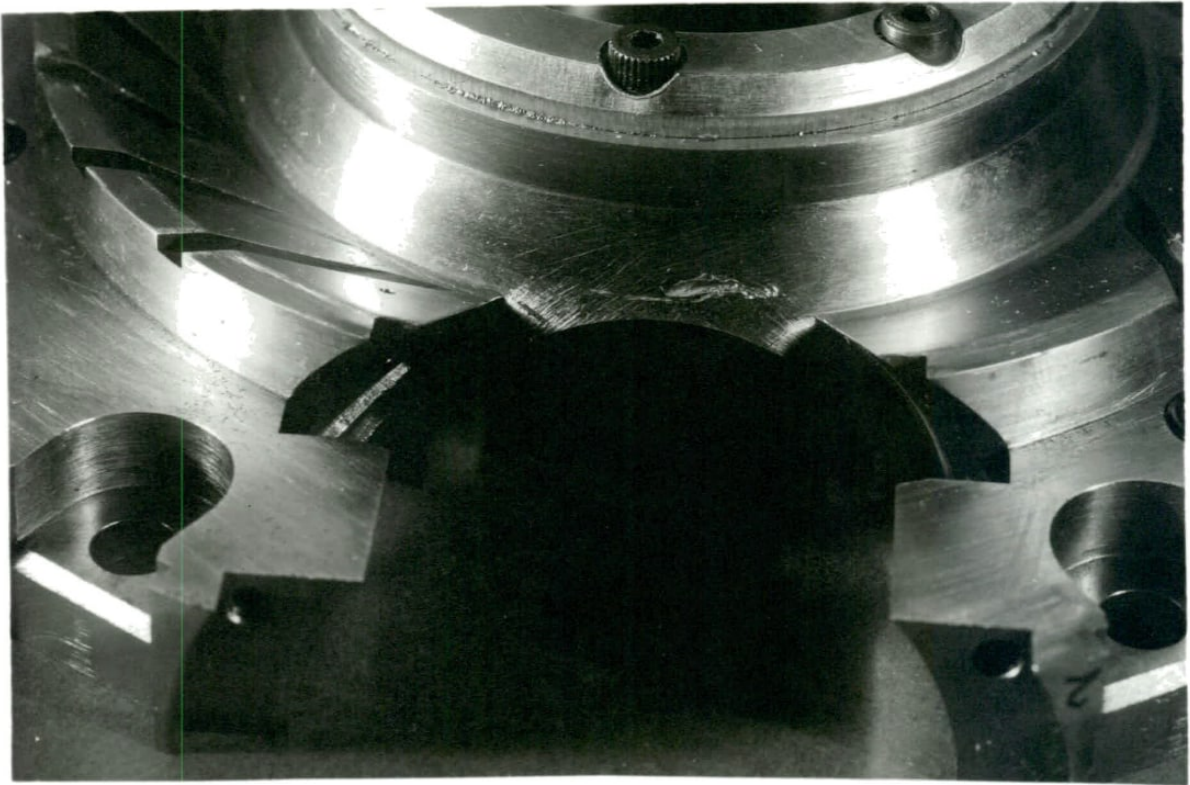
FIG. 4

DAMAGE MARKS ON HOUSING

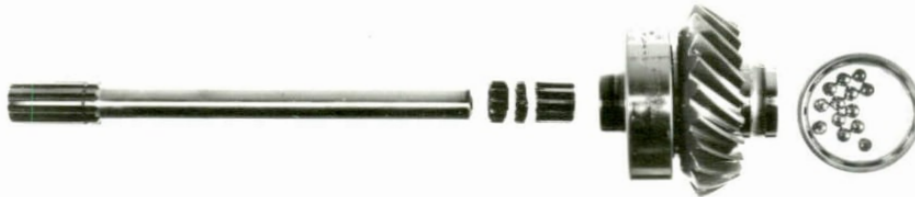
The shaft had failed at the driving end in the splines within the bevel gear, see Figure 1.

Figure 1. Failed Assembly.

A visual examination of the parts, Figure 1, showed an unusual failure, with the splined section of the driving end of the quill shaft having separated into three pieces. It is logical to assume that the initial failure of the quill shaft was to separate that portion farthest inside the gear, followed by subsequent separation of another piece with eventual fracture of the shaft at the end of the splined portion.

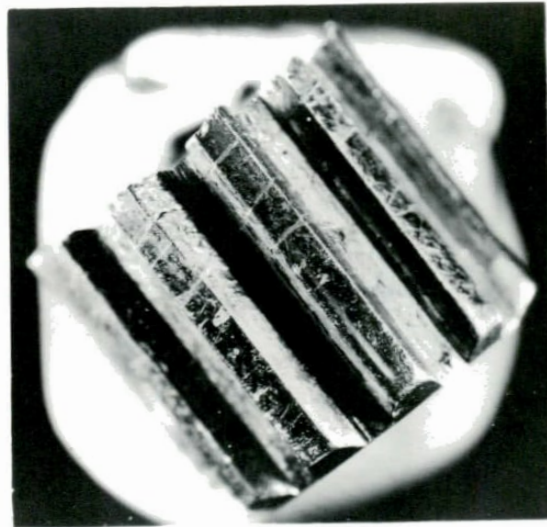
A more detailed examination of the largest, inboard, portion of the spline (see Figure 2) showed the additional presence of several circumferential cracks. Cracks running in this direction will only be caused either by torsional stress or by some longitudinal tensile stress. As the fit of this portion of the spline into the bevel gear was still adequately tight and no appreciable spline wear is evident, it is very unlikely that sufficiently high torsional stresses were developed. The conclusion, therefore, must be that the failures were due to the action of the longitudinal tensile stresses.

Figure 2. Quill Shaft Spline Tip.

The presence of such longitudinal tensile stresses would have been caused by misalignment of the gear with respect to the quill shaft. The obvious source of this misalignment is the failure of the inboard bearing, allowing the gear to tilt on the splined end of the quill shaft due to the separating forces of the meshed gears. This tilting action is equivalent to a bending moment across the length of the splines and results in alternating tensile stresses at the surface of the male splines. Compensatory loads of opposite sign will be induced in the female splines, but due to the increased section, the stresses would have been lower. Therefore, there is a much lower probability of cracking in the bevel gear splines.

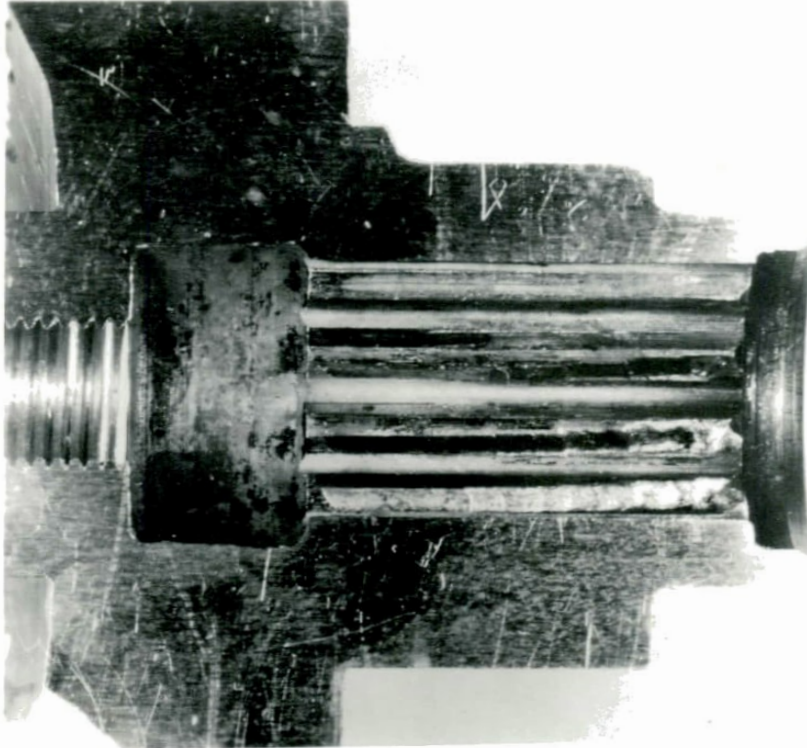
To study the female splines more adequately, the bevel gear unit was cut through the centre to expose the splines. The wear pattern on these splines was in accordance with the progressive failure of the quill shaft splines, becoming much more pronounced as the driven area became less, see Figure 3. In addition, the profile of the wear pattern was in accordance with the hypothesis of tilting of the bevel gear with respect to the quill shaft. Magnaflux examinations, both before and after cutting the gear, did not show any cracks either in the spline or anywhere else in the unit.

Figure 3. Bevel Gear Splines.

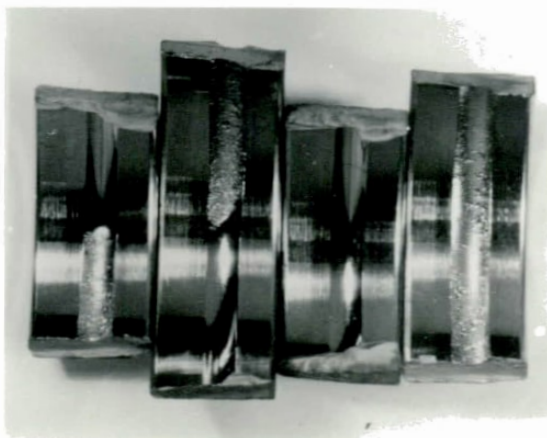
There is considerable evidence to support the hypothesis that tilting of the bevel gear was the cause of failure of the quill shaft. The outer race of the inboard bearing is stationary and it showed an uneven breakdown of the bearing surface. Figure 4 shows this race after fracturing into four pieces.

Figure 4. Inboard Bearing Outer Race.

The failure of the surface over only a part of the race is strongly suggestive of excessive force in one direction. In normal operation the loading of this bearing will be largely unidirectional due to the separating thrust of the gears. The conclusion is, therefore, that either the bearing failed due to these normal loads or that there was a loss of the preload applied to maintain correct alignment of this and the outboard bearing.

It is recommended that steps be taken either to increase the capacity of this bearing or to redesign the assembly to reduce the bearing loads.
