Drone Impact Damage Assessment on a Legacy Transport Aircraft Structure: Empennage Testing

Report No: LTR-GTL-2021-0002

Prepared for: Defence Research and Development Canada

Aerospace Research Centre, Gas Turbine Laboratory
January 18, 2021

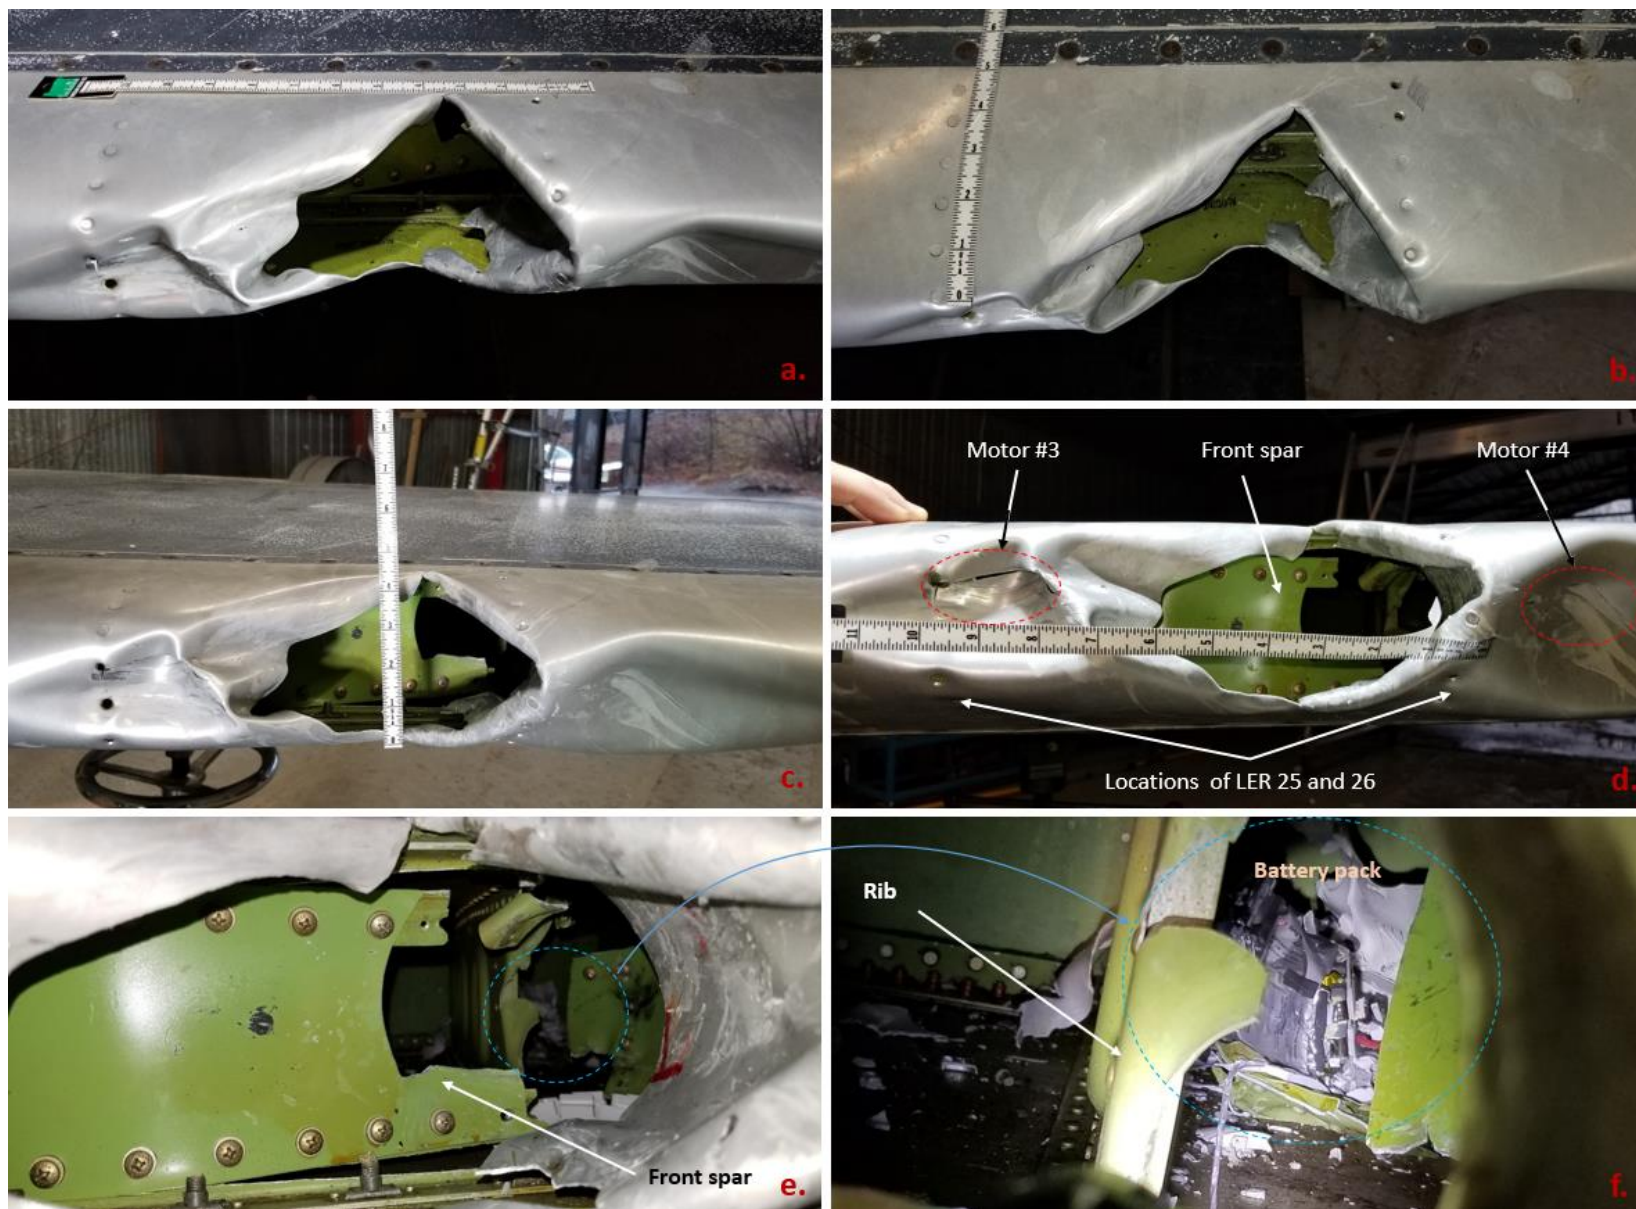
Selected pictures of the leading edge after the impact are presented in **Figure 14**. The impact resulted in an opening in the leading edge measuring 15.2x10.1x10.1 cm (6x4x4 inch), significant damage to the LER 26 and caused damage to the front spar and rib. Defective parts of the drone body and battery pouches landed at the back of the HS close to the rear spar as depicted in bottom pictures of **Figure 14**. Motor M3 damaged the LER 26, deformed the skin of the leading edge and caused a 5 cm (2 inch) long tear (**Figure 14d**). M4 was the last part of the drone to impact the HS causing a deep and extended deformation to the skin.

Figure 14: Pictures of damaged HS leading edge (Test #1: HS-T1)

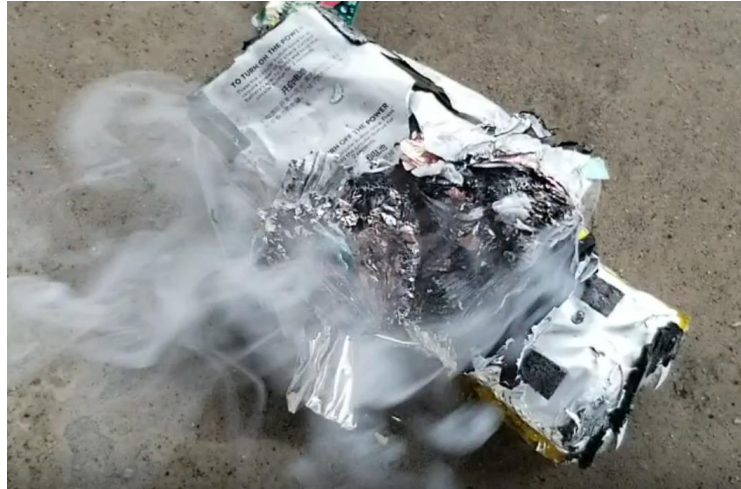
It is important to note that the test drone had a discharged battery (under 25% of full charge). During inspection after the test, a very slight burning smell was reported. However, after extracting the battery cells from the back of the HS, the cells continued overheating and generating smoke and fumes as depicted in **Figure 15**. This was the direct effect of mechanical deformation of the battery assembly as well as its manipulation during extraction from the horizontal stabilizer. This may have caused a short circuit and ignition of the cells.

Figure 15: Status of the drone battery after impact

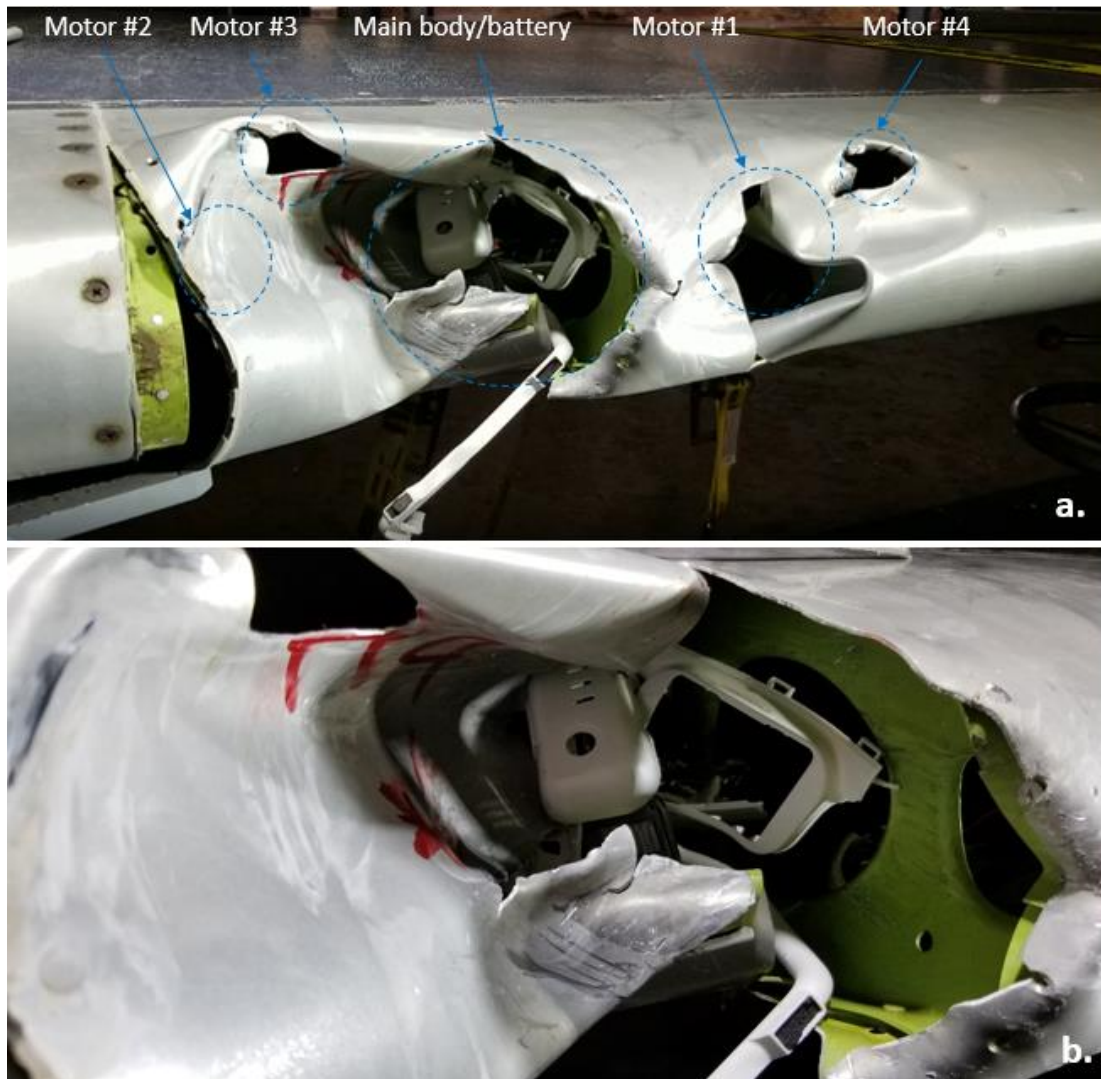
The impact resulted in multiple openings on the leading edge as depicted in **Figure 18**. Three out of the four motors punctured the leading edge and the skin was disjoined from the LER 15 and was severely torn. Both leading edge ribs (15 and 16) were deformed. The front spar was also deformed and bent at its top. **Figure 19** gives the main dimensions of the various openings that resulted from the impact. Parts of the test drone were found inside the HS ahead of the spar and at the back of the HS as depicted in **Figure 20**. Battery pouches overheated and failed. Their remains were found inside the HS as the figure shows.

Figure 18: Overall view and close-up of damaged areas (HS-T2)

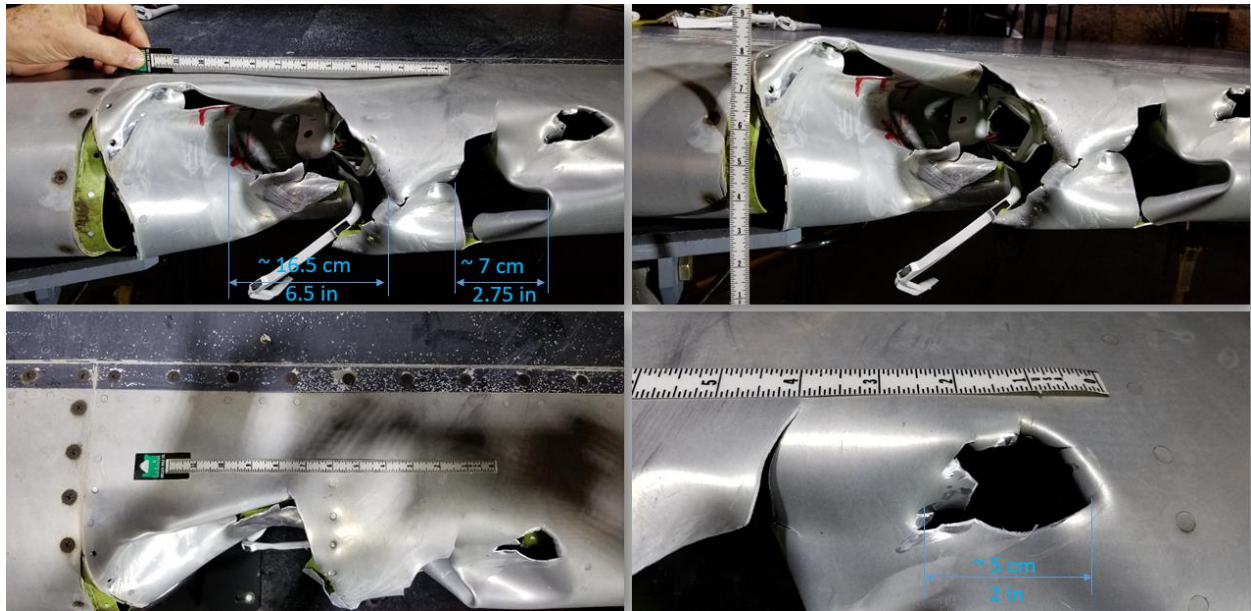
Figure 19: Main dimensions of the damaged areas (HS-T2)

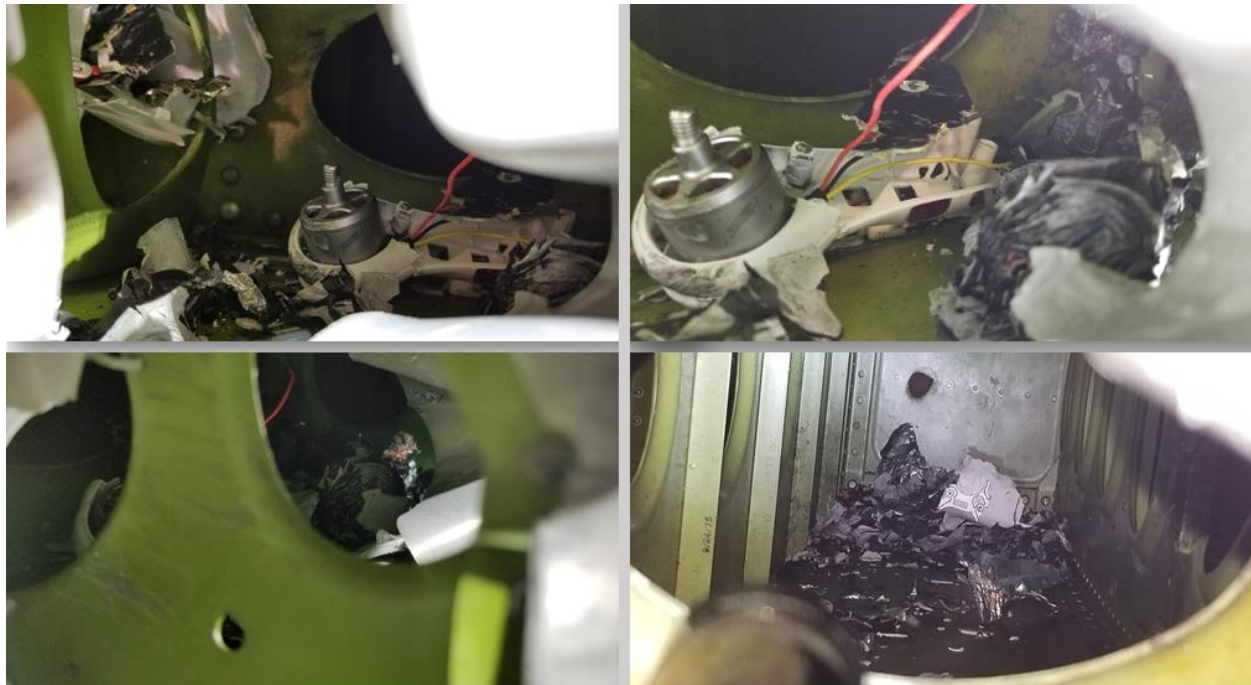
Figure 20: Remains of the test drone inside the HS (HS-T2)

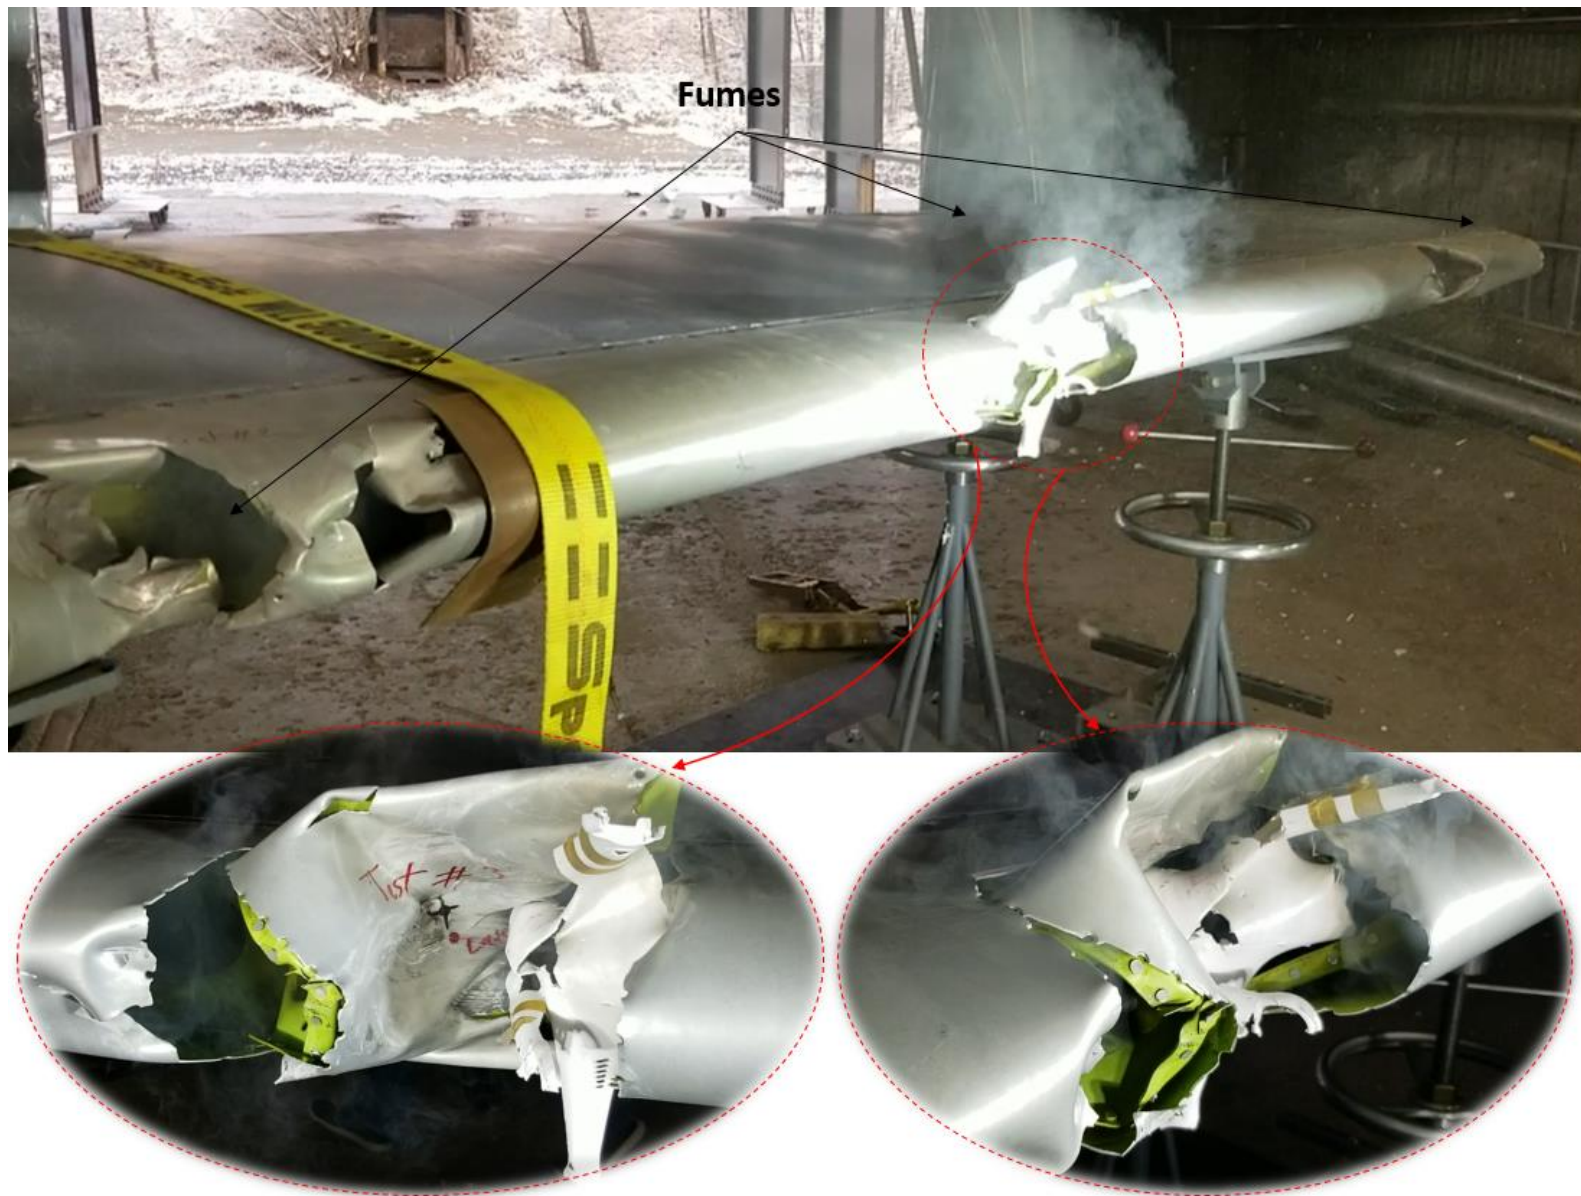
Figure 23 depicts pictures of the HS segment right after the test. The shot was on target at a speed of 126.4 m/s (245.7 kt). The drone penetrated the leading edge and the impact resulted in severe damage to its structure. The impact has also caused smoke to come out through the various openings of the HS. The smoke was dense and the fan was immediately employed to clear the test room. The HS segment was quickly dismantled and moved outside of the testing facility to prevent exposure to the smoke (**Figure 24**). Based on thermal images of the HS upper skin surface of the structure adjacent to the rear spar, the temperature was 104°C (219°F) suggesting ignition of the battery cells near this location. The outdoor ambient was near freezing with a wind both of which were contributing towards cooling the structure.

Figure 23: Post-test pictures (HS-T3)

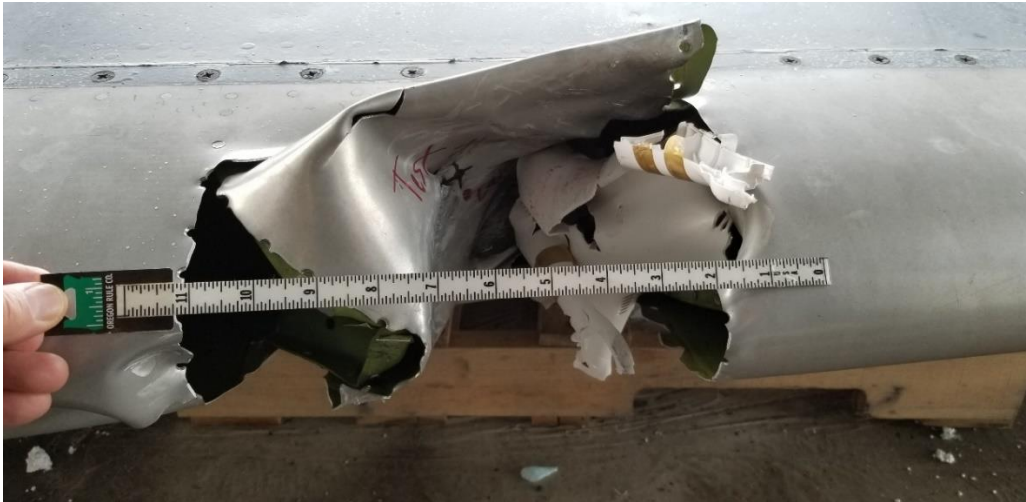
The damage to the leading edge structure covered the total distance between the leading edge ribs (Figure 26). The skin of the leading edge sheared along the rivet lines. Both LERs (20 and 21) were deformed, torn and displaced as was the front spar as depicted in Figure 27.

Figure 26: Damage dimension (HS-T3)

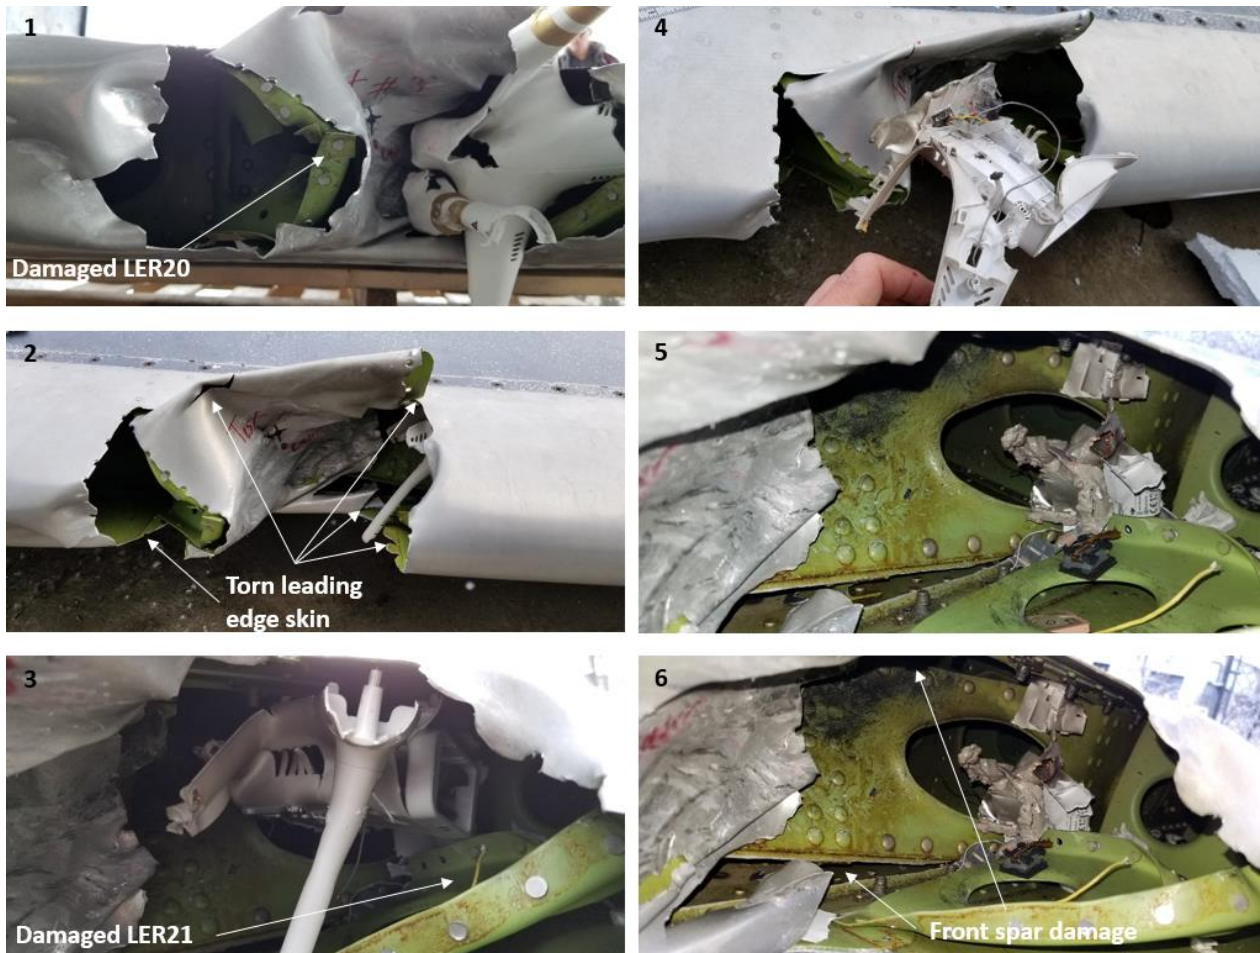
Figure 27: Damage to the leading edge structure (HS-T3)

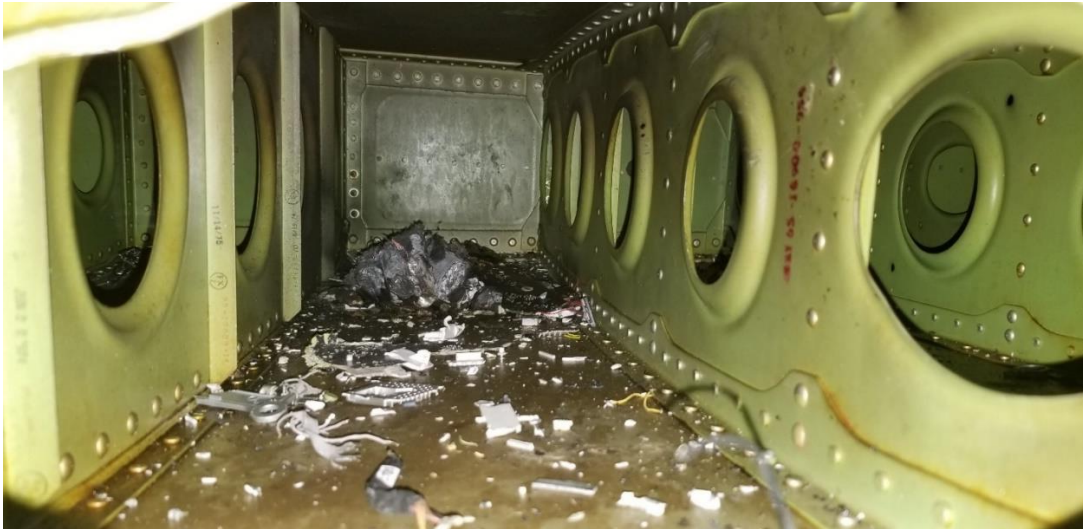
Pieces of the drone structure were found in the opening caused by the impact (**Figure 27**) and other debris, including the remains of the burnt battery, were located at the back of the HS close to the rear spar as depicted in **Figure 28**.

Figure 28: Shattered drone structure and burnt battery debris (HS-T3)

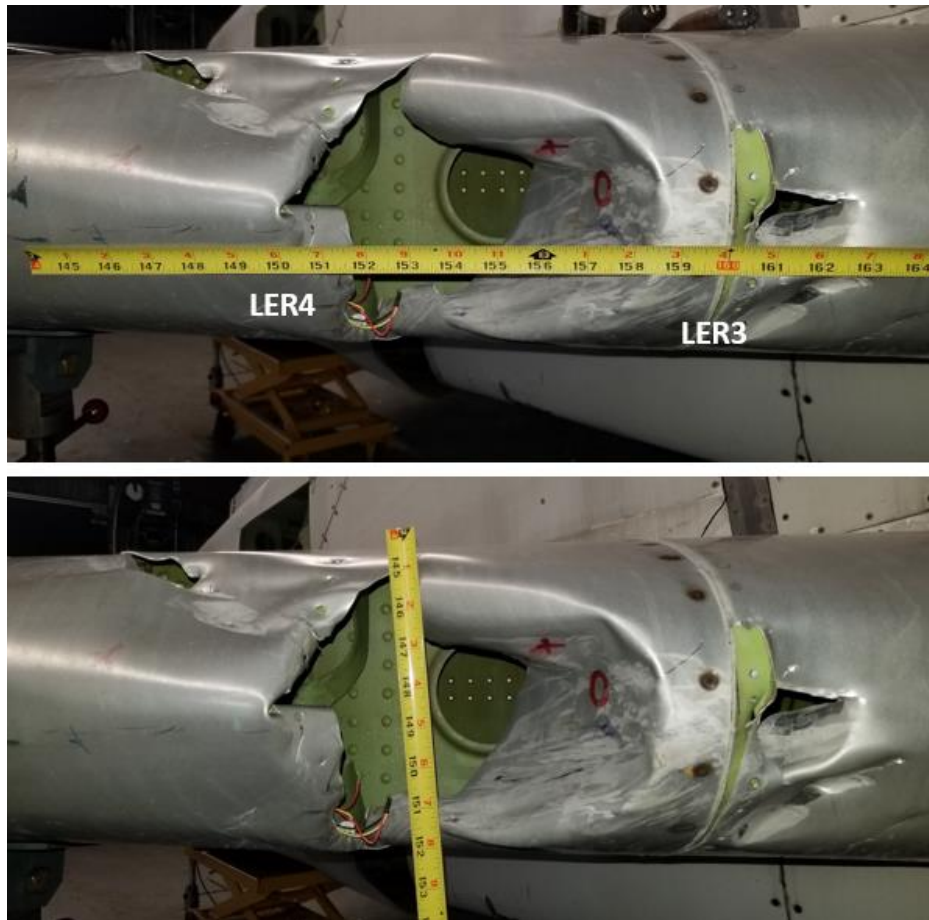
The drone impact caused damage to the leading edge that extended over a distance of 48.2 cm (19 in). The width of the damage at the centre of the impact was about 20 cm (8 in) as depicted in **Figure 31**. The impact locations of the four motors on the leading edge are indicated in **Figure 32**.

Figure 31: Damage to the leading edge structure (HS-T4)

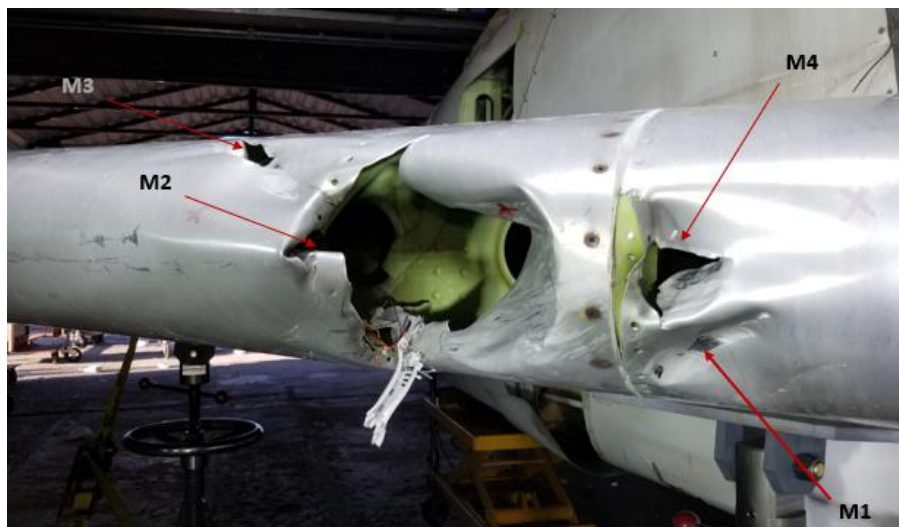
Figure 32: Impact locations of the motors (HS-T4)

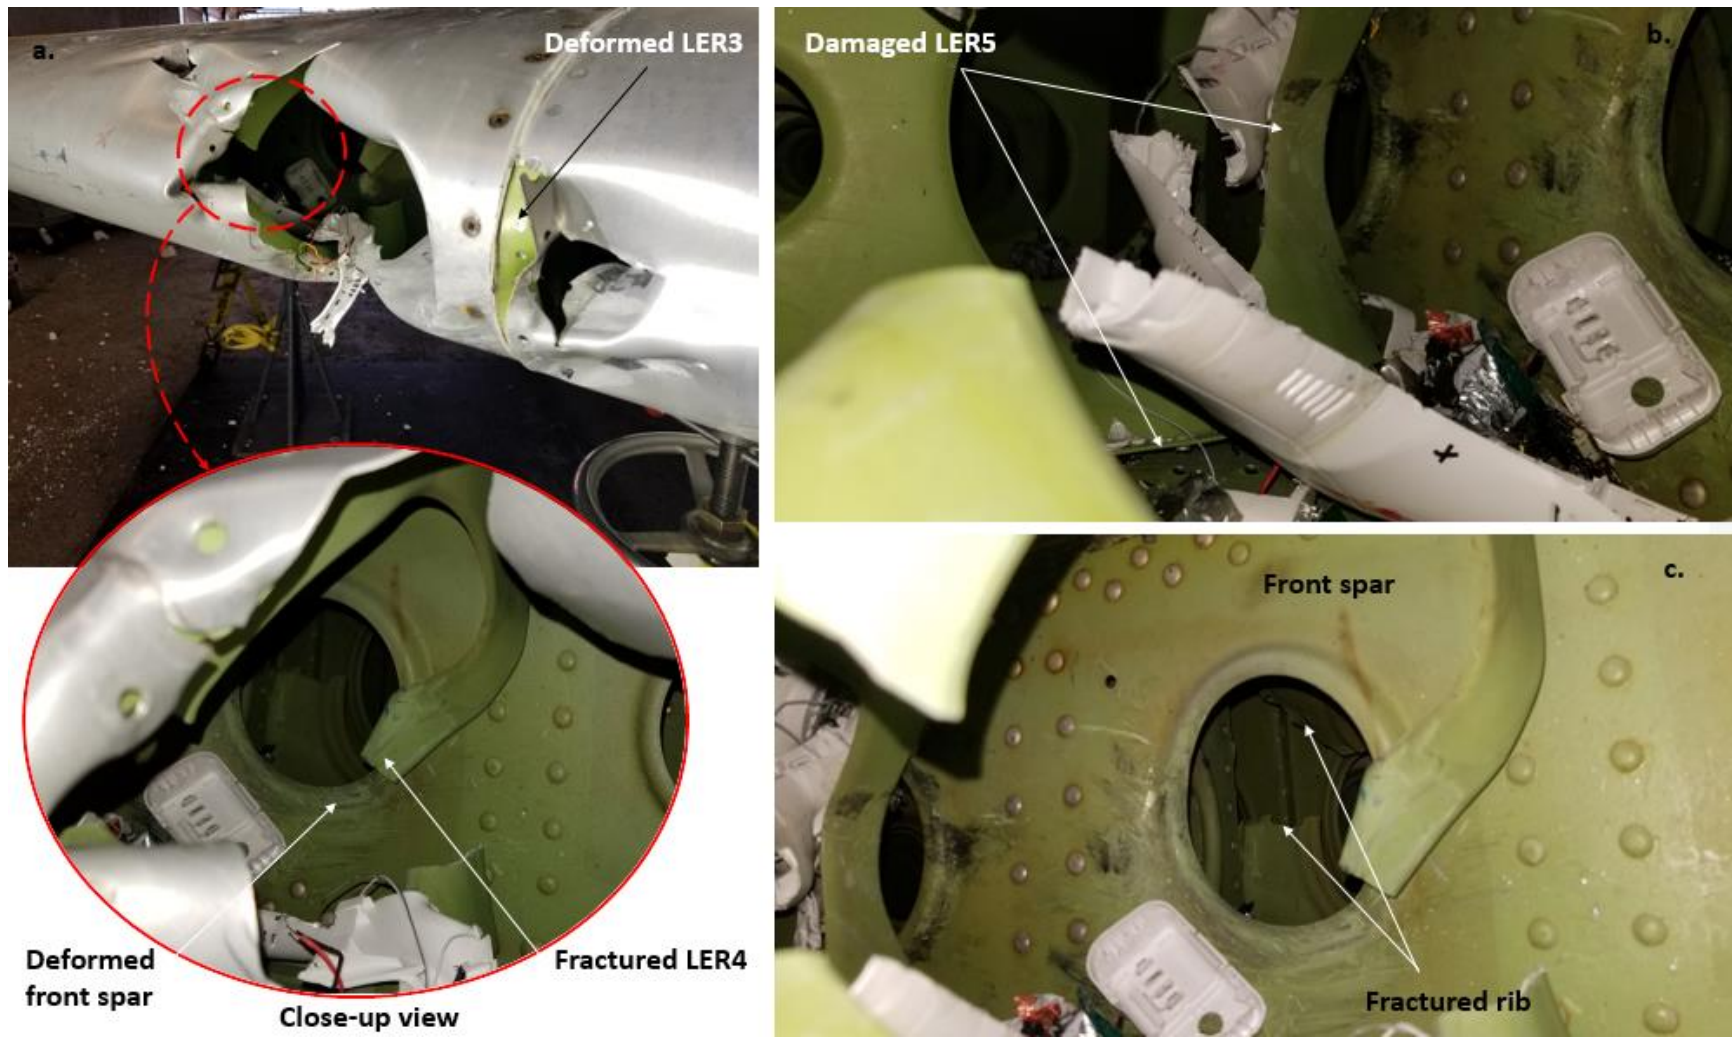
Figure 33: Damage to internal structure (HS-T4)

Figure 33 shows pictures of the damage incurred to the HS interior structure. LER3 was deformed and LER4 suffered severe damage and fractured at two locations. LER 5 was also deformed and disjointed from the lower skin surface. The front spar was also deformed in the vicinity of a lightening hole. Similarly to the previous tests, the battery pack passed through the lightening holes of the front spar, caused damage to the internal structure and landed near the rear spar of the HS. **Figure 34** shows damage to the leading edge as viewed from above (a) and debris of the drone body found inside the damaged section of the leading edge (b) as viewed from the side through the lightening holes of the LE ribs (looking inboard).

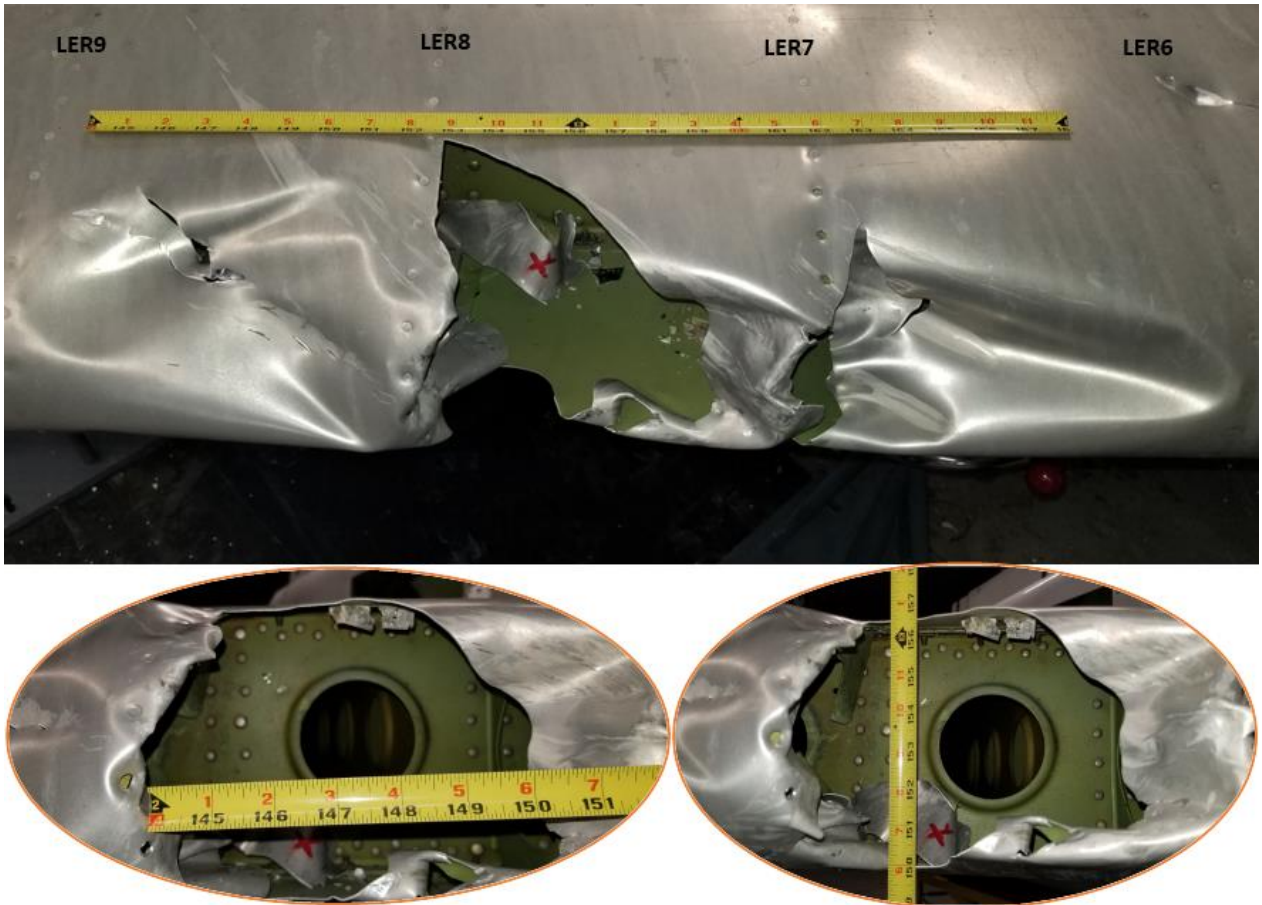
The damage to the leading edge extended from LER6 to LER 9 over a total distance of 71 cm (28 in) as shown in **Figure 37** The main penetration of the leading edge measures 15.2Wx16.5H cm (6.0Wx6.5H in). **Figure 38** identifies the drone components that caused the various damages on the leading edge skin.

Figure 37: Damage to the leading edge structure (HS-T5)

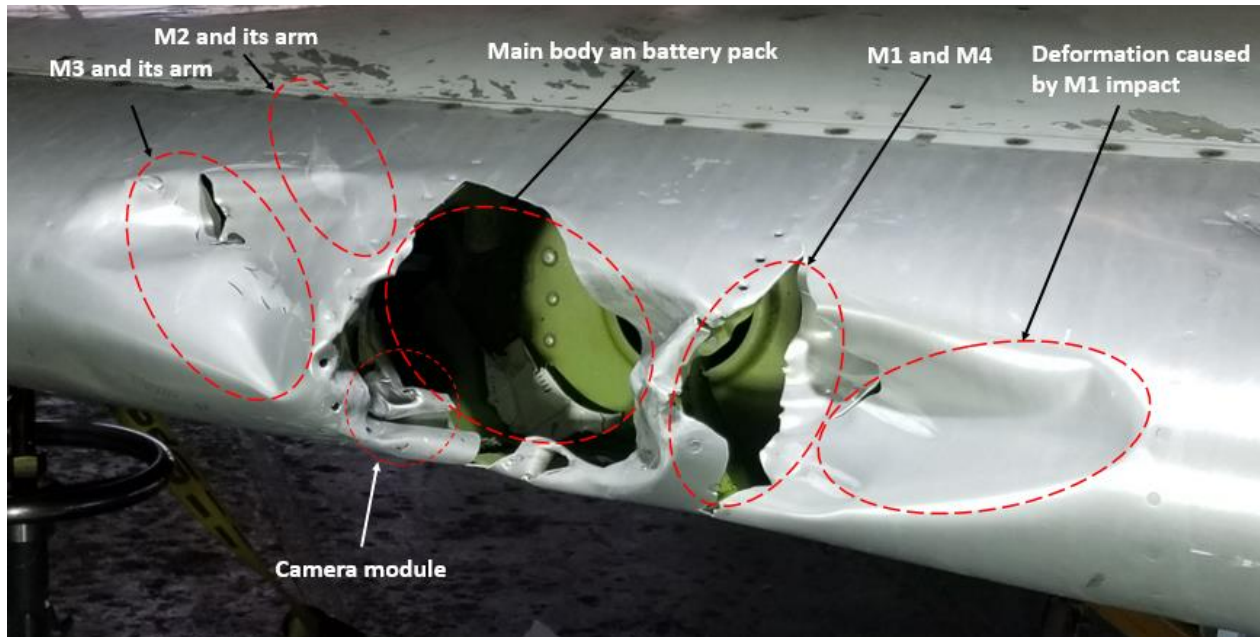
Figure 38: Impact locations of the drone components (HS-T5)

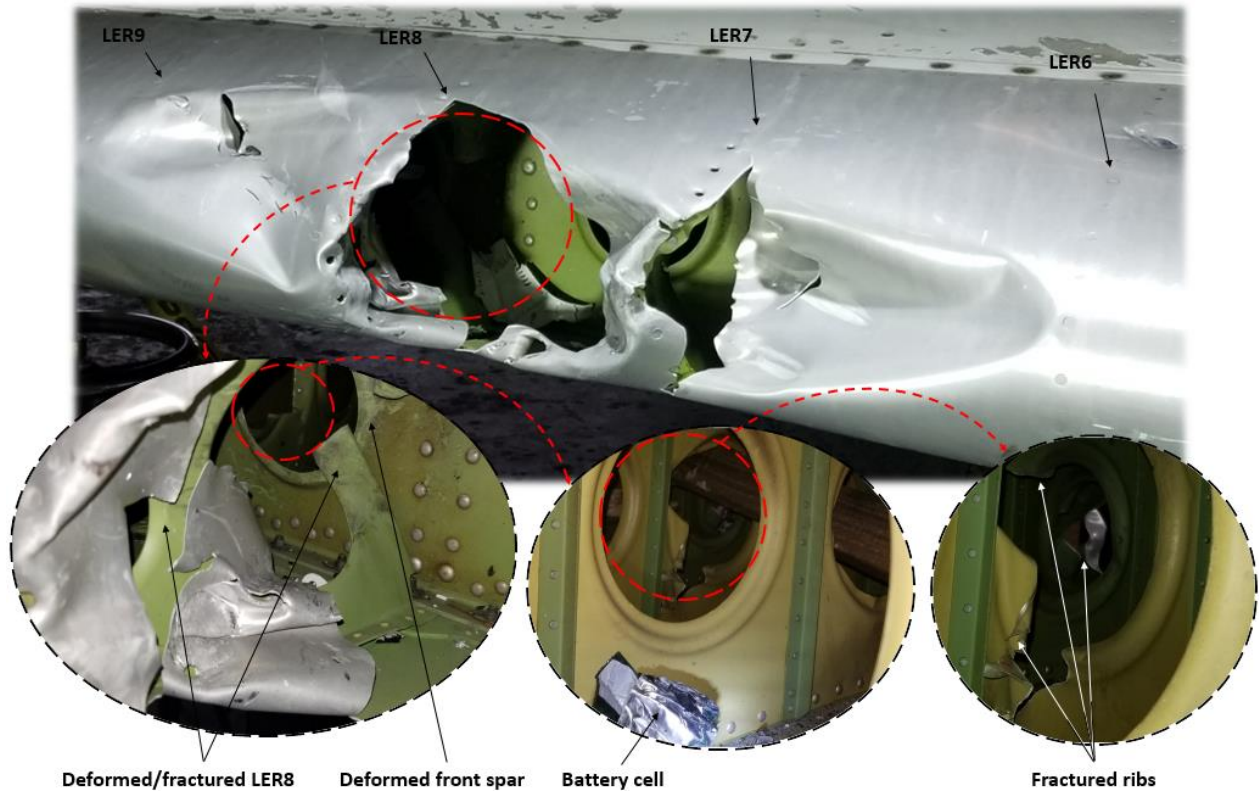
Figure 39 shows the damage caused to the internal structure of the HS. LER8 was deformed, detached from the LE skin and fractured. **Figure 40** shows the damage caused to LER 7 and the surrounding leading edge skin. Parts of the drone were found inside the HS in various locations.

Figure 39: Damage caused to the HS internal structure (HS-T5)

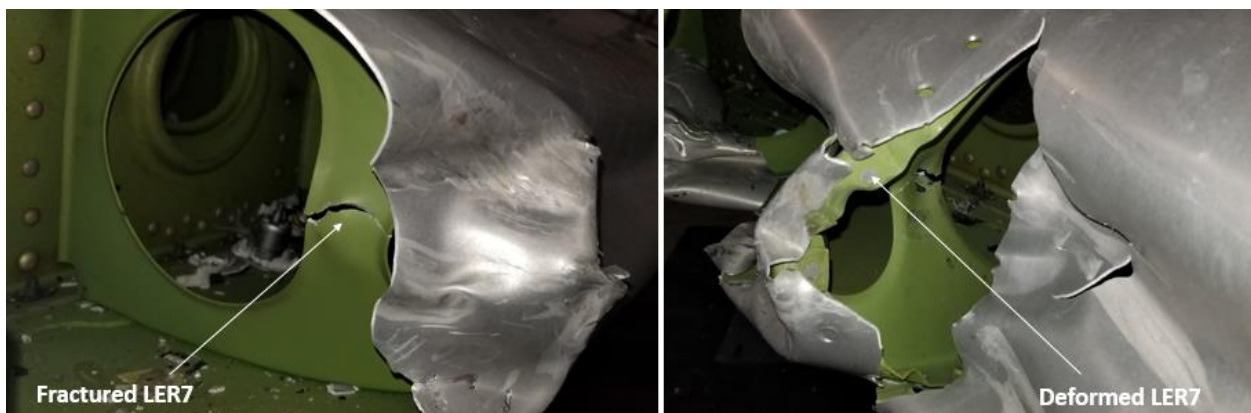
Figure 40: Damage caused to LER7 and its vicinity (HS-T5)

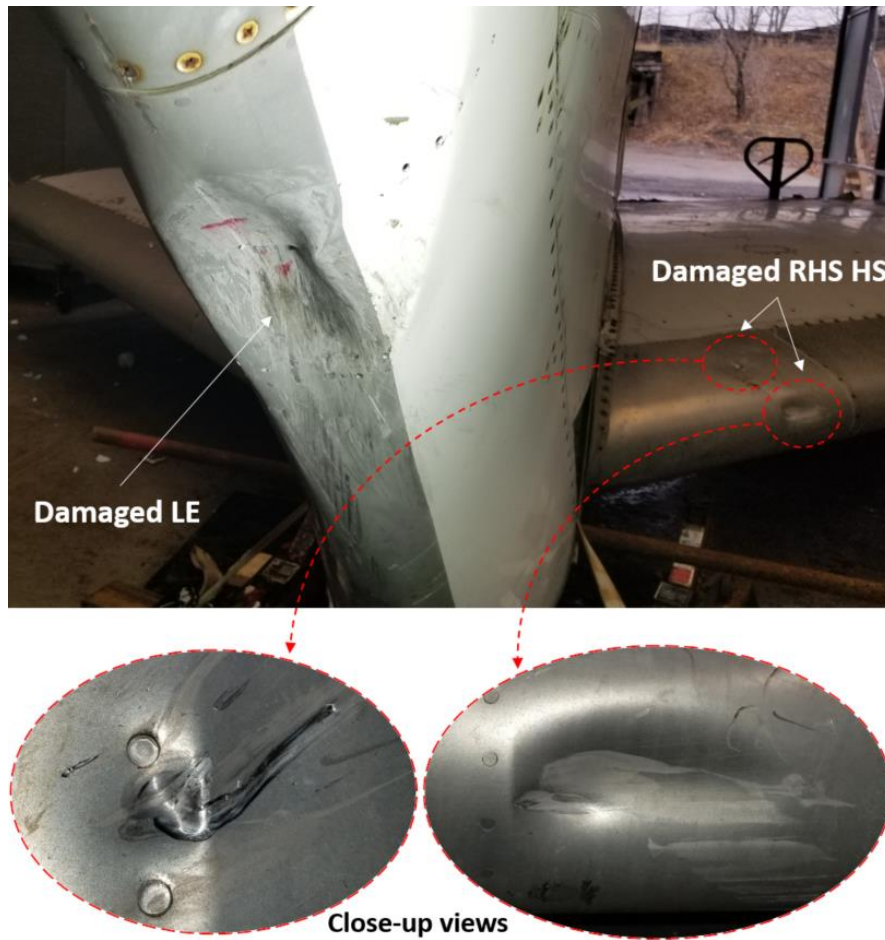
Figure 48: Collateral damage on RHS HS (VS-T1)

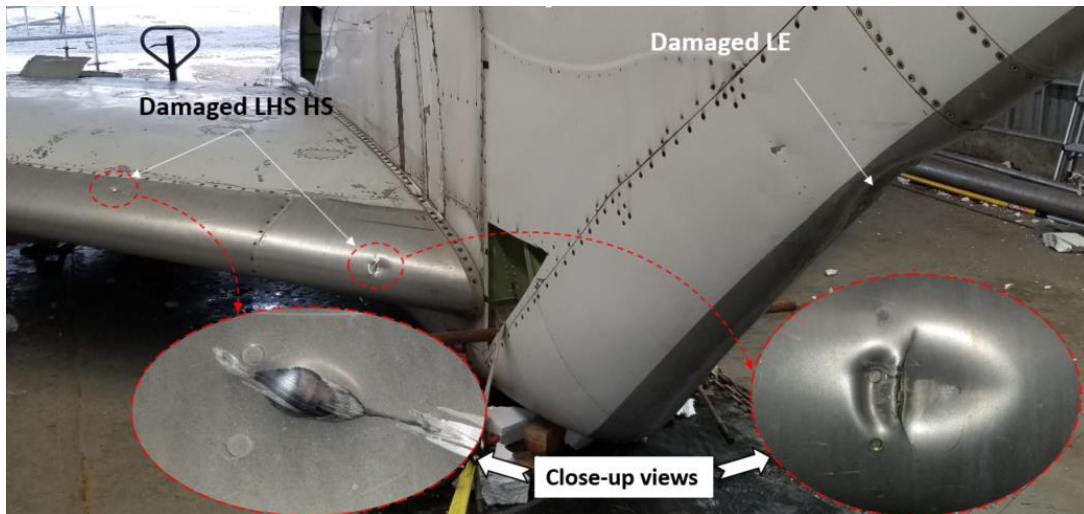
Figure 49: Collateral damage on LHS HS (VS-T1)

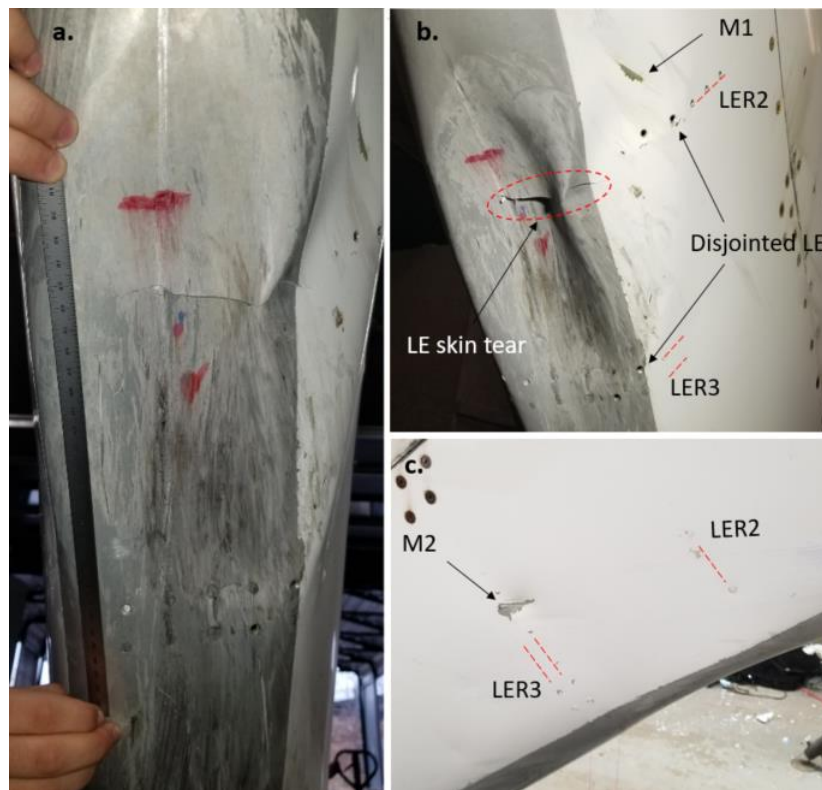
The damage on the VS leading edge extended over a distance of about 30 cm (11.8 in) and was more pronounced on one side of the LE where the rivets failed and the skin was partially disjointed from the LERs 2 and 3 (**Figure 50**). As opposed to the drone impact on the HS, the VS withstood the impact and no penetration was reported. The impact caused a permanent deformation and tears on the LE skin. It is worth noting that motors M1 and M2 grazed both sides of the VS leading edge as they were deflected away after the impact (b and c).

Figure 50: Damage to the leading edge structure (VS-T1)

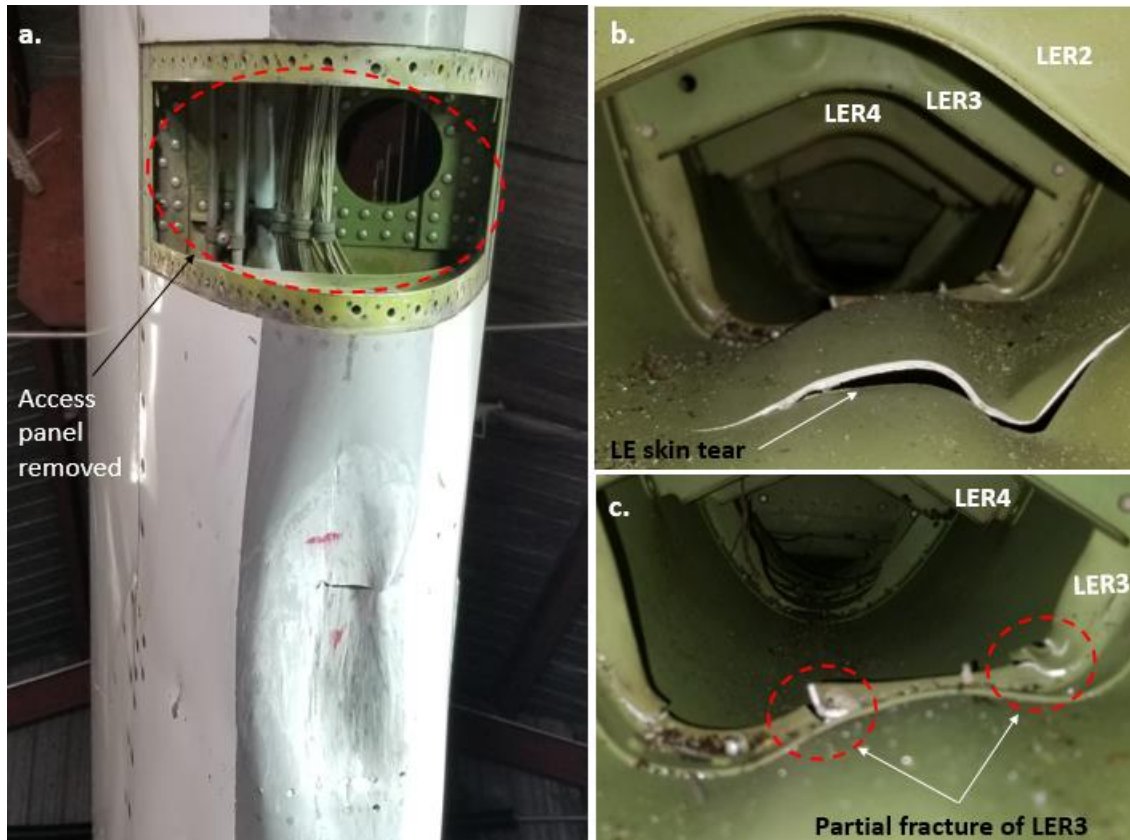
The access panel was removed to allow inspection of the interior of the leading edge. **Figure 51** clearly shows the tear on the leading edge skin as well deformation and partial fracture to LER3.

Figure 51: Damage caused to the VS internal structure (VS-T1)

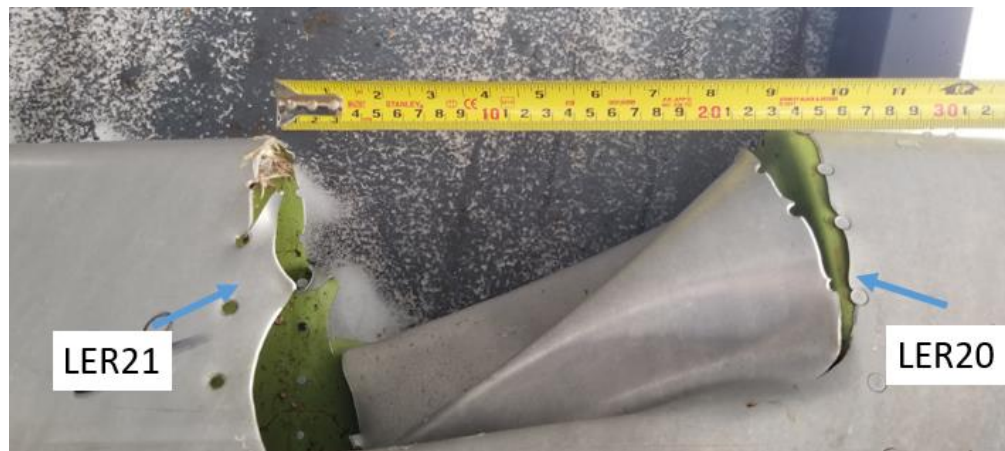
The bird impact was on target at a speed of 128.4 m/s (249.5 kt). The bird penetrated the leading edge of the HS and caused permanent damage as shown in the impact sequence images extracted from the high speed cameras C1, C2 and C3 (**Figure 54**). The damage extended over a distance of 24.5 cm (9.6 in) between the leading edge ribs as shown in **Figure 55**.

Figure 55: Damage length on the leading edge (HS-T6)

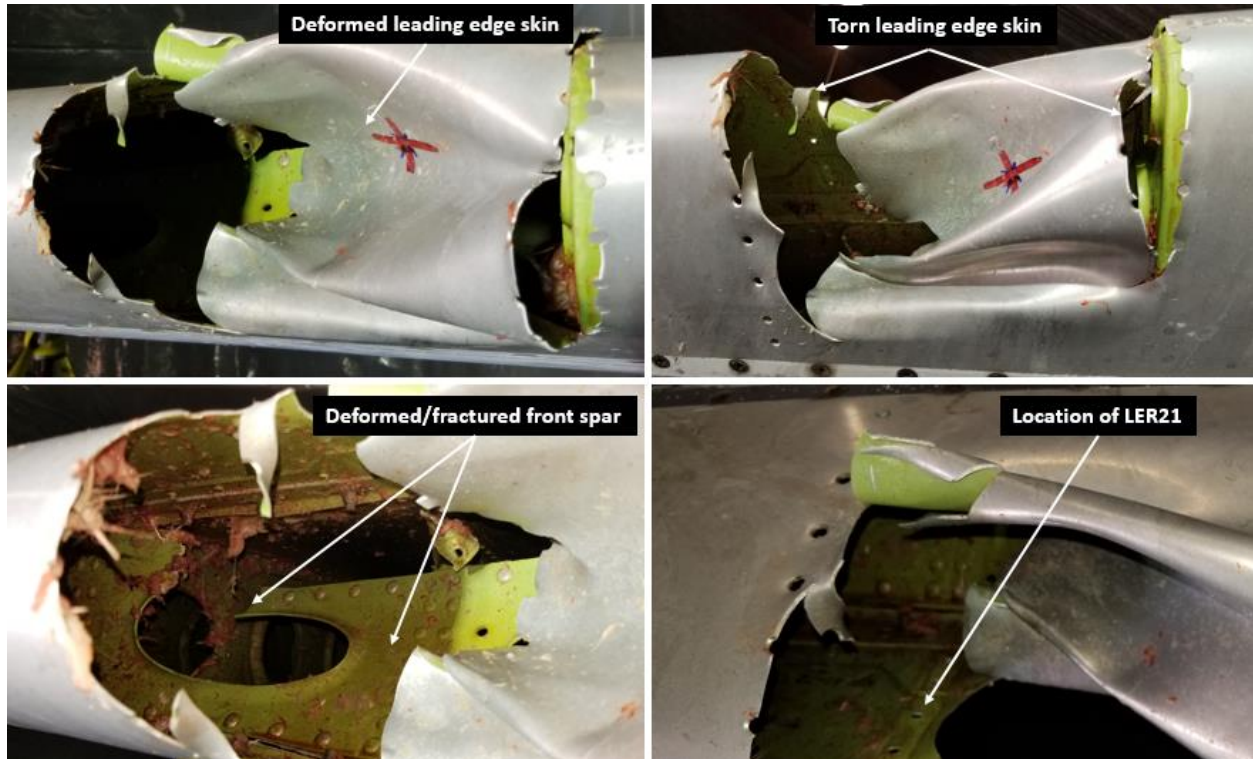
Figure 56 presents pictures of the various HS parts that were damaged by the bird strike. The whole leading edge skin section extending from LER20 and LER21 was damaged. The leading edge skin was torn at the mounting rivets with the ribs. LER21 was fractured and dislocated from the LE skin. The front spar was also deformed and fractured. No damage to any structure located behind the front spar was reported.

Figure 56: Damage to the RHS HS leading edge structure (HS-T6)

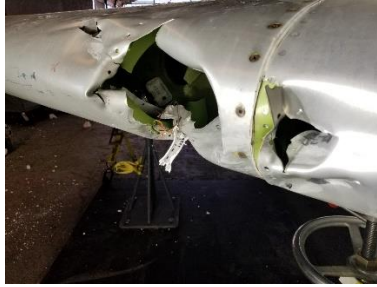
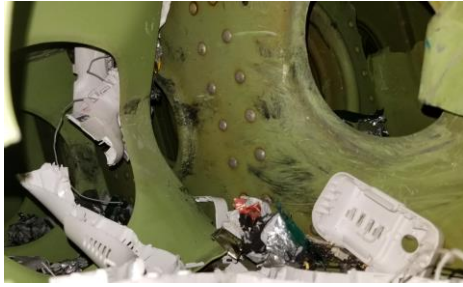
| Test ID, speed (kt) | Severity | Selected damage pictures | |
|---|---|---|--|
| HS-T4, 250 | Level 4 | | |

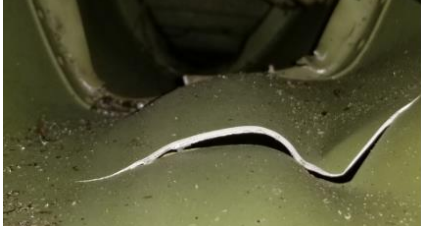
| Test ID, speed (kt) | Severity | Selected damage pictures | |
|---|---|---|--|
| VS-T1, 250 | Level 3 | | |
