De-icing flight tests of a Boeing-Vertol 107-II helicopter: part 2: 1962/63 tests

AERONAUTICAL REPORT
LR - 382

DE-ICING FLIGHT TESTS
OF A BOEING-VERTOL 107-II HELICOPTER
PART 2-1962/63 TESTS

BY
G. A. GIBBARD AND R. D. PRICE
DIVISION OF MECHANICAL ENGINEERING

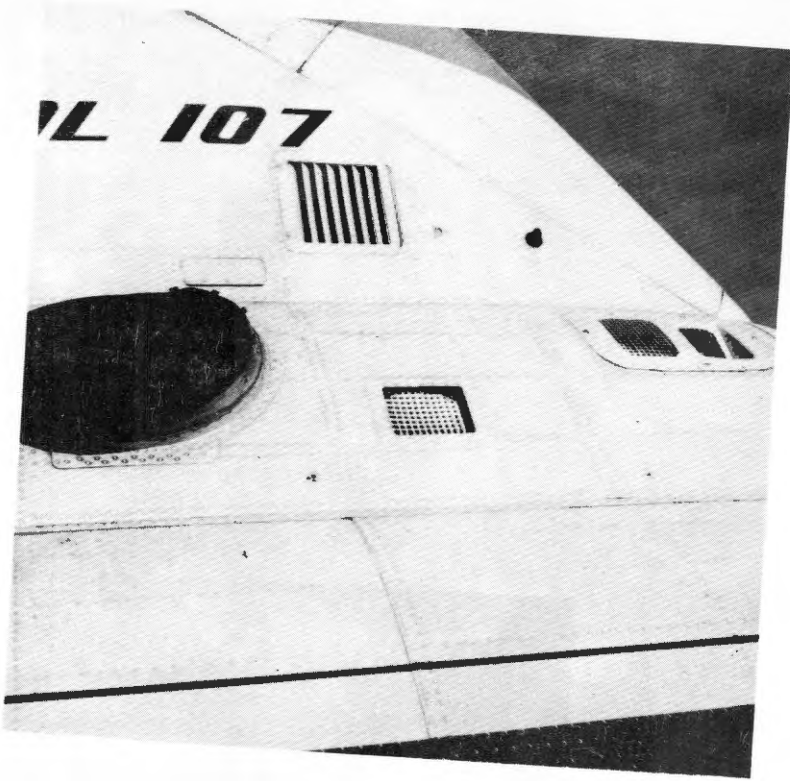
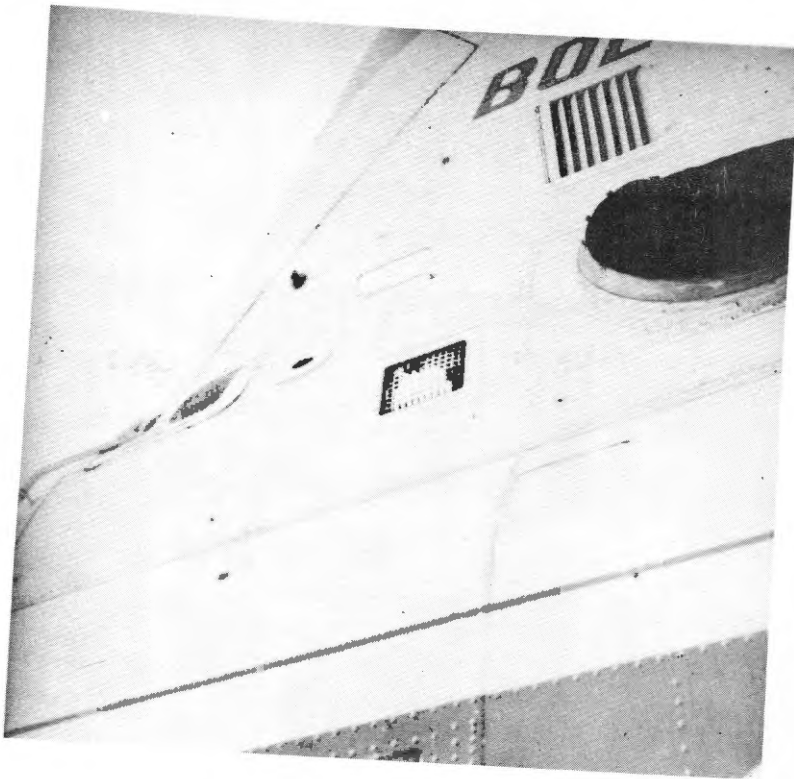
Some small scale components of the helicopter such as screens and grilles picked up icing (Fig. 3) and a heavy frosting of a large portion of the fuselage was noticed on long duration flights, but no detrimental effects of this icing were experienced. One possibly serious effect that was encountered was

STARBOARD SIDE — AFTER RUN 166-2

PORT SIDE — AFTER RUN 183-2
ICING OF SCREENS

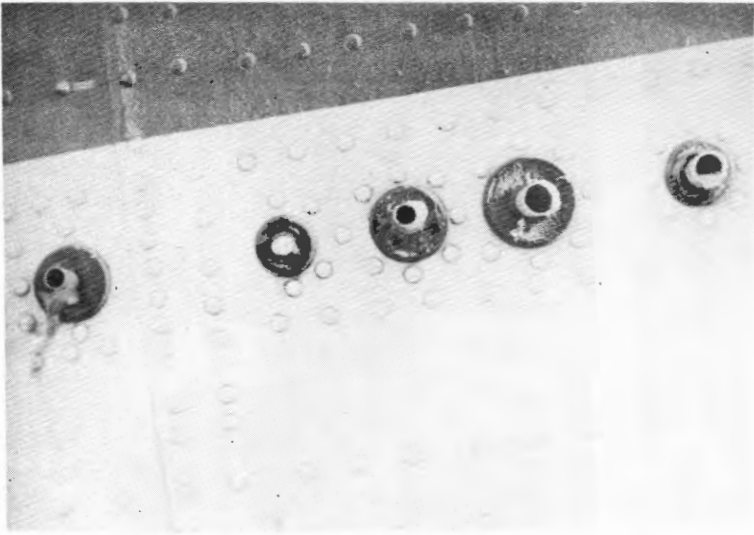
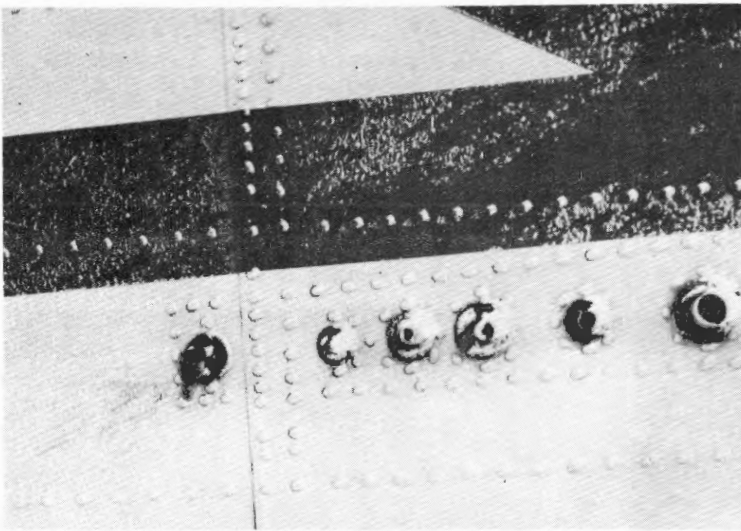
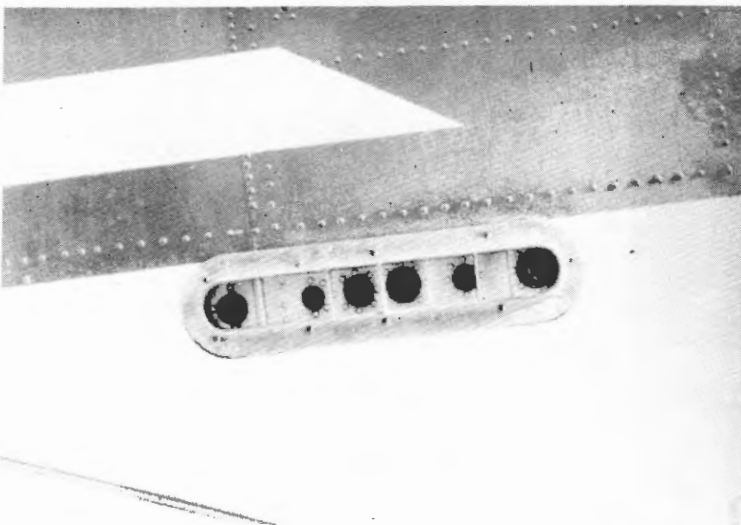
ENGINE DRAIN ICING

the freezing over of the ends of some of the engine drain pipes (see Fig. 4). The pipes were being blocked partly from direct icing on their tip and partly from the freezing of the water dripping from the pipes. A few modifications were tried to overcome this problem but no positive solution was found.

AFTER RUN 177-3

AFTER RUN 184-3

AFTER RUN 190-2
WITH BAFFLE
INSTALLED

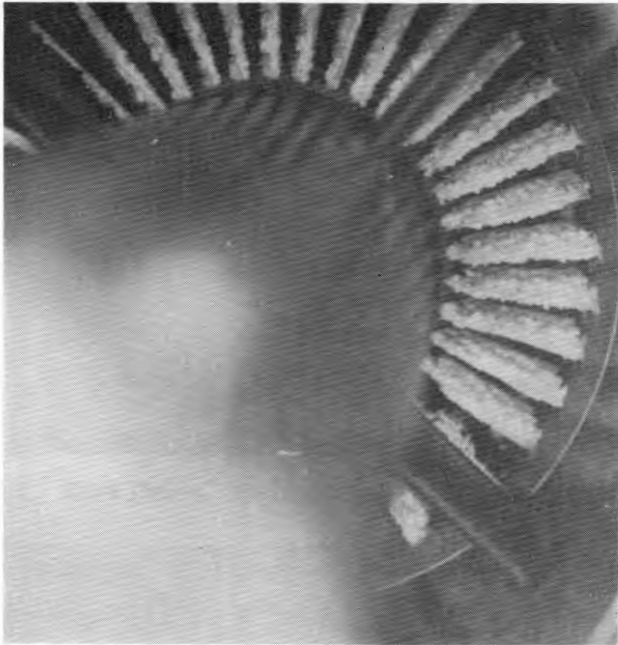
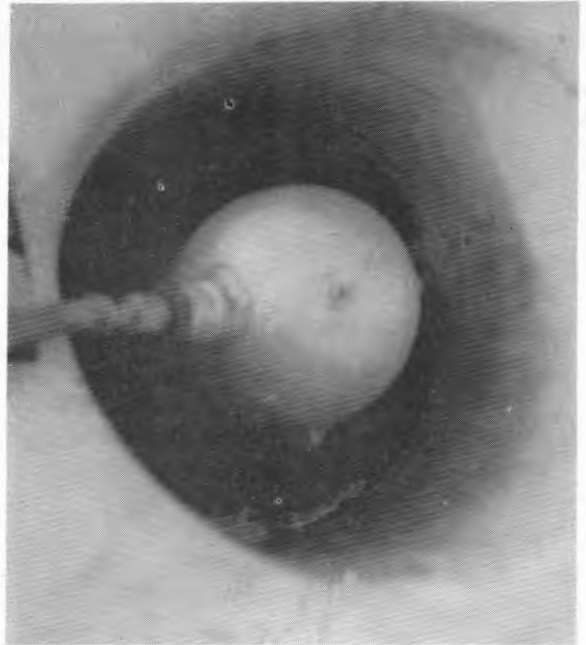
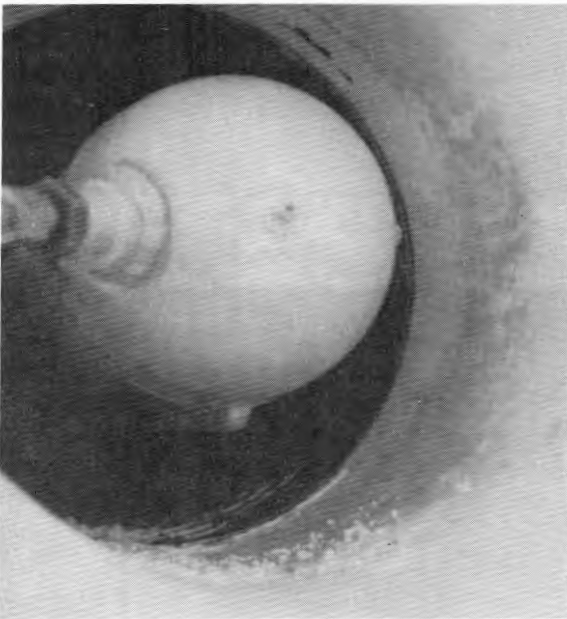
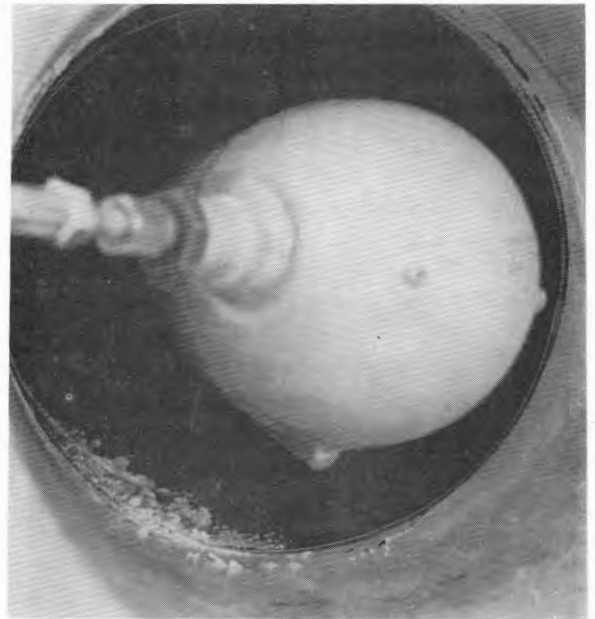
ENGINE INLET ICING

As had been the case the previous year, the electro-thermal anti-icers on the leading edge lips of the engine inlets prevented icing on the heated area, but water was running back to form into thick ice accretions on the unheated areas behind, both inside and outside the inlet tunnel. Examples of this icing can be seen in Figure 5. This runback was appreciably greater when the anti-icing system was operated in snow or blowing snow conditions because of the melting of the solid crystals and the resulting water running back into the inlet. On two occasions damage was caused to the inlet guide vanes and to the first stage rotor blades, probably by fragments of this runback ice breaking off and being ingested into the engine. On run 185-1 several guide vanes and rotor blades were bent on both engines and on run 190-4 one inlet guide vane was bent. Figure 5b shows some of the ice remaining in the inlet after run 185-1. In all cases it was possible to inspect and repair the damage without having to remove the engines from the aircraft.

The engine and engine inlet anti-icing systems are still not adequate and this remains the major problem existing with the helicopter's icing protection capability. The electro-thermal anti-icing of the inlet lips produced considerable runback ice on the unheated areas behind and the shedding of the resulting ice was a serious hazard to the engines. The damage that was caused to inlet guide vanes and first stage rotors did not necessitate the changing of the engines, but the aircraft had to be towed back to the hangar and extensive inspection and repair work had to

be done before the helicopter was serviceable again. It is possible that much greater damage could have been caused if the run had been continued longer than the 20 min. There can be no doubt that this icing is an unacceptable hazard to the engine. The only time it was reduced to an acceptable level was when low liquid water contents were used and when the ambient temperature was fairly high (above -10°C).

(a) I.G.V. ICING, RUN 166-2
T = -24.3°C, L.W.C. = 0.2 gm./m³, 4 min.
52% torque

(b) RUN 185-1
T = -13.0°C, L.W.C. = 0.5 gm./m³.
20 min.

(c) RUN 190-3
T = -19.5°C, L.W.C. = 0.32 gm./m³
4 min.

(d) RUN 192-1
T = -20.4°C, L.W.C. = 0.15 gm./m³.
10 min.

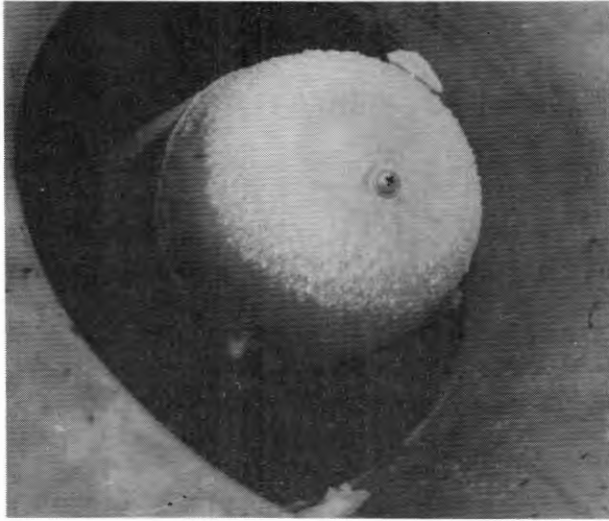
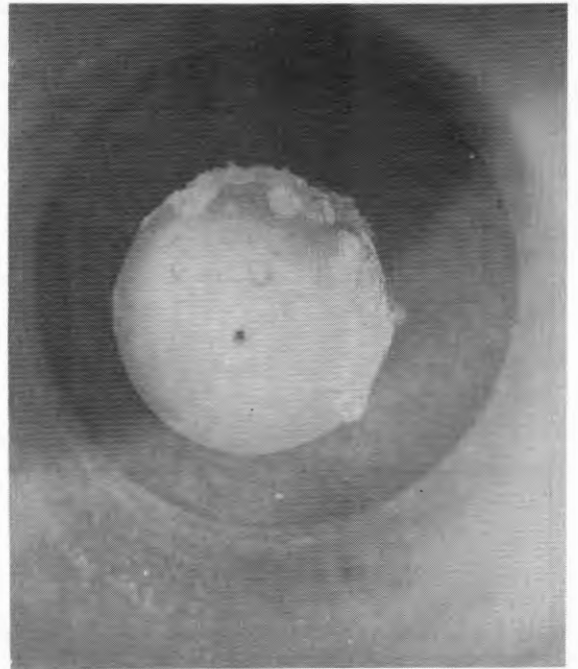
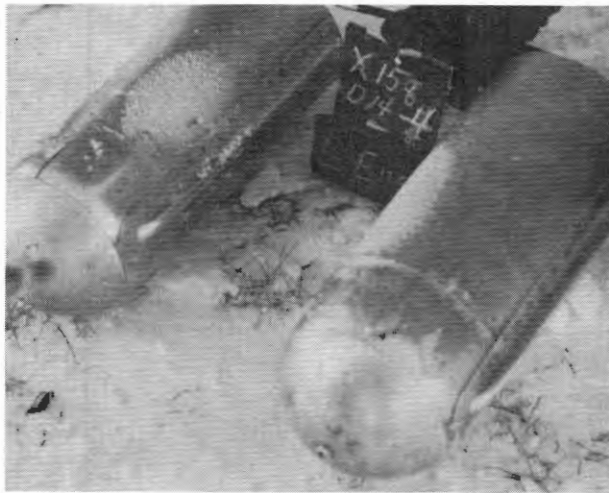
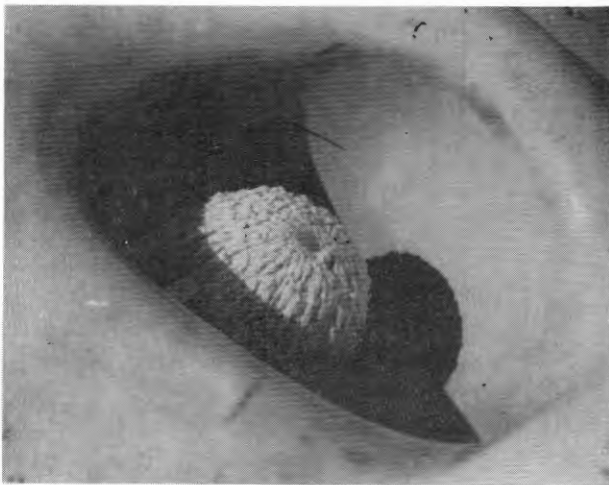
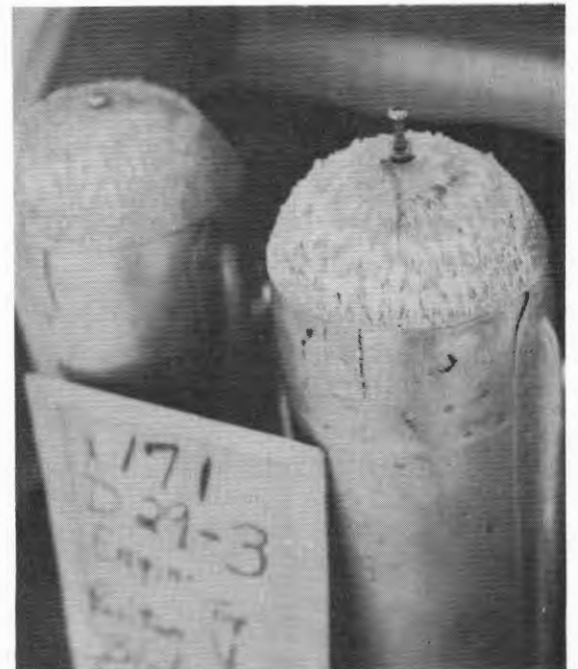
ICING ON STARTER COVERS

The engine inlet anti-icing systems were not adequate to prevent ice from building up in the inlets and becoming a hazard to the engines. Thus, the icing of the inlets and not the rotor blades remains the major problem limiting the operation of the helicopter in icing conditions. The electro-thermal heaters in the cowling lips produced large amounts of runback ice around the inlet and the hot air protection of the starter covers was inadequate.

(a) RUN 195-4 ANTI-ICING SYSTEM OFF

(b) RUN 159-2

(c) RUN 160-1

(d) RUN 166-2

(e) RUN 171-3

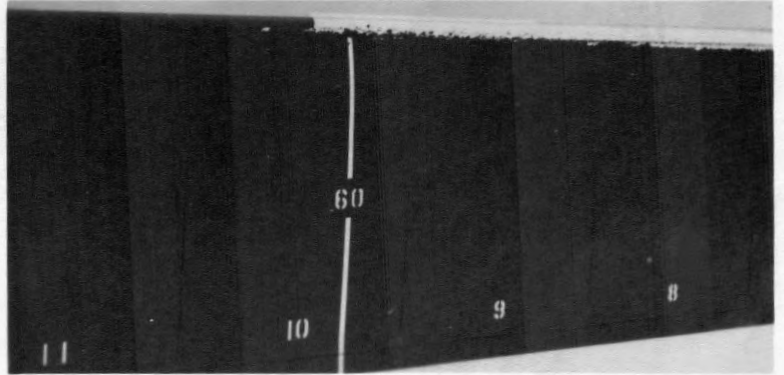
RUN 181-2 INCOMPLETE SHEDDING FRONT SPRAYMAT BLADE

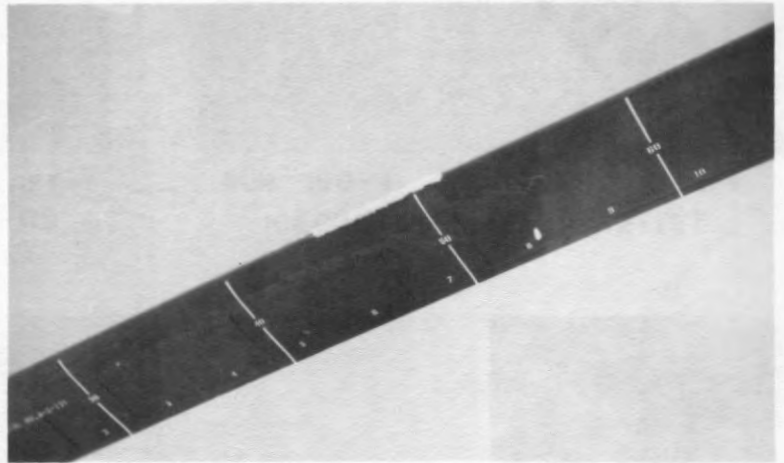
RUN 184-1 PATCH OF ICE ON AFT SPRAYMAT BLADE

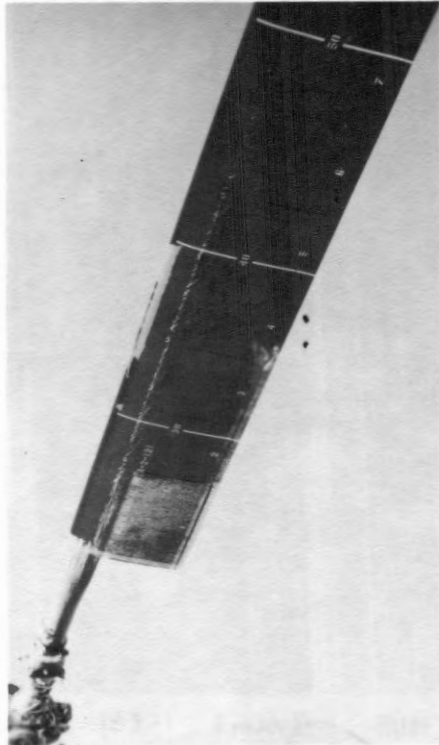
RUN 185-1 PATCH OF ICE ON AFT ICEGUARD BLADE

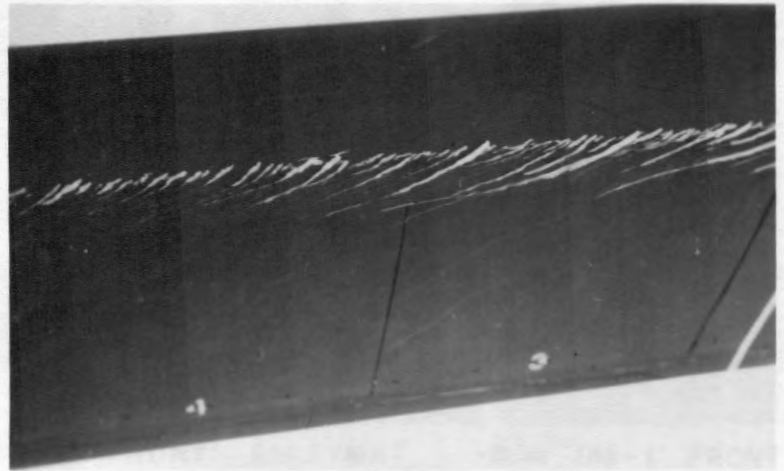
RUN 185-1 RUNBACK ICE

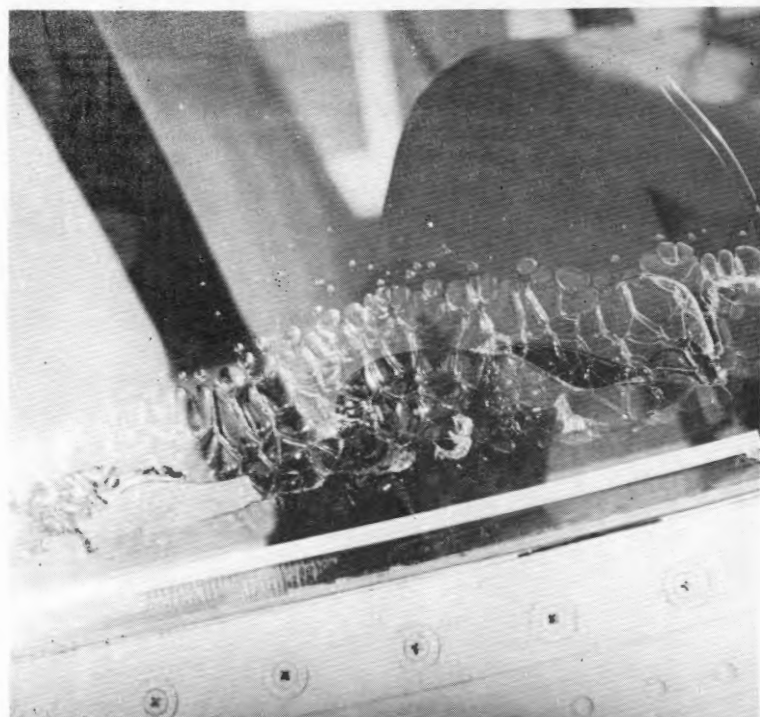
run, the electric windshield and the hot defrost air were inadvertently selected 'on' at the same time and in a few minutes the windshield became overheated and was partially destroyed (see Fig. 14). The unserviceable right-hand windshield was then replaced by a standard windshield and a heated panel was fitted to the left-hand side. To avoid any further damage the hot air defroster was then not used while the windshield was being electrically heated. The windshield remained serviceable throughout the remainder of the test period.

Care must be exercised to ensure that the electrical heaters and the defrost air are not used simultaneously on the windshield when the aircraft is stationary. Otherwise delamination of the electro-conductive layers and cracking of the outer glass could occur (see Fig. 14).

CRACKING OF WINDSHIELD FROM OVERHEATING

The windshield anti-icing systems both operated satisfactorily, but the electrically heated window was more effective than the hot air defroster system. The possibility of operation of both systems simultaneously when the aircraft is on the ground should be excluded because it may result in damage to the windshield.

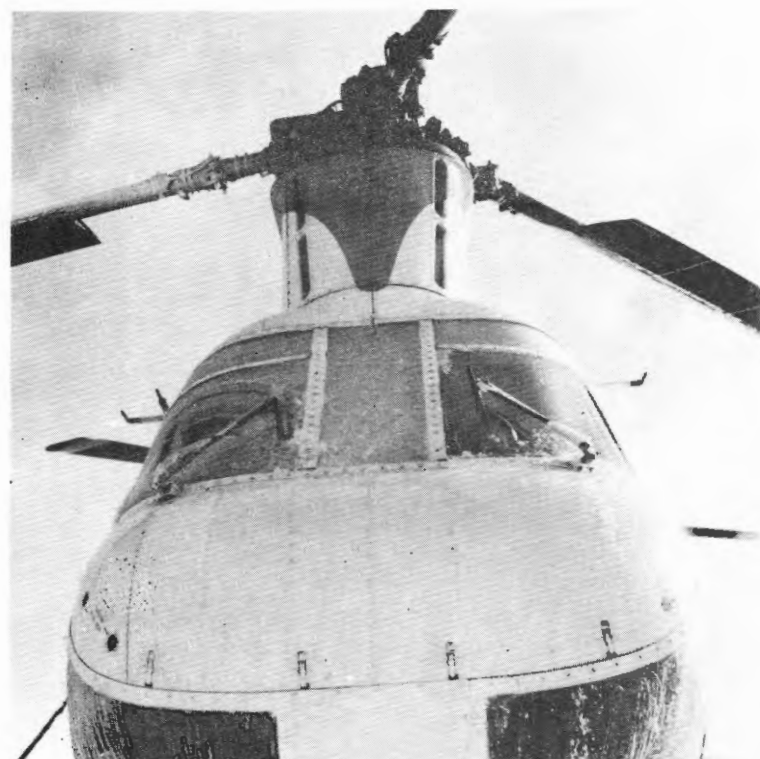
The electric windshield anti-icer was tested on one run (run 202-2) in simulated freezing rain conditions. The panel was kept completely clear during the 45-min. run (Fig. 14). The anti-icer was also used successfully on the runs in the icing cloud, but only small amounts of frosting were picked up under those conditions because of the low forward speed and the low collection of the windshield surface.

The hot air defroster was also tested on run 202-2 and, used in conjunction with the windshield wiper, it maintained partial visibility through the window. However, it was not as effective as the electric anti-icer used on the other side (Fig. 14).

HOT-AIR
DEFROSTER
ON STARBOARD
SIDE

ELECTRICAL
ANTI-ICER
ON PORT SIDE
