The Hagersville Tire Fire February 12 to 28, 1990

J.R. Mawhinney

Internal Report No. 593

Date of issue: May 1990

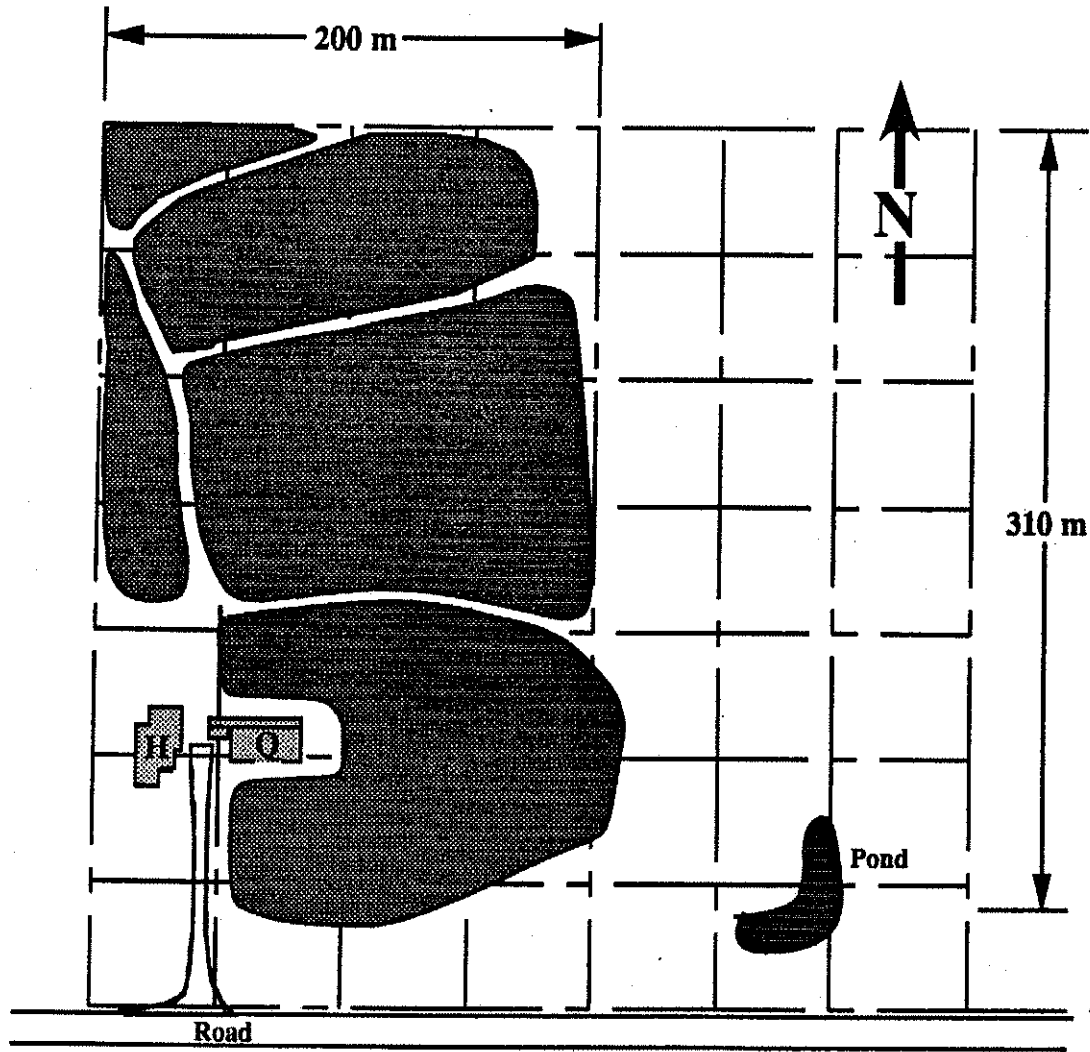
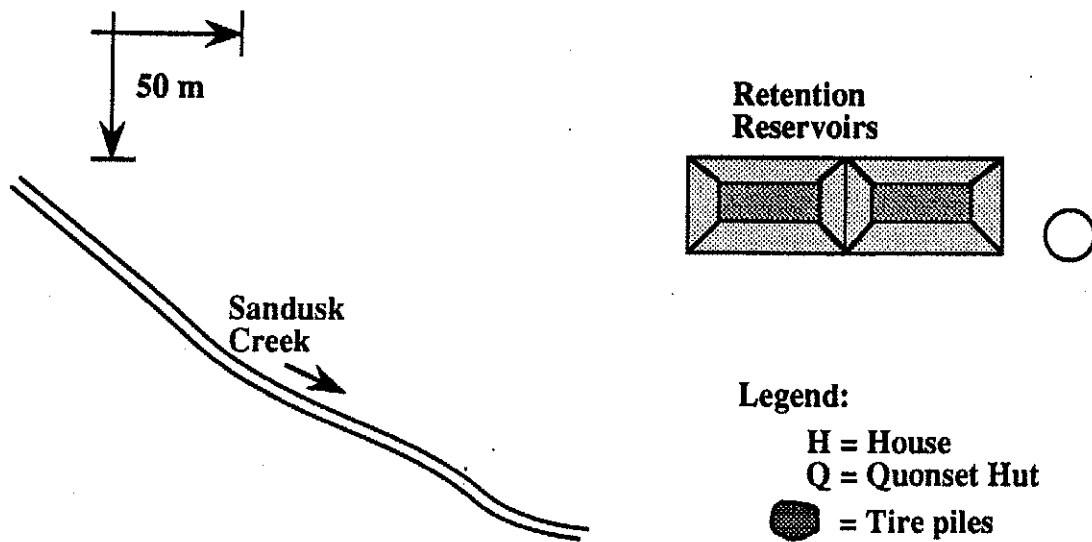
Figure 1 shows a sketch of the Tyre King property, based on a 1:2000 scale aerial photograph of unknown date (Appendix A), and on measurements taken by the Ontario Ministry of Natural Resources at the time of the fire. The storage area measured 200 metres by 300 metres, or about 6 hectares, less approximately 1 hectare of land occupied by the residence and Quonset hut work shop. Thus, the tires themselves covered approximately 5 hectares. An informal road provided access to the west side of the pile and two transverse alleys divided the pile into three distinct sections. The transverse alleys are estimated from the aerial photograph to have been between 3 and 5 metres wide. There was no substantial fencing around the property.

Figure 1: Plan of Tyre King scrap tire storage yard, Hagersville, Ontario. Taken from sketch prepared by Ontario Ministry of Natural Resources staff at time of fire.

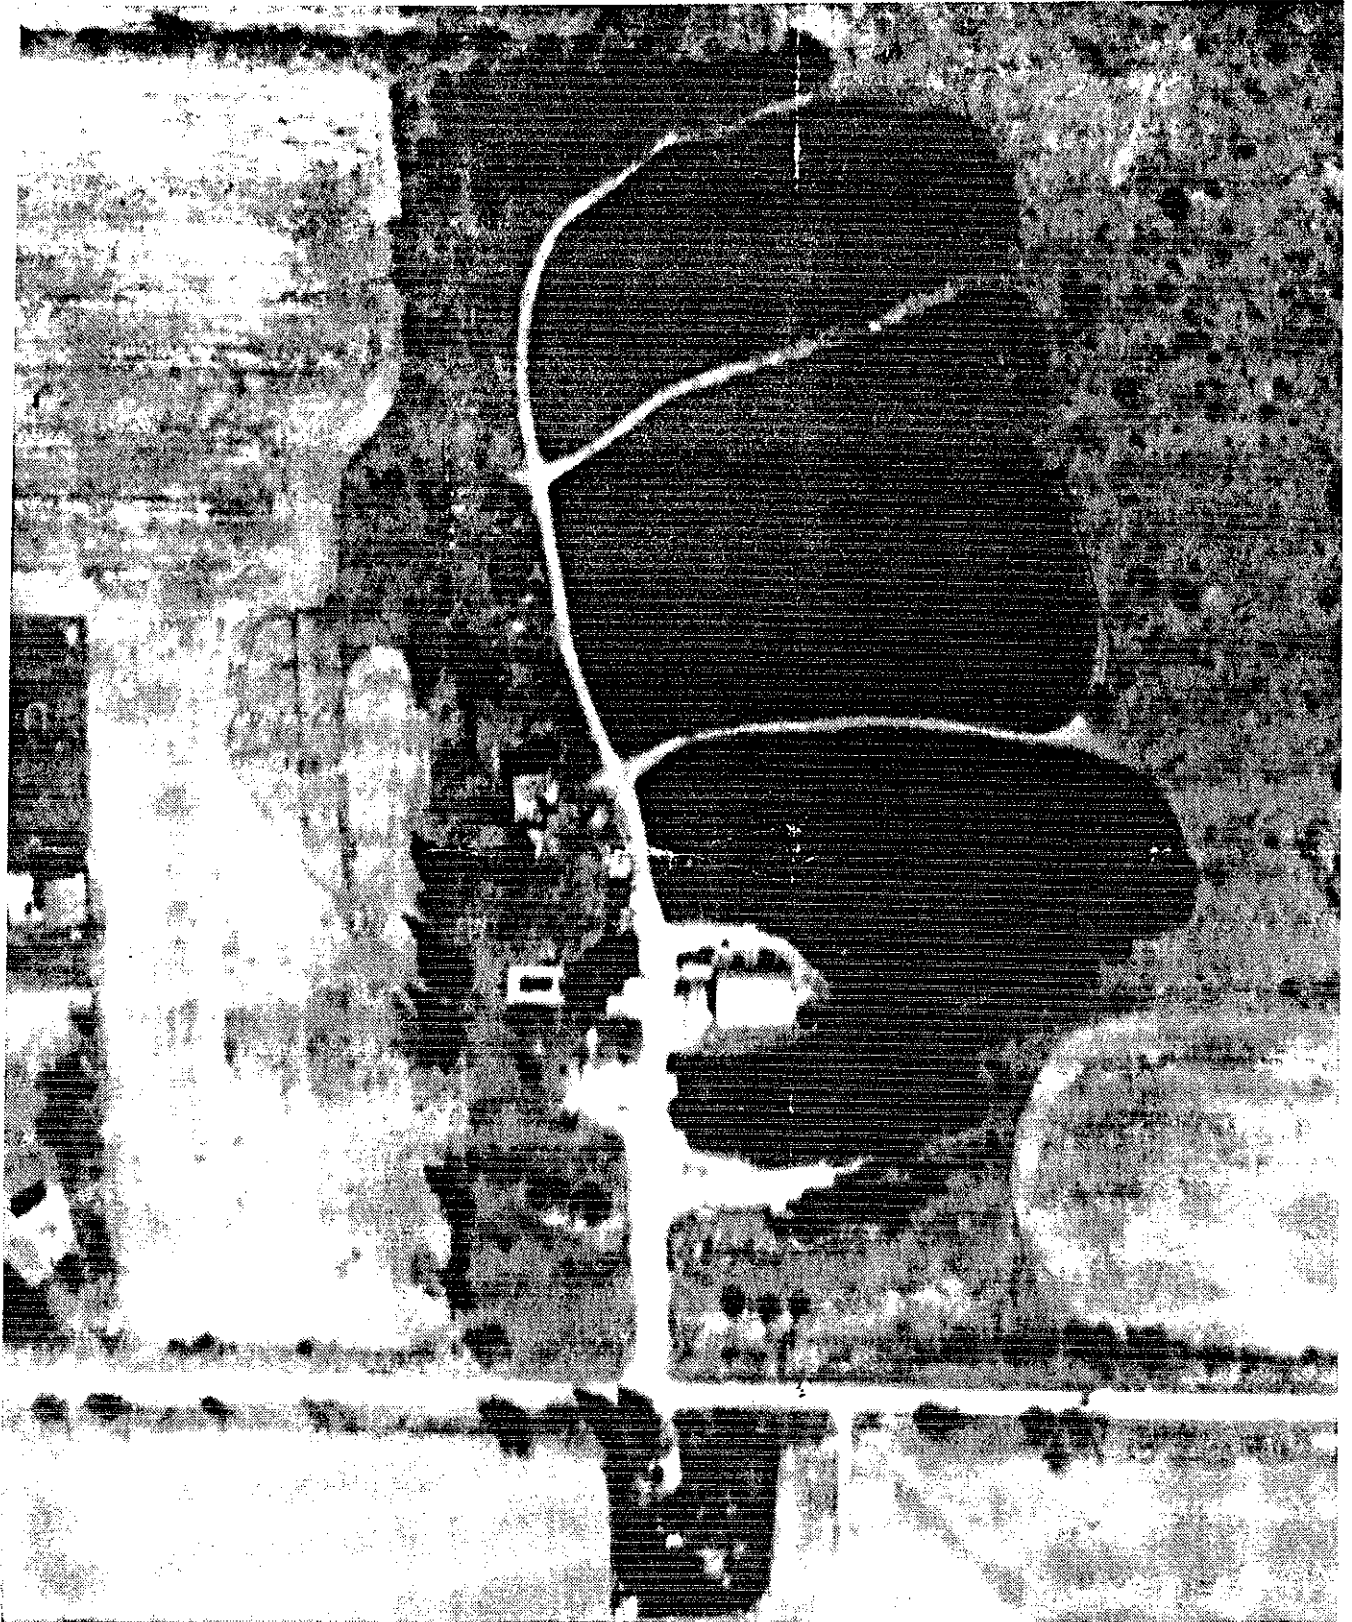
Ontario Provincial Police suspect that the fire was deliberately started, on February 12, in the northwest corner of the pile. It spread rapidly. By the end of the first day all 5 hectares were involved. The fire easily jumped the two internal separating alleys, evident in the aerial photo, probably aided by the wind. The owner reportedly asked arriving volunteer fire fighters to move trucks and hoses into one of the transverse alleys, in order to stop the advance of the fire but the fire fighters concluded that they would lose their equipment if they moved into that location, and did not do so.

Appendix A. Aerial photograph of the Tyre King scrap tire storage yard near Hagersville, Ontario. Approximate scale 1:2000. Date of photograph unknown.
