The Hagersville Tire Fire February 12 to 28, 1990

J.R. Mawhinney

Internal Report No. 593

Date of issue: May 1990

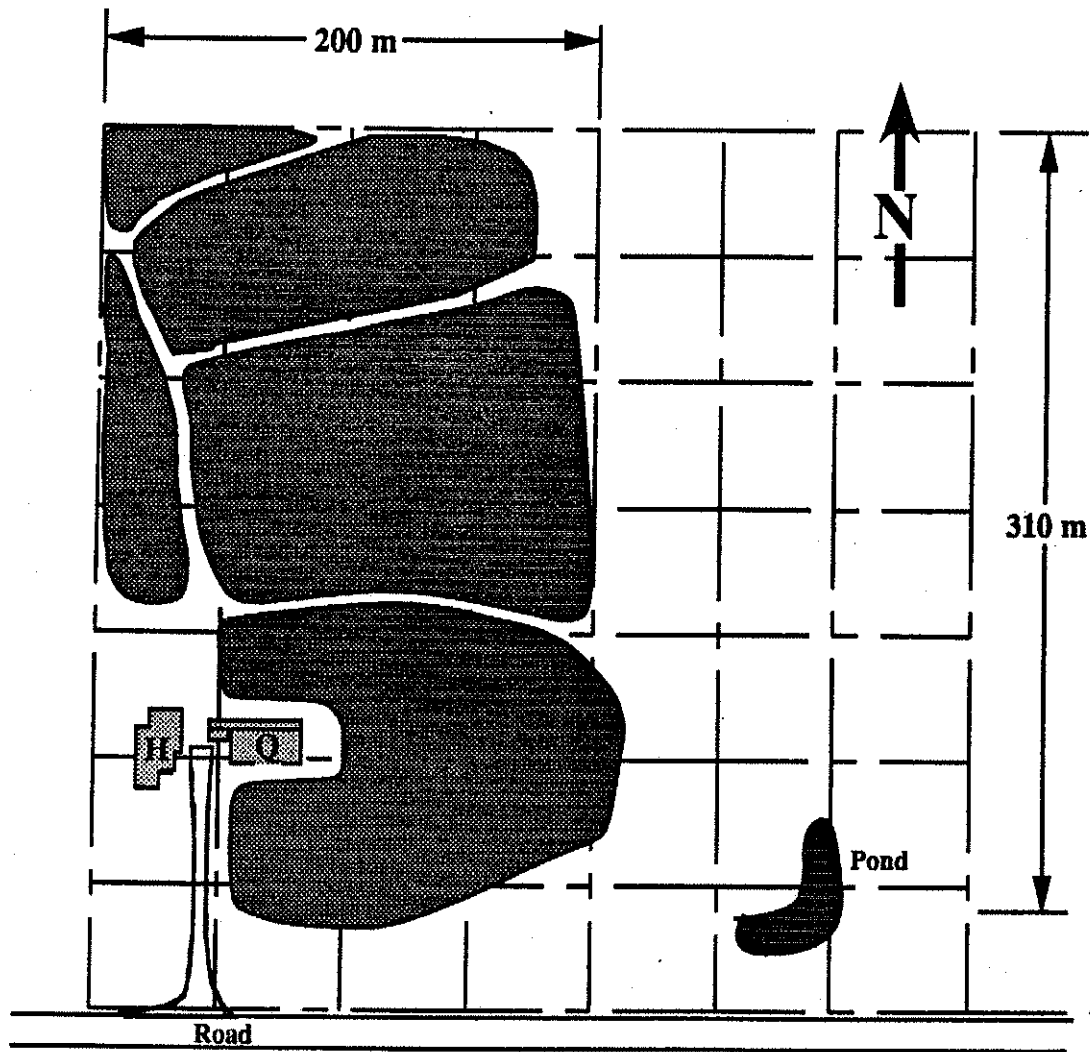
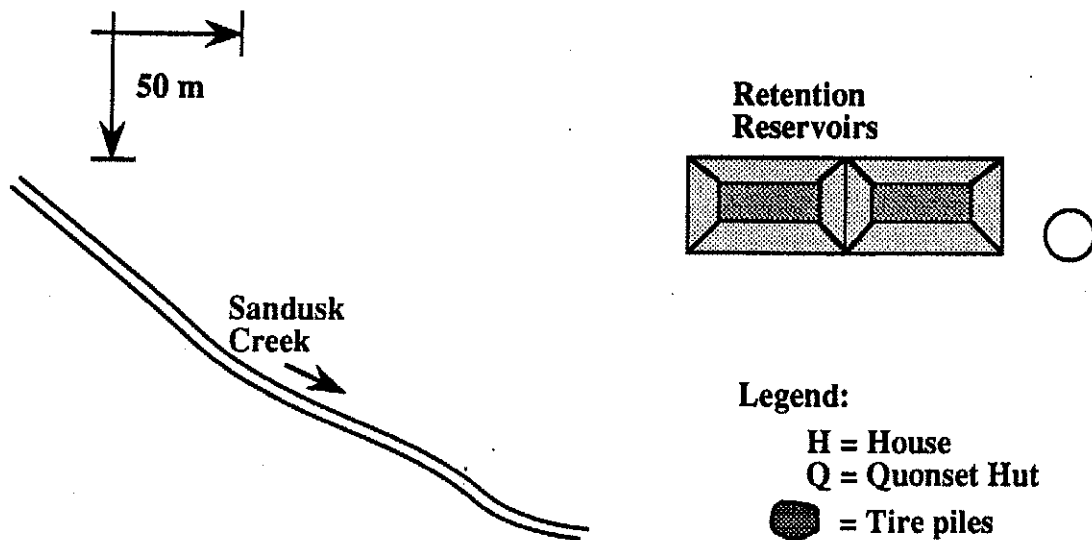
Figure 1: Plan of Tyre King scrap tire storage yard, Hagersville, Ontario. Taken from sketch prepared by Ontario Ministry of Natural Resources staff at time of fire.

Ontario Provincial Police suspect that the fire was deliberately started, on February 12, in the northwest corner of the pile. It spread rapidly. By the end of the first day all 5 hectares were involved. The fire easily jumped the two internal separating alleys, evident in the aerial photo, probably aided by the wind. The owner reportedly asked arriving volunteer fire fighters to move trucks and hoses into one of the transverse alleys, in order to stop the advance of the fire but the fire fighters concluded that they would lose their equipment if they moved into that location, and did not do so.

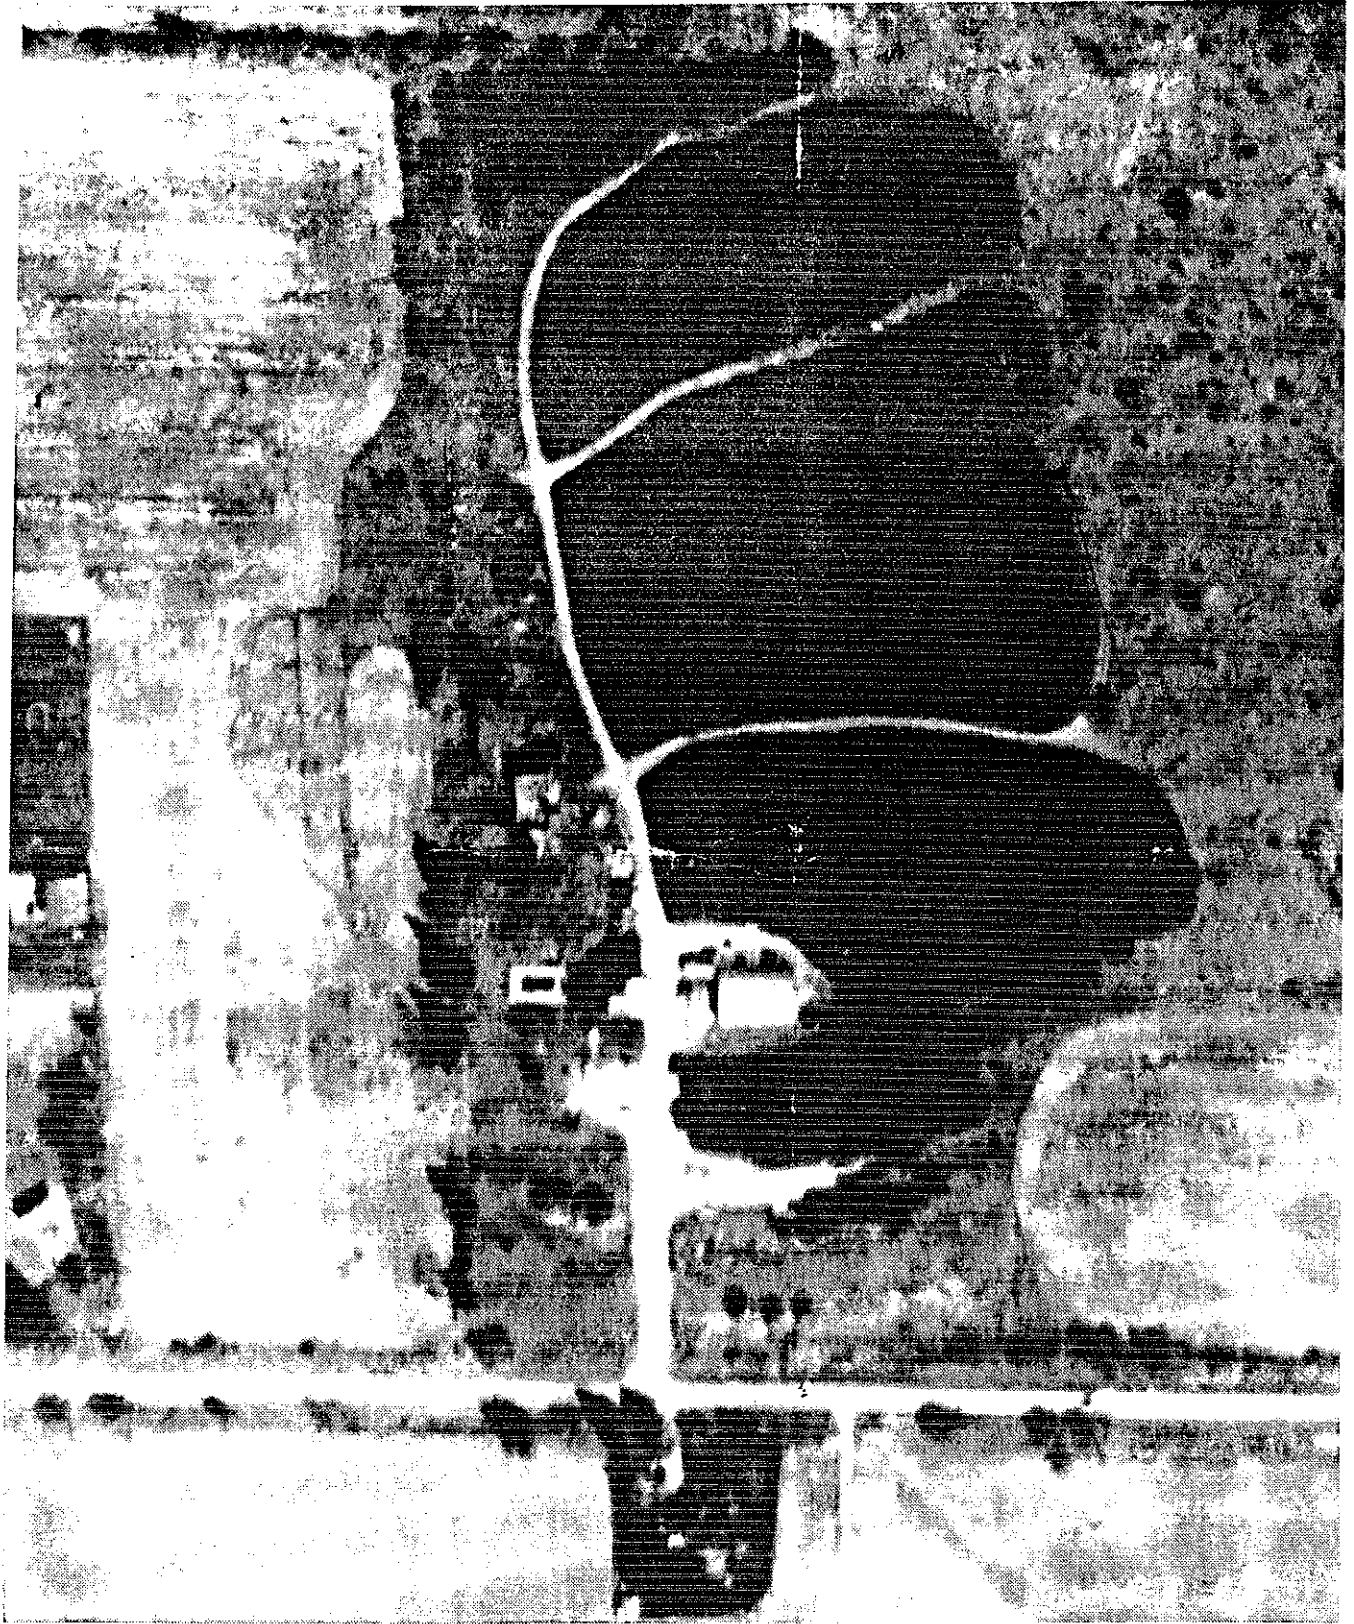
Appendix A. Aerial photograph of the Tyre King scrap tire storage yard near Hagersville, Ontario. Approximate scale 1:2000. Date of photograph unknown.
