### Survey of basements in Aklavik

A SURVEY OF BASEMENTS IN AKLAVIK

Report No. 114  
of the Division of Building Research

February, 1957

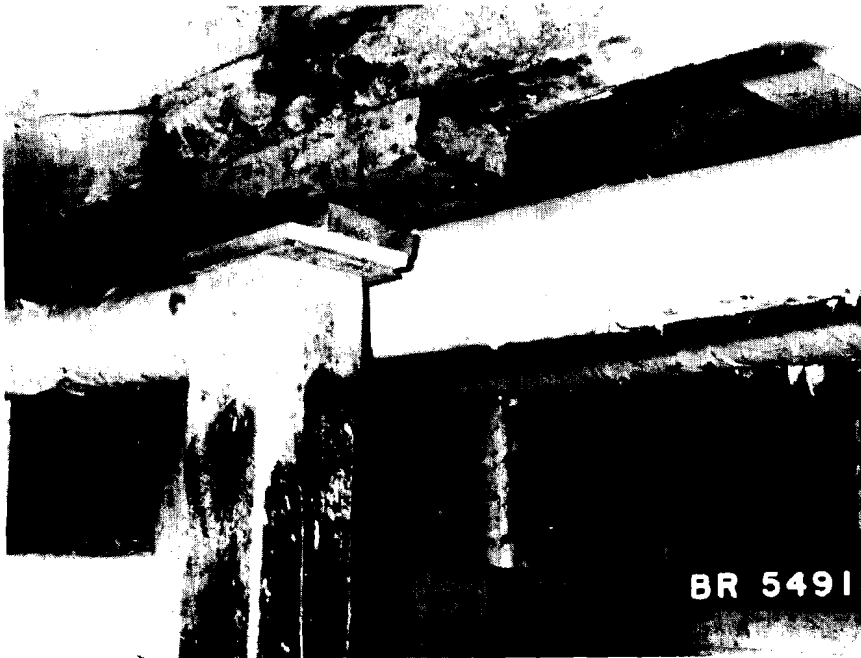
Figure 3    Basement Construction.

Condition: The concrete floor is badly cracked and there is evidence of considerable leakage into the basement through the floor. A groove 1 1/2 inches wide and 1 inch deep has been cut into the concrete floor presumably to lead accumulated water to the sump. The wood walls have been pushed-in several inches by the pressure of the earth behind. At a few locations wood cross braces have been placed to keep the walls of the basement in place. The posts supporting the main beams have been shimmed up as much as 4 inches to compensate for settlement that has occurred (Fig. 3).

Remarks: The ground under the building was still frozen when the basement was dug in 1953. The heat from the furnace has since thawed the unexcavated ground around the basement, causing settlement and a generally wet condition.

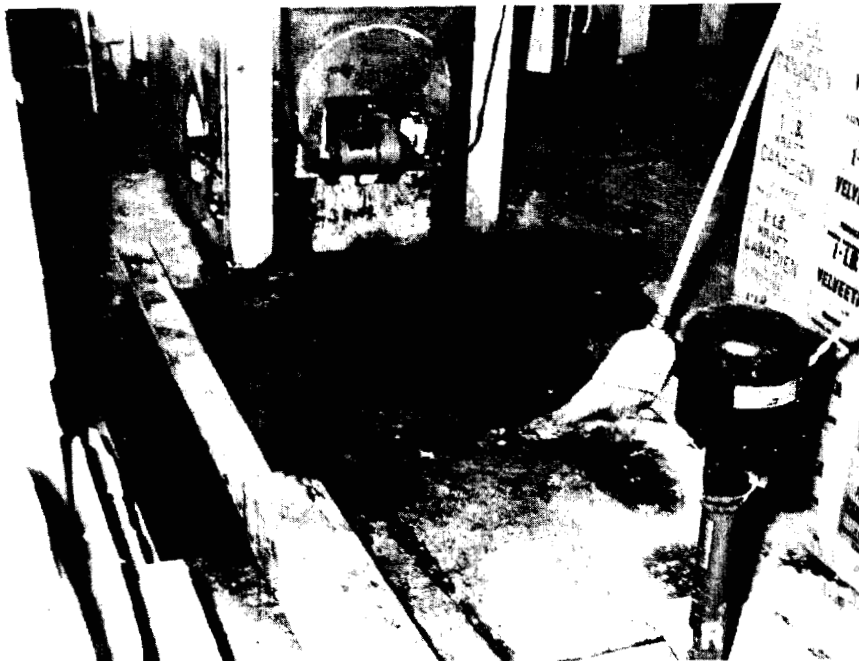
Condition: The floor of this basement showed a few minor cracks but its general condition was good. There was some evidence of dampness (Fig. 16); it was reported, that enough leakage had occurred on a number of occasions to necessitate care in the storage of food supplies in the basement. A groove, several feet in length, had been cut into the concrete floor presumably to obtain better drainage to the sump.

Figure 16 Water on Basement Floor

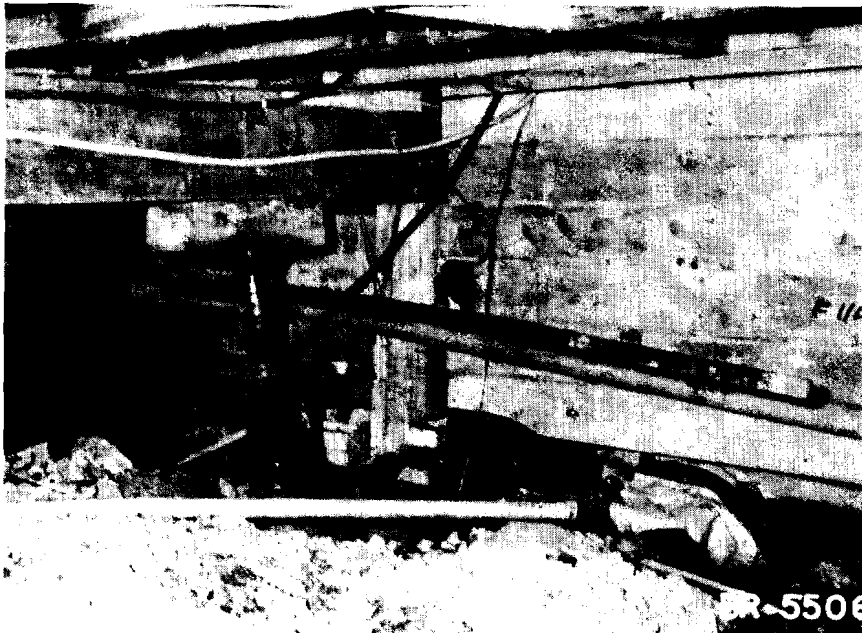
Figure 20 Jack on Unexcavated Area

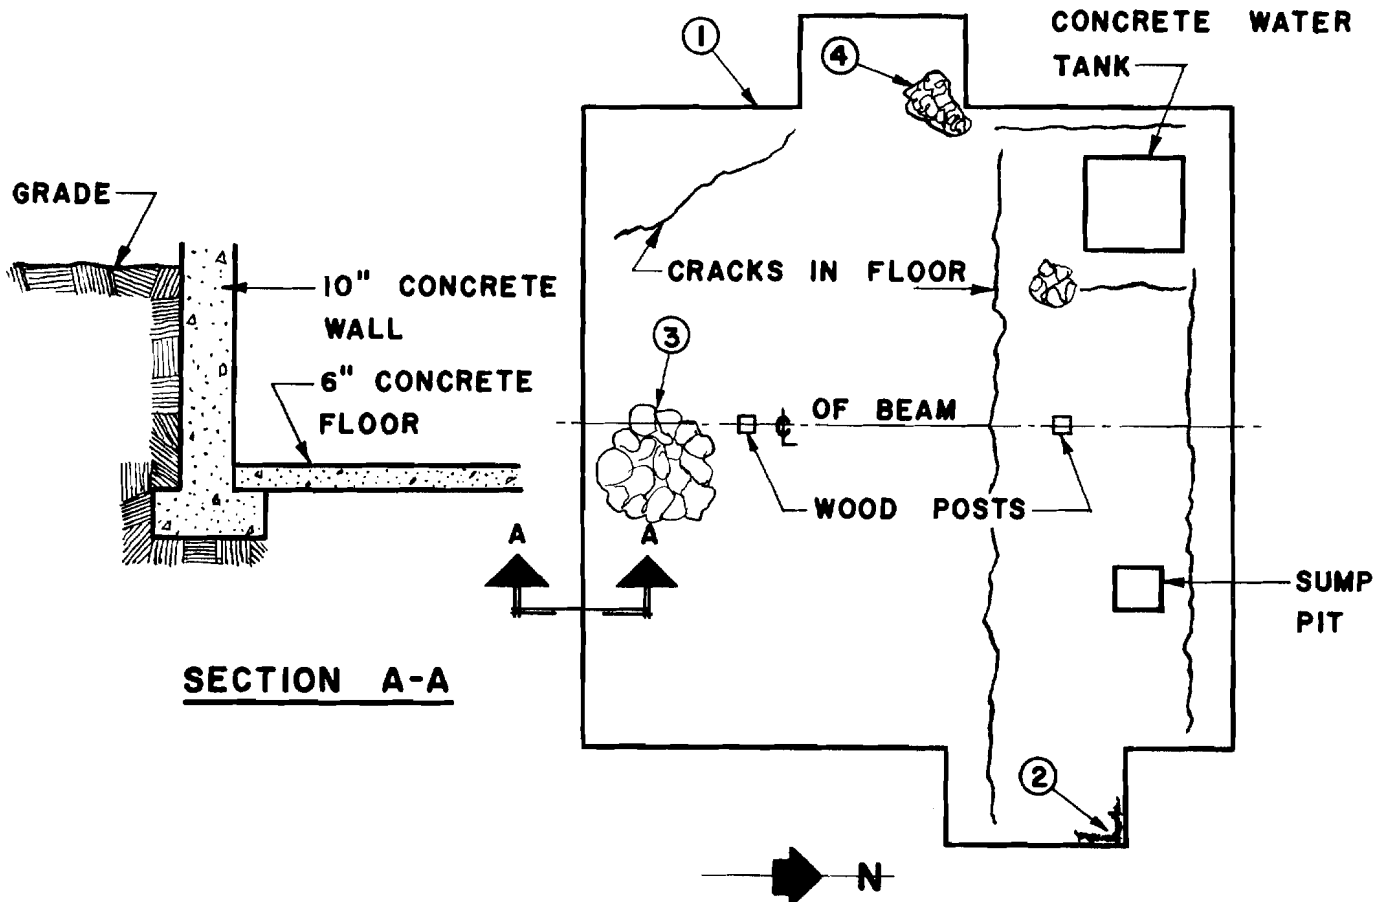
FIGURE 22

Condition: Walls - There are no obvious cracks in the concrete basement walls apart from a narrow crack at location (1) in Fig. 22, which extends diagonally up the wall.

The concrete in the walls is honeycombed in several places. Floor - The concrete floor is badly cracked (Fig. 22). The cracks vary in length but average between 1/32- and 1/16-inch in width.

At location (3) in Fig. 22, crazing has occurred over a large area; the top 1/2- to 3/4-inch layer of concrete has begun to separate from the base concrete and is flaking off in large pieces (Fig. 24). Water has accumulated beneath this spalled area and bubbles up through the cracks when the concrete is walked on. A similar condition is developing at location (4) in Fig. 22; the top 1/2 inch of concrete has begun to separate from the base and free water has accumulated under it.

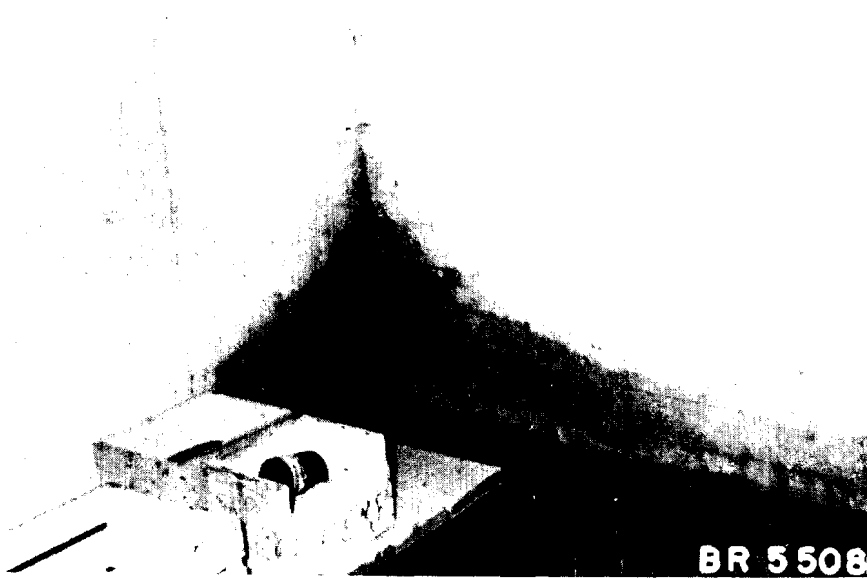
There is no evidence of leakage through the wall itself but there is an extensive area of dampness at location (2) in Fig. 22 (junction of the floor and the wall), where the wall is damp to an average height of 1 foot in the corner. The damp area extends up the wall to a height of 2 1/2 feet (Fig. 23).

Figure 23 Leakage at Junction of Basement Wall and Floor (location (2) on basement plan, Fig. 22)

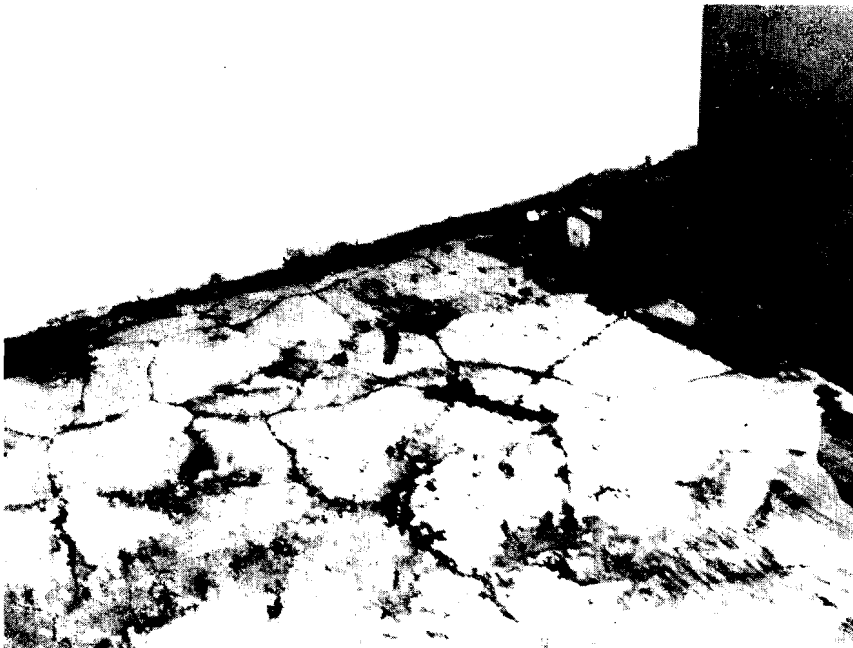
Figure 24 Section of Concrete Basement Floor (location (3) on basement plan, Fig. 22)

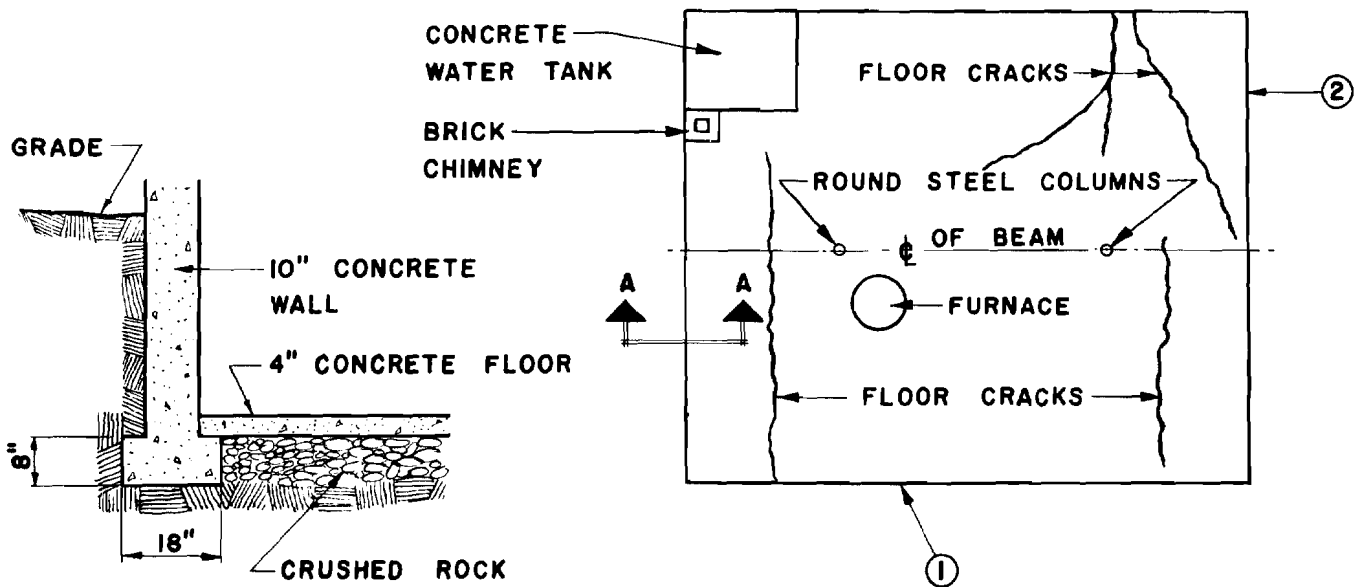
FIGURE 26

Condition: Walls - The basement walls, especially the north and east walls, are cracked in a number of places. Photographs of typical cracks taken at locations (1) and (2) in Fig. 26 are shown in Figs. 28, 29 and 30. In general, the cracks are vertical and run the full height of the wall. Some diagonal cracking has occurred at the junction of an opening, such as a window or door. The cracks range in width from 1/16 to 5/8 inch and are of varying depths. The crack at location (2) is especially bad and has penetrated through the wall (Figs. 29 and 30), indicating that the two ends of the wall have undergone settlement.

Floor - Some cracking has occurred in the concrete floor at locations shown in Fig. 26, but these cracks are not large and this floor is in better condition than are most other floors in the area.

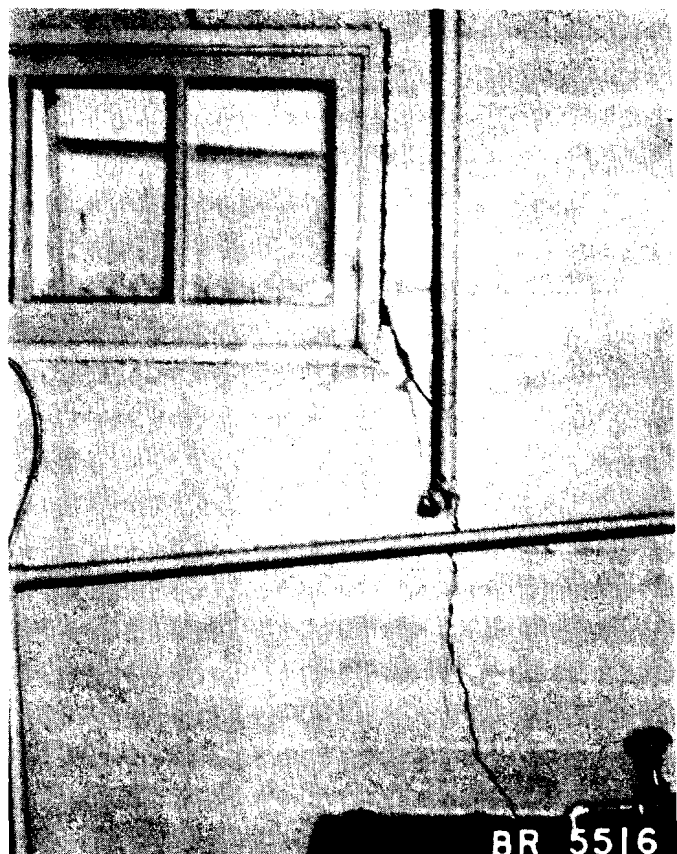
Figure 28 Crack in East  
Wall of Basement  
(location (1) on  
basement plan, Fig.26)

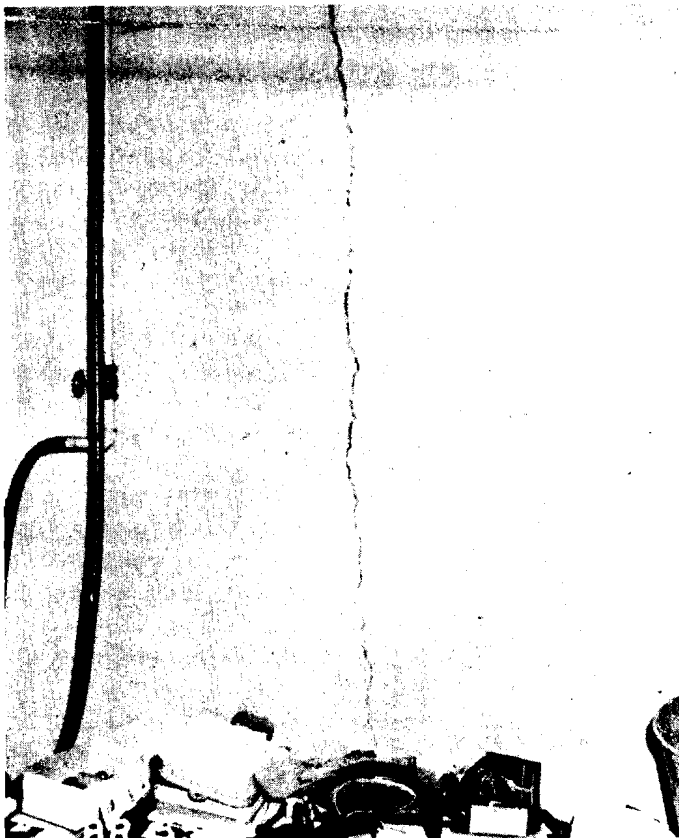
Figure 29 Interior view of  
Wall Crack at location (2)  
on basement plan

The two last-mentioned basements have 10-inch concrete walls and 4- to 6-inch concrete floors. No special precautions were taken against the problems of permafrost in their design and construction; both basements show signs of failure. The R.C.M.P. basement has severe cracks in the concrete floor with a resultant moisture problem (Fig. 24). The N.A. and N.R. basement has badly cracked walls due to settlement caused by thawing of the permafrost (Figs. 29 and 30).

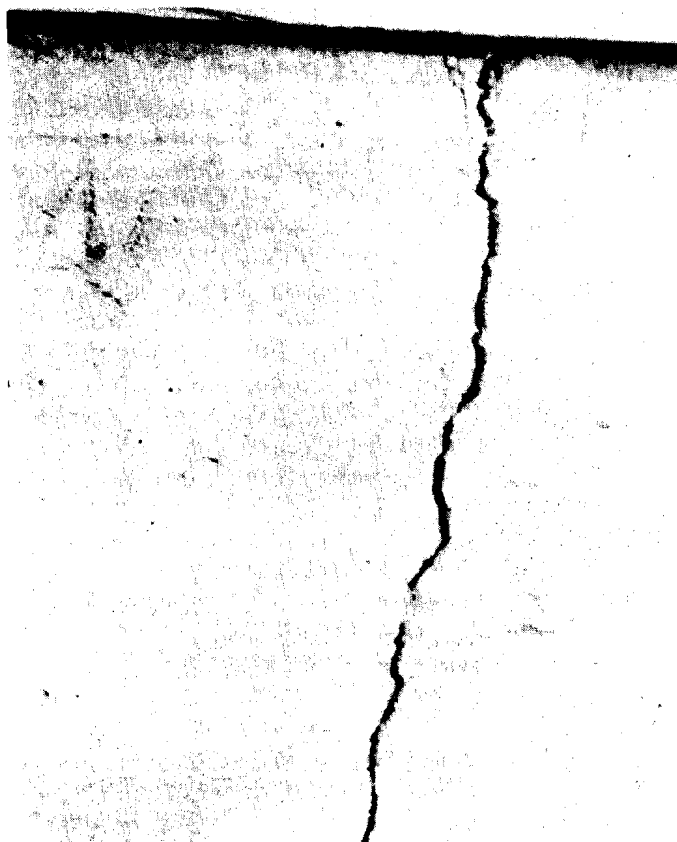
Figure 30 Exterior view of  
Wall Crack at location (2)  
on basement plan (upper  
portion of crack)

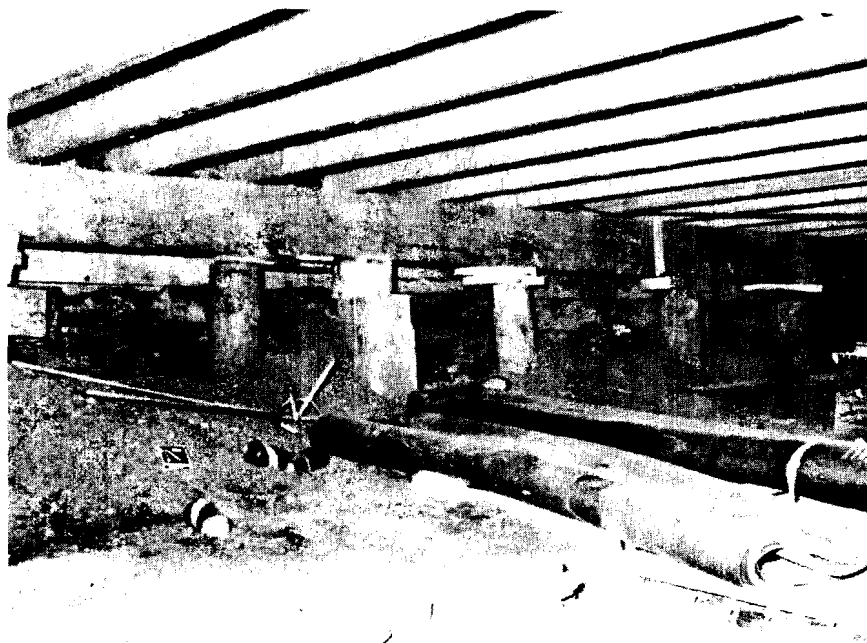
There are nearly 100 log posts supporting the first floor construction, many of which have had to be shimmed at the top under the beams. One of the Mission staff reported that the building has had to be jacked-up every spring and additional shimming installed. In some cases, the shims indicate settlement of 10 to 12 inches (Fig. 35). Settlement has been especially severe next to the water storage tanks. Settlement has also occurred on the exterior of the building. In order to level the building, shims have been placed at the top of the posts (Fig. 33).

Figure 33 Surface Foundations under Exterior Wall of Building  
(showing unexcavated area next to basement space)

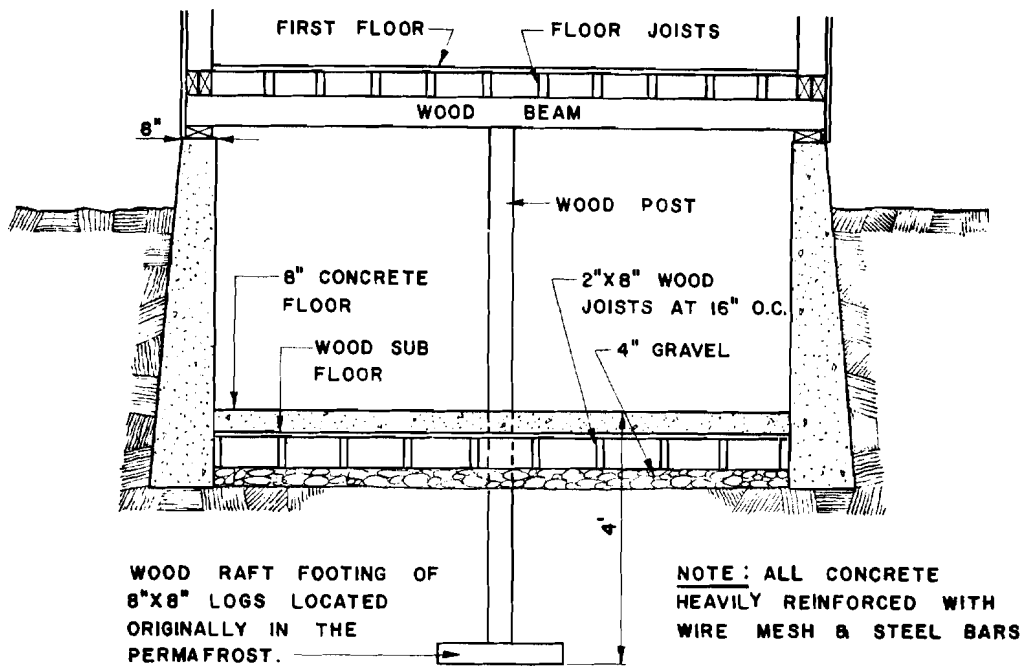
FIGURE 37      BASEMENT PLAN

In the R.C.N. building, some precautions against possible permafrost problems were taken during construction of the basement floor (Fig. 37). To reduce heat loss downward to the permanently frozen ground, the concrete floor was separated from the permafrost by a layer of gravel, 2- by 8-inch joists, and a rough wood flooring. The posts supporting the first floor beam were put down through the basement floor a distance of 4 feet into the permafrost. In addition, the concrete walls were heavily reinforced and battered on the outside to resist frost heaving. The R.C.N. building has been in use in its present location only since 1953 and it may be too early to evaluate its performance.

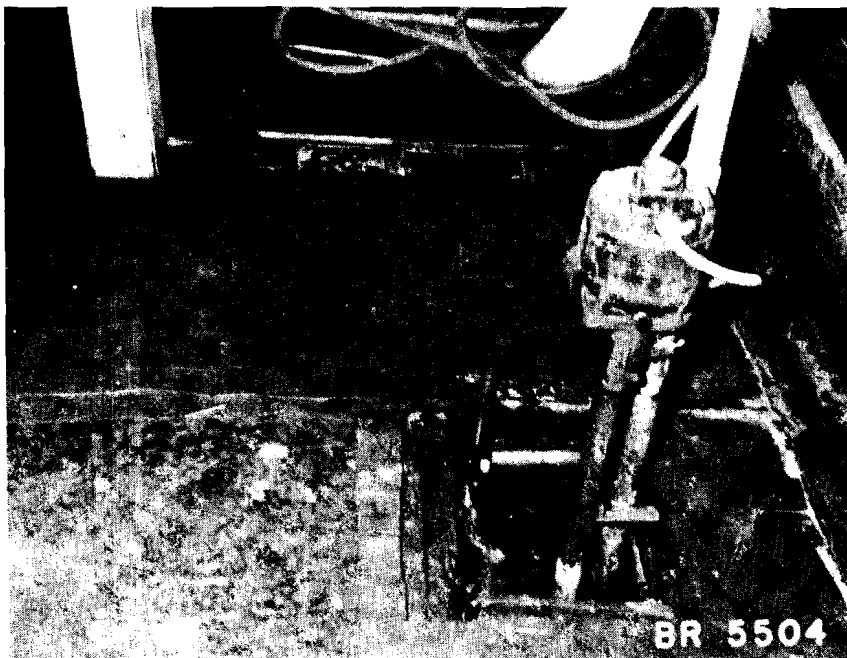
The remaining two full-size basements are the R.C. Mission Hospital and the D.N.D.- R.C.C.S. dwelling on Lot 16. The former has a concrete floor and wood walls; the latter is of all-wood construction. The R.C. hospital basement, like that of the school, was built many years after the building was first occupied when the permafrost had receded thus minimizing the problems. The R.C.C.S. basement is in the poorest condition of all the full-size basements. The wood walls have been pushed-in by earth pressure, and settlement of the basement has caused movement in the structure above grade. Infiltration of moisture is a major problem and the wood in the floor is decaying and disintegrating because of its wet condition (Fig. 39).

A contributing factor to the difficulties with basements at Aklavik is that many of them are constructed with wood as the main material in walls and floor. In the north, wood offers many advantages as a construction material above grade, but it is not suitable for basement construction. Wood walls are not made watertight readily nor do they normally have sufficient strength to resist inward pressure of the soil; wood itself is subject to decay and disintegration when exposed to soil under wet conditions (Fig. 39).

Figure 39 Basement of R.C.C.S. Dwelling  
on Lot 16 showing Decay of Wood  
Floor
