EFFECT OF THE 1950 WINNIPEG FLOOD ON HOUSE FOUNDATIONS

A. BARACOS

TECHNICAL PAPER NO. 17
OF THE
DIVISION OF BUILDING RESEARCH

REPRINTED FROM THE MAY 1954 ISSUE OF
WESTERN CONSTRUCTION AND BUILDING

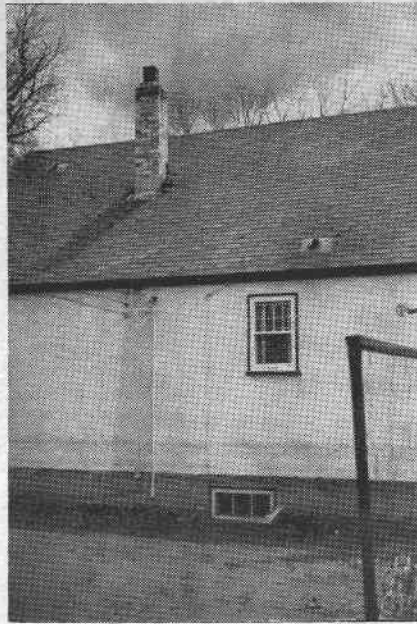
CHIMNEY lifted 3 inches by differential movement between foundation walls and chimney footings.

A few indications of foundation damage were observed when the water was still at a high level. In one particular house, differential movements between foundation wall and chimney footings had caused the chimney to lift 3 inches above the rest of the house. The metal flashings attached to the chimney had lifted above the roof shingles by this amount. Later examination revealed that non-uniform soil swelling under the footings had been responsible. Smaller wood frame structures such as garages and outbuildings were lifted off their footings by the buoyant force of the water and often carried several miles away.

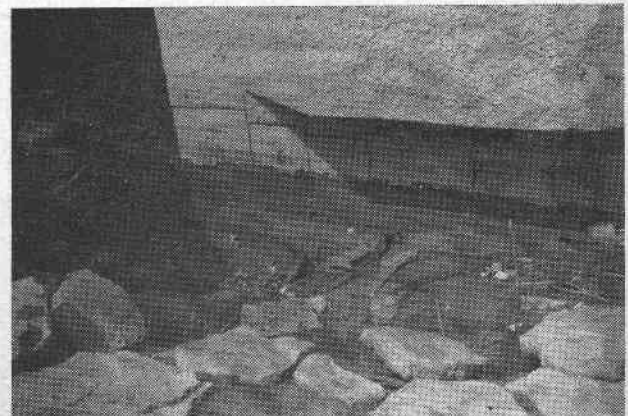
Erosion caused by scouring action of flood waters.

The velocity of the water flowing past houses directly in the path of the flood was sufficient in many cases to cause soil erosion. The scouring action removed backfill around basement walls, from under door steps, and from the edges of shallow footings. No damage resulted to the basement walls thus scoured although the soil in some cases was removed down to the base of the footings, exposing weeping tile drains. Concrete door steps and sidewalks resting on back fill often settled, appreciably.

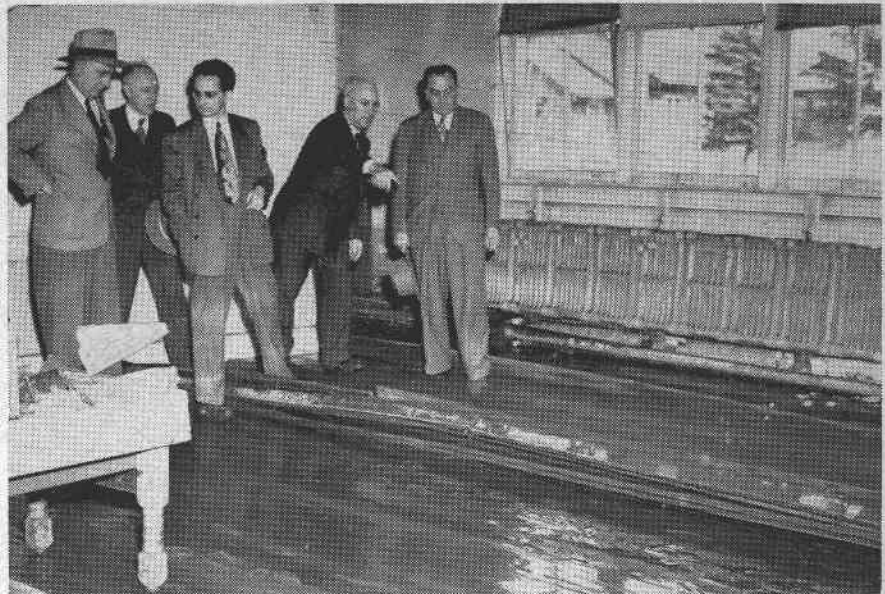
WINNIPEG School Board members inspect flood damage to a Winnipeg school.

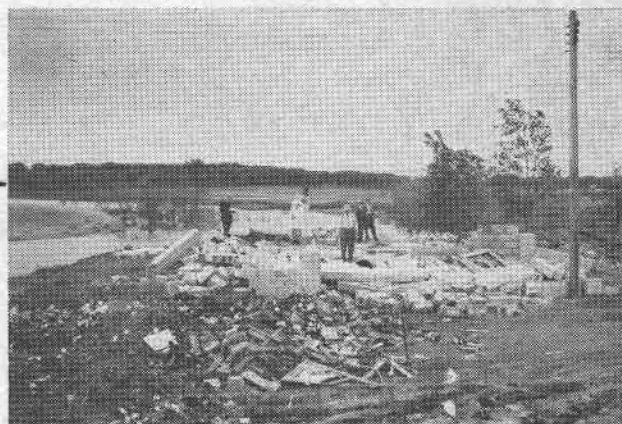
Another form of construction which caused trouble was the use of hollow concrete blocks with lime mortar for basement walls in municipalities outside the City of Winnipeg which does not permit this type of construction below ground level. Two such walls collapsed after saturation had increased the lateral pressure against the wall and water had weakened the mortar. Similar difficulty, but to a smaller extent, was experienced where cracked concrete or poorly constructed stone foundation walls bulged inwards into the basement. Well built stone foundation walls suffered little or no damage even where poor mortar had been used. No damage to reinforced concrete walls was noted and only minor cracks resulted where no reinforcing had been used in solid walls of good quality concrete.

**Complete
destruction of
walls of hollow
concrete blocks.**
