Marine Icing Events: an Analysis of Images Collected from the Marine Icing Monitoring system (MIMS)

Student Report, 2007

SR-2007-07

Leah Gibling

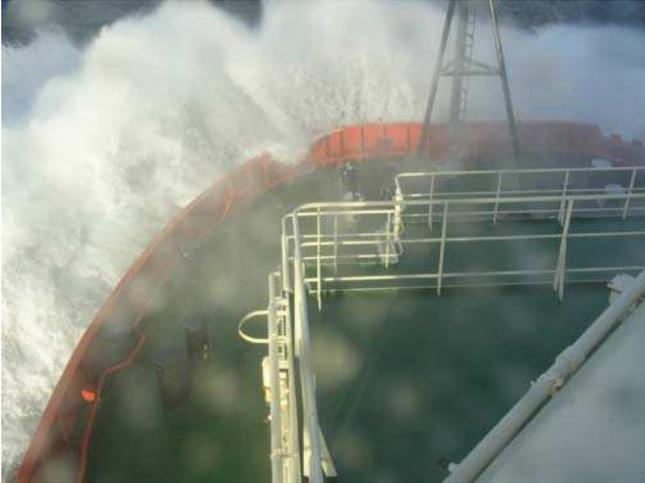
Figure 1a. Wave induced deck spray

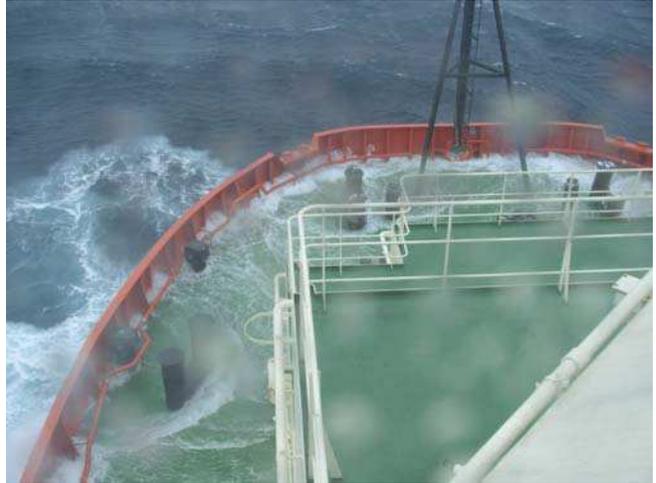
Figure 1b. Water on the deck

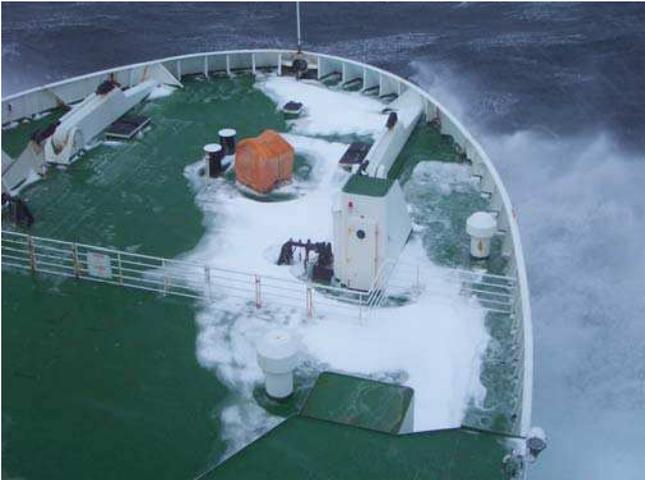
Figure 1c. Wet snow on deck

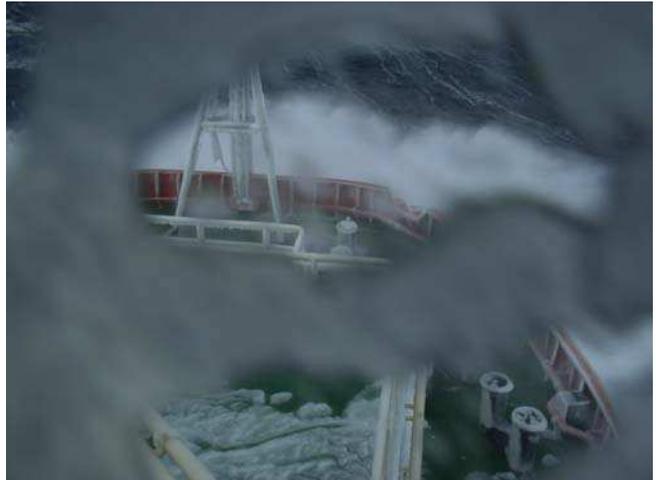
Figure 1d. Partial camera coverage

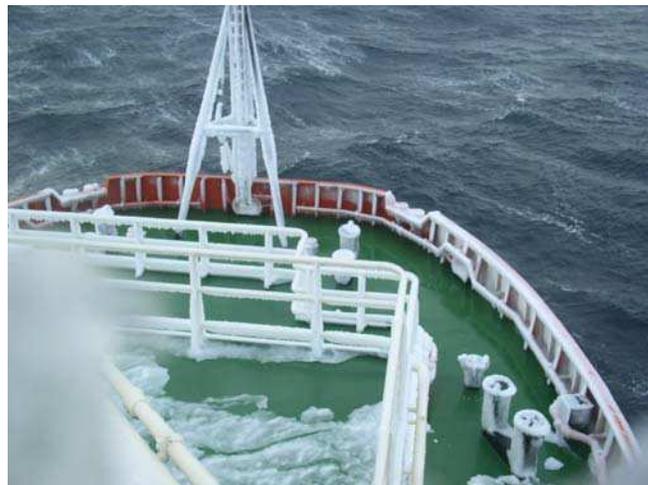
Figure 1e. Ice on the vessel

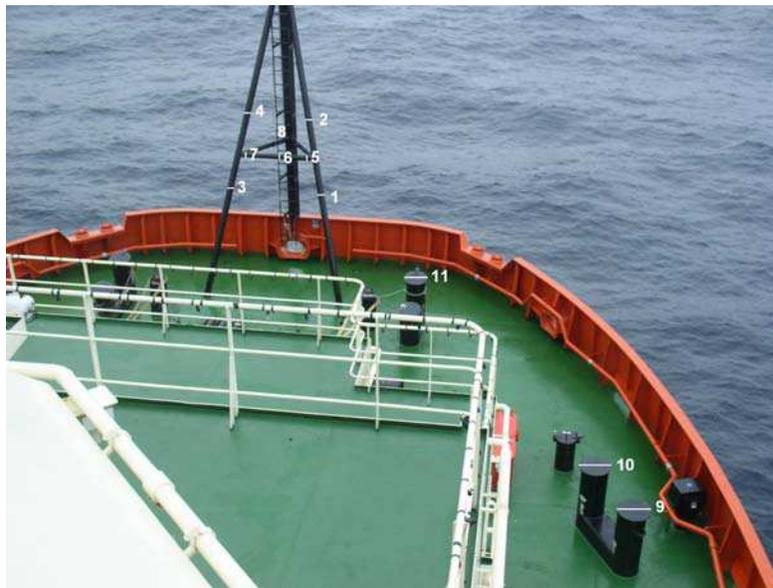
Figure 2. Points selected for measurement of ice thickness

Certain areas on the vessel experienced greater ice accumulation than others. The area labelled point 8, which was located on a rope in Figure 3 experienced a significantly larger fractional growth than all other points of measurements. The rope was the only object selected for measurements that was not made of metal. This could indicate why it had a larger fractional growth. The two points that experienced the second and third highest fractional growth were points 5 and 7. These points were located on the black structure at the front of the bow, at each end of the horizontal pole. Significant ice build

up here could have been caused by water running off the vertical poles, pooling, and freezing on the ends of the horizontal bar. The points 9, 10, and 11 (the posts along the deck of the vessel) experienced the least fractional growth.

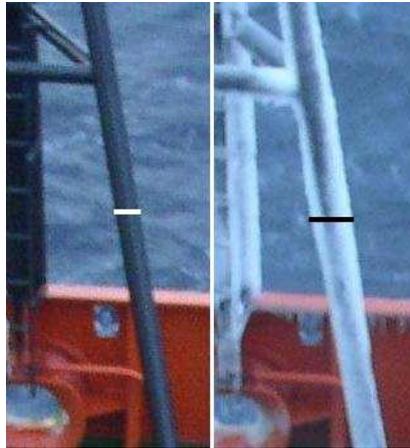
Figure 4. Measurements of Point 1 before and during an icing event

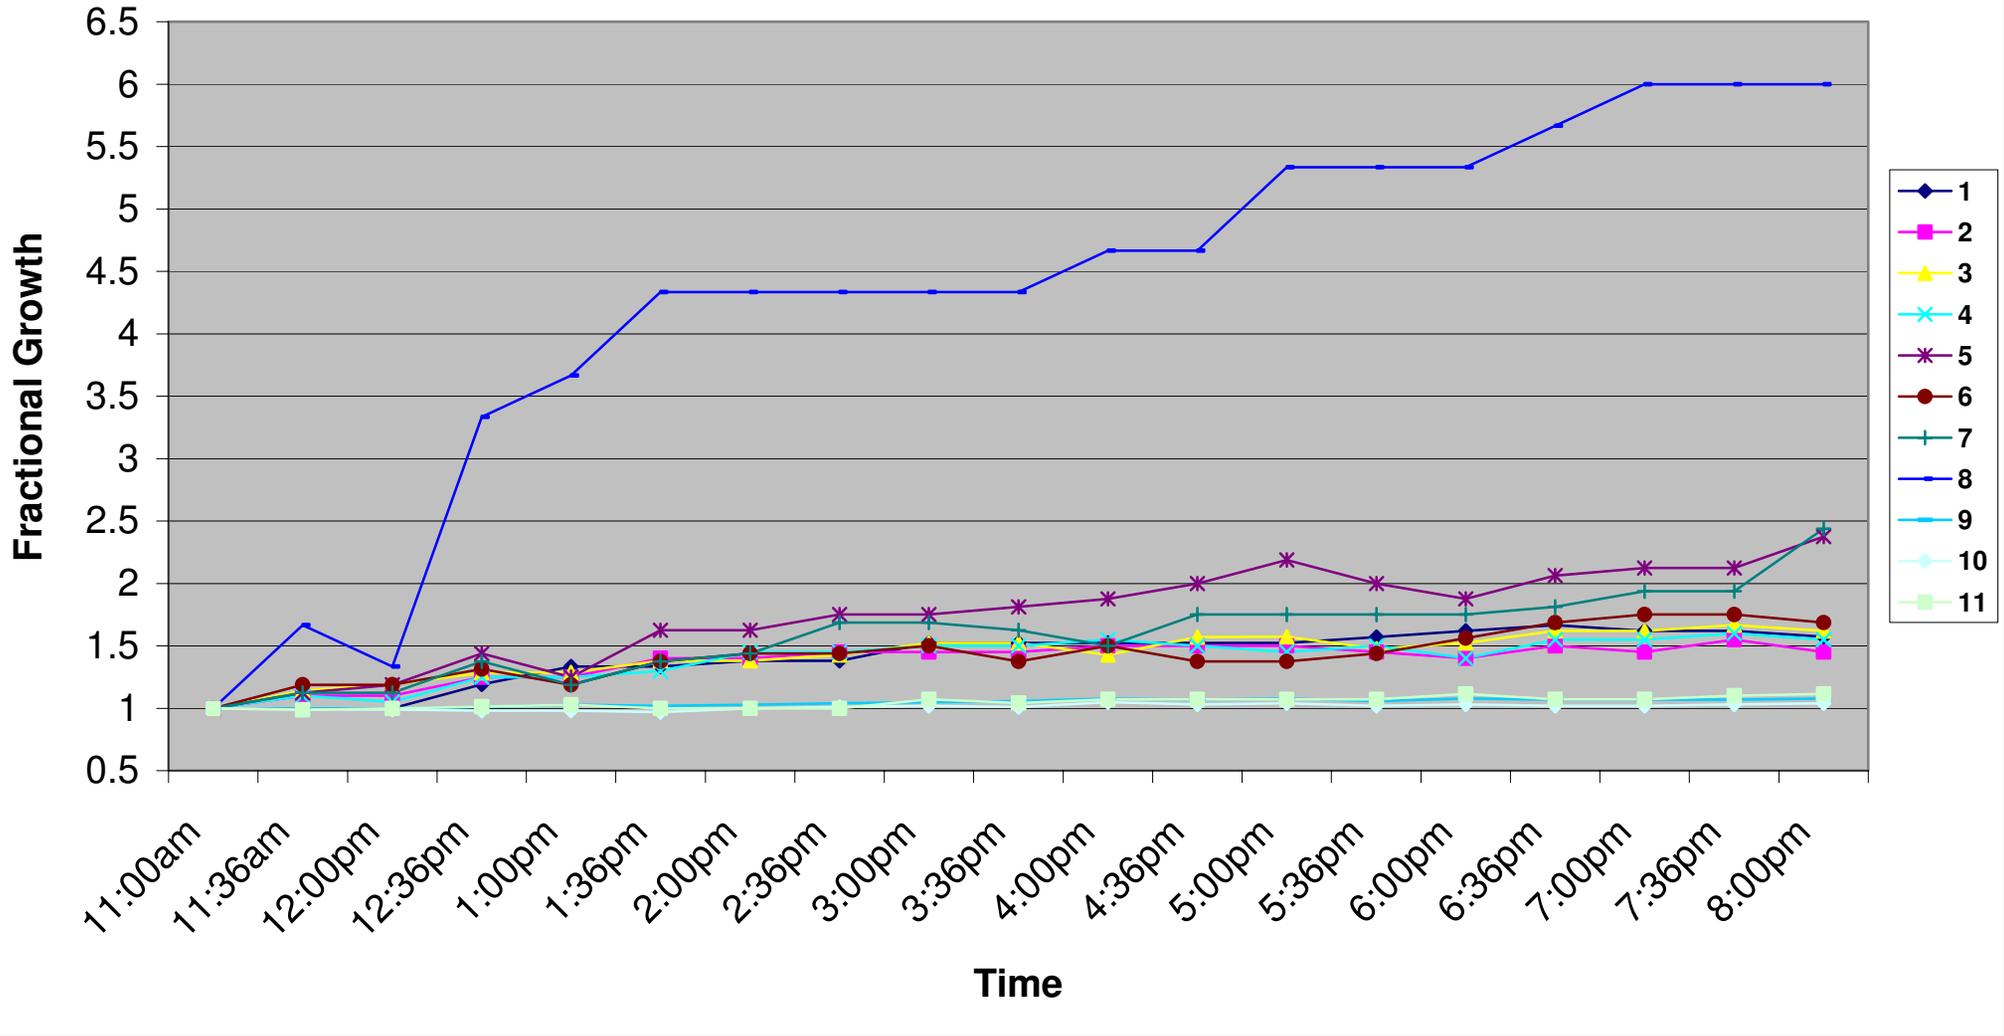
Ice Growth Starboard Camera Dec. 29, 2006

It was also determined that the perspective of each camera gave different results concerning ice accumulation. Generally, the fractional growth in the starboard images was greater than in the port images. Despite the differences, overall the two graphs had very similar shapes.
