Appendix C

MEDOF PANEL PERFORMANCE ASSESSMENT BY NRC-CHC

R. Frederking and D. Sudom

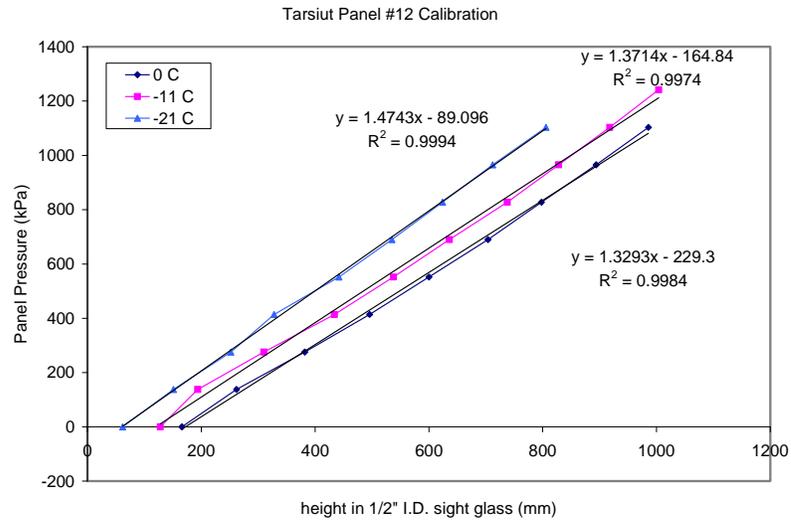
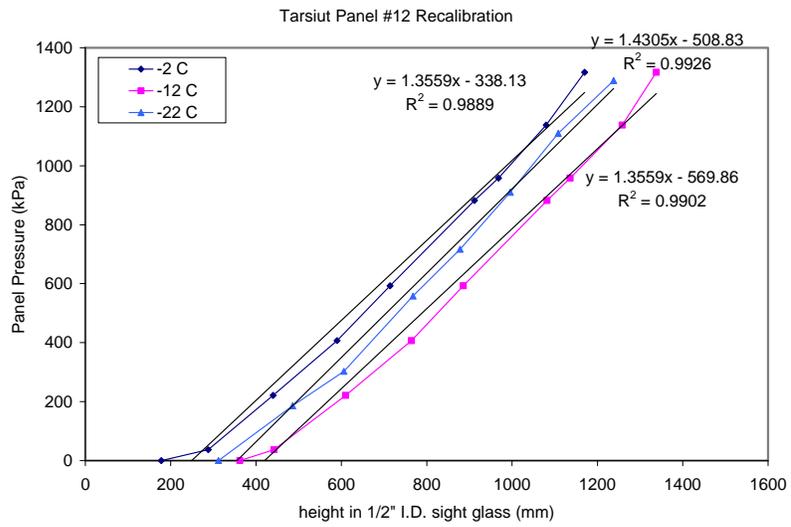
Figure 1 Panel #12 Calibration and recalibration

These calibration data are summarized in Table 1. It can be seen that panel #12 experienced no change in calibration. At -10 C panel #14 showed about a 30% reduction (softening) of the calibration factor. The recalibrations of panels #20 and # 37 showed reductions of 30.5 and 33 %, respectively.

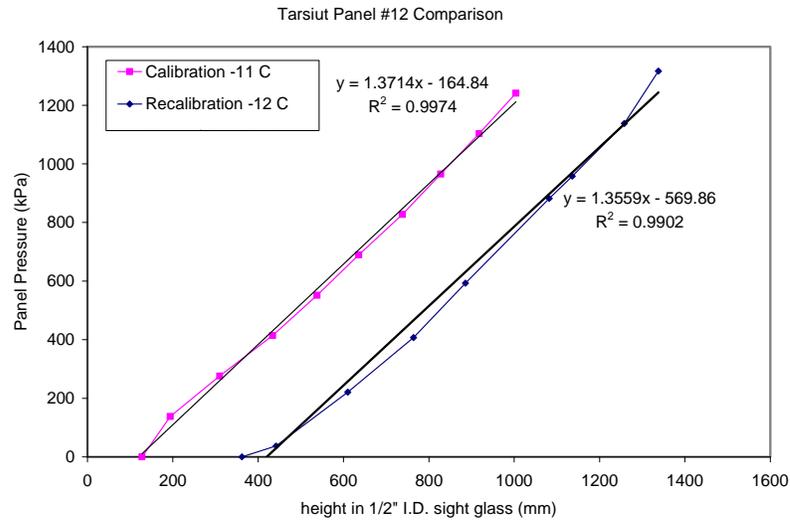
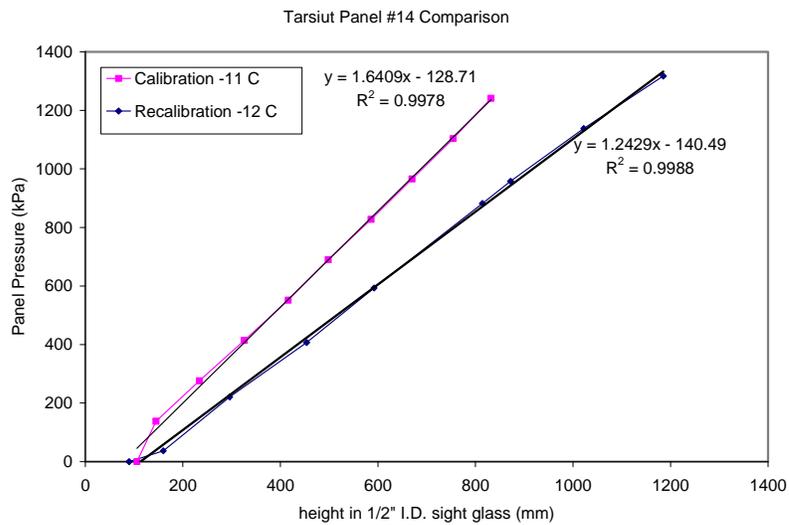
Figure 3 Panel #12 and #14 Calibration and recalibration comparison at -10 C

To make the comparison between the calibration and recalibration test results clearer, plots for panel #12 and #14 at a nominal temperature of -10C are presented in Figure 3.

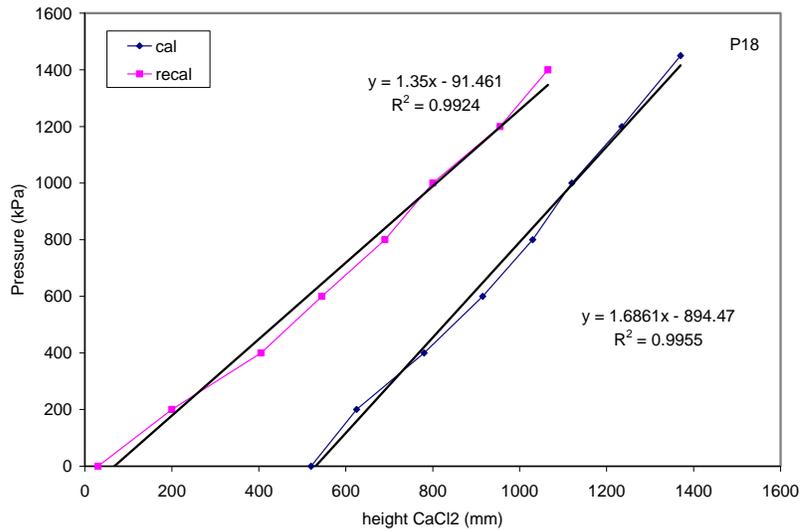
Figure 5 Replot of calibration and recalibration of Panel P18

softening of 20%. There is no explanation for this difference other than that slopes of in Figure 4 may have been determined from an “eye-ball” fit to the data.

Calibration and recalibration factors taken from the plots in the FMA (1983a) report are summarized in Table 2. The results indicate an average softening of about 15%. The original FMS report did recognize this difference. The panels were frozen into the ice around the Tarsiut caissons and removed in the spring. It is possible that they were damaged or deformed, either during the winter, or on removal.

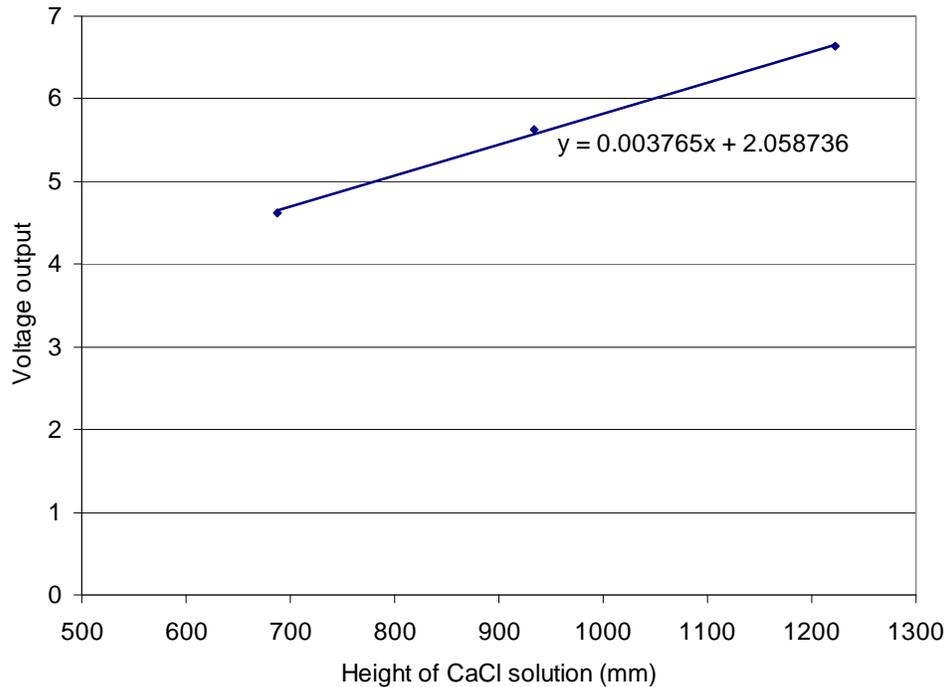
Figure 6 Field calibration of MEDOF panel 1001

An example of one field calibration is shown for panel 1001 in Figure 6. Measurements were taken at three different times. The slope of the best fit line gives a calibration factor of

0.003765 volts/mm. Converting to tonnes per volt using the calibration factor of 1.755 kPa/mm in Table 3 gives a calibration factor of 146.47 tonnes/volt. This is very close to the calibration factor of 145.73 tonnes/volt used in the CDF.

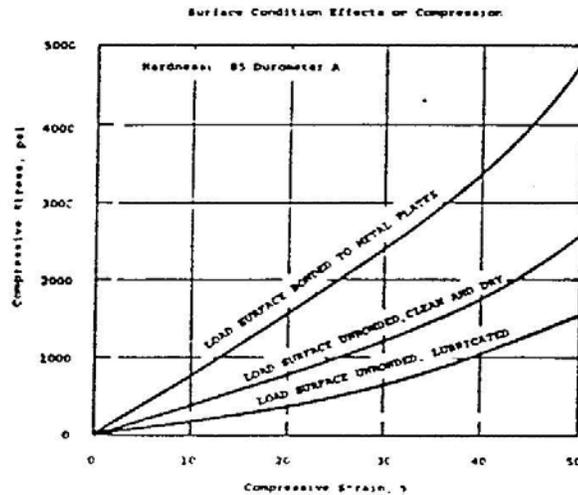
Figure 7 Surface condition effects on apparent stiffness of buttons

The report provided new information on panel performance. Of particular interest was the information on the polyurethane (Adiprene L-100) buttons in the panels. Figure 7 from the report is reproduced below. The top curve is for the stiffness of a low aspect ratio button bonded to a metal surface, and has an apparent modulus of 56 MPa at a strain of 25%. The two lower curves are for when the button is un-bonded on a dry surface and a lubricated

surface, respectively. The figure clearly shows that if a button separates from the steel plate, its apparent stiffness decreases significantly. This is one possible mechanism for softening of the MEDOF panels on the Molikpaq. The figure also suggests pressures of up to 35 MPa (5000 psi) on a bonded button could be sustained at 50% strain. Unbonded pressures were much less, at 17 MPa and 7 MPa for 50% strain.

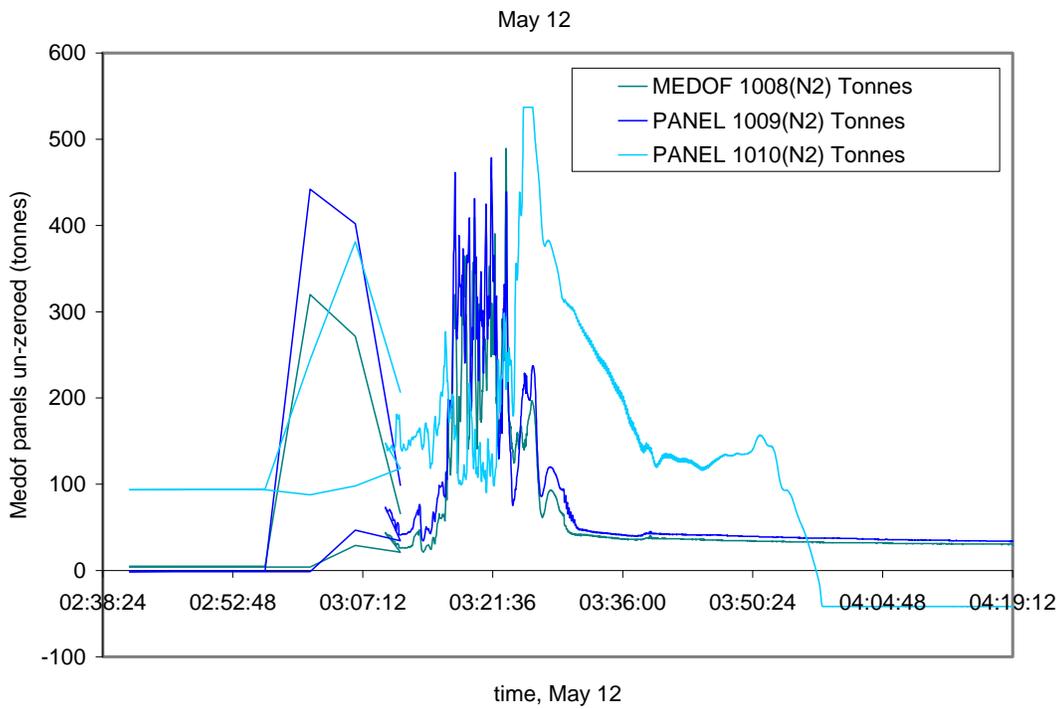
Figure 10 Time series plot, May 12 02:38 – 04:19

Panel 1010 on the north face experienced significant loads on May 12. The lower panels on the northeast corner and east faces were also checked (1020 and 1030), but no loads were registered on them. The records for 1008, 1009 and 1010 are presented in Figure 10. At about 03:25 the record for 1010 was cut off and after time 03:58 the record also looks suspicious – it is unnaturally flat. The flat line portion around 03:25 is blown up (Figure 11) and it is clear the instrument went off scale. Panel 1010 was numbered 1002 in the original calibration and had a factor of 1.432 kPa/mm for a 1 inch (25.4 mm) diameter sight tube. For the 1985-86 season tube diameters were standardized to 3/4 inch (19.1 mm) so the factor became 0.81 kPa/mm. Panel 1010 had the lowest calibration factor of all 31 panels, and was thus the softest panel. This was noted at the time. With a factor of 0.81 kPa/mm, 1MPa would produce a 1235 mm increase in level in the sight tube. A pressure of 1 MPa is equivalent to a force of 3 MN or 300 tonnes on the 3 m² panel. The measured load increase on panel 1010 was about 450 t (1.5 MPa), so the elevation change should have been 1852 mm. Depending on the initial fluid level, this could have been sufficient to produce an off-scale condition. The measured load decrease was about 600 t (2 MPa), equivalent to a 2470 mm level drop. The record after 03:58:08 is also expanded (Figure 12) and it is unusually constant. Such a constant level record could be produced if sufficient fluid was lost from the top of the sight tube that after the ice load was removed, the fluid level dropped below the location of the pressure transducer. The sight tubes were originally 2 m long, but were lengthened to about 2.4 m (Allan Strandberg, 2008, personal communication). Thus the

“overload” level and the “off-scale” level are consistent with a 2.4 m long sight tube. A softening of the Adiprene buttons from their original stiffness would make the “overload” even more likely.

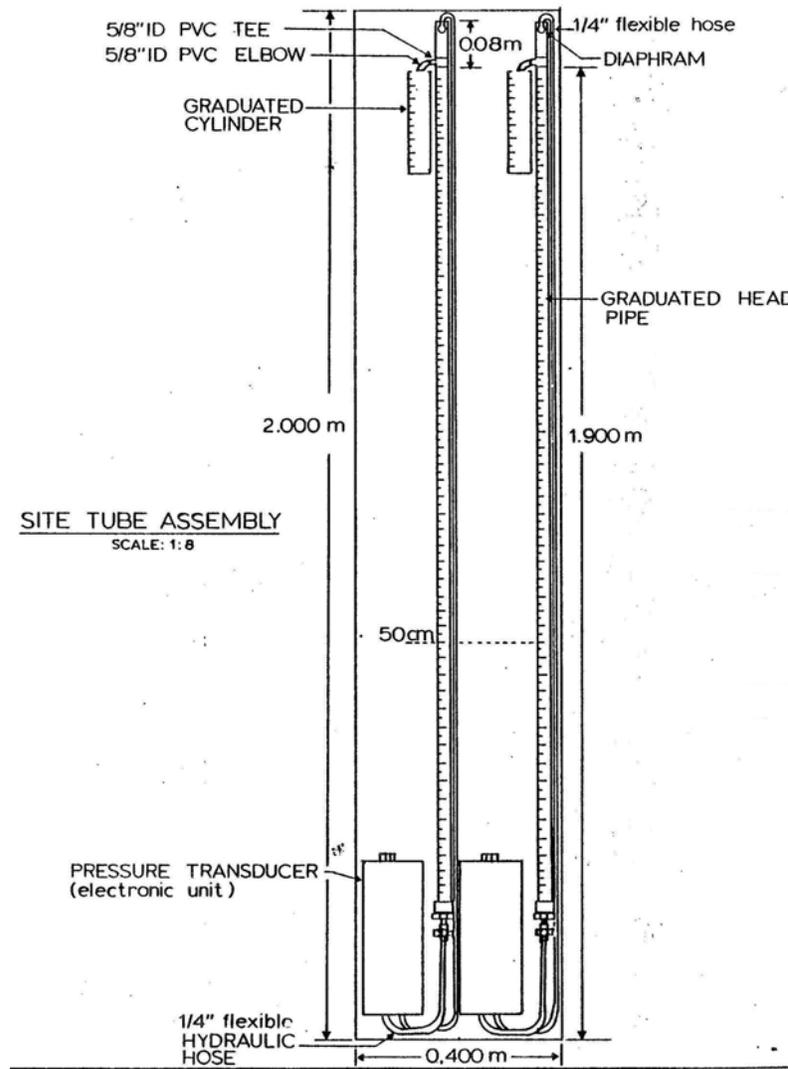
Figure 13 Sight tube and pressure transducer set-up for MEDOF panels

To make the overload circumstances easier to follow, the arrangement of the sight tube and pressure transducer, taken from the original FMS Engineers (1983) report is illustrated in Figure 13. This shows the original installation where the sight tube was 2000 mm long. It can be seen that if a sufficiently large load is applied to the MEDOF panel it is possible for the fluid level in the sight tube to reach a point where it would overflow into the Graduated Cylinder at the top of the tube. Presumably this would allow the overflow to be measured and the maximum load determined. Once overflow had occurred, and the load was removed, it is possible for the fluid level in the sight tube to drop below the bottom inlet to the transducer and it would give a constant output, representing zero pressure.
