Report (National Research Council of Canada. Radio and Electrical Engineering Division : ERB); no. ERB-481, 1958-01

HIGH ALTITUDE TESTS AND MODIFICATIONS
ON AN/APX-6 IFF TRANSPONDERS

J. S. RIORDON

JANUARY 1958 NRC# 35590

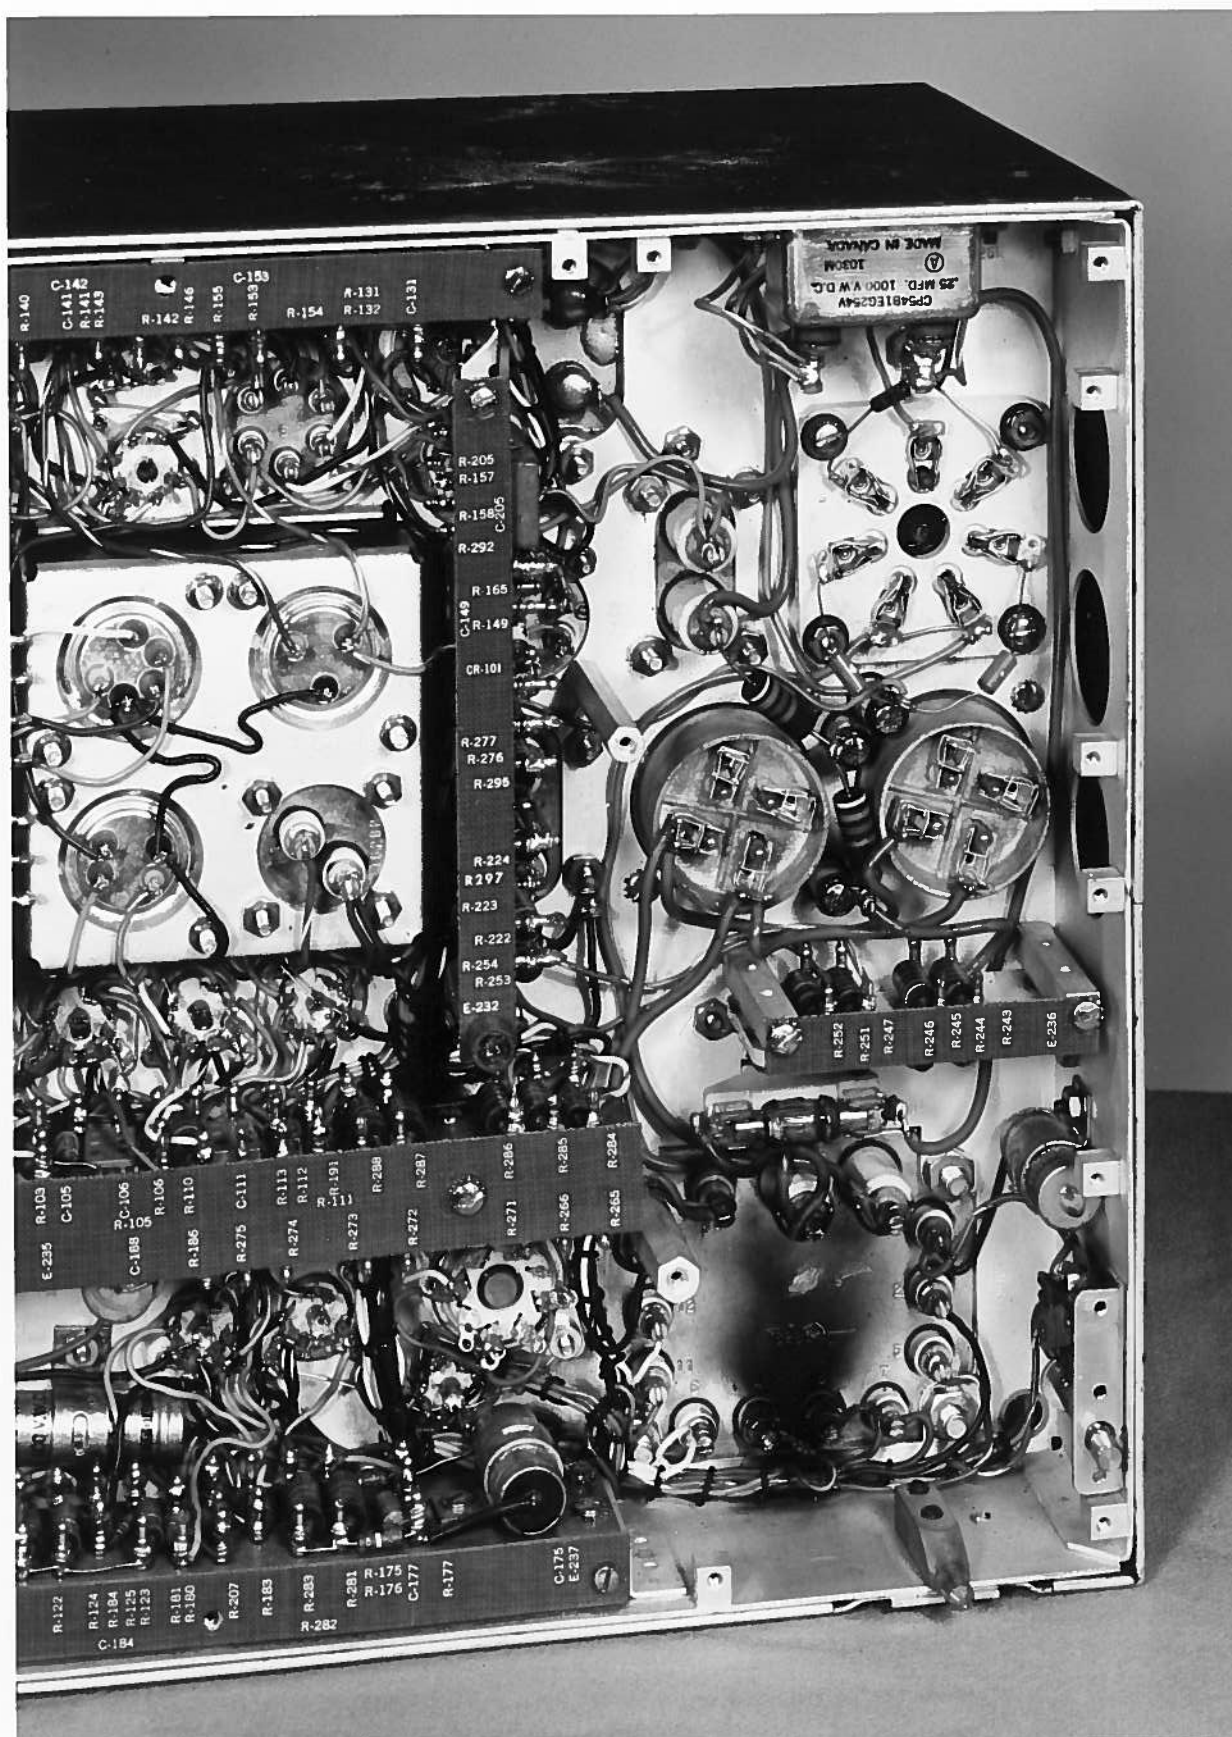
The first type of failure above disappears when the set is brought down below the critical altitude (43,000 - 48,000 feet indicated altitudes for the sets tested). In the second case, of course, the set does not resume operation. In order to determine the cause of the latter failure, three of the sets were allowed to run with fuses of higher current rating. In each case the high voltage supply wiring insulation was broken down by arcing (at altitudes of 43,000, 52,000, and 56,000 feet). Two points of breakdown are shown in Figs. 1 and 2. It is worth noting that each breakdown took place at a different point in the circuit. Tests carried out at 60 cycles on a sample of the high voltage supply wire showed that a single layer of the insulation breaks down at 32 kilovolts r.m.s. at atmospheric pressure. As this type of insulation breaks down at 1050 volts d-c at a height of about 50,000 feet, it is probably rather porous, and obviously unsuitable.

This is a problem of both insulation and lead dress, as may be seen from Figs. 1 and 2. To remedy it, all wiring at potentials above 600 volts was replaced with wire whose insulation rating was 12 kilovolts d-c. (This insulation was actually tested to 50 kilovolts r.m.s. without breakdown.) This wiring was placed so as to avoid positions likely to cause arcing; in addition, rubber boots were placed over critical terminals. These changes are shown in Figs. 5 and 6.

FIG. 1. INSULATION BREAKDOWN BETWEEN TERMINALS 4 AND 8 OF POWER SUPPLY TRANSFORMER

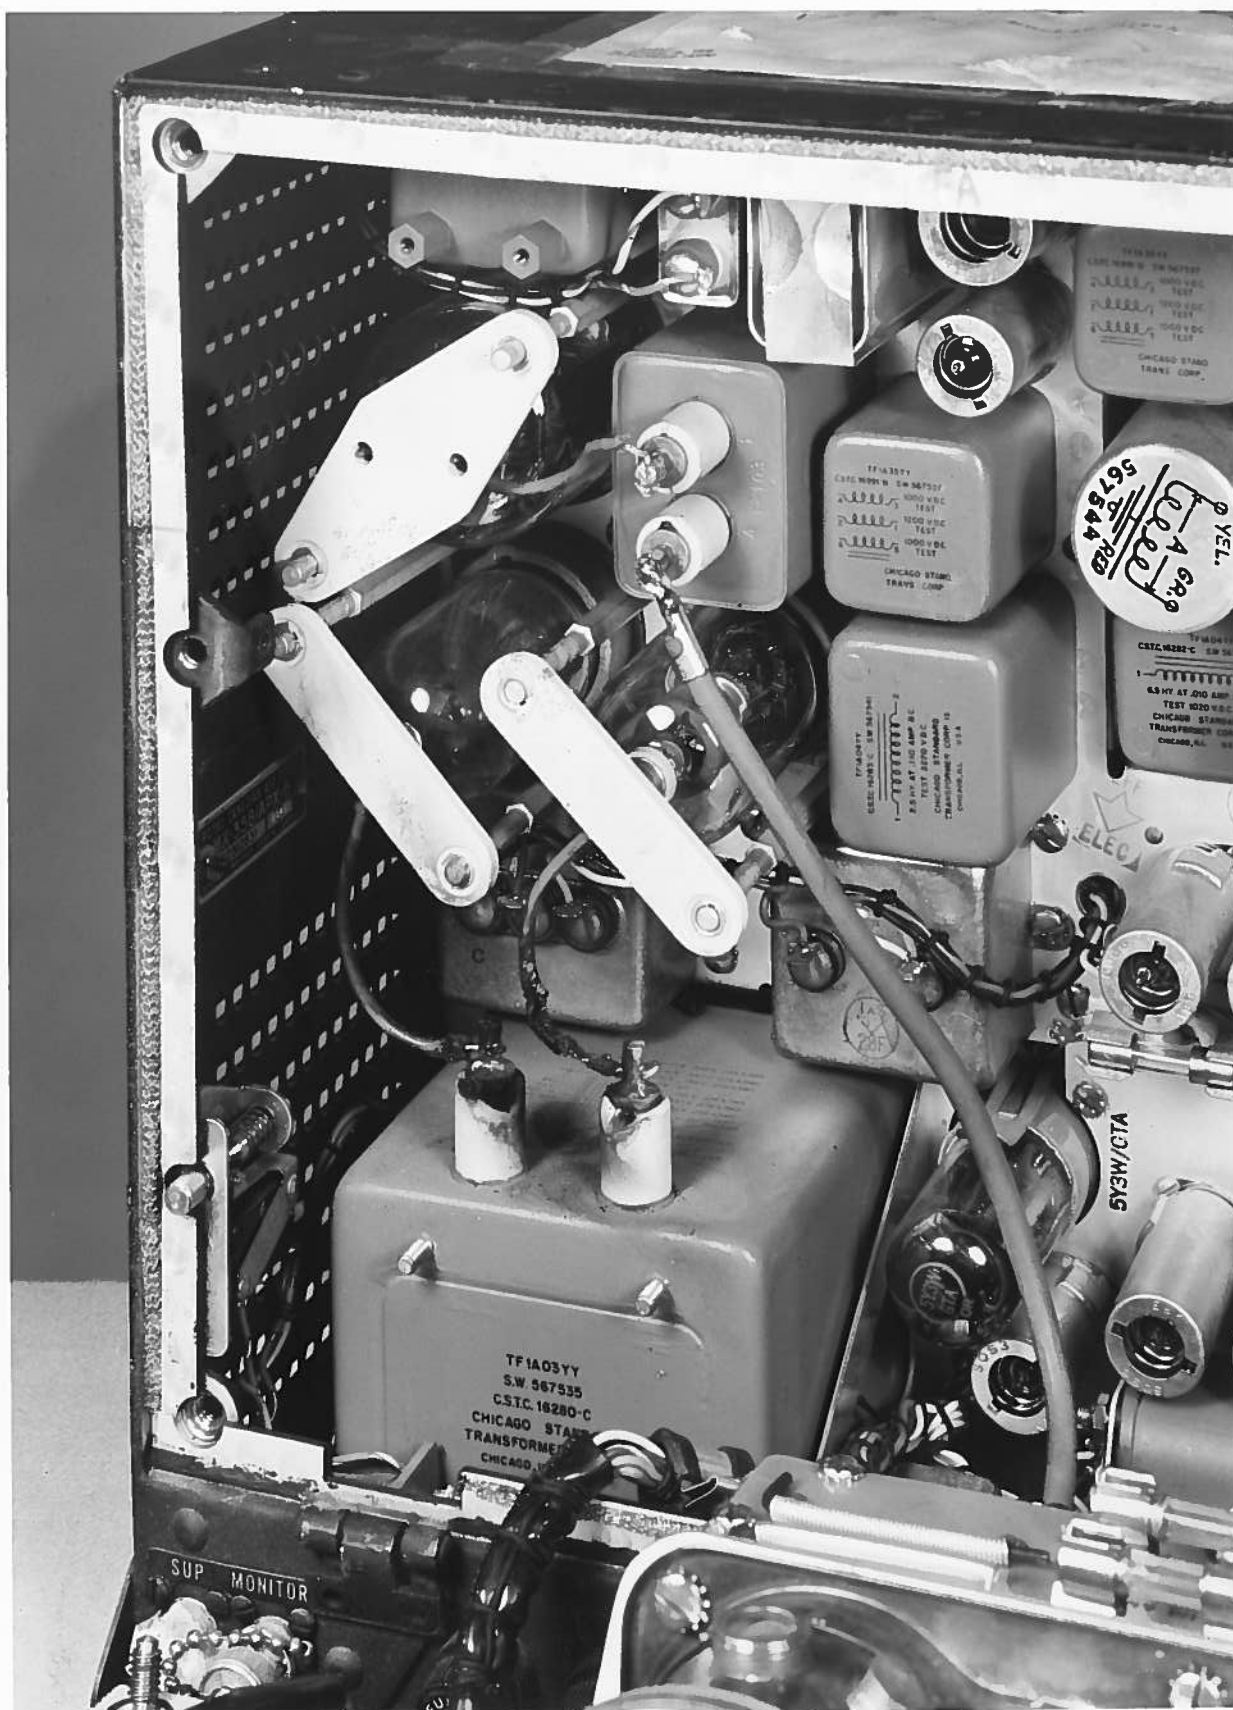
FIG. 2. INSULATION BREAKDOWN BETWEEN TERMINALS 15 AND 16
OF POWER SUPPLY TRANSFORMER

- a) Open front panel of transponder.
- b) Remove porcelain insulators from rods.
- c) Remove wires from plate of V-119 to terminal 15 of T-104 and from plate of V-120 to terminal 16. Replace these with short pieces of high voltage wire, and place rubber boots over terminals 15 and 16. See Fig. 6.
- d) Remove wire from plate of V-111 to terminal 1 of T-103, and replace with a 100-ohm 2-watt $\pm 5\%$ resistor, as shown in Fig. 6.

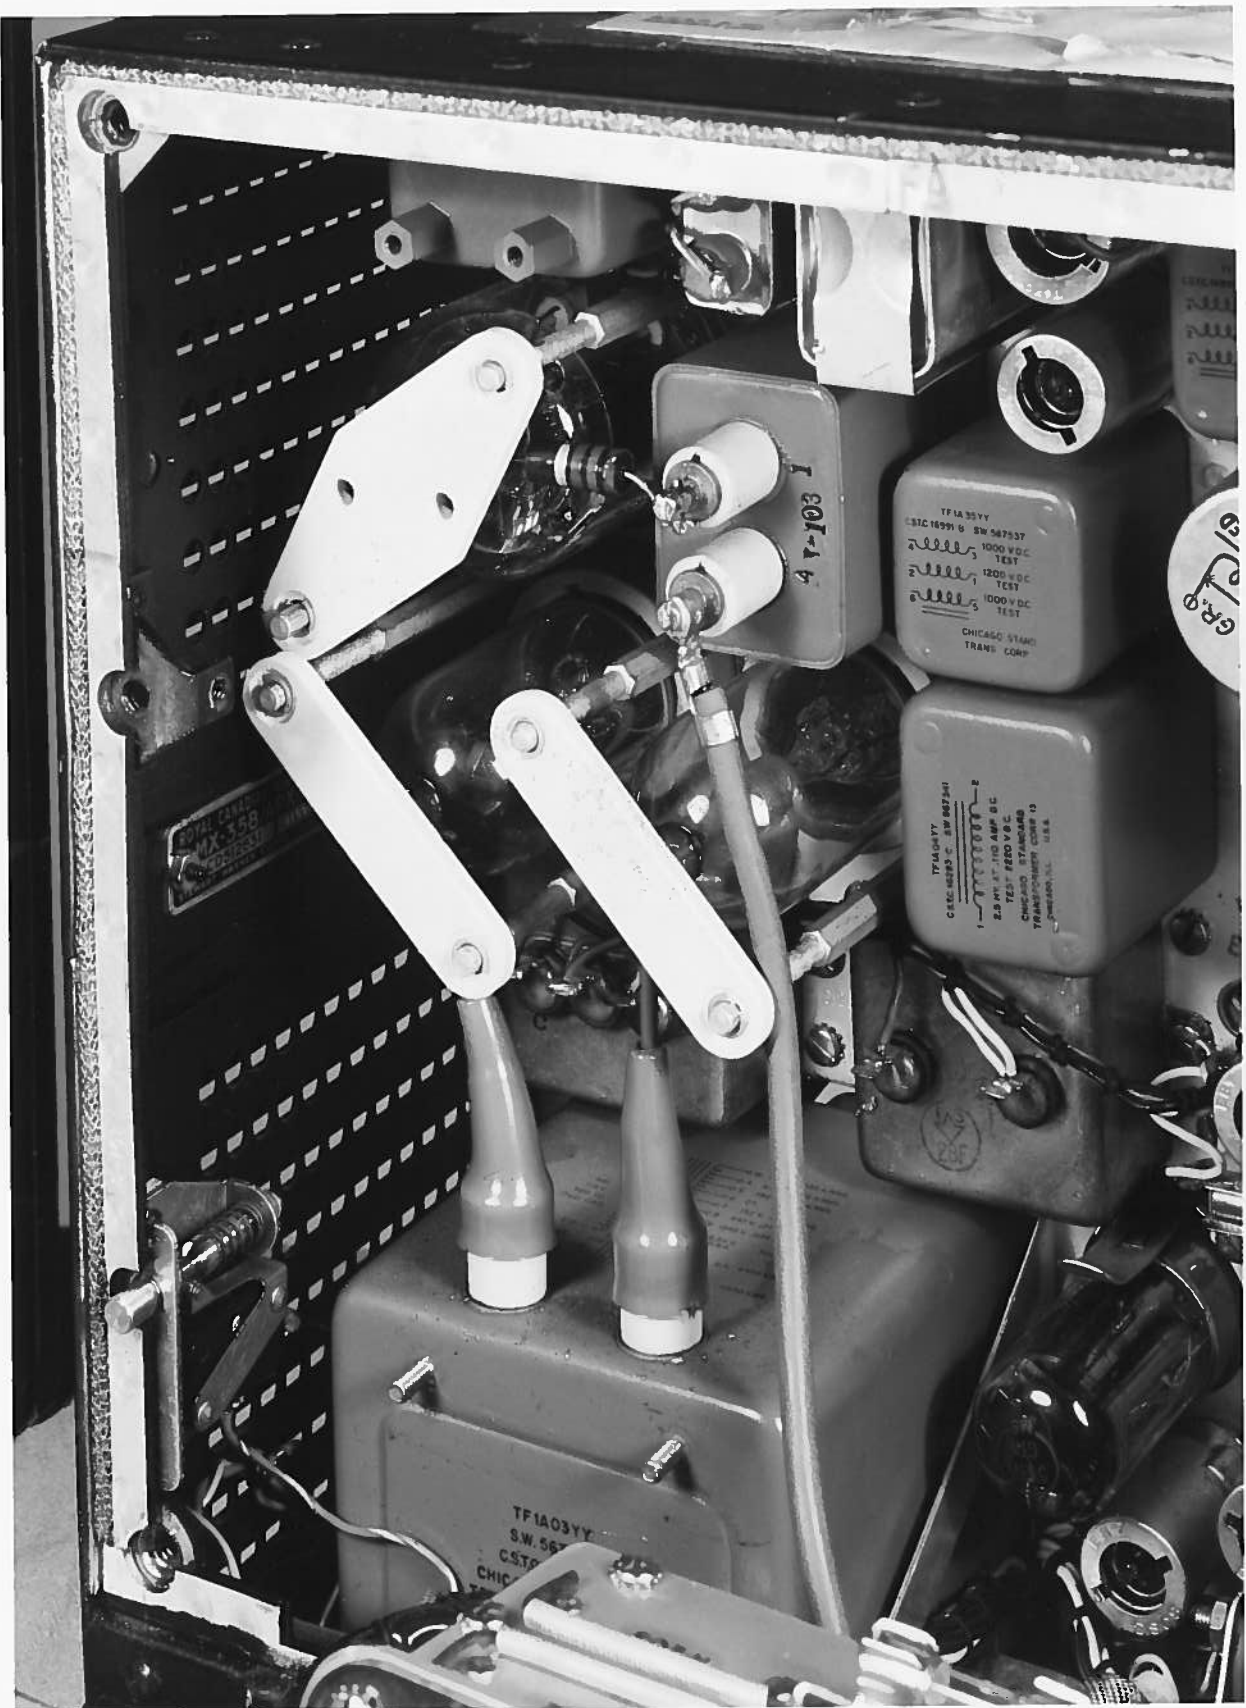
**FIG. 6. REVISED LAYOUT OF HIGH VOLTAGE WIRING (front of chassis)
WITH 100-OHM RESISTOR INSTALLED**

NOTE 3: Although adequate for trial purposes, the method shown in Fig. 6 is not recommended for service use since vibration may cause failure. An under-chassis mounting in the high voltage lead to terminal 2 of T-103 should be investigated.
