**SOUTH NATION RIVER LANDSLIDE, 16 MAY 1971**

**W. J. EDEN, E. B. FLETCHER AND R. J. MITCHELL**

*Reprinted from*  
CANADIAN GEOTECHNICAL JOURNAL  
VOL. 8, NO. 3, AUGUST 1971  
p. 446

TECHNICAL PAPER NO. 344  
OF THE  
DIVISION OF BUILDING RESEARCH

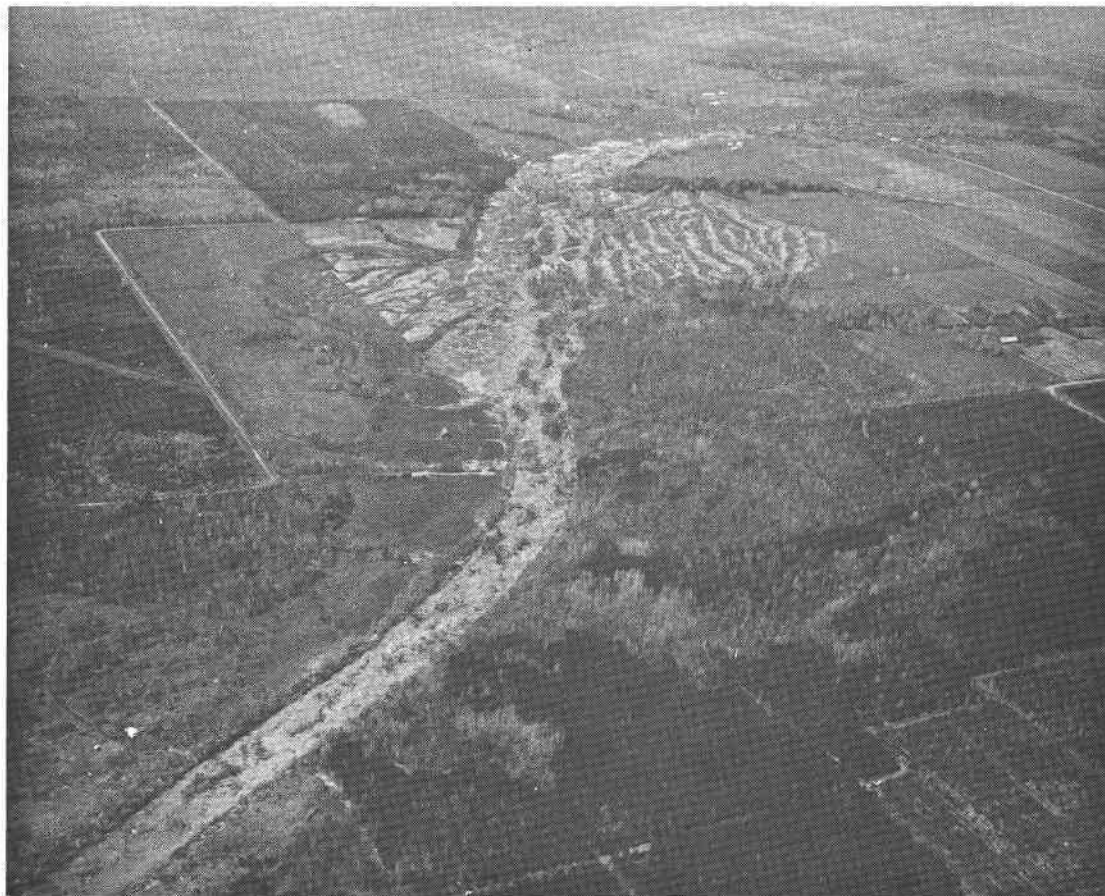
Figure 1 is an oblique aerial view of the site looking downstream. The landslide scar is on the right (east) bank of the river. On the left bank, immediately upstream, is the scar of an old landslide that took place within the memory of the residents of the area and has been dated as 28th February 1910.

FIG. 1. Oblique aerial view of the South Nation River landslide.

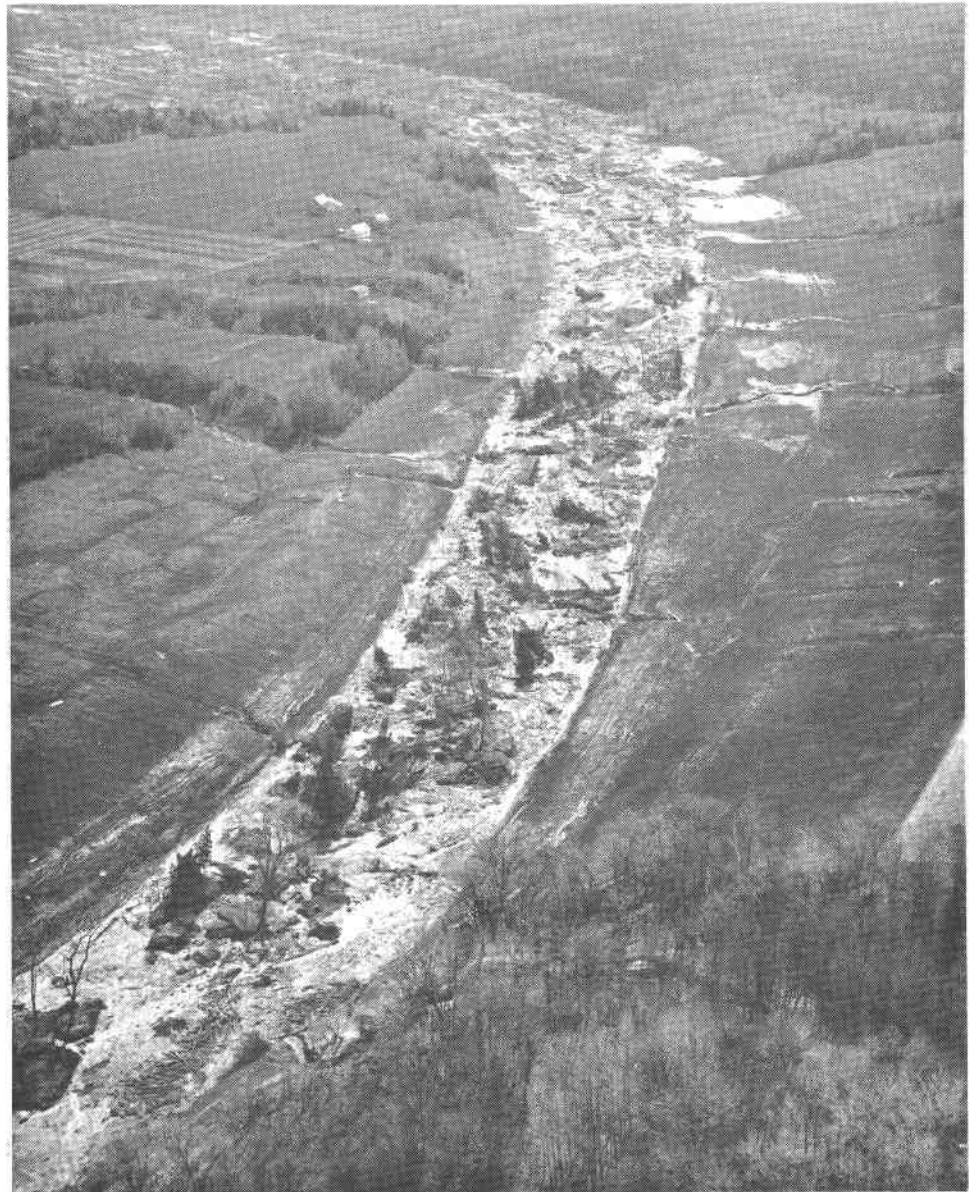
The present landslide occurred during a heavy thunderstorm and is believed to have started after 11:00 p.m. A power failure occurred about midnight, when trees being carried along in the landslide debris knocked down power lines spanning the river downstream from the slide. Figure 2 is a view of the downstream end of the debris, showing many trees still in an upright position. The disrupted power line is located in the middle of the photograph.

FIG. 2. View of debris in the river downstream from the landslide.

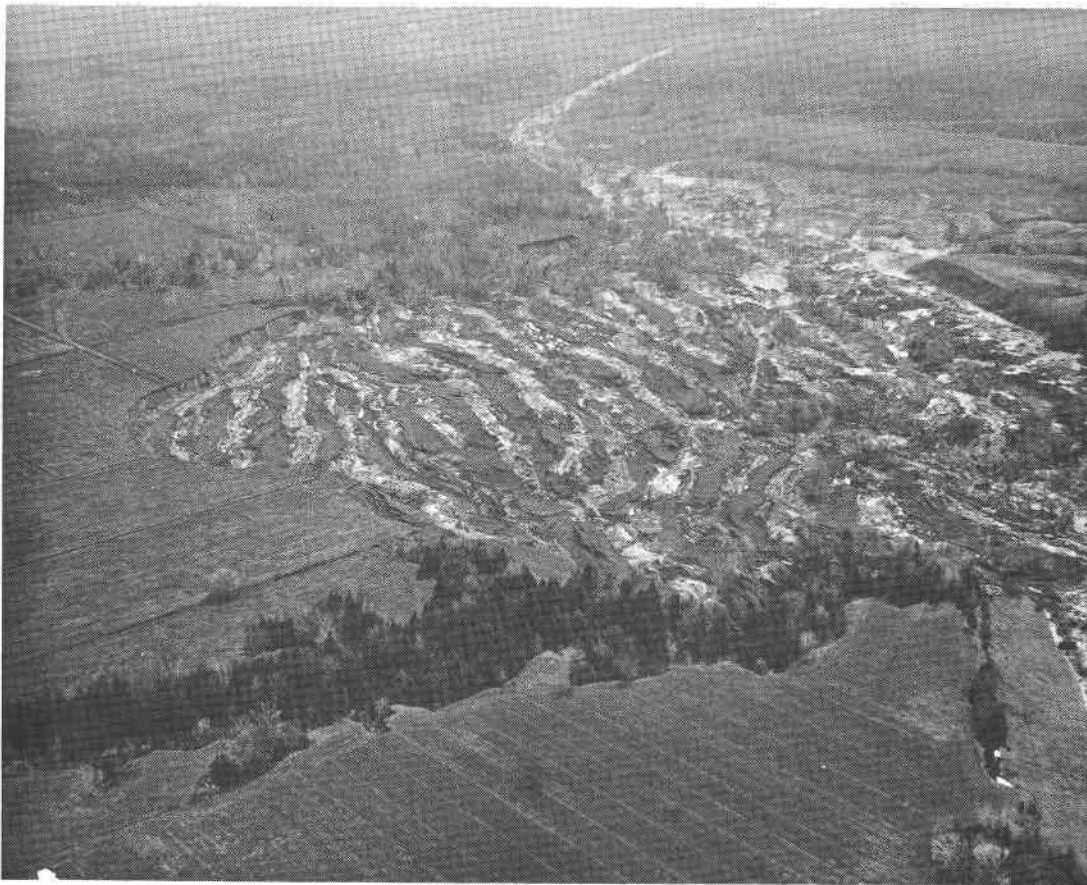
Figure 3 is a view of the cavity formed by the landslide. The succession of individual failures

are well preserved by sod on the sand horizon overlying the clay. Figure 4 is a closer view of the succession of slips and shows the back scarp, which is about 30 ft (~9 m) high.

FIG. 3. Aerial view of cavity formed by the landslide.

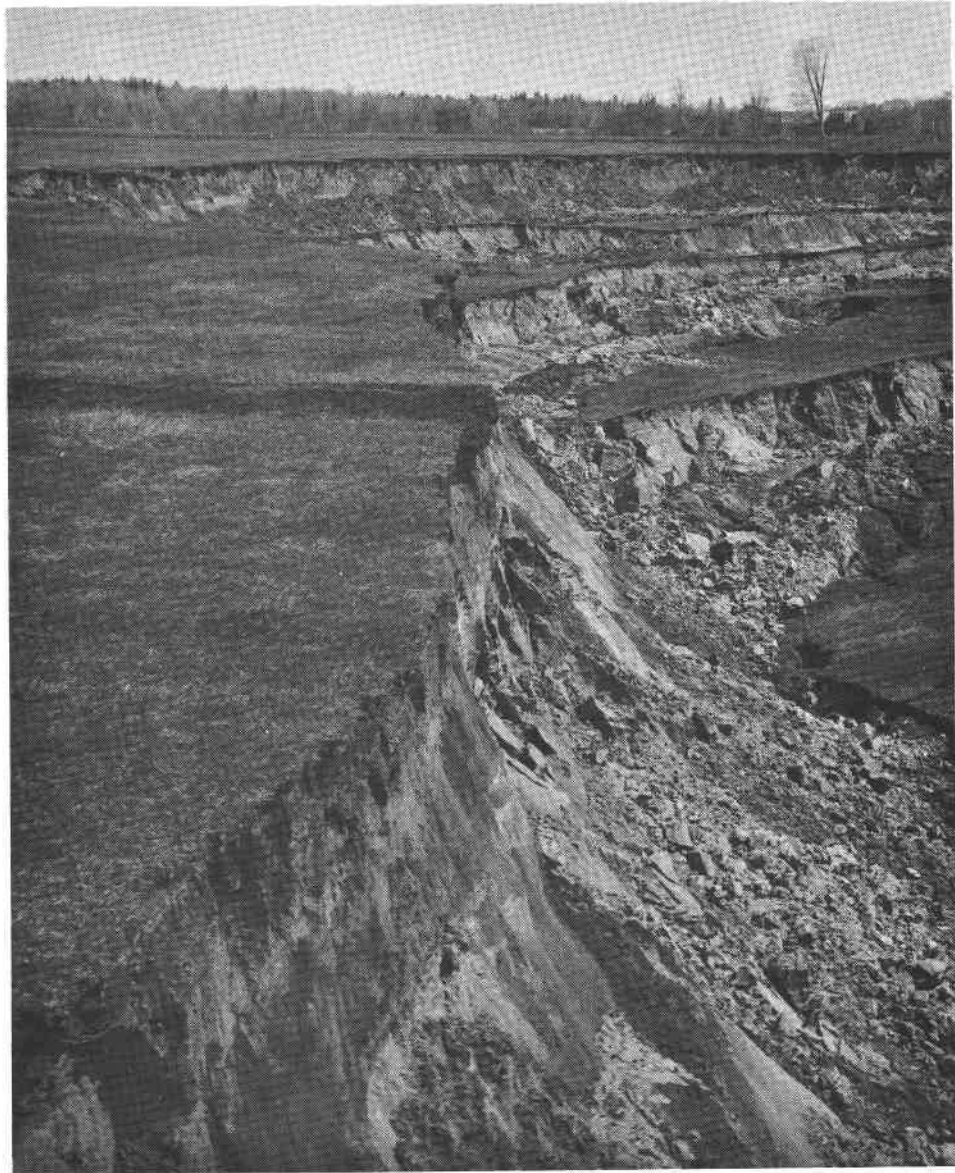
FIG. 4. View of back scarp of the landslide.

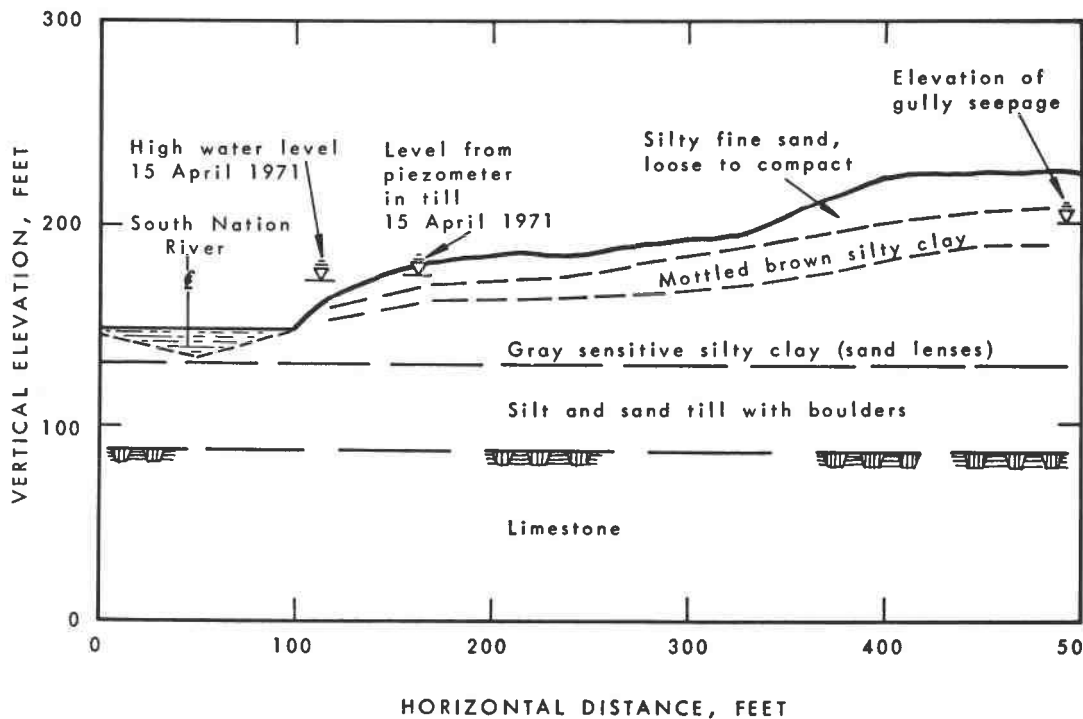
section and geotechnical profile at the landslide site have been reconstructed as shown in Fig. 5. The river water level had risen as much as 26 ft (8 m) (to elevation 172 ft (52.4 m)) during spring floods at the location of the landslide. Piezometer readings indicate a rise in groundwater levels as the river level rose. After about one week of flooding, the river level dropped quite rapidly but the groundwater pressures in the slopes remained high. The river level had dropped to about elevation 145 ft (~44 m) at the time of the slide, but the general groundwater level was nearly coincident with the ground surface (elevation 210 ft (64 m)) over most of the lower part of the slope. It is not known whether there were artesian groundwater pressures in any part of the slope at the time of the slide. Groundwater seepage was

noted on 3 June 1971 near the bottom of the gullies flanking the landslide; the approximate elevation of this seepage is indicated on Fig. 5.

Amid the grassy top surfaces of the retrogressive slices evident in the photographs there are pinnacles of gray clay pushed up by the rotation. These clay pinnacles seem to indicate that the failure did not extend into the till layer. Average properties of the gray clay layer, as obtained from the investigations noted above, are as follows:

FIG. 5. Cross section and geotechnical profile of the site of the South Nation River landslide.
