# WHAT FROST ACTION DID TO A COLD STORAGE PLANT

J. J. Hamilton, D. C. Pearce and N. B. Hutcheon

REPRINTED FROM THE ASHRAE JOURNAL

TECHNICAL PAPER NO. 69

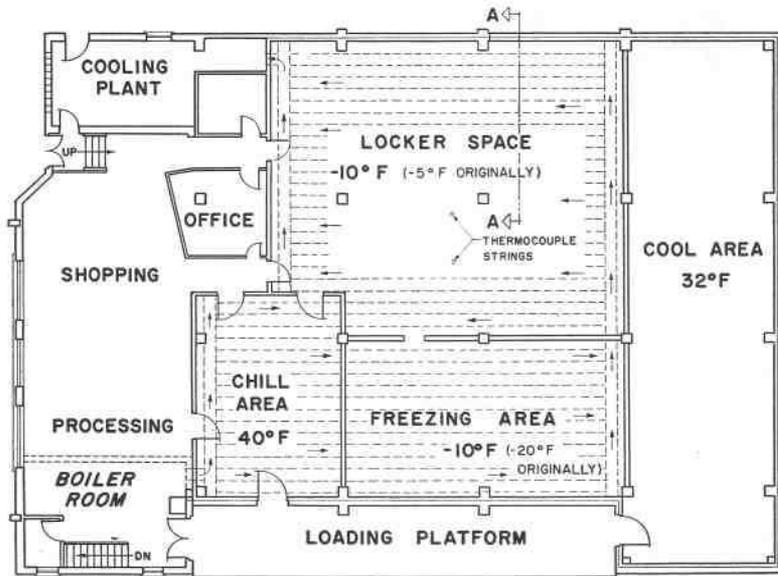
Fig. 1 Ground floor plan

In Cornwall, Ontario, the Stormont Cold Storage Co-operative operates a conventional locker plant having office and processing rooms, sharp freezing facilities, holding rooms and rental lockers in a large locker room. The building is a single story reinforced concrete structure founded on shallow spread footings. It has a steam boiler in a basement boiler room for heating the office and retail store area in the front of the building. Refrigeration is by a direct expansion system with pipe coils suspended from the roof of the cold rooms. The water-cooled compressors are located in a semi-basement machinery room also located in the front of the building. The main floor plan of the original plant is shown in Fig. 1.

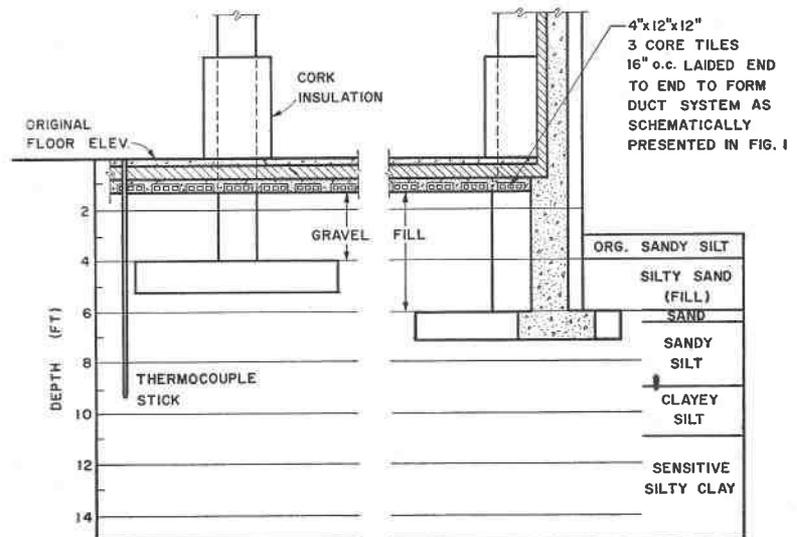
Fig. 2 Section A-A. Typical floor slab, columns and footings

Fig. 2 shows a typical section through the floor slab, a column and footing, and also shows a soil profile representative of the subsoil

adjacent to the floor slab and footings. The floor slab is of sandwich construction with two 3-in. reinforced concrete layers separated by 6 in. of cork insulation. The tiles, as shown, were introduced as a modification to the original design. They were intended to provide a ventilating duct system, below the slab, to assist in preventing freezing of the ground. Hollow structural clay tiles were laid end to end, in parallel rows terminating in 9 x 9-in. headers formed in the concrete at either end. It was intended that air from the boiler room should flow through this system and be discharged into the compressor room. This system was ineffective since no fan was provided. It did, however, serve a useful purpose as later described.

At the time of construction the site was observed to be generally low lying, having poor natural surface drainage and a higher groundwater table. According to the contractor the original surface of the ground was from 1 to 2 ft below the present outside grade as shown in Fig. 2. Individual excavations were made for interior column footings and perimeter wall footings. Some difficulty with groundwater in the deeper excavations for wall

footings was noted during the forming and concreting operations, the water table then being from 3 to 4 ft below the original ground surface. After placing of the concrete for the footings, the excavations were backfilled with "pit-run" gravel to the required grade of the tiles and the bottom of the slab. This gravel is locally used for concrete aggregate and was described as being "clean and of good quality." Owing to the method of placing the footings, the present soil profile below the building may not have a regular horizontal stratification. In areas where no excavation for footings was required it is assumed that the gravel backfill was placed directly on the original ground surface while over the footings the gravel was backfilled from the top of the footing to the bottom of the floor slab.

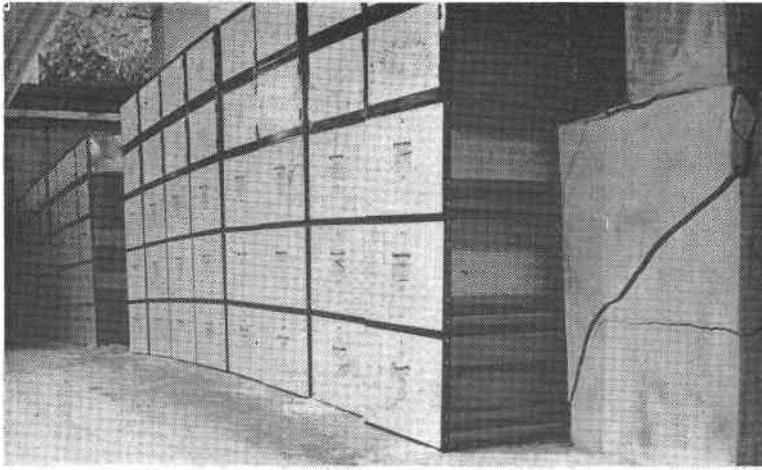
Fig. 3 Interior view of refrigerated locker room showing extent of heave

In addition to subsurface temperature measurements, periodic level surveys of the floor and the roof were made. By June 1957, the deflection experienced by the slab had reached the proportions illustrated in Fig. 3. The extent of the

heave is strikingly reflected by this row of lockers which were located near the region of maximum heave. The rather alarming crack to be noted at the base of the column is of no structural significance since only the hardboard covering the cork insulation has been damaged. It resulted from a combination of lateral movement and differential vertical movement of the floor and column. This column was the only one in the building to suffer other than vertical movement. The upward movement of the structure caused this column to be moved nearly 5 in. from the vertical.

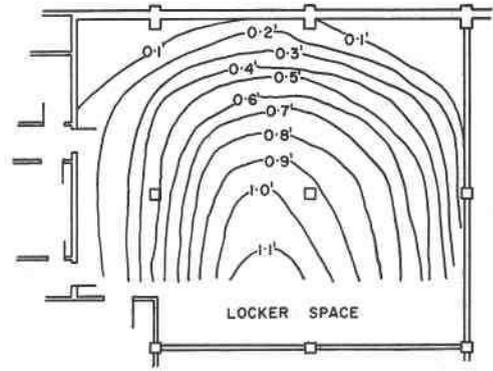
Fig. 4 Maximum heave contours in feet June 11, 1957

Fig. 4 shows the floor heave contours for the worst condition. These contours outline the general symmetry of the heaving with the point of maximum heave being near the dimensional center of the freezing space.

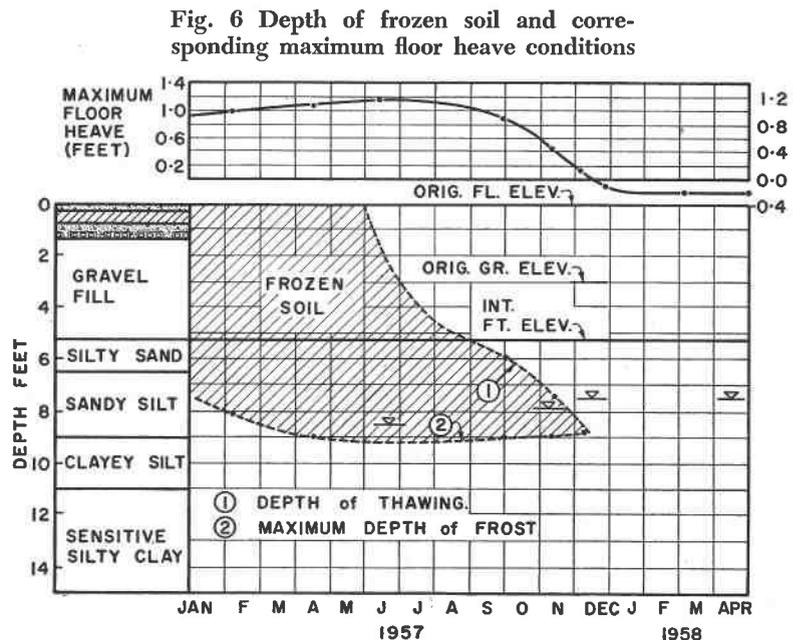
Fig. 6 Depth of frozen soil and corresponding maximum floor heave conditions

During the subsoil heating operations thermocouple readings were taken periodically. The first 6 ft of soil thawed rather quickly, the rate of thaw decreasing somewhat below this depth. This is depicted in Fig. 6 As can be seen

from the maximum heave curve the rate of heave and depth of frozen soil show a roughly linear relationship. This would imply that throughout the frost-susceptible soil, the thickness of ice varied from 3 to 4 in. per ft of frozen soil. From an examination of the heave experienced by the roof slab it appears that the heave below the footings would be less than 2½ in. per ft of frozen soil. This difference may be due to the effect upon the ice formation of increased bearing pressures under the footings.
