Laboratory tests of water penetration through wall-window interfaces based on U.S. residential window installation practice

NRCC-50033

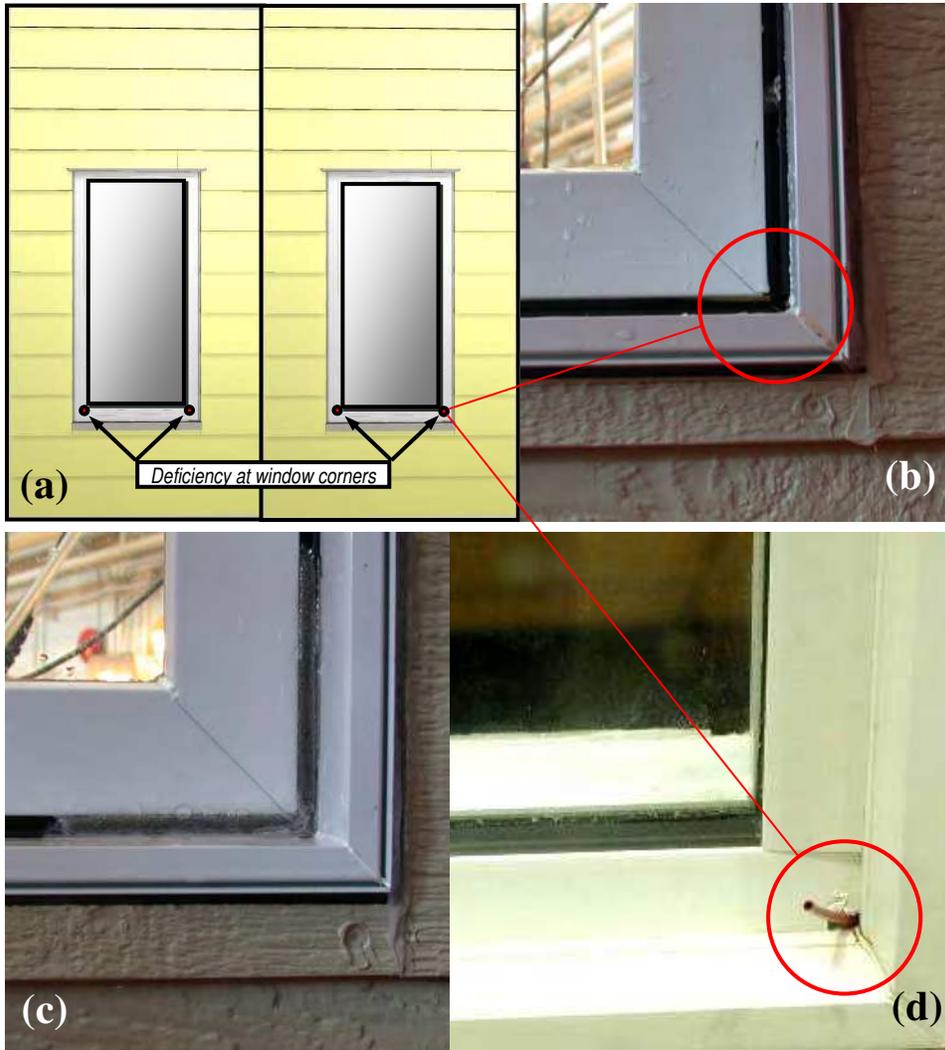
Deficiencies — The locations of deficiencies in the respective windows for either side of wall specimen B-W1 or B-W3 are given in Figure 9. The intent of including deficiencies in the window components was to simulate conditions of a prematurely failed window or of a window that had deteriorated over time; either would be expected to result in water penetration into the sill space of the rough opening. Performing trials with deficiencies permitted determination of the robustness of the flashing details and allowed observation of the manner in which penetrating water was managed.

As can be seen in Figure 9a, the deficiencies are located at the lower and opposing corners of each window. For specimen B-W1 (Figure 9b) the deficiencies were approximately 1-mm in diameter. These openings were sealed with elastomeric sealant for those test trials in which no deficiencies were being tested as shown in Figure 9c. Similar size openings were placed at the lower corner of the windows of specimen B-W3 as shown in Figure 9d. When specimen B-W3 was tested with no deficiencies (i.e. B-W3 Test trial 1 “As constructed”), these openings were likewise sealed with caulking as was done with the other specimen.

Figure 9 — (a) Pictorial representation showing front elevation of test specimen (cladding exterior) and nominal location of deficiencies at lower corners of windows; (b) Photo of specimen B-W1 of deficiency (ca. 1-mm diameter) at lower right corner of window; (c) Photo of specimen B-W1 showing lower right hand corner with deficiency “plugged” with sealant; (d) Specimen B-W3 showing “un-plugged” lower right corner of window

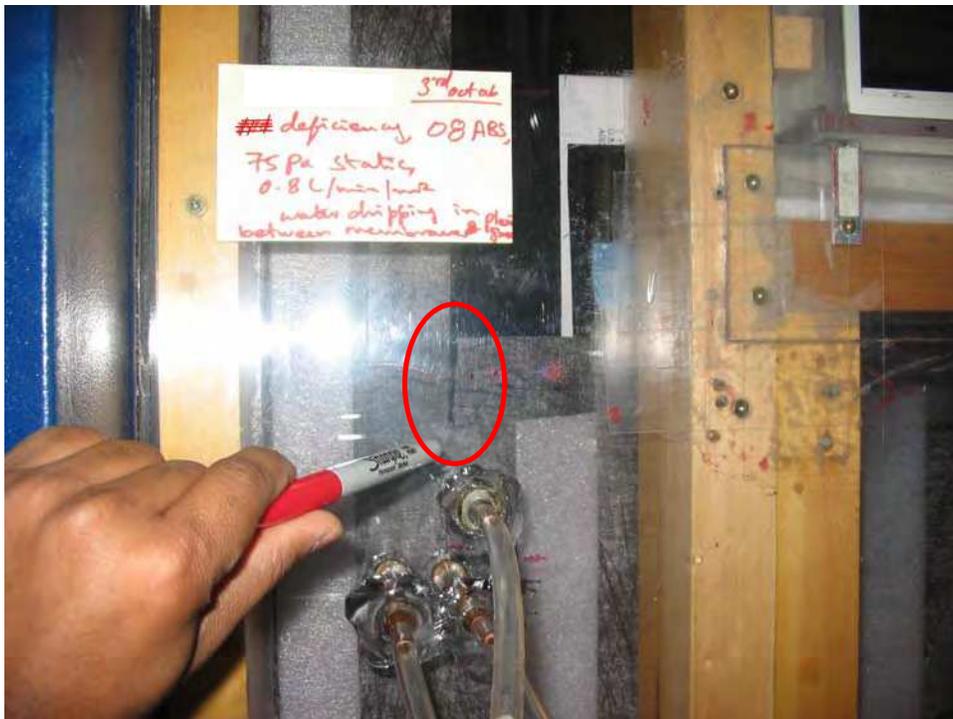
Figure 17 — B-W3 — Observed water leak behind WRB at the bottom corner of the window flashing; window installed before WRB; testing with deficiencies

However, and as was the case for test trial 1 of B-W3, on the side of the specimen where the window was installed before WRB, water was observed to occasionally intrude behind the WRB through the layers of jamb

flashing, (Figure 17). As indicated previously in the Results section of this manuscript, the amount of water that entered through the layers of jamb flashing was of insufficient quantity to reach collection trough 3.

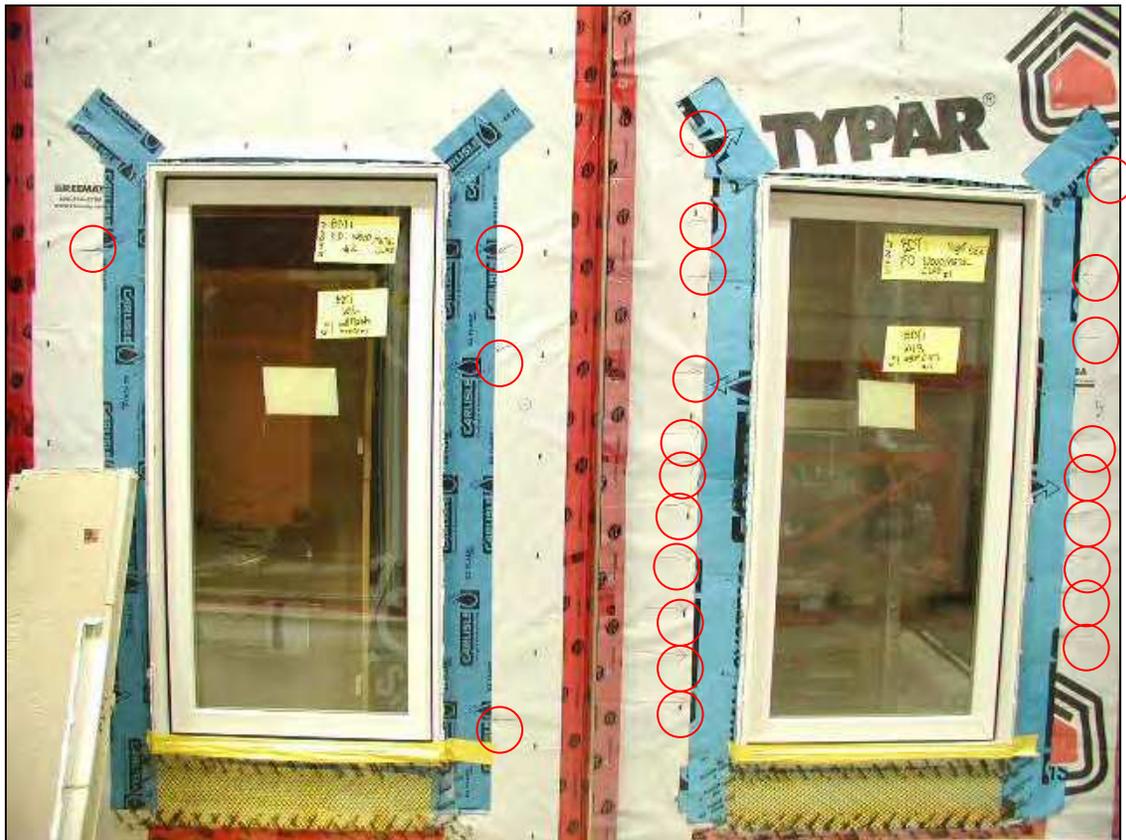
In the installation on the A-side of the specimen, self-adhering flashing membrane was applied over the jamb flanges, this presumably added another layer of protection from water entry (in addition to the sealant behind the flange). However in locations where the self-adhering flashing failed to adhere to the window flange or to the WRB, the non-adhered areas could provide paths for water entry. Removal of the lap siding from the specimen following completion of the test trials, it was found that the self-adhered flashing had lost adhesion to the WRB in certain locations. This created openings sometimes called “fish mouths” (Figure 18). The fish mouths proved to be

leakage paths. Several “pour test” into these openings located along the jambs showed that water that entered at these locations reached collection trough T1.

Given that openings for water entry exist, the presence of water at these locations combined with a pressure differential necessarily brings about water penetration. As previously mentioned, at the same differential pressure across the assembly, the pressure drop across the A-side was greater than the B-side. This evidently raised the potential for water entry. This is almost certainly the reason why greater amounts of water accumulated at the sill on the A-side of this specimen than on the B-side.

Figure 18 — Location of Fish Mouths on the B-side (left) and V-side (right) of B-W1

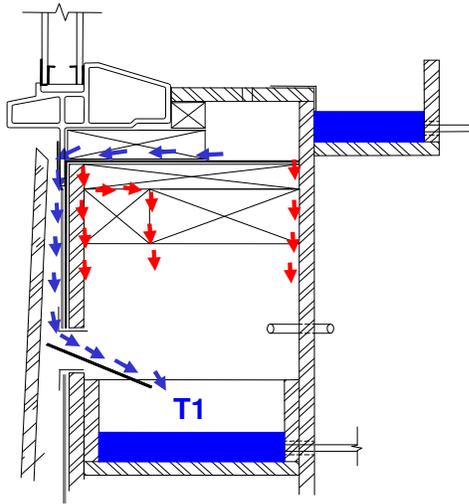
area of the rough opening, even at lower driving pressures, and showed little or no drainage from this area, particularly at higher driving pressures.

Figure 19 - Water entry path from subsill to collection trough T1 (A-side)
