Canadian Building Digest

Division of Building Research, National Research Council Canada CBD 97

Look at Joint Performance

Originally published January 1968. G.K. Garden

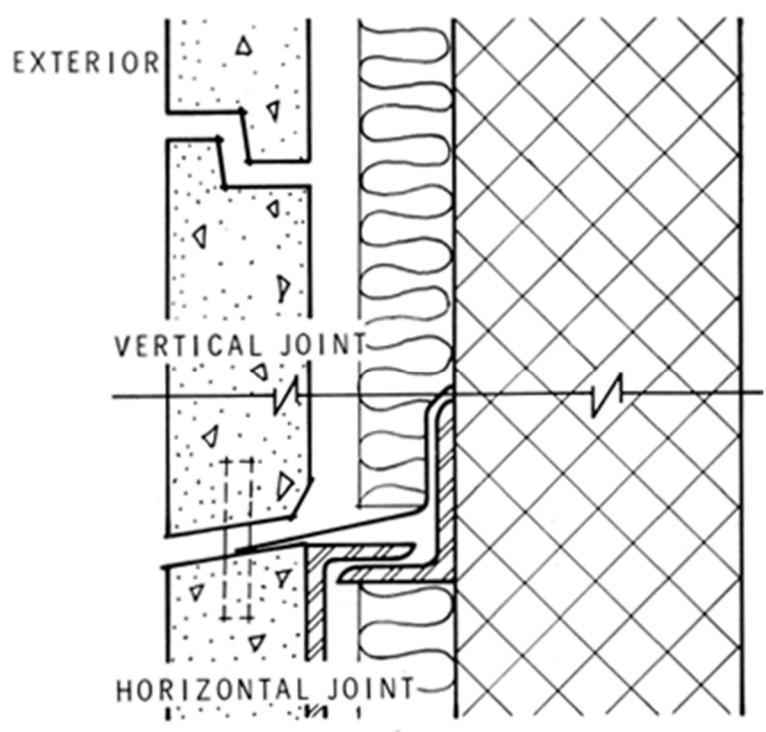
Study No. 2. Both shingled and cavity walls are construction systems in which joints are not continuous from outside to inside. This feature can be used to advantage in designing with contemporary materials and methods of construction, an approach that was employed in the design of the walls of a large concert hall. The masonry back-up walls were insulated on their outer surface and large precast concrete facing elements were used as the exterior finish. As they were aware of the rain screen or two-stage weatherstripped principle (CBD 40), the designers specified that all joints in the precast concrete cladding should be left open. The horizontal joints were sloped toward the exterior and the vertical joints were half-lapped, but a 1/2-in. wide clear space was maintained between all panels (Figure 1). In the four years this building has been in service there has been no indication of rain penetration, nor even of partial penetration of the open joints.

Figure 1. Joints between concrete cladding panels.

It should be mentioned that the cavity was not left continuous around the building or throughout its height. To minimize the inward air pressure drop across the facing elements that

could normally develop from wind pressure variations over the building surfaces the cavity was blocked vertically at approximately 4-ft centres for 20 ft from each corner and horizontally at panel supports.

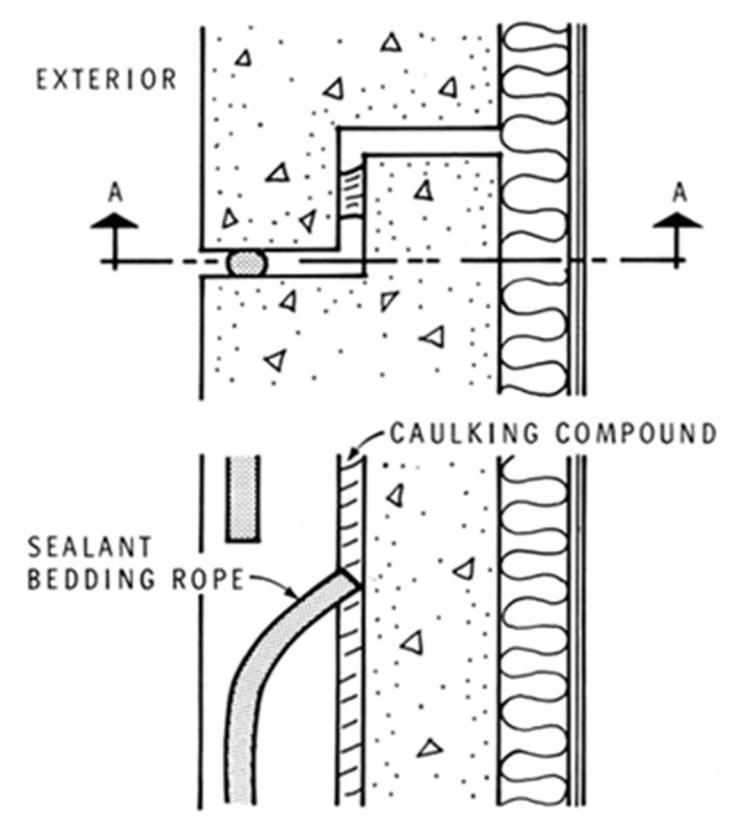
SECTION A-A

Study No. 3. Through-wall joints are employed in many contemporary buildings, and a number of studies of individual cases have been made. A particularly interesting and informative experience was gained during construction of a tall building in Eastern Canada. During installation of the precast concrete wall panels, a bead of caulking compound was placed in the half-lapped joints (Figure 2). The fact that it did not provide an airtight seal was not considered important because a bead of elastomeric sealant was to be installed at the outside face of the joint. The installation of this sealant, however, had to be delayed because of cold weather, and only the sealant bedding rope was placed in the joint. Because the delay was expected to be more than six months the sealant bedding rope was installed with the upper end of each length turned inward to flash the joint space, incidentally leaving a 2- to 3-in. gap at frequent intervals. No rain penetration was noticed during the delay. Only after installation of the elastomeric sealant at the outside of the joint was leakage observed, and after a few months it became a serious problem.

Figure 2. Vertical joint between concrete wall panels. Note: Although rain penetration can be controlled in the joints, the use of this wall design is not recommended (CBDs 98 and 94)

Study of the situation that existed during the delay indicated that although the caulking had not provided a complete air seal, it was considerably more airtight than that provided by the sealant bedding rope. The air pressure on both sides of the sealant bedding rope could equalize and the air pressure difference required to move water past it could not develop (<u>CBD 96</u>). When the elastomeric sealant was finally installed, however, it was far more airtight than the caulking bead, with the result that the air pressure difference between inside and outside the building was borne by it. With both air and water leakage resisted at the same point, rain penetration occurred at even minor failures of the seal. As the outer seal was better than the

inner seal, any water that entered the joint could only drain to the building interior. The same conditions and performance were experienced at the window joints.
