Frost damage to clay brick in a loadbearing masonry building

Frost damage in the exterior, loadbearing, clay brick walls of two 5-storey apartment buildings could have seriously affected their loadbearing capacity if left unchecked. A coating applied to the exterior had not stopped further damage from occurring. This paper describes the work to determine the cause of the damage. The work included a condition survey, tests on the brick, and monitoring temperature and moisture levels in a section of the wall. Bricks on an easterly exposure suffered the most damage. The cause was traced to poor quality bricks combined with water infiltration mainly from rain. Remedial measures included cladding the exterior of the brickwork with an insulated siding and replacing severely damaged bricks.

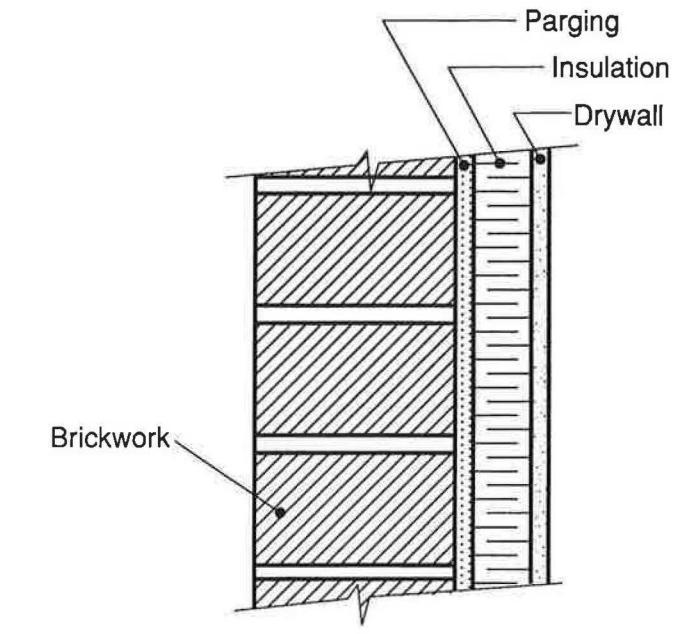
FIG. 2. Wall cross section.

The exterior walls on the buildings under investigation have 12 mm thick parging, 36 mm expanded polystyrene insulation, and 12 mm drywall (Fig. 2). The brickwork contains nominal seismic reinforcement both vertically and horizontally. The floors bear a minimum of 100 mm onto the brickwork; a 50 mm brick facing covers the slab edges for a continuous masonry appearance of the exterior.

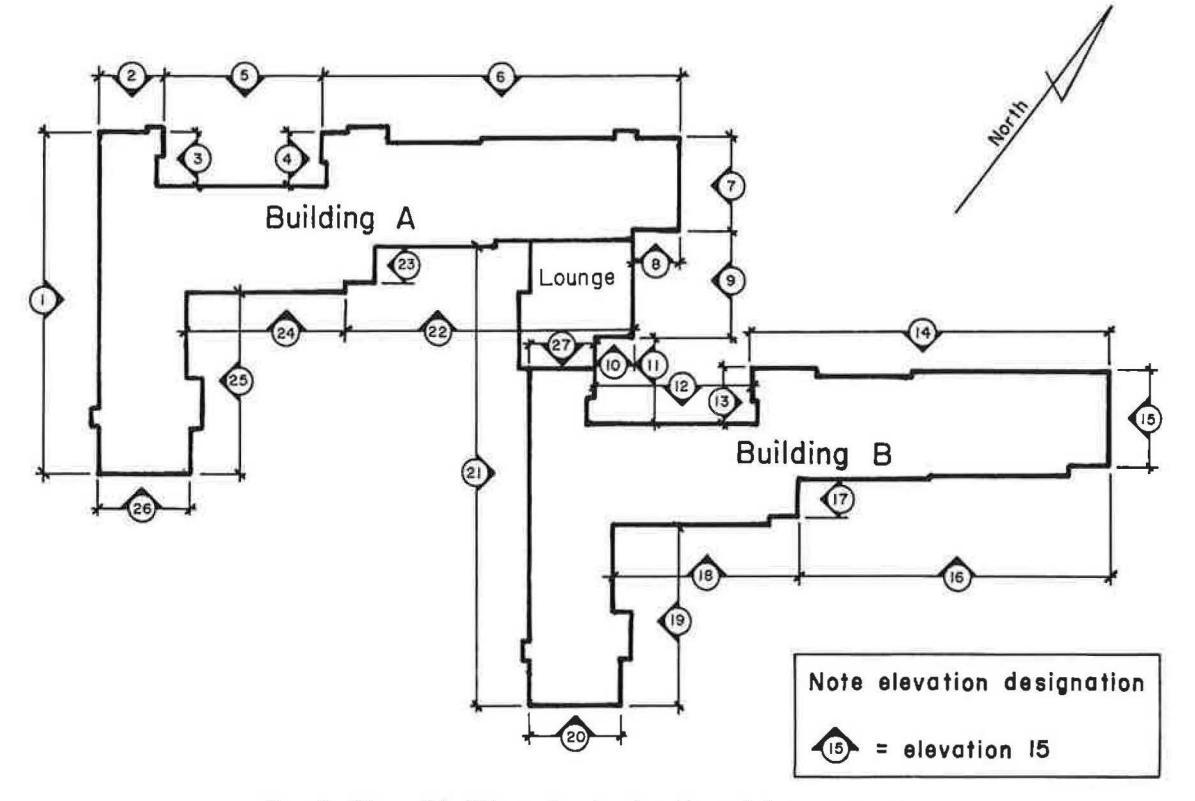
FIG. 3. Plan of buildings showing location of damage maps.

Detailed spalling maps were produced for each of the elevations (Fig. 3). Figure 4 illustrates such a map for a badly distressed region of elevation 15. The map is based on visual observation with the help of binoculars. The coating painted onto the wall can stretch considerably before tearing, therefore the onset of brick spalling can remain hidden for some time. This means that the amount of spalling is likely to have exceeded that recorded visually. Figure 5 shows photographs of the distressed region shown in Fig. 4. The damage there is typical of other badly deteriorated areas (about 5% of the total wall area).

- All elevations displayed some spalling distress. This included exterior brick piers supporting balconies.
- The most serious spalling occurred at NE elevations.
- The frequency of spalling increased near openings such as windows and at corners.

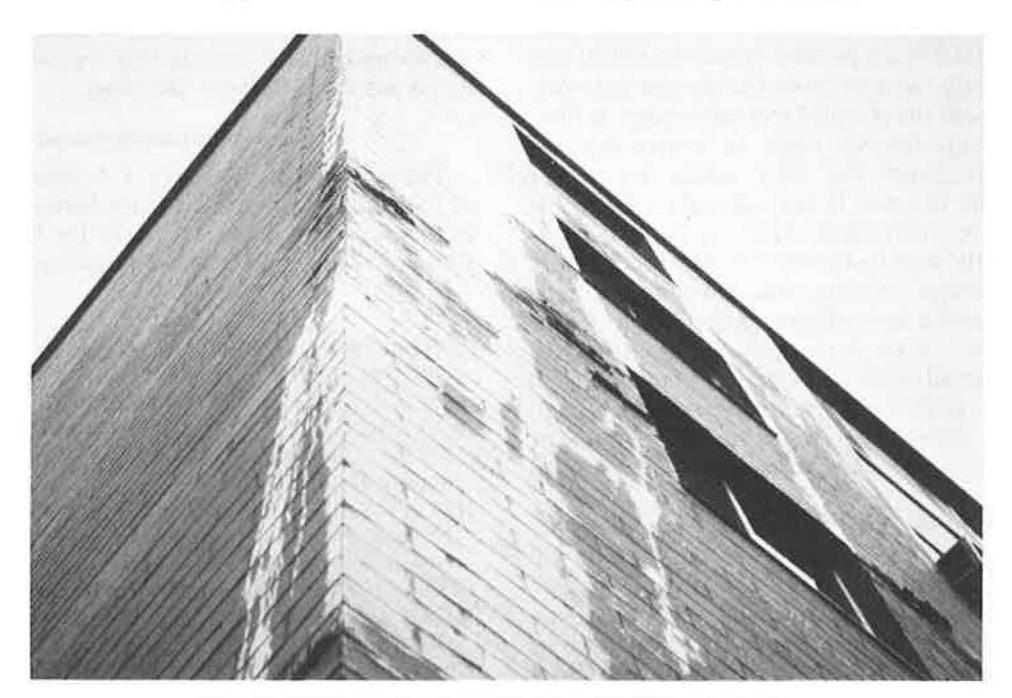
FIG. 6. Wetting pattern on elevation 15 (NE exposure).

and Baker 1975). Tests in Ottawa also showed that, during the winter months, bricks facing east and north had a high moisture content while those facing south and west had a low one (Ritchie and Davison 1968; Crocker 1970). These factors explain why most damage occurred on the NE elevations of the walls. Figure 6 shows a typical wetting pattern on a NE elevation. The monitoring also indicated that rain had the largest effect on the moisture levels in the wall. This is confirmed by the badly damaged balcony piers which could only have received their moisture from an external source such as rain. Prevailing winter winds from a WNW direction cause net outward air pressures on the ESE exposure. In upper floors, these outward pressures can combine with those of stack effect to produce exfiltration of moist air. However, the building was not pressurized (the apartments use electric baseboard heating). The monitored area of the wall did not show any noticeable contribution from exfiltration except at a damaged corner of the wall where local delamination had occurred and the interior drywall was damaged. There, air exfiltration temporarily increased the moisture on the inside surface of the brickwork on calm days or with winds from a westerly direction.
