FIRE TEST OF A "TRI-SEAL" FLOOR AND CEILING ASSEMBLY

FIRE STUDY NO. 5

This report describes a fire test conducted on a "Tri-Seal" floor and ceiling assembly of the Gypsum, Lime and Alabastine Limited, on November 11, 1959. The test was requested by the Toronto Office of the Gypsum, Lime and Alabastine Limited.

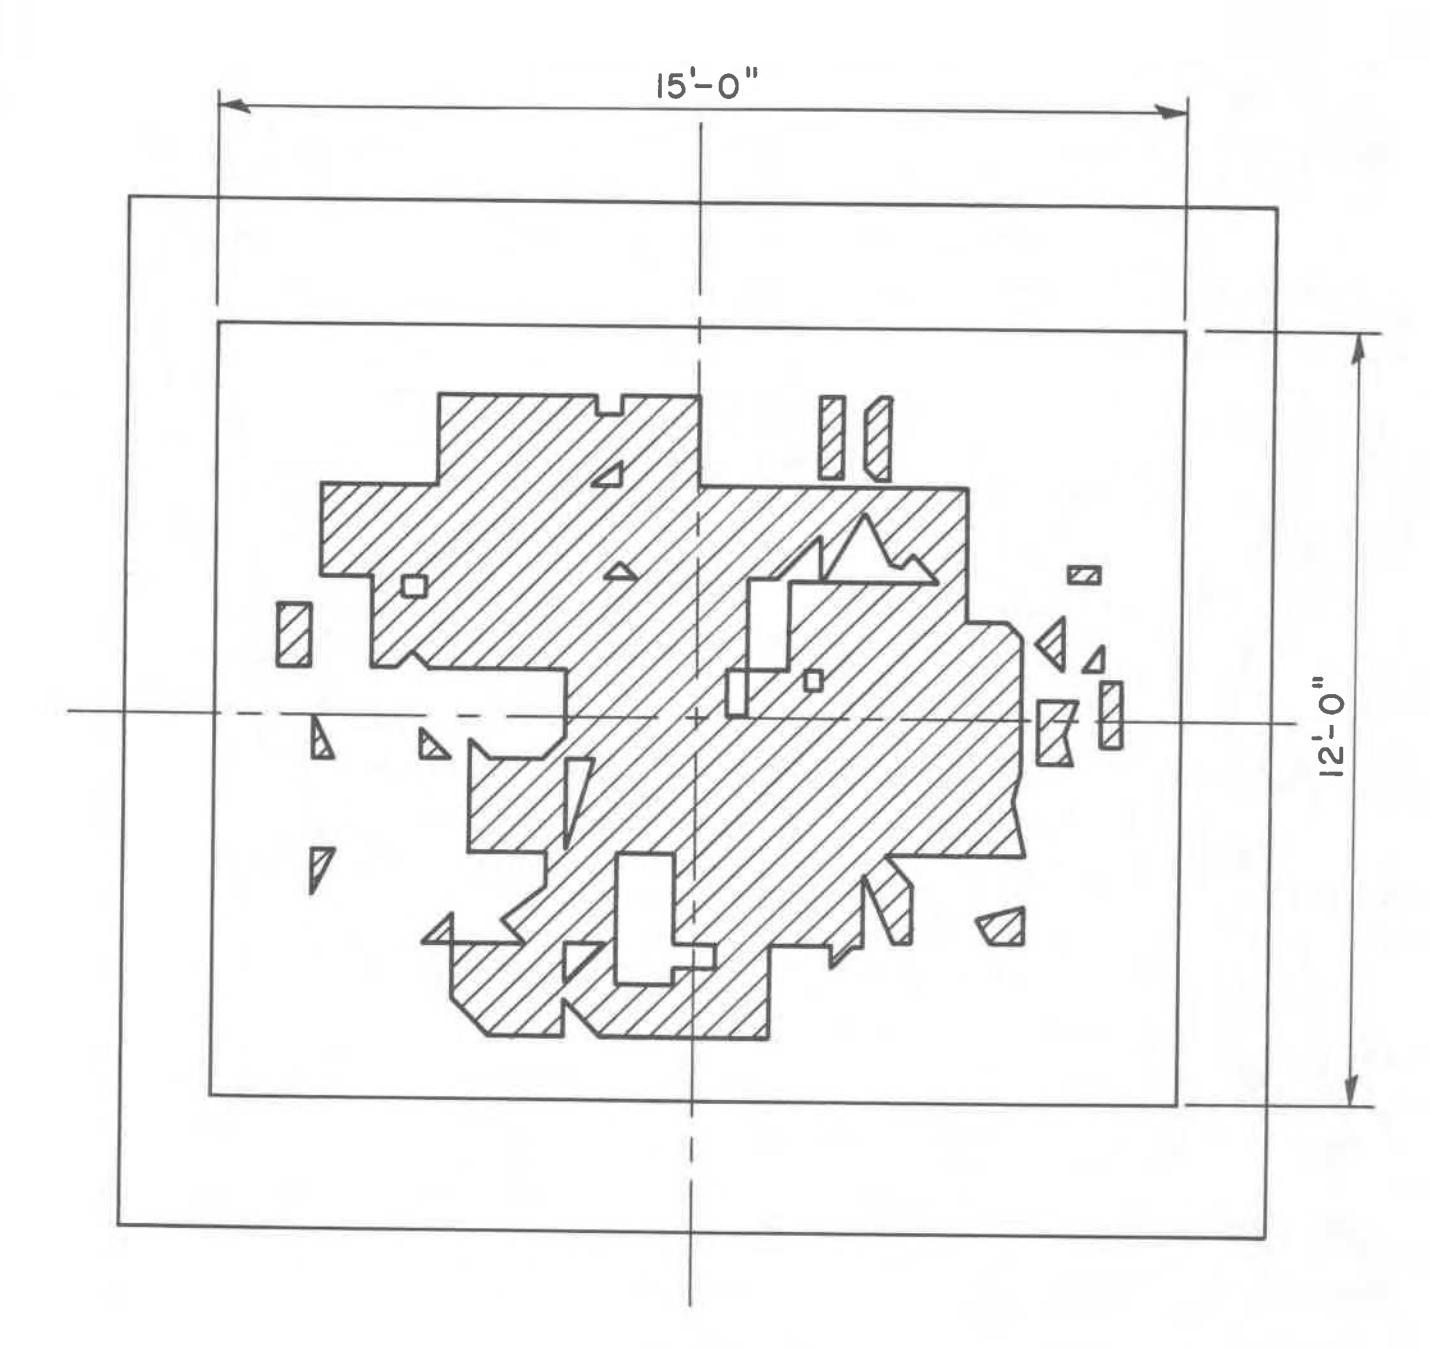
FIGURE 6

Figure 6 shows the state of the ceiling after the test. The diagram was reconstructed from two photographs taken immediately after termination of the test; one of these is shown as Fig. 12. The area of complete disintegration is cross-hatched. Within this area several fragments of gypsum lath and plaster were still hanging on the tie wires, but these pieces no longer constituted significant shielding for the steel joists.

THE STATE OF THE CEILING AFTER FIRE TEST (DISINTEGRATED PORTIONS CROSS HATCHED)

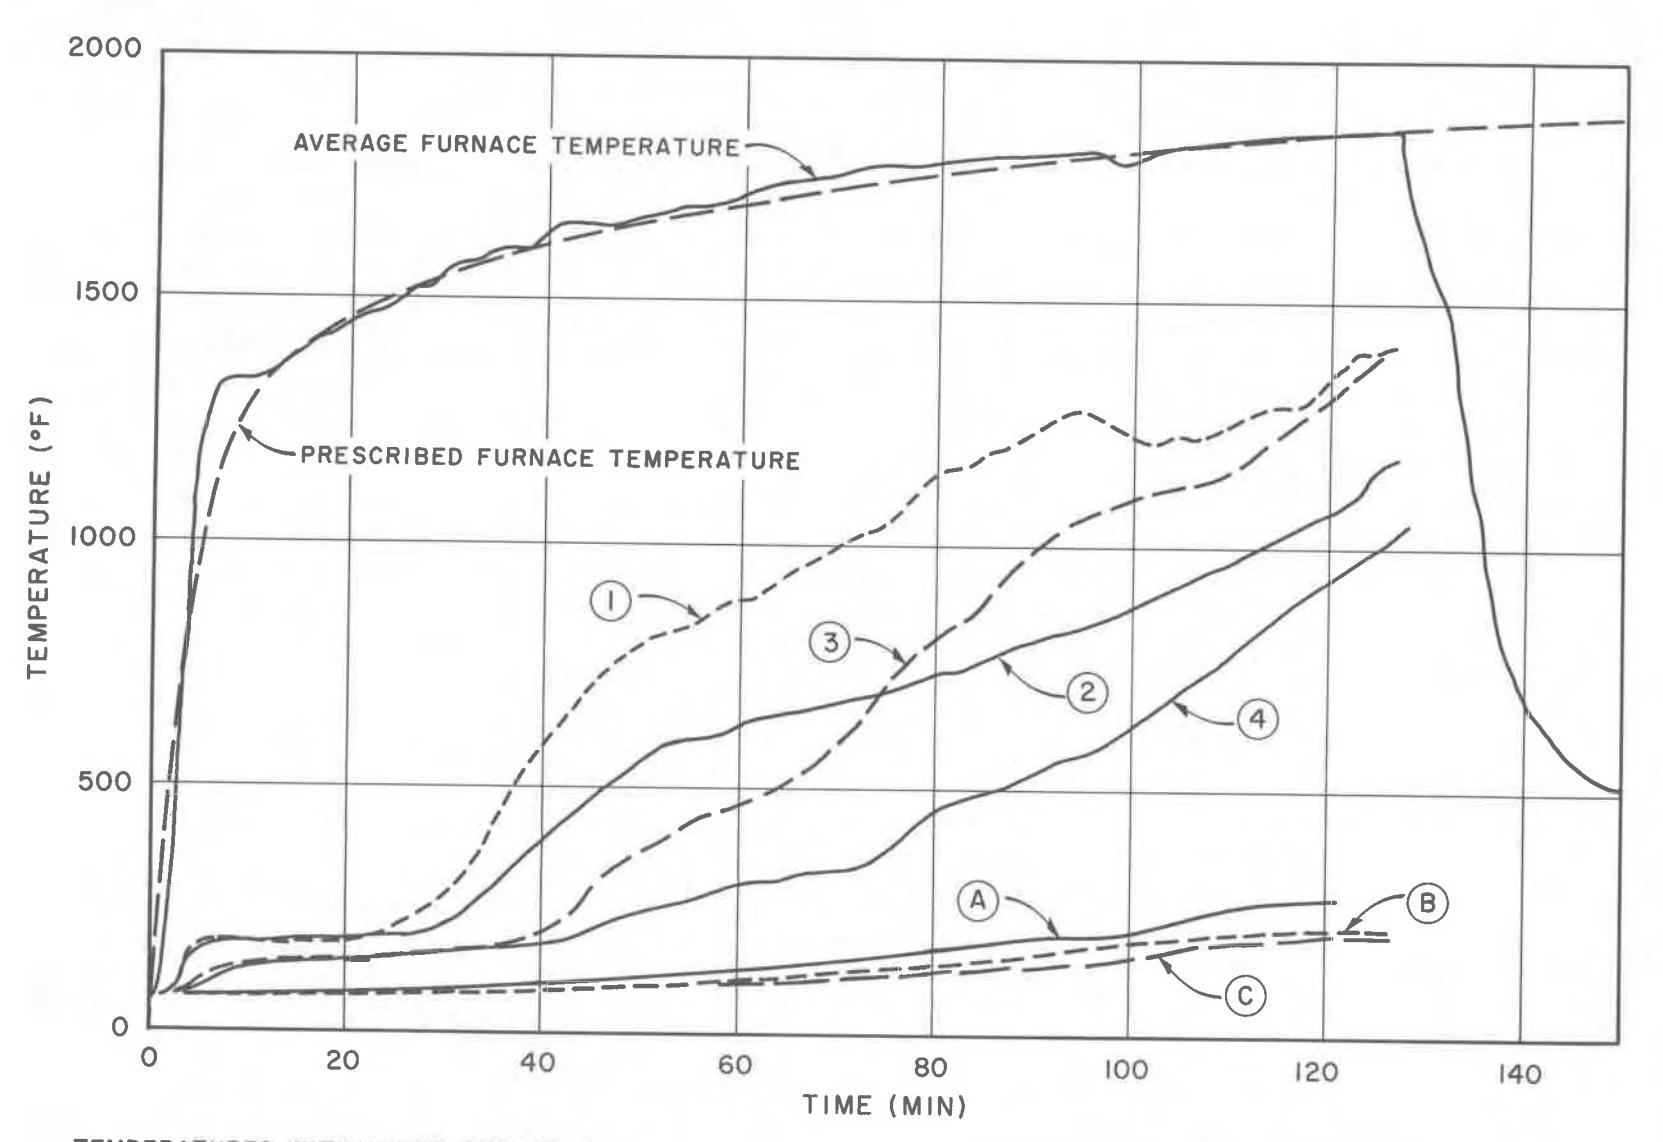
FIGURE 7 - TEMPERATURE MEASUREMENTS DURING FIRE TEST

Variation of the unexposed surface temperature was roughly indicative of structural disintegration of the ceiling construction. Where the disintegration developed more rapidly, moderately higher temperatures were recorded on the unexposed surface. In Fig. 7 the variation of both the average and the maximum temperatures of the unexposed surface are shown. Thermocouples cemented to the surface recorded somewhat lower temperatures, the average of which is also plotted in the same figure.

Temperatures obtained from various points in the interior of the structure showed a very remarkable spread. This was obviously due to the irregular disintegration of the plaster layer and the gypsum lath. Generally speaking, the thermocouples placed nearer the centre or the exposed surface recorded higher temperatures than those farther from the centre or the exposed surface. Characteristic curves are shown in Fig. 7.

Within ½ minute of the start of the test the finish plaster began to peel from the ceiling in large patches. In other places moisture stains appeared on the surface. After 12 minutes the base plaster coat commenced to crack along the "Tri-Seal Loop Channels". Cracks gradually opened to a 4-inch width as the pieces of gypsum lath and adhering base coat began to sag. After 25 minutes other cracks running at right angles to the previous ones, mostly at the joints of the pieces of gypsum lath, also appeared. Where the various pieces sagged differently, these latter cracks grew rapidly, and at 27 minutes the first gap on the ceiling, about 1 inch in width, became visible. In quick succession other gaps formed and at 35 minutes the first larger section of the gypsum lath, approximately 16 by 36 in. in size, fell off the ceiling together with the adhering base coat. The gap and hole formation on the ceiling marked the beginning of a rapid temperature rise inside the ceilingfloor assembly, as may be seen in Fig. 7, and resulted in an increased rate of deflection (Fig. 8).

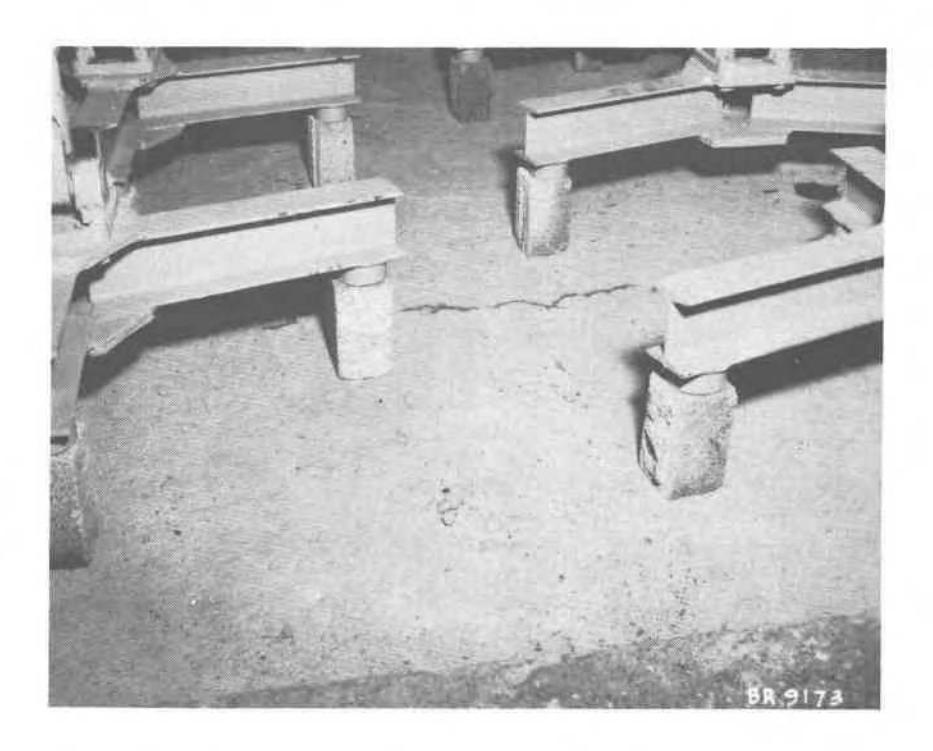
The floor and ceiling assembly was of ordinary good workmanship. During the conditioning period several cracks developed on the surface of the concrete slab; the largest continuous crack was approximately 30 in. in length and 1/16 in. in width.

As mentioned earlier, several cracks were observed on the surface of the concrete slab before the test. After 80 minutes a number of other cracks gradually developed, from some of which steam was issuing. At such places where the surface was below boiling point, the steam partly condensed in the cracks and slowly filled them up with moisture, as is shown in Fig. 11.

Figure 11 Development of cracks on the unexposed surface

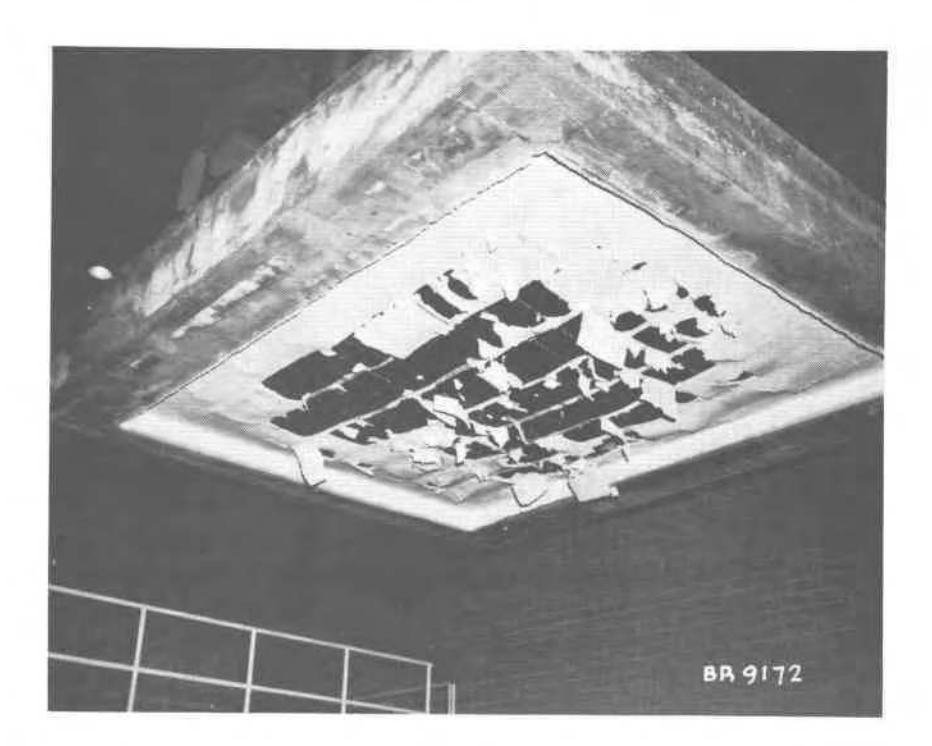
As may be seen from Fig. 12, the base coat adhered very well to the gypsum lath throughout the test. The two layers acted as a single unit, apparently because of the perforations of the lath. It may also be seen that the tie wires played an important part in the fire endurance of the structure. They held the pieces of plaster and gypsum lath in position even after most of their strength had been lost, and in this way, though indirectly, protected the load-bearing steel joists from the radiating heat.

Figure 12 The specimen after the fire test
