Toronto fire of 1904

Shorter, G. W.

Fire Study (National Research Council of Canada. Division of Building Research), 1964-03

FIRE STUDY NO. 13

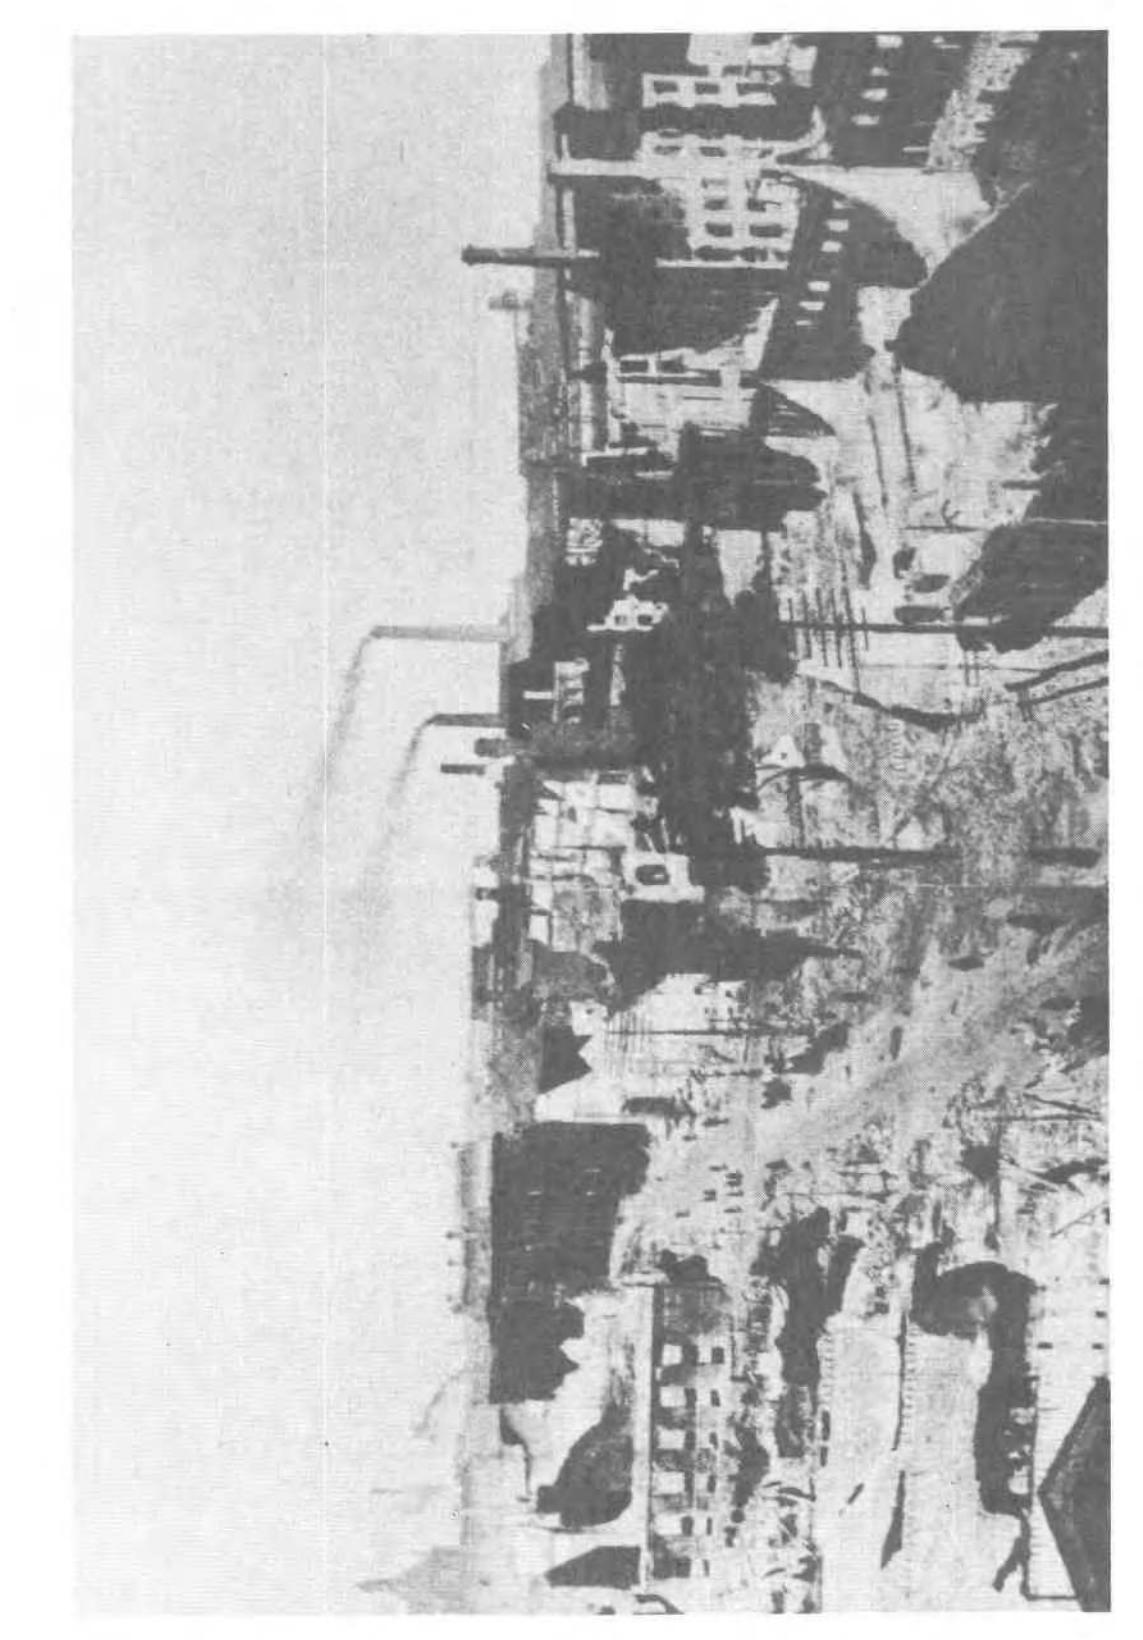
DESTRUCTION COMPLETE FROM LORNE ST. TO NEAR YONGE ST.

VIEW (FOLLOWING FIRE) LOOKING EAST ALONG FRONT ST.

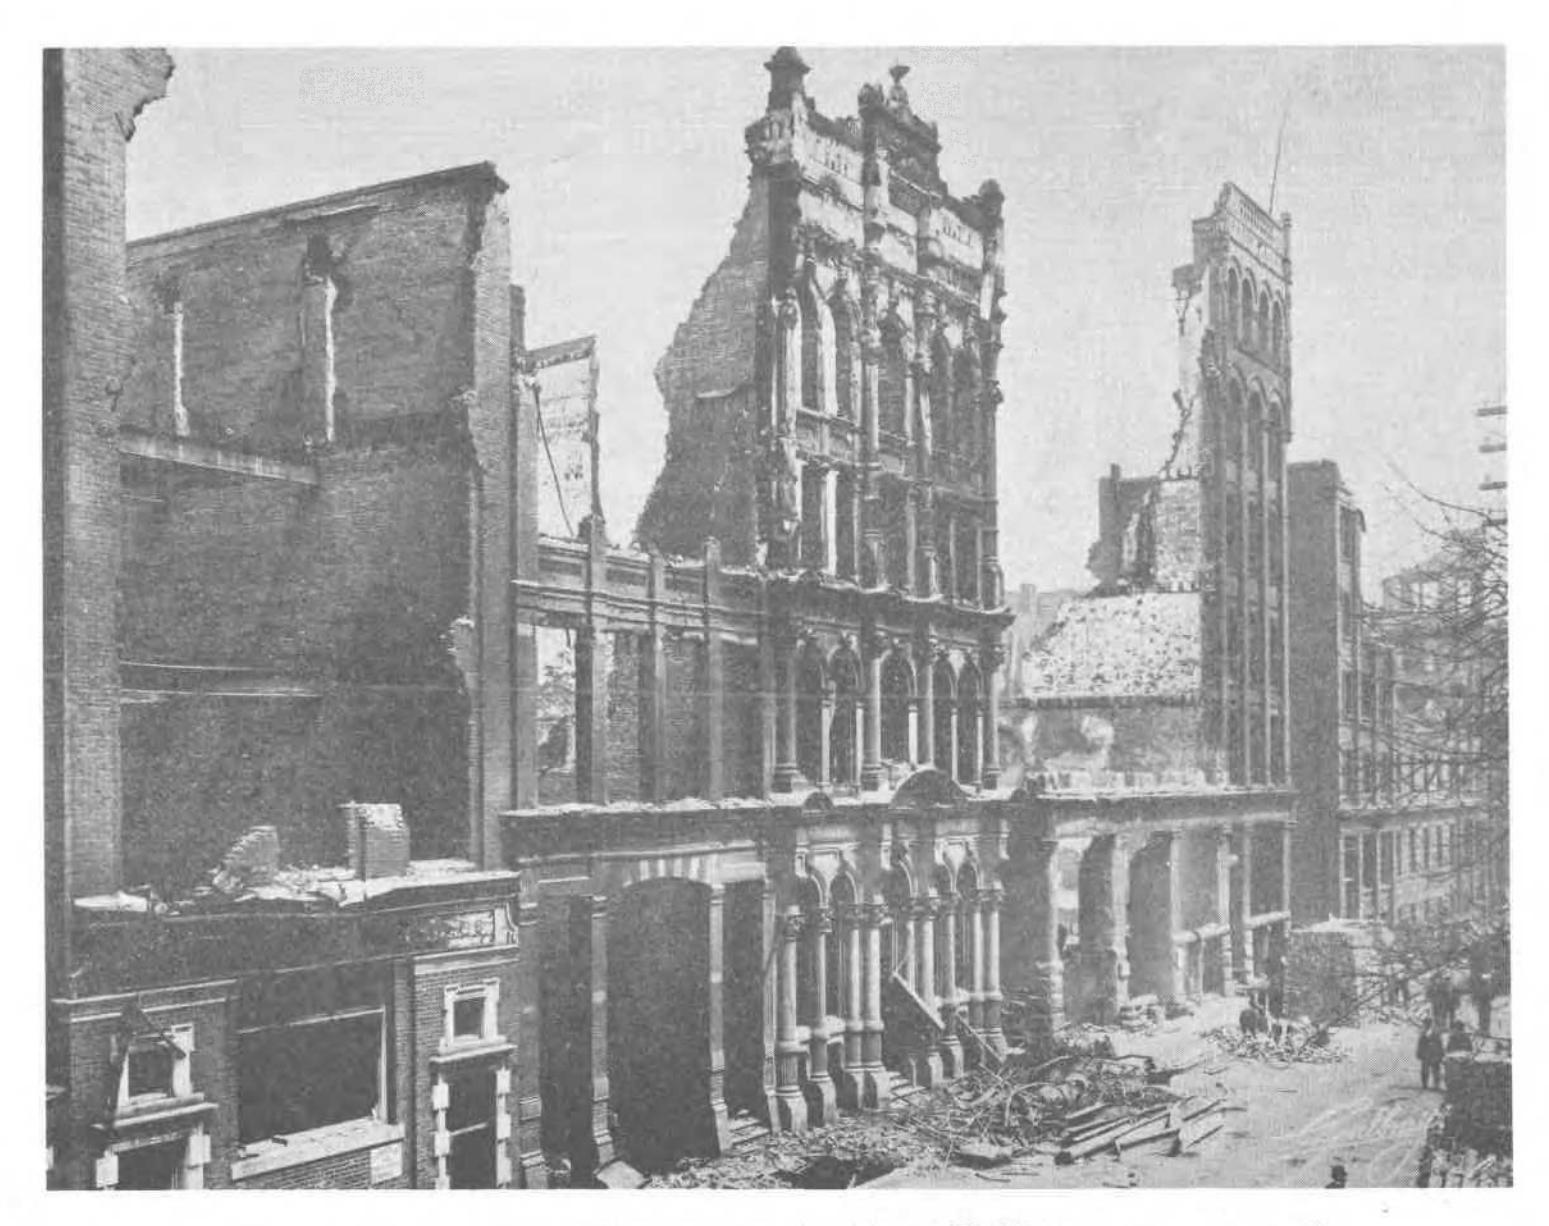
Figure 1 View of buildings on north side of Wellington St., west of Bay St. following fire. Fire started in 4-storey building (Currie) in centre of photo.

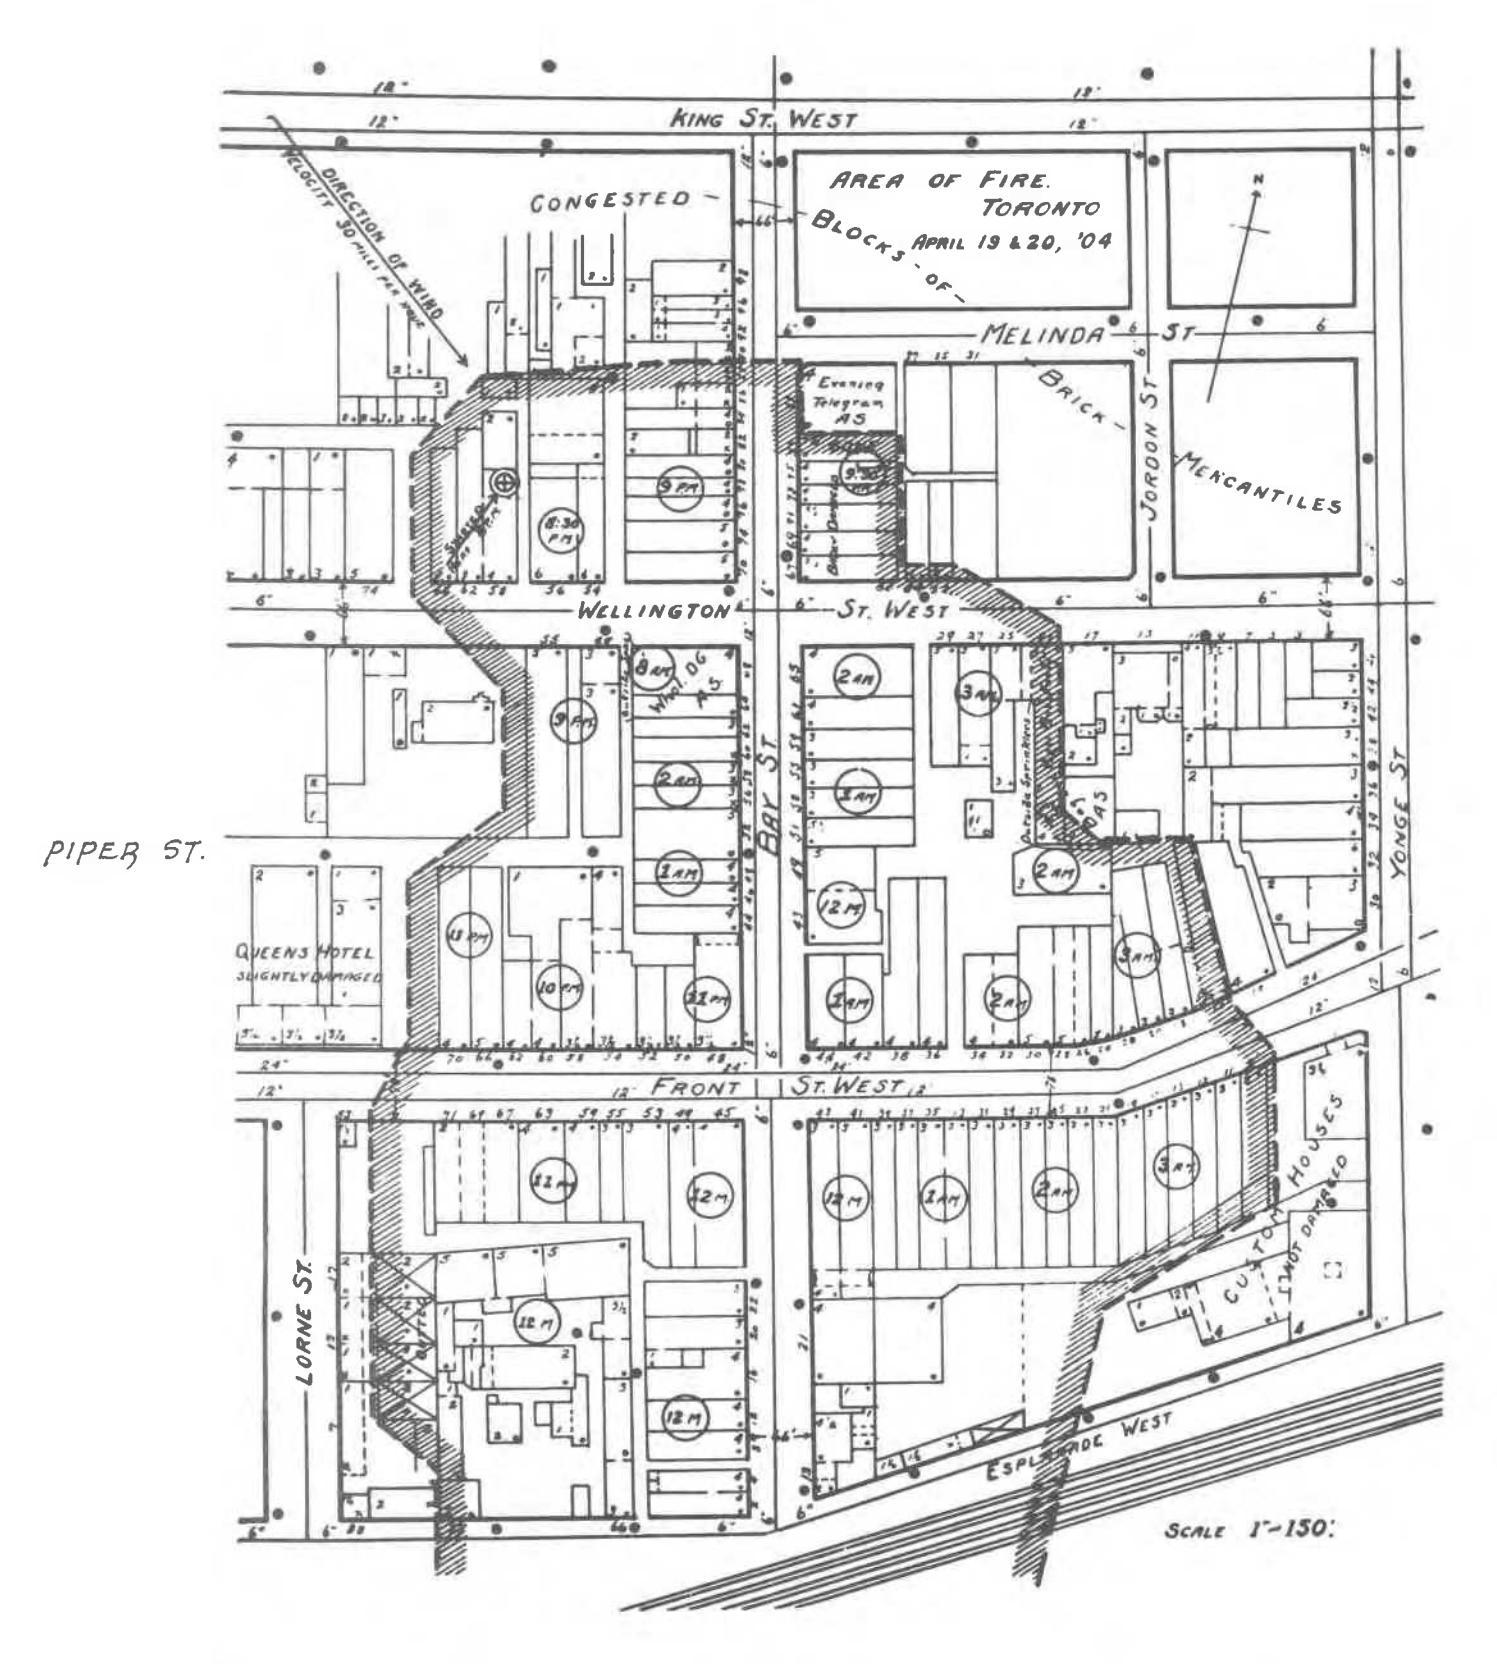
With both the Currie and the Gillespie-Ansley buildings now burning the fire began to spread rapidly to other buildings in the immediate area. The times at which the various groups of buildings began to burn are shown in Figure 2. Fanned by the high wind the fire spread from building to building with such rapidity that within an hour at least 12 separate structures were ablaze with street widths offering no bar to the fire's progress.

The development of the fire may be studied by using the plan shown in Figure 2. The fire crossed Wellington St. which is 66 ft wide, and swept in a very short time from end to end of the warehouse and book bindery of Brown Bros. and Co., 55 Wellington St. and the lithographing establishment of Rolph Smith and Co., 49 Wellington St. (Figure 3). It then spread south across Piper St. and the courtyard (which is about 40 ft in width) to the warehouses on the north side of Front St. The fire was prevented from spreading further in an easterly direction on the south side of Wellington St. by the action of the sprinkler systems installed in the Brock Building at the southwest corner of

Figure 2 Plan of fire area, showing place where fire started and times (figures in circles) when various groups of buildings were burning. (photograph courtesy N. F. P. A.)

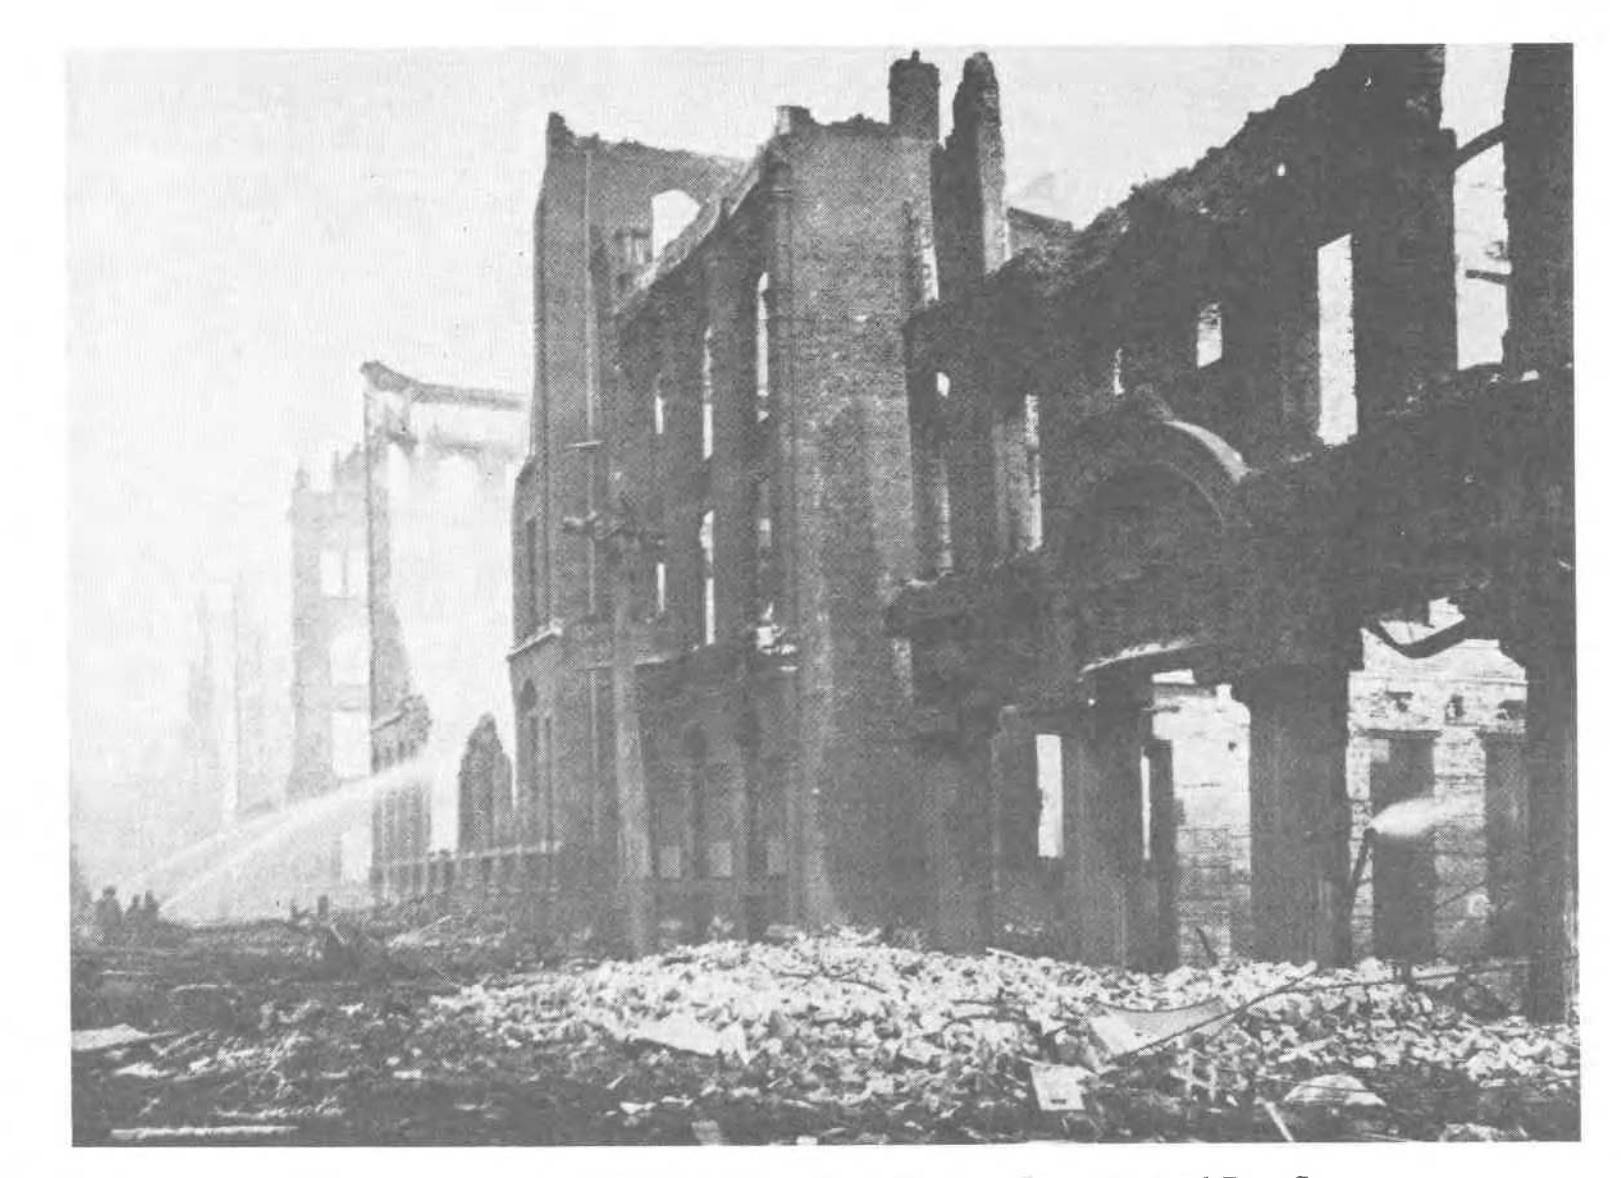
Figure 3 View of south side of Wellington St., west of Bay St. following fire. These buildings were opposite the Currie Building where fire started. (photograph courtesy Public Archives)

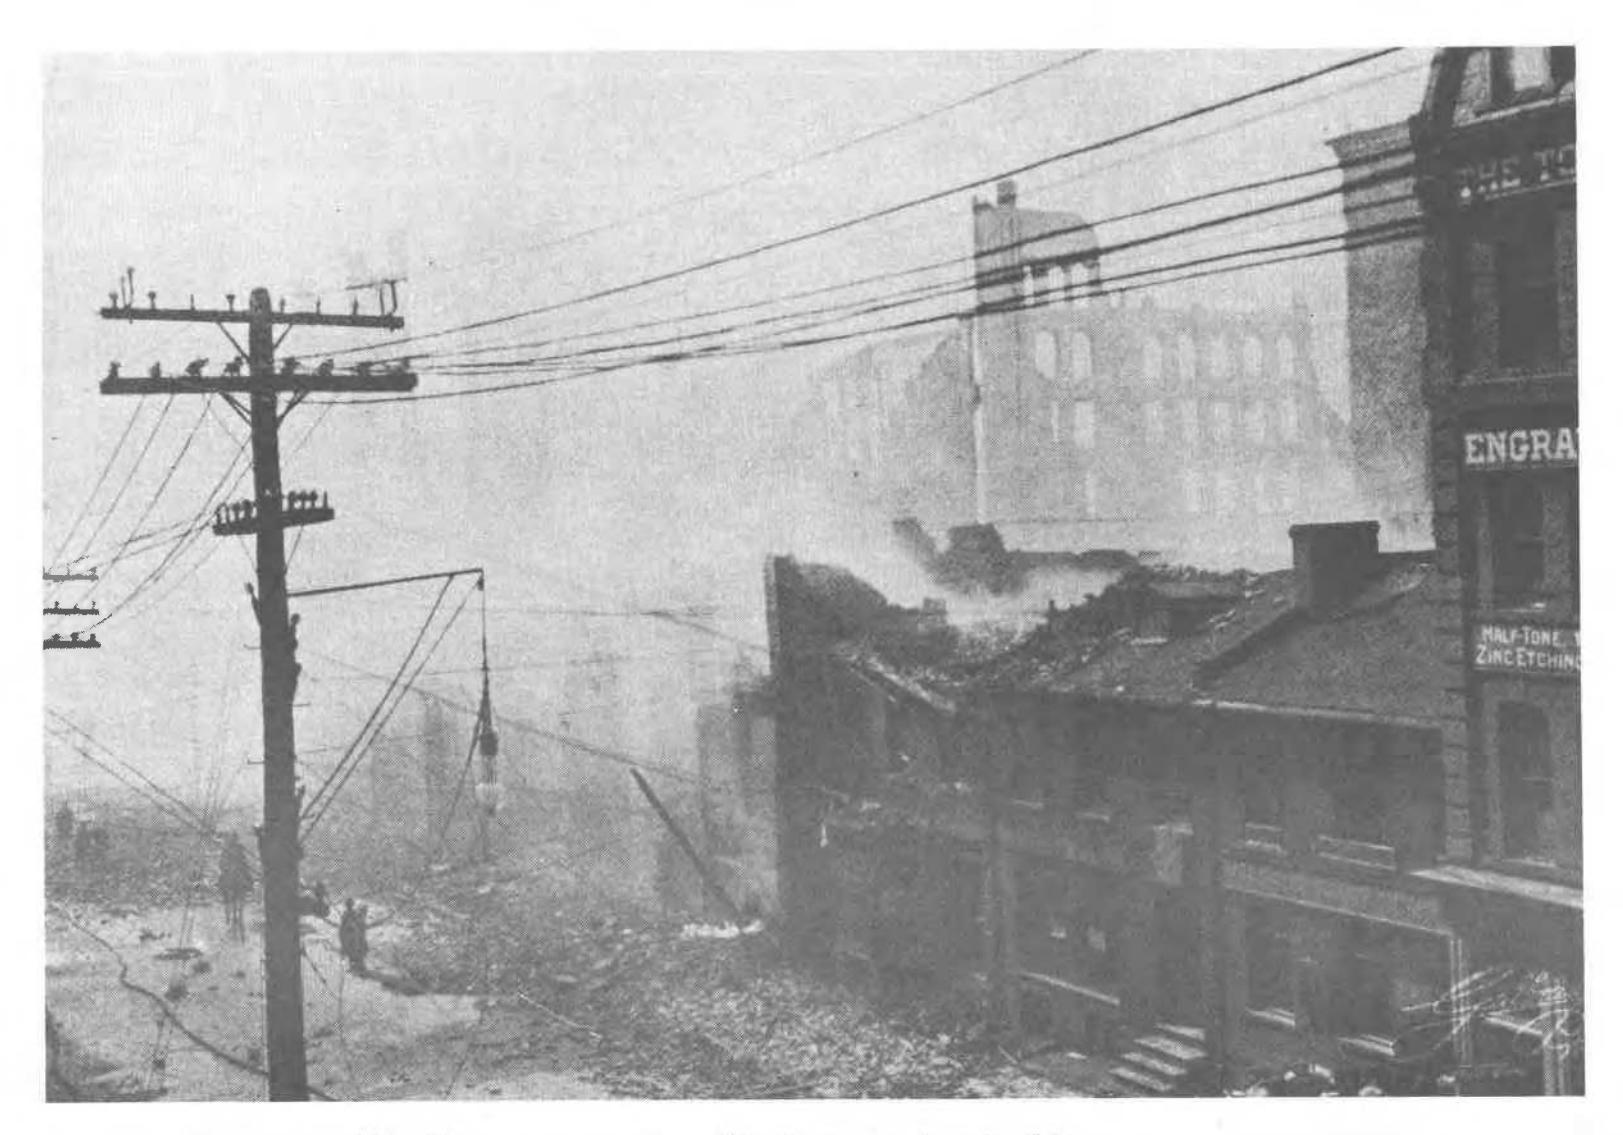
In its earlier stages, the fire had spread up the west side of Bay St. as far as the Toronto Engraving Co., 92 Bay St. (Figure 4). On the east side of Bay St. the fire had been held at the Evening Telegram Building, 81 Bay St. at the corner of Melinda St. This building was also equipped with a sprinkler system but, although the front of the building was badly damaged, the fire was successfully fought with inside hand hose and no sprinkler heads opened. Good work was done at this building with a length of hand hose attached to a roof hydrant.

Figure 4 The fire swept up Bay St. to some low buildings next to the Toronto Engraving Co. These low buildings enabled the firemen to stop the northward progress at this point. (photograph courtesy Public Archives)

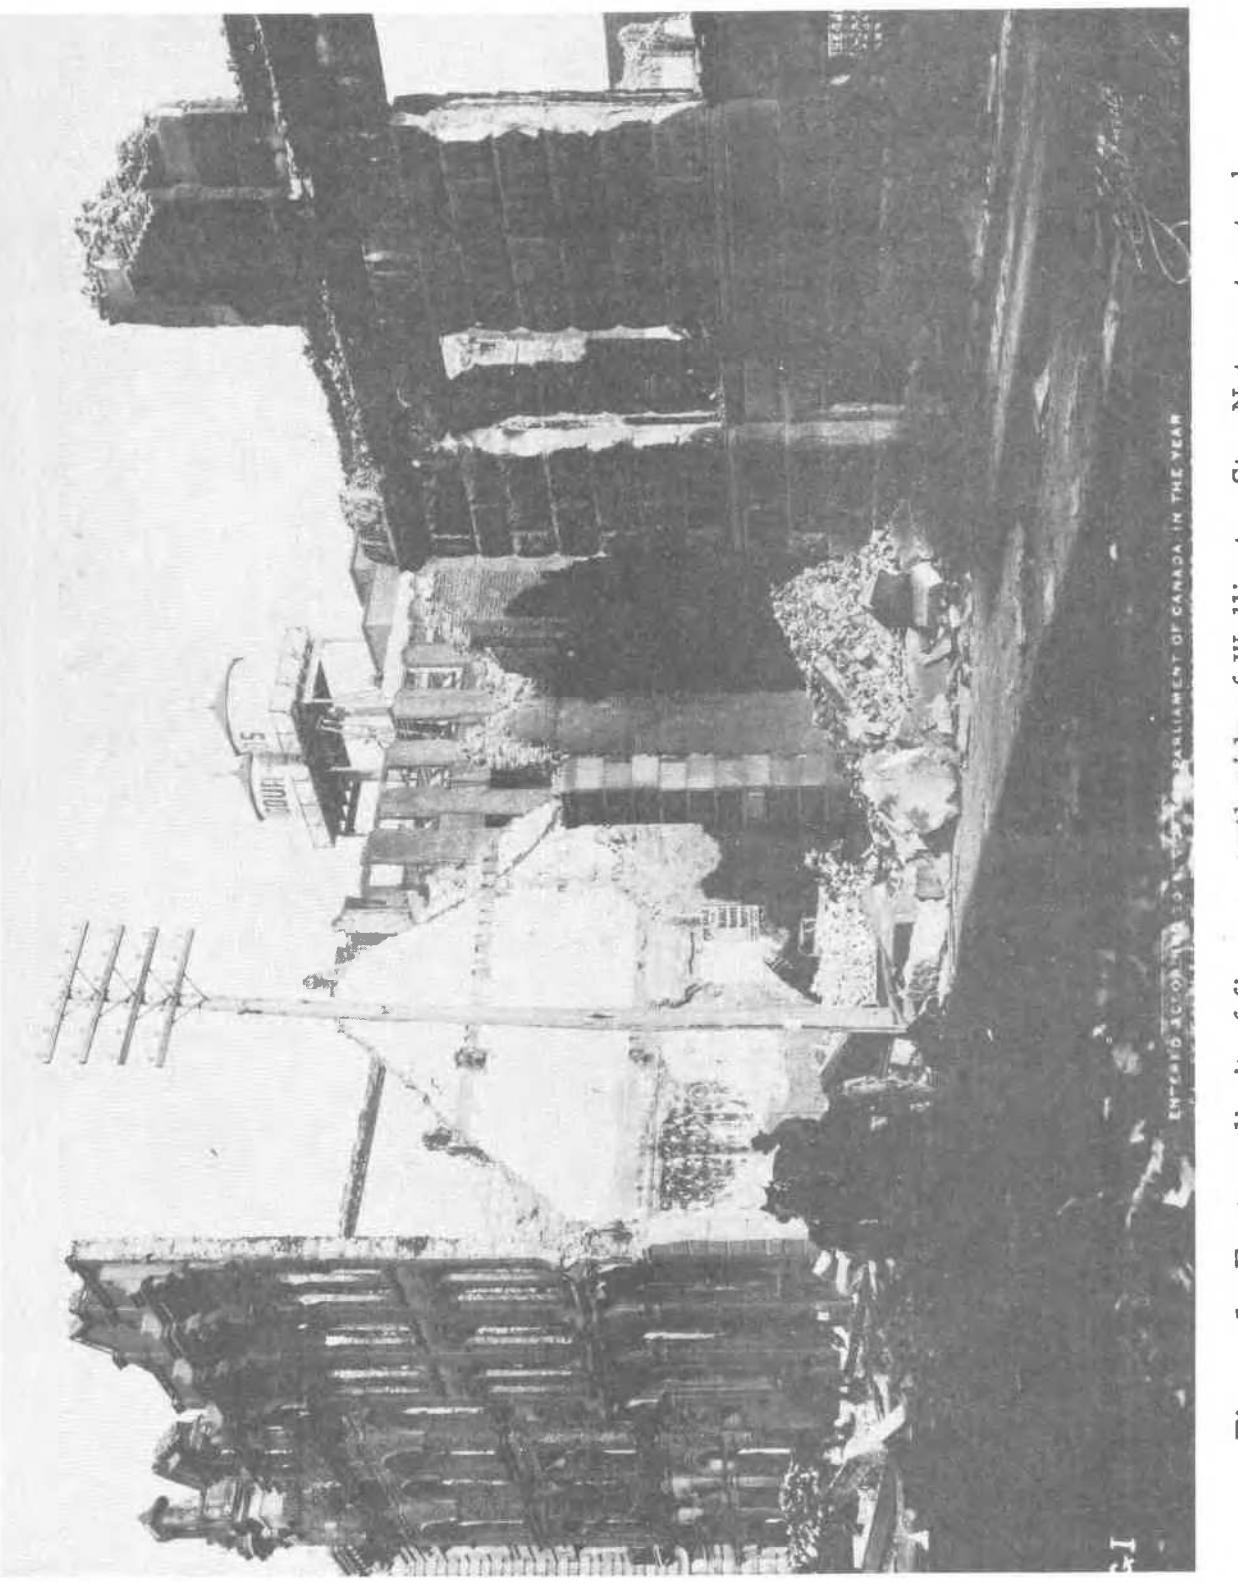
When the warehouses on Wellington St. east of Bay St. were reached, the wind was unfavourable to its further progress and the firemen were able to make a stand, preventing the conflagration from crossing Wellington St., but not without considerable damage to the buildings on the north side of that street. The fire was finally controlled at the envelope factory of Kilgour Bros. on the south side of Wellington St. The sprinkler system and water curtains installed at the Kilgour Bros. Bag and Box Factory, 21 Wellington St., played a most important role in the fire's control. Water for the inside automatic heads was provided by two gravity tanks (Figure 5) and by city water connections, while the outside heads were supplied by city water and an auxiliary steamer connection. In this instance the sprinkler systems functioned in much the same manner as those at the Brock Building. The exterior sprinklers continued to function effectively until the pressure was reduced (the steamer connection was not used) to a point where water was not supplied to the heads at the upper windows. The result was that the roof of that portion of the building fronting on Wellington St. and extending 200 ft to the south was completely burned with serious damage to every window. The inside sprinklers fed by the two large gravity tanks, however, continued to operate after the mains' pressure failed. The operation of this sprinkler

installation together with a system of good division walls prevented the fire from involving the whole structure.

Eastern limit of fire on south side of Wellington St. Note water tanks (photograph courtesy Public Archives) on roof of Kilgour Bros. Building. Figure 5

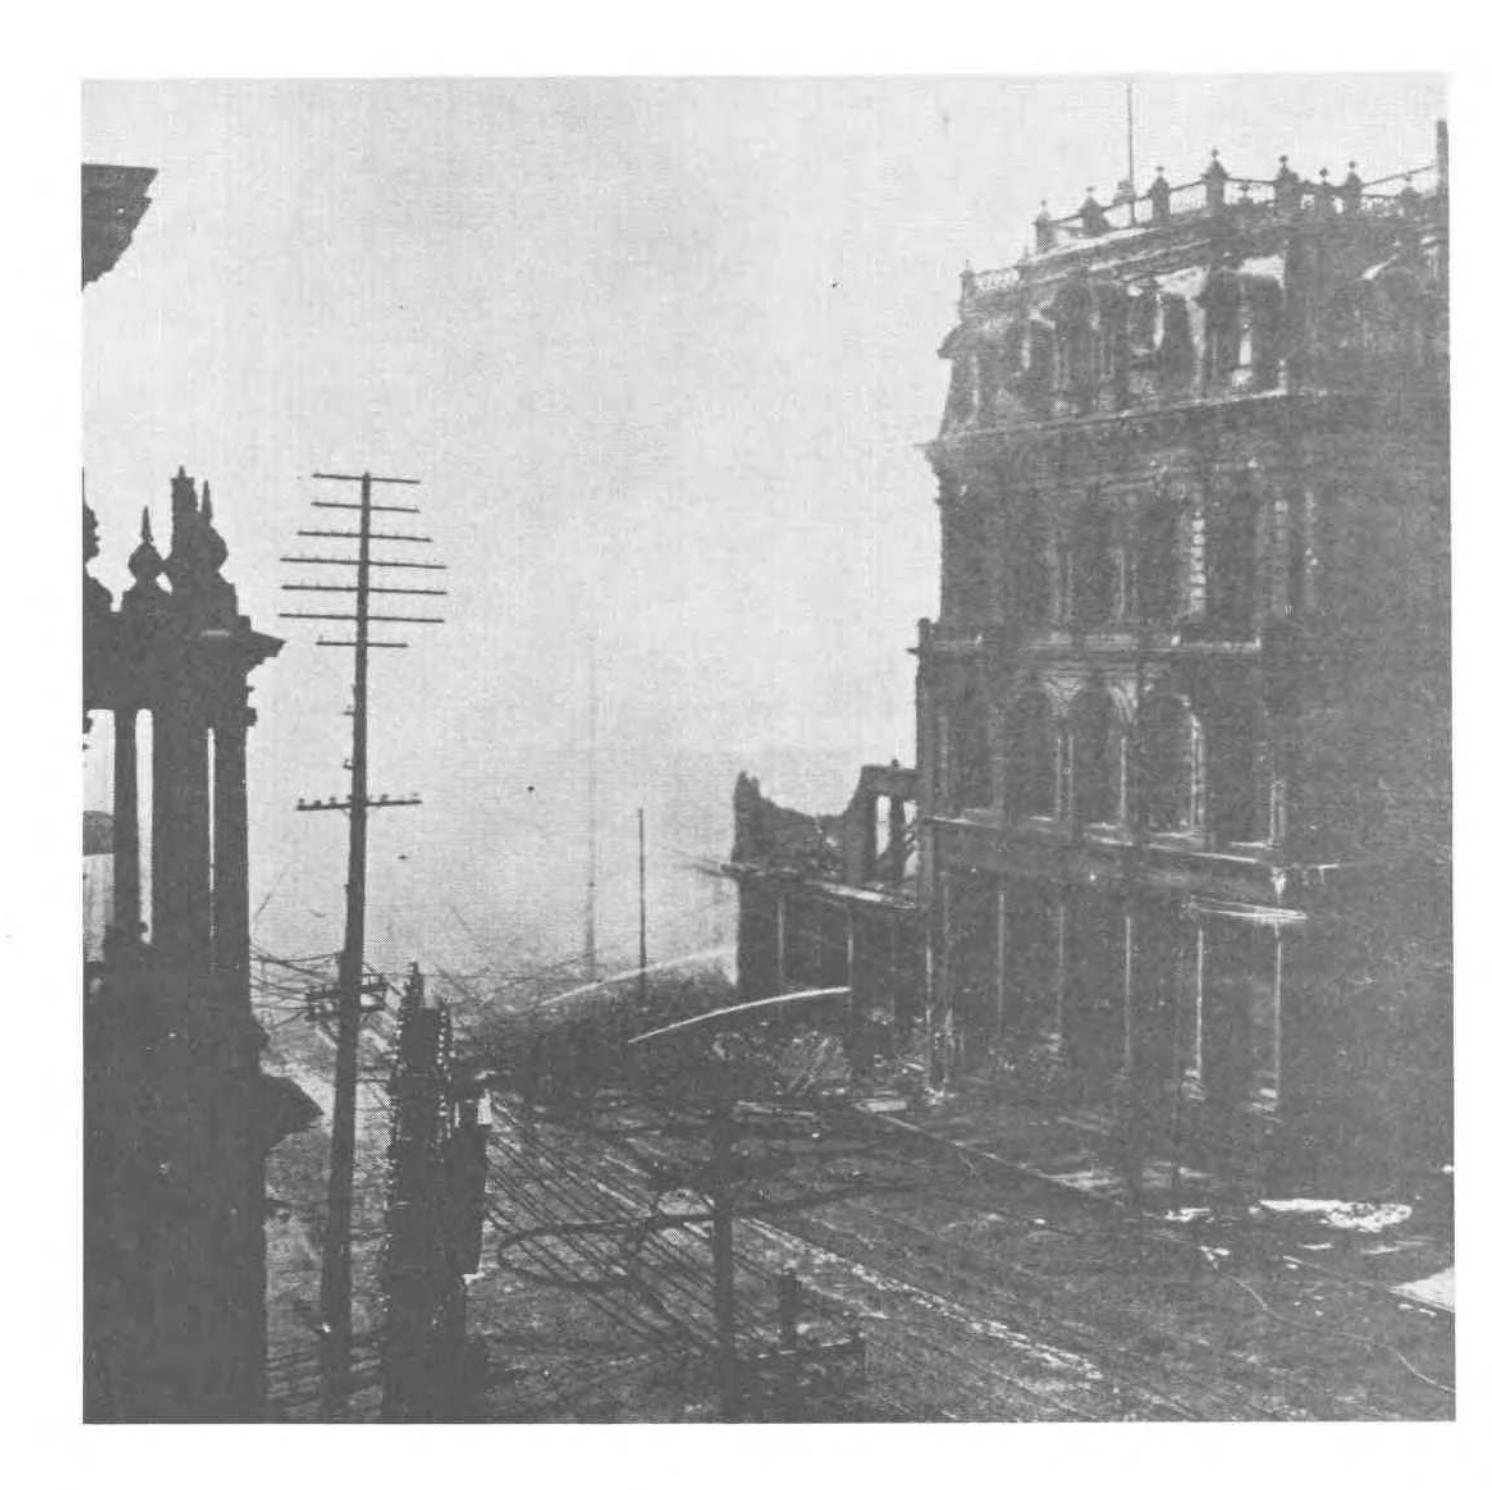
The eastward advance of the fire on the north side of Front St. was stopped at the Minerva Building, 12 Front St. (Figure 6). On the south side of Front St. nothing interfered with its progress, all the buildings up to and including the premises of McMahon, Broadfield and Co. (wholesale crockery dealers) were destroyed. This point marked the extreme eastern limit of the fire, a space of about 25 ft separating the last mentioned building from the Customs House and examining warehouse, neither of which were damaged. The Customs House had been chosen as one point for a last stand but so overcome were the firemen by heat and smoke that for a time it appeared as though the vantage point had been selected too late; they hung on, however, and made a desperate stand at the Minerva Building to stop the eastward spread of the fire. The fire had spread south by this time to the wharves on Lake Ontario and boats had moved out into Toronto Bay for safety.

Figure 6 The Minerva Building which barred the progress of the fire on the north side of Front St., near Yonge. (photograph courtesy Public Archives)

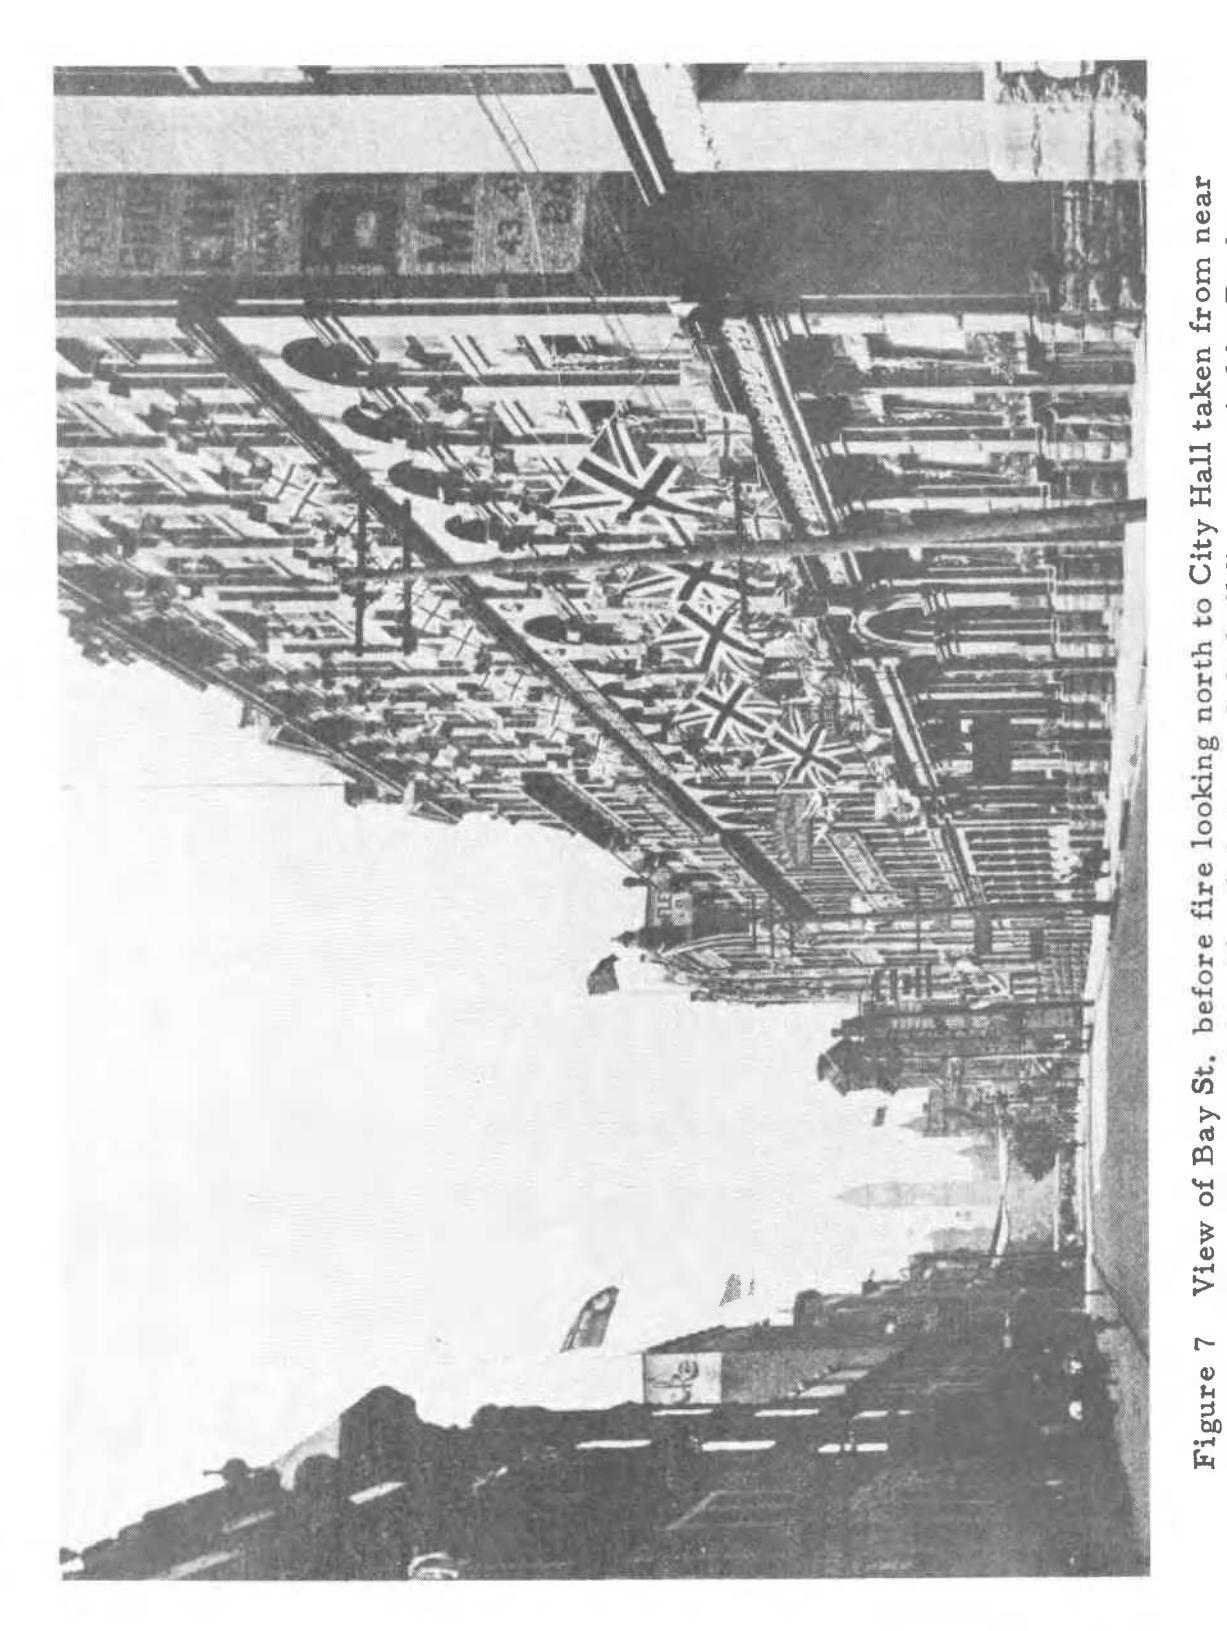
Front St. At right side of photograph is building occupied by Barber and Ellis Co. to which fire spread across Bay St. around midnight. (photograph courtesy Public Archives)

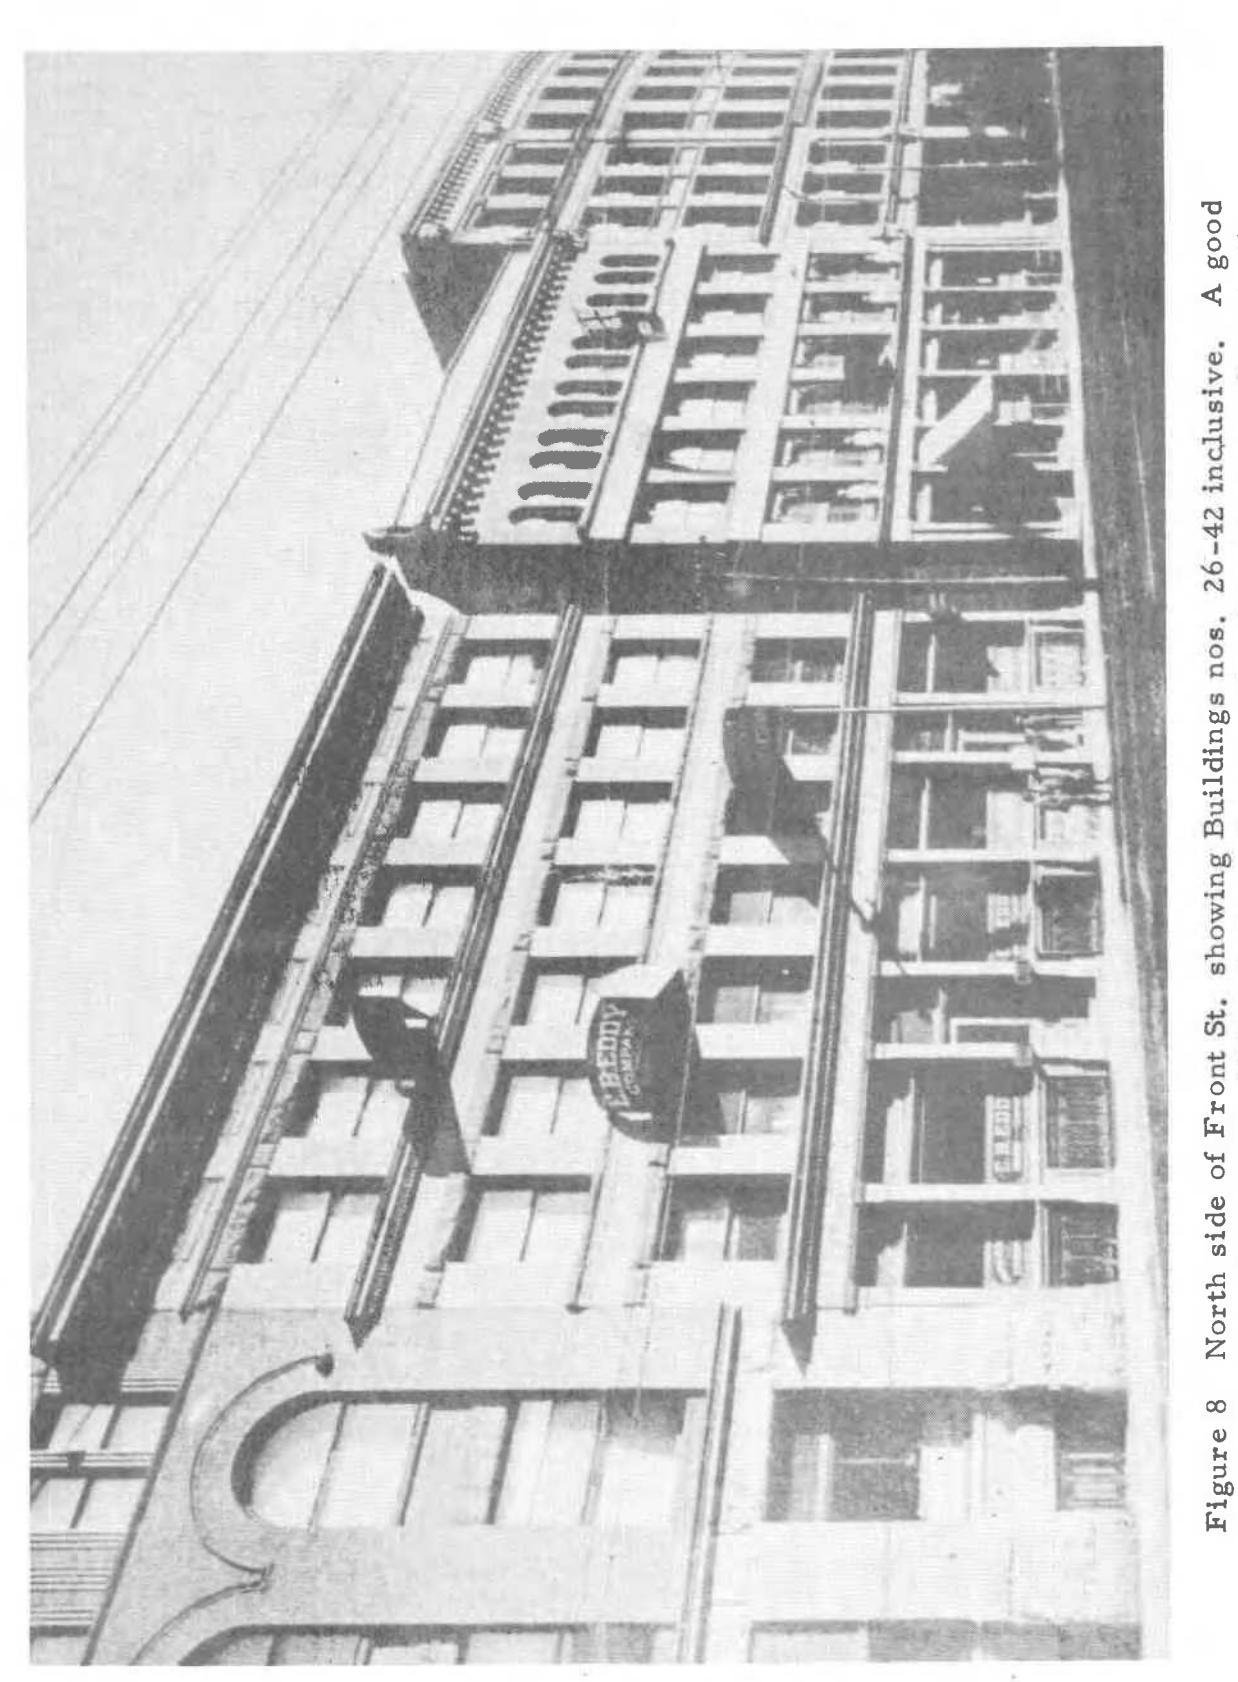
to one across which fire jumped early in its history. All buildings shown view of type of building destroyed. Also showing a narrow alley similar North side of Front St. showing Buildings nos. 26-42 inclusive. A good in this view are entirely gone.

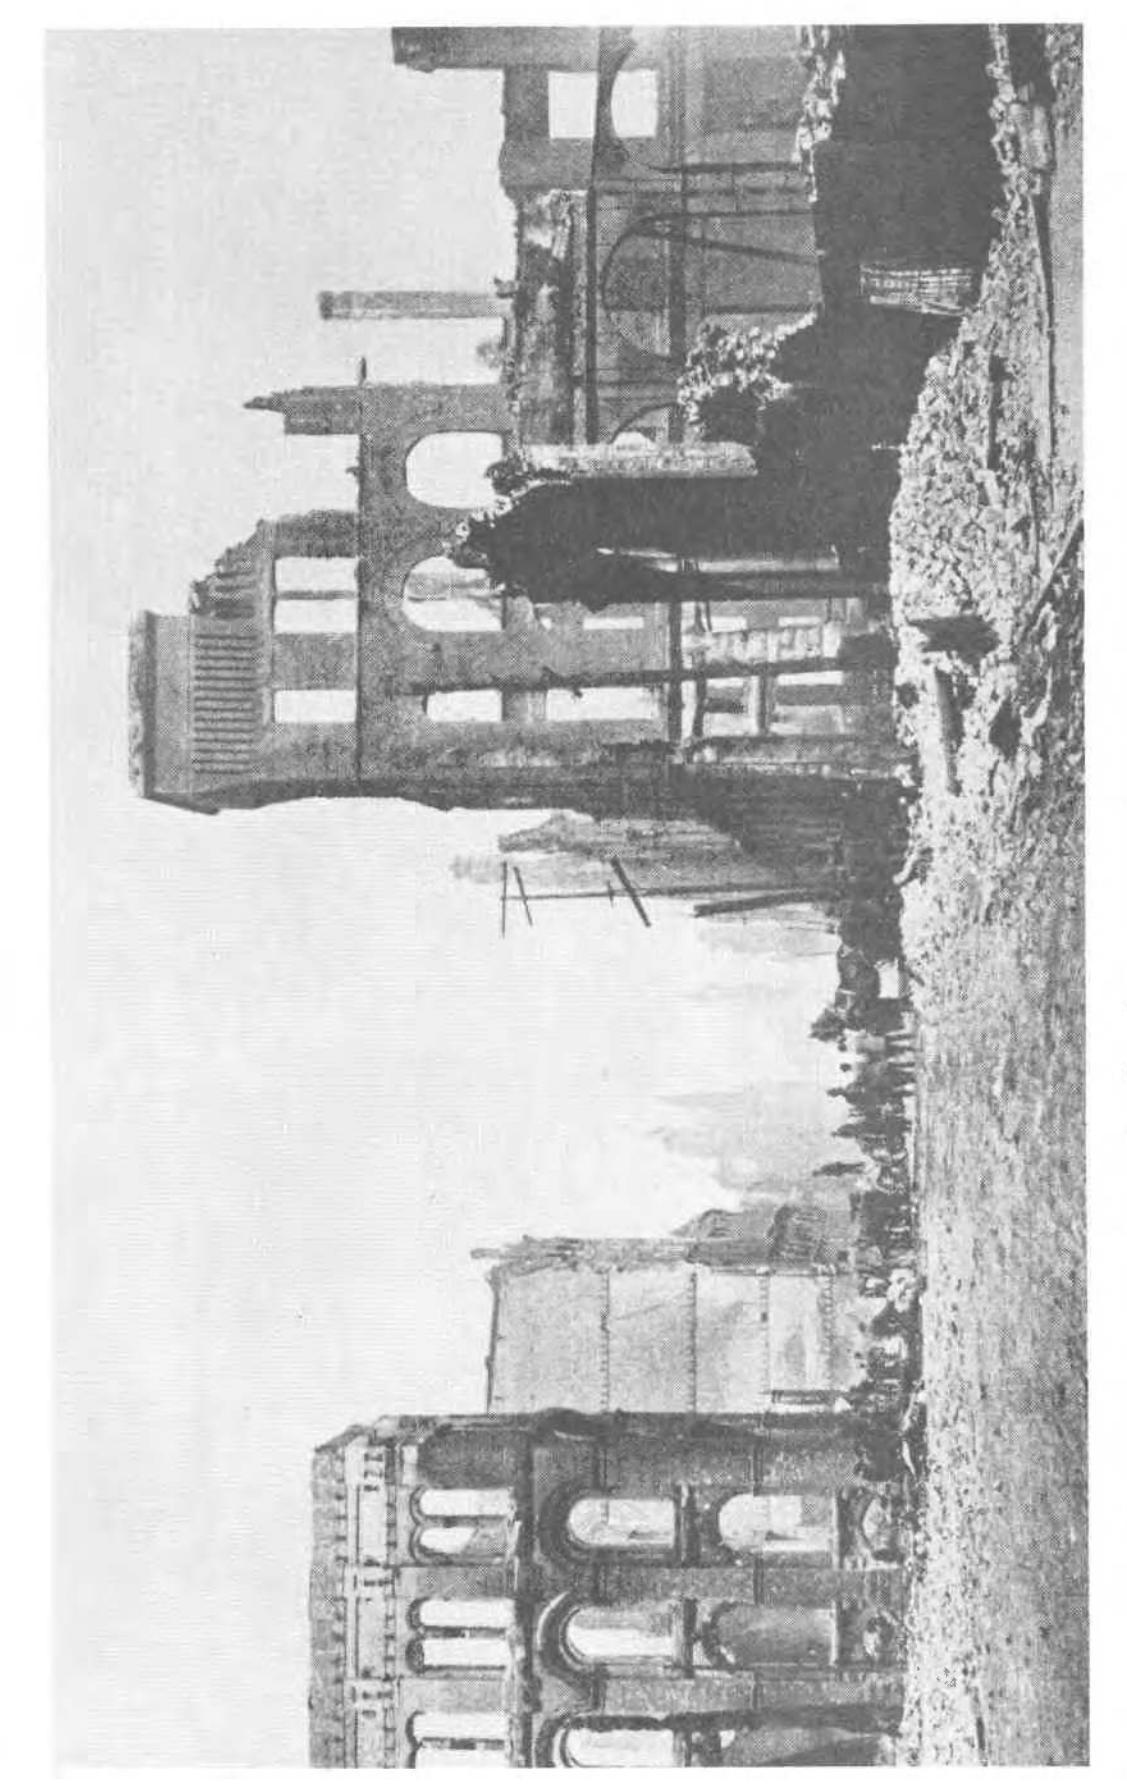
Figure 9 shows the severe damage suffered by the massive masonry buildings shown in Figure 7. Undoubtedly the lack of effective compartmentation between storeys due to inadequate fire resistance of floor assemblies and absence of protective enclosures at vertical openings was the major construction deficiency.

The Bay St. after the fire (approximately same view as in Figure 7). impressive masonry buildings now lie in ruins. (photograph courtesy Public Archives) Figure 9
