Toronto fire of 1904

Shorter, G. W.

Fire Study (National Research Council of Canada. Division of Building Research), 1964-03

FIRE STUDY NO. 13

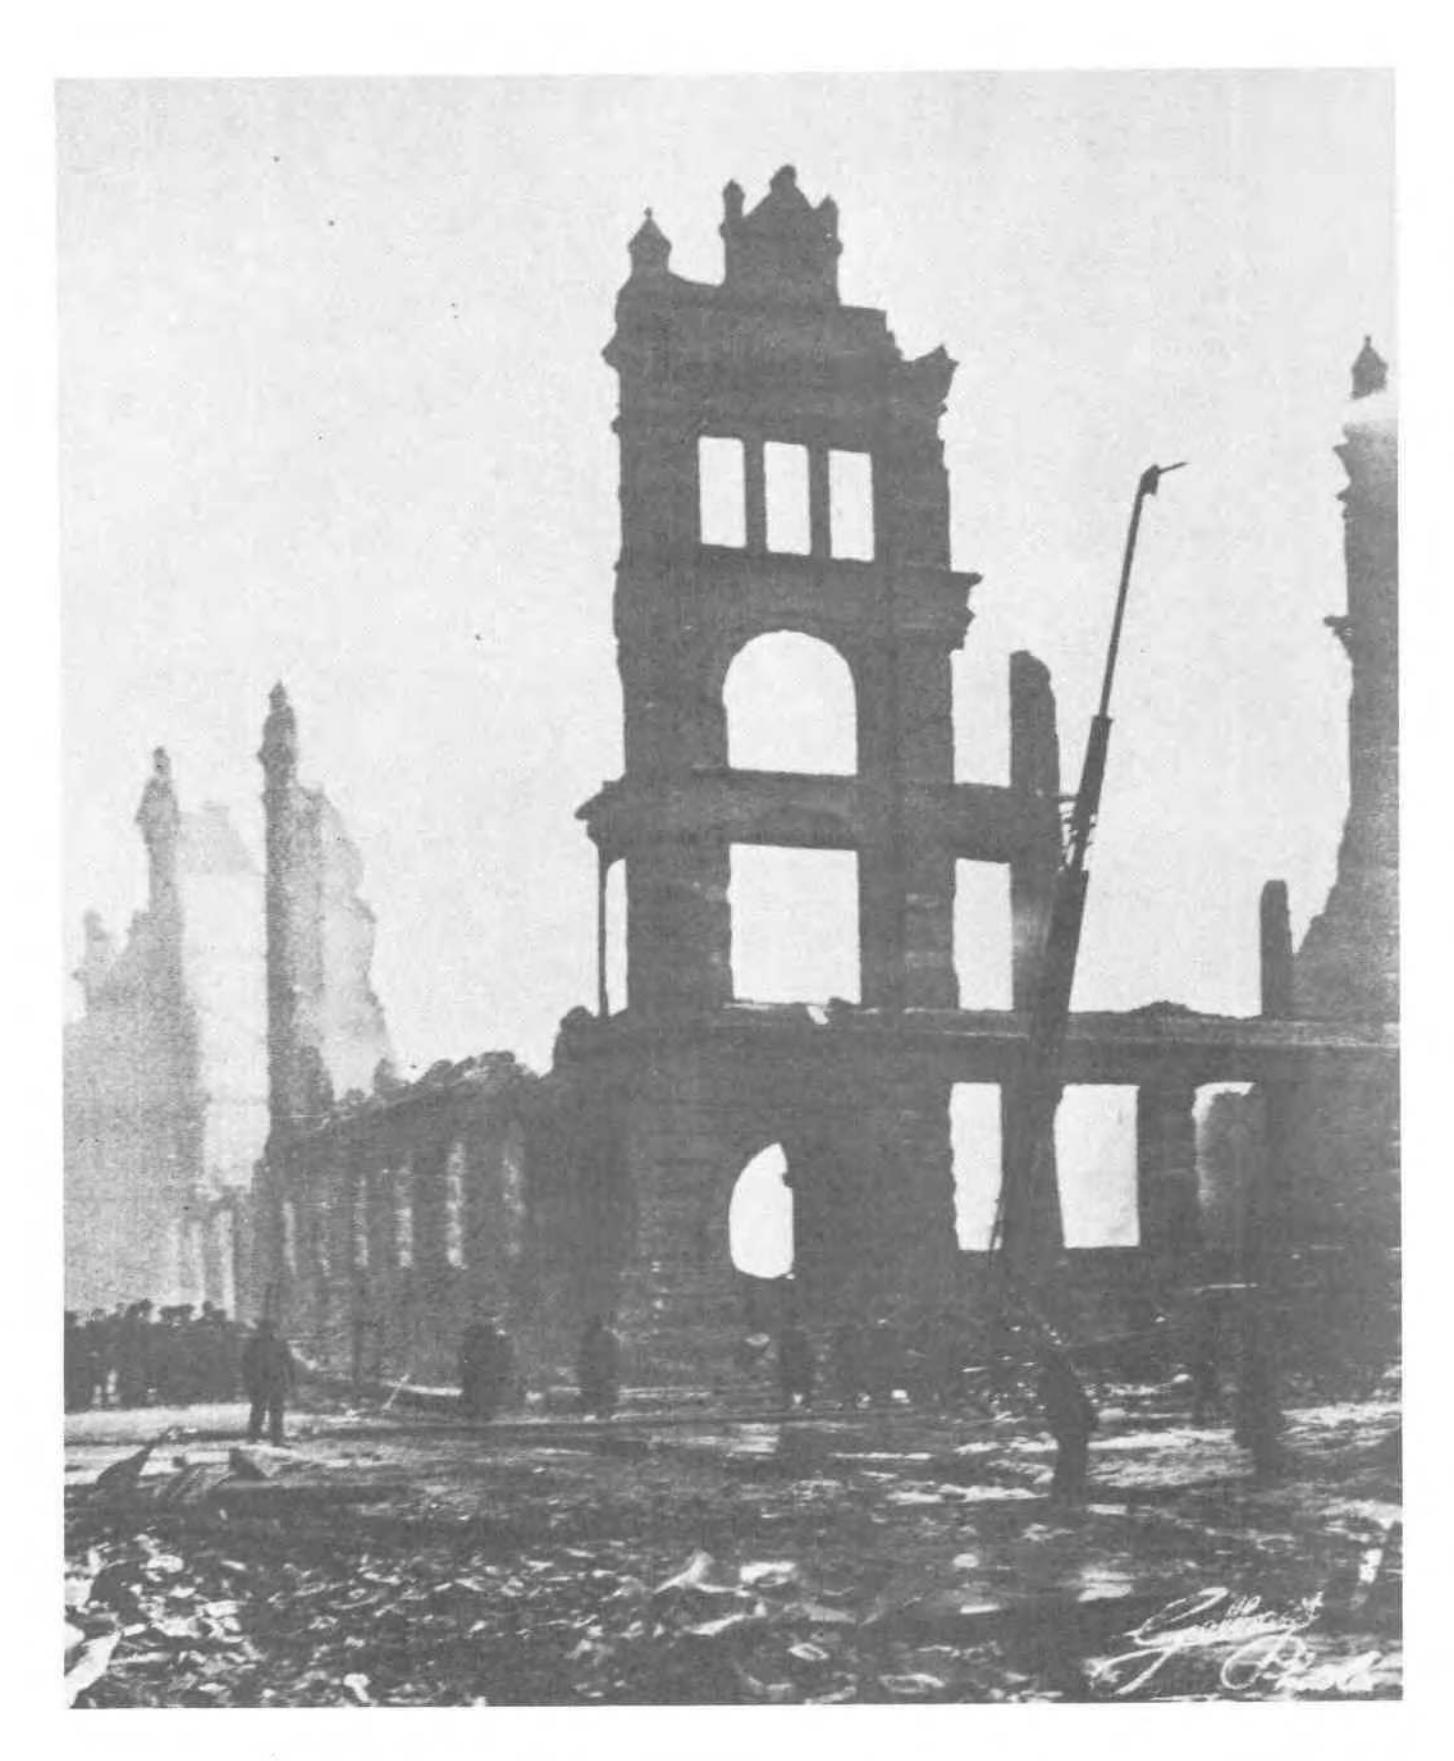
Figure 10 Corner of Bay and Wellington St. - water tower at work. (photograph courtesy Public Archives)
