## NRC Publications Archive Archives des publications du CNRC

### Report from Task 6 of MEWS Project: experimental assessment of water penetration and entry into wood-frame wall specimens: final report

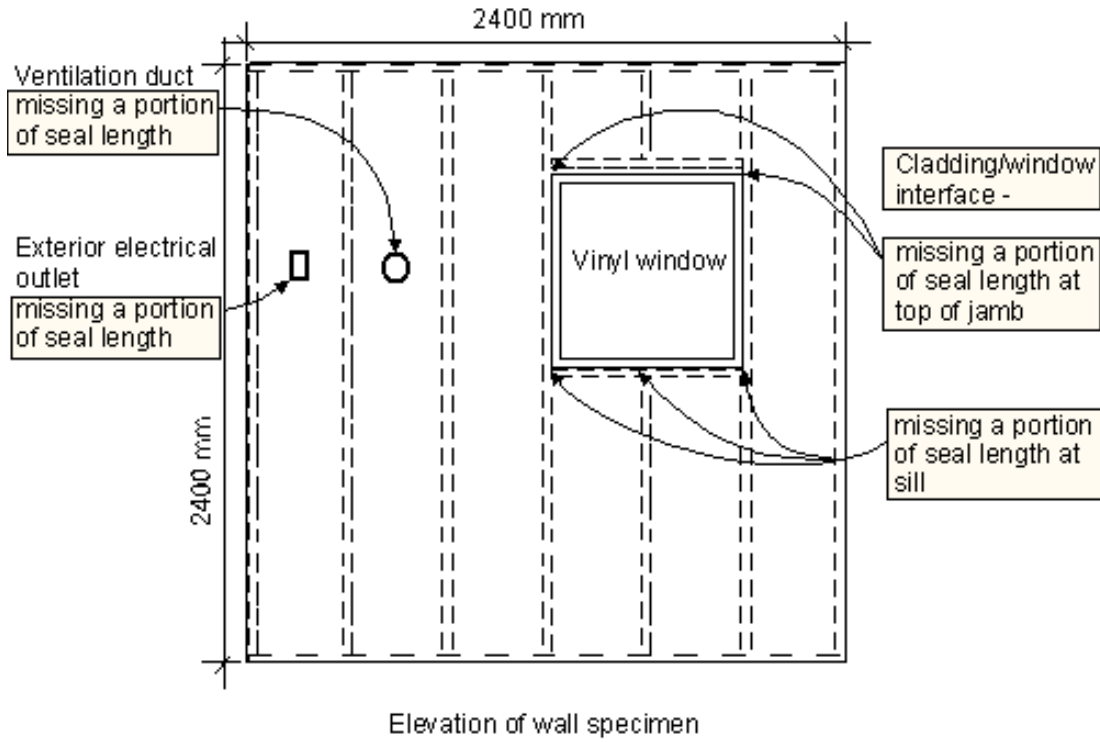
Figure 1.1 Generic deficiencies in the first line of defense of a typical wall specimen

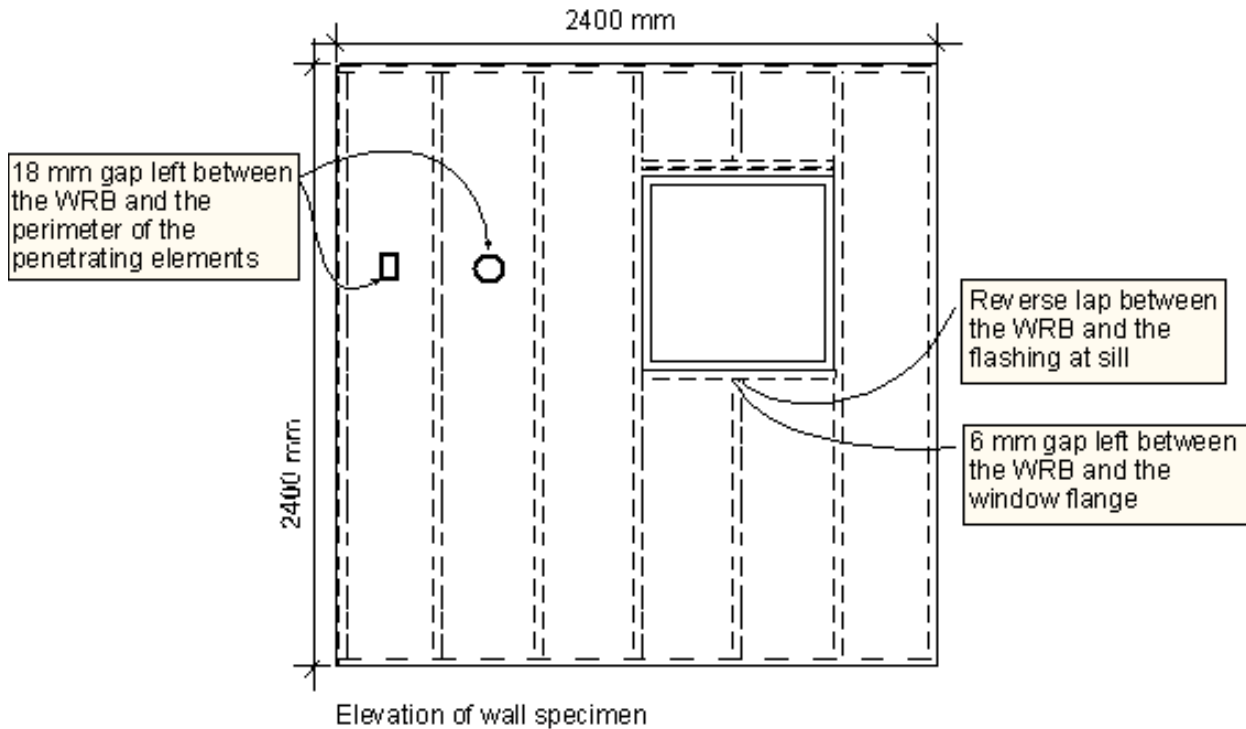
Figure 1.2 Generic deficiencies in the second line of defense of a typical wall specimen

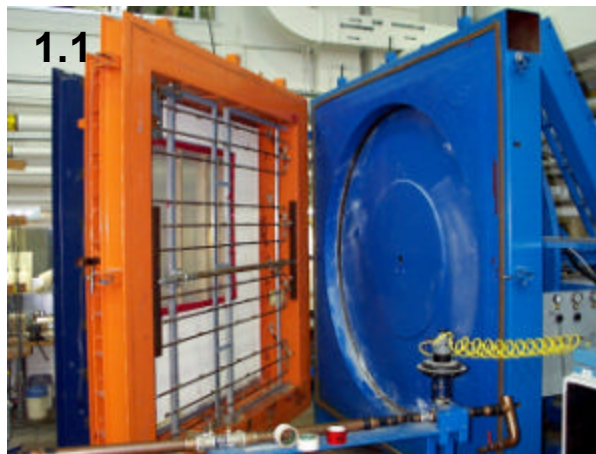
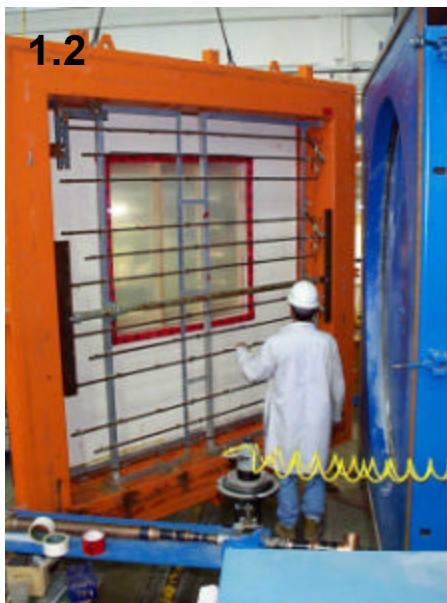
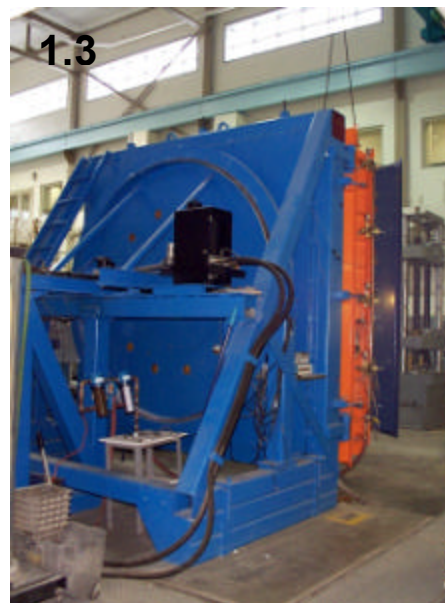
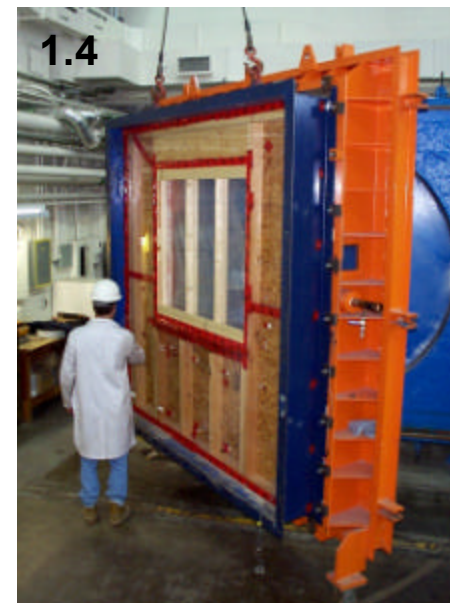
Figure 1.3 - **Inside view of apparatus** showing test specimen (sizes up to 2.44 by 2.44-m). The exterior cladding faces the inside of the apparatus.

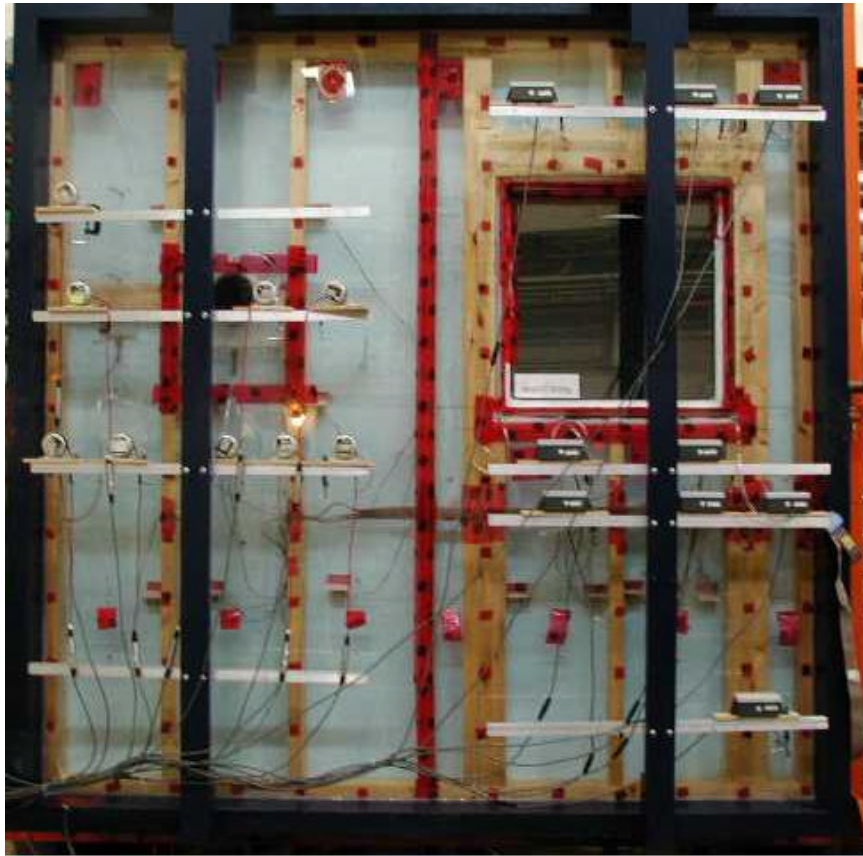
Figure 1.7 : View of 'stud-cavity' side of specimen WA-17 (Brick masonry veneer)

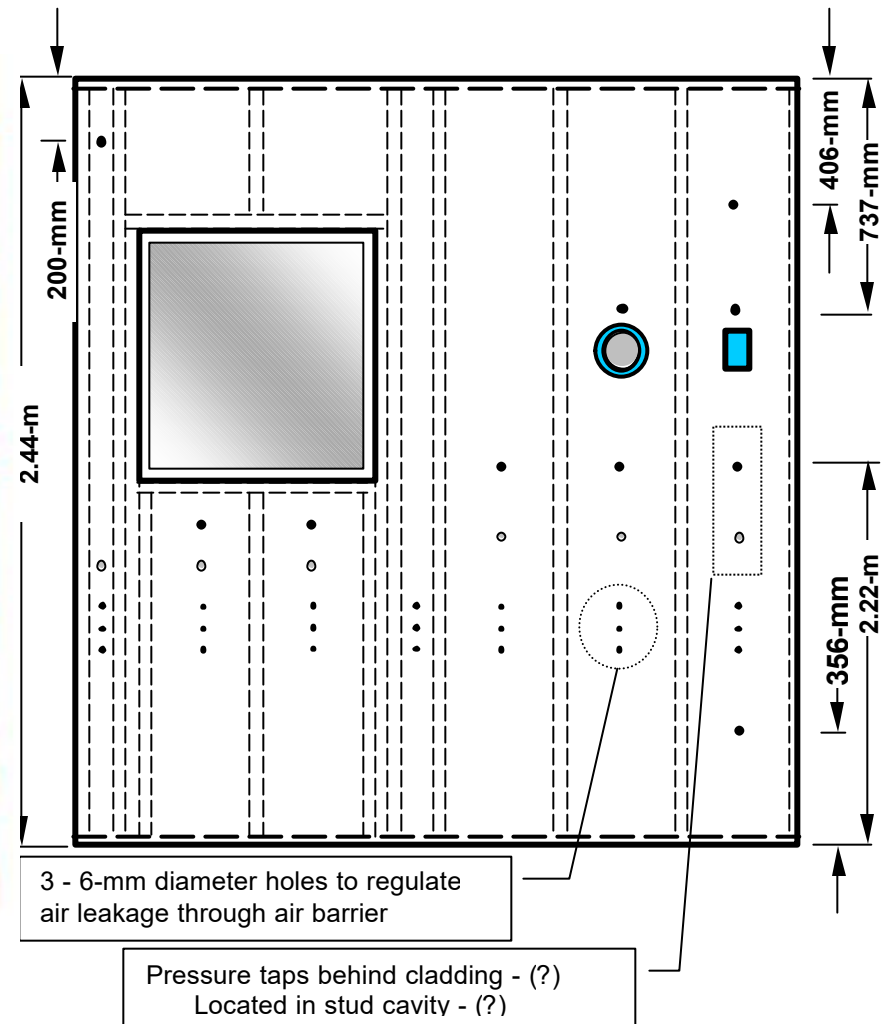
Figure 1.8 : Location of pressure taps and air leakage openings

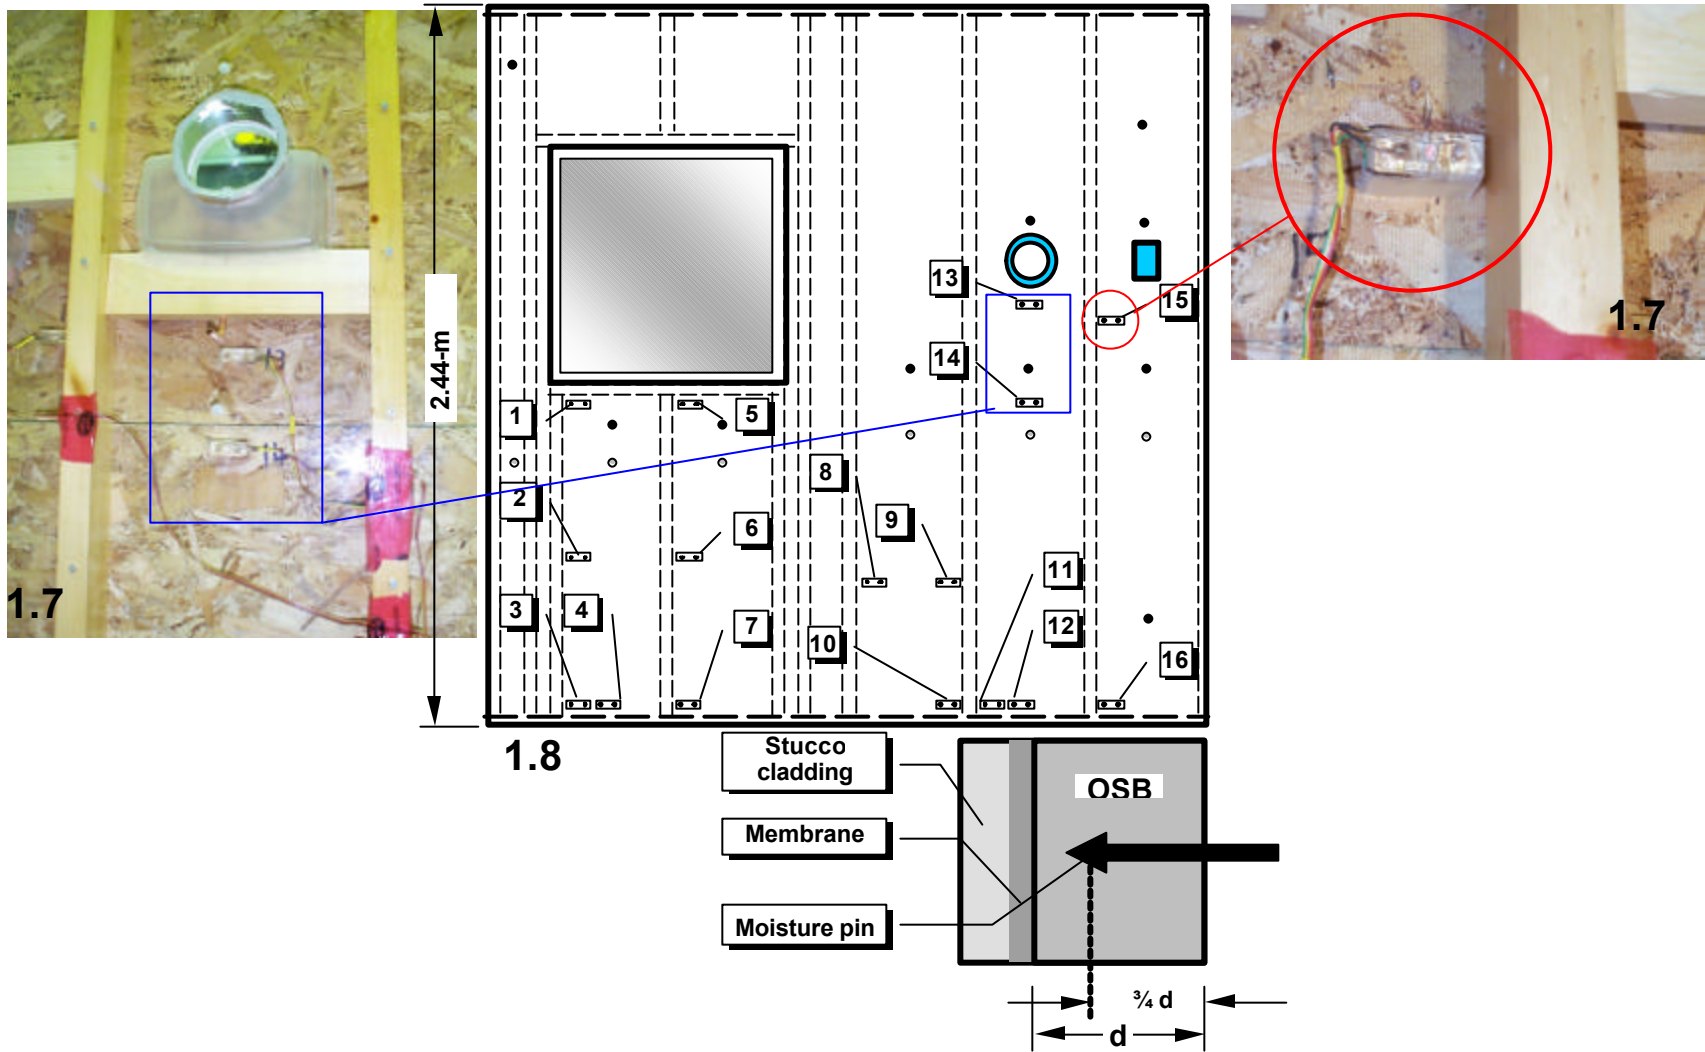
Figure 1.9: View of moisture sensors in stucco wall specimen (WA-2A)

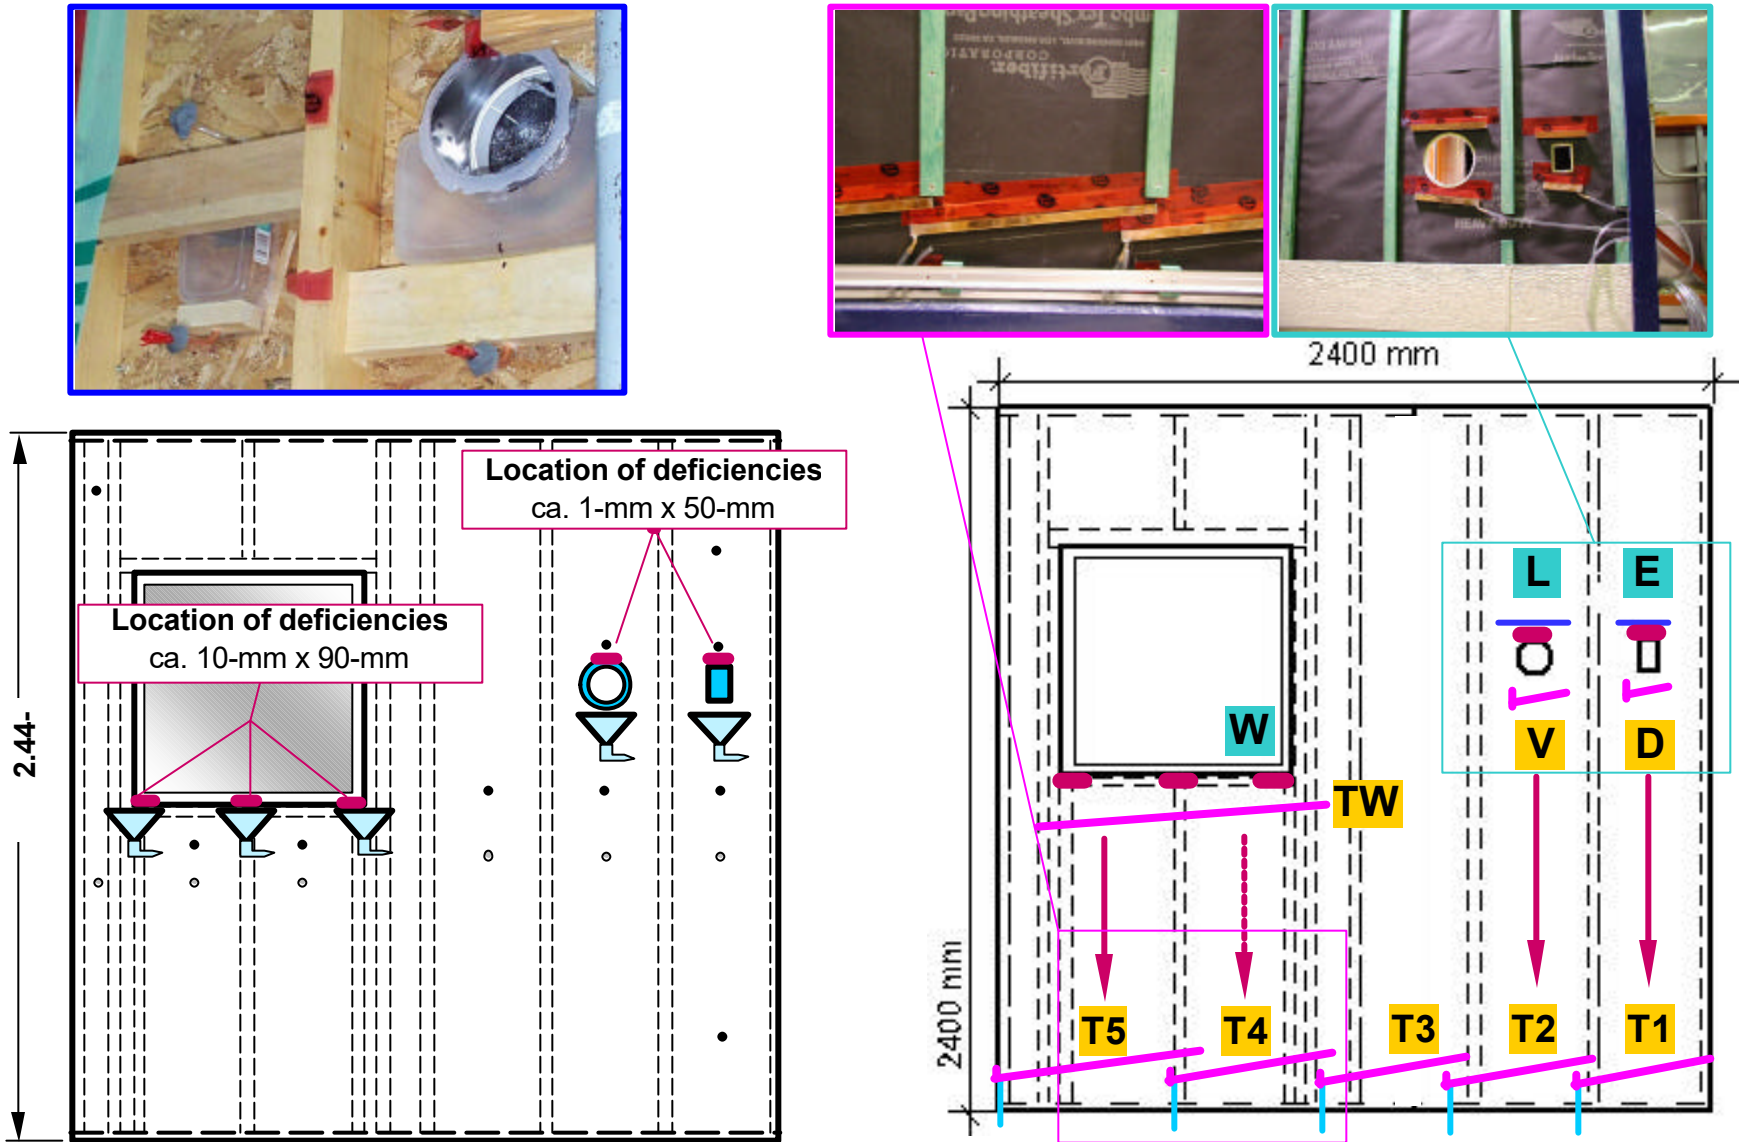
Figure 1.11 : Location of water collection points and troughs

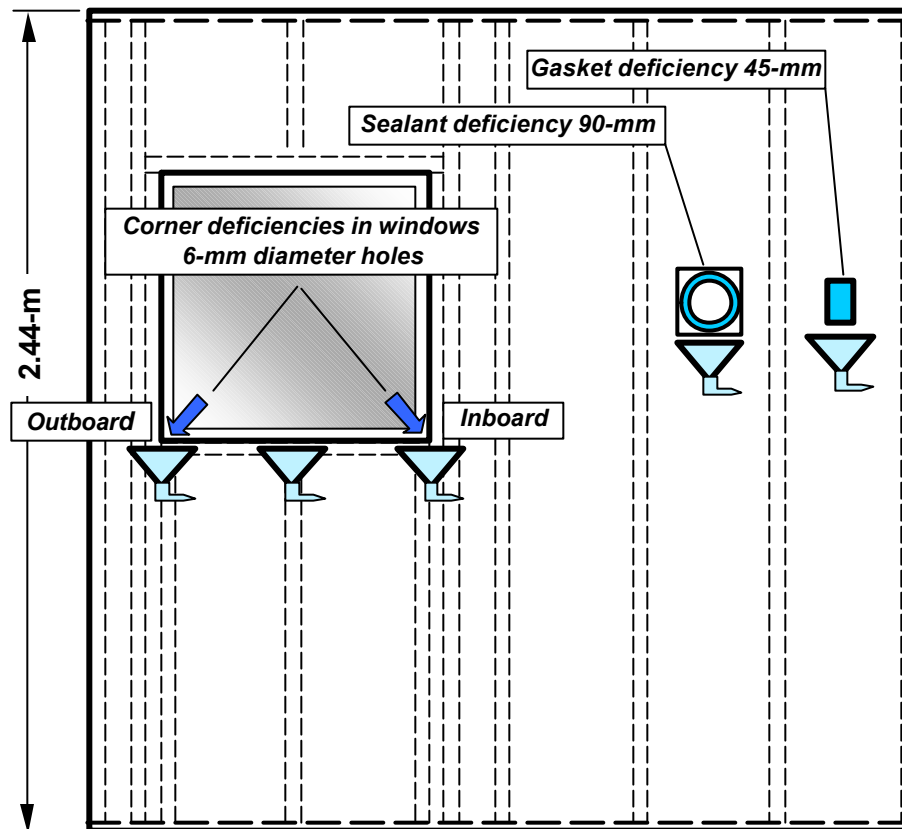
**Figure 2.1** - General configuration of the Base-Case wall assembly showing location of nominal deficiencies in wall assembly and water collection troughs

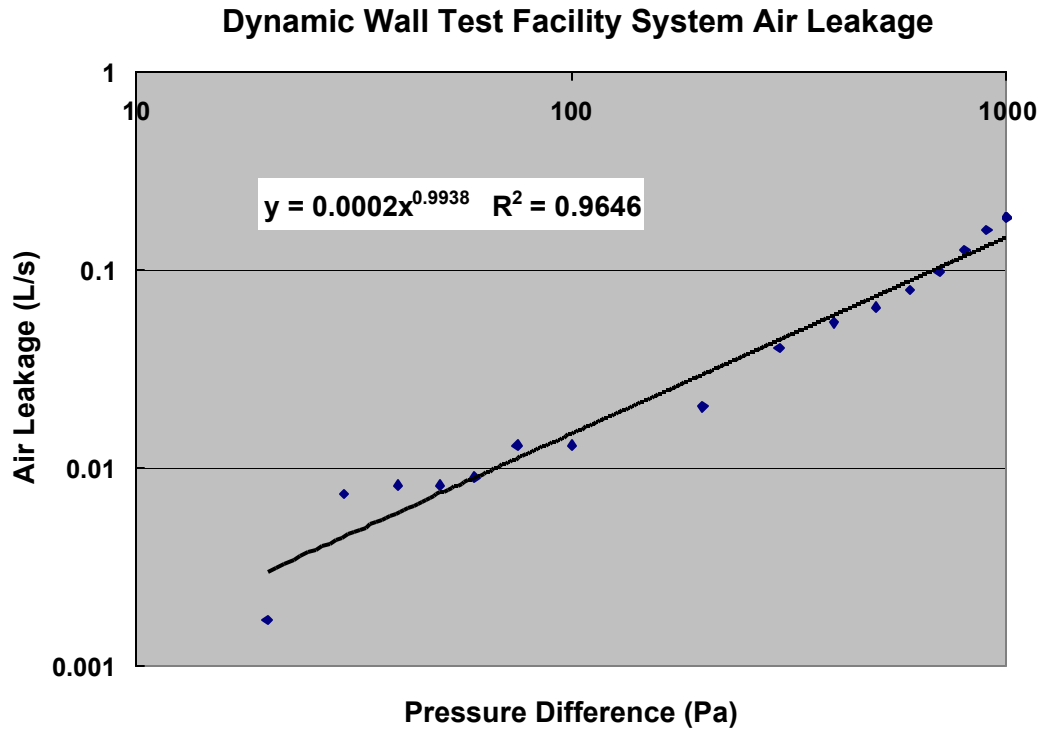
Figure 2.2 - DWTF System Air Leakage, Pressure Difference vs. Air Leakage

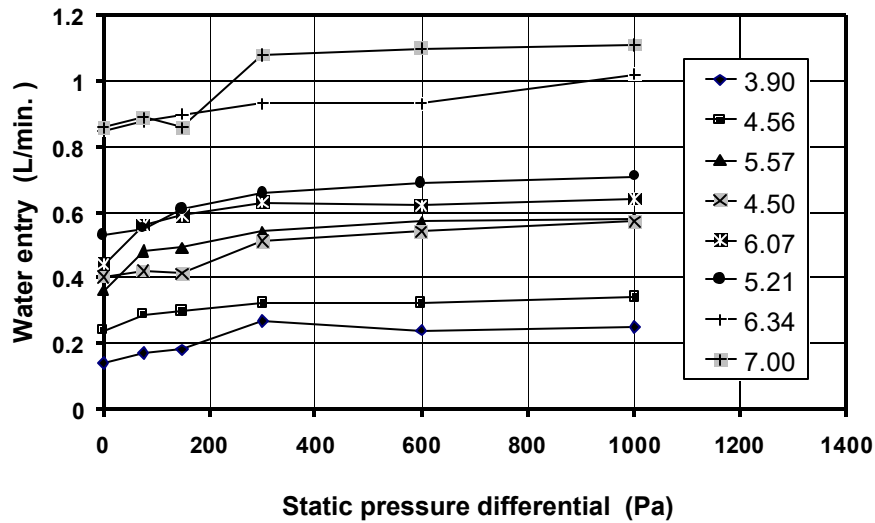
**Figure 2.3** - Water entry through deficiency as a function of differential chamber pressure – 90-mm<sup>2</sup> Ventilation duct deficiency through a non-vented rainscreen having a sealed second line of defence

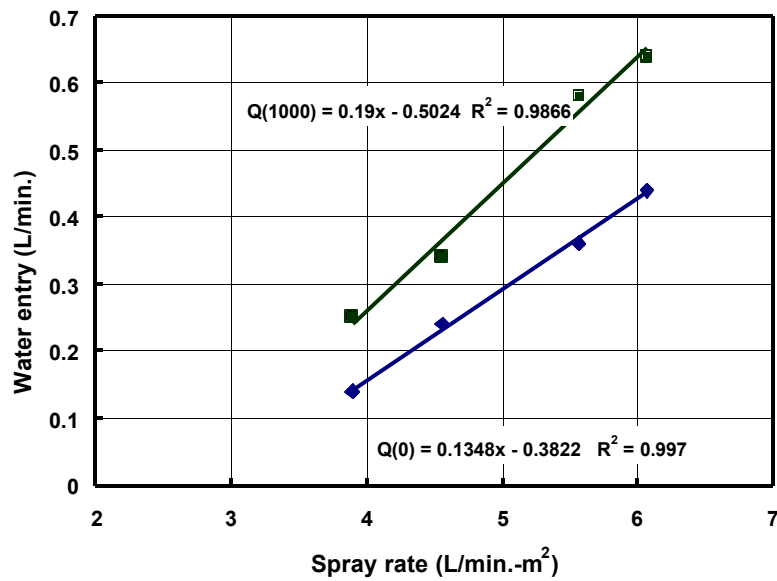
Values in the legend relate to spray rate (L/min.-m<sup>2</sup>)

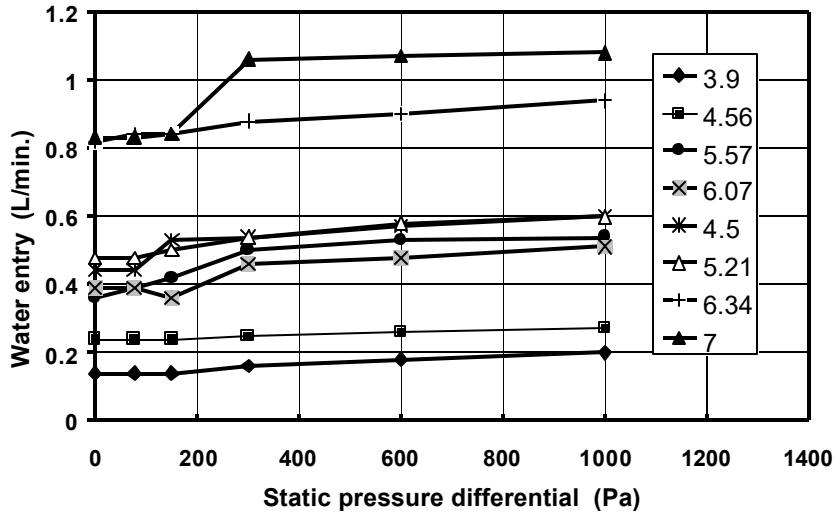
**Figure 2.5** – Water entry through deficiency as a function of differential chamber pressure – 90-mm<sup>2</sup> Ventilation duct deficiency through a fully vented rainscreen having a sealed second line of defence  
Values in the legend relate to spray rate (L/min-m<sup>2</sup>)

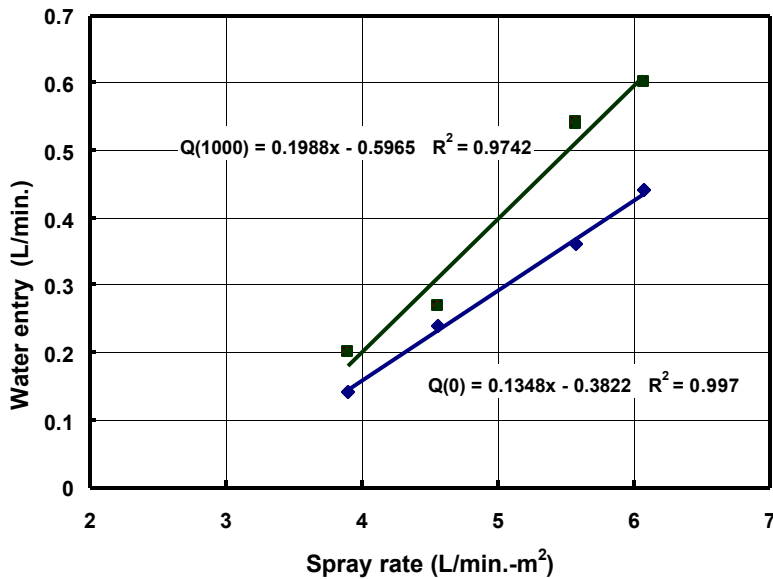
**Figure 2.6** – Water entry through deficiency as a function of differential chamber pressure – 90-mm<sup>2</sup> Ventilation duct deficiency through a fully vented rainscreen having a sealed second line of defence

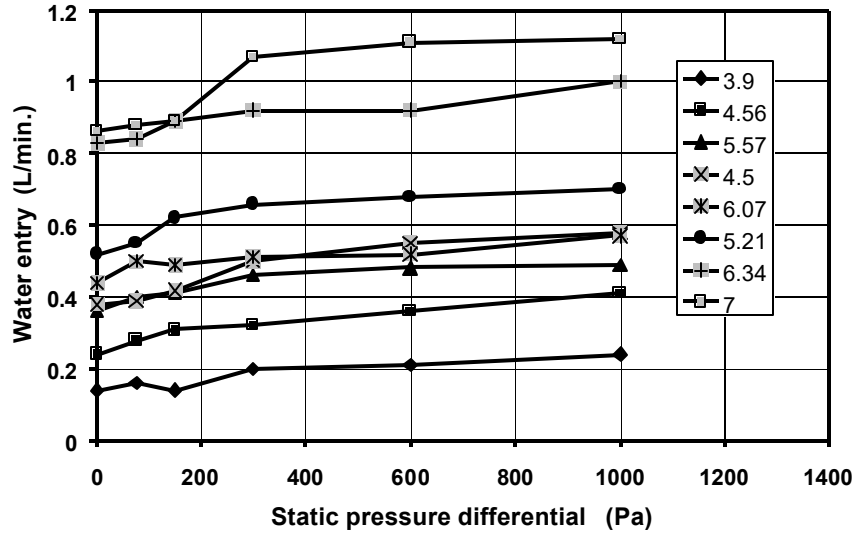
**Figure 2.7** – Water entry through deficiency as a function of differential chamber pressure – 90-mm<sup>2</sup> ventilation duct deficiency on non-vented rainscreen having the second line of defence not sealed Values in the legend relate to spray rate (L/min-m<sup>2</sup>)

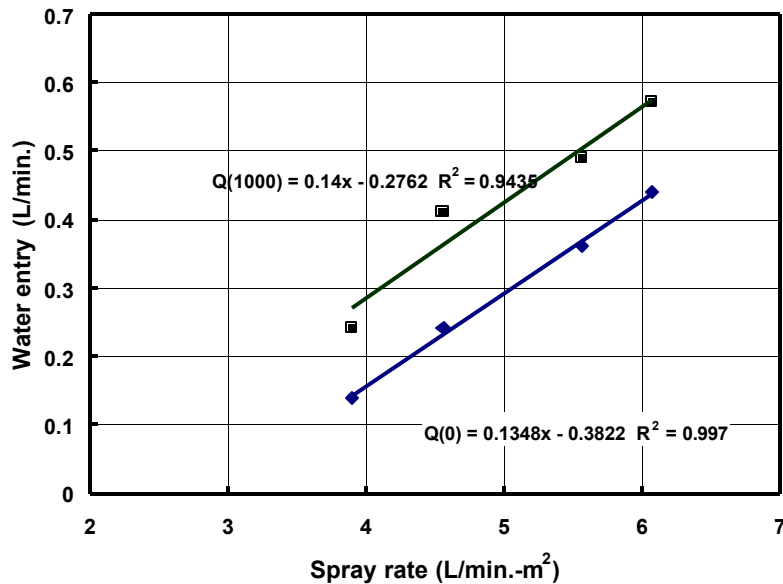
**Figure 2.8** – Water entry through deficiency as a function of differential chamber pressure – 90-mm<sup>2</sup> ventilation duct deficiency on non-vented rainscreen having second line of defence not sealed

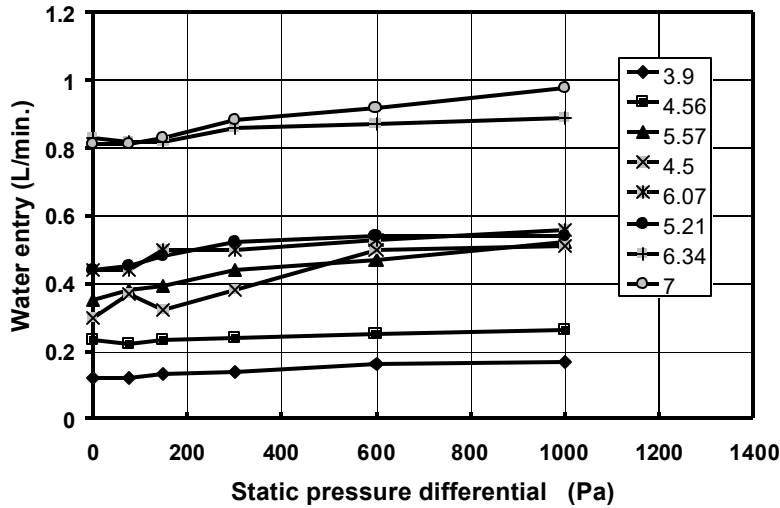
**Figure 2.9** – Water entry through deficiency as a function of differential chamber pressure – 90-mm<sup>2</sup> Ventilation duct deficiency; fully vented rainscreen; second line of defence not sealed  
Values in the legend relate to spray rate (L/min.-m<sup>2</sup>)

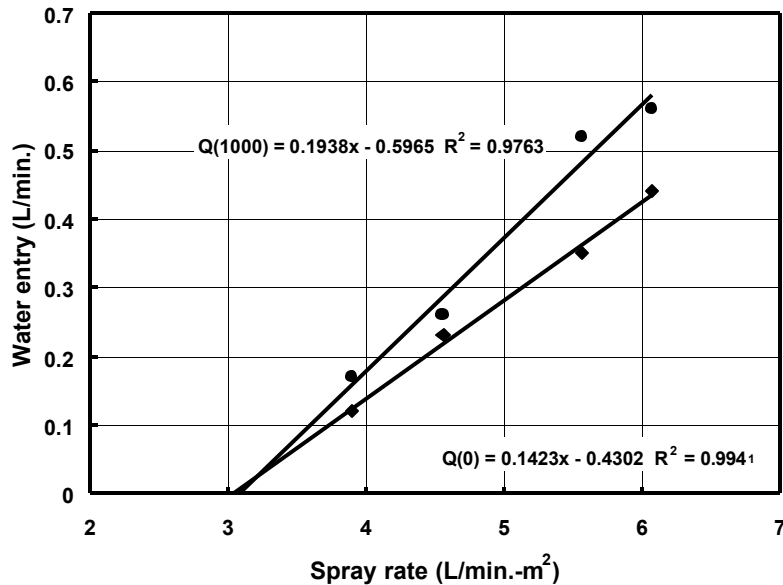
**Figure 2.10** – Water entry through deficiency as a function of differential chamber pressure – 90-mm<sup>2</sup> Ventilation duct deficiency on fully vented rainscreen having second line of defence not sealed

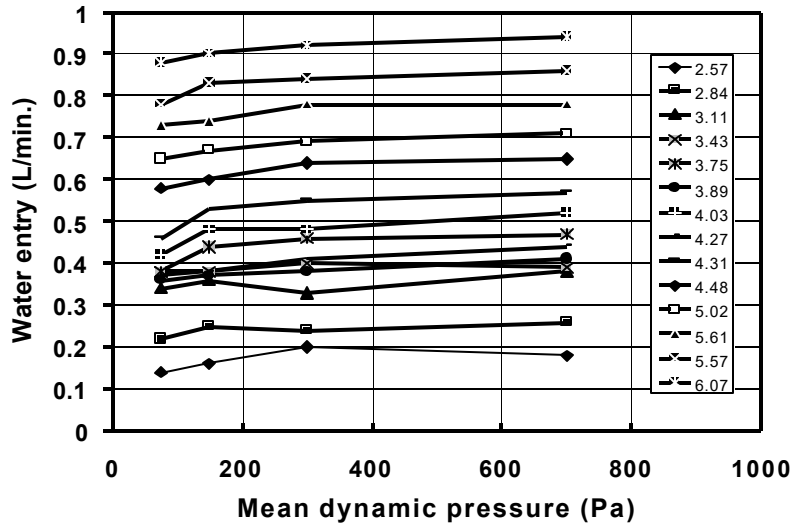
**Figure 2.11** - Water entry through deficiency as a function of differential dynamic pressure – 90-mm<sup>2</sup> Ventilation duct deficiency; rainscreen not vented; second line of defence sealed  
 Values in the legend relate to spray rate (L/min.-m<sup>2</sup>)

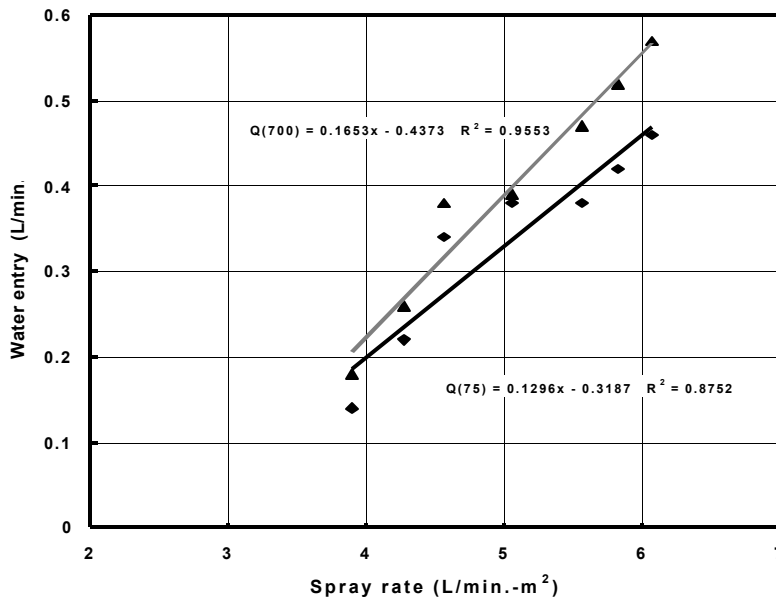
**Figure 2.12** - Water entry through deficiency as a function of differential dynamic pressure – 90-mm<sup>2</sup> Ventilation duct deficiency on fully vented rainscreen having the second line of defence sealed

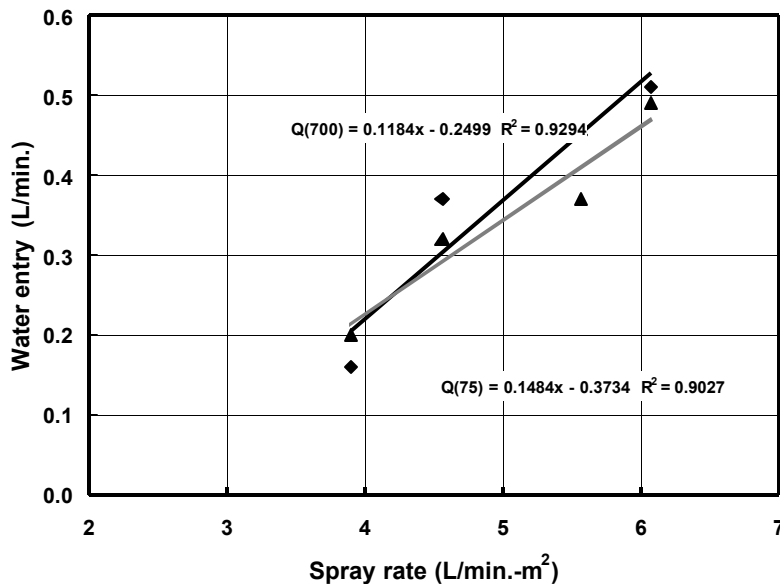
**Figure 2.13 - Water entry through deficiency as a function of differential dynamic pressure – 90-mm<sup>2</sup> Ventilation duct deficiency on fully vented rainscreen having the second line of defence sealed**

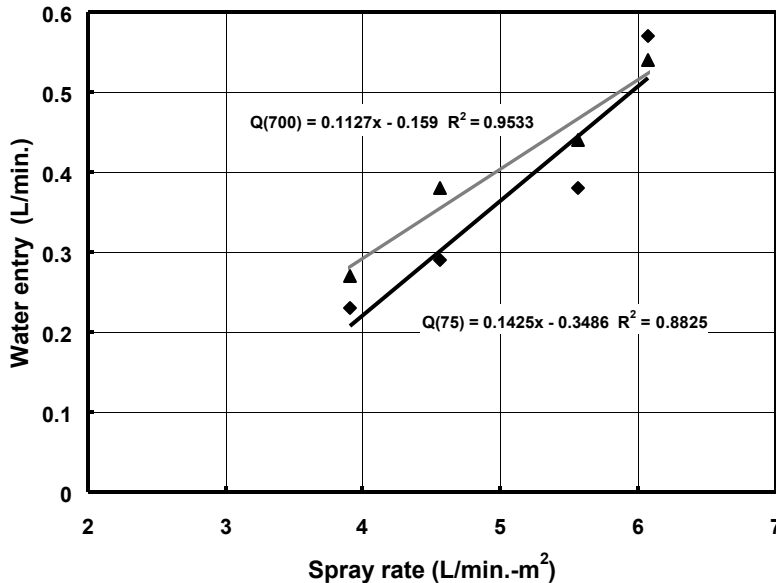
**Figure 2.14 - Water entry through deficiency as a function of differential dynamic pressure – 90-mm<sup>2</sup> Ventilation duct deficiency on not vented rainscreen having the second line of defence not sealed**

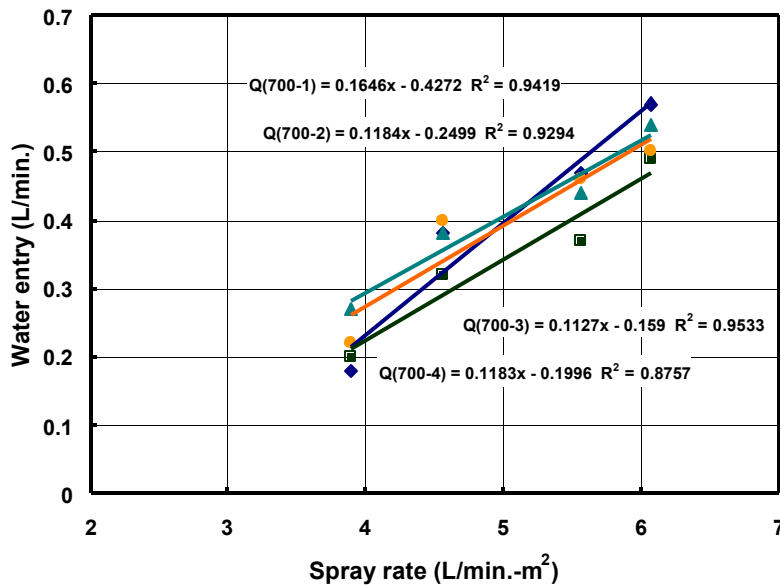
Chamber Dynamic Pressure @ 5 Hz. (Pa)	Volume through deficiency (L/min.)			
	Nominal Water Spray rate (L/min.-m <sup>2</sup> )			
	3.90	4.56	5.57	6.07
75 ± 50	0.14	0.38	0.42	0.45
150 ± 60	0.16	0.38	0.43	0.45
300 ± 125	0.17	0.39	0.43	0.46
700 ± 300	0.22	0.40	0.46	0.50

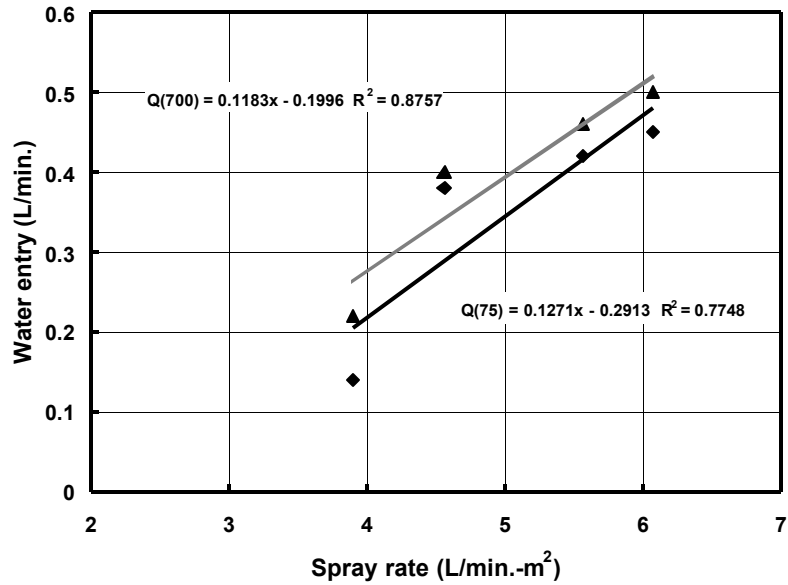
Figure 2.15 - Water entry through deficiency as a function of differential dynamic pressure – 90-mm<sup>2</sup> Ventilation duct deficiency on fully vented rainscreen having the second line of defence not sealed

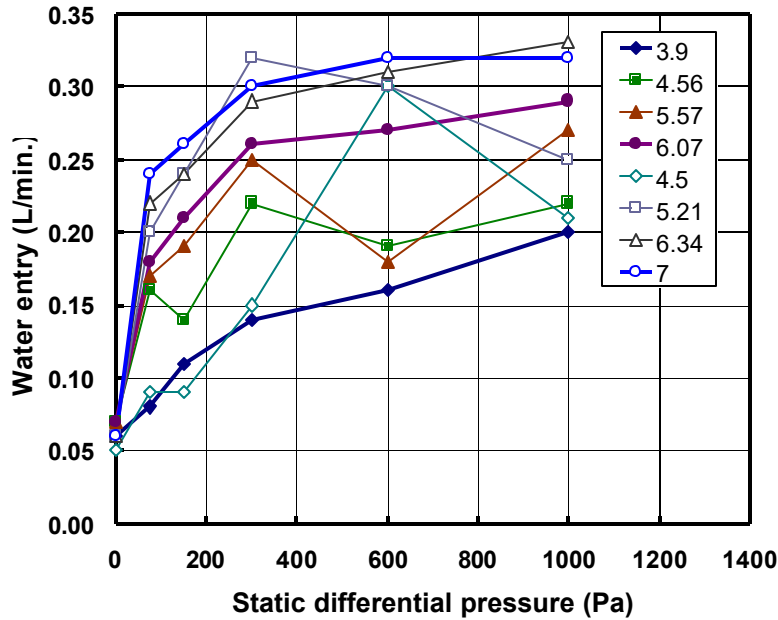
**Figure 2.17** – Water entry (L/min.) through deficiency as a function of static differential pressure – 45-mm<sup>2</sup> deficiency above electrical outlet ; non-vented rainscreen; second line of defence not sealed. Values in the legend relate to spray rate (L/min-m<sup>2</sup>)

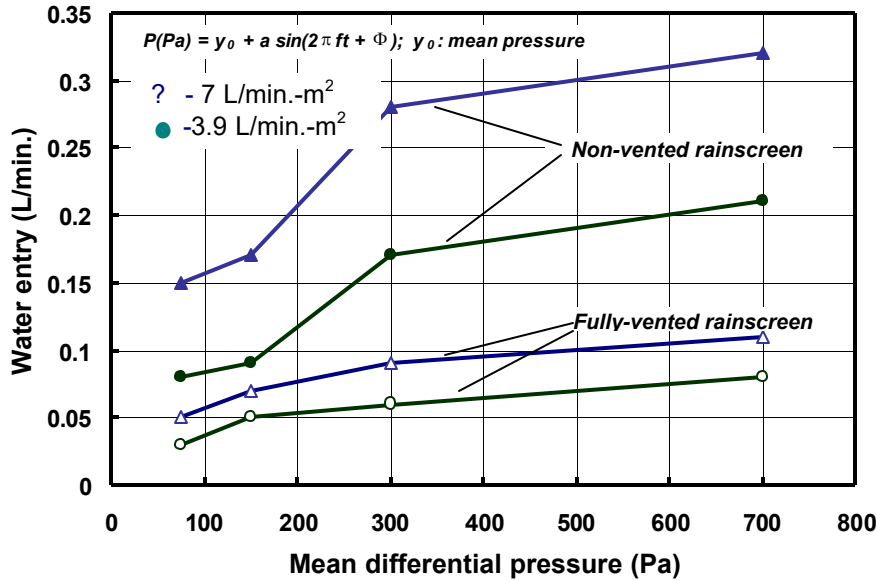
**Figure 2.18** – Water entry (L/min.) through a 45-mm<sup>2</sup> deficiency above electrical outlet as a function of mean dynamic differential pressure. Comparison of results derived from a non-vented rainscreen and fully vented rainscreen having the second line of defence not sealed

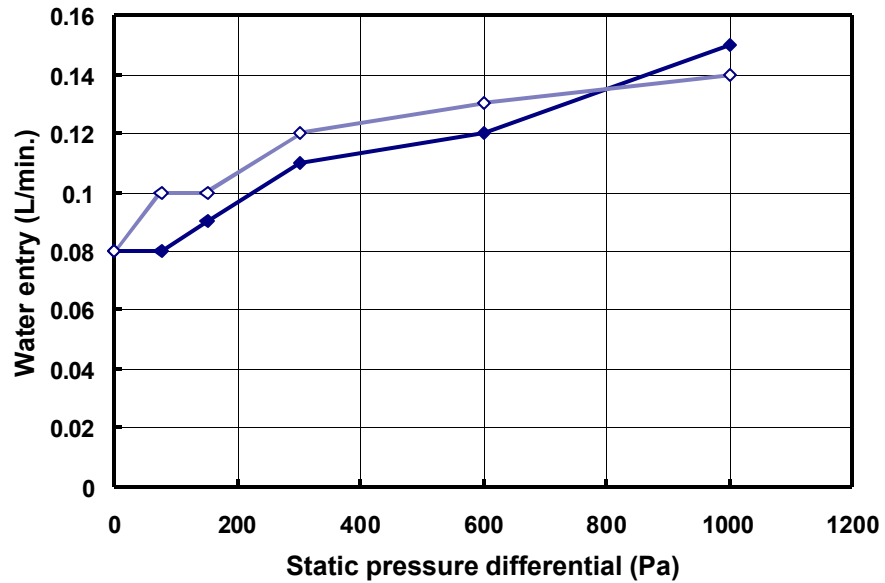
**Figure 2.19** – Water entry (L/min.) through a 6-mm diameter deficiency in OUTBOARD corner of window as a function of static pressure differential. Results derived from a non-vented rainscreen having the second line of defence not sealed

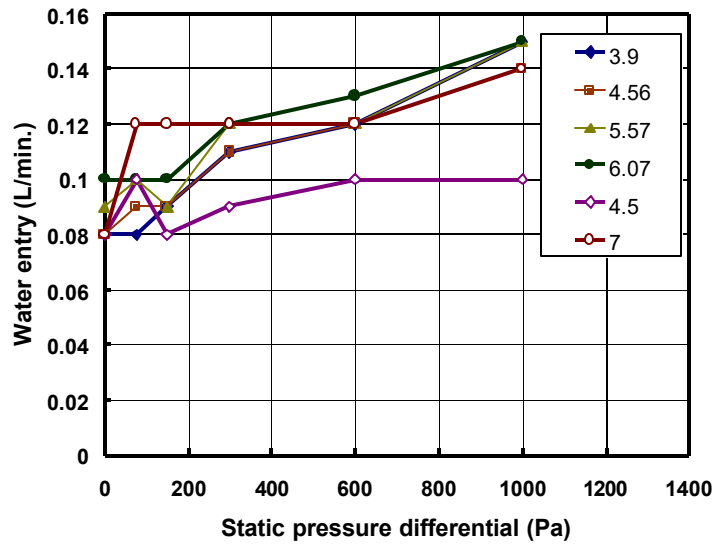
Figure 2.20 – Water entry (L/min.) through a 6-mm diam. deficiency in OUTBOARD corner of window as a function of static pressure differential. Results from vented and non-vented rainscreens; second line of

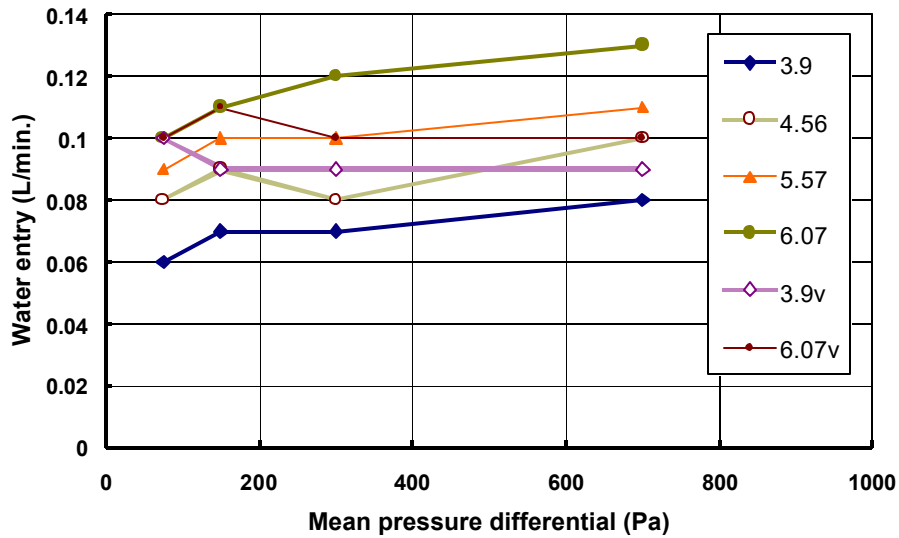
defence not sealed; Values in the legend relate to spray rate (L/min-m<sup>2</sup>)

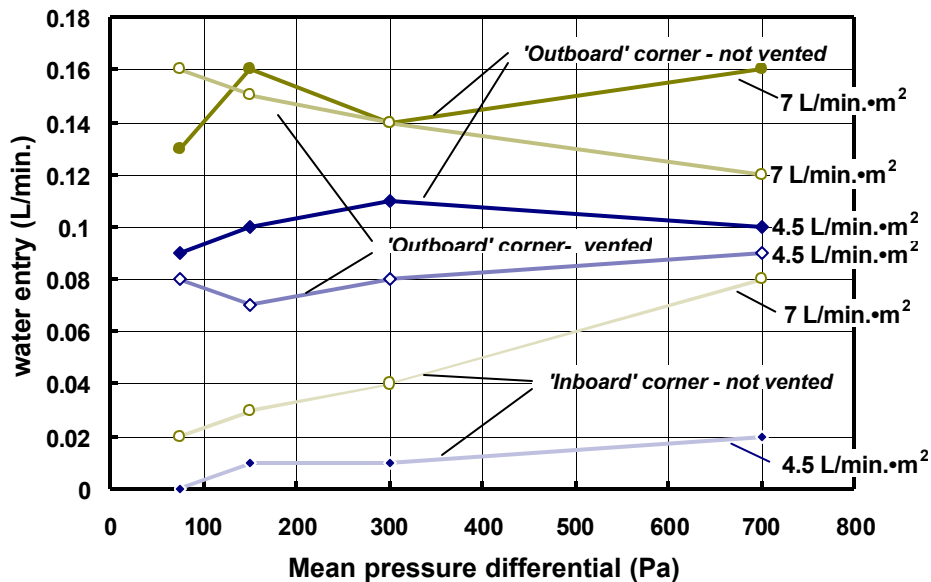
**Figure 2.22 – Water entry (L/min.) through 6-mm diameter deficiencies in corner of window as a function of mean dynamic pressure differential for both non-vented and vented rainscreens having the second line of defence not sealed**

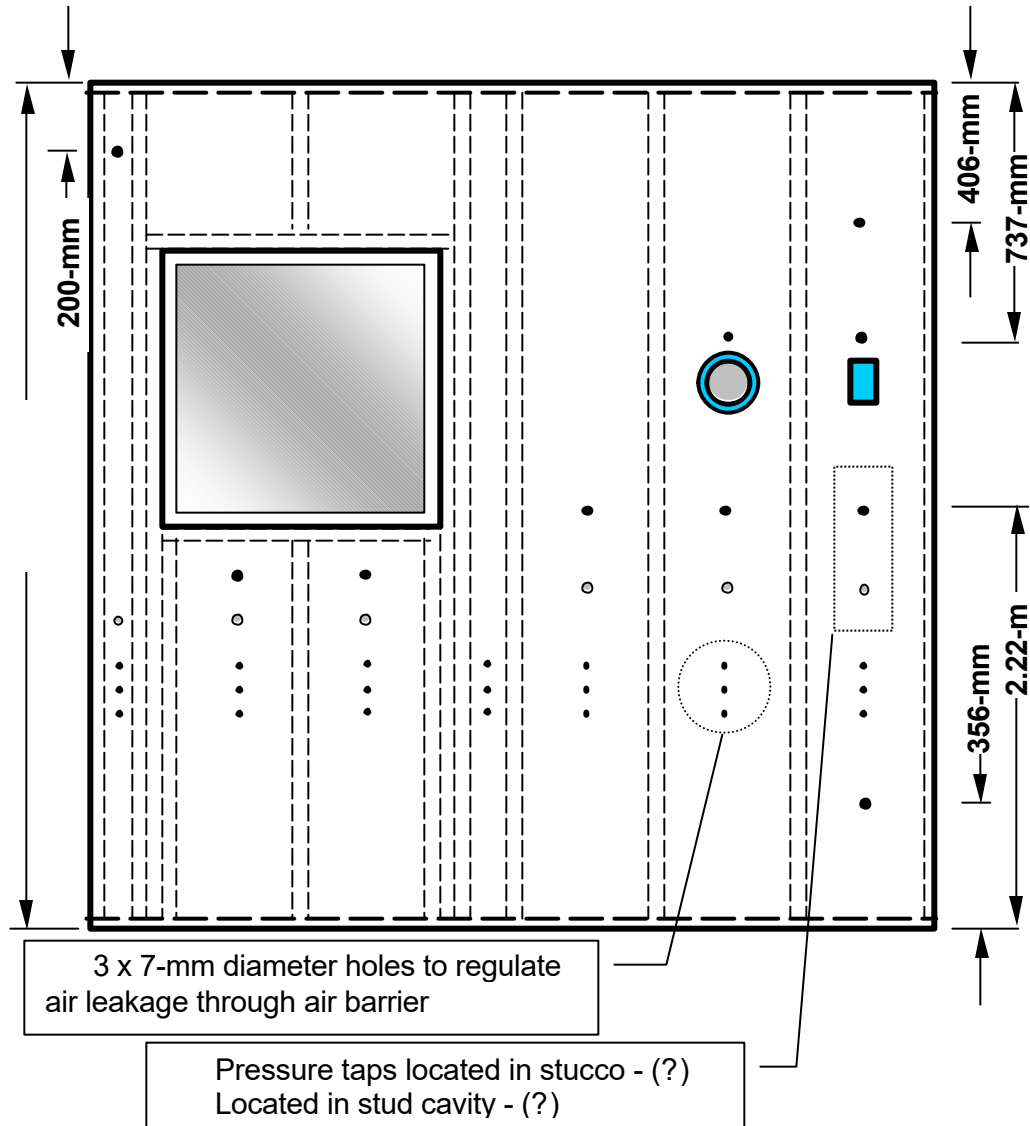
**Figure 3.1 - Location of pressure taps and air leakage openings**

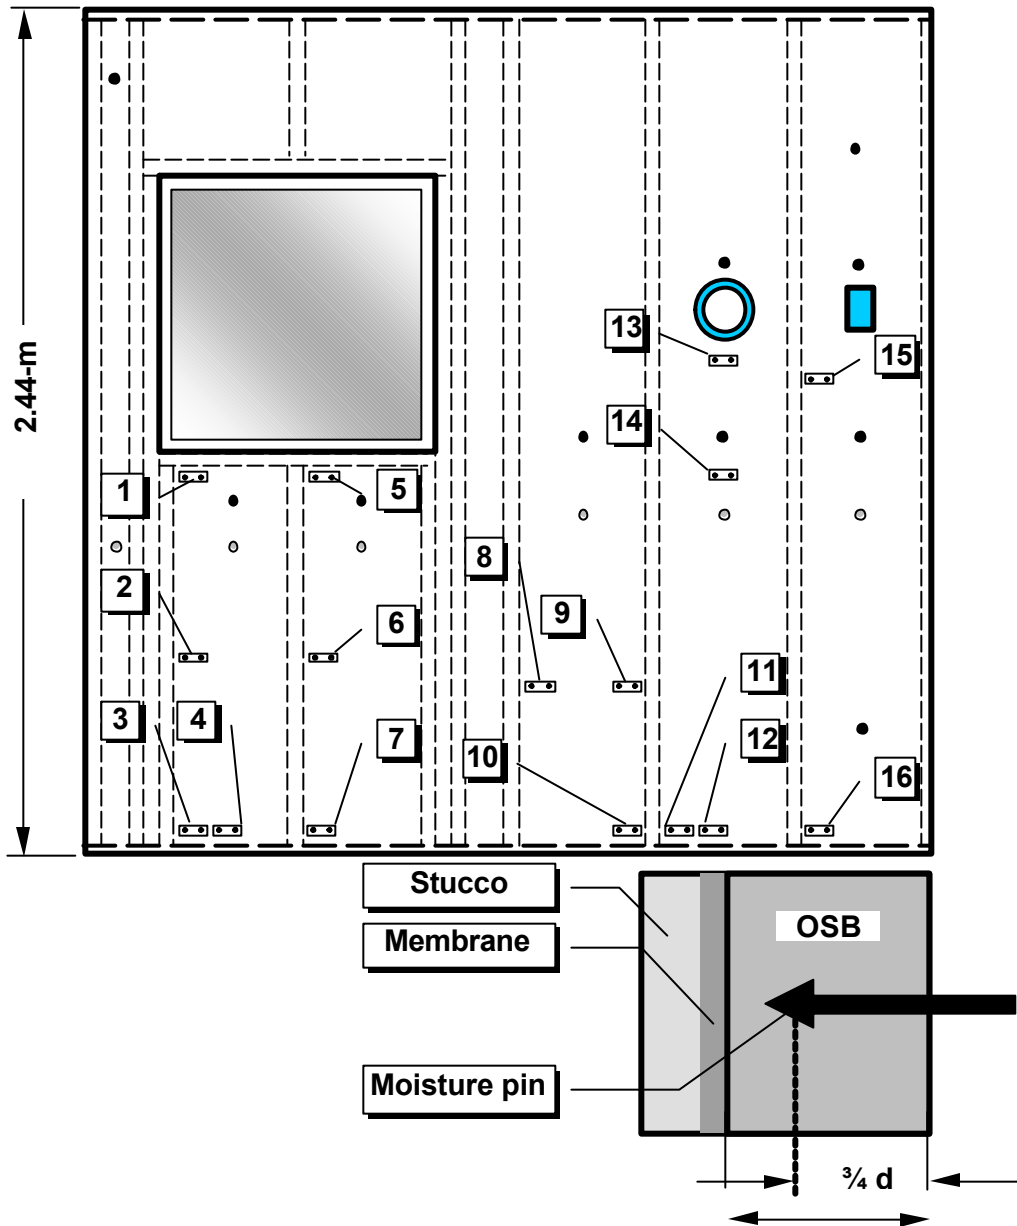
Figure 3.2 - Location of moisture sensors
