## NRC Publications Archive Archives des publications du CNRC

### Report from Task 6 of MEWS Project: experimental assessment of water penetration and entry into wood-frame wall specimens: final report

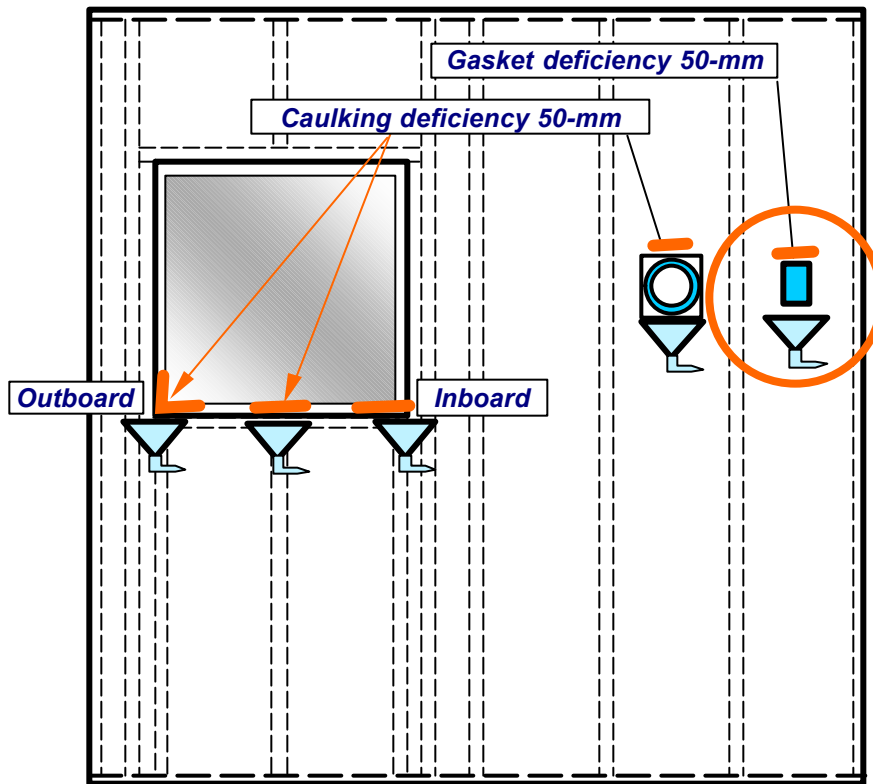
**Figure 3.3 - Location of water collection points and troughs**

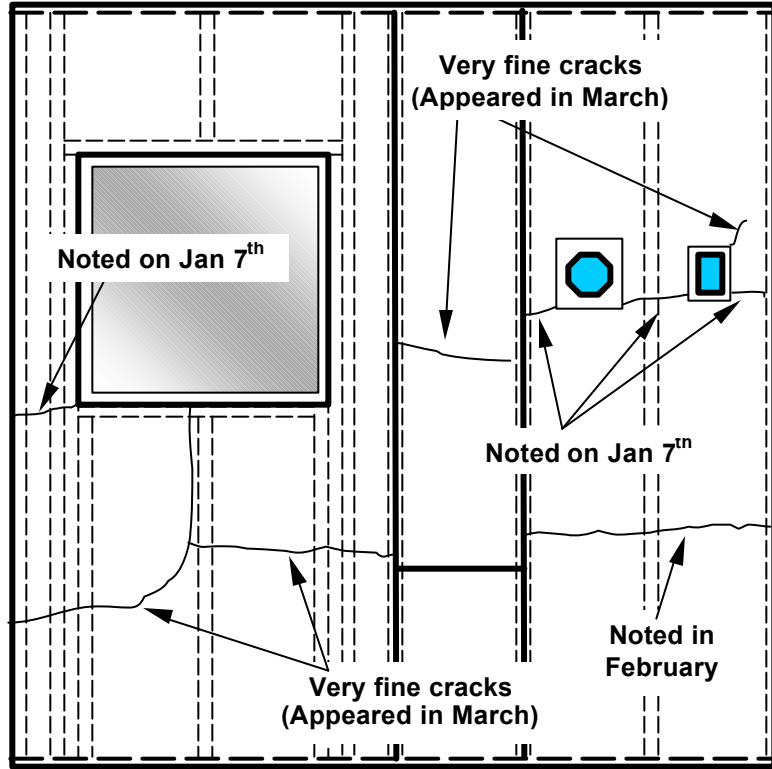
Figure 3.4 – Wall Assembly 2A before transport

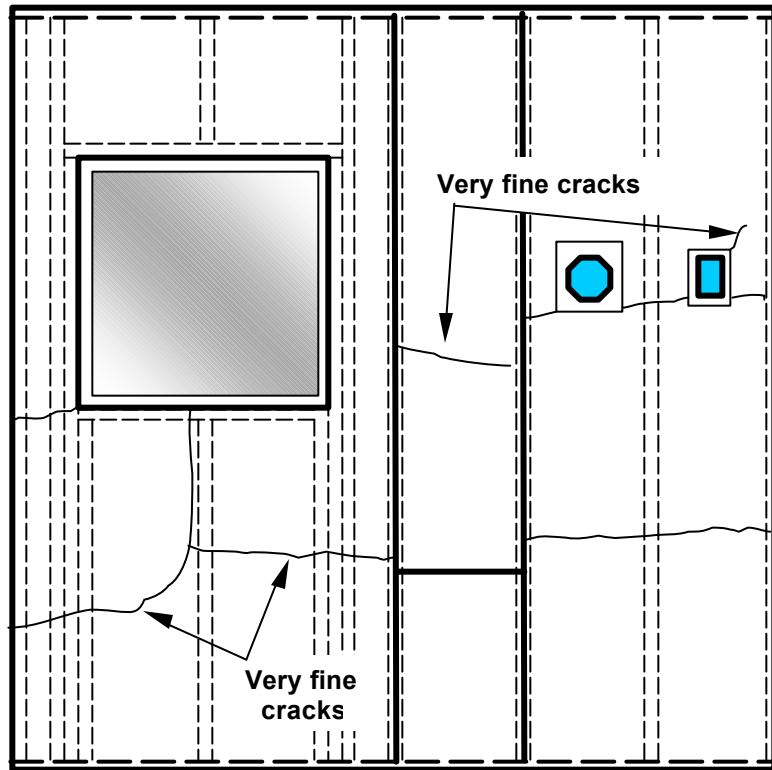
Figure 3.5- Wall Assembly 2A after transport – visual inspection of the surface did not reveal any additional cracks due to transport (6 April 02) – hence figures depict the same series of cracks

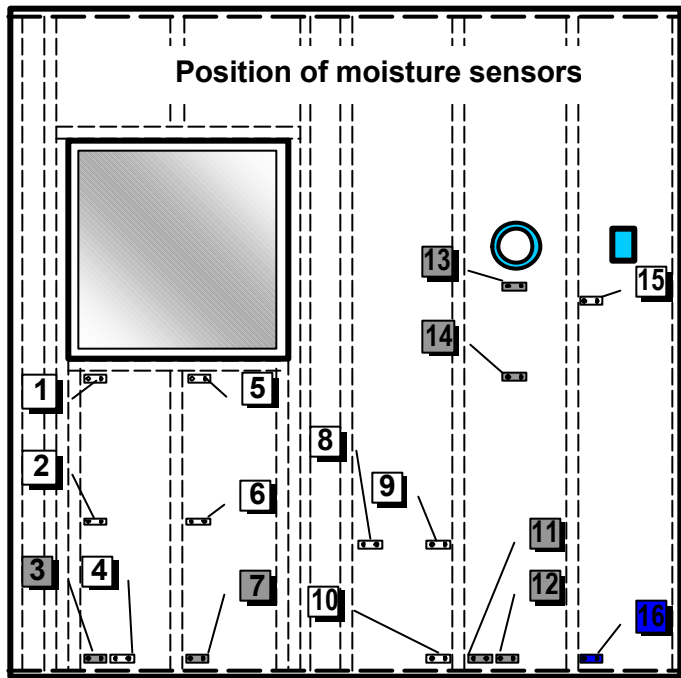
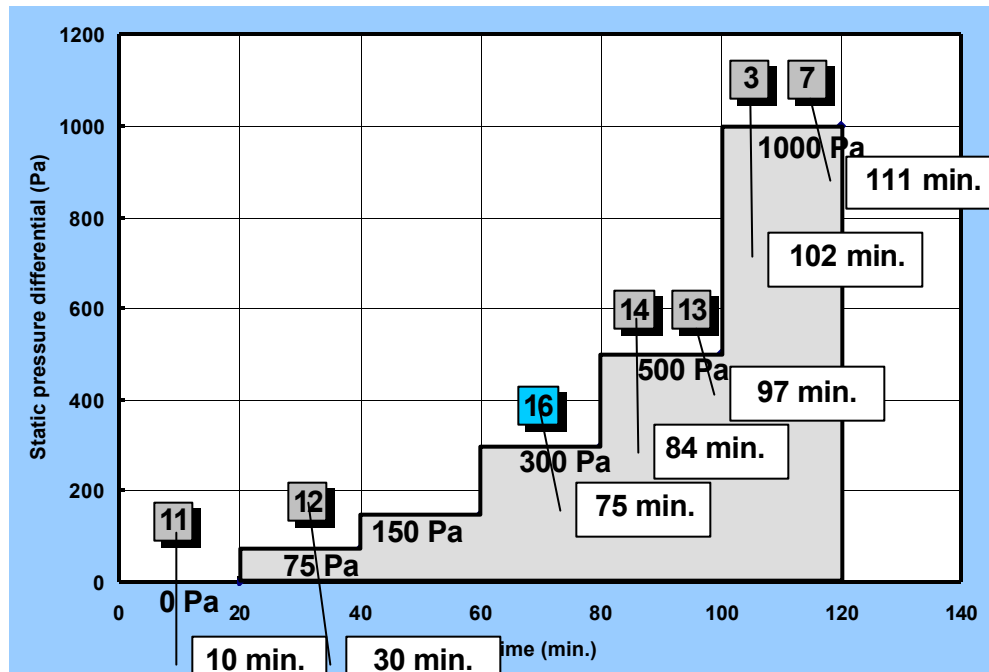
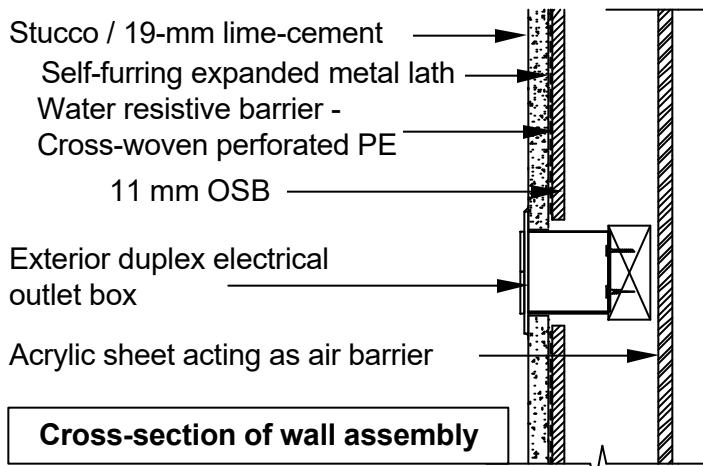
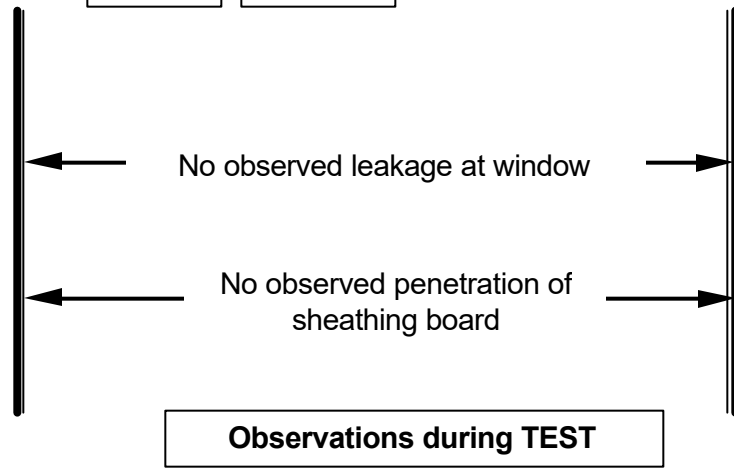
Figure 3.6 - Stage 2 Water penetration of WA-1 - Static test on Stucco-clad walls

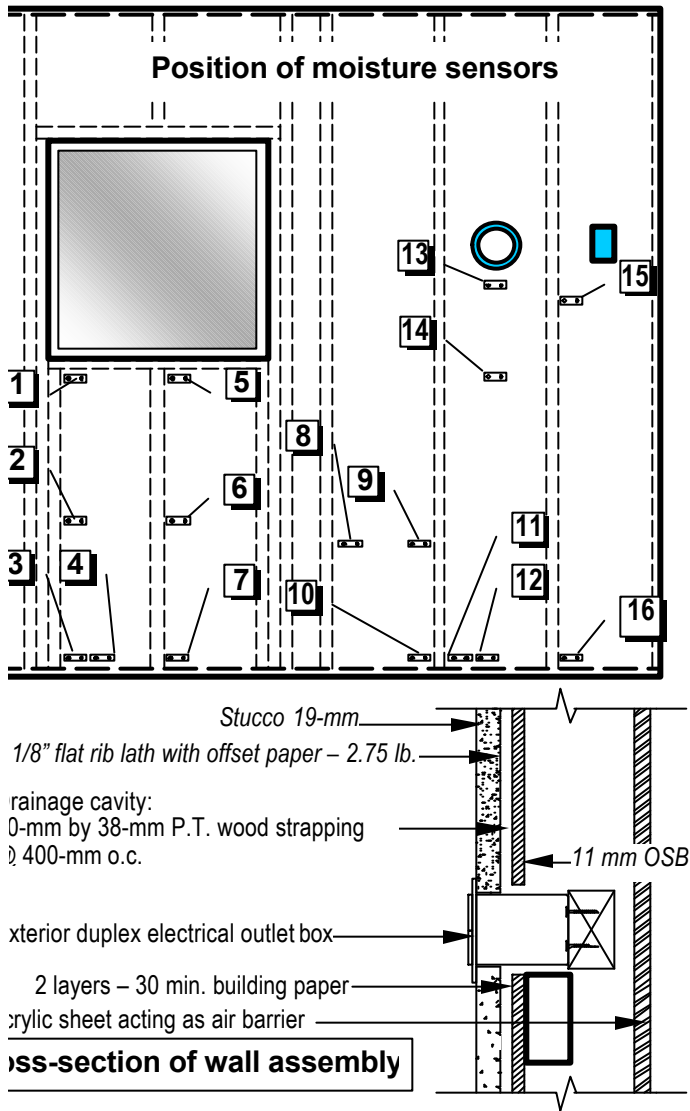
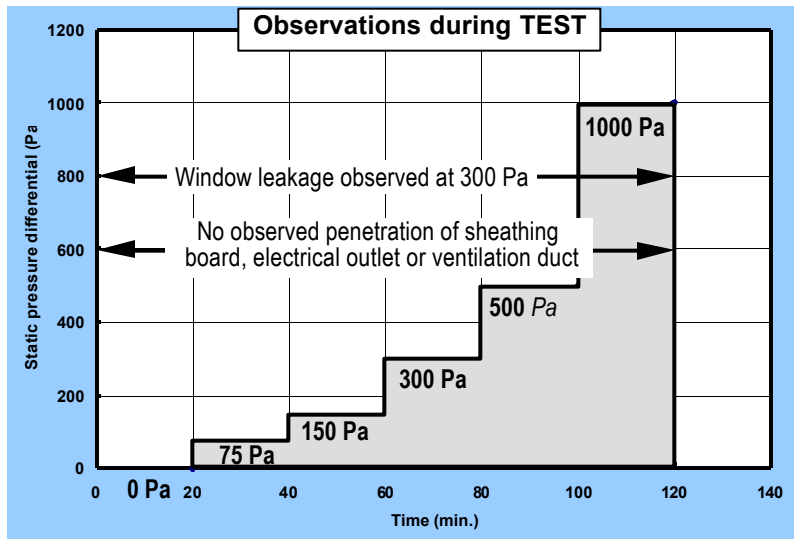
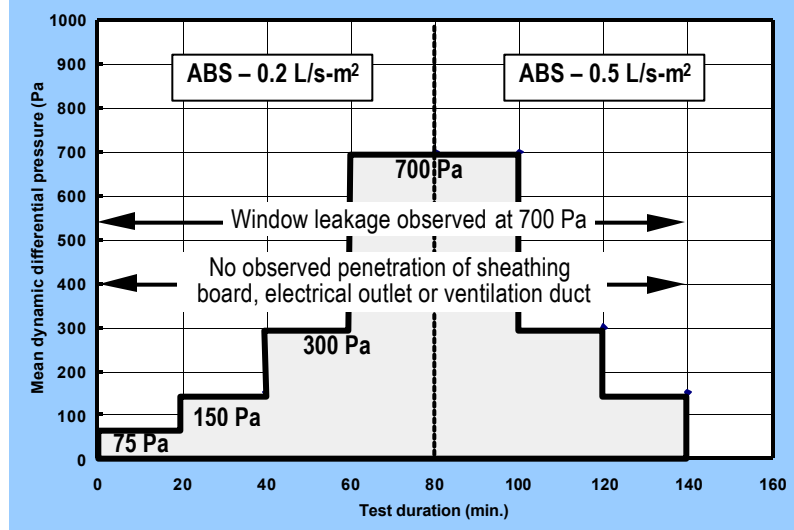
Figure 3.16 - Stage 2 Water penetration of WA-5 - Dynamic test on Stucco-clad walls

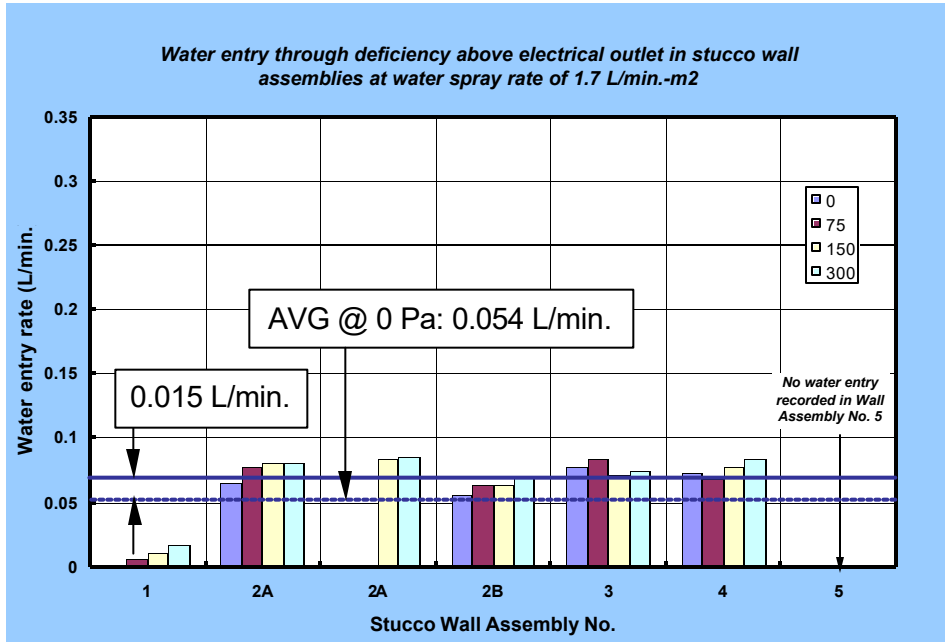
Figure 3.17 – Water entry under static pressure differential through deficiency above electrical outlet for stucco wall assemblies at a spray rate of 1.7 L/min.-m<sup>2</sup>

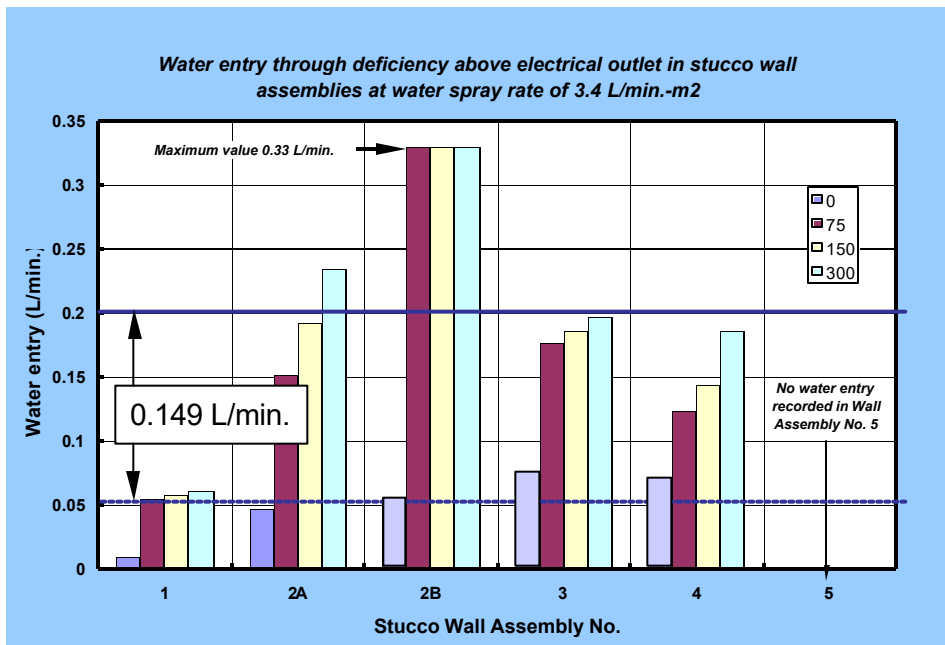
Figure 3.18– Water entry under static pressure differential through deficiency above electrical outlet for stucco wall assemblies at a spray rate of 3.4 L/min.-m<sup>2</sup>

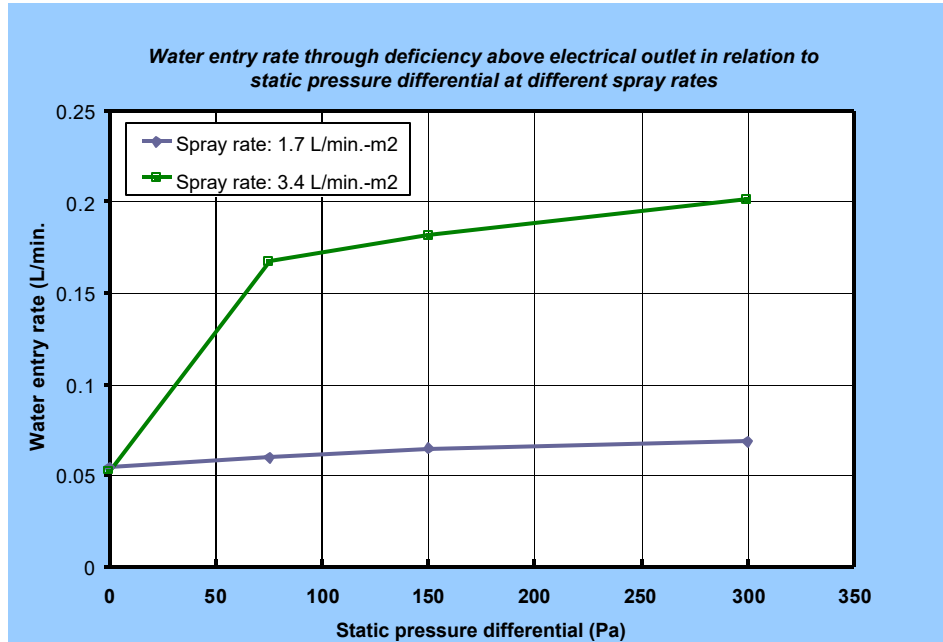
**Figure 3.19 – Water entry through the deficiency above the electrical outlet in relation to static pressure differential at different spray rates**

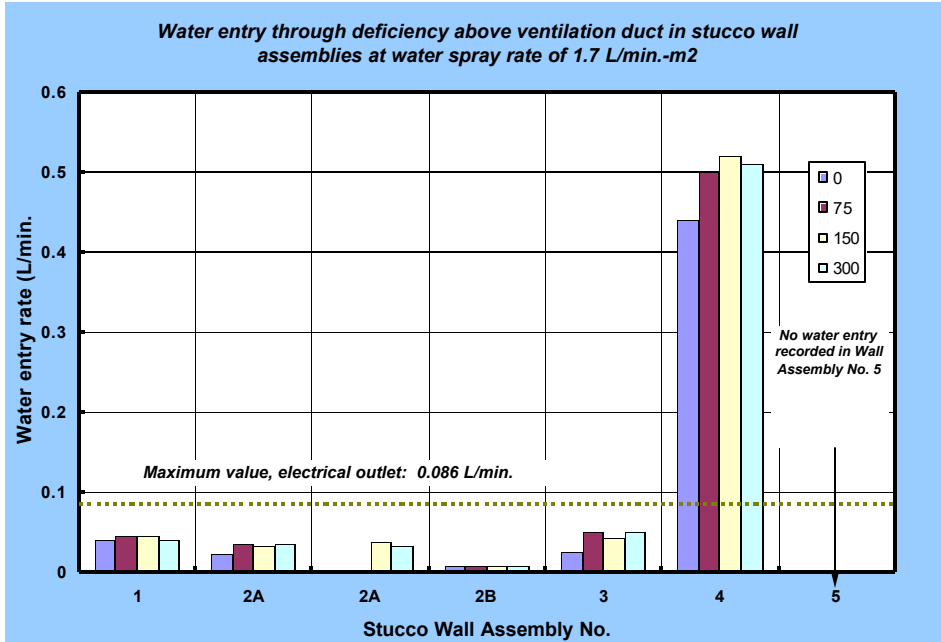
Figure 3.20 – Water entry under static pressure differential through deficiency above ventilation duct for stucco wall assemblies at a spray rate of 1.7 L/min.-m<sup>2</sup>

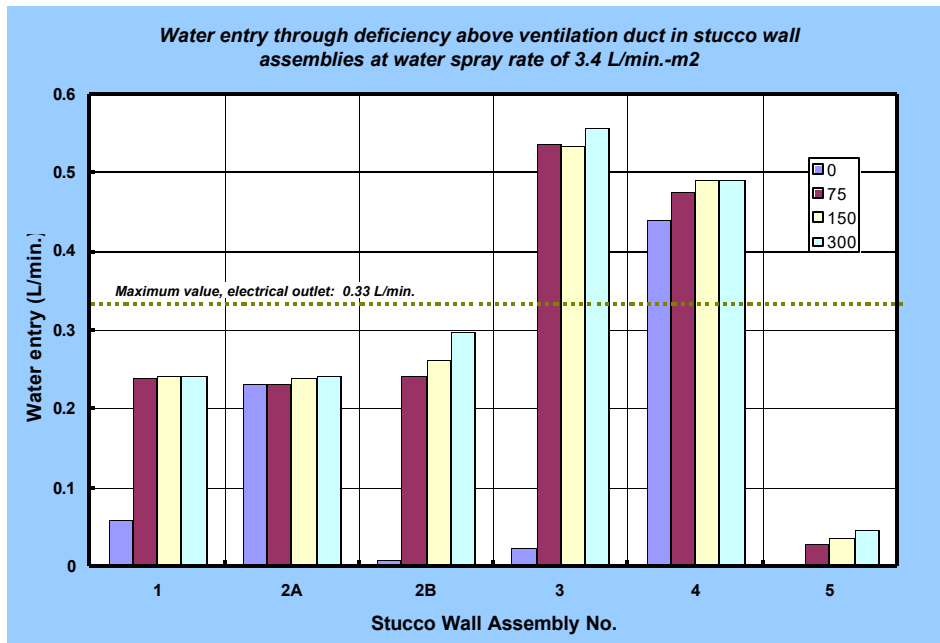
Figure 3.21– Water entry under static pressure differential through deficiency above ventilation duct for stucco wall assemblies at a spray rate of 3.4 L/min.-m<sup>2</sup>

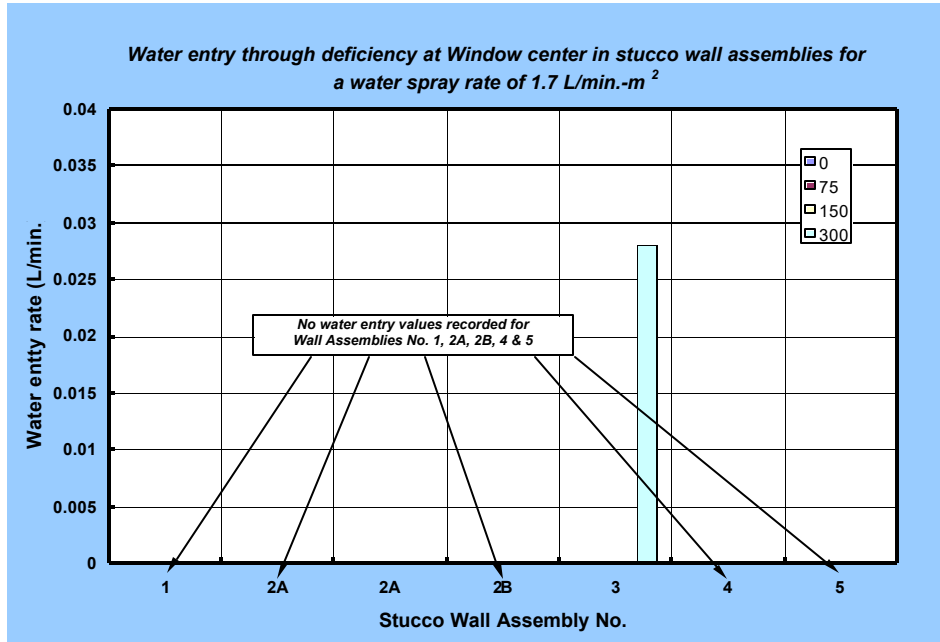
Figure 3.22– Water entry under static pressure differential through deficiency at window centre for stucco wall assemblies at a spray rate of 1.7 L/min.-m<sup>2</sup>.

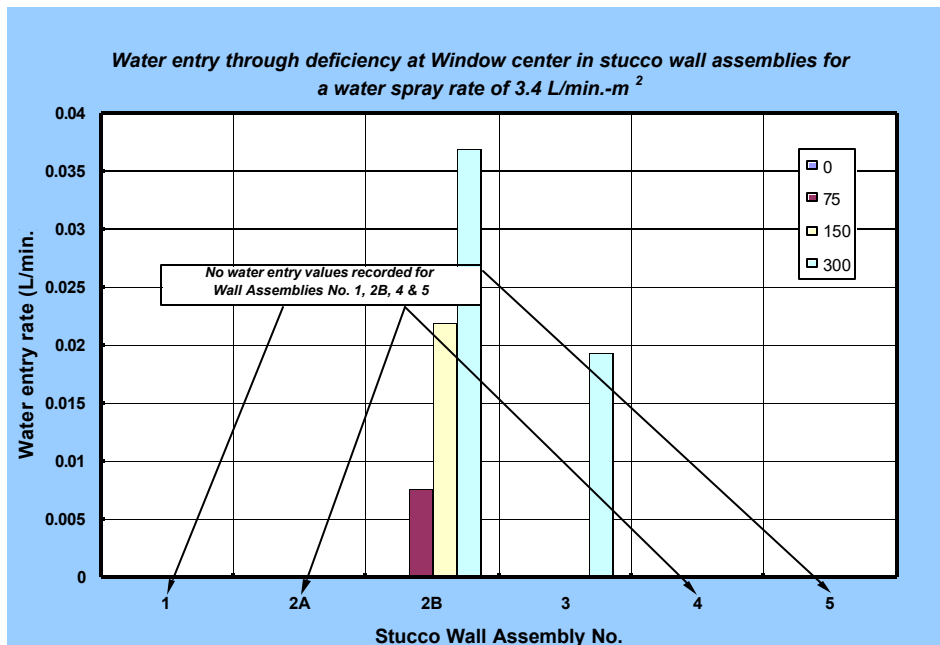
Figure 3.23– Water entry under static pressure differential through deficiency at window centre for stucco wall assemblies at a spray rate of 3.4 L/min.-m<sup>2</sup>.

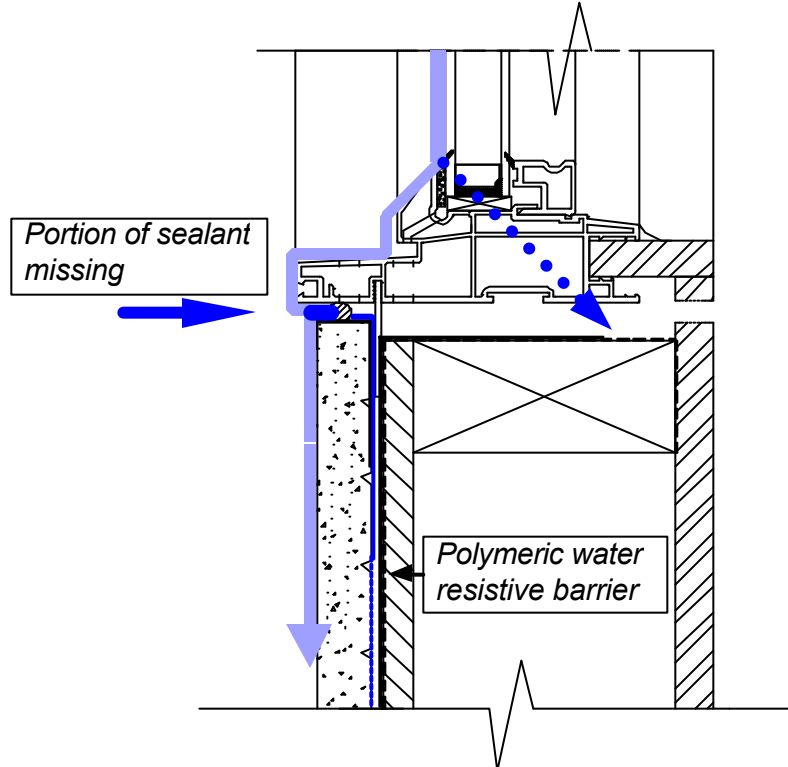
Figure 3.24 – Notional path of water entry at wall-window interface about deficiency

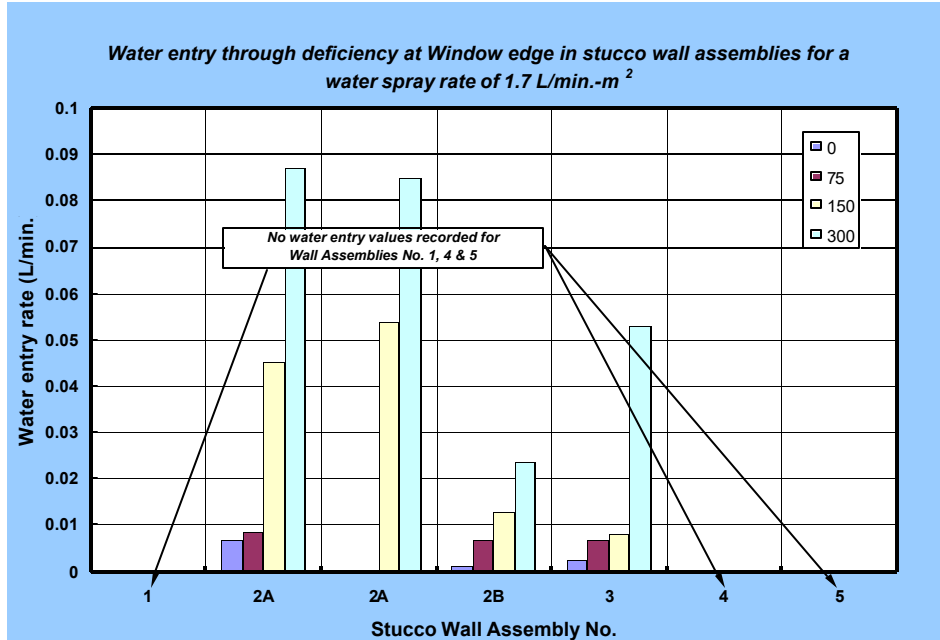
Figure 3.25– Water entry under static pressure differential through deficiency at window edge for stucco wall assemblies at a spray rate of 1.7 L/min.-m<sup>2</sup>.

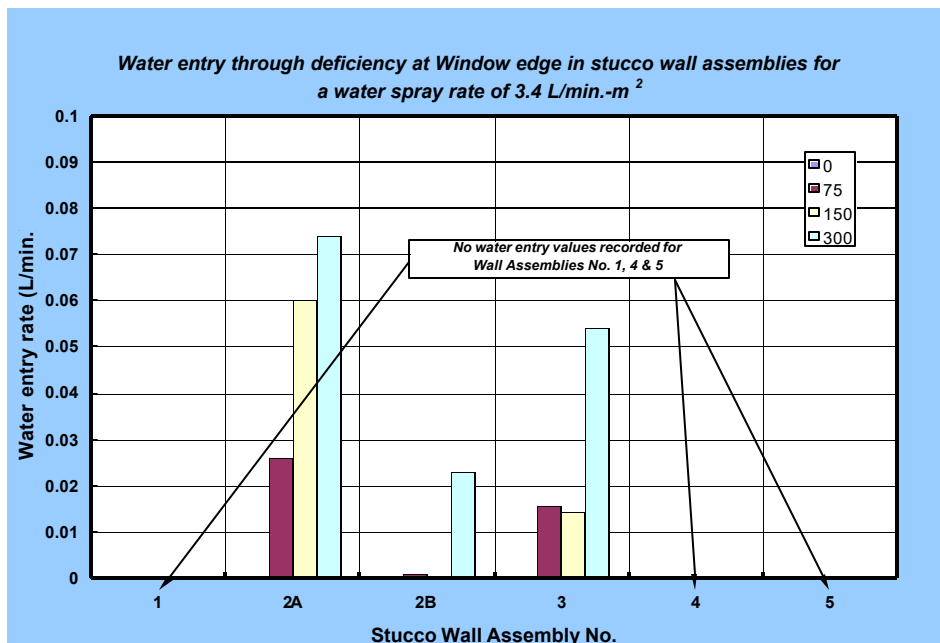
Figure 3.26– Water entry under static pressure differential through deficiency at window edge for stucco wall assemblies at a spray rate of 3.4 L/min.-m<sup>2</sup>.

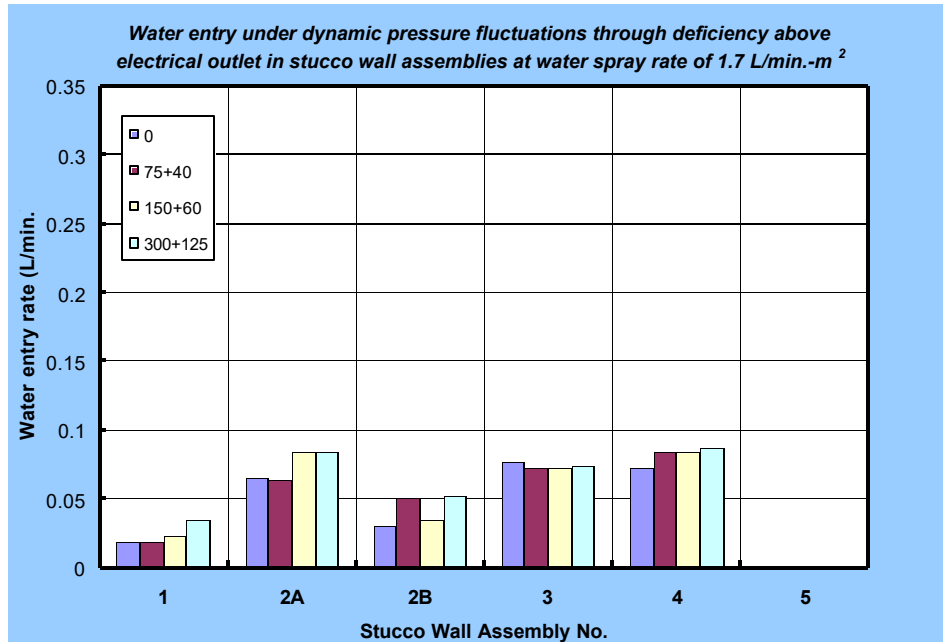
Figure 3.27– Water entry under dynamic pressure fluctuations through deficiency above electrical outlet of stucco wall assemblies at a spray rate of 1.7 L/min.m<sup>2</sup>

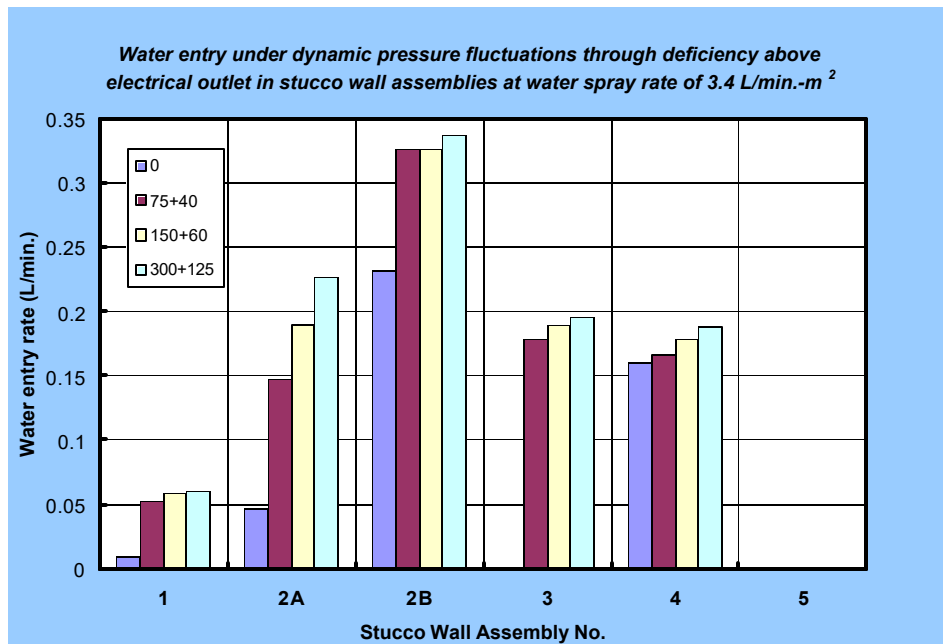
Figure 3.28– Water entry under dynamic pressure fluctuations through deficiency above electrical outlet of stucco wall assemblies at a spray rate of 3.4 L/min.m<sup>2</sup>

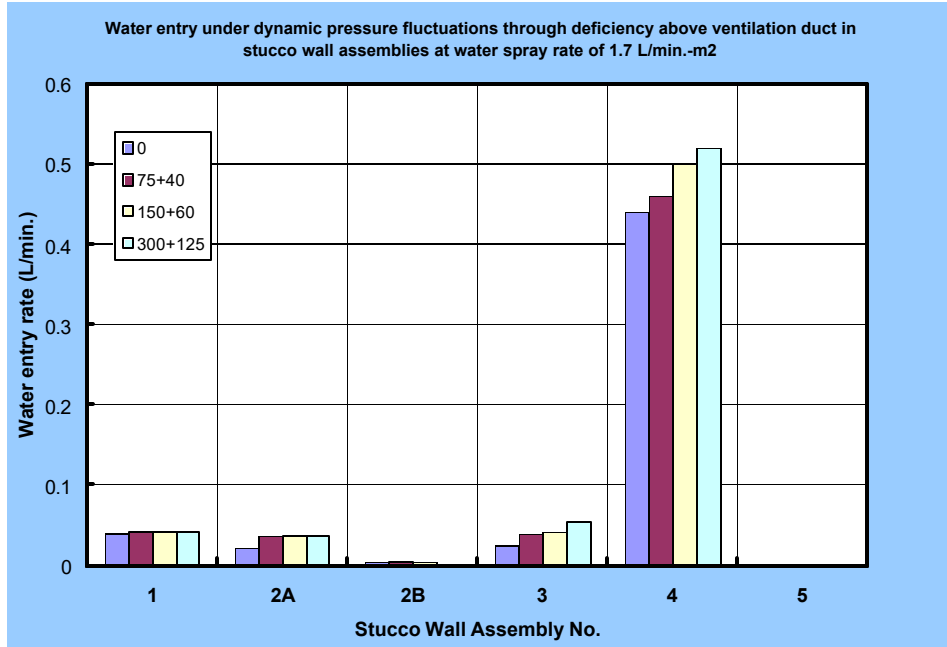
Figure 3.29– Water entry under dynamic pressure fluctuations through deficiency above ventilation duct of stucco wall assemblies at a spray rate of 1.7 L/min.-m<sup>2</sup>

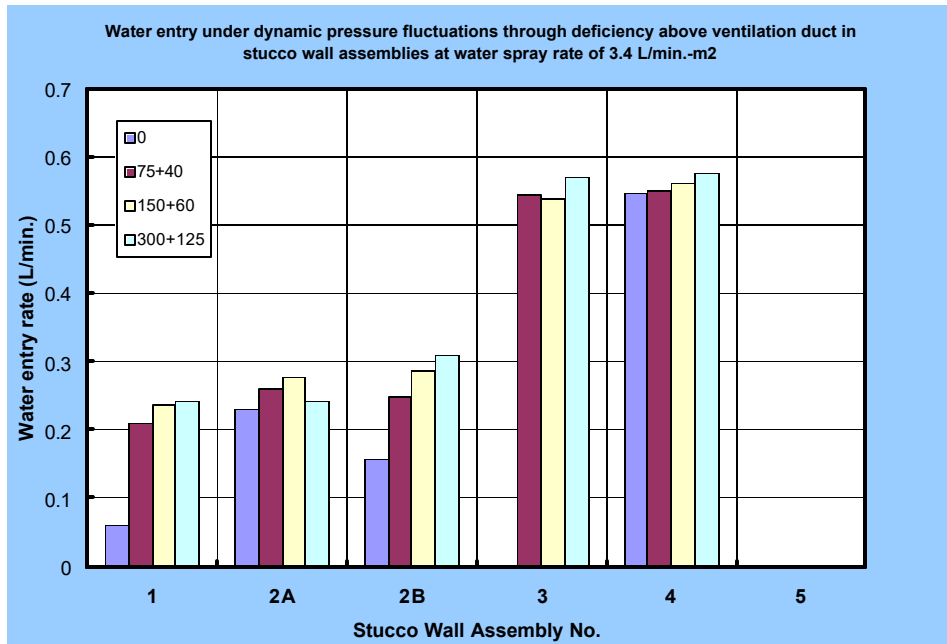
Figure 3.30– Water entry under dynamic pressure fluctuations through deficiency above ventilation duct of stucco wall assemblies at a spray rate of 3.4 L/min.-m<sup>2</sup>

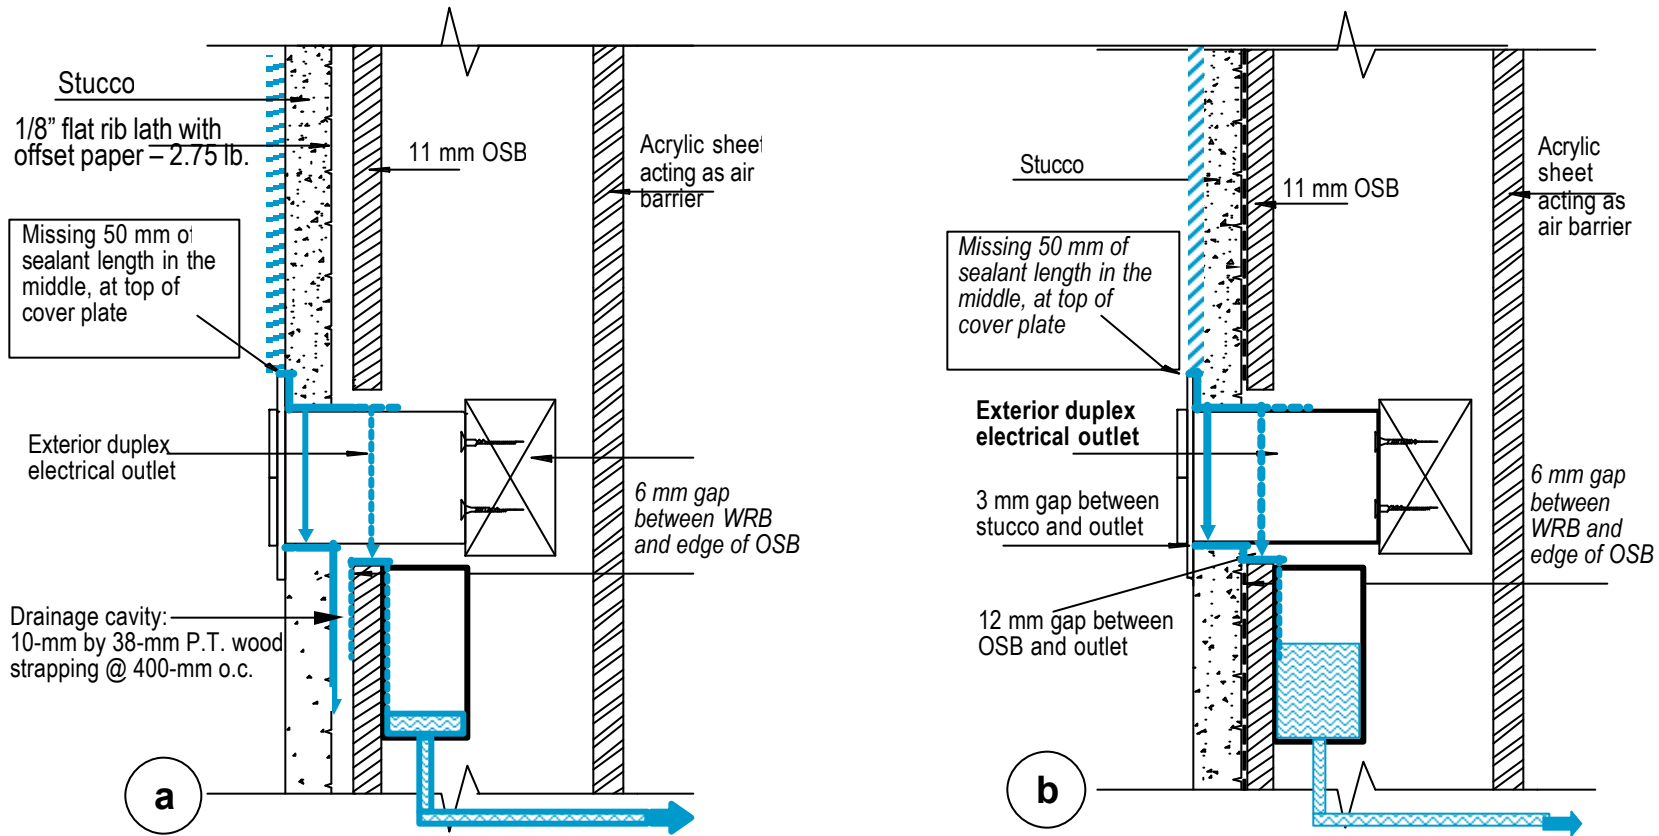
Figure 3.31– Sectional views representative of (a) WA-5, having a 10-mm drainage cavity, and (b) the other stucco wall assembly types showing the notional path of water entry through a deficiency above the electrical outlet.

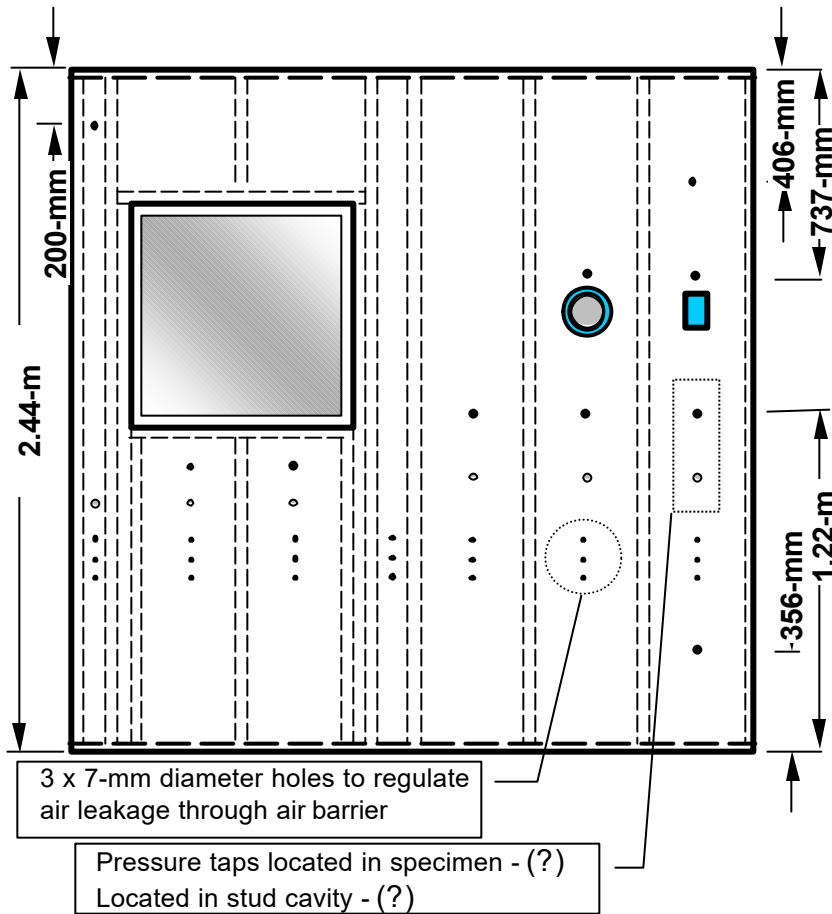
**Figure 4.1 - Location of pressure taps and air leakage openings.**

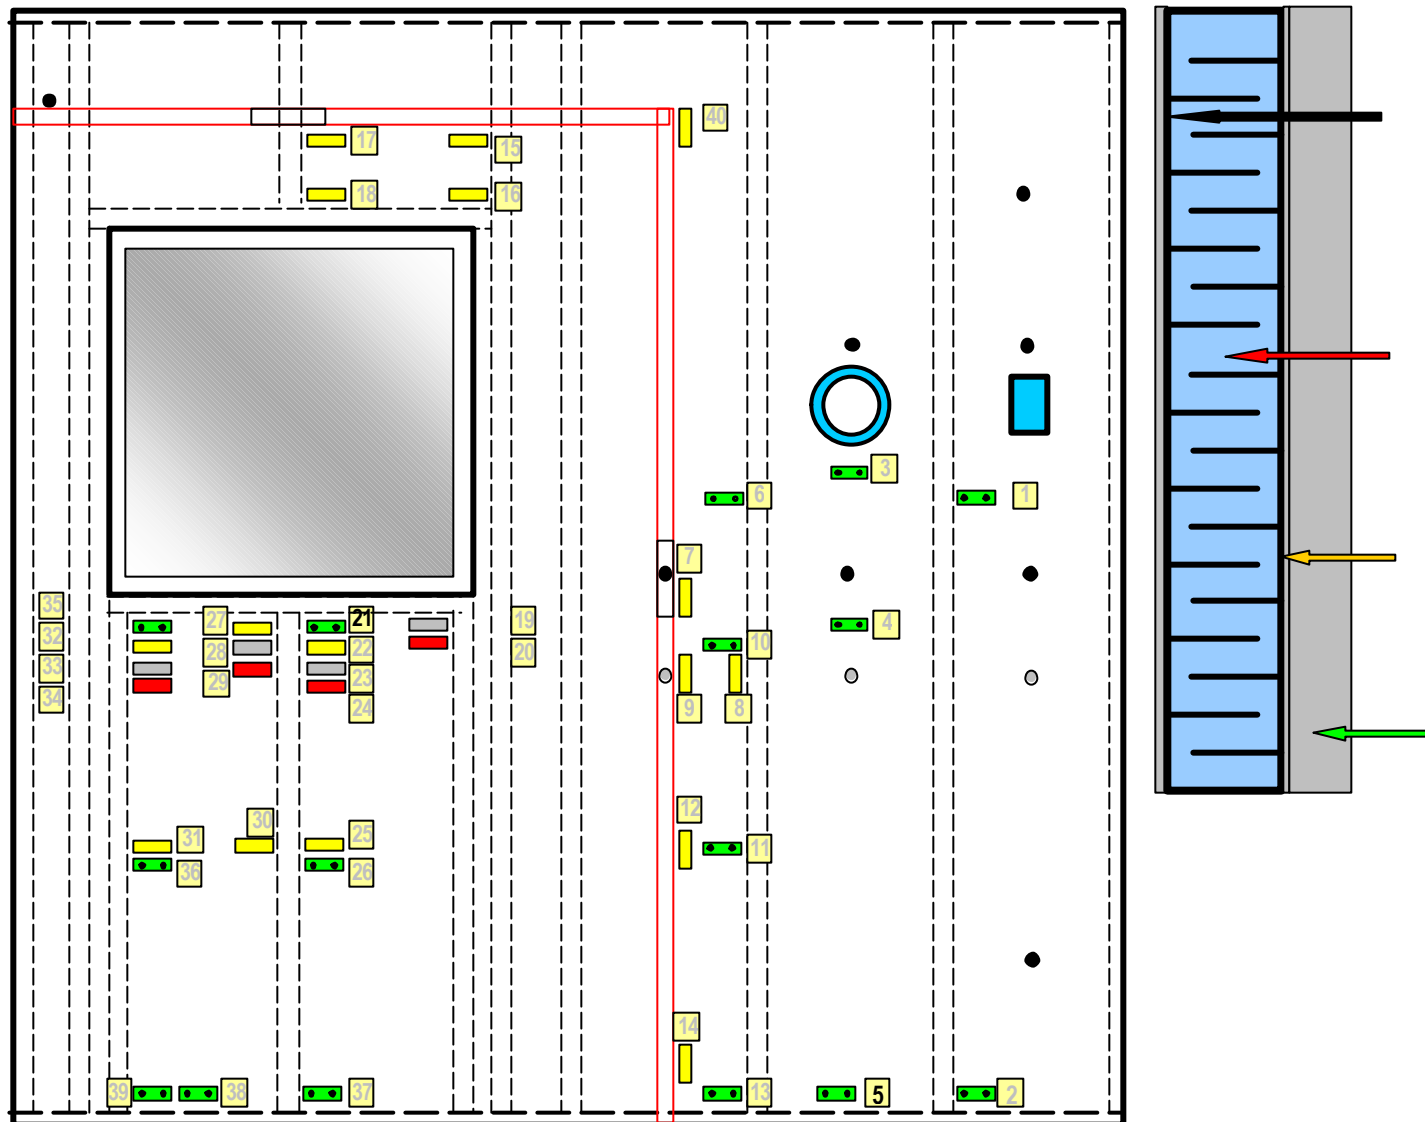
Figure 4.2 - Location of moisture sensors

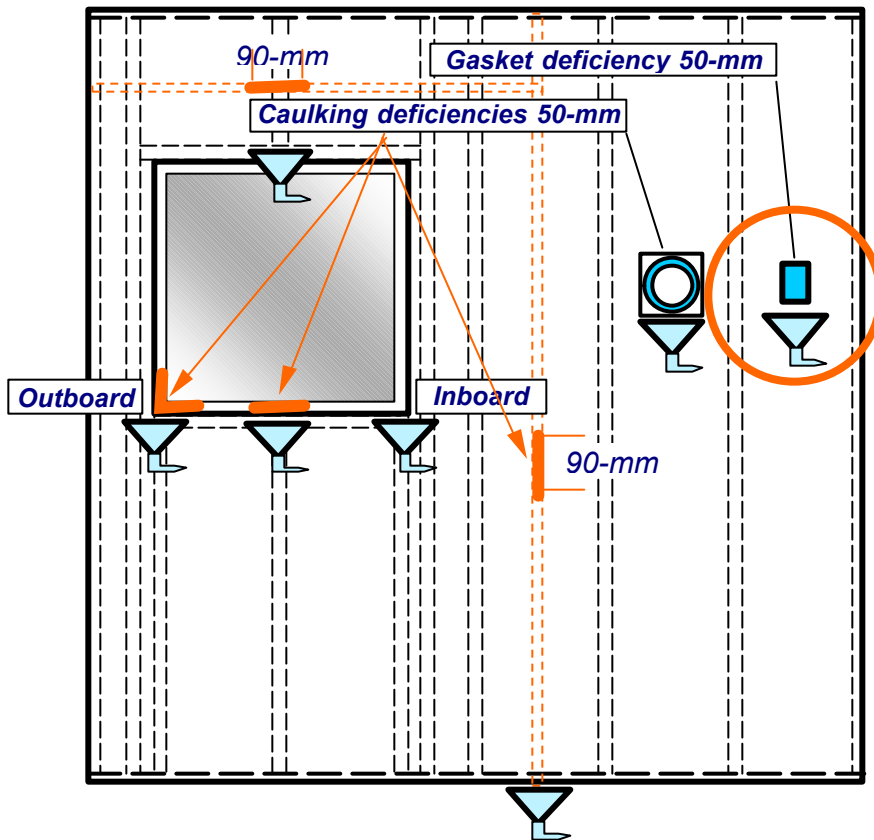
Figure 4.3 - Location of water collection points at specified deficiencies and collection troughs

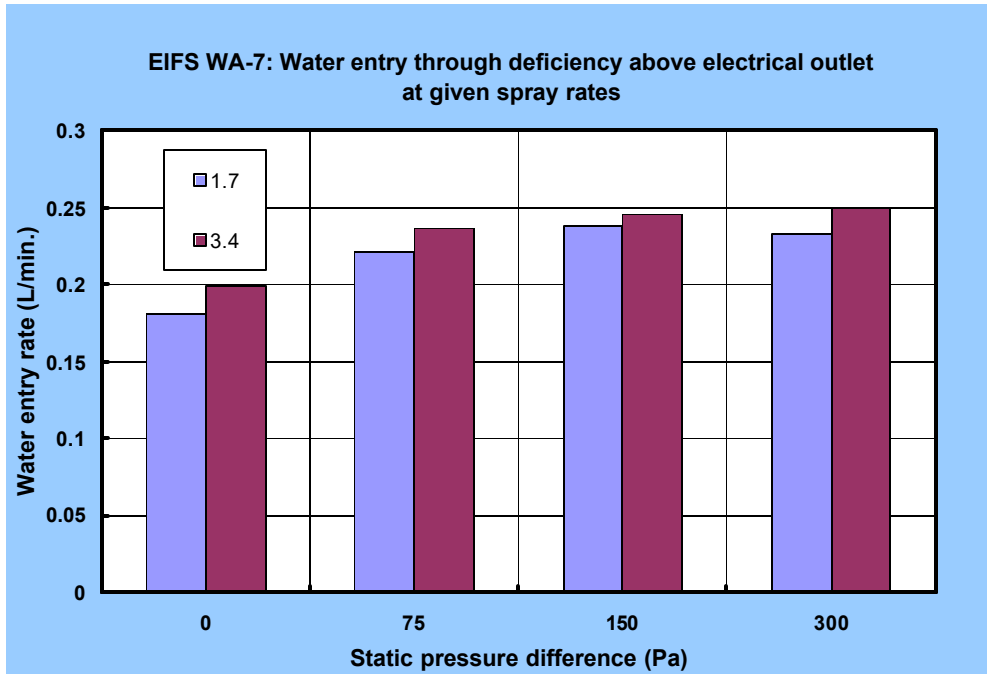
Figure 4.4 – EIFS WA-7 : Water entry under static pressure differential through deficiency above electrical outlet

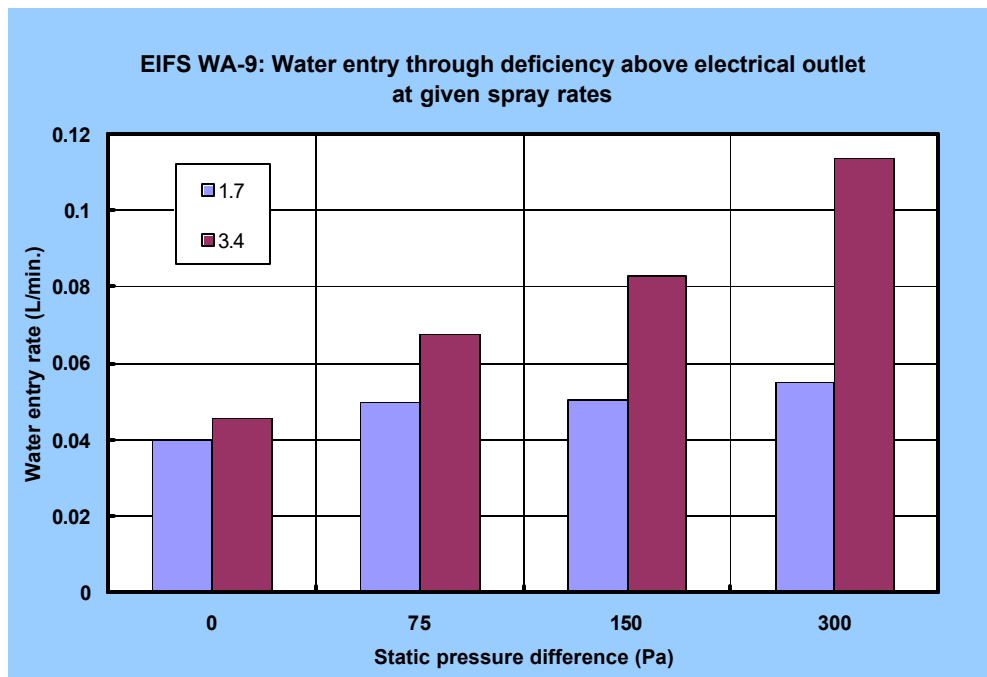
Figure 4.5 – EIFS WA-9 : Water entry under static pressure differential through deficiency above electrical outlet

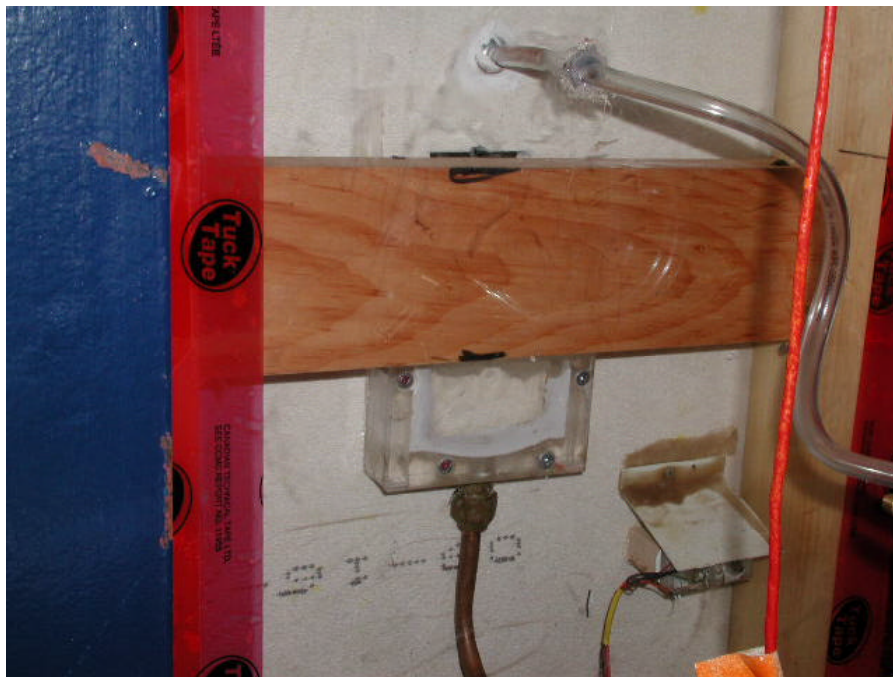
**Figure 4.6 – EIFS WA-8 : Water entering through deficiency above electrical outlet but draining between gypsum board and EPS insulation.**

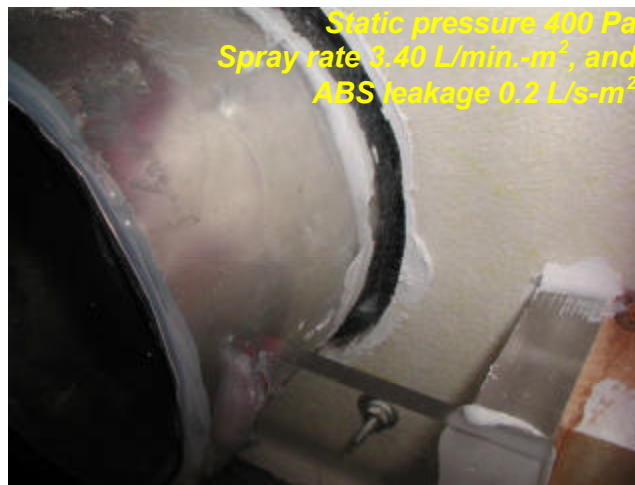
**Figure 4.7 – EIFS *WA-8* : Stage 7 - at test initiation, water coming through deficiency above ventilation duct and slowly draining between glass mat gypsum board and insulation**

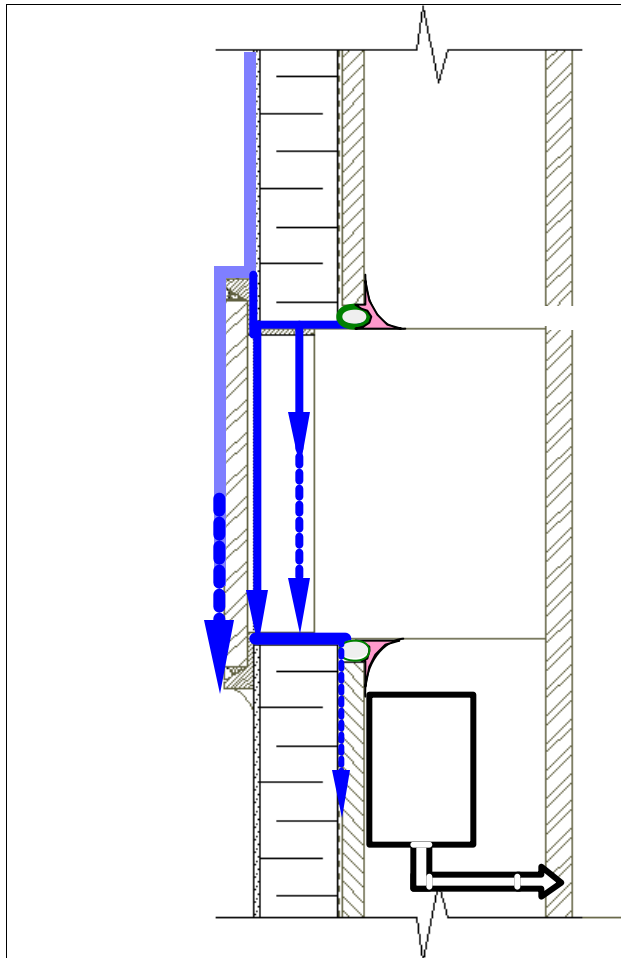
**Figure 4.8 – EIFS WA-8: deficiency above vent duct presumed water entry path – caulking and backer rod in place – no water entry; probable drainage through vertical channels between adhesive layer and cementitious membrane coating**

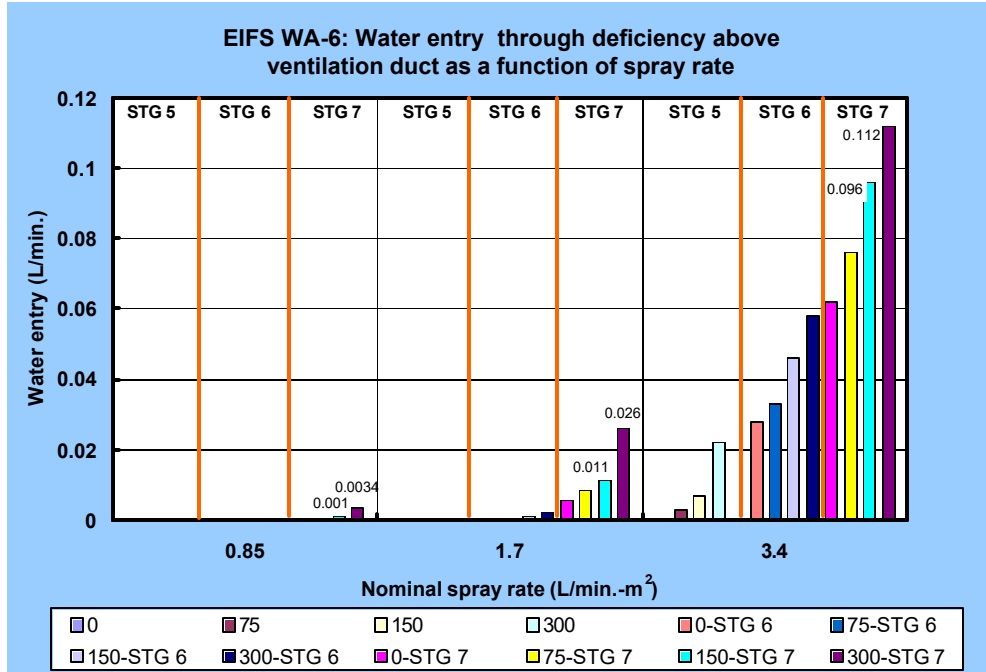
Figure 4.9 – WA-6: Water entry ventilation duct - Stages 5 through 7
