## NRC Publications Archive Archives des publications du CNRC

### Report from Task 6 of MEWS Project: experimental assessment of water penetration and entry into wood-frame wall specimens: final report

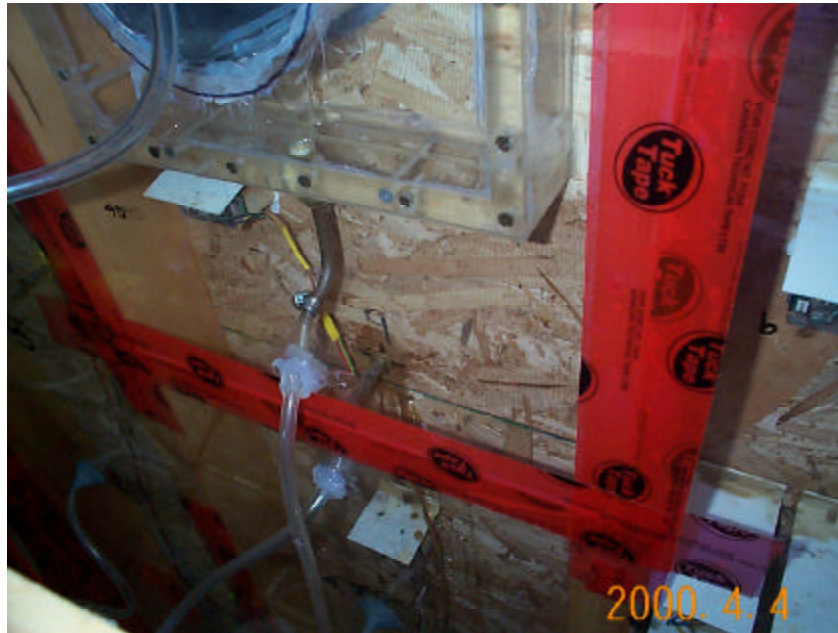
**Figure 4.11 – EIFS WA-6 : Water coming through deficiency above ventilation duct and between top and bottom sheathing boards (Stage 5- sealant and backing rod in place). Conditions - Static pressure difference: 300 Pa; Spray rate: 3.4 L/min.-m<sup>2</sup>; Air Barrier System Leakage: 0.2 L/s-m<sup>2</sup>**

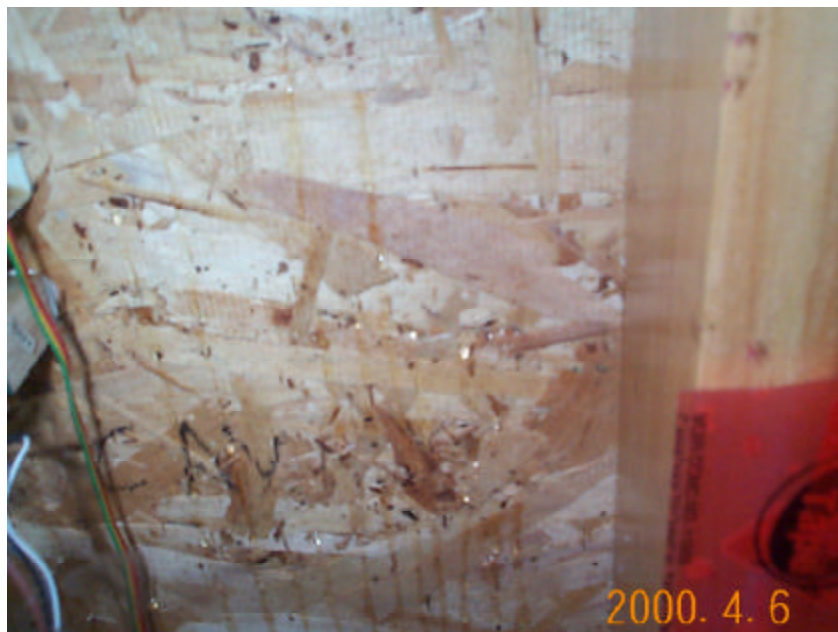
**Figure 4.12 – EIFS WA-6 Stage 6 (sealant removed and backing rod in place): Cavity beneath ventilation duct. Water coming through pores in sheathing at the start of test – continued throughout Stage 6 and thereafter in Stage 7.**

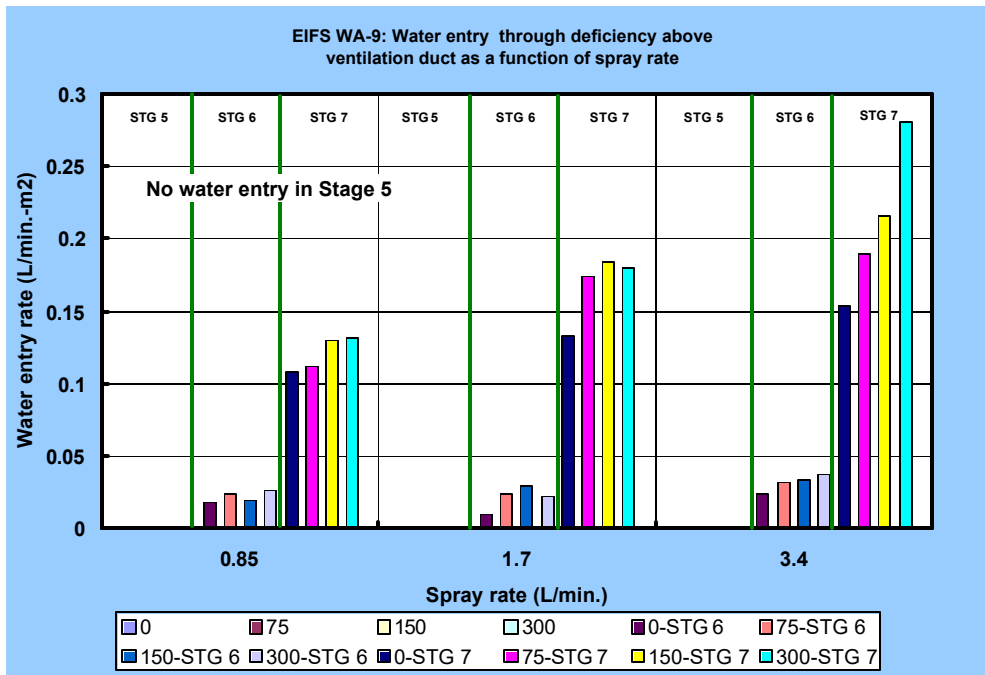
Figure 4.13 – EIFS Water entry - WA-9: vent duct - Stages 5 through 7

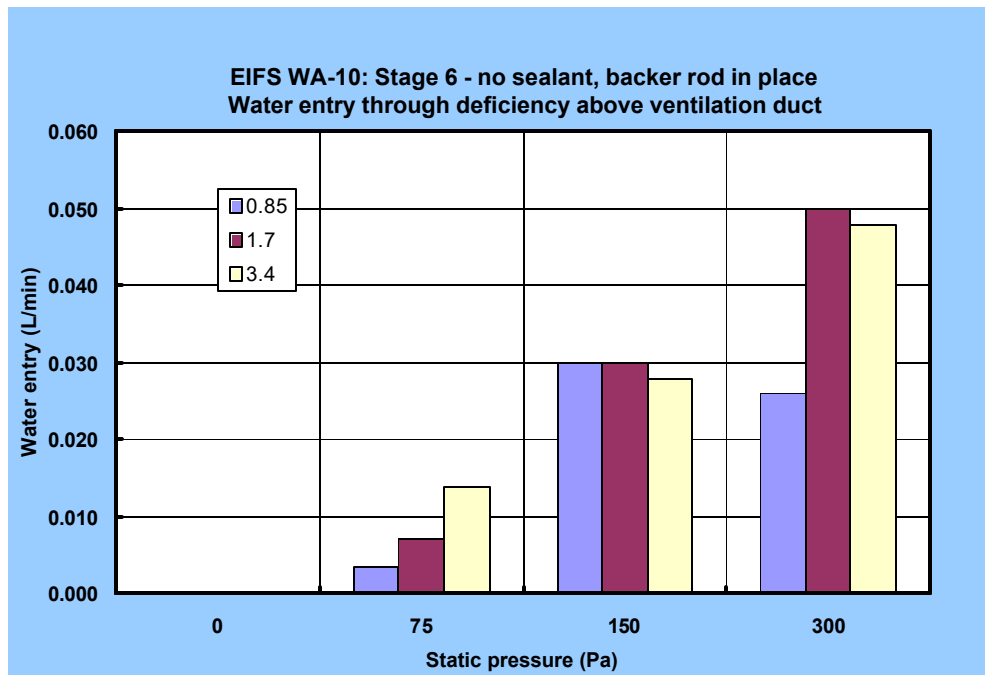
(0.037 L/min.) and ca. 4 times less than that found for WA- 7 (0.220 L/min.).

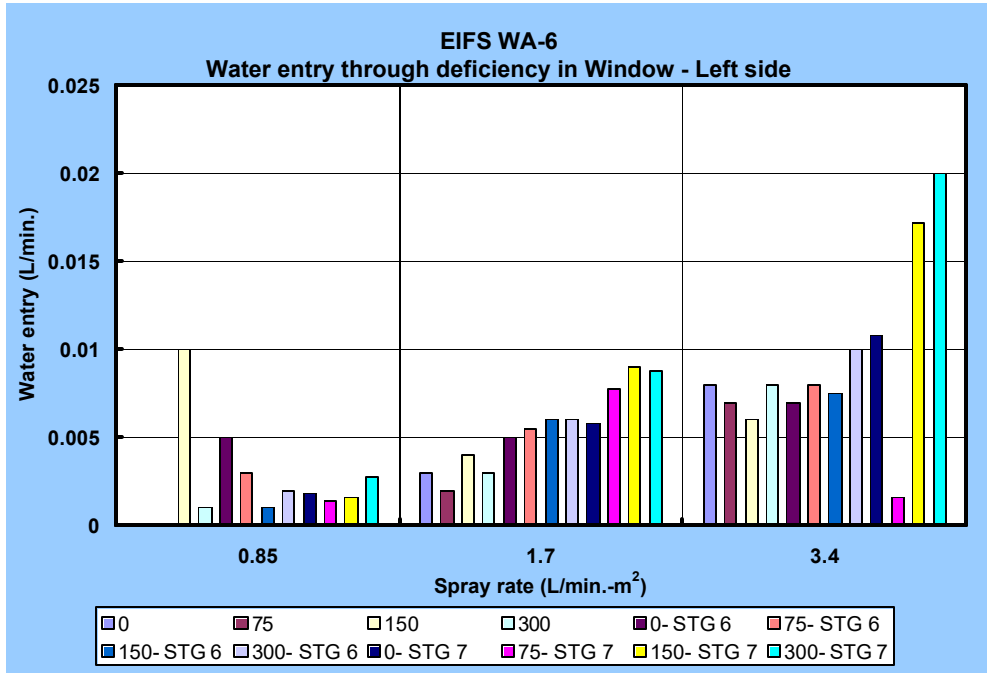
Figure 4.16 – EIFS WA-6: Water entry at various spray rates and at given static pressure differentials through deficiency at RS of window

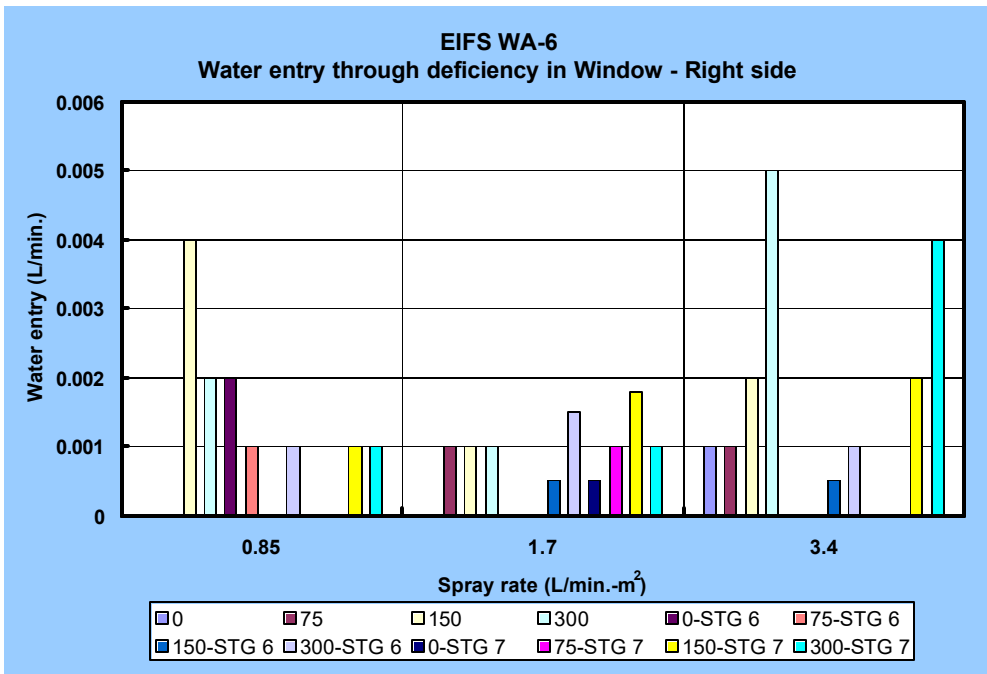
Figure 4.17 – EIFS WA-6: Water entry at various spray rates and at given static pressure differentials through deficiency at LS of window

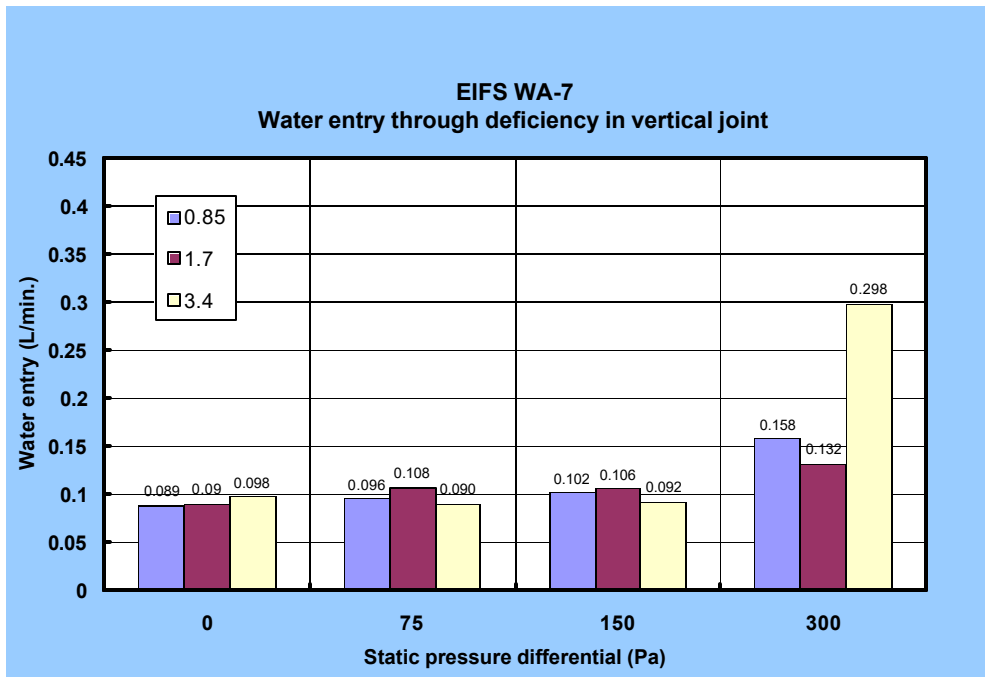
Figure 4.18 – EIFS WA-7: Water entry under static pressure differential through deficiency in vertical joint

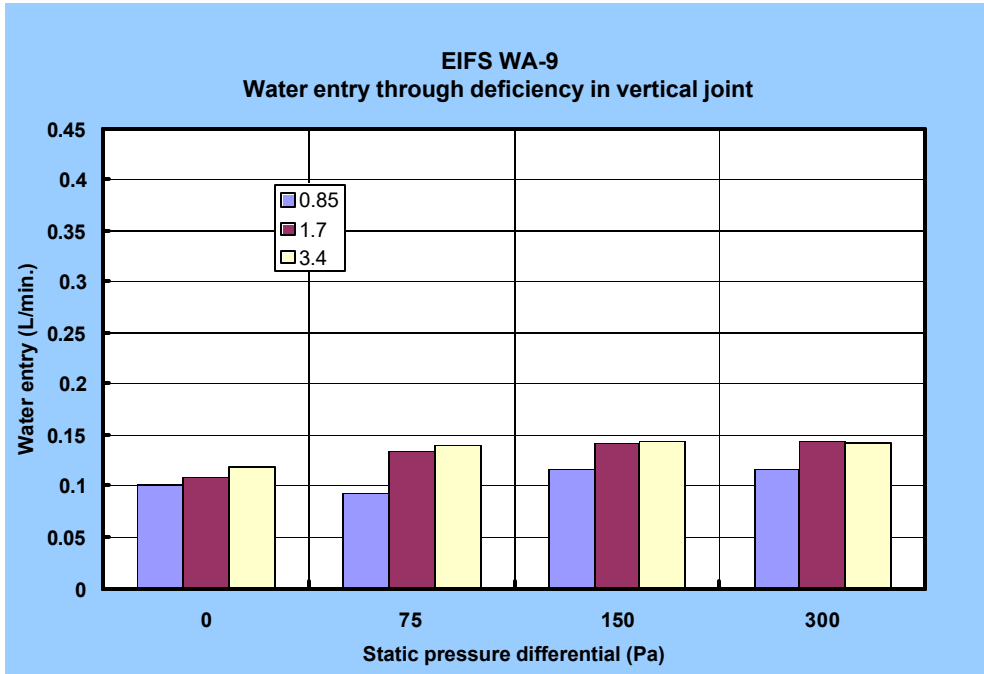
Figure 4.19 – EIFS WA-9: Water entry under static pressure differential through deficiency in vertical joint

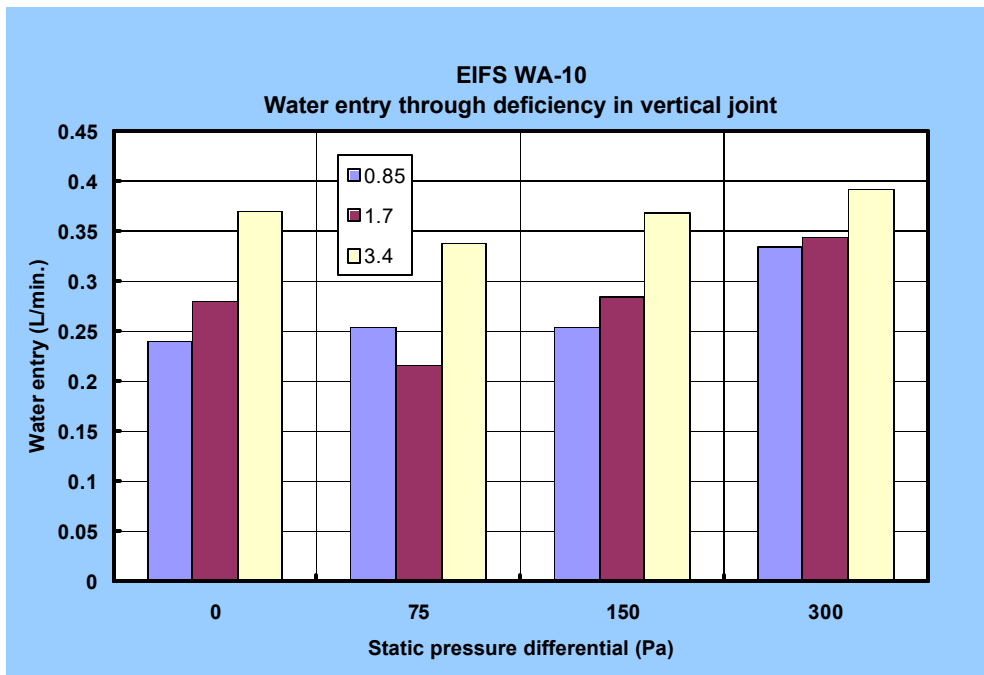
Figure 4.20 – EIFS WA-10: Water entry under static pressure differential through deficiency in vertical joint

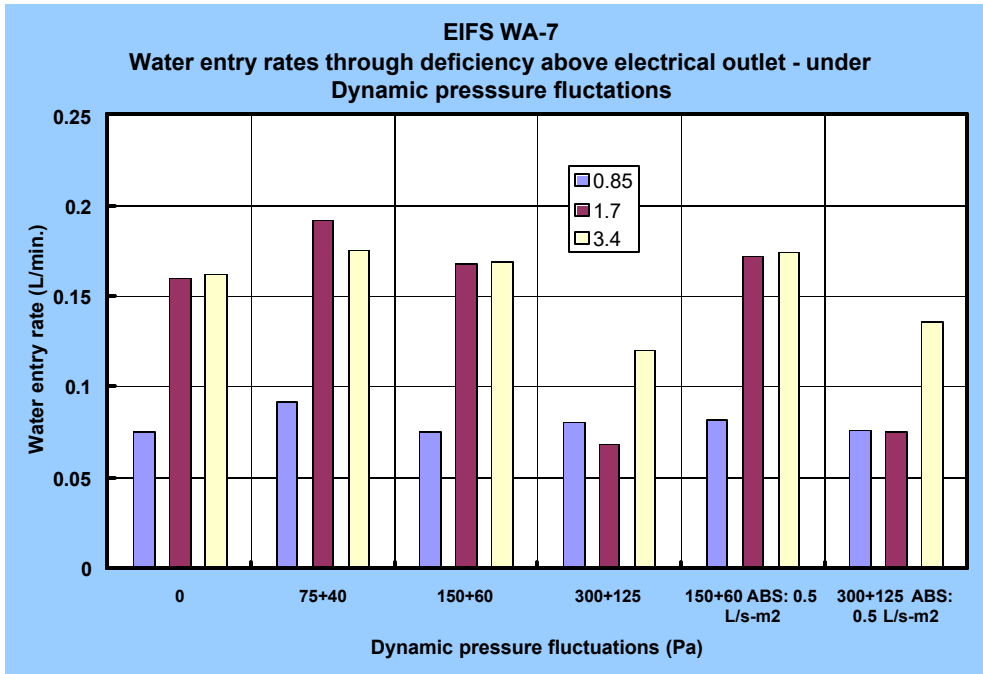
Figure 4.21 – EIFS WA-7: Water entry rates under dynamic pressure fluctuations through deficiency above electrical outlet

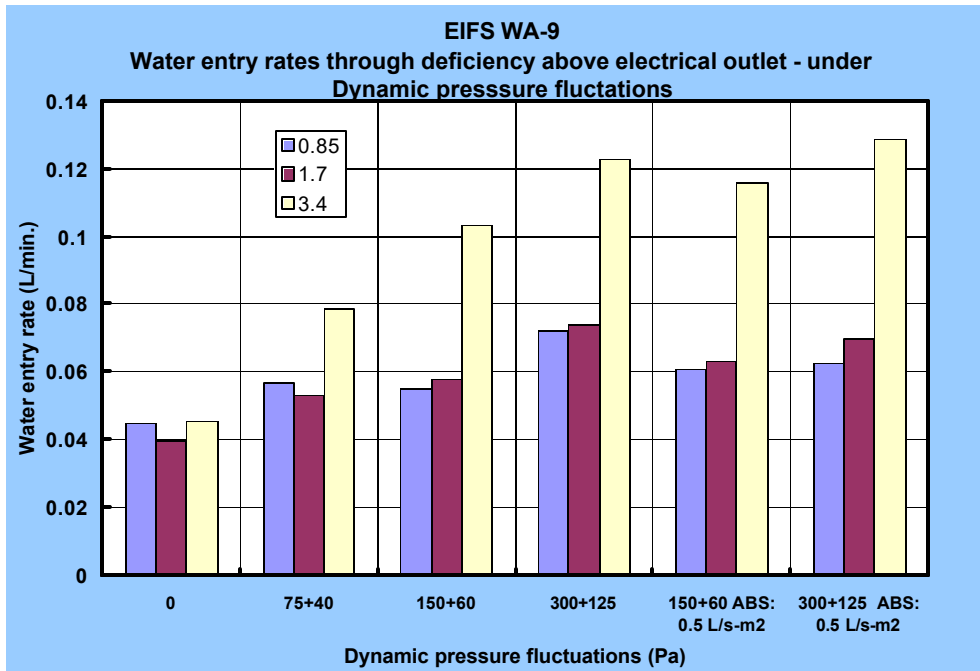
Figure 4.22 – EIFS WA-9 : Water entry rates under dynamic pressure fluctuations through deficiency above electrical outlet

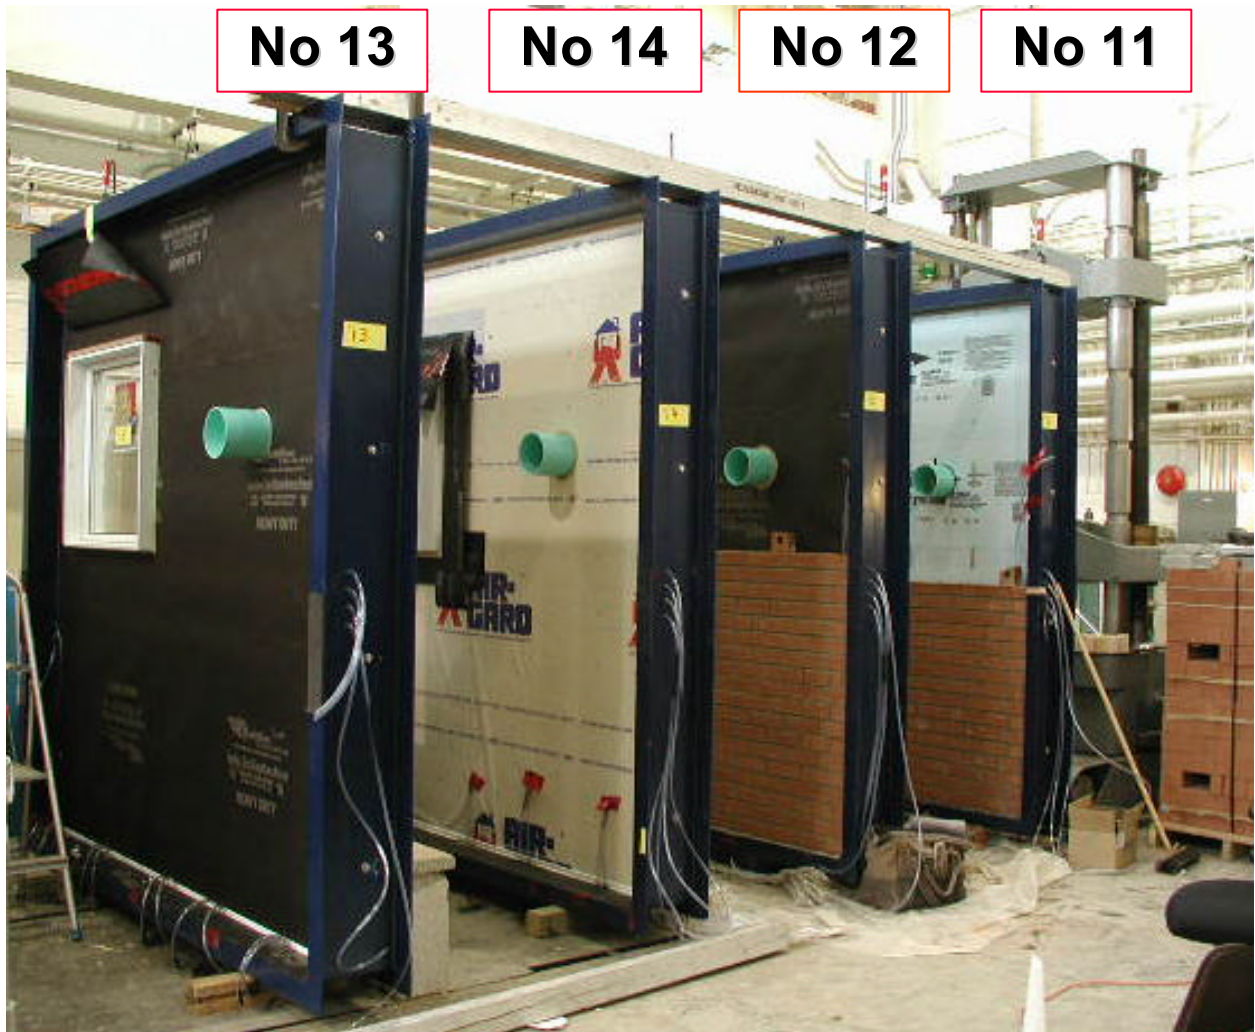
Figure 5.1 - Masonry walls assemblies (WA-11, -12, -13, -14) in various stages of fabrication

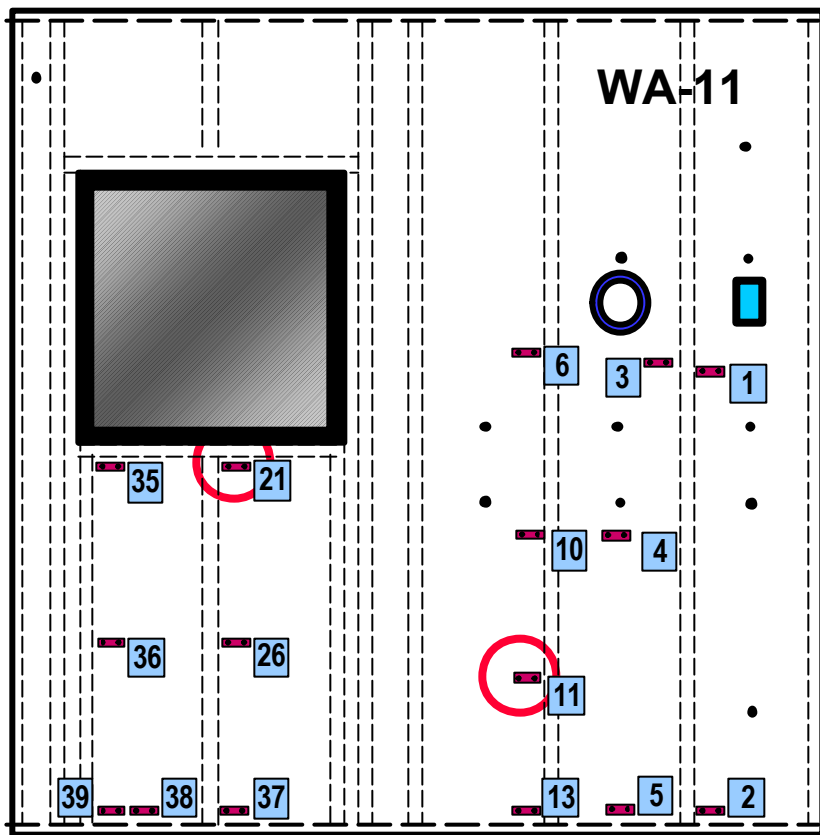
**Figure 5.5 - WA-11:** During static & dynamic tests - Water entry about window; MS-21 activated; After continuous water spray of 16-h (0.4 L/min.-m<sup>2</sup> at 50 Pa) MS-11 activated.

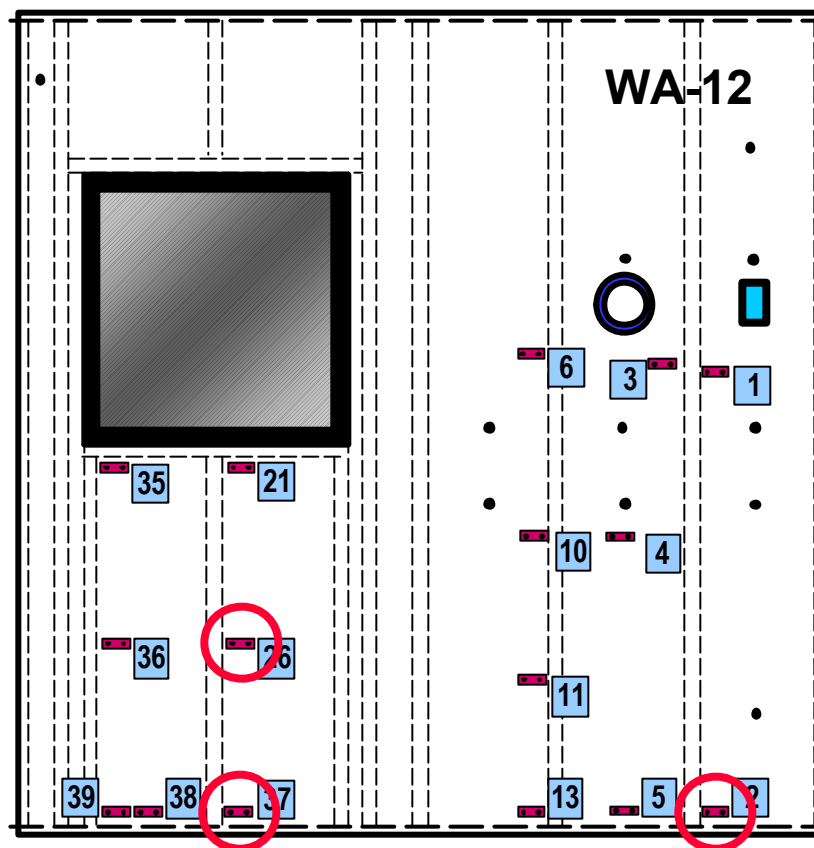
**Figure 5.6 - WA-12 :** No sensors activated over course of either static or dynamic trials; water entry observed at 500 Pa  $\Delta P_s$  at electrical ; water entry @ 1000 Pa  $\Delta P_s$ ; water entry evident in other collectors; After 16-h continuous MS-2 and MS-37 - due to seepage at base; MS-26 - possible seepage about window

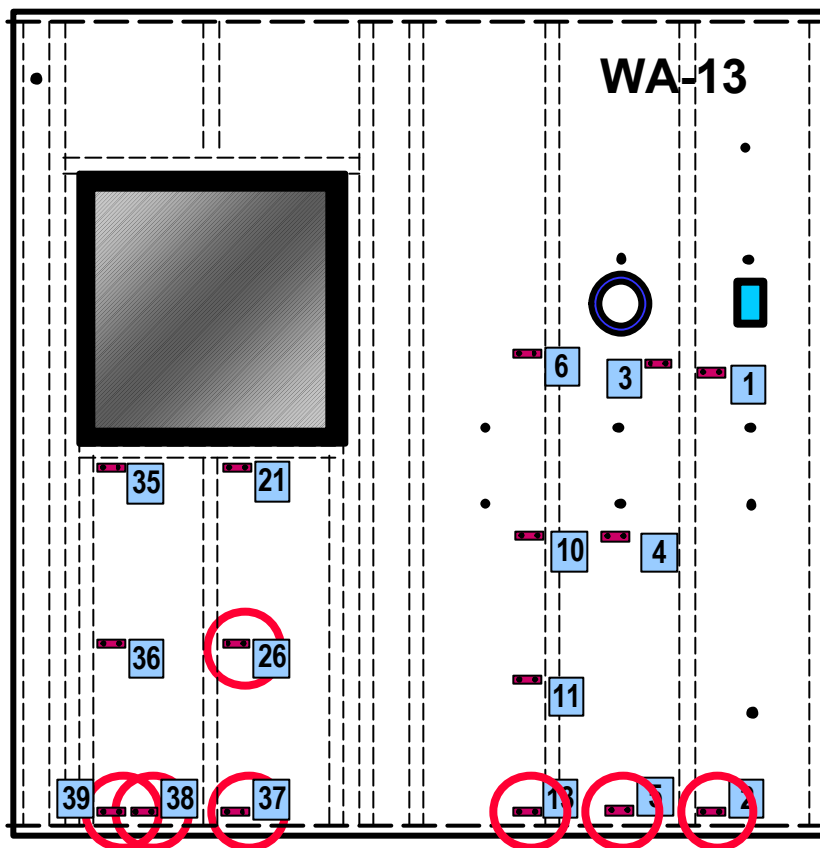
**Figure 5.7** – WA-13: During static & dynamic tests - Water entry about window; After 16-h continuous spray: Moisture sensors activated: MS-26; Activated due to seepage at base of wall: MS-2, -5, -13, -37, -38, -39

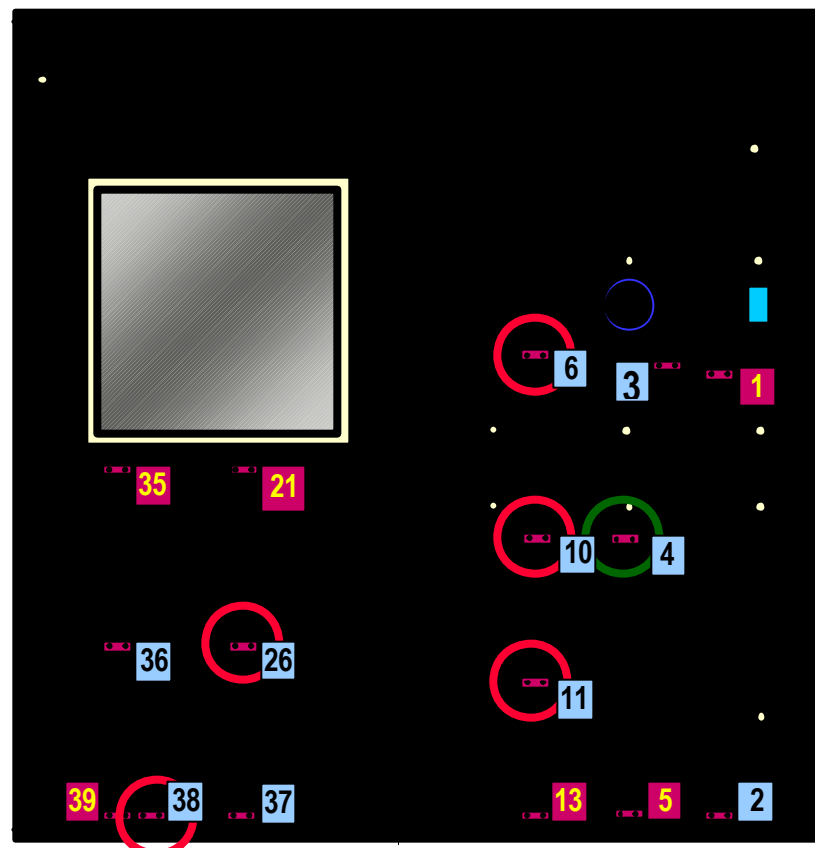
**Figure 5.8** – WA-14: No water entry observed during static test; MS activation during dynamic trials, MS-6 ( $300 \pm 125$  Pa); MS-10 ( $150 \pm 60$  Pa); MS-11 ( $700 \pm 300$  Pa); MS-26 ( $300 \pm 125$  Pa); MS-38 ( $300 \pm 125$  Pa); MS-4 activated during 16-h continuous water spray

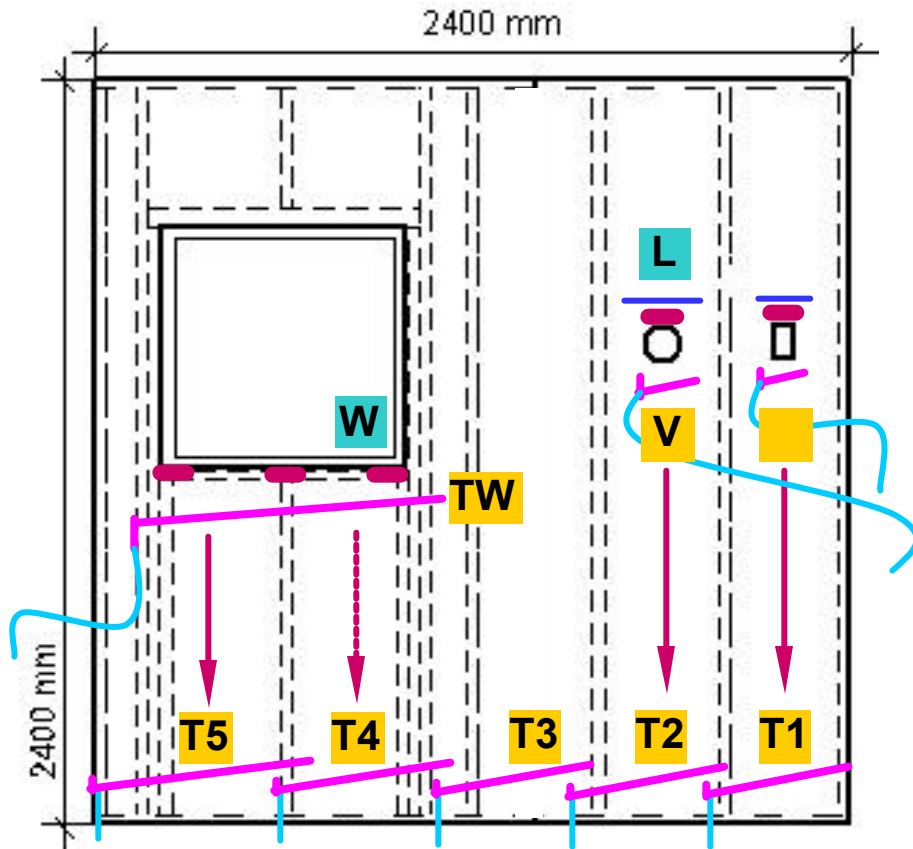
Figure 5.9 - Location of collection troughs

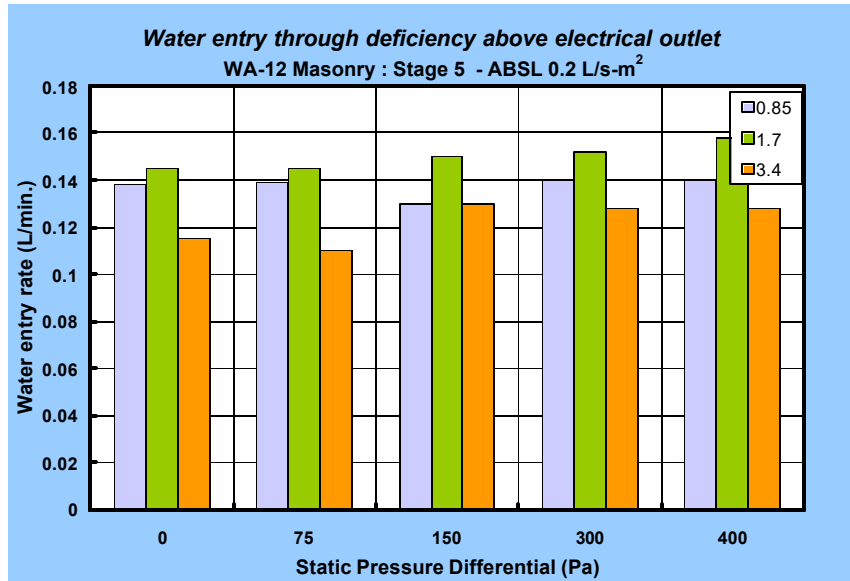
**Figure 5.10**– WA-12 (brick masonry veneer): Water entry rates through deficiency above electrical outlet as a function of static pressure and spray rates for Stage 5

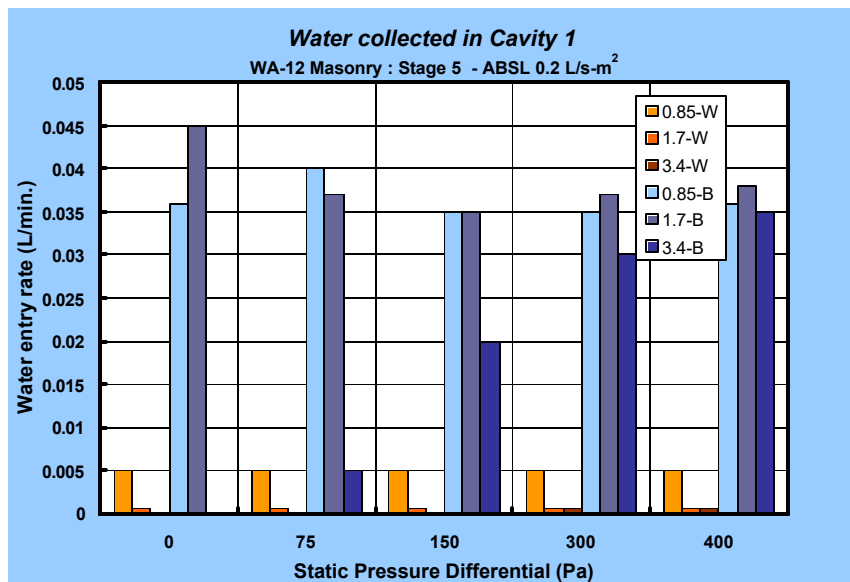
**Figure 5.11**– WA-12 (Brick masonry veneer): Water collection rates for troughs T1-B and T1-W (below electrical outlet) as a function of static pressure and spray rates for Stage 6

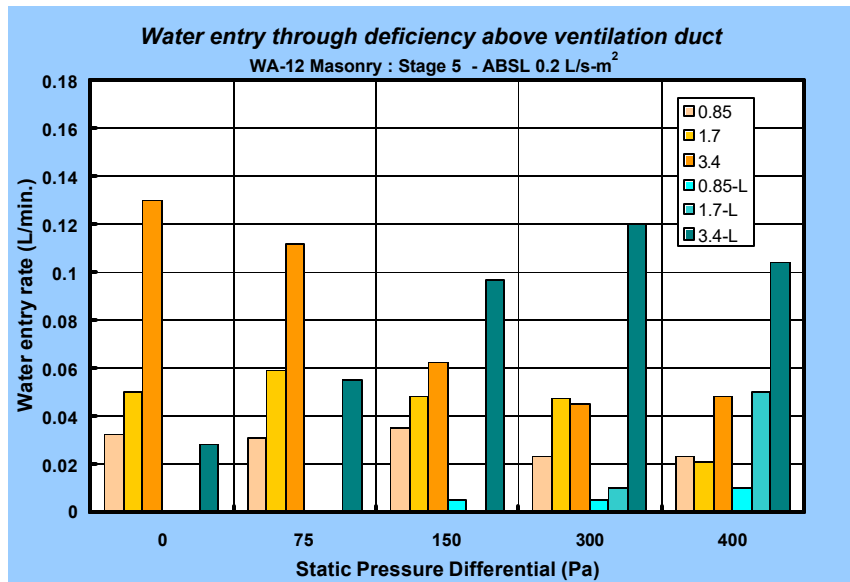
**Figure 5.12**– WA-12 (Brick masonry veneer) Water entry through deficiency above ventilation duct as a function of static pressure and spray rate – Stage 6 test conditions

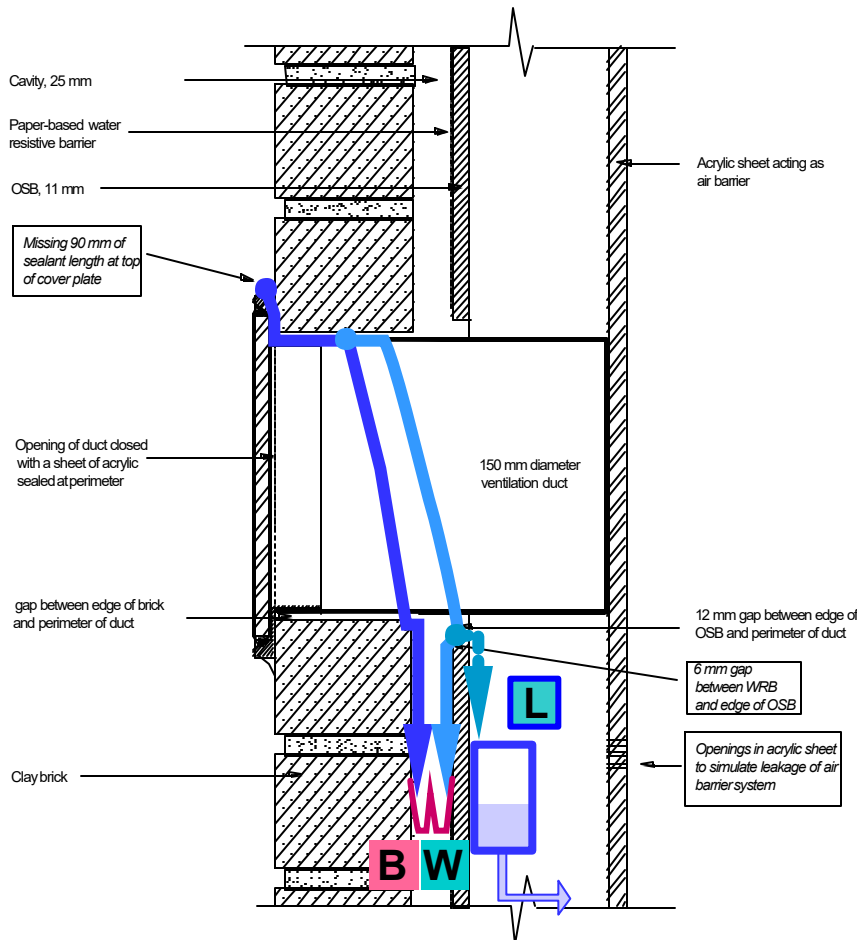
**Figure 5.13**– WA-12 (Brick masonry veneer) Sectional view through wall assembly at ventilation duct showing path of water entry into stud cavity and drainage space.

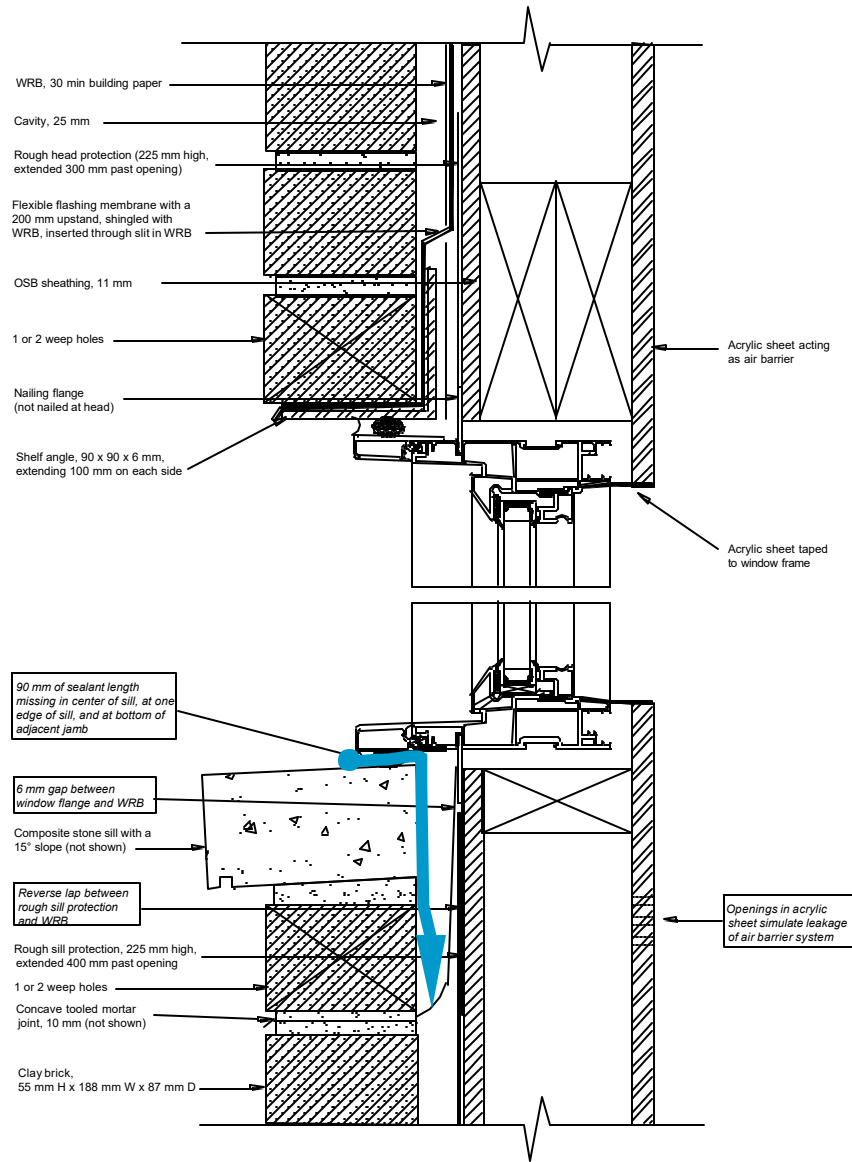
**Figure 5.14**– Section view of WA-12 at window opening showing water entry path from deficiency to collection troughs

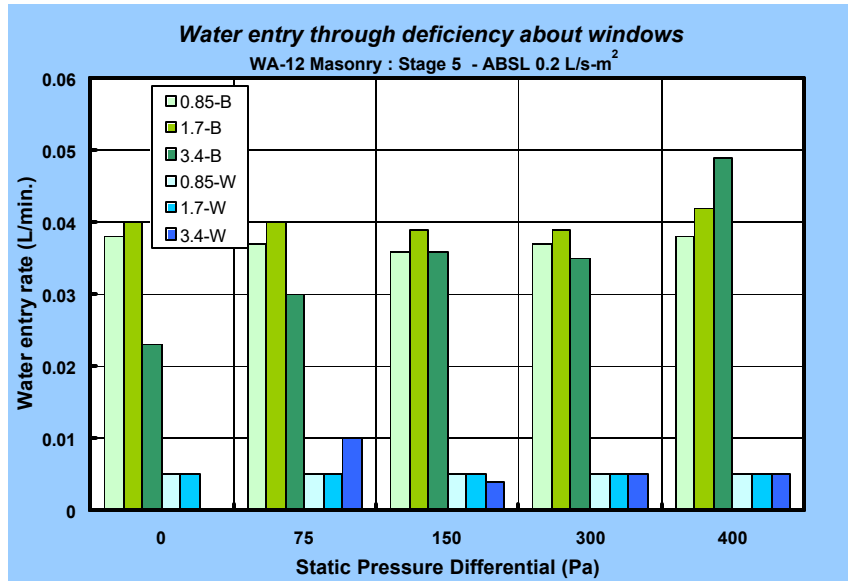
**Figure 5.15**– WA-12 (Brick masonry veneer) Water entry through deficiency about window as a function of static pressure level and spray rate for Stage 6

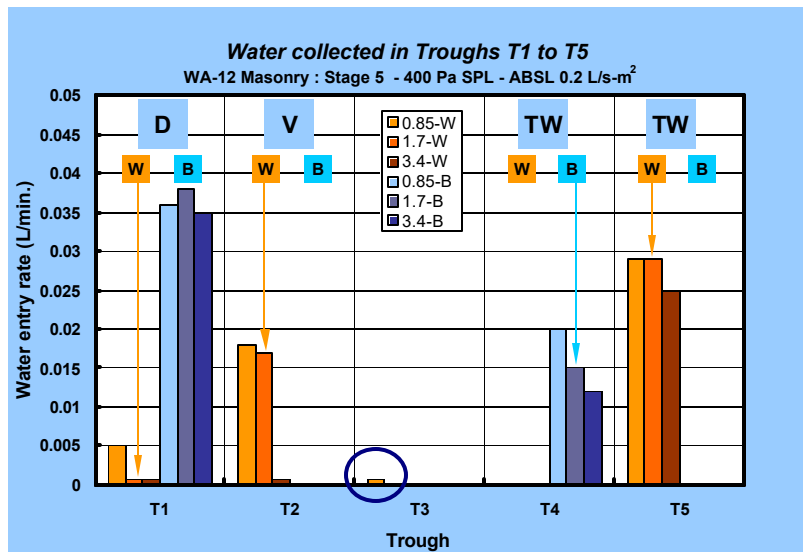
**Figure 5.16** – WA-12 (Brick masonry veneer) Water collection rates troughs T1 to T5 for Stage 6 in static pressure conditions

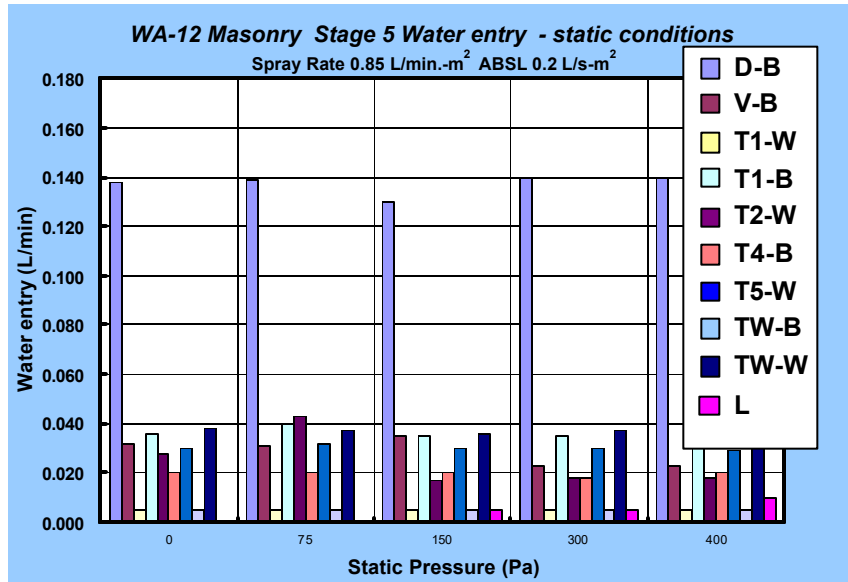
Figure 5.17– WA-12 (Brick masonry veneer) Water collection rates troughs T1 to T5 for Stage 6 in static pressure conditions

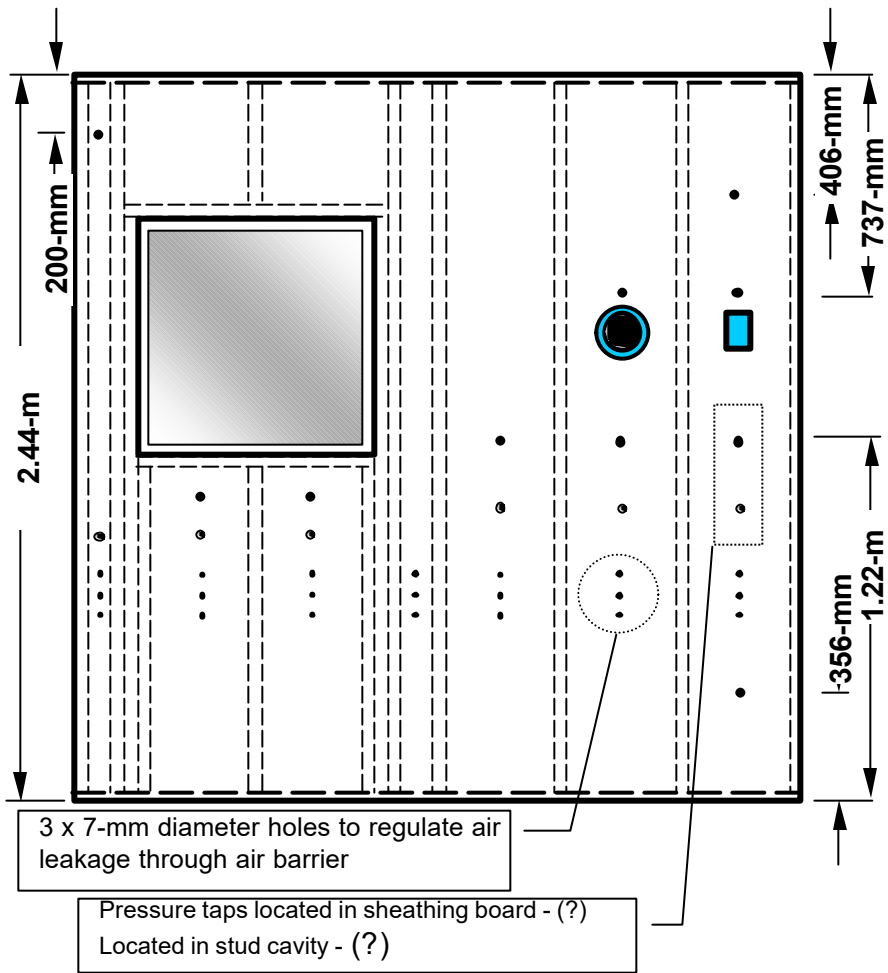
Figure 6.1 - Location of pressure taps and air leakage openings.

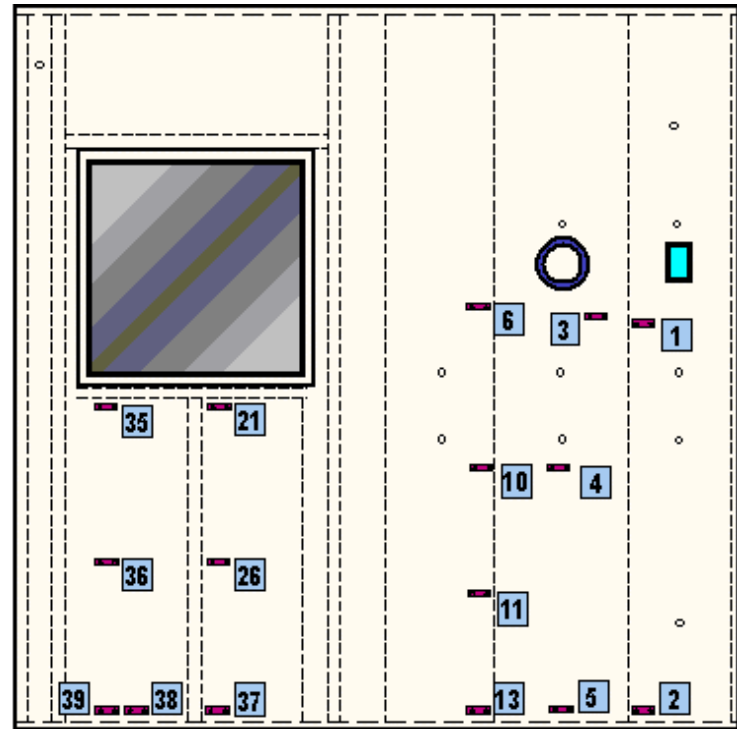
Figure 6.2 - Location of moisture sensors

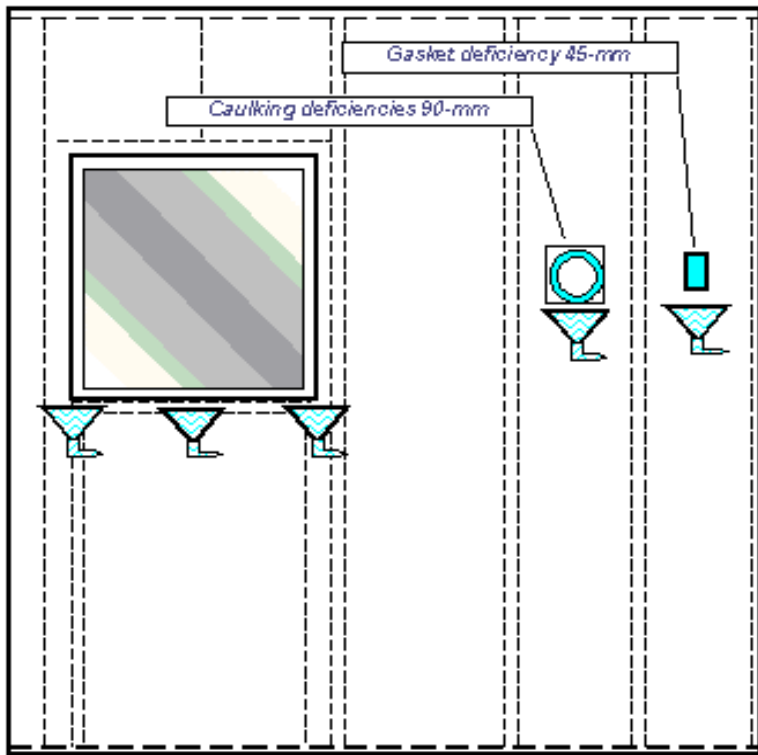
Figure 6.3 – WA-15 & WA-17:  
Location of water collection points and troughs

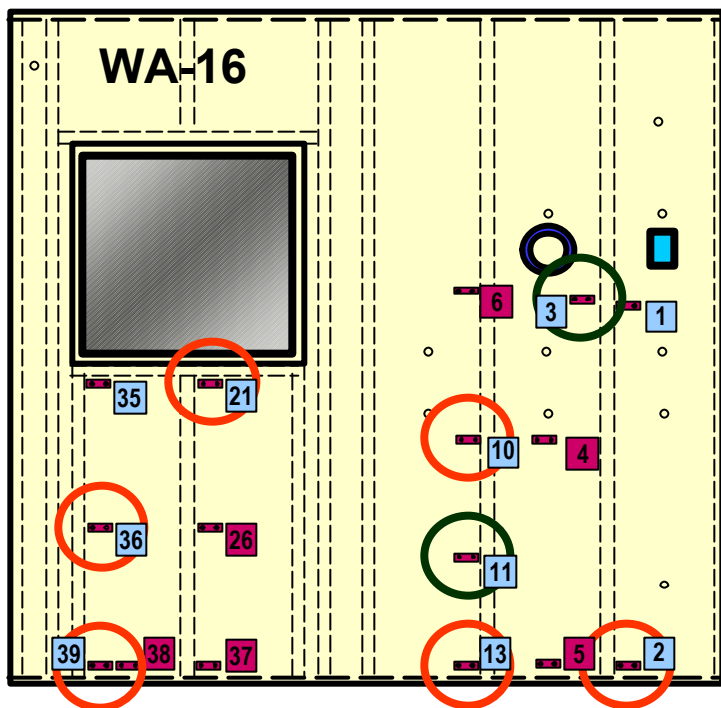
**Figure 6.5**– WA-16 Hardboard: Water collection in troughs E and V; Following static & dynamic tests - Sensors : # 2, # 10, # 13, # 21, # 36, # 39; Following 16-h continuous - Sensors: # 3 and # 11

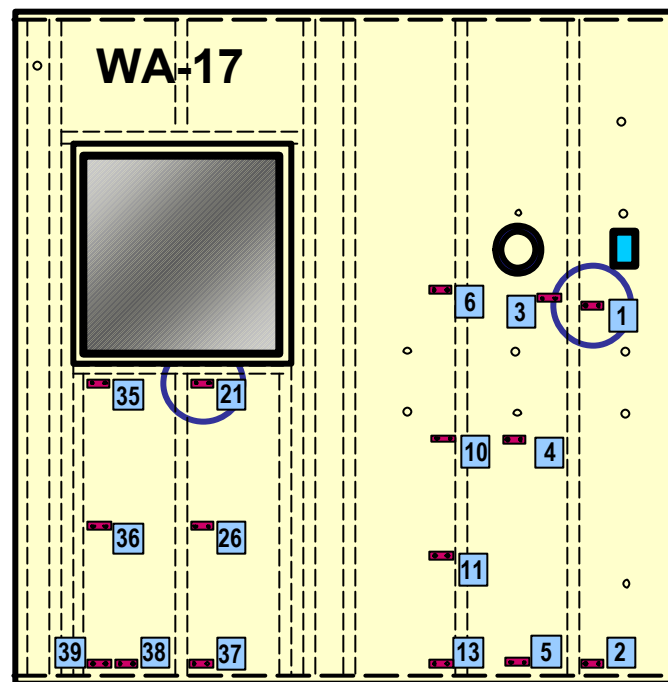
**Figure 6.6**– WA-17 Vinyl: Water collection in troughs E and V; Following Static test – Sensors # 1 and # 21; Dynamic test @ 700±300 Pa - Water entry of XPS at ship-lap joint; Following 16-hrs continuous - No additional sensors activated

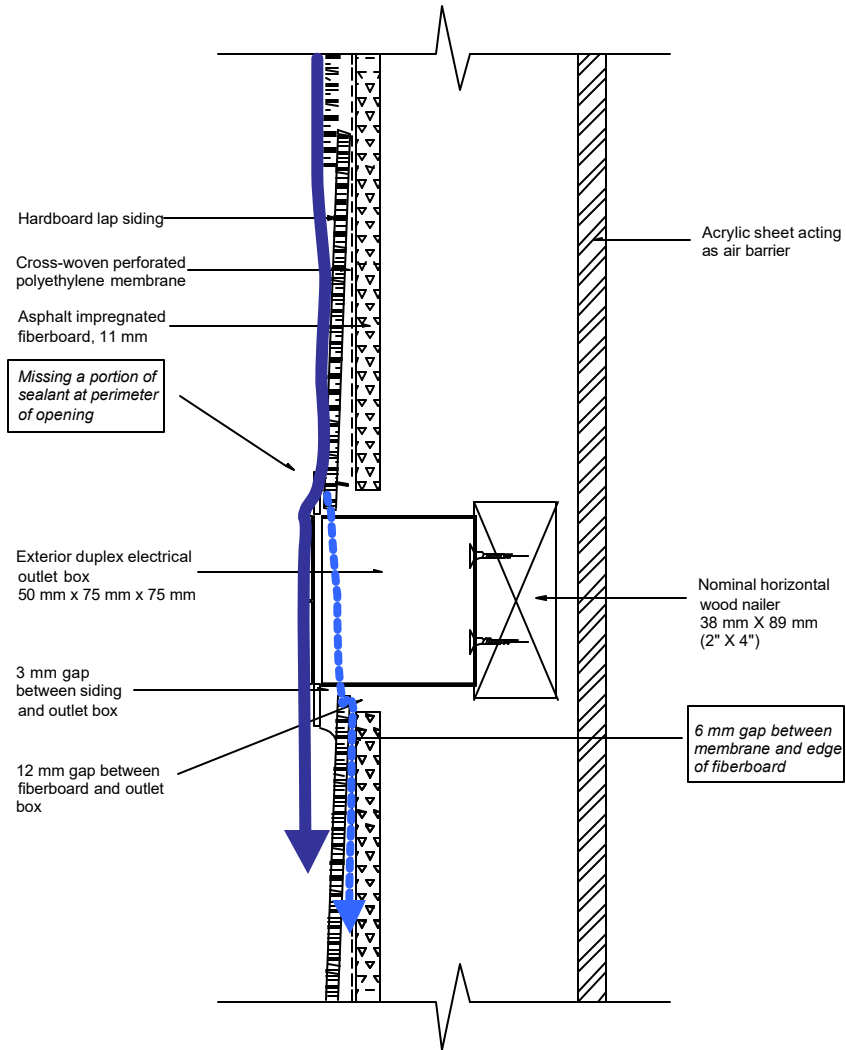
**Figure 6.7– WA-15 Hardboard siding: sectional view showing detail for electrical outlet and water entry path to interstitial space between cladding and sheathing**

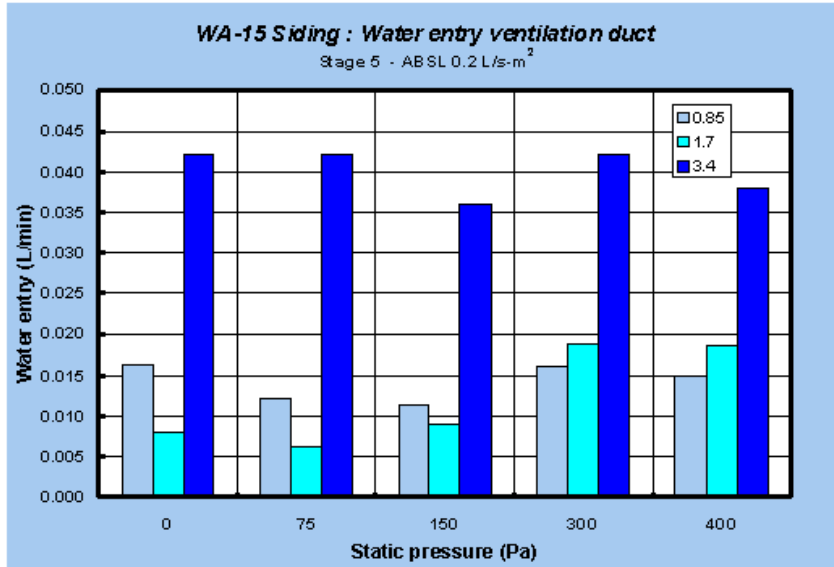
Figure 6.8– Siding WA-15 : Stage 5 - Water entry under static pressure differential through deficiency above vent duct

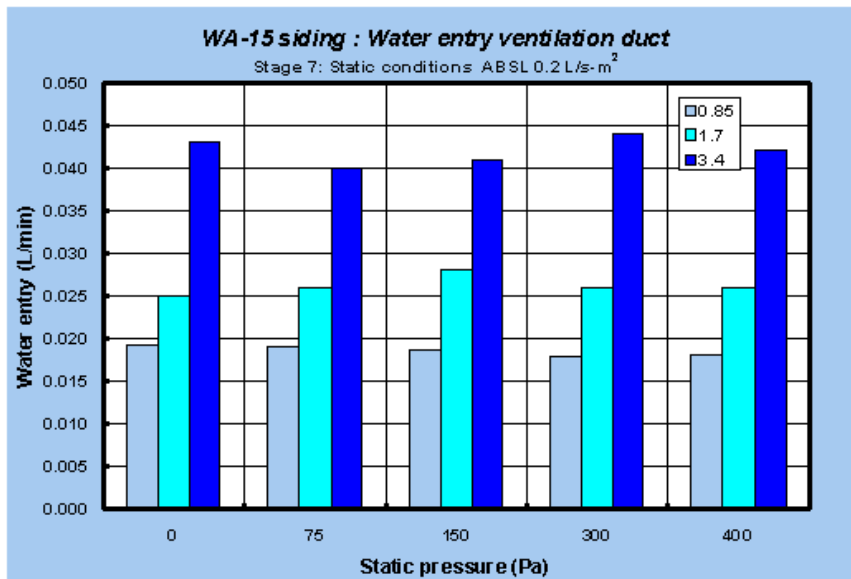
Figure 6.9– Siding WA-15 : Stage 7 - Water entry under static pressure differential through deficiency above vent duct
