## NRC Publications Archive Archives des publications du CNRC

### Report from Task 6 of MEWS Project: experimental assessment of water penetration and entry into wood-frame wall specimens: final report

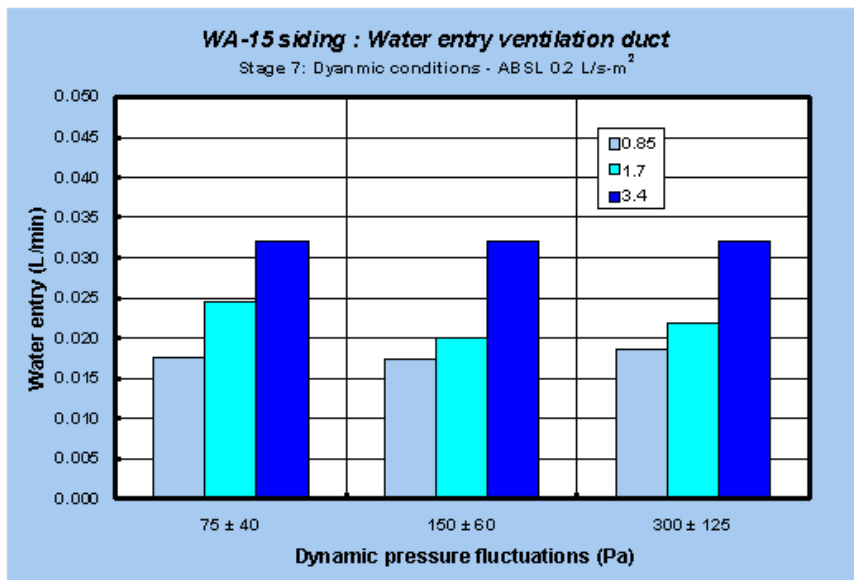
**Figure 6.10– Siding WA-15 : Water entry rates under dynamic pressure fluctuations through deficiency above ventilation duct**

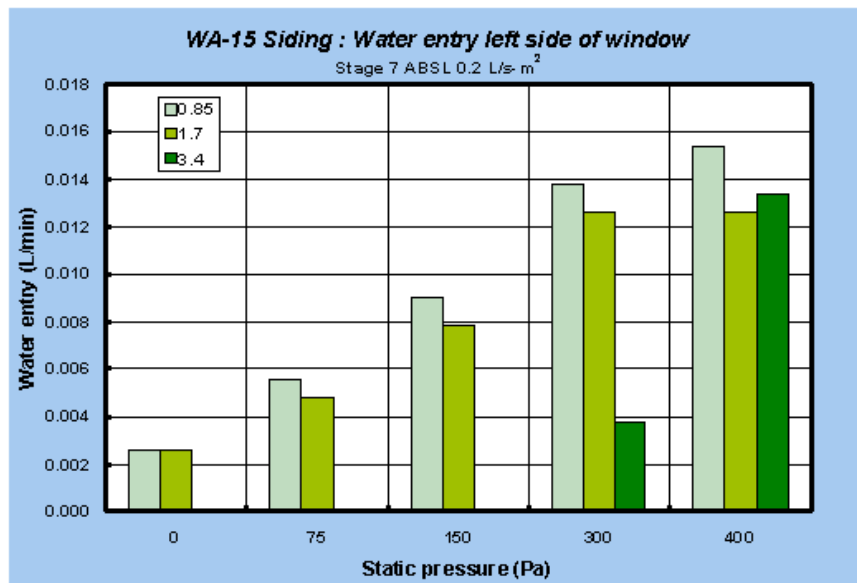
**Figure 6.11: Siding WA-15 – Water entry at various spray rates and at given static pressure differentials through deficiency at Left Side (LS) of window**

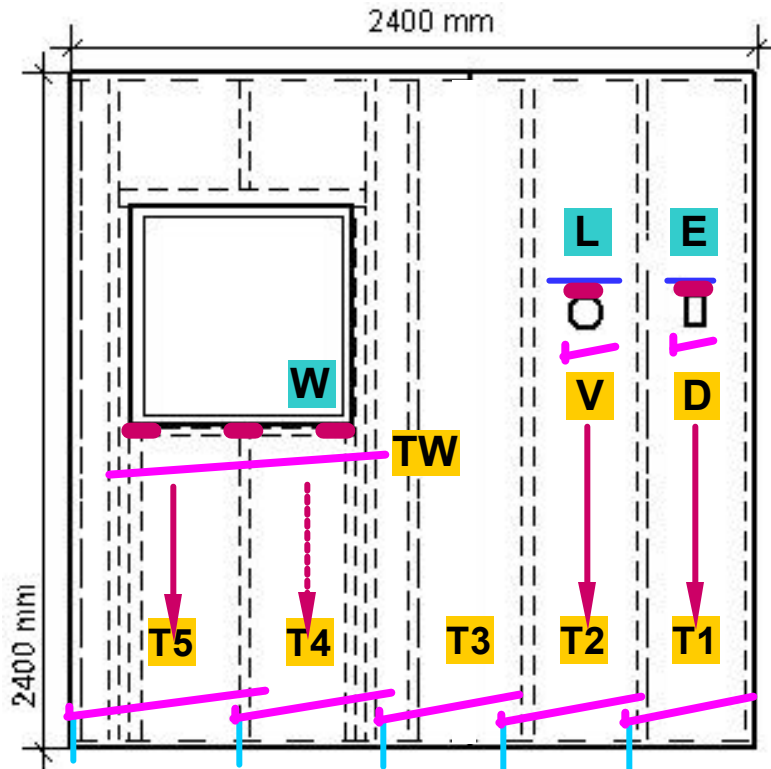
Figure 6.12– WA-16 Hardboard siding: water entry points and collection of data

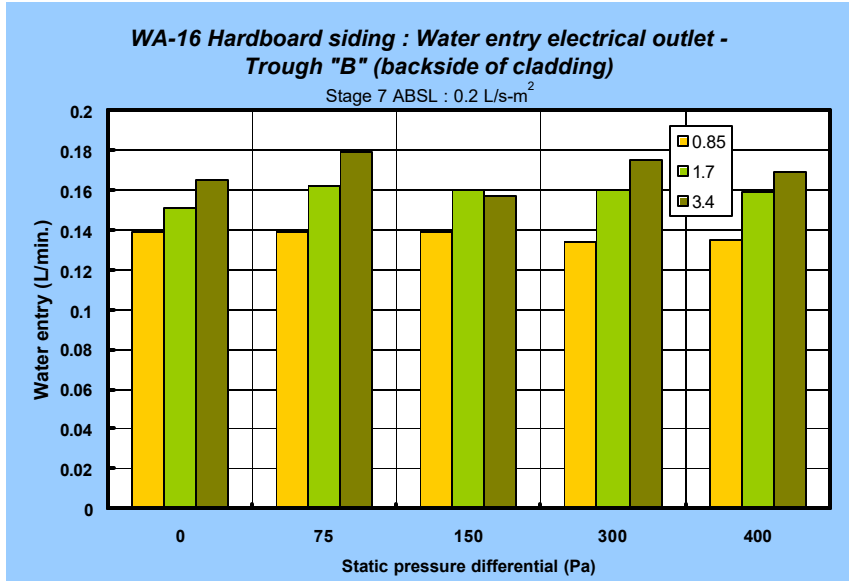
Figure 6.13– Siding WA-16 : Water entry under static pressure differential through deficiency above electrical outlet. Water collected in trough “B” (backside of cladding)

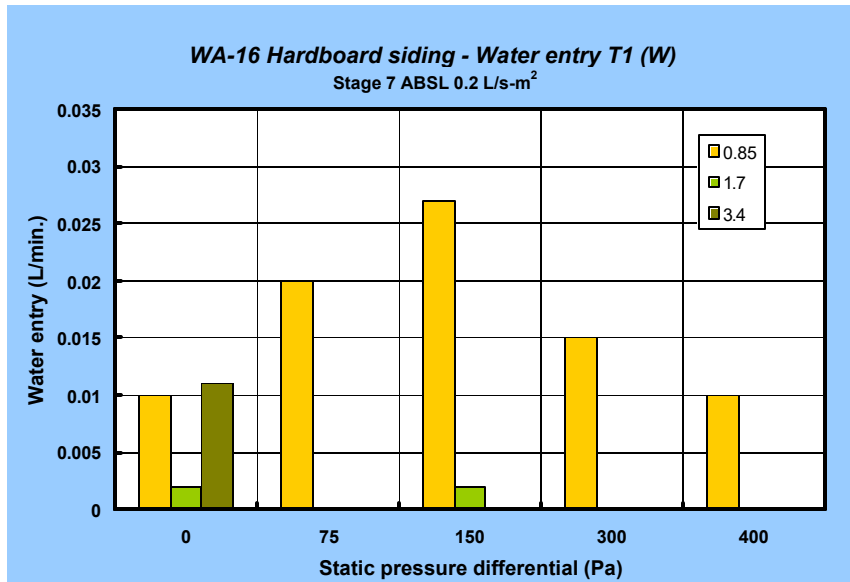
Figure 6.14– Siding WA-16 : Water entry under static pressure differential through deficiency above electrical outlet. Water collected in trough “T1” (W)

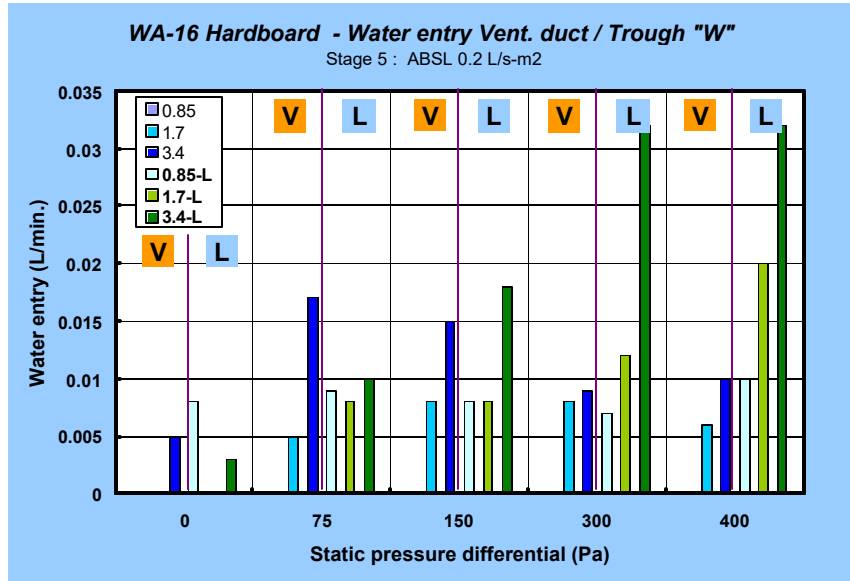
Figure 6.15—WA-16 hardboard siding: Stage 5 - Water entry under static pressure differential through deficiency above vent duct (Trough "W")

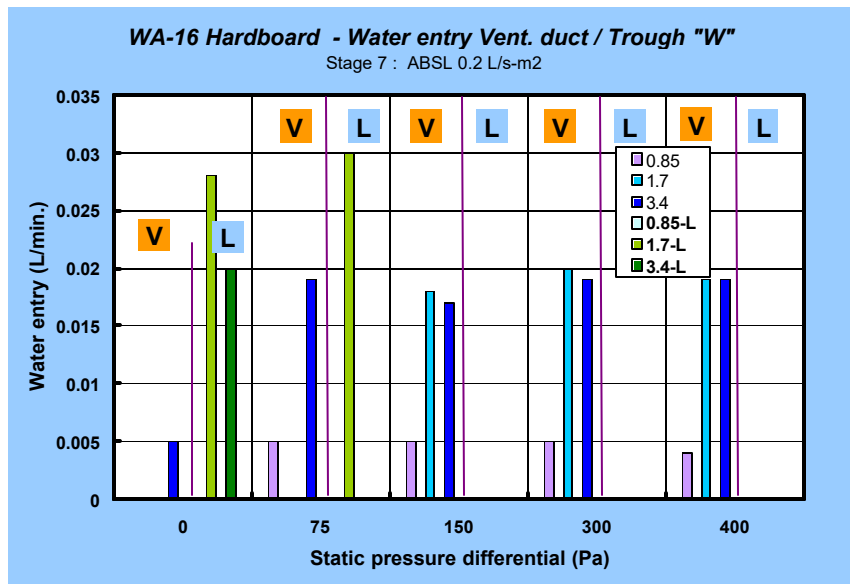
Figure 6.16—WA-16 hardboard siding: Stage 7 - Water entry under static pressure differential through deficiency above vent duct (Trough "W")

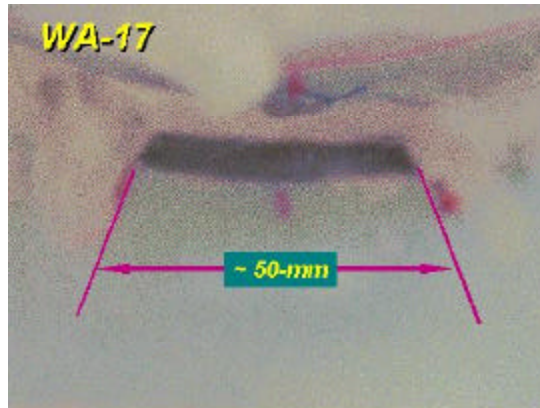
**Figure 6.17– WA-17 : Stage 5 - Close-up view of opening (~ 4-mm x 50-mm) beneath the ventilation duct**

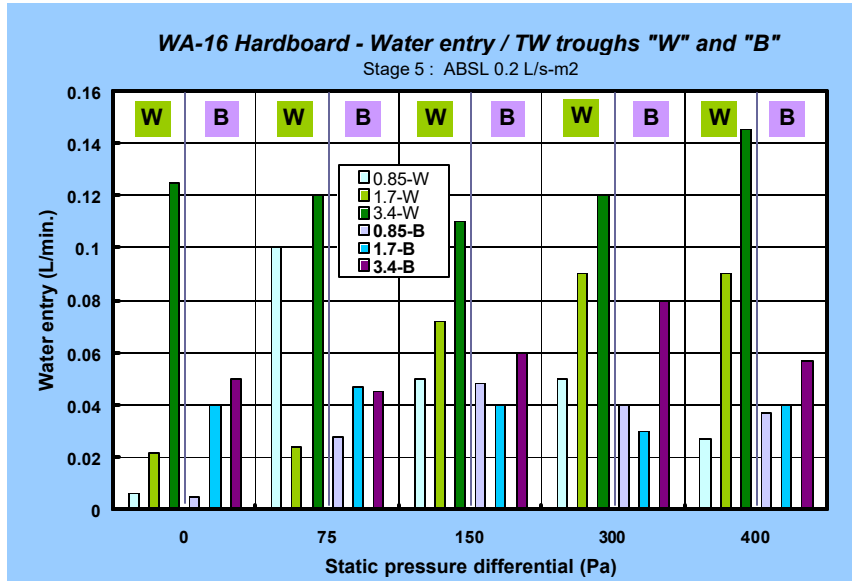
Figure 6.18: Siding WA-16 – Water collection in trough “TW” for both the W-wall side and B-back of cladding at various spray rates and for given static pressure differentials.

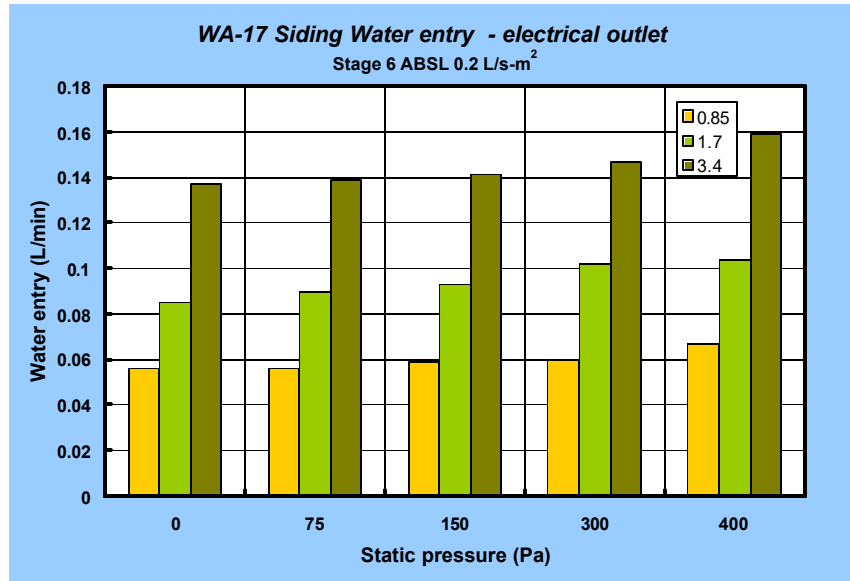
Figure 6.20 – Siding WA-17 : Water entry under static pressure differential through deficiency above electrical outlet

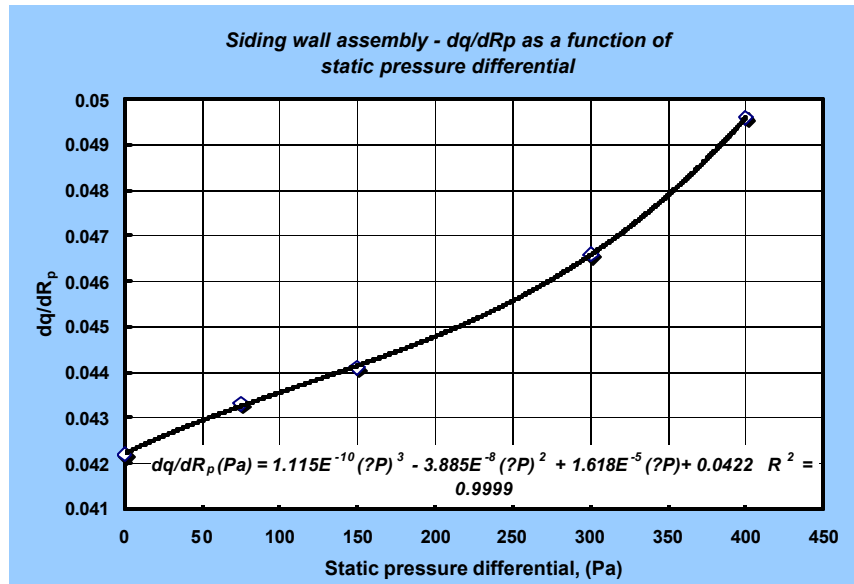
**Figure 6.21: Siding WA – Water entry function derived from results of water entry through the electrical outlet of WA-17**

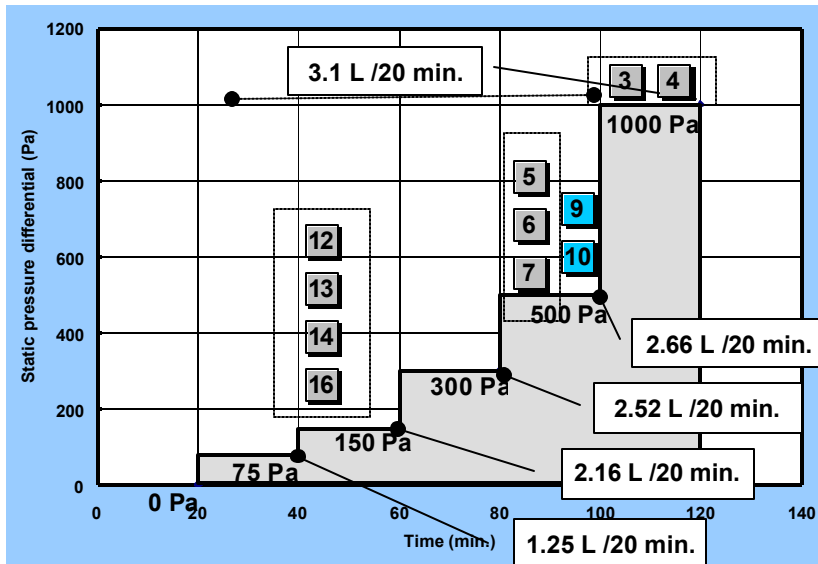
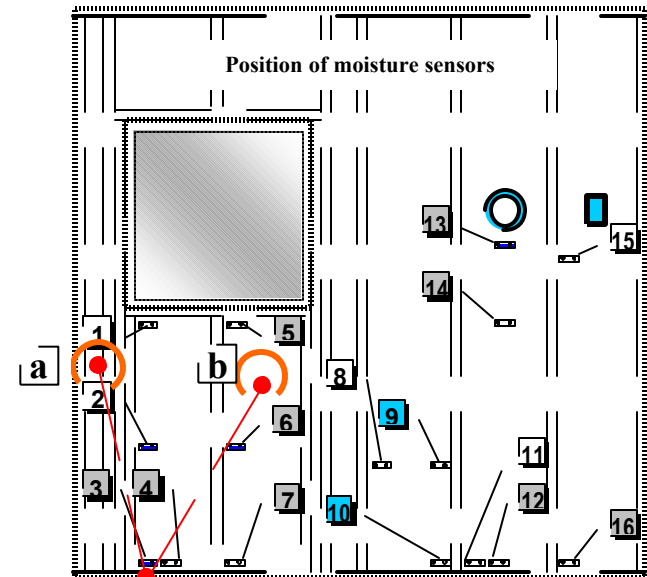
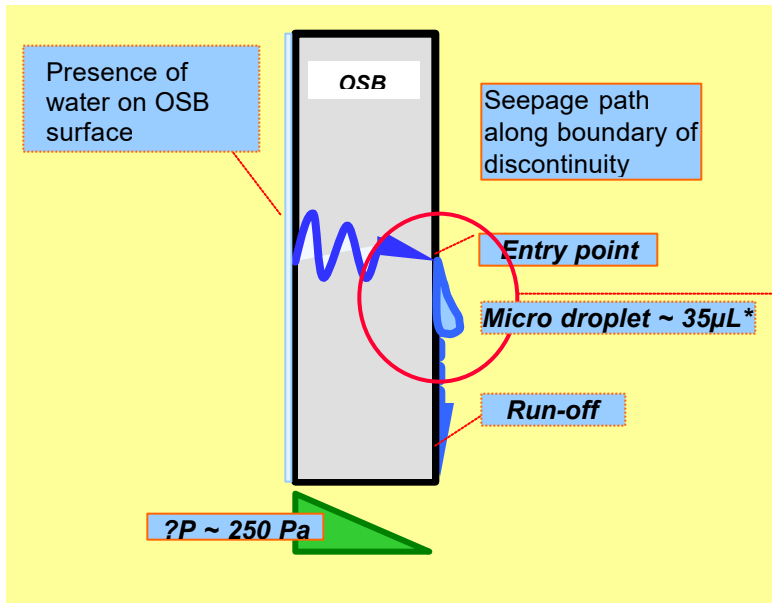
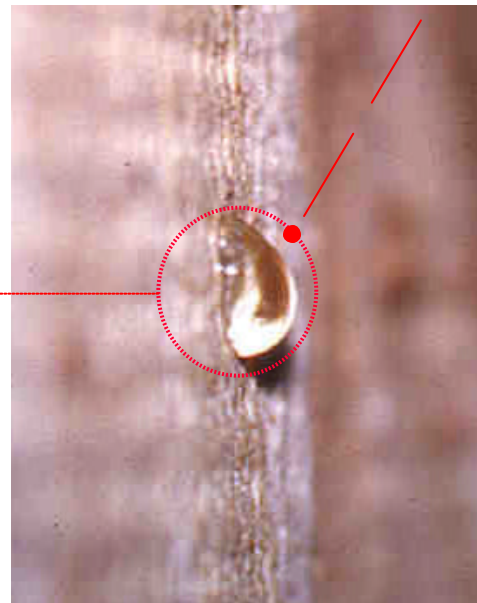
Penetration of sheathing board at (a) - 35 min. and in cavity at (b) beneath window - 90 min.

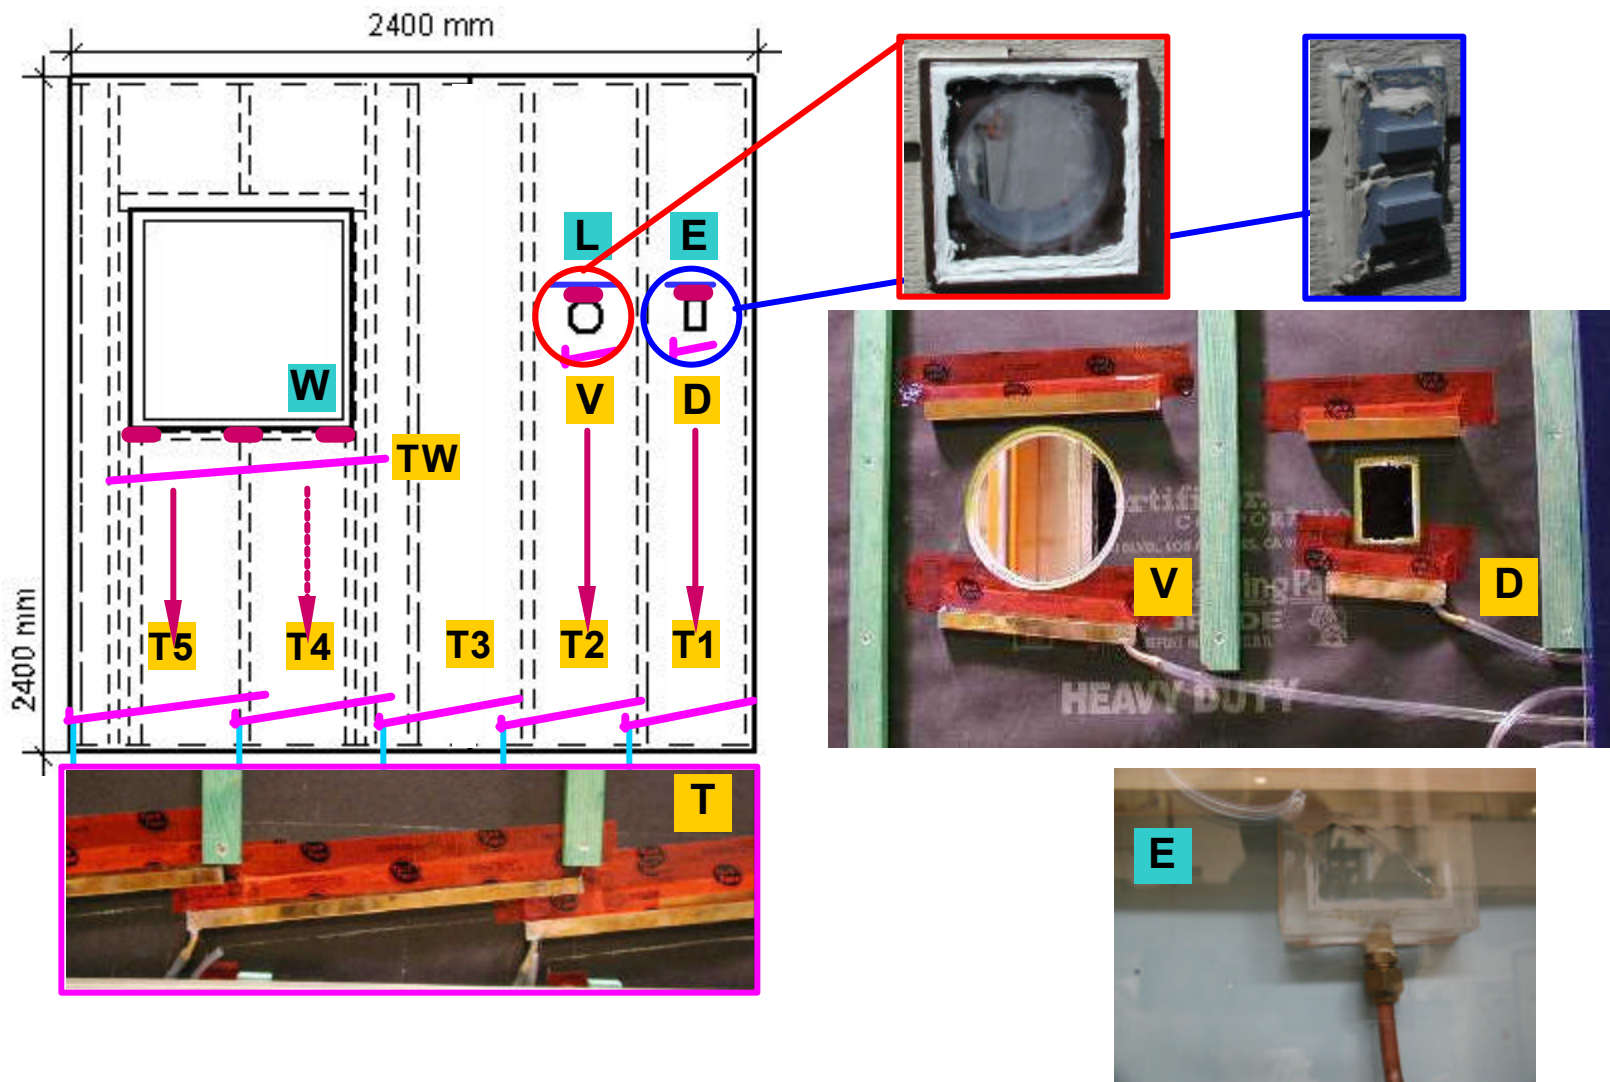
Figure 7.2 – Location of water entry points through specified deficiencies and identification of collection troughs

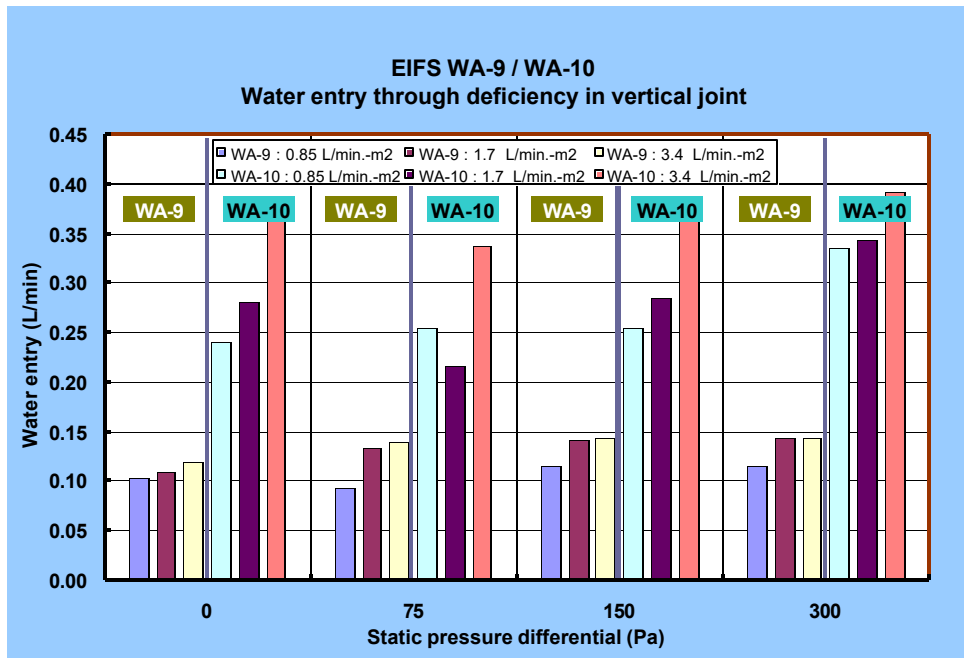
Figure 7.4 – Water entry rates through deficiencies in vertical joints of EIFS wall assemblies

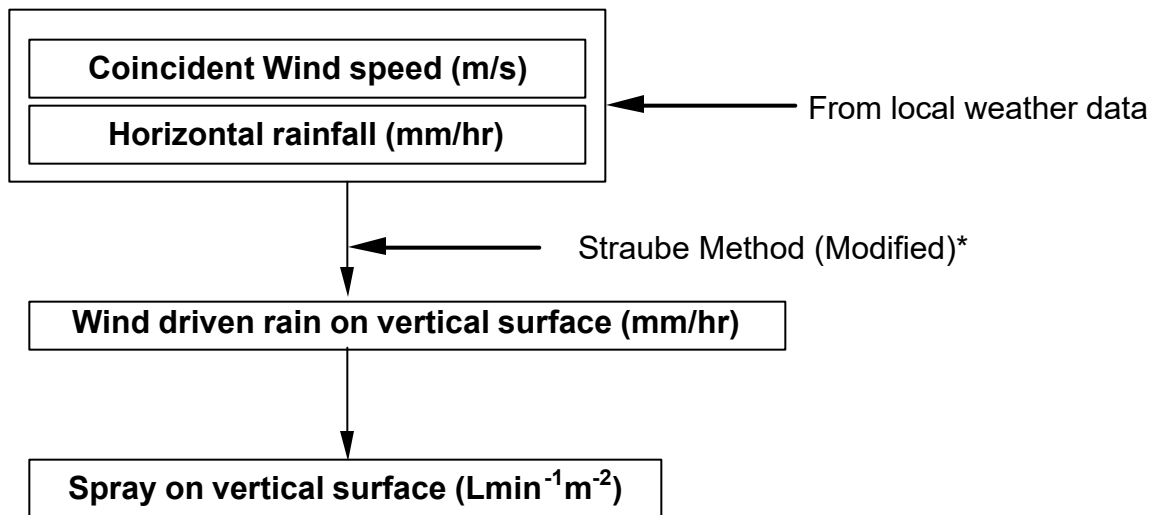
Figure 7.5 - A schematic flow-chart of the process to depict the conversion of the climatic variables to the hygIRC input data - \* Modified Straube method was used as provided in the Task 4 report<sup>1</sup>

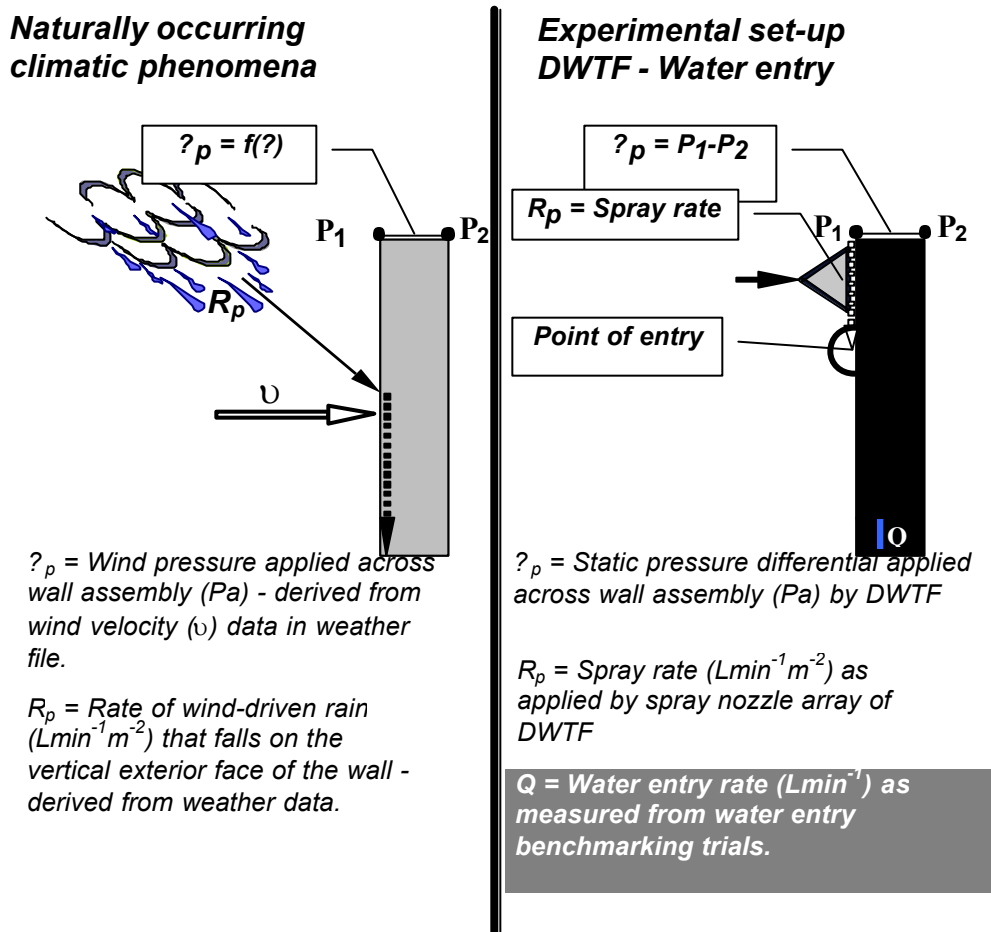
Figure 7.6 - Combining natural phenomena with experimental observation

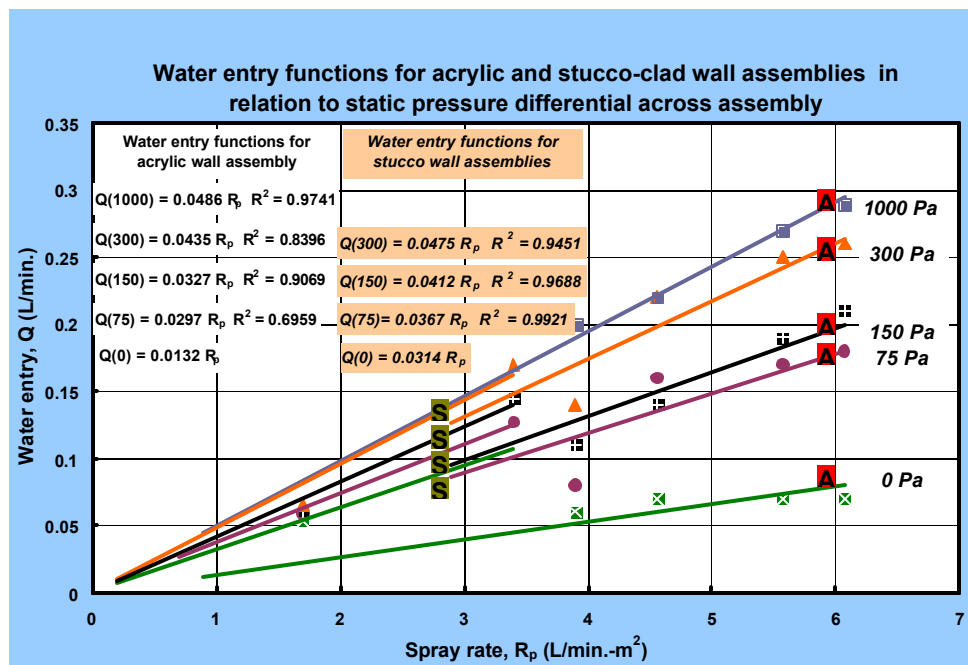
Figure 7.7 – Water entry rates in relation to spray rate at different pressure levels for acrylic (A) and stucco (S) wall assemblies

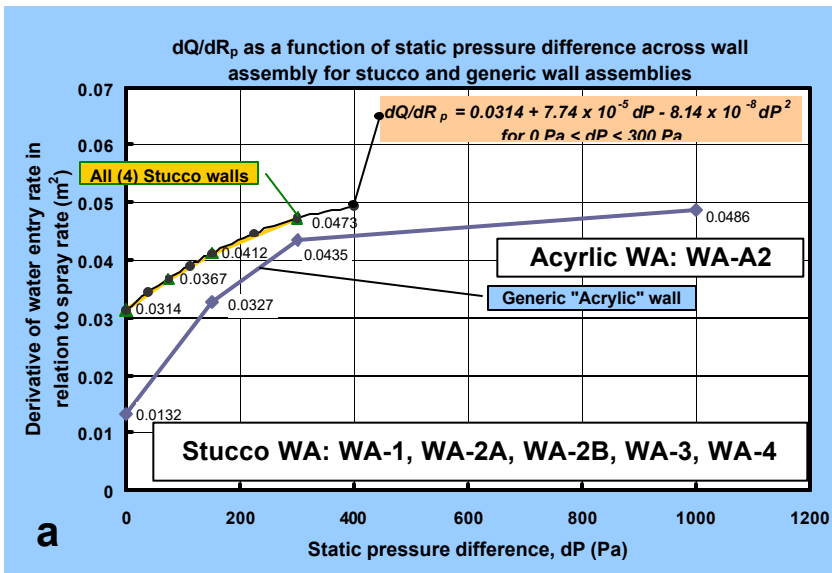
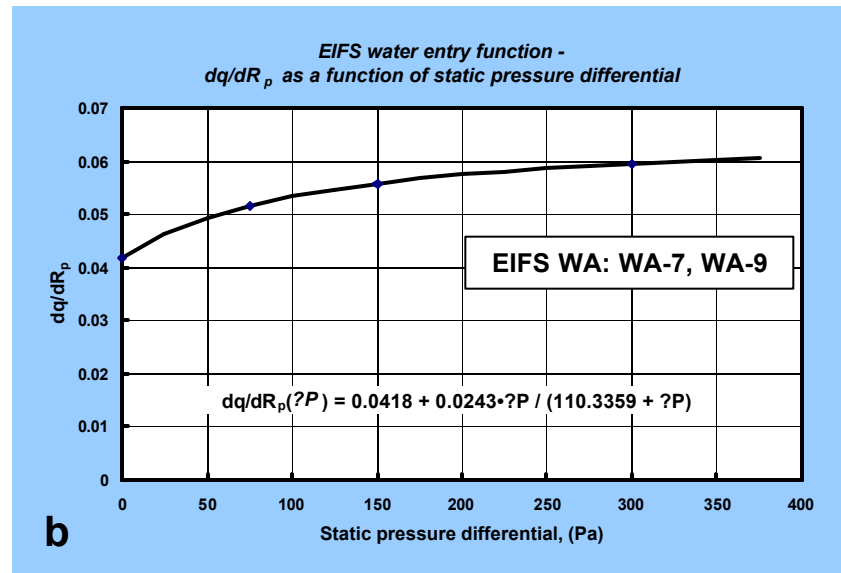
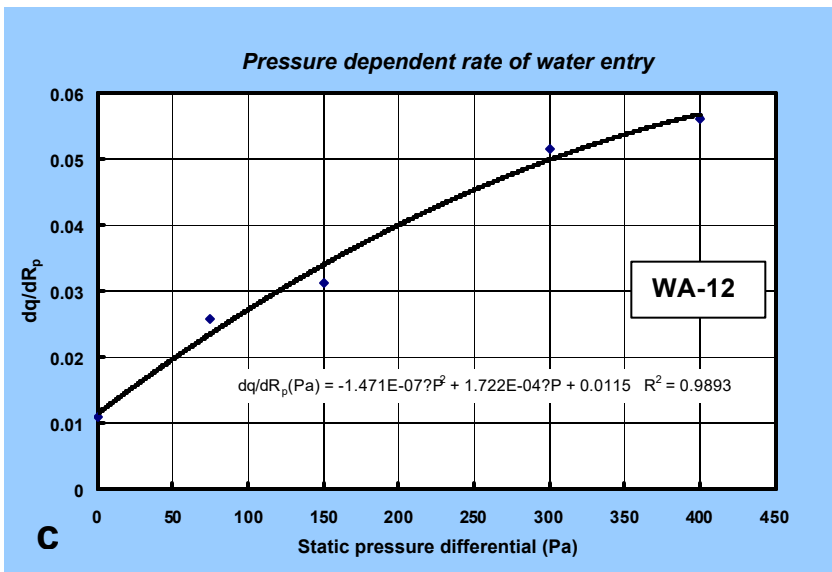
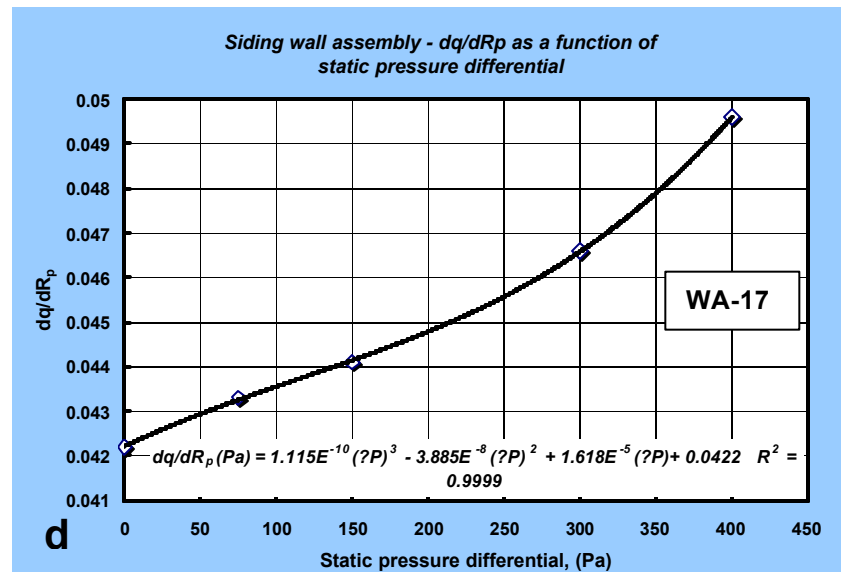
Figure 7.8 – Water entry functions for (a) stucco wall and acrylic (b) EIFS, (c) brick masonry veneer and (d) siding wall assemblies

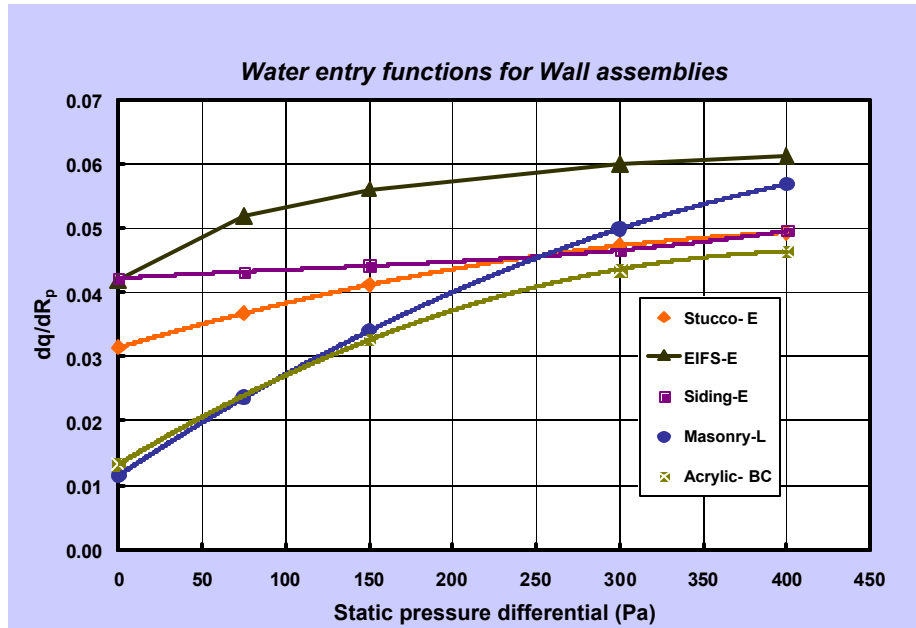
Figure 7.9 – Water entry functions for wall assemblies –  $dq / dR_p$  as a function of static pressure differential

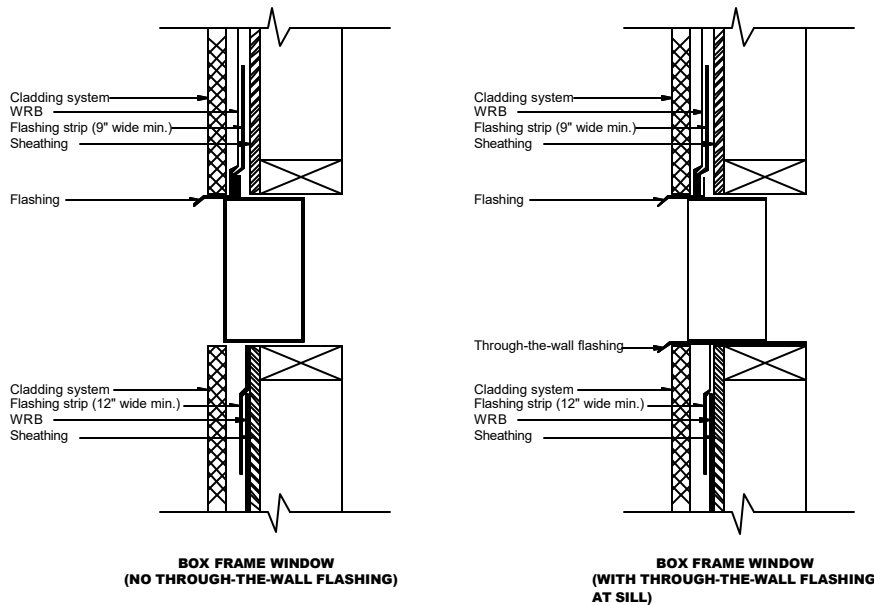
Figure A.1. Flange-mounted window and recommended overlap between flashing membrane and WRB

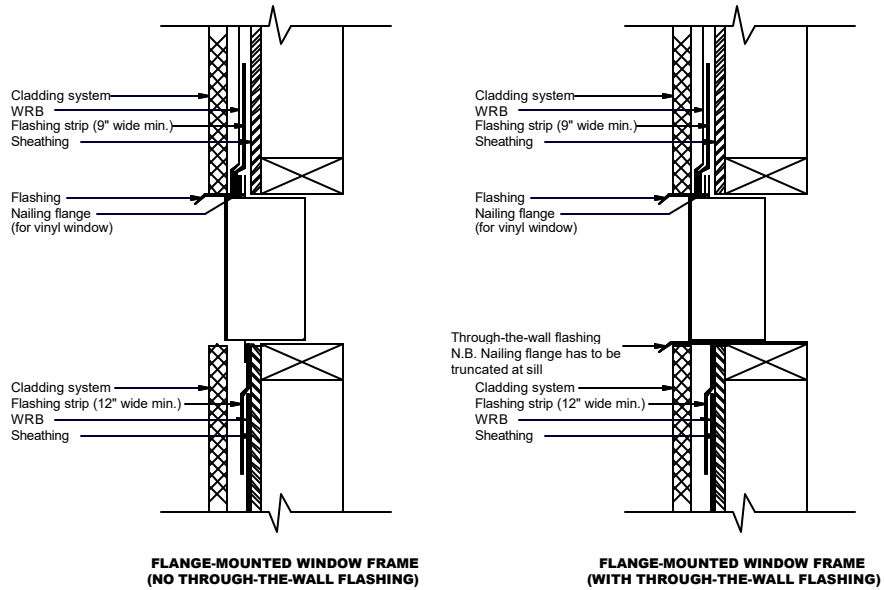
Figure A.2. Box frame window and recommended overlap between flashing membrane and WRB

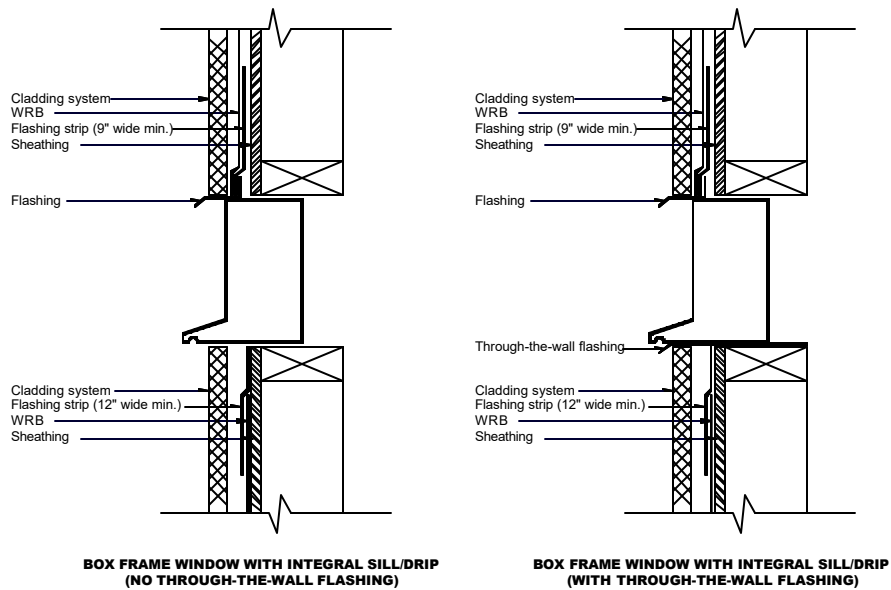
Figure A3. Box frame window with integral sill and recommended overlap between flashing and WRB

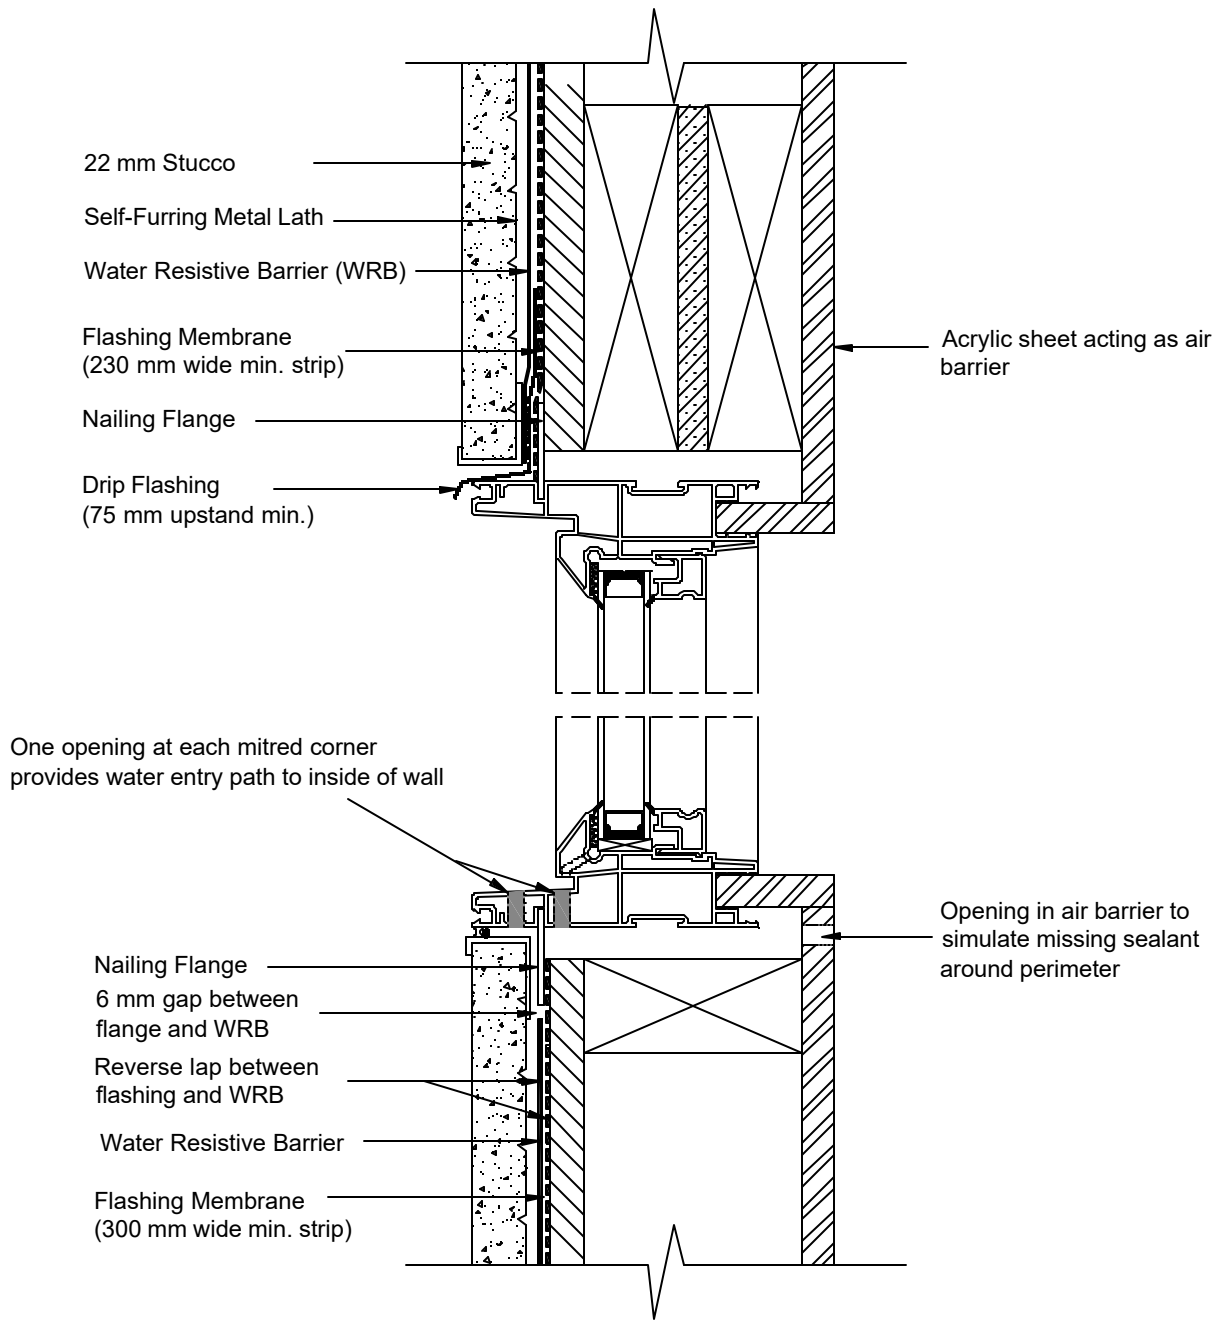
Figure A.4. Vertical section of flange-mounted vinyl window installed in a stucco-clad wood-frame wall. Location of holes in window sill for water entry into the wall assembly

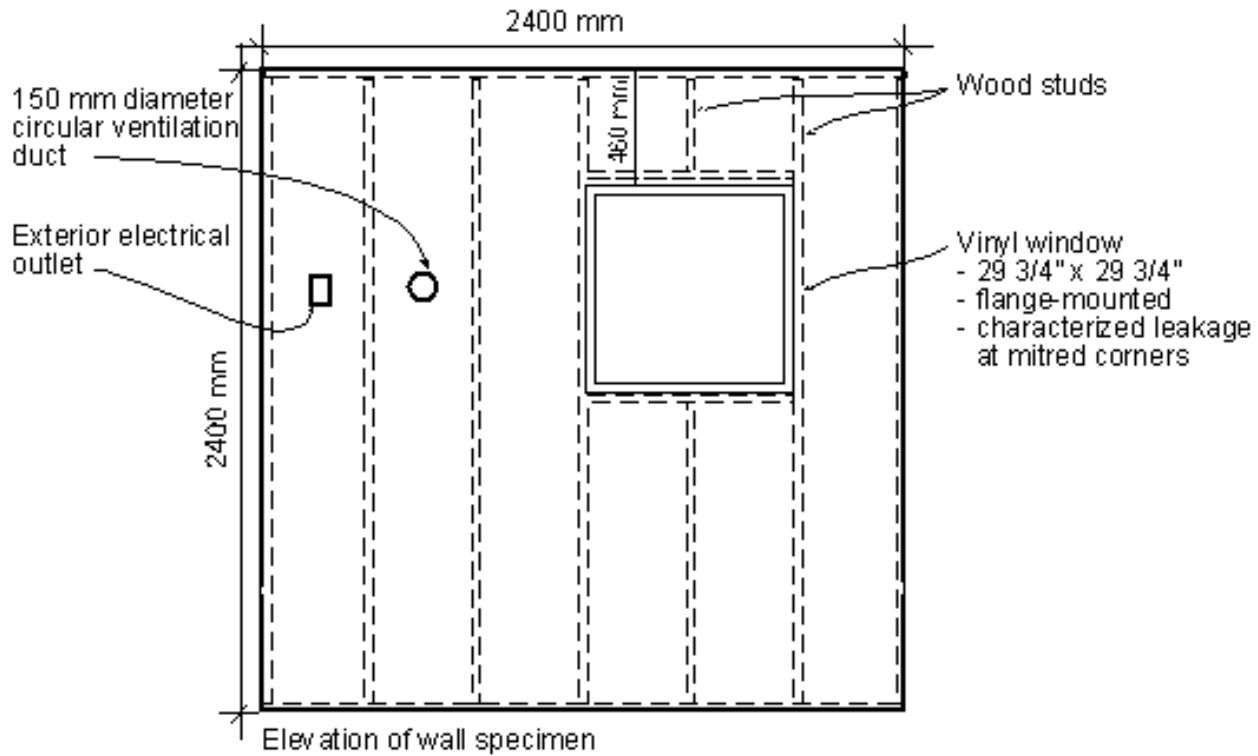
Figure A.5. Suggested positioning of penetrations in a typical wall specimen

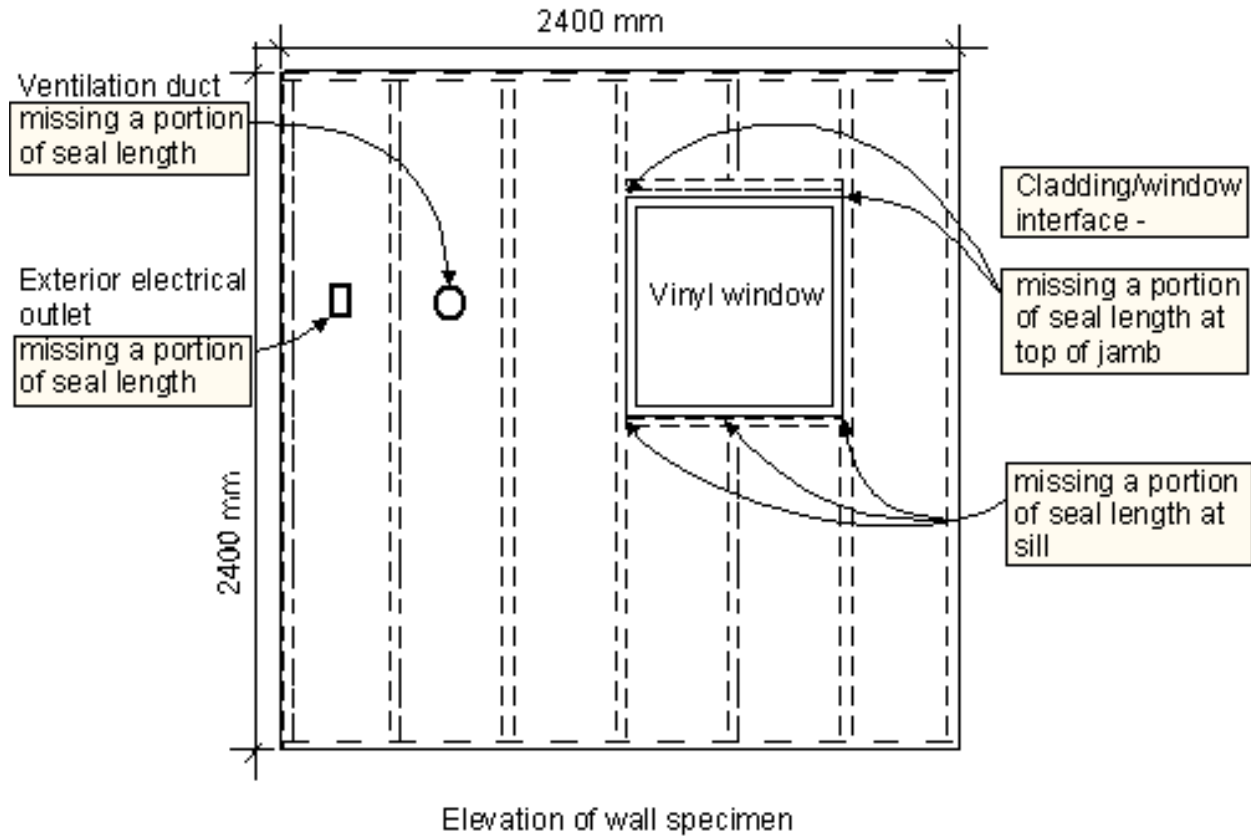
Figure A.6. Generic deficiencies in the first line of defense of a typical wall specimen

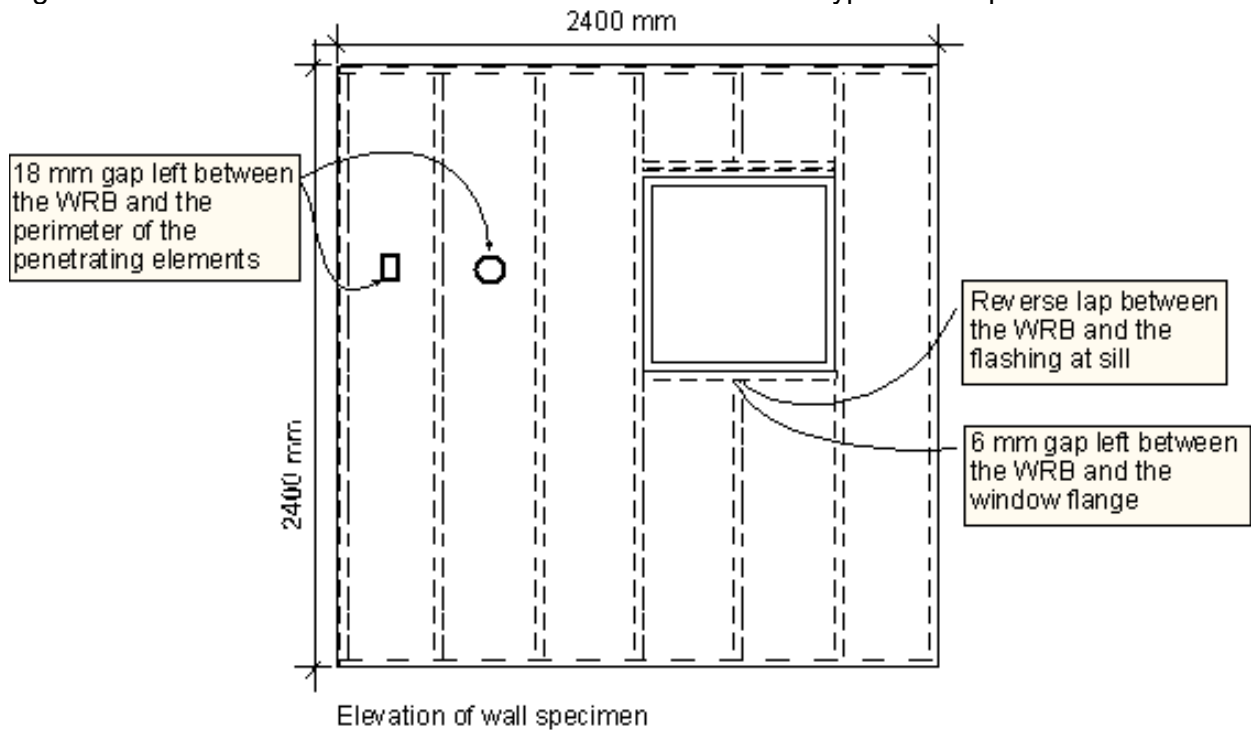
Figure A.7. Generic deficiencies in the second line of defense of a typical wall specimen

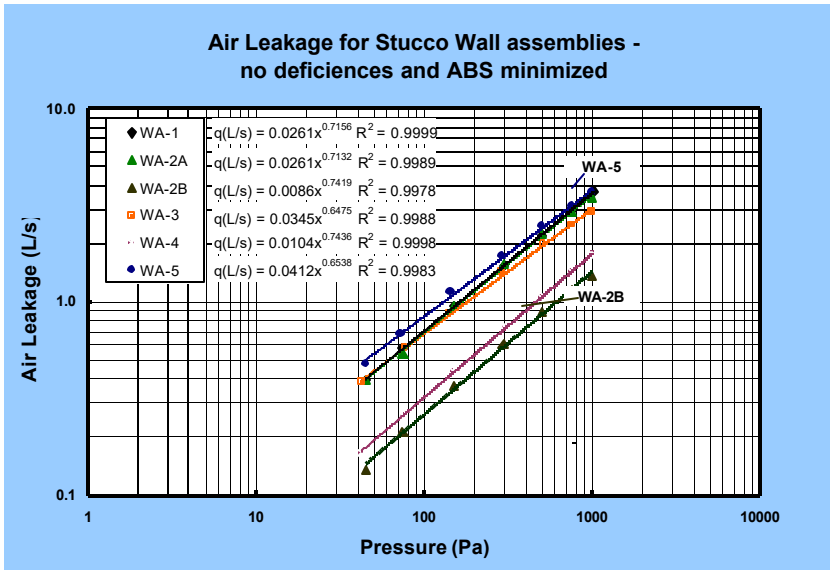
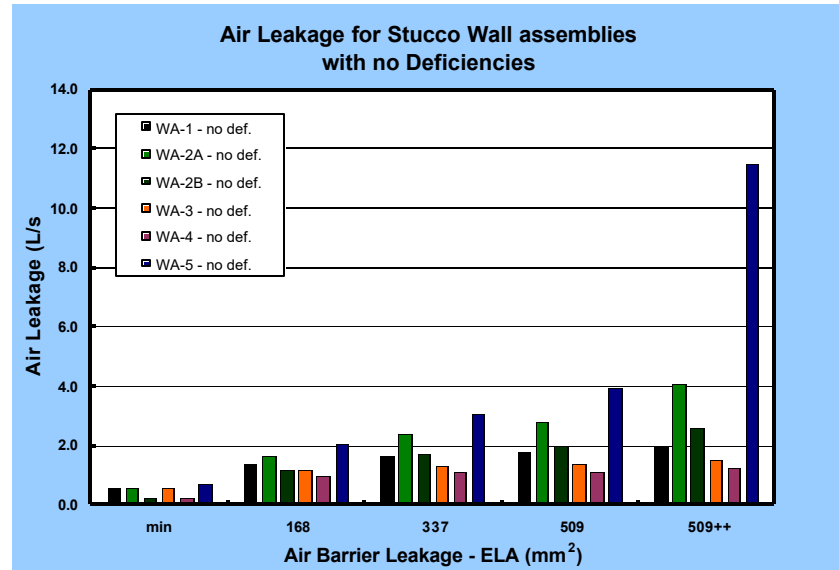
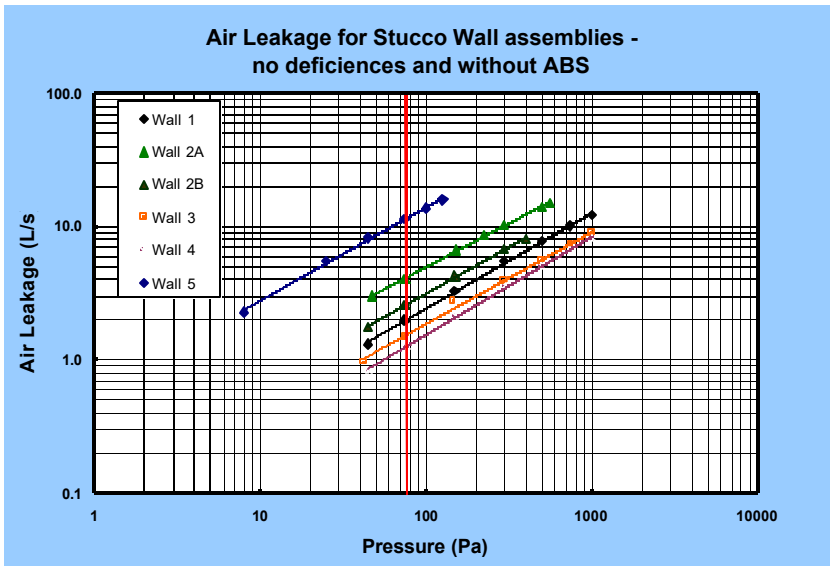
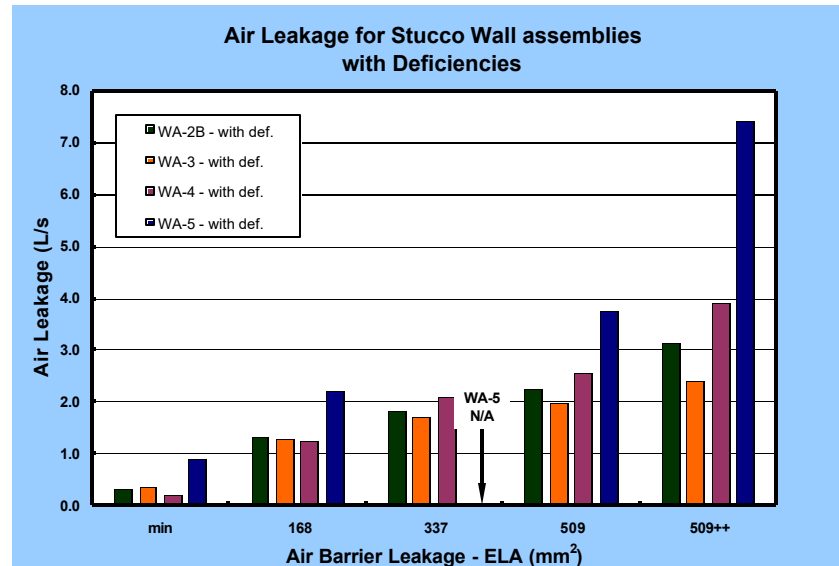
Figure B.1– Air leakage of stucco WA having no deficiencies and without air barrier system (ABS) in place
