## NRC Publications Archive Archives des publications du CNRC

### Report from Task 6 of MEWS Project: experimental assessment of water penetration and entry into wood-frame wall specimens: final report

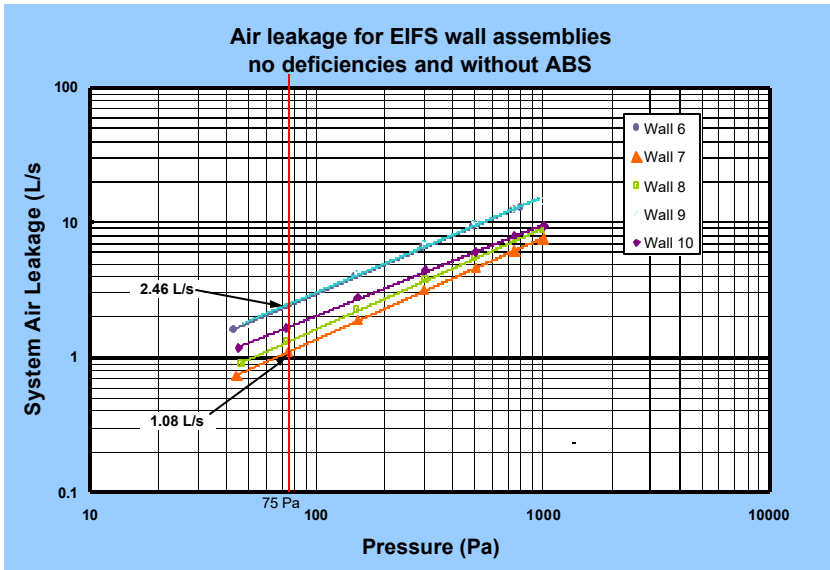
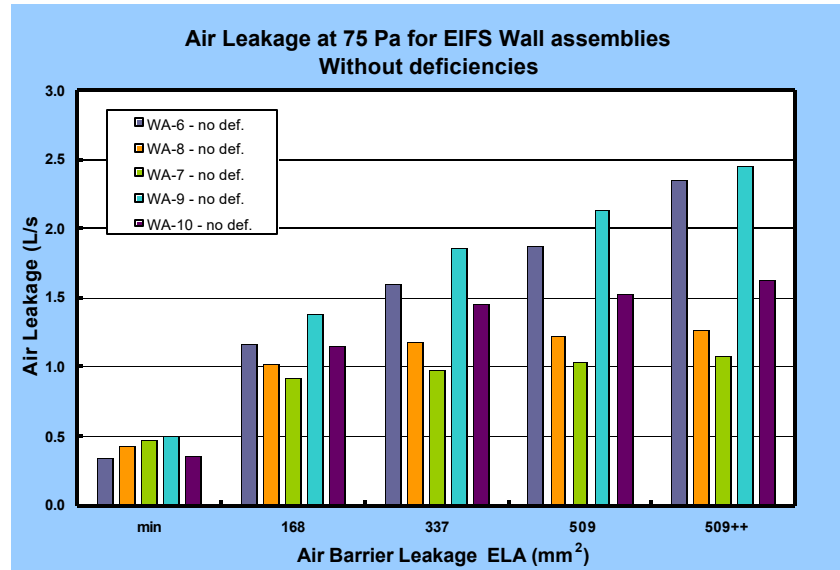
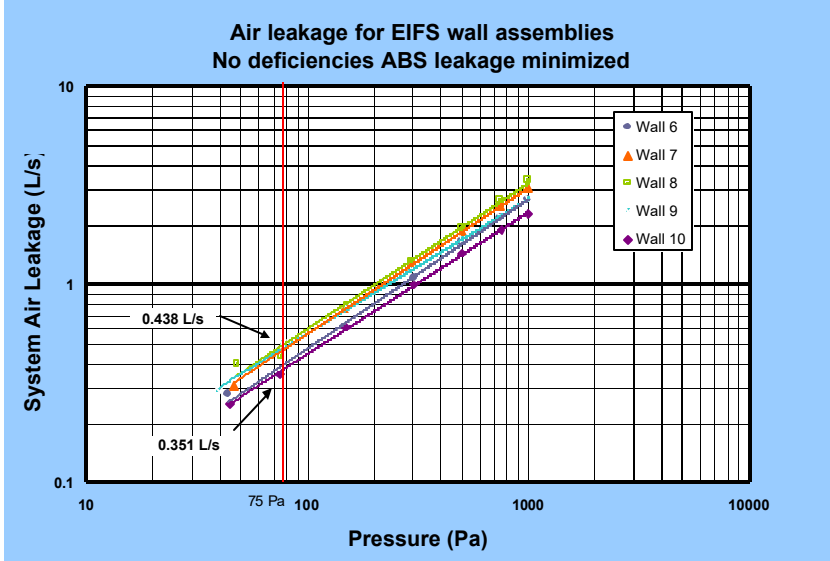
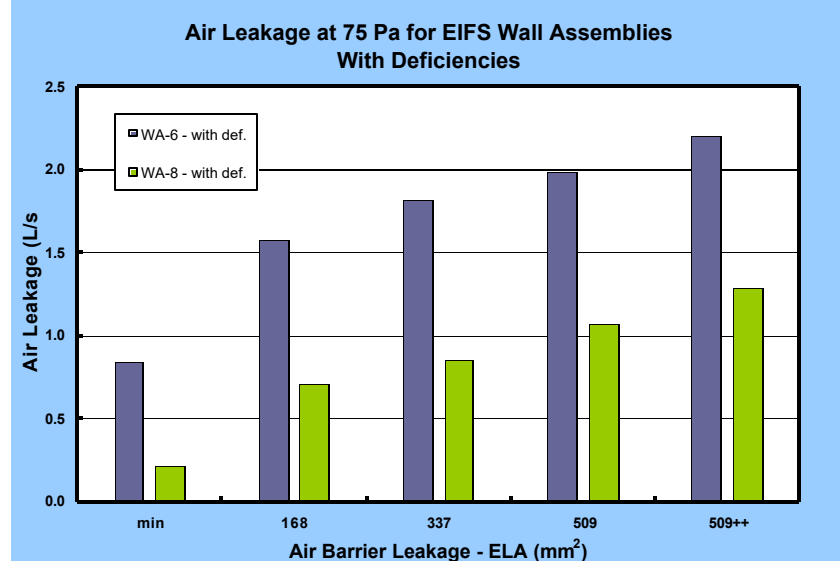
Figure B.5 – Air leakage of EIFS WA having no deficiencies and without air barrier system (ABS) in place

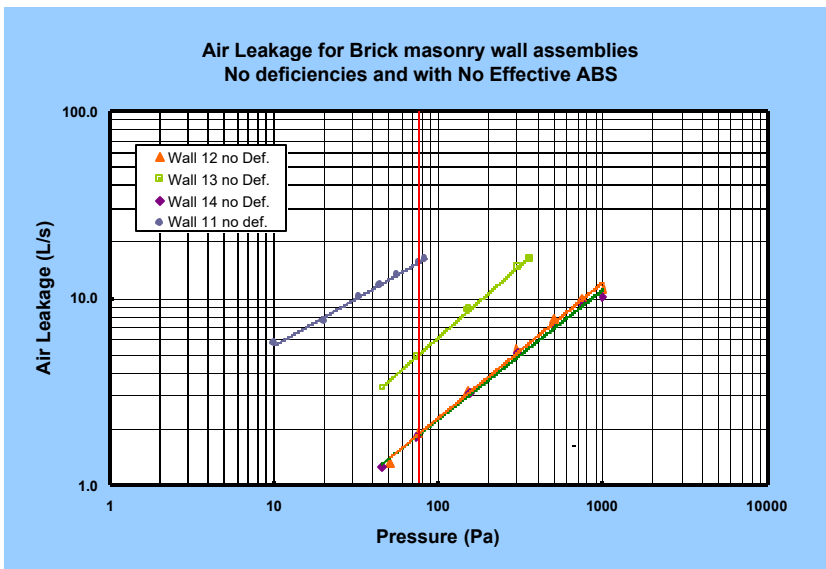
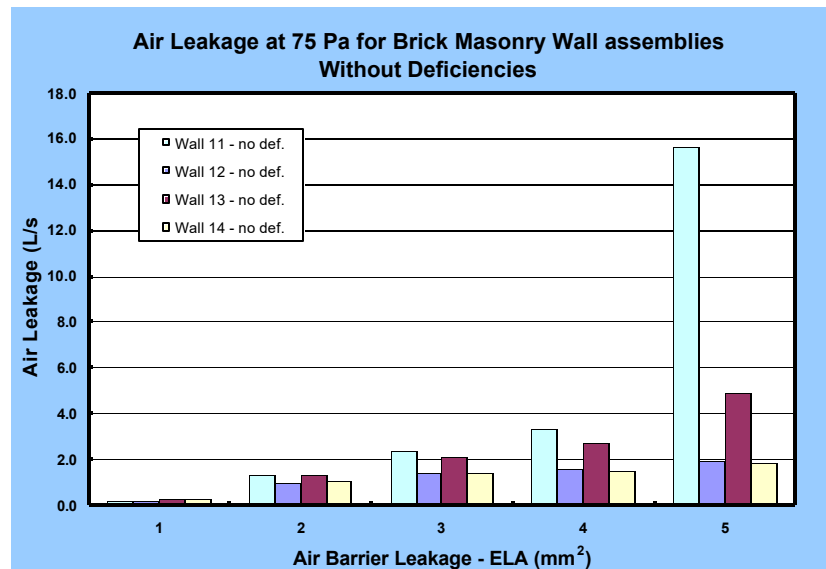
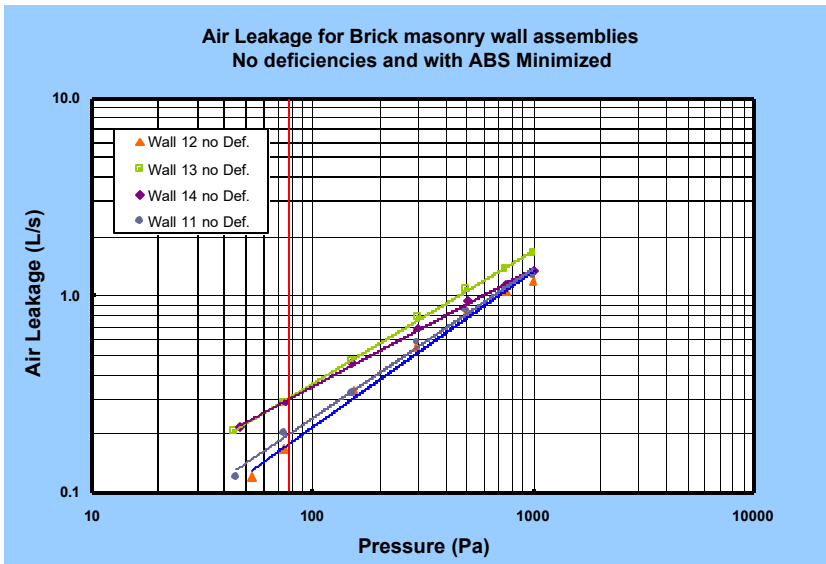
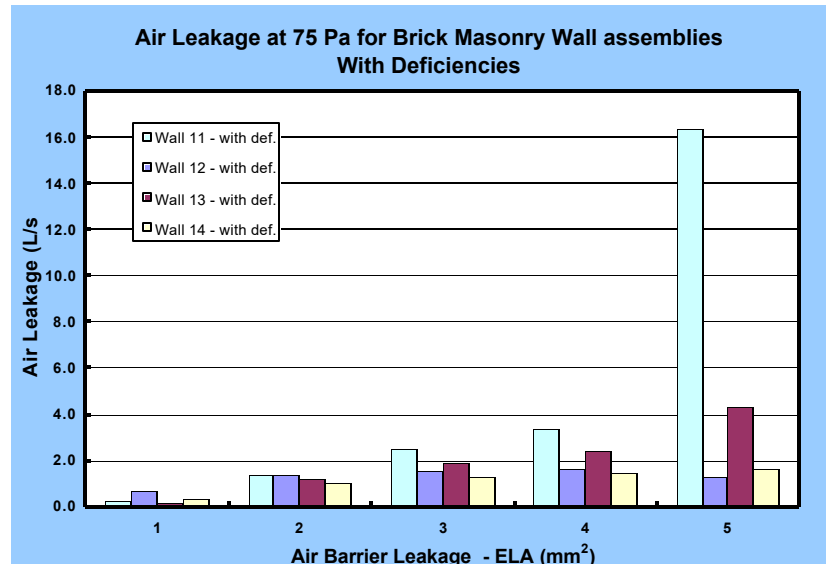
Figure B.9 – Air leakage of brick masonry wall assemblies having no deficiencies and without air barrier system (ABS) in place

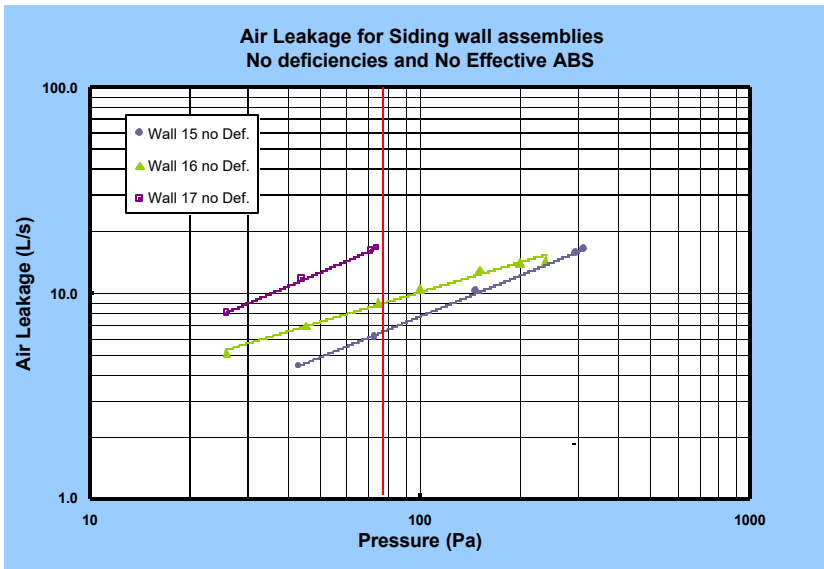
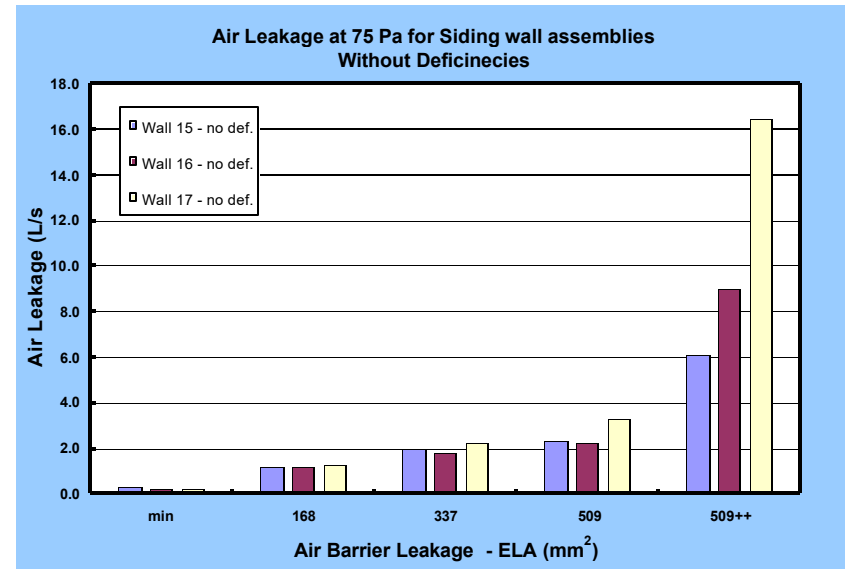
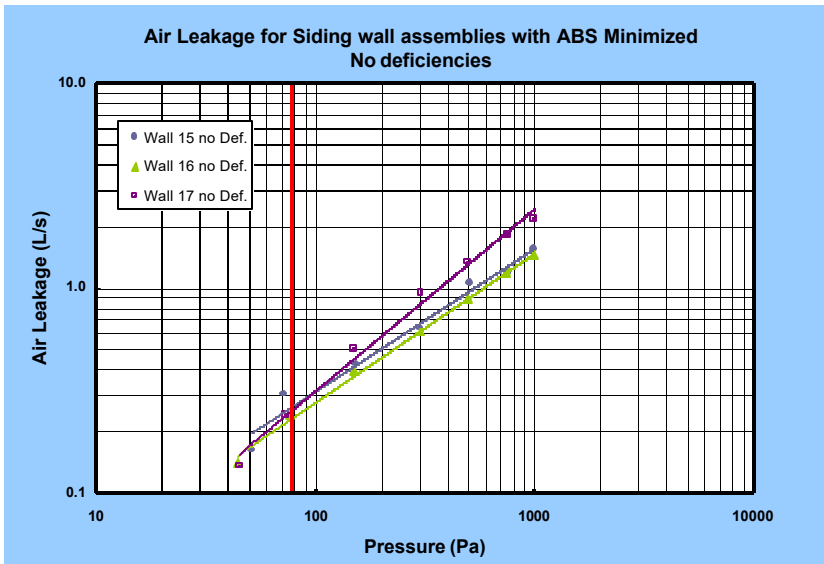
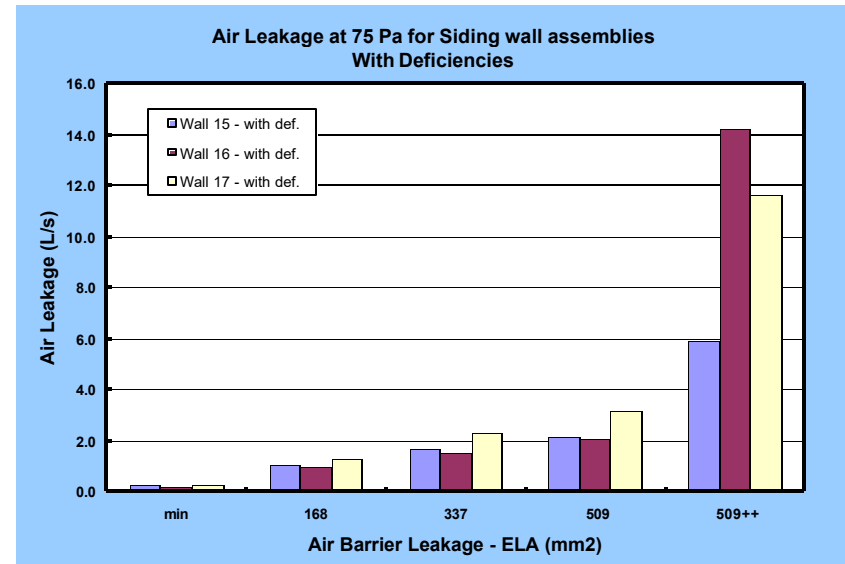
Figure B.13 – Air leakage of **siding** wall assemblies having no deficiencies and without air barrier system (ABS) in place

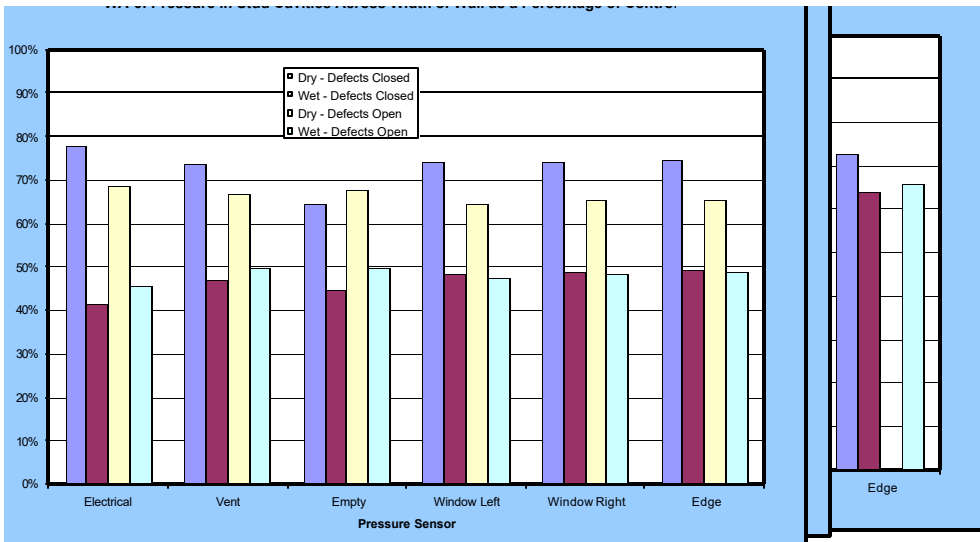
6: Moisture Control Performance Of Wall Systems & Subsystems

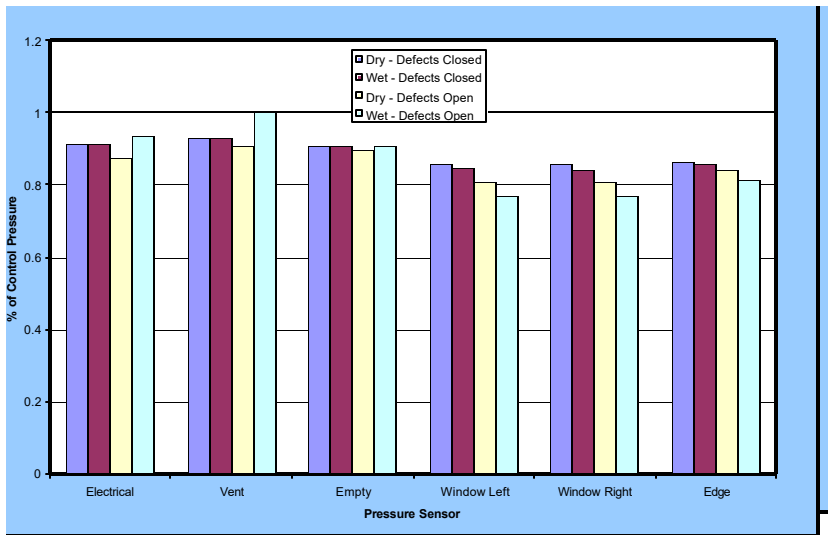
Figure B.25 – Pressure response WA-12 - across stud space

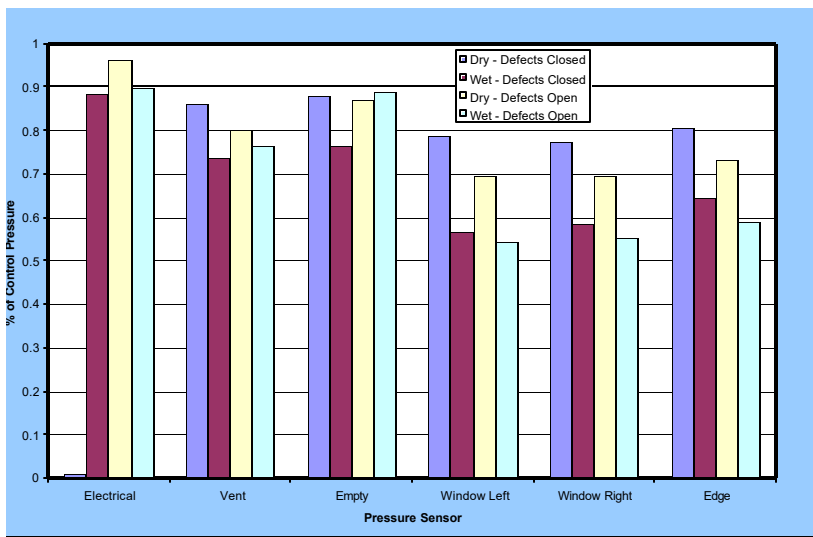
Figure B.27 - Pressure response WA-14 - across stud space

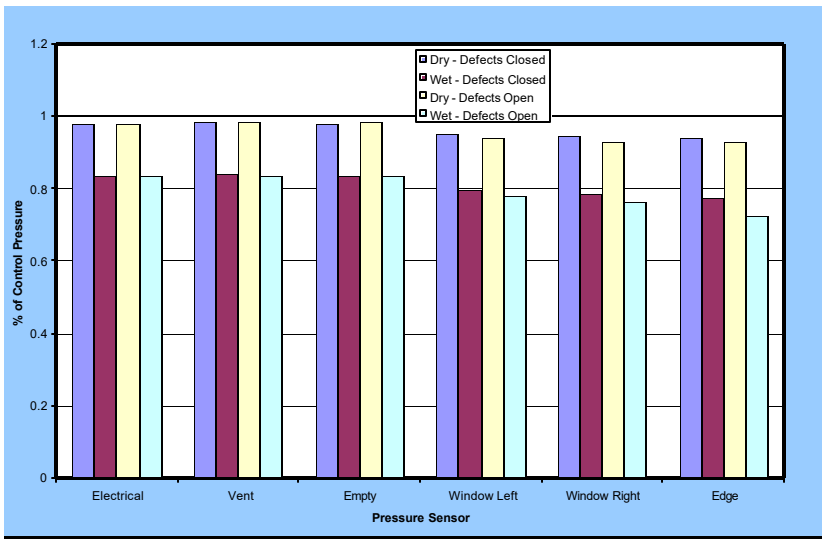
Figure B.29 - Pressure response WA-16 - across stud space

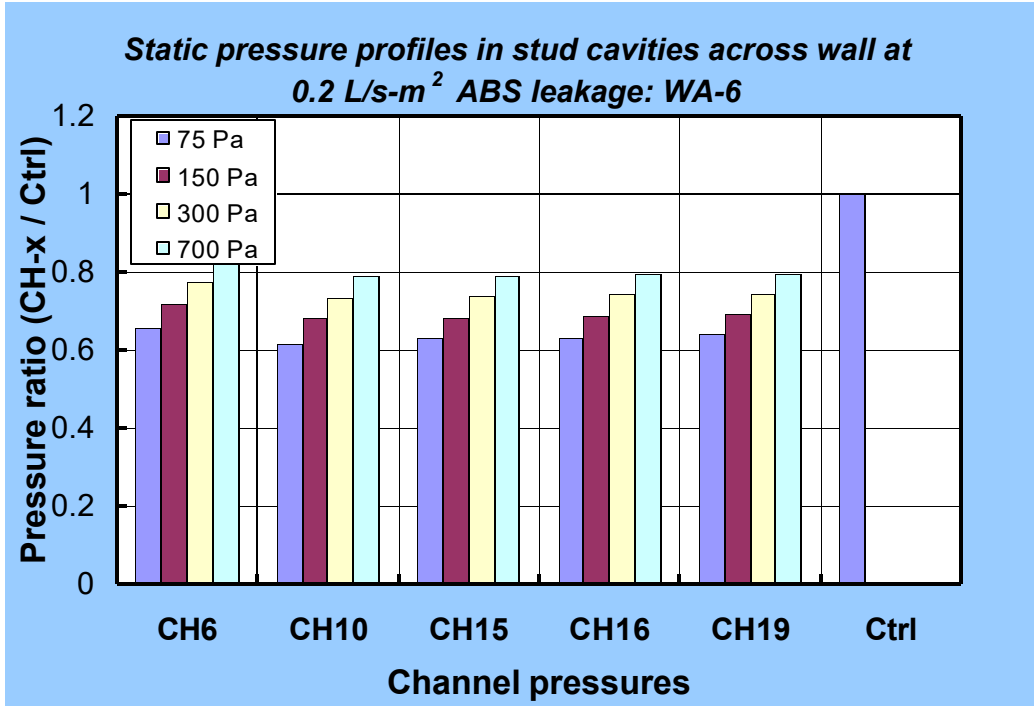
Figure B.31 – WA-6: Static pressure ratios over a range of driving pressures in stud cavities across width of wall. Nominal air barrier system leakage: 0.2 L/s-m<sup>2</sup>

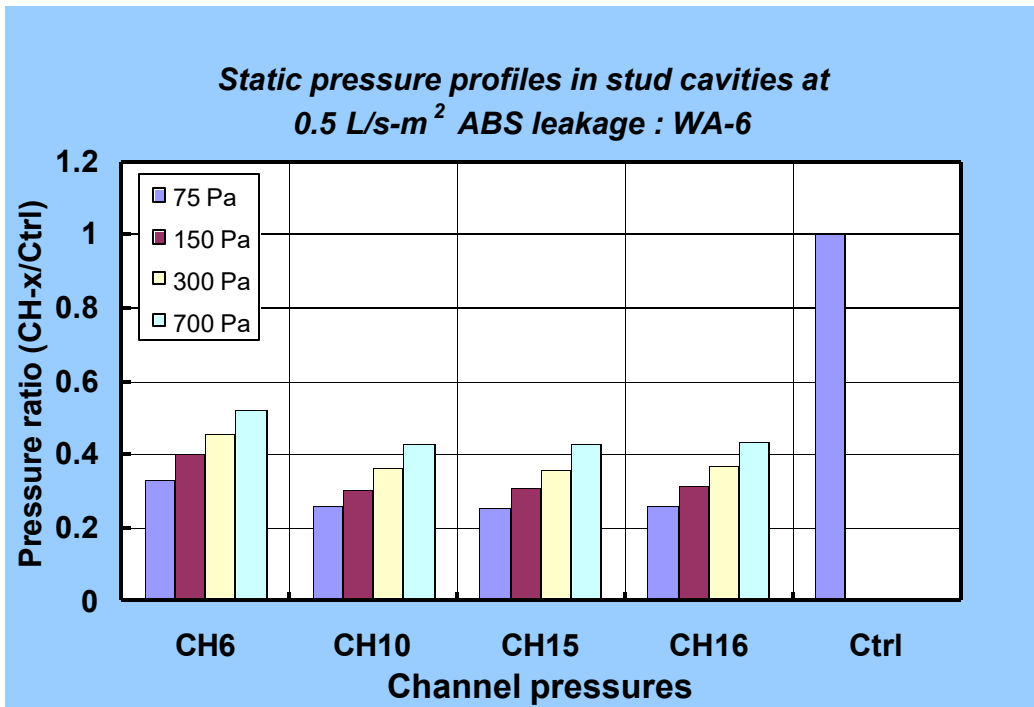
Figure B.32 – WA-6: Static pressure ratios over a range of driving pressures in stud cavities across width of wall. Nominal air barrier system leakage: 0.5 L/s-m<sup>2</sup>

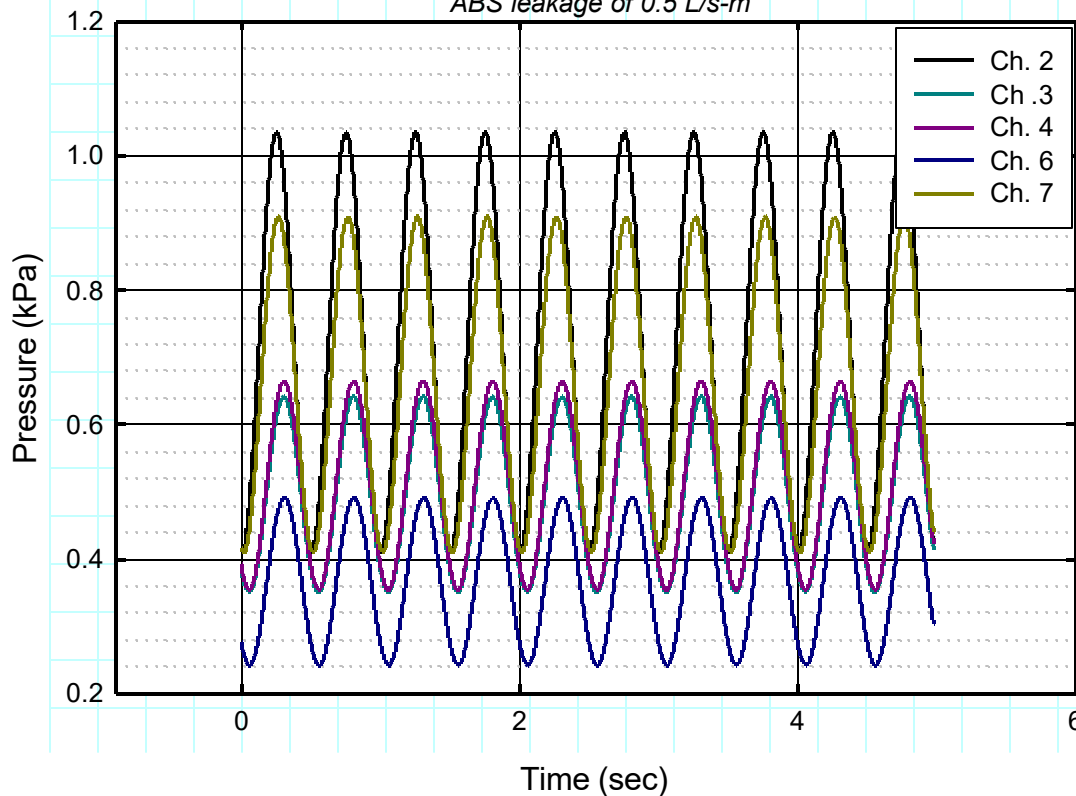
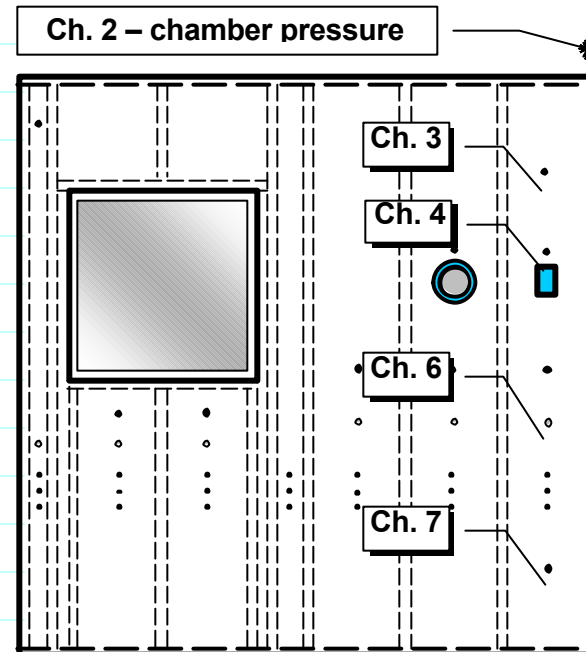
Figure B.33 – Pressure fluctuations across wall portion No. 1 for a pressure of  $700 + 300\sin(2\pi ft)$  at 2 Hz and ABS leakage of  $0.5 \text{ L/s-m}^2$

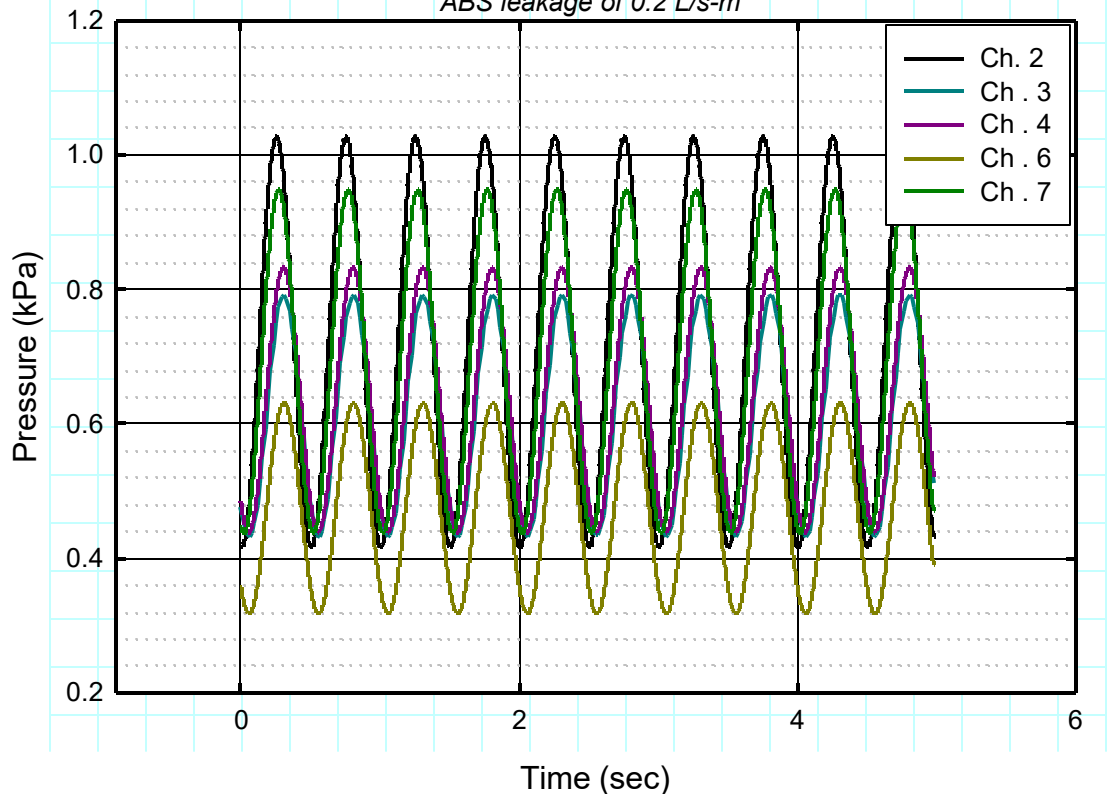
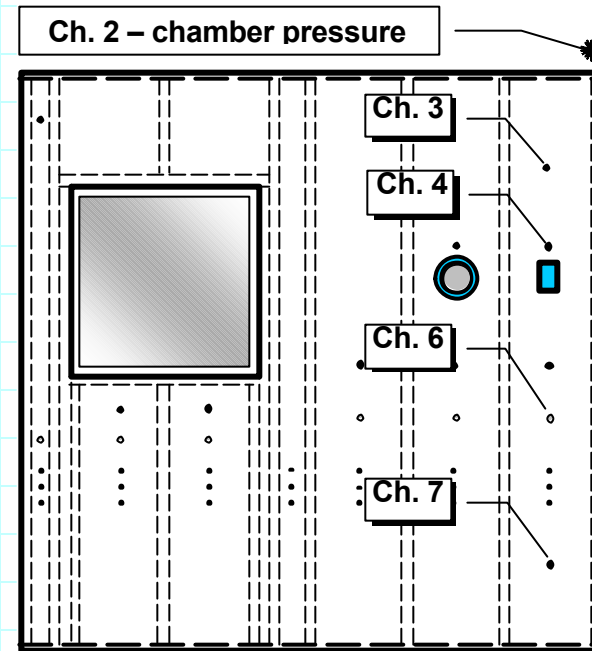
Figure B.34 – Pressure fluctuations across wall portion No. 1 for a pressure of  $700 + 300\sin(2\pi ft)$  at 2 Hz and ABS leakage of  $0.2 \text{ L/s-m}^2$

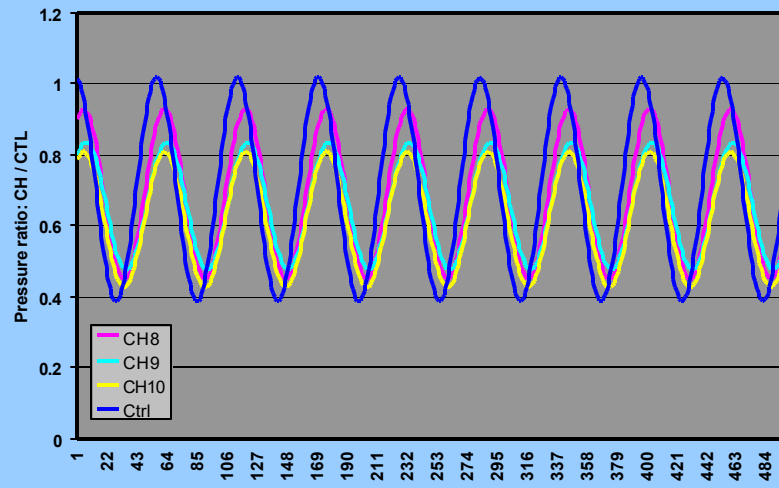
Figure B.42 - WA-16 Dynamic pressure response at 700 DPL – ABL 0.2 L/s-m<sup>2</sup>

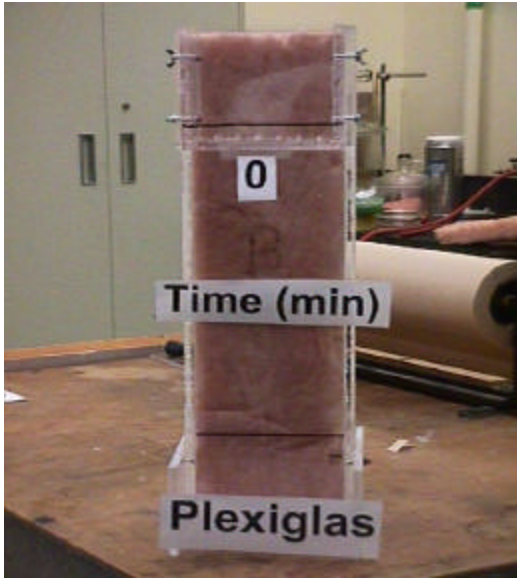
Figure B.44 - Set-up for initial test with plexiglas backing

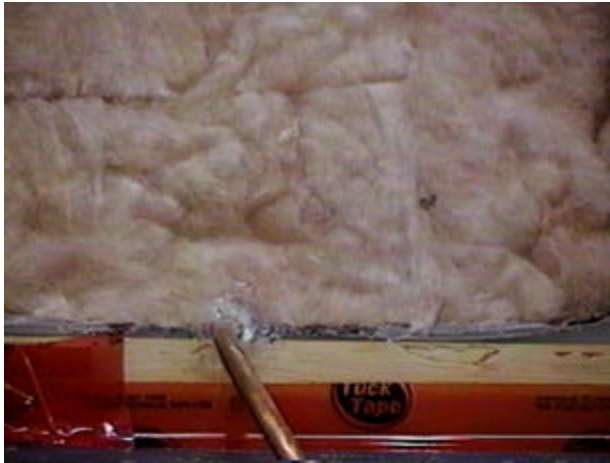
Figure B.49 - Bottom plate of cavity showing insulation batt and collection point prior to start of test

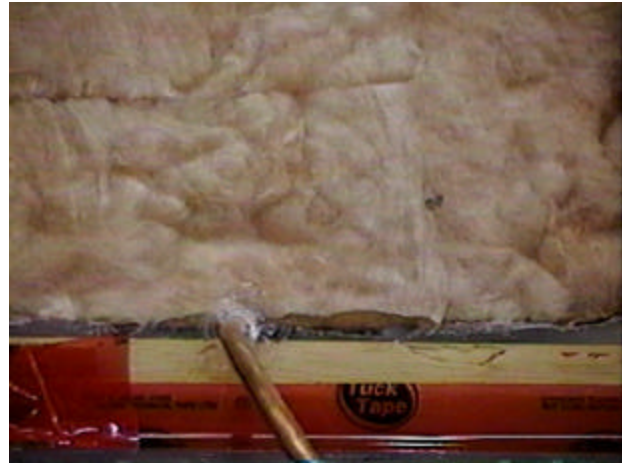
Figure B.50 - Stud cavity at bottom plate after 20 minutes of water accumulation

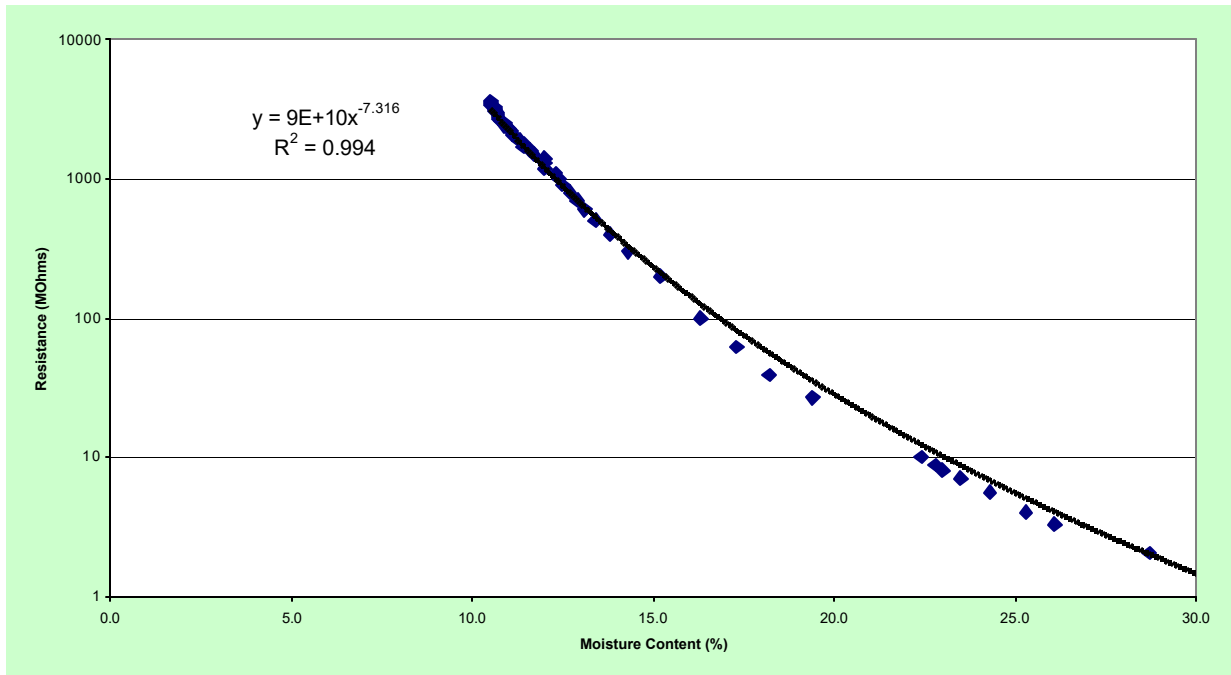
Figure B.71 – Resistance (MO) in relation to moisture content of OSB
