Some icing tests on selected screen samples

LTR-ENG-17

SOME ICING TESTS ON
SELECTED SCREEN SAMPLES

DECEMBER 1972

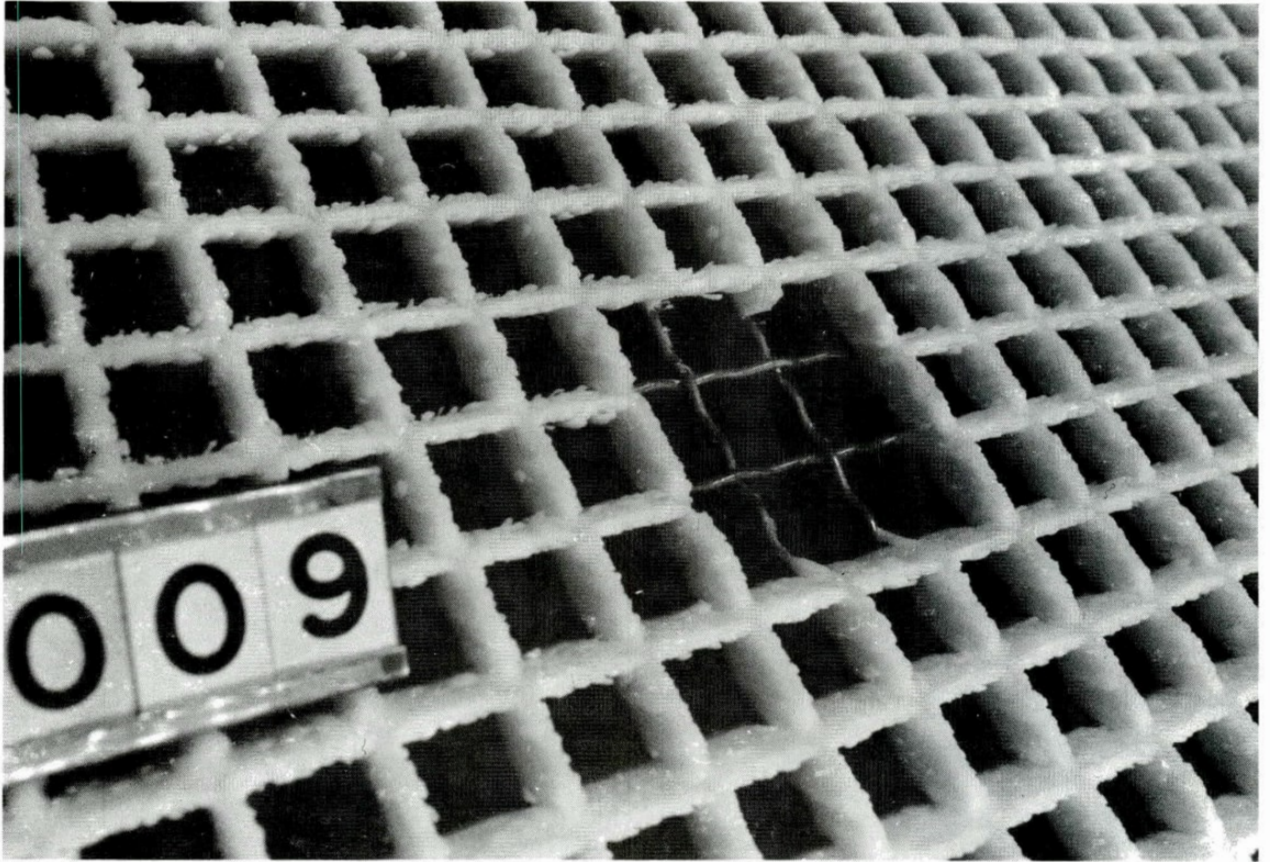
The ice actually created in the tunnel was glaze, rime, or intermediate ice, sometimes referred to as glime. The type of ice formed in aircraft turbine engine anti-icing work is primarily a function of air temperature and velocity. In the present tests, ice which formed at -5°C was judged to be mostly rime ice, with perhaps some cases of glime ice mixed with the rime, see Figure 4. As can be seen, the rime ice formed (on the upstream screen face) in a ragged spearhead shape, somewhat blunter at the leading edge than is usually found at higher velocities.

FIG. 4: TYPICAL RIME ICE FORMATION ON SCREEN

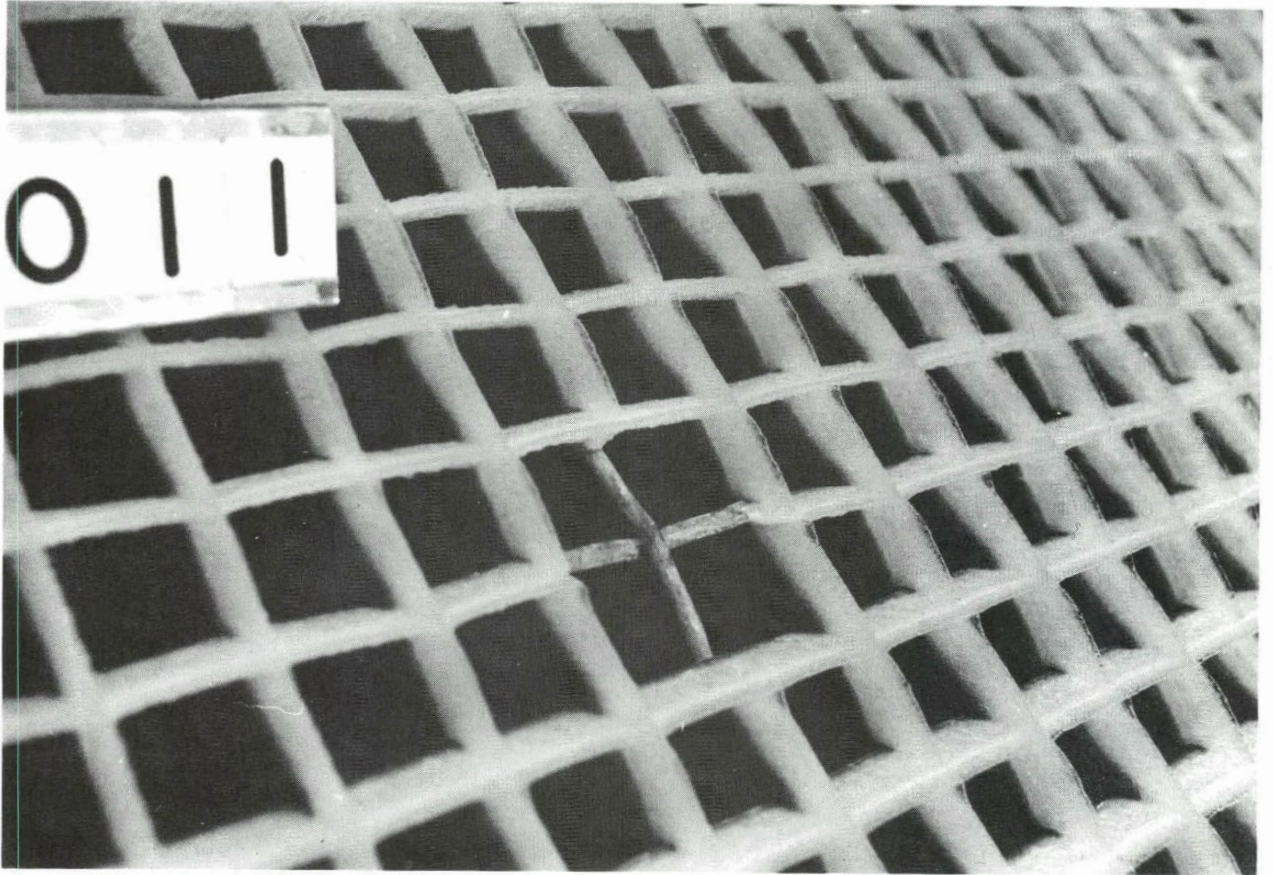
At a tunnel temperature of -1°C , glaze ice invariably formed on the screens, see Figure 5. This glaze ice, which at typical flight velocities freezes into hammerhead-shaped cross sections causing excessive drag, had an unfamiliar knife-edge profile. Because of the low tunnel velocity and the absence of any above-freezing temperatures, no runback ice formed behind the screen, see Figures 6, 9, and 10. At the upper portion of the screen, where the temperature was close to freezing, a few small frozen globules formed of, typically, $1/4$ -inch diameter, see Figure 7.

FIG. 5: KNIFE-EDGE GLAZE ICE FORMATION ON SCREEN

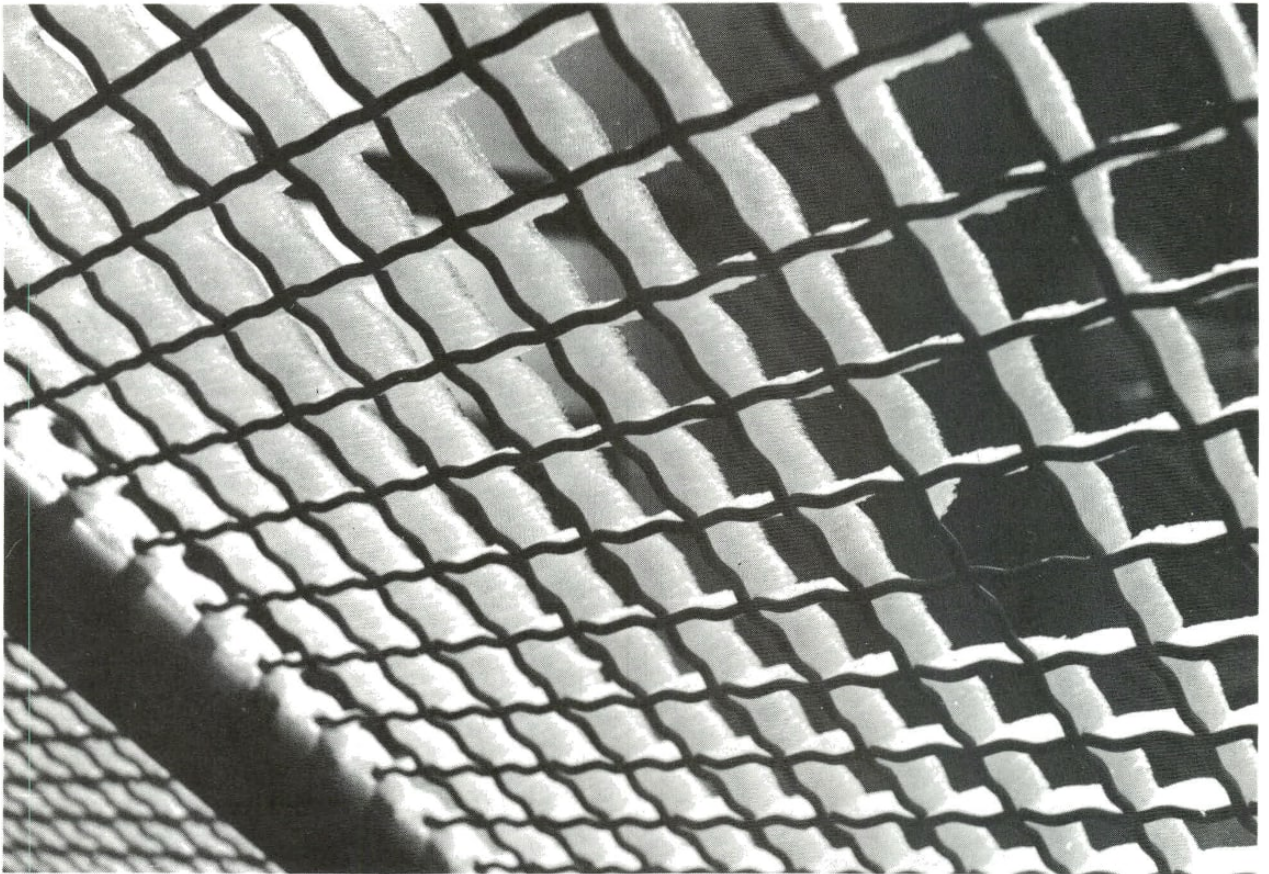
All ice formations, rime, glime, or glaze, formed a strong lattice which was firmly bonded to the screen. Although a quantitative assessment was not made, it took considerable effort in all cases to break a piece out of this structure. Once the lattice was breached, subsequent pieces could be dislodged with somewhat less effort. As one would expect, the strength of the ice formations increased with decreasing screen pitch. No ice shedding was recorded during any of the tests. These observations had to the conclusion that aerodynamic forces and/or engine vibrations present at a field site are unlikely to induce any appreciable shedding of ice accretions similar to those created in the icing tunnel. If icing conditions were followed by above-freezing temperatures, it is predicted that the ice would commence to melt with some sections possibly sliding off the screen once the bond were sufficiently weakened. The ice accretions on the screen, even after the severe conditions of these tests, were definitely not heavy enough to damage compressor blading should they be inhaled by the engine. Furthermore, under these warming conditions, there is no evidence or expectation of runback or refreezing causing dangerous glaze ice accretions behind the screen.

FIG. 6: CLEAR DOWNSTREAM SIDE OF HEAVILY ICED SCREEN

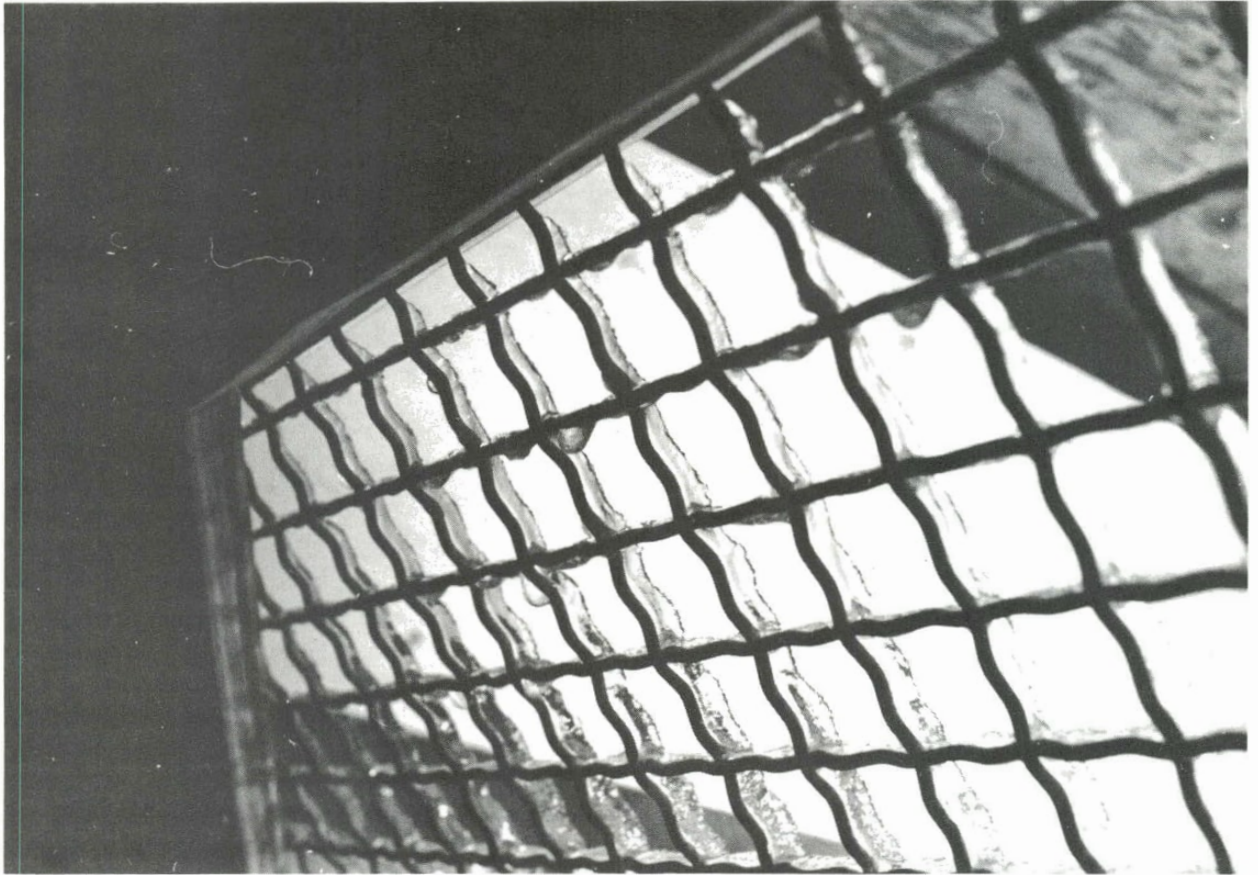
FIG. 7: ICE GLOBULES SUSPENDED FROM WIRES AT NEAR-FREEZING AIR TEMPERATURE

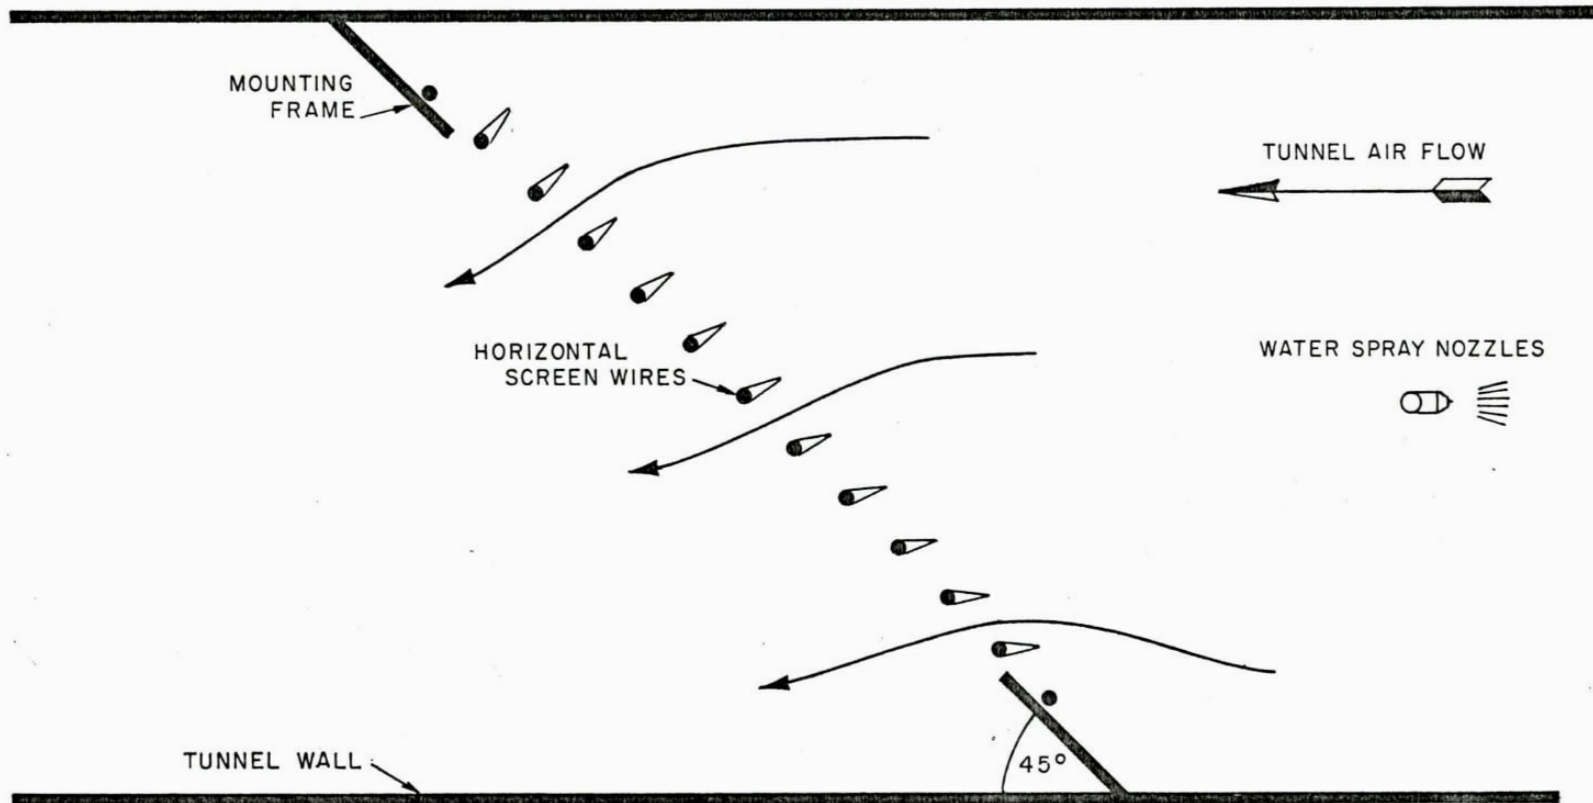
In tests in which the screens were inclined rearward 45 degrees, the attitude of the ice formations on the horizontal wires changed over the length of the screen, approximately as shown in Figure 8.

FIG.8: SCHEMATIC OF ICE FORMATION ON INCLINED SCREEN

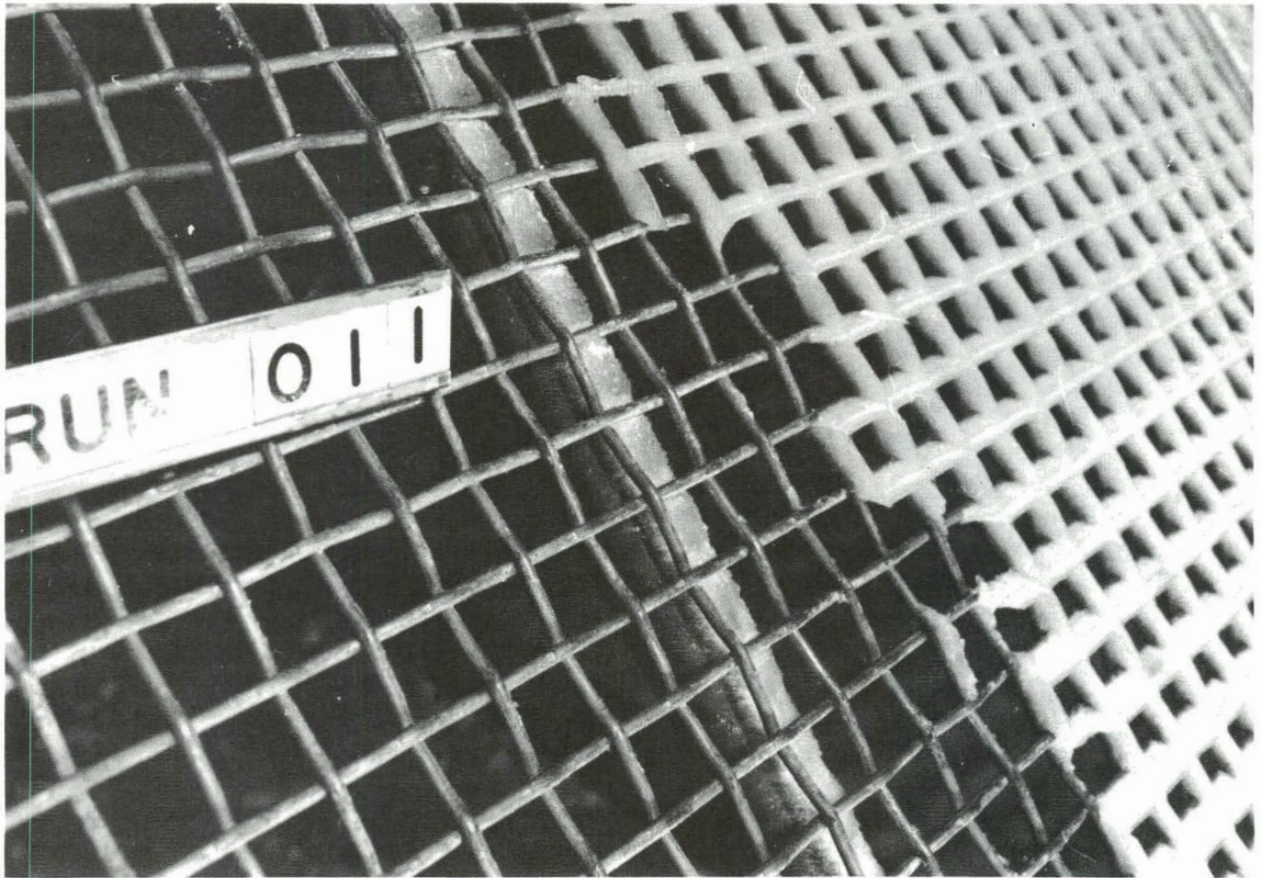
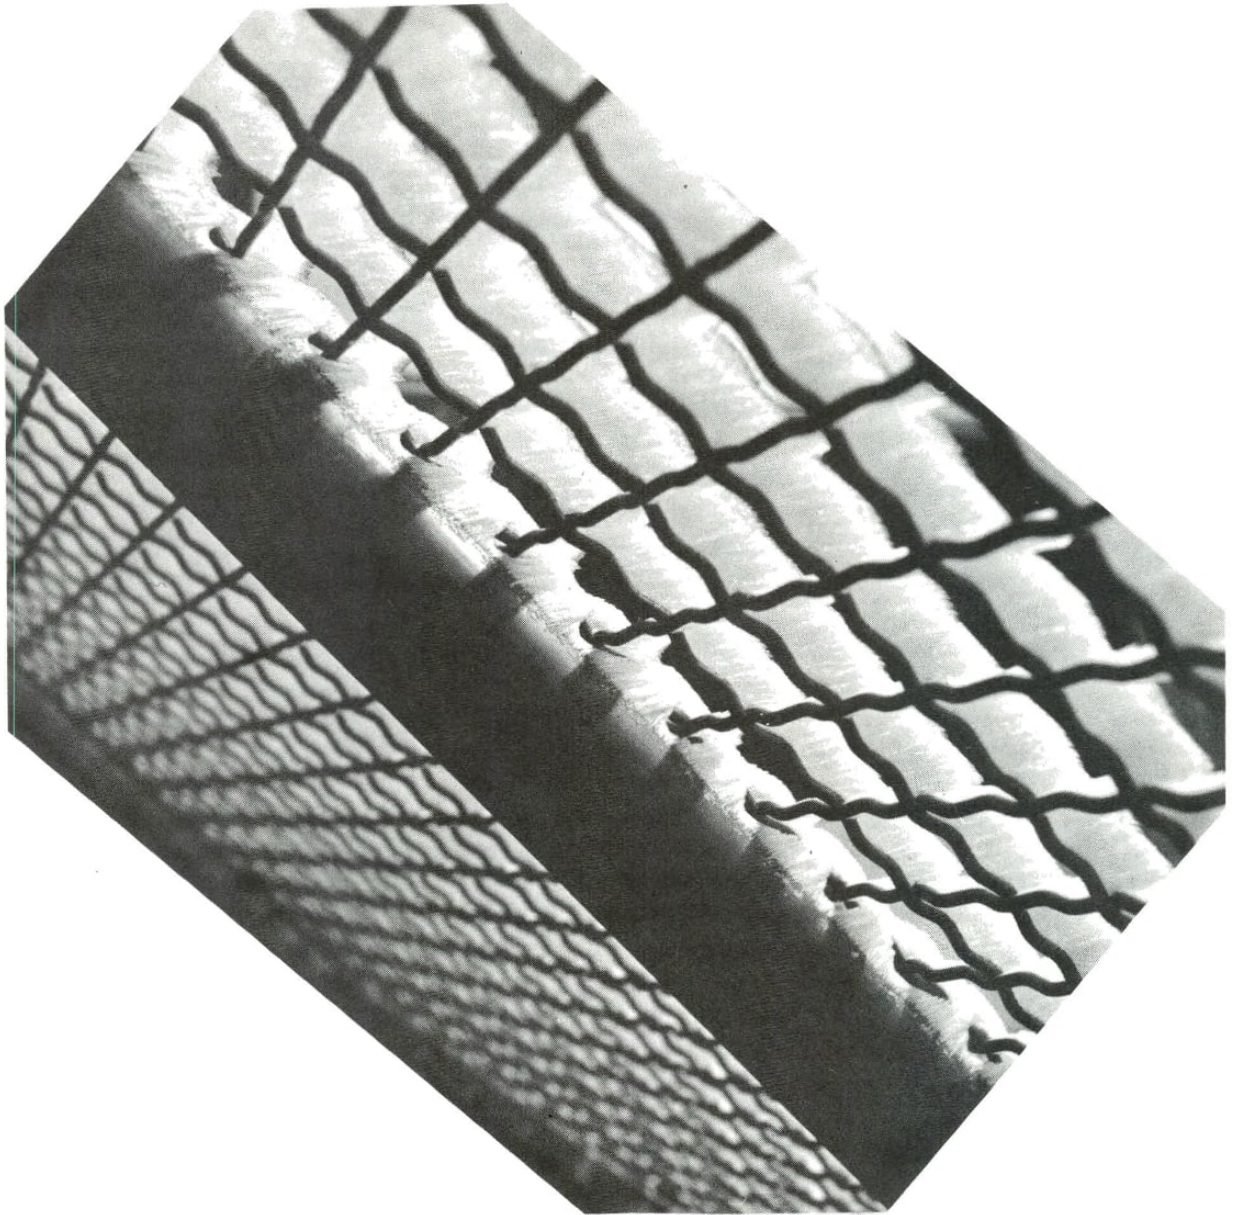
For the last three tests, pieces of pipe were strapped behind the screen to simulate structural members. Ice formed on impact in the cavity between pipe and screen, but no runback icing occurred, see Figures 9 and 10. The ice build-ups, being behind the screen, could possibly be shed, if rising air temperatures should loosen the bond, and be ingested. This possibility should be taken into consideration when designing the support structure of the screen.

FIG. 9: GLAZE ICE FORMATION ON UPSTREAM SIDE OF PIPE BEHIND SCREEN

FIG. 10: GLAZE ICE FORMED BETWEEN SCREEN AND PIPE

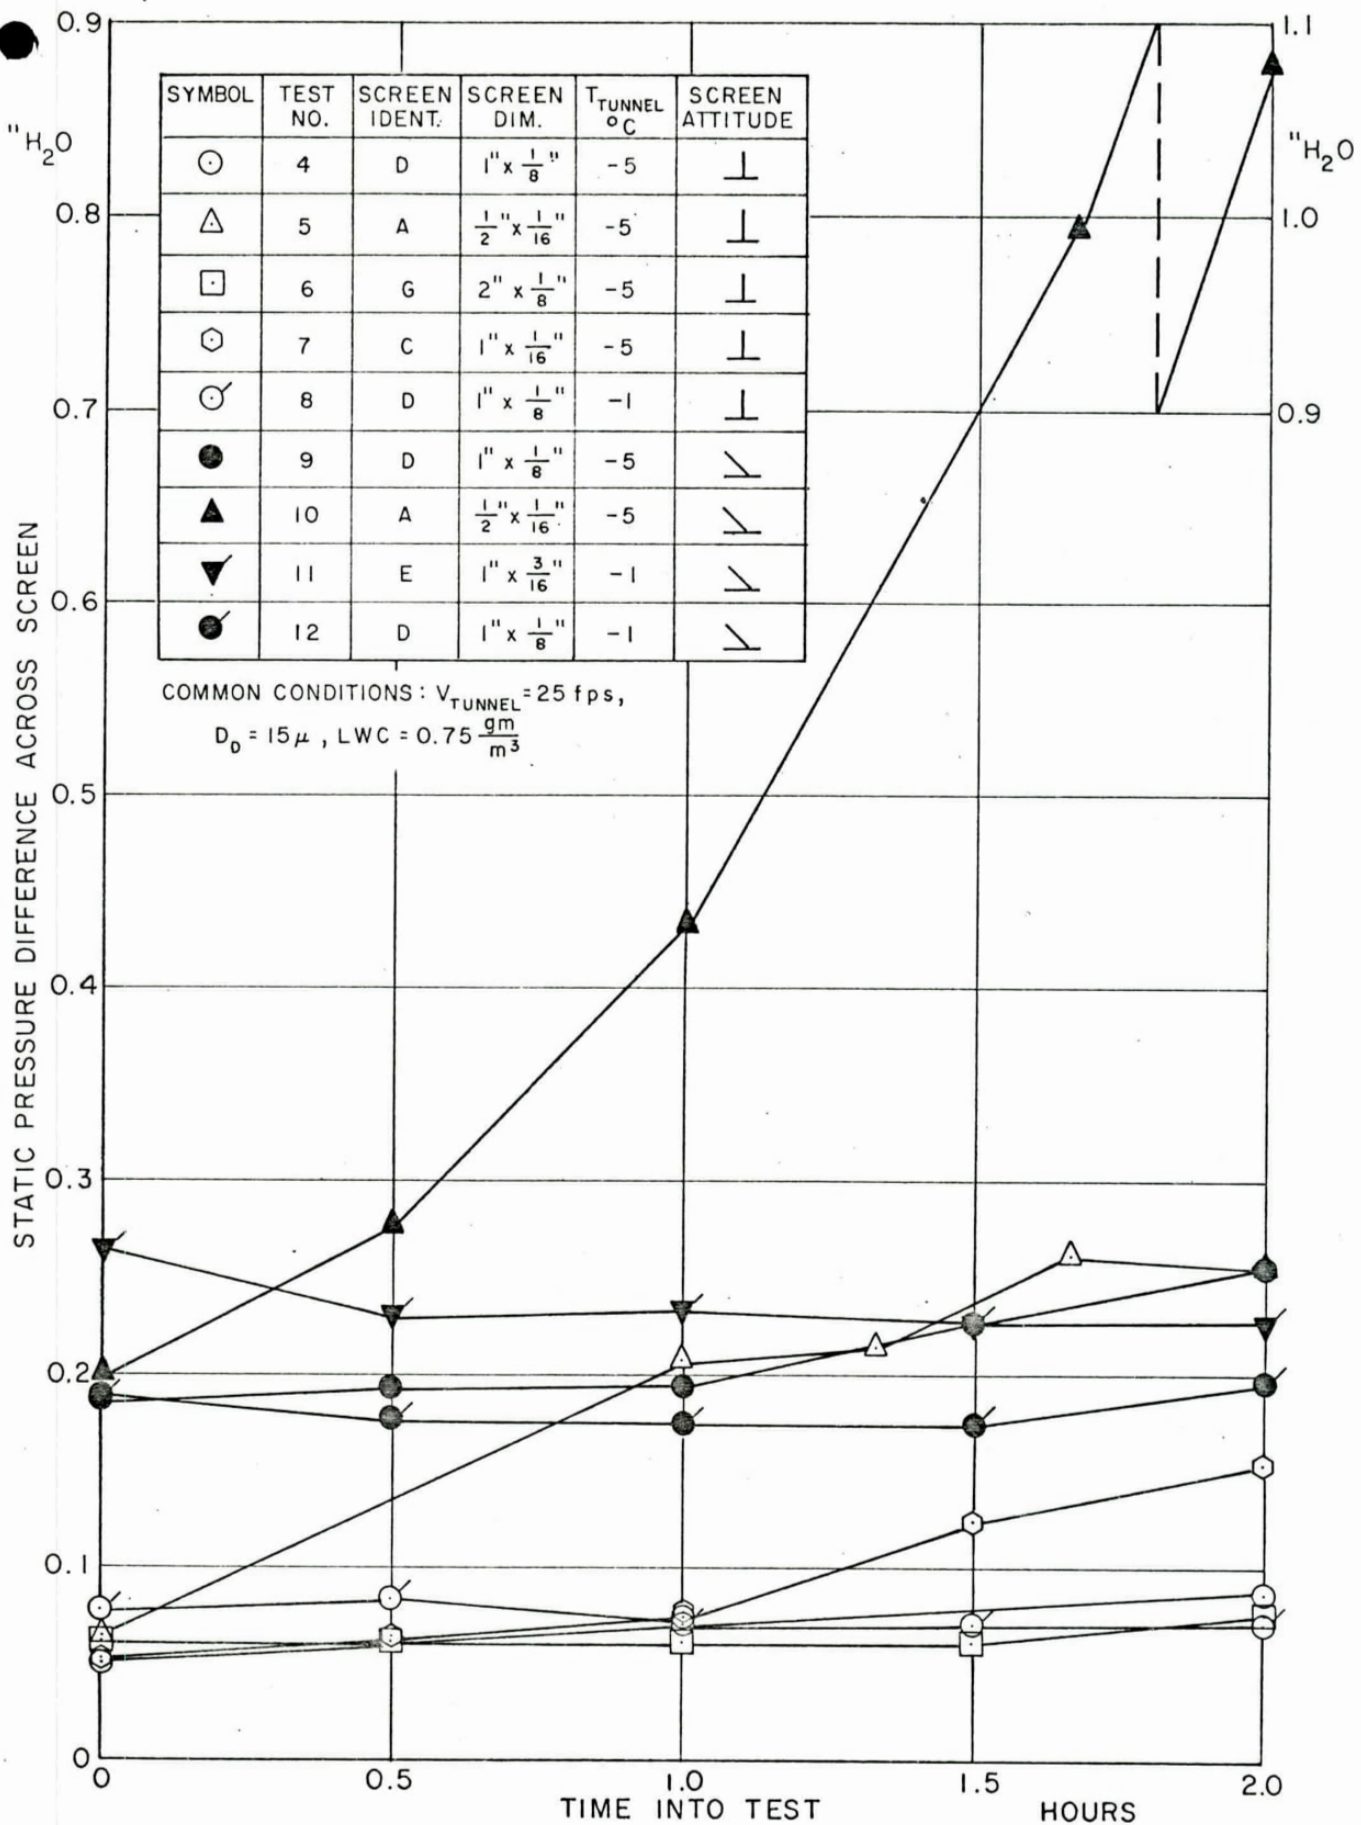
In vertical attitude (tests No. 4 to 8), the dry screen losses were approximately 1/16 inches WG for all specimens, see Figure 11. The two-inch screen (G), even though heavily iced, did not affect the pressure drop noticeably during the two-hour test. The loss across the 1/2-inch screen (A), on the other hand, increased about four-fold. The increase was gradual, however, and the final difference across the screen did not exceed 1/4-inch WG. The knife-edge glaze ice formations of test No. 8 actually decreased the drag of the screen resulting in a slightly lower pressure drop in the iced condition. For no apparent reason, the smaller wire of screen C caused a greater pressure drop during the second hour of the test period than the "standard" mesh of screen D.

The dry screen losses at the inclined attitude varied from .20 to .25 inches WG. This higher initial drop must be attributed largely to the plywood frame and the higher air velocity through the screen. Tests No. 9, 11, and 12 (see Table 1) compared well with the pattern of the previous tests. The 1/2-inch screen (A) of test No. 10, however, collected a heavy rime ice lattice and closed up rapidly during the latter half of the test, see Figure 12. At the termination of the run, the screen was about 75% blocked, resulting in a static pressure difference of nearly 1.1 inches WG, or more than five times the dry value. While the absence of screen material at the bottom would assure an adequate air inlet flow, the severe inlet flow distortion may not be acceptable to the engine. Operation in a less severe icing environment but over much longer periods may conceivably produce ice formations comparable to the ones observed in the tunnel, which would preclude the use of a screen of 1/2-inch openings. Time and tunnel availability did not permit checking the 3/4-inch screen; it must be considered marginal with respect to pressure loss in icing.

FIG.II: STATIC PRESSURE DIFFERENCE ACROSS SCREEN vs TIME INTO TEST

(ii) The opening of a square-mesh ingestion protection screen should be one-inch with a wire size of 1/8 inch. If the wire contact points are not welded, the screen should be inspected periodically for fretting.

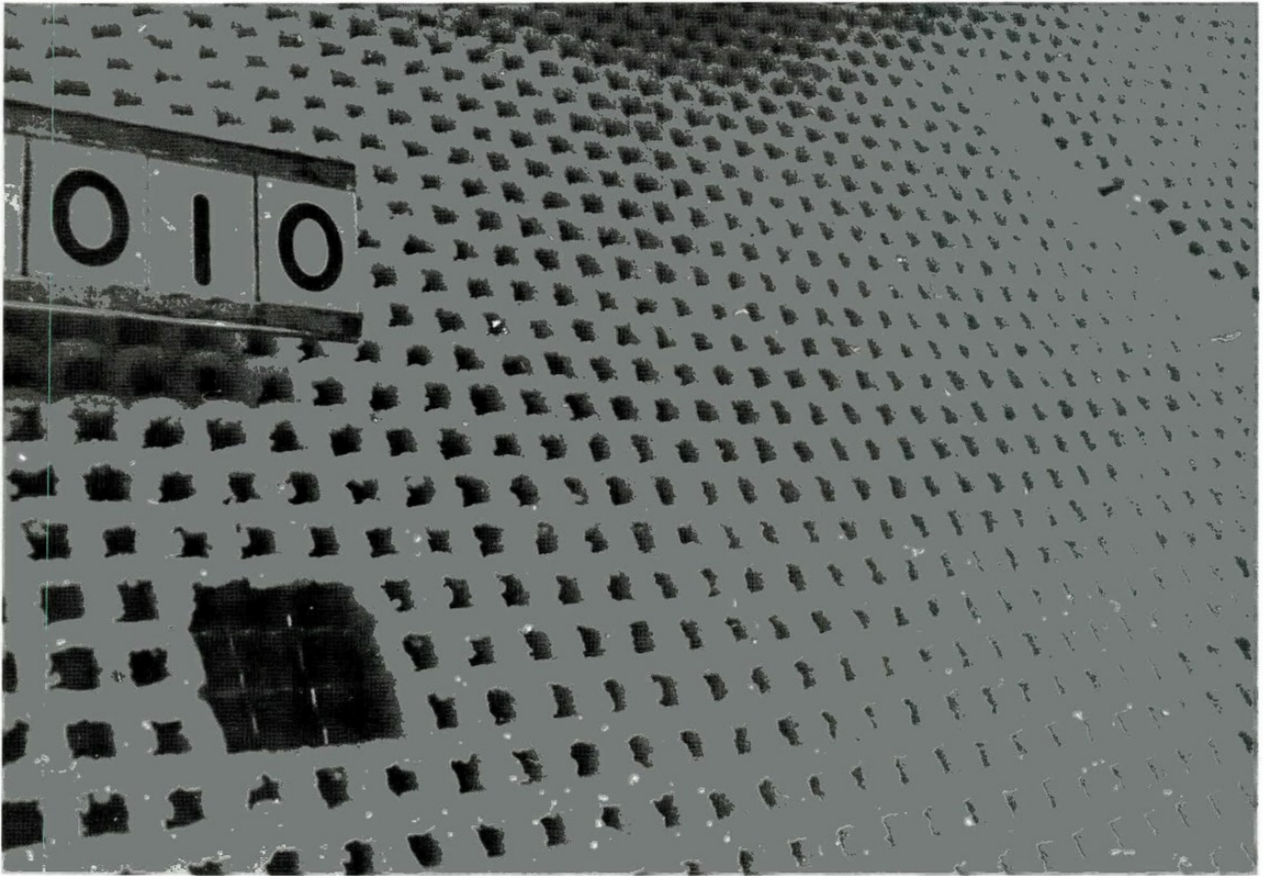
FIG. 12: HEAVY RIME ICE BUILD-UP ON INCLINED 1/2-INCH SCREEN AFTER 2 HOURS OF TESTING
