Construction Technology Update; no. 53, 2002-06-01

Behaviour and Performance of Concrete Sidewalks

by Balvant Rajani

Sidewalks are key elements of urban infrastructure, have a high replacement cost and often fail prematurely. This Update reviews current construction practices and the types of deformation and damage that reduce service life.

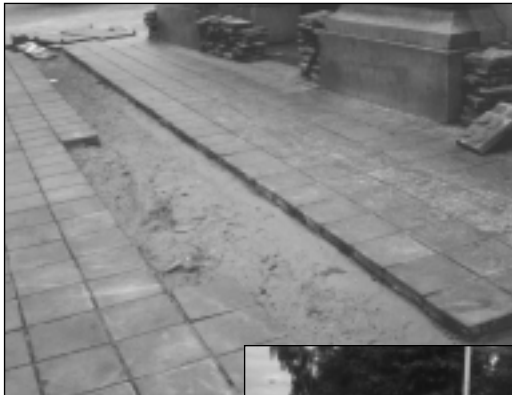
Figure 1. Flexible sidewalk under construction.

In North America, there are two broad categories of sidewalks – flexible and rigid. Asphalt and interlocking brick sidewalks are flexible (Figure 1). However, the vast majority of sidewalks in North America are the rigid concrete slab-on-grade type (Figure 2). This Update therefore focuses on performance issues of concrete sidewalks with emphasis on why they fail. Another Update reviews best practices for prolonging sidewalk life.¹

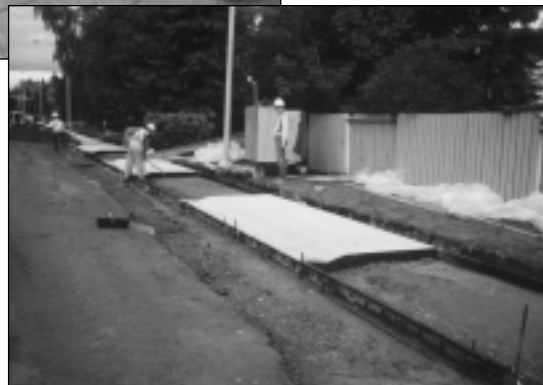
Figure 2. Concrete slab-on-grade sidewalk under construction.

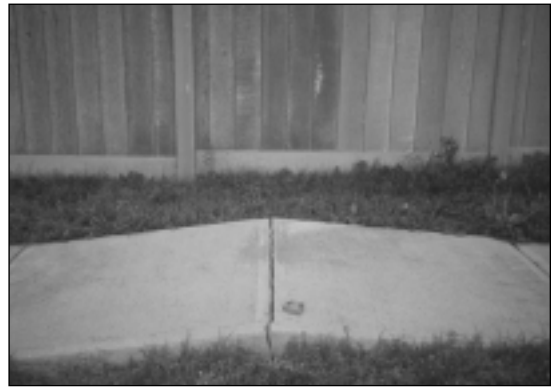
Figure 3. Rigid body uplift (tilt).

1. Rigid body uplift or settlement is the tendency for a sidewalk slab to rise, subside or tilt as a result of expansive native soils, frost action, or thermal expansion of the concrete slab (even when a good granular sub-base is provided) (Figure 3).
2. Tensile-shrinkage is deformation resulting from tensile stresses (Figure 4a) caused by the shrinkage of underlying soils from

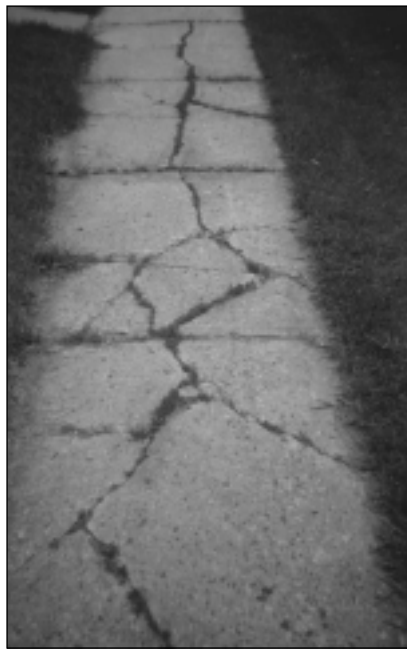
Figure 5. Two or more deformation modes often occur simultaneously.

It is rare to find one form of deformation in isolation. Often, two or more forms of deformation are evident (Figure 5). Deformation may or may not result in damage. Damage to sidewalks only occurs when tensile strains caused by one or more modes of deformation exceed the tensile failure strain of the concrete.

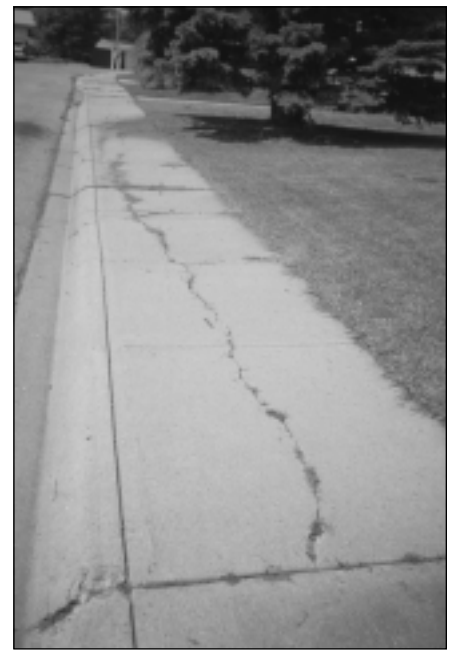
Figure 6. Longitudinal cracks usually occur in the middle third of the sidewalk.

Longitudinal cracks (Figure 6) occur primarily in the middle third of the sidewalk and are prevalent in the Prairie Provinces. These cracks can extend through several expansion joints before stopping abruptly. If the cracks do not open, and if no faulting develops along them, they do not pose a safety hazard. However, this type of crack normally opens up with time and it is common to observe faulting of 10 mm or more (Figure 7a).
