Development of a marine icing monitoring system

Proceedings of the 20th International Conference on Port and Ocean Engineering under Arctic Conditions, 2009-01-01

Development of a Marine Icing Monitoring System

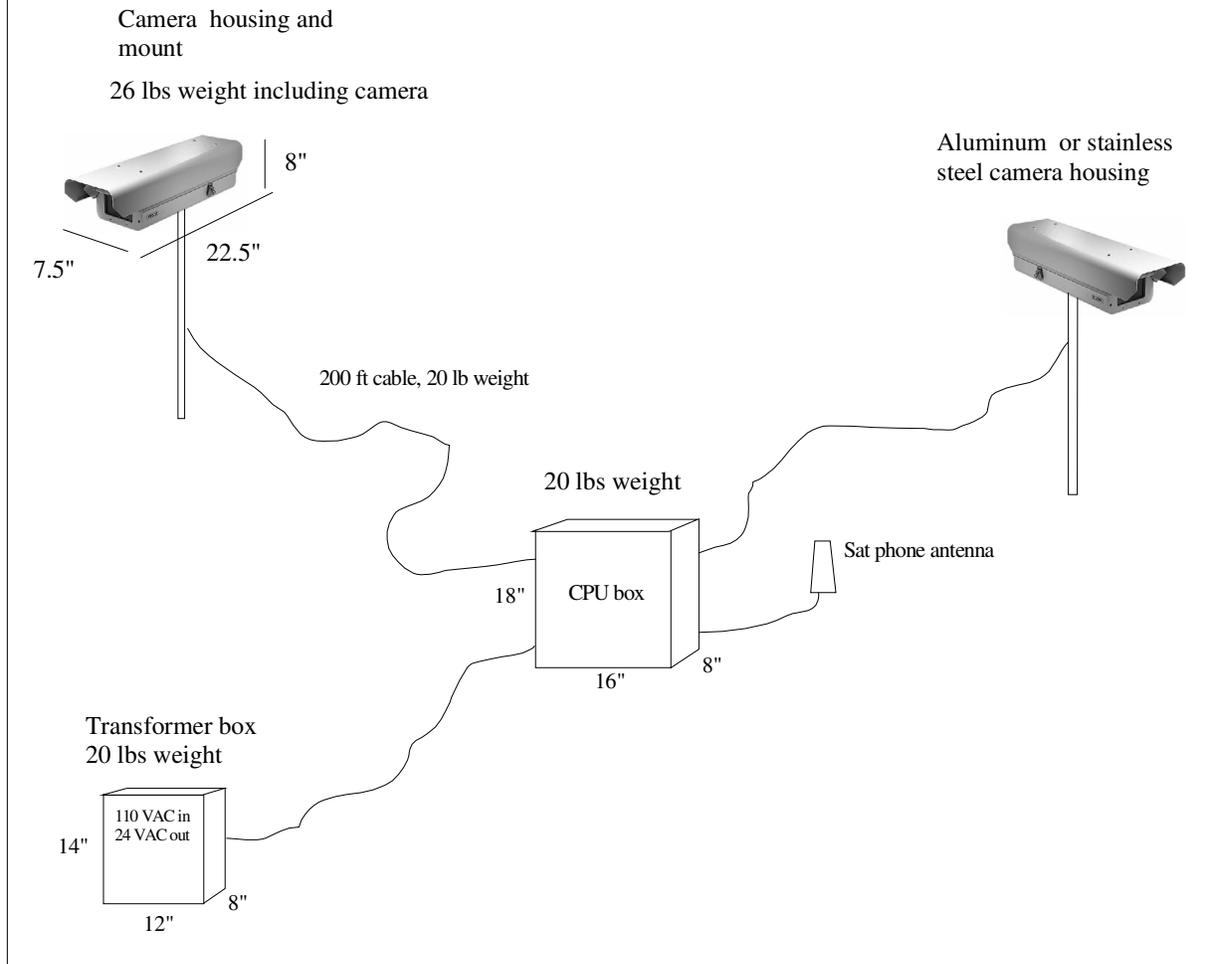
Marine Icing Monitoring System

Total system power is approximately 250 Watts
Total system weight, including cables, is approximately 132 lb

Figure 1. Schematic of the Marine Icing Monitoring System. Details in Farr (2004).

The Marine Icing Monitoring System (MIMS) is a visual-based technique for monitoring marine ice accumulation on offshore rigs and vessels where icing poses operational and safety hazards (Figure 1). The system consists of a CPU connected to two high-resolution digital cameras that are positioned to view expansive areas, or smaller areas depending on requirements, where icing could occur when environmental conditions are within certain parameters. The system is modular, so multiple units could be used to cover more sites on the rig/vessel. The system is completely stand-alone, requiring no maintenance and needing only a standard 110 VAC power source, and it draws about 300 Watts. All components of the system are weatherproofed so that installation can be anywhere on the deck or superstructure of a facility. When turned on, the computer controls each camera and causes the cameras to take pictures at regular intervals (e.g. every 12 minutes) that are downloaded immediately to the computer's hard drive. Data are retrieved from the hard drive at the end of the icing season. The system has a satellite phone so that it can be controlled from IOT. Thumbnail images can be quickly downloaded to monitor current conditions at the site, and the cameras can be controlled to zoom in or out. Full size images may also be downloaded, however, several minutes are required to download an image, whereas thumbnail images can be retrieved in a matter of a few seconds.

In its present configuration MIMS has two digital photo cameras and they were mounted on the port and starboard railings on the top deck above the bridge of the ships. Each camera viewed the foredeck of the vessel and a portion of the ocean ahead and beside the vessel to record sea state. The basic system was purchased from Erdman Video. Modifications and extensive ruggedization of the equipment were carried out at IOT prior to all three deployments.

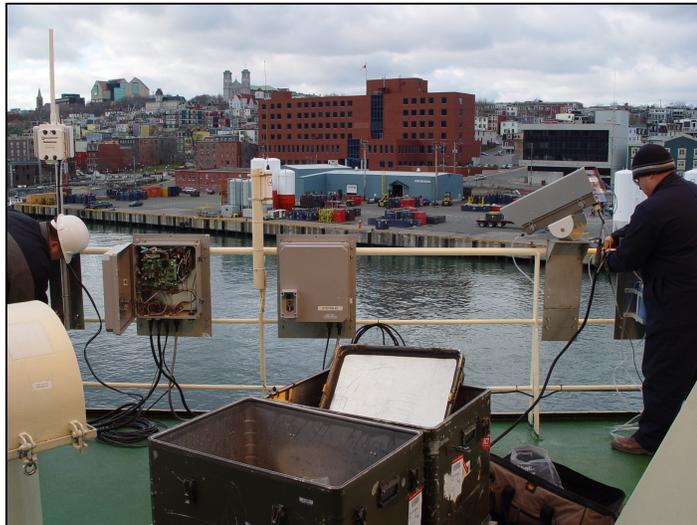
Figure 2. MIMS installation on the Atlantic Kingfisher at dockside in St. John's harbour. All components are attached to the railing on the top deck of the vessel. One of the camera housings is visible at the right and the power supply box and CPU box are visible at the center and left. The satellite phone antenna is visible at the far left.

The Marine Icing Monitoring System (MIMS) has been deployed on the Marine Atlantic Ferry Caribou (October 2003), then on an offshore supply vessel Atlantic Kingfisher (October 2005) (Figure 2), and its last deployment was on the supply vessel Atlantic Eagle (November 2007). These deployments of MIMS served two purposes. One was primarily intended as a ground-proofing and equipment development exercise for the system during actual winter seasons. The second was the collection of actual icing data that could be useful to researchers. The vessels served as convenient venues since equipment maintenance and data retrieval were relatively easy tasks to conduct at either of the Caribou's two ports, Port-aux-Basques NL and North Sydney NS, and in St. John's NL harbour for the two supply vessel deployments. All three vessels experience icing events from time to time, more so for the two supply vessels that are smaller than the Caribou Ferry and have decks closer to the water that are more susceptible to spray.

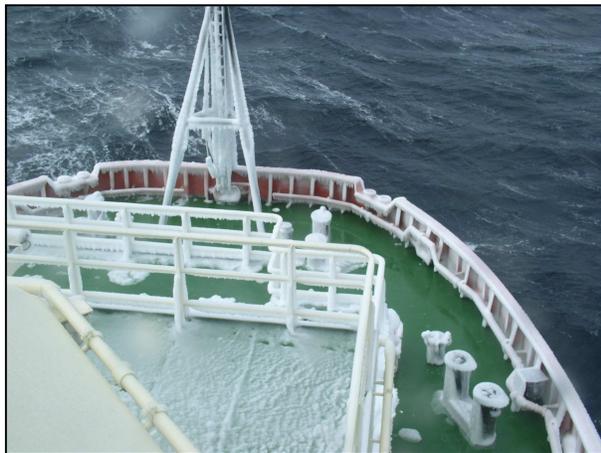
Figure 3. Marine icing accumulation on the deck and rail structures of the Atlantic Kingfisher.

While icing images (Figure 3) are the main focus, occasionally wave impacts on the hull that produce spray are recorded and these are also useful for understanding the dynamics of the spray generation aspect of the marine icing process (Figure 4).

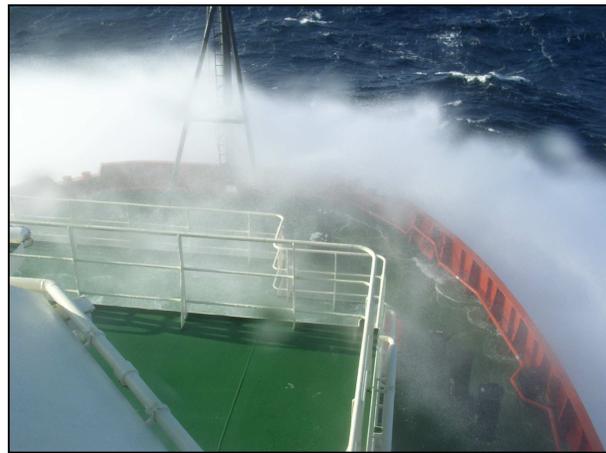
Figure 4. Spray event on the deck of the Atlantic Kingfisher arising from a bow-wave impact event.

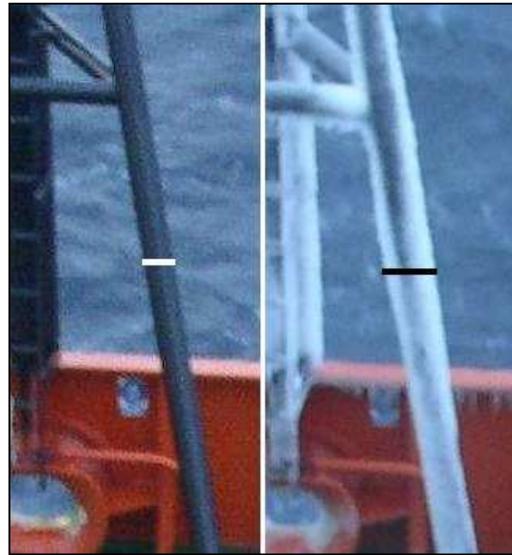
Figure 5. Example of an icing measurement obtained manually. The left image shows a structural component's horizontal width at the measurement location (white line) and the right image shows the width including the ice layer during an icing event (black line).

The manual analysis of images was fairly straightforward. A specific location on some structural component such as a rail or pole was chosen and the change in width of the ice-covered structure as ice accumulated was measured in pixels using basic image analysis software (Figure 5). The pixel data were then converted to actual width measurements using the known dimensions of the structures as determined in ice-free conditions at dockside. The first sets of manual-type measurements looked reasonable and clearly showed the growth of icing at various locations during the event. Getting measurements for a large number of locations on the vessel's structures would be rather tedious and time consuming, however, so an automated system of analysis would be much more desirable. With an automated system many locations could be interrogated in a systematic and fast way, while avoiding person-to-person bias that naturally arises when manual analysis techniques are applied to visual data. The following strategy was

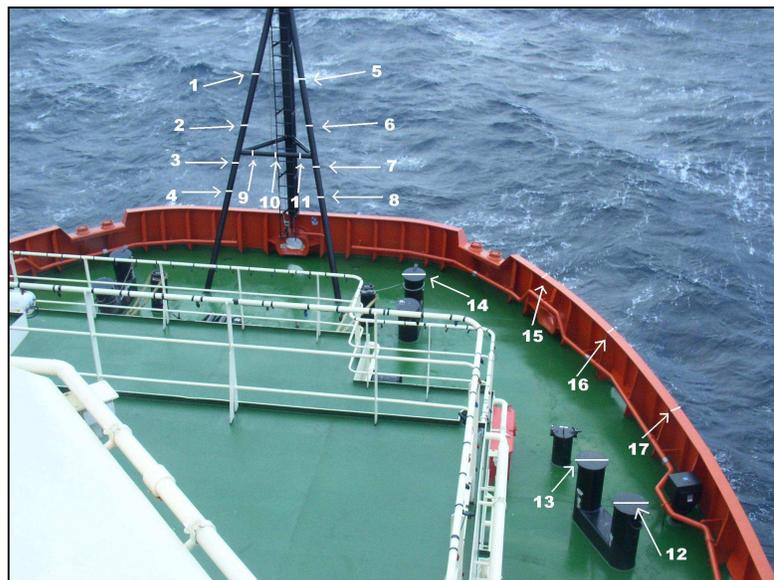
Figure 6. Locations on the deck structures and rails of the Atlantic Kingfisher where automated icing thickness measurements were made.

Seventeen locations were chosen for measurement on poles on the foreword mast, side rails and round deck structures (Figure 6). For each location a box was defined (60 x 60 pixels for the pole structure and 100 x 60 pixels for the rail structure). The image was rotated so that the linear features of the structure were vertical, to enhance edge-detection later. The rest of the image was cropped out and the analysis conducted on the box. Each box was converted to grey scale and then an edge detection routine was applied (Figures 7 and 8). Some filtering was also applied to enhance contrast and reduce noise at the grey scale and edge-detection phases. Then a routine was applied to the edge-detected image so that the edge locations at the right and left, corresponding to the edges of the icing accumulation, could be determined. The standard way this was done was by taking each of the vertical columns of pixels spanning the width of the image and summing the intensity values of all 60 pixels in each column. This would yield high numbers for columns that had many bright pixels in them and low numbers for dark columns. The icing edges on the right and left were found by finding the first column of pixels that had distinctly high values (i.e. by at least a prescribed amount from the preceding columns) starting from the left side of the image and moving right, and then starting at the right side of the image and moving left. Each box was previously scaled using actual dimensions of the structures in the boxes. The width of the icing layer plus structure dimension (in pixels) was then converted to actual dimensions and the structure width subtracted to give the sum of the icing thickness on both sides. Dividing this by 2 would yield the average thickness of icing at that location on the structure.

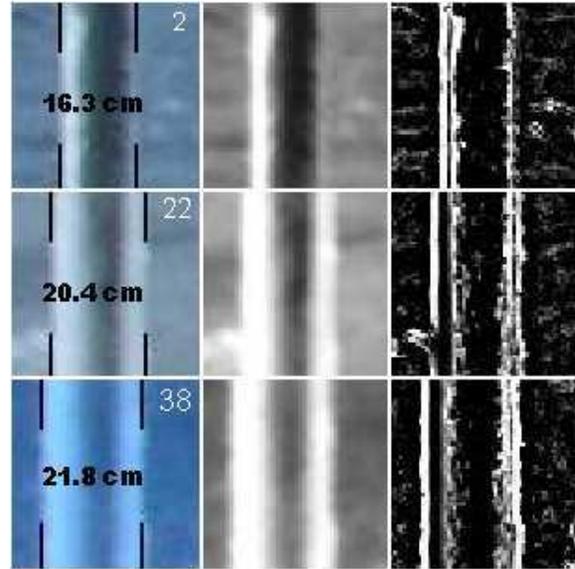
Figure 7. Composite images stacked vertically of position 3 on the pole structure at three times (image numbers at upper right in left boxes) in the icing event sequence. In each case the original image is in the box at the left, the grey scale enhanced version is at the center and the edge-detected image is at the right. Black vertical lines overlaying the original images indicate the calculated positions of the edges of the icing layers.

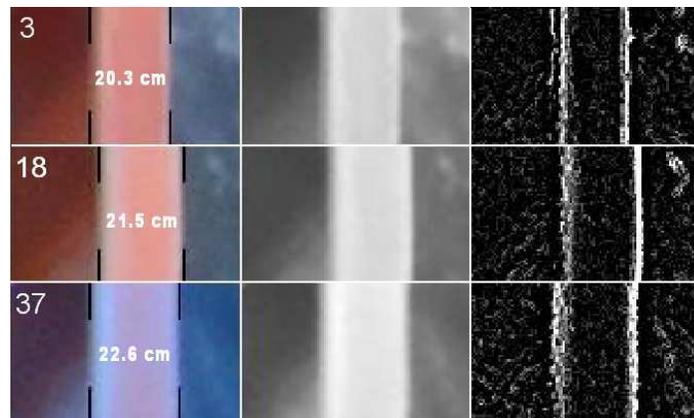
Figure 8. Composite images stacked vertically of position 17 on the rail structure at three times (image numbers at upper left in left boxes) in the icing event sequence. The rest of the figure layout follows the same format as in Figure 7.

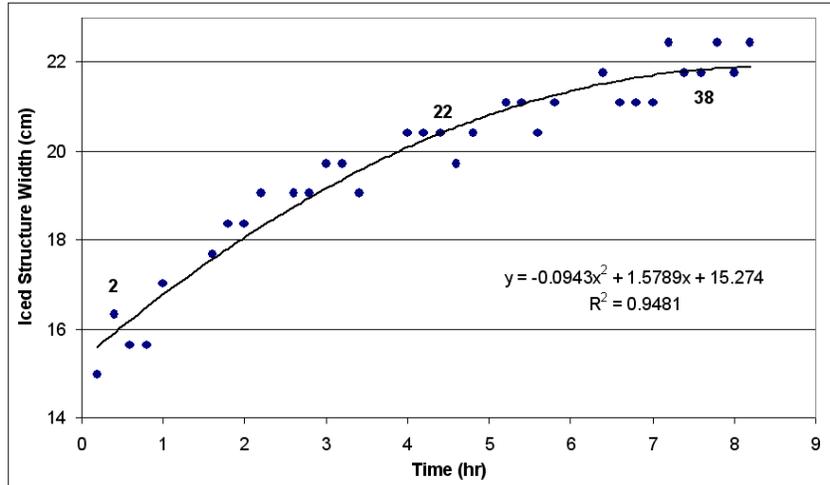
Figure 9. Pole structure width, including icing layer, versus time at position 3. Image numbers, corresponding to the images in Figure 7, are placed directly above or below the data points associated with those images.

acquired during the icing event are shown for position 3 on a pole structure (Figure 9) and position 17 on the rail structure (Figure 10). In cases where it was obvious that the automated analysis was having trouble getting a measurement for a particular image, that is, where it could not find the right or left edge of the ice due to image quality problems, then that data point was not included in the plot. That is why Figure 9 shows a few more data points than Figure 10. The present analysis technique is not well-suited to the round structures (Figure 6) and produces only marginal results that consequently are not included here. The algorithm for the analysis of these structures will necessarily be different than that of the linear structures. The required analysis strategy will involve elliptical fits to the ice-covered tops of the round structures and this has not been implemented in the computer program code yet.

Figures 9 and 10 show fairly uniform increases in icing thickness for the duration of the icing event. The trend in Figure 9 shows a definite decreasing slope, and the mild decreasing slope in Figure 10 may be real. The ship's log indicates that the air temperature ($\sim -3^{\circ}\text{C}$), wind speed (Beaufort 8) and direction (West) were fairly constant throughout the icing event (Gibling, 2007) and the ship maintained a near constant heading directly into the wind. This corroborates with the uniform trends in accumulation over time, that is, no sudden increases or decreases in growth rate. The decreasing rate of change of ice thickness in Figure 9 may be the result of the pole being a spray target that will accumulate icing more readily on its front portion that directly faces the bow spray. Its profile elongates in the spray-facing direction causing the side areas to 'stretch' in that direction while the amount of spray available at the sides has not changed, i.e. the growth rate decreases at the sides. We also note that the thickness of the icing

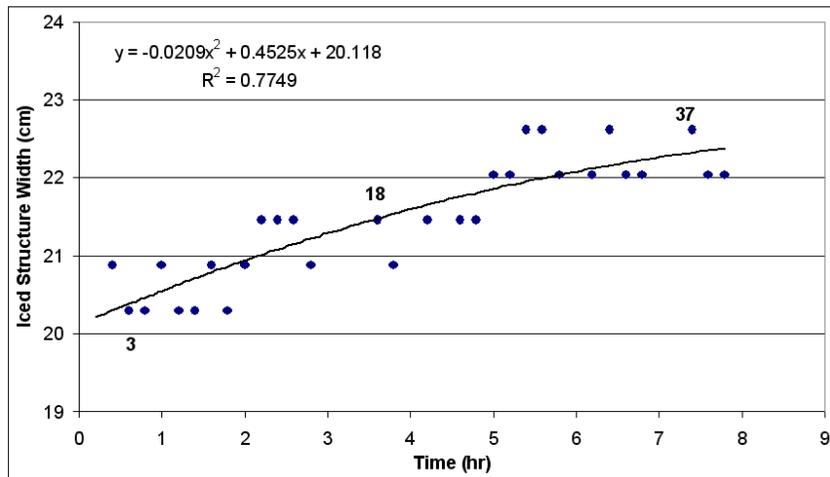
Figure 10. Rail structure width, including icing layer, versus time at position 17. Image numbers, corresponding to the images in Figure 8, are placed directly above or below the data points associated with those images.

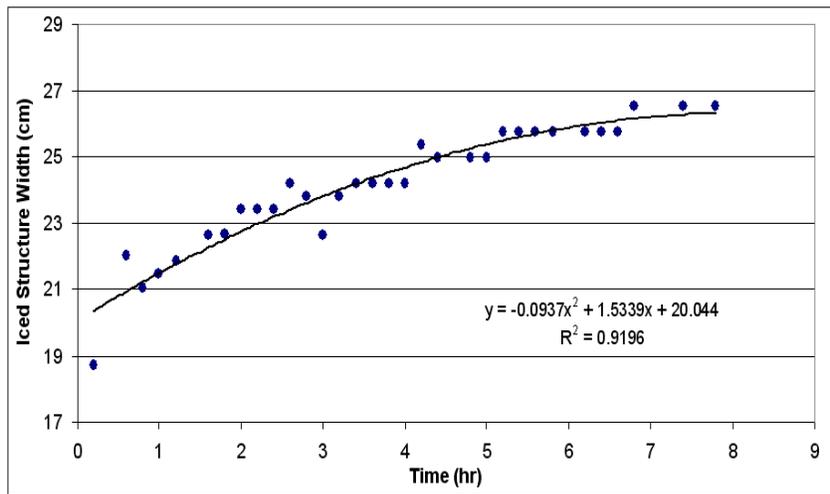
Figure 11. Rail structure width, including icing layer, versus time at position 16. Note that several data points included in the chart were generated using the alternate methods of image analysis.

is greater on the pole structure than the rail structure and that this is most likely due to the more forward position of the pole than the rail position, hence the pole gets more spray. Stronger evidence of this effect is seen if we look at the data for position 16 on the rail (Figure 11), which is more forward than position 17 and has the same structural shape and elevation. We can see from the graph that the icing accumulation is significantly greater than that at position 17 in Figure 10, as anticipated.

use cameras with greater resolution or to increase local resolution by using the camera's zoom capability. An alternate technique we used to reduce the effect was to divide the columns of pixels described above in the standard analysis method into several smaller columns, instead of just one column of 60 pixels. Whereas before the standard routine looked for the first full-box-height column of pixels that met the brightness criteria to consider it the ice edge, now the analysis looked for several smaller columns that each define the ice edge and that generally exhibit some variation in position. The average horizontal position of these small bright columns was taken as the ice edge, thereby achieving a sub-pixel measurement. Another method we used was to artificially increase the 'resolution' of the images by applying a resizing algorithm to the image to increase its size (i.e. more pixels) before the analysis was performed. While these techniques, utilized separately or combined, helped to somewhat reduce the pixilation effect the scatter in the data tended to increase as a side effect, so the benefit was questionable. However, a real and unexpected benefit arising from these modified techniques was that some images that the standard method failed to analyze, because it could not find one or both icing edges, now could be analyzed to yield the ice edge locations. So in cases where the standard method fails for several images then the other techniques can be applied to fill in the gaps for some of the images at least. That was the case with the images for position 16 on the rail structure (Figure 11) where several data points determined utilizing the alternate methods were combined with the data that came from the standard analysis method.
