FLOORING DAMAGE BY HEELS

H. J. THORBURN

REPRINTED FROM
MATERIALS RESEARCH AND STANDARDS, VOL. 2, NO. 9,
SEPTEMBER 1962, P.734 - 737

TECHNICAL PAPER NO. 144

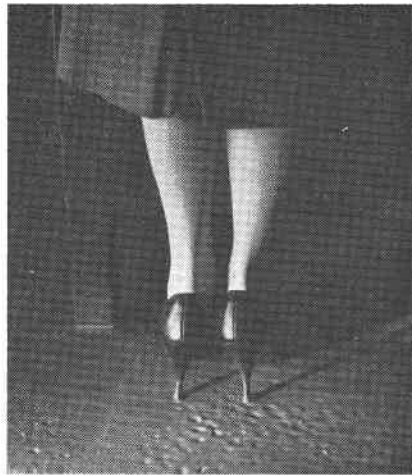
Fig. 1.—Perpendicular indentations.

Examination of damaged floors indicates two general types of indentation: (1) those made with the heel perpendicular to the floor (Fig. 1), and (2) those made with the heel at an angle to the floor and in contact only along one edge (Fig. 2). Although only static or quasi-static loads have been considered in this paper, dynamic or impact loads

pressures of some materials. The flooring in Fig. 1 was subjected to these conditions.

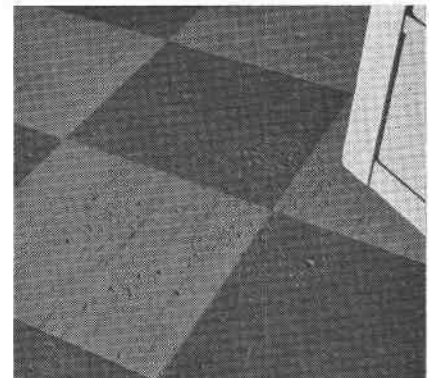
Fig. 2.—Angular indentations.

The most damaging combination of these variables is a new metal tip applying the load at an angle to the floor. Although the total load transferred by the heel at an angle is not large, the exposure of the sharp edge of the tip to the floor has a knife-like effect. Frequently such an exposure is accompanied by a rocking motion that adds substantially to the cutting action and leaves marks that are usually crescent-shaped, fairly deep, and very noticeable (Fig. 2). Well-worn metal tips with rounded edges have a similar but less damaging effect.

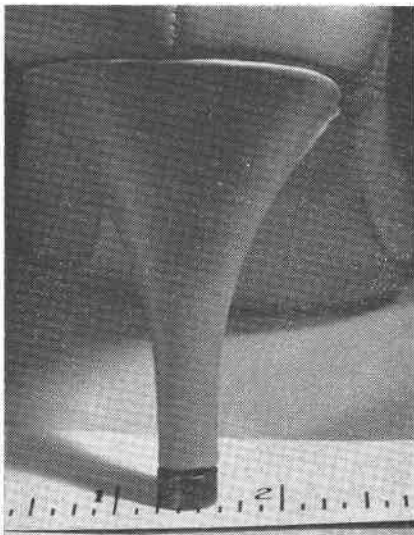
Fig. 3.—Metal-tipped heel (scale in inches).

Aside from the magnitude of the load, any damage that occurs depends on the type and condition of the bearing surface of the heel. Two damaging types of heel surfaces have been common: (1) cylindrical metal tips fastened to the body of the heel with a screw or other device (Fig. 3), and (2) a thin metal shaft extending from the body of the heel and enclosed in a washer-shaped piece of compressible material (Fig. 4), which, when new, extends slightly

and-washer or metal-tipped heel. On the basis of the same weights being transferred by a $\frac{3}{8}$ in. diam heel surface (Fig. 3), the bearing pressure would be 900 psi. Diameters down to $\frac{1}{4}$ in. (2000 psi), however, are not uncommon.

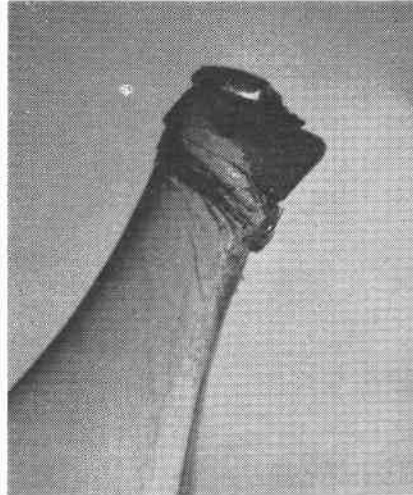
Fig. 4.—Shaft-and-washer heel (worn).

Thus, if the heel is a well-worn shaft-and-washer type with a shaft diameter of $\frac{3}{16}$ in., or an area of 0.0276 sq. in., the initial bearing pressure is 3500 psi. Thinner shafts, larger weights, and higher pressures are quite possible. A pressure of 3500 psi might be compared with a pressure of 20 to 30 psi exerted by the tire of an automobile, or with the pressure of 50 to 100 psi developed under an elephant's foot, or with the allowable bearing stress on concrete, approximately 1500 psi.

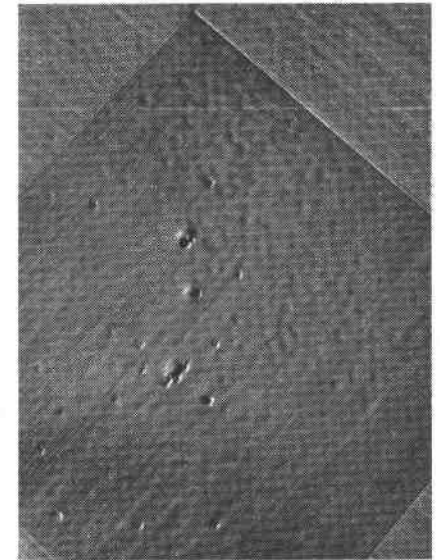
Fig. 5.—Indentations due to worn shaft-and-washer heels.

Another damaging combination is a worn shaft-and-washer heel applying a load perpendicular to the floor. Since the compressible washer wears away more rapidly than the metal shaft, the exposed shaft on the bearing surface of the heel exerts very high unit pressures on the floor (Fig. 5).

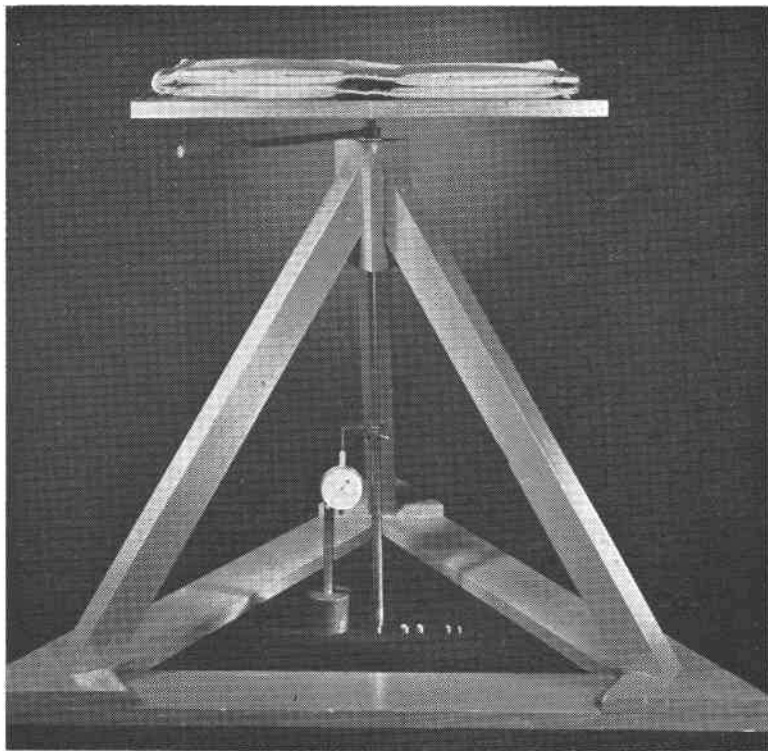
Fig. 6.—Heel load simulator.

A second method of approximating the pressure involves duplication of the actual indentations by an apparatus applying a known force through a known area (Fig. 6). For a bearing area of 0.20-in. diam, a force of 30 to 40 lb, or a bearing pressure of 1000 to 1200 psi, was required to produce an indentation similar to the actual heel indentation.
