*2011 CSCE Annual Conference: 14 June 2011, Ottawa, Canada [Proceedings], pp. 1-10, 2011-06-14*

### **NRCC-54442**

# Early-Age Cracking of Steel- and GFRP-Reinforced Concrete Bridge Barriers

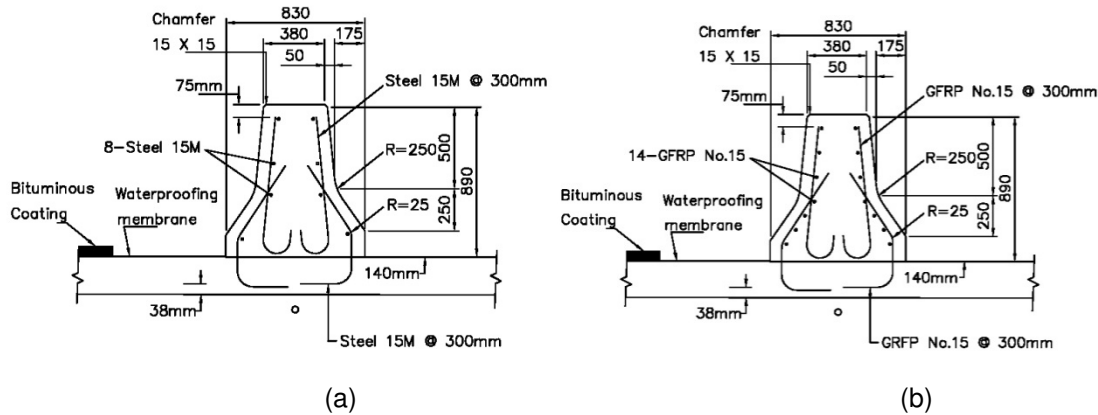
Figure 1: Standard designs of barriers of Type MTQ 202ME: (a) Steel-reinforced; (b) GFRP-reinforced

The MTQ is currently using two standard designs for the GFRP and steel-reinforced barriers of Type MTQ 202ME. Both of them have the same transverse reinforcement amount of GFRP or steel bars (15M@300 mm). However, the steel-reinforced barrier (Figure 1. (a)) contains 8 steel bars (15M) as longitudinal reinforcement and the GFRP-reinforced barrier (Figure 1. (b)) contains 14 GFRP bars (No. 15) as longitudinal reinforcement. As the longitudinal reinforcement plays the main role in controlling restrained shrinkage and consequently transverse cracking in the barrier walls, the MTQ aims at investigating the optimum design of the barrier wall and determining the horizontal reinforcement amount that should be provided, which is planned in the collaborative project presented in this paper.

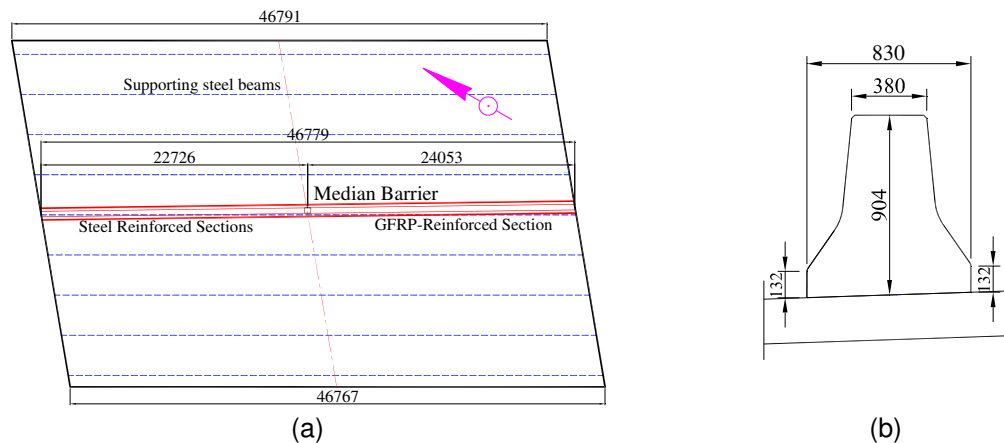
Figure 2: Layout of the project: (a) Hwy 410 overpass bridge; (b) Median barrier cross-section (Dimensions in mm)

The median barrier considered in this investigation was part of the Hwy 410 overpass bridge going over Boulevard de l'Université in the municipality of Sherbrooke, and was built in June 2010. The six-lane bridge was constructed using typical slab-on-girder structural system with a total length of about 47.0 m. The median barrier was of Type MTQ 202ME. Figure 2 shows the general layout of the bridge (plan view), and the cross-section geometry of the median barrier.

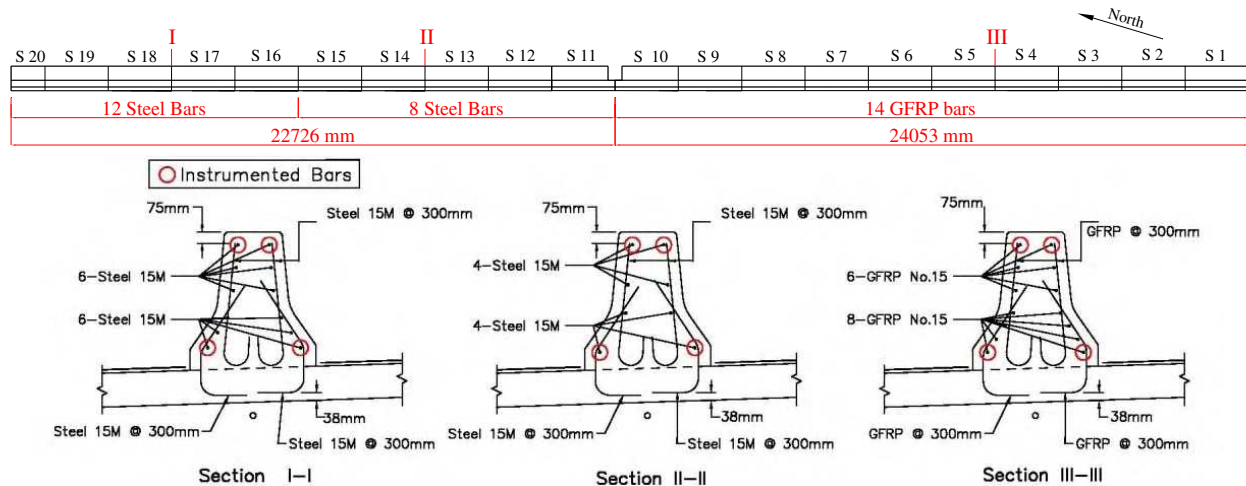
Figure 3: Reinforcement details of the median barrier

The median barrier has a total length of about 47.0 m. The barrier was divided into two main portions. The first portion was reinforced with GFRP bars No. 15 designated according to CAN/CSA S807-10 (CSA 2010) with a total of 14 GFRP bars No. 15 as longitudinal reinforcement. Figure 3 illustrates the reinforcement details of the median barrier of the Hwy 410 overpass bridge. The second portion was reinforced with galvanized steel bars 15M, which, in turn, was divided into two sub-sections according to the amount of longitudinal bars. The first sub-section was reinforced with a total of 8 galvanized steel bars 15M while the second sub-section was reinforced with a total of 12 galvanized steel bars 15M. It should be mentioned that the GFRP-reinforced portion of barrier was subdivided into 10 small sections (S1 to S10) to facilitate monitoring and crack mapping. The steel-reinforced portion was also subdivided into 10 sections (S11 to S20), including 5 sections (S11 to S15) with 8 longitudinal galvanized steel bars, and 5 sections (S16 to S20) with 12 longitudinal galvanized steel bars (Figure 3). Both of the GFRP-reinforced and steel-reinforced portions of the median barrier were reinforced with the same amount of transverse reinforcement, which was GFRP bars No. 15 @ 300 mm, and galvanized steel bars 15M @ 300 mm, respectively. Figure 4 presents a photograph of the reinforcement configuration of both reinforced sections. It should be mentioned that the concrete cover was equal to 75 mm in steel- and GFRP-reinforced sections. This concrete cover is devoted to protect the steel bars against the infiltration of salts. However, for the GFRP bars, this concrete cover may be reduced.

The FOS, VWSG, and ESG were attached to four longitudinal bars. As illustrated in Figure 3, two bars located at the bottom of the barrier section and two bars at the top were selected to capture the strain variation along the depth of the barrier. The vibrating wire strain gauges for concrete were installed in the concrete at the level of the instrumented longitudinal bars (top and bottom). The thermocouples were installed close to these reinforcing bars to determine the actual temperature surrounding the bars for temperature corrections of the strain data. It is worth mentioning that the vibrating wire strain gauges are equipped to measure temperature in addition to strain.

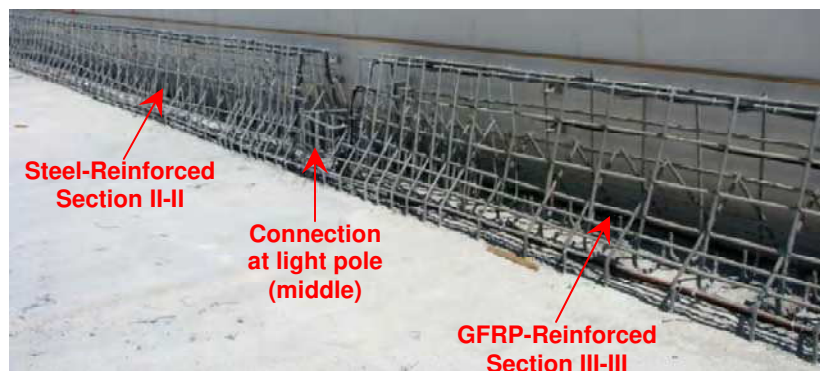
Figure 4: Reinforcement configuration of the median barrier at different sections

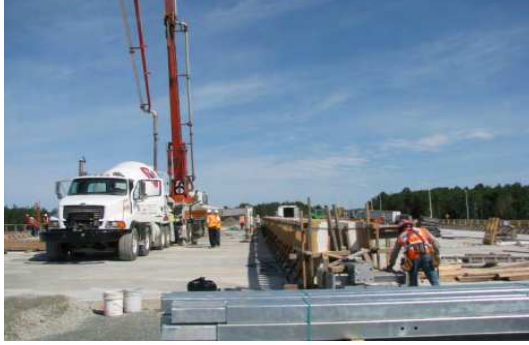
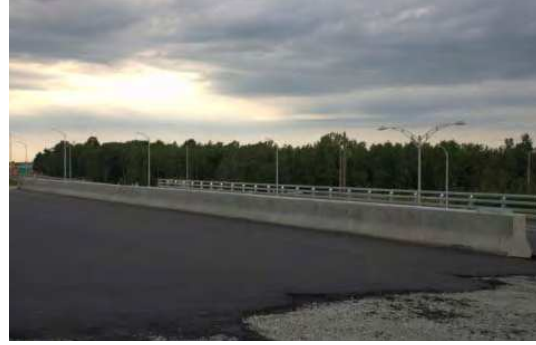
(a) During concrete casting

(b) After formwork removal

Figure 5: Fabrication of the median barrier in June 2010

The formwork was made of plywood panels for both barrier wall sides. The reinforcement configuration of both of the GFRP-reinforced and steel-reinforced sections of the median barrier were prepared and cast in June 2010 using ready-mix high-performance concrete of Type MTQ XIII. The top surface of the barrier wall was covered with wet burlap until the formwork was removed 7 days after concreting. Figure 5 shows the casting of the barrier and a general view of the barrier after the casting and removal of the formwork.

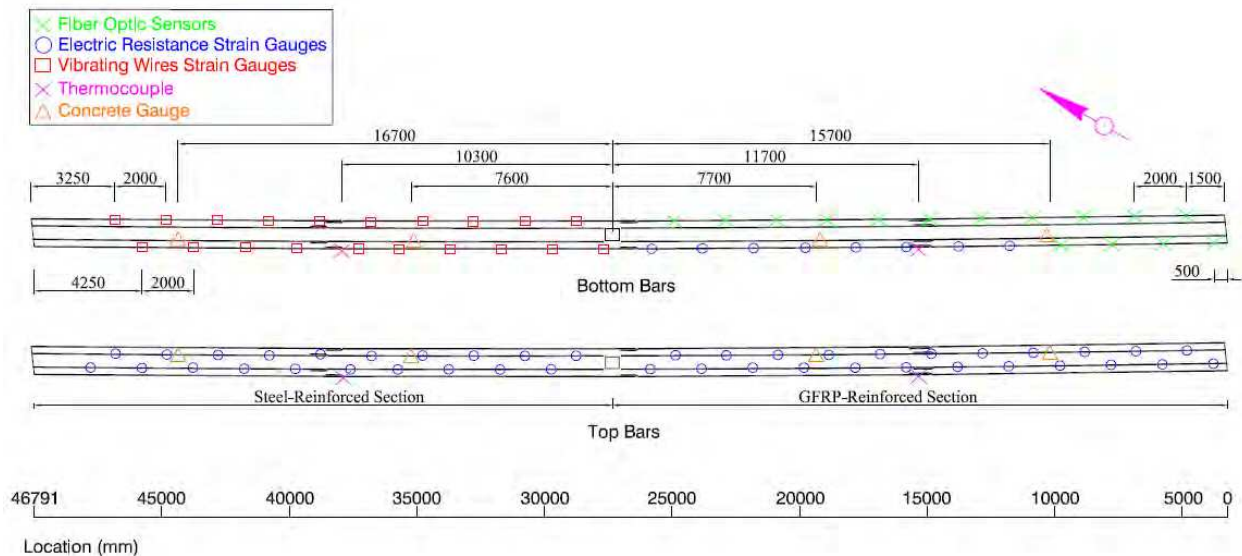
Figure 6: Instrumentation details of the median barrier (plan view)

Since the main objective was to investigate and monitor the shrinkage and cracking behaviour of the median barrier of Type MTQ 202ME, a multitude of sensors were selected to capture the strain and temperature variations of the barrier over time. A total of 98 sensors were attached to the reinforcing bars and embedded in concrete. The sensors include 15 fibre-optic strain sensors (FOS) attached to the GFRP reinforcing bars; 20 vibrating wire strain gauges (VWSG) attached to the steel bars; 8 vibrating wire strain gauges (VWSG) embedded in the concrete; 4 thermocouples (TH); and 51 electrical resistance strain gauges (ESG) attached to the GFRP and steel bars. The instrumented bars are identified in Figure 3, while Figure 6 shows the locations of the different sensors that were attached to the top and the bottom reinforcing bars (steel and GFRP).

Regardless of the types of strain sensors used on reinforcing bars, the sensors (FOS, VWSG, ESG) were distributed with a longitudinal spacing of 2.0 m to capture the strain variation along the whole length of the median barrier, and to trace and evaluate the effects of cracking and temperature variation.

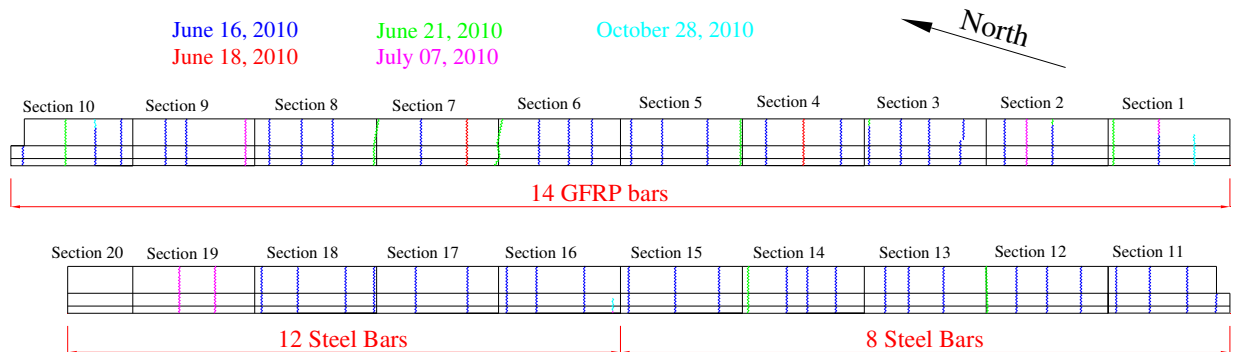
Figure 7: Crack mapping of the median barrier (elevation view)

As soon as the formwork was removed on June 16, 2010 (7 days after casting), the crack pattern and the initial crack widths in the GFRP- and steel-reinforced sections were recorded. The initial maximum crack width recorded in the steel-reinforced sections of the barrier (with either 8 or 12 bars) was 0.15 mm. The initial crack spacing ranged from 406 mm to 1434 mm with an average of 749 mm in the section reinforced with 8 steel bars 15M (S11-S16). However, in the section reinforced with 12 steel bars 15M (S16-S20), the initial crack spacing ranged from 316 mm to 2195 mm with an average of 905 mm. The

GFRP-reinforced section exhibited an initial maximum crack width of 0.18 mm, which is almost the same as that of the steel-reinforced section. The initial crack spacing ranged from 406 mm to 1166 mm with an average of 705 mm, which is also close to the average value measured in the steel-reinforced section. It should be noted that the sudden changes in the barrier geometry and reinforcement detail at the light pole between S10 and S11 resulted in the formation of two additional transverse cracks with larger widths (0.33 mm and 0.34 mm).

The crack propagation over time is shown in Figure 7, while the time evolution of crack width and crack spacing are presented in Figures 8 and 9, respectively. The cracks in both of the GFRP- and steel-reinforced sections developed in the first month after removing the formwork. Since then, only one crack appeared in each of the two sections on October 28, 2010. However, the crack width in both reinforced sections has increased from June 16 to October 28, as clearly shown in Figures 8 and 9. Thereafter, the crack widths followed the seasonal temperature variation and have decreased with decreasing ambient temperature in the winter season.

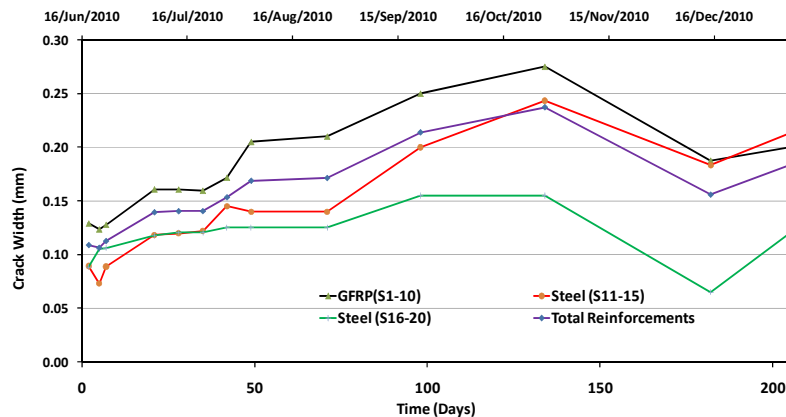
Figure 8: Evolution of average crack width

On the other hand, the crack widths recorded in the steel-reinforced section with 12 steel bars 15M (S16 to S20) were smaller than that of the other section reinforced with 8 steel bars 15M (S11 to S15). This is attributed to the difference in the number of longitudinal reinforcing bars as well as in the boundary conditions. Moreover, after 7 months of monitoring, the GFRP-reinforced section (S1 to S10) showed larger crack widths than those of the steel-reinforced section due to the lower axial stiffness of the GFRP bars in comparison to steel bars.

Starting on October 28, 2010, it can be observed that the crack widths have decreased due to the decreasing temperature. The crack widths are expected to follow the seasonal temperature changes.

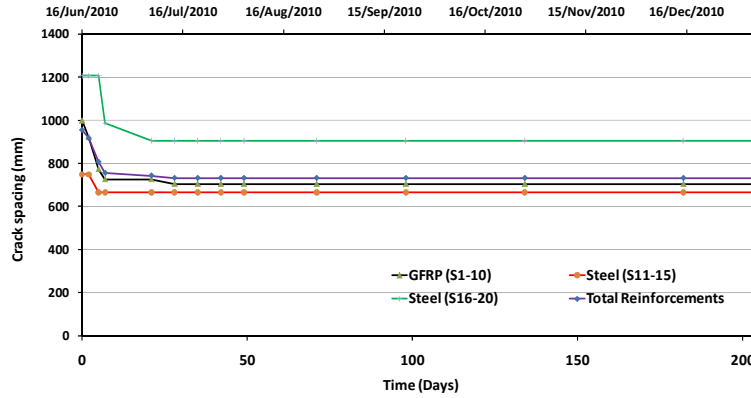
Figure 9: Evolution of average crack spacing

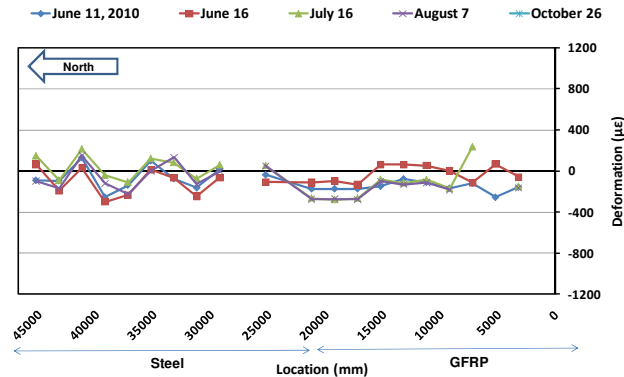
Figure 10: Strain profile in the bottom instrumented bars - East side

The strain variation in the reinforcing bars (GFRP and steel) was recorded with the FOS, VWSG, and ESG, and plotted in Figures 10 to 13 depending on the location of the instrumented bars in the barrier section. It should be noted that the strain values presented in these four figures which were measured between June 11 to October 26, 2010, were specifically selected for times when the temperature was equal to  $20 \pm 1^\circ\text{C}$  in order to eliminate the effect of temperature on the recorded strain. Also, the measured temperature variation inside the barrier wall is presented in Figure 14, where the effect of cement hydration heat can be clearly observed during the first day after casting, after that time the concrete temperature followed the ambient air temperature.

From Figures 10 to 13, it can be first observed that the strain variation recorded at the bottom bars in the East side of the barrier was small in comparison to the other instrumented bars. It can also be observed that the strain variation in the top bars was higher than in the bottom bars of the barrier. This is attributed to the restraint from the bridge slab, which affects more the deformation at the bottom of the barrier than at the top. However, higher tensile stresses should be expected to develop where the restraint is higher.

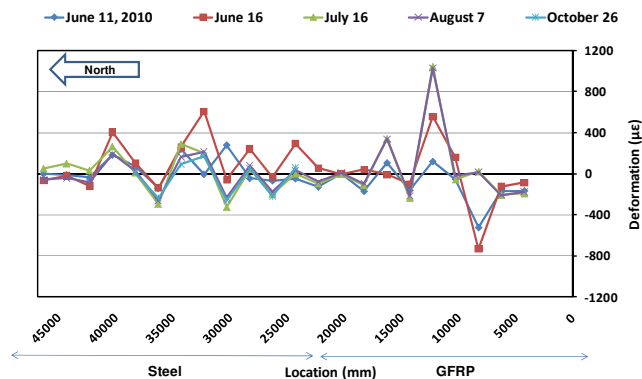
Figure 11: Strain profile in the bottom instrumented bars - West side

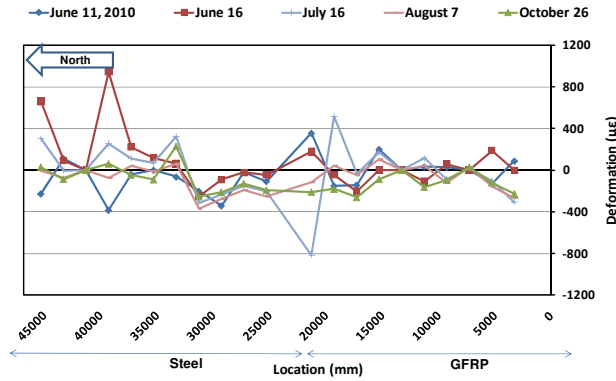
Figure 12: Strain profile in the top instrumented bars - East side

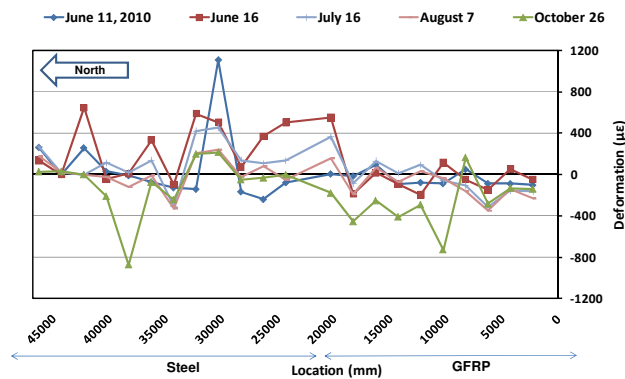
Figure 13: Strain profile in the top instrumented bars - West side

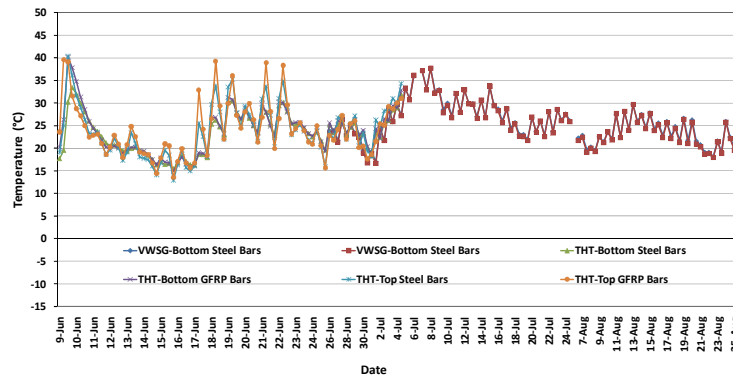
Figure 14: Temperature variation in the median barrier
