Effect of Ductile Thermal Spray Coatings on Fatigue Performance of 7075-T651 Aluminum Alloy

Arsenault, B.; Lynn, A. K.; Duquesnay, D. L.

Canadian Metallurgical Quarterly, 44, 4, pp. 495-504, 2005-10-01

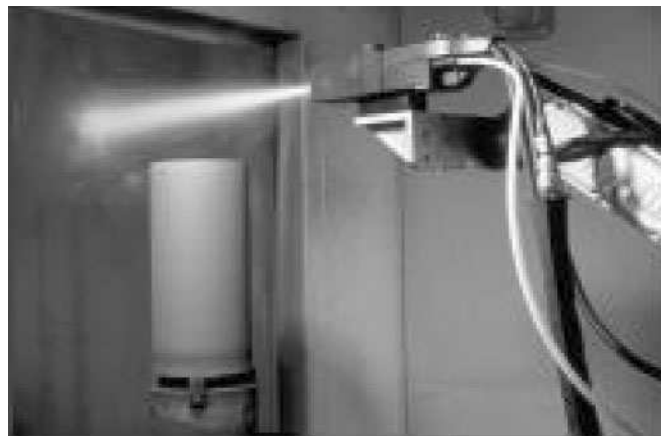
Fig. 1. A typical arc spray process in operation - JP 9000 system shown.

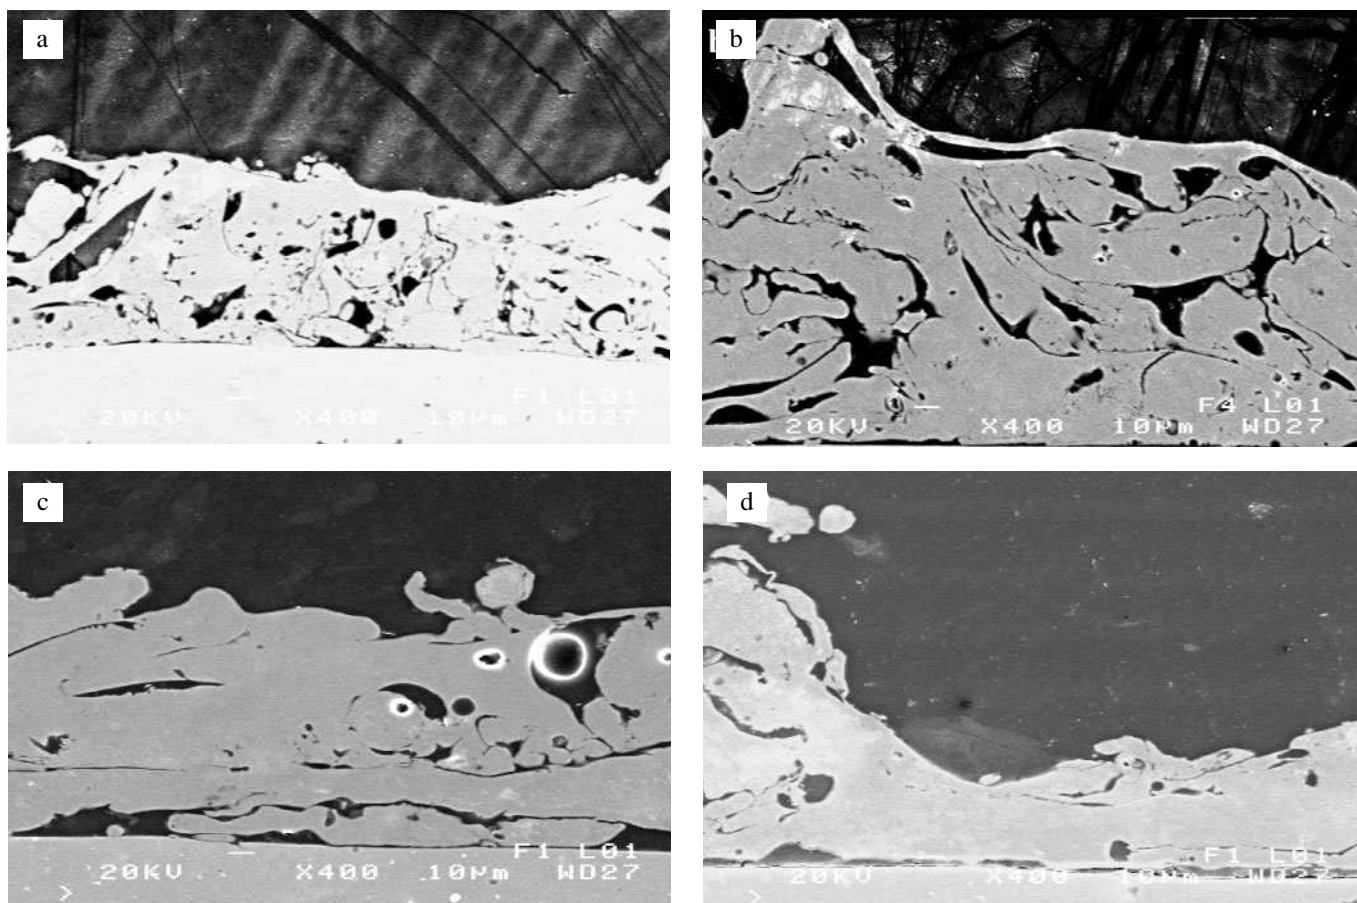
Fig. 2. Cross-section microstructure resulting from four arc sprayed guns: a) Smart Arc, b) BP 400, c) JP 9000 and d) Thermion.

microstructures resulting from the successive accumulation of coating splat particles that form the lamellae type microstructure. The coating cross section was taken in the short transverse direction perpendicular to the scanning direction of the arc spray gun from the shoulder of the tested fatigue coupons.

Each of the commercial arc spray guns used in this study had a specific nozzle design and therefore different atomization results and microstructure for the same energy input. Among the four guns, the Thermion was the most distinct with its large atomization nozzle. Consequently, as this is an ongoing work, the focus is on results obtained using common parameters with attention given to the resulting specific lamellae in the microstructure, the coating/substrate

interface and the coating roughness produced by each gun. The effect of the porosity size, volume fraction and distribution will be addressed in the future using one arc spray gun with different process parameters, atomizing gases and surface preparations.

From the four microstructures, it is evident that the atomization made by these guns varied significantly. While the Smart Arc produces the smallest lamellae, the JP 9000 and Thermion guns produced coarser lamellae (Figure 2). It is important to note that larger lamellae are associated with more delamination, larger pores and coatings with less uniformity in thickness as described in Figures 2c and 2d.

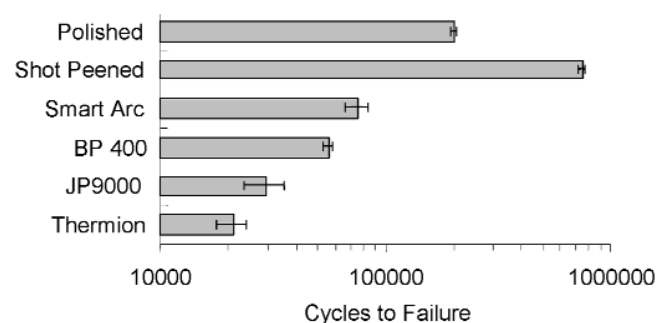
Fig. 3. Fatigue lives of polished, shot peened and coated specimens. Fully reversed ± 225 MPa constant amplitude loading; error bars represent one standard deviation, $n = 2$ for all groups.

Results from fatigue testing of all the coupons are shown in Figure 3. It can be seen that the shot peening pretreatment increased the fatigue resistance of polished coupons. Application of the coatings, however, subsequently led to a severe reduction in fatigue life whose magnitude exceeded the initial increases observed following shot peening. Fatigue lives for specimens with each of the four coatings were thus shorter than for the original polished specimens. Among the coated specimens, fatigue lives were greatest for coupons coated using Smart Arc parameters with cycles to failure diminishing from BP 400 to JP 9000 to Thermion, in decreasing order.

Comparison of the results presented in Tables II and III with the fatigue lives of each coating group (Figure 3) revealed that coatings producing the lowest fatigue lives are characterized by both greater surface roughness and a higher incidence of delamination. To evaluate the contribution of each of these two phenomena to the observed reduction in fatigue life, it is necessary to consider the mechanisms underlying each.

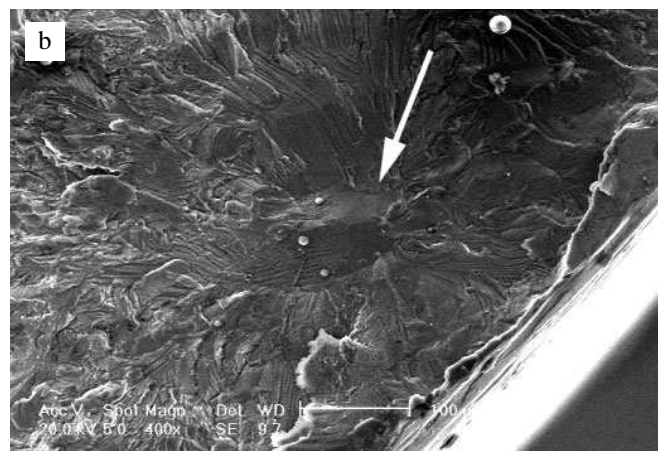
Fig. 4. Crack initiation sites: a) on a polished specimen and b) on a shot peened specimen.

Characteristic initiation sites for polished and shot peened coupons, respectively are shown in Figures 4a and 4b. Failure in the polished specimens was generally characterized by a single initiation site located on the coupon surface. For the shot peened coupons, however, failure was characterized by initiation sites located away from the coupon surface, often at multiple sites.

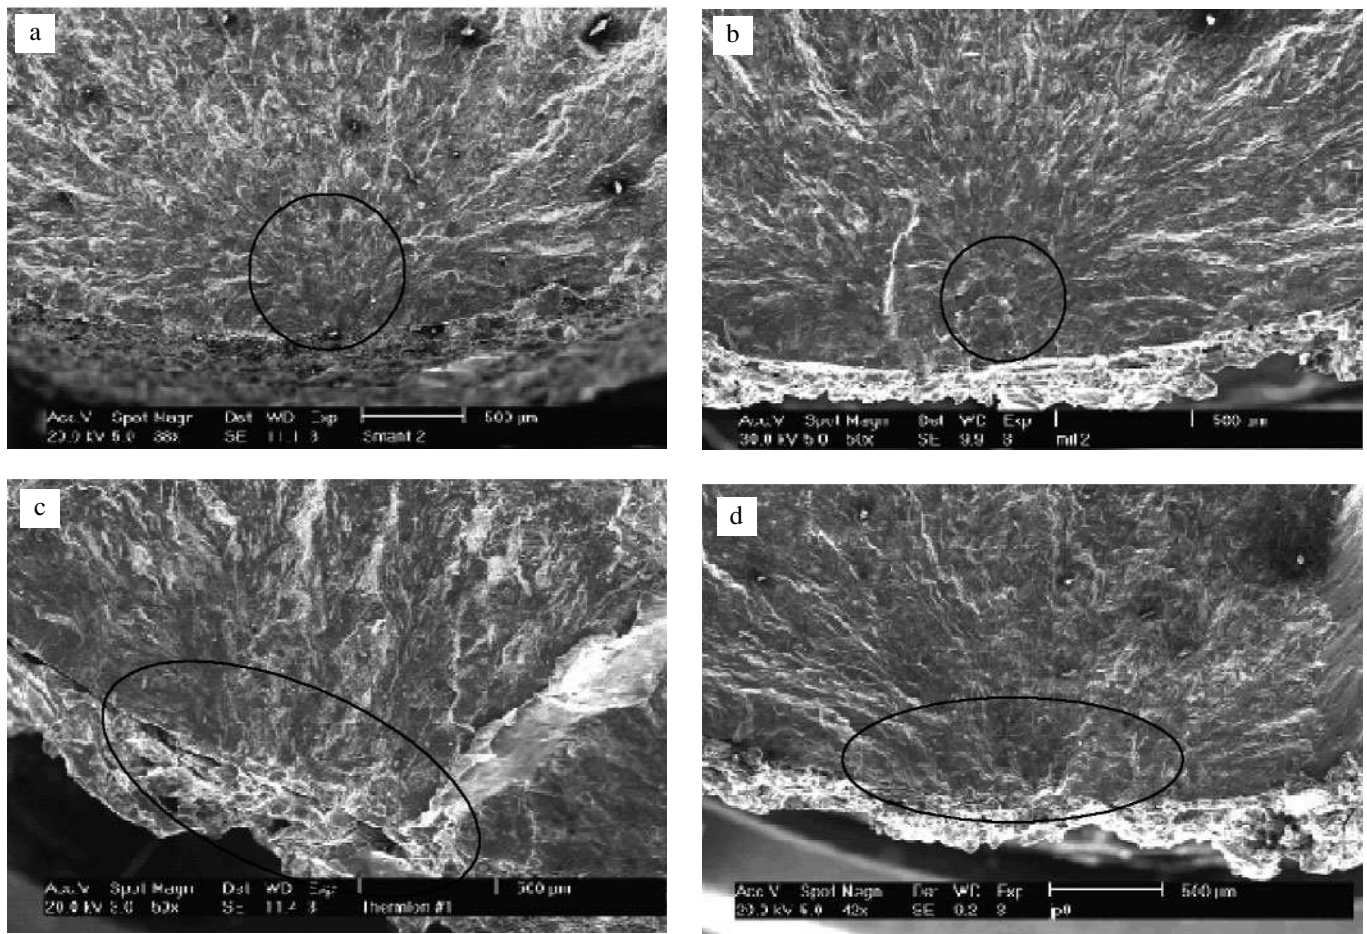
Fig. 5. Crack initiation sites for coated coupons by a) Smart Arc, b) BP 400, c) Thermion and d) JP 9000. The circle areas indicate the estimated location of initiation sites.

Typical crack initiation sites for the coated coupons are shown in Figure 5. In all cases, initiation occurred near the edge of the substrate at the interface with the coating. No sub-surface initiations were observed in the coated coupons. Multiple initiation sites were observed in some coupons; however, no apparent trend for this occurrence was evident (Table III).

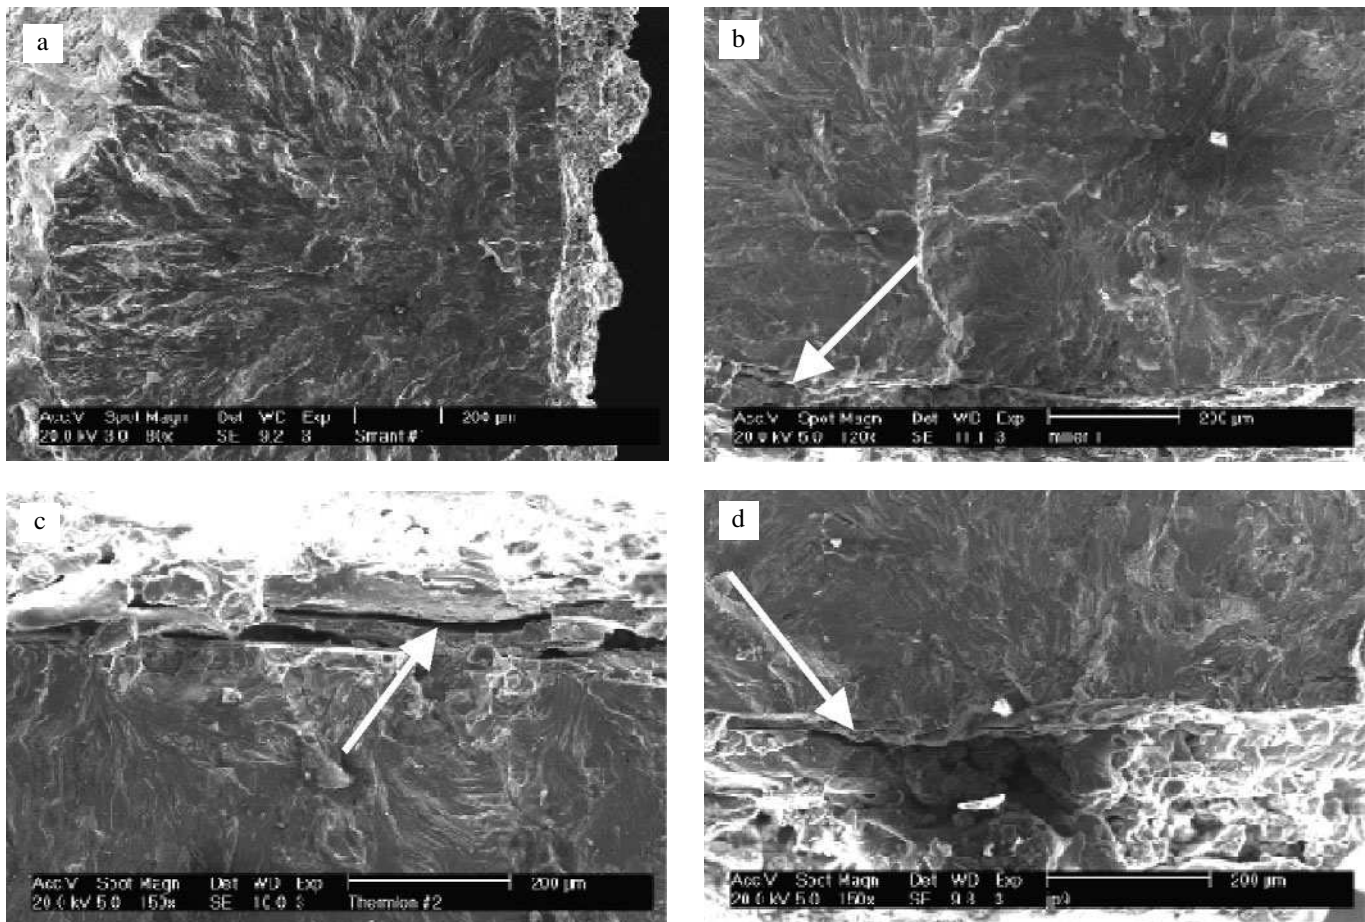
Fig. 6. Coating delamination in: a) Smart Arc, b) BP 400, c) Thermion and d) JP 9000 coupons.

Some delamination was observed at the interface between the coating and substrate (Figure 6), for the coating groups identified in Table III. The extent of damage at the interface appeared to correspond to the experimental fatigue lives (Figure 3). The most severe delamination was observed in coatings with low fatigue lives and are shown with arrows in Figures 6b to 6d; however, no evidence of delamination

was observed in the coupons exhibiting the greatest fatigue resistance (e.g., Smart Arc coating shown in Figure 6a).

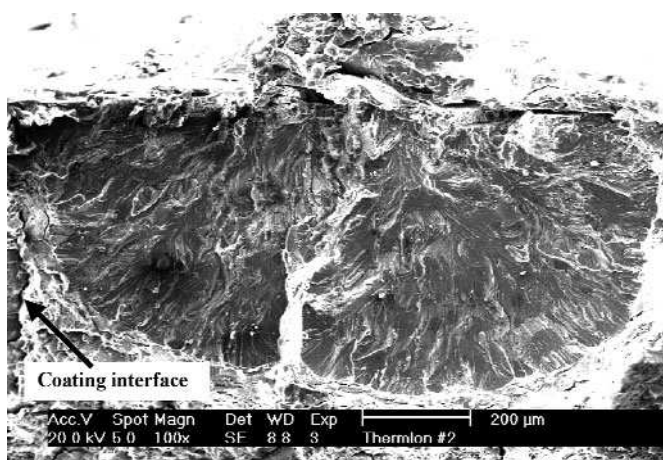
Fig. 7. Crack propagation pattern in a Thermion coupon.

Evidence of crack propagation into both the substrate and the coating was observed in some groups. Figure 7 shows

the crack propagation pattern from a Thermion coupon indicating clear damage in both the substrate and coating that appears to emanate from an initiation site at the interface and propagated into both the coating and the substrate. Similar

evidence indicative of crack initiation at the interface exists in all four groups. It should be noted that there was no evidence of cracks having propagated from the coating into the substrate.

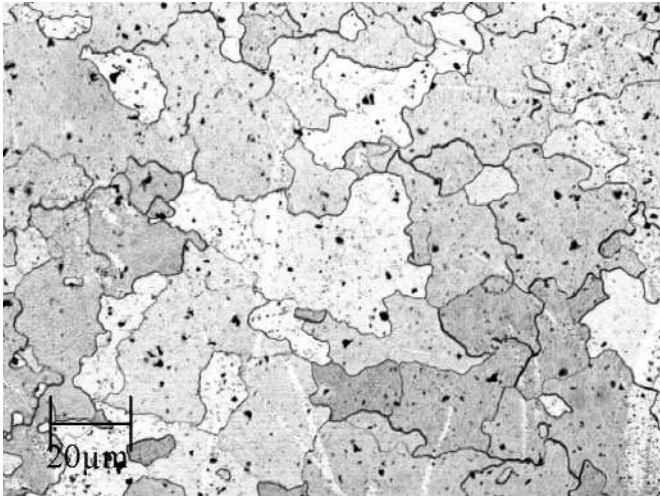
Fig. 8. Micrograph of 7075-T651 short transverse for the as-received extruded rod.

Figure 8 shows an optical micrograph of a sample taken from the center of a 7075-T651 Al alloy fatigue specimen.

The sample was etched with a Keller solution for micro-examination as shown in Figures 8 and 9. Figure 9 shows optical micrographs of each coating/substrate interface for the four arc spray guns. The optical micrographs of Figure 9 show no noticeable evolution in the grain structure of the substrate at the boundary of the coating with respect to the 7075-T651 alloy shown in Figure 8.

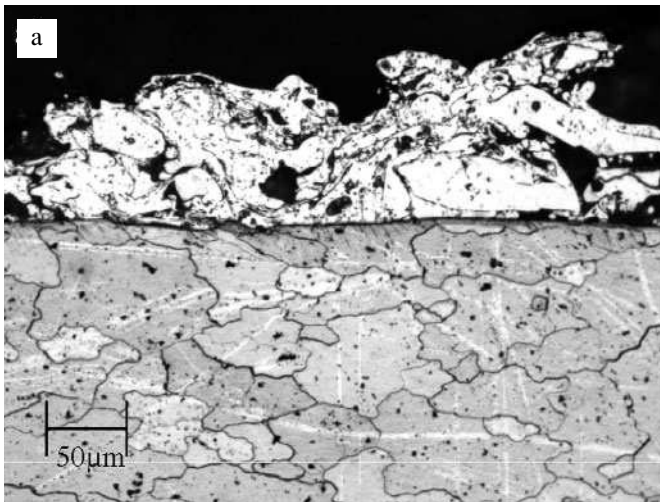
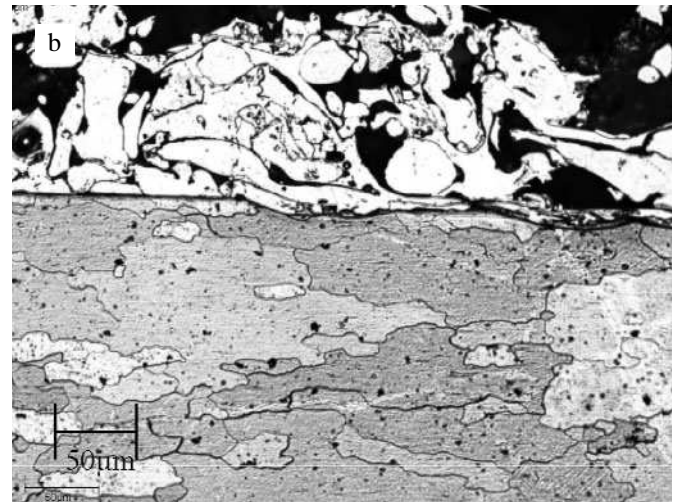
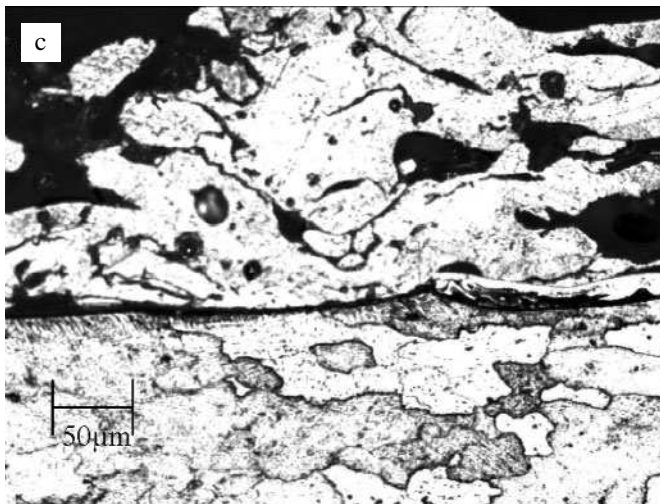
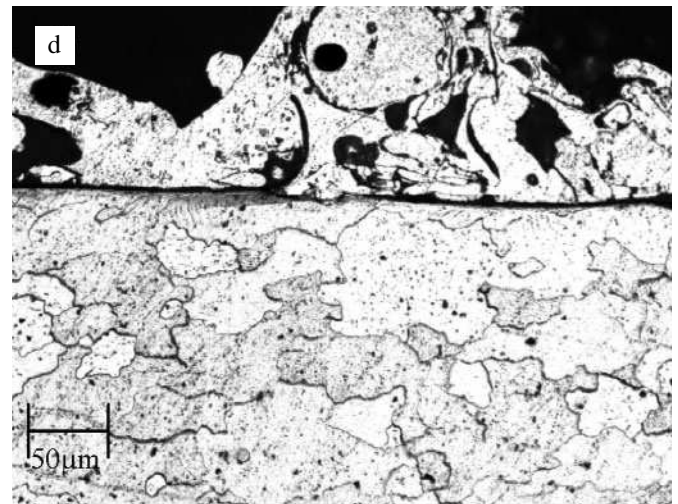
Fig. 9. Optical micrograph of the coating/substrate interface for the four arc sprayed guns: a) Smart Arc b) BP 400 c) JP 9000 and d) Thermion.

after high velocity oxy-fuel (HVOF) deposition. Hence, the drastic decrease in the fatigue life of the coated 7075 Al alloy cannot be justified by heat affected substrates. Considering the atomized Al particle temperature during arc spraying reaches a temperature above the Al melting point, the heat transported by the sprayed particle could possibly perform a localized micro-annealing on the surface boundary during spraying. Gougeon *et al.* [22] observed that thermal sprayed particles flatten and solidify on a substrate in less than 20 μ s. Such a short dwell time provides an extremely brief heat flux to the substrate surface and therefore a limited exposure in time to elevated temperatures during spraying. Therefore, this could explain the absence of noticeable microstructure evolution in Figure 9.

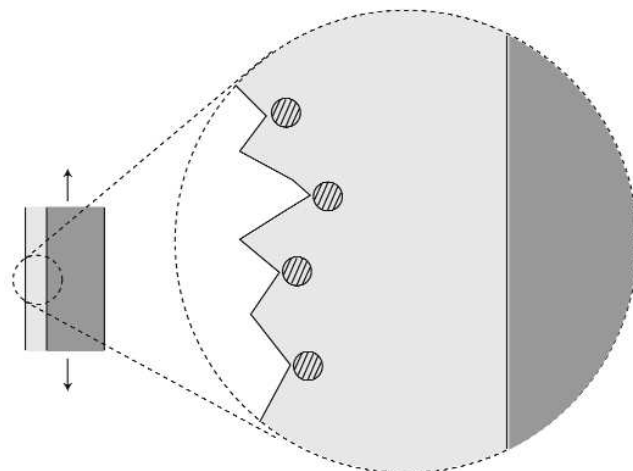
Fig. 10. Zones of local stress concentration along the surface of a rough coating.

Surface roughness in a coating produces local areas of stress concentration along the surface of a coupon as illustrated schematically in Figure 10. These local stress concentrations can, in some cases, induce the formation of fatigue cracks within the coating which then propagate toward the interface.

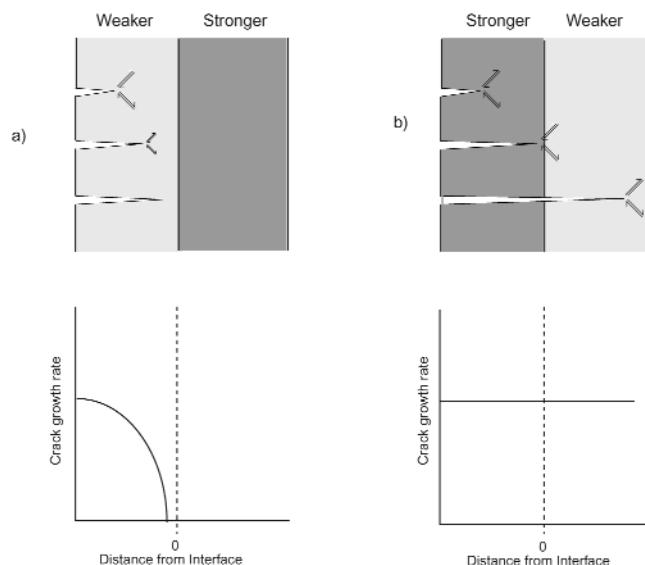
Fig. 11. Behaviour of cracks propagating towards a bimaterial interface a) from a weaker material towards a stronger material and b) from a stronger material towards a weaker material.

it is propagating where the term ‘strength’ is defined by the strain hardening response and ultimate tensile strength [10,25]. In cases where a crack propagating in a lower strength material approaches an interface with a higher strength material, the plastic slip mechanisms acting ahead of the crack tip are restricted by the presence of the stronger material, subsequently leading to crack arrest (Figure 11a). In the inverse case (Figure 11b), a crack propagating from the stronger material towards the weaker one, the crack proceeds unimpeded across the interface and continues to propagate in the weaker material [25]. For the coatings observed in the present study, high strength Al 7075-T651 substrate and the

comparatively weak coatings form an analogous case to that shown in Figure 11a.

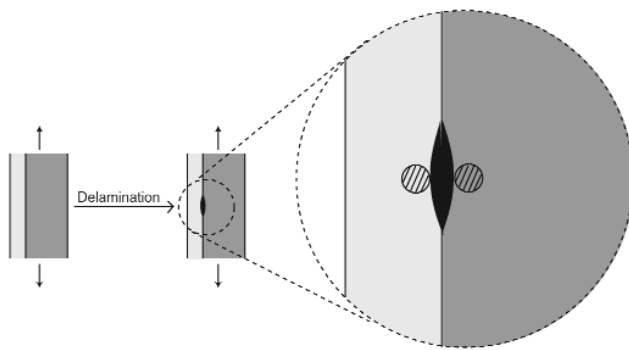
Fig. 12. Stress concentrations around a zone of delamination.
